HISTORIC CHARLESTON FOUNDATION  
HURRICANE HUGO DAMAGE ASSESSMENT FORM

Date of Survey: 11.28.89

Street Address: 43 Church

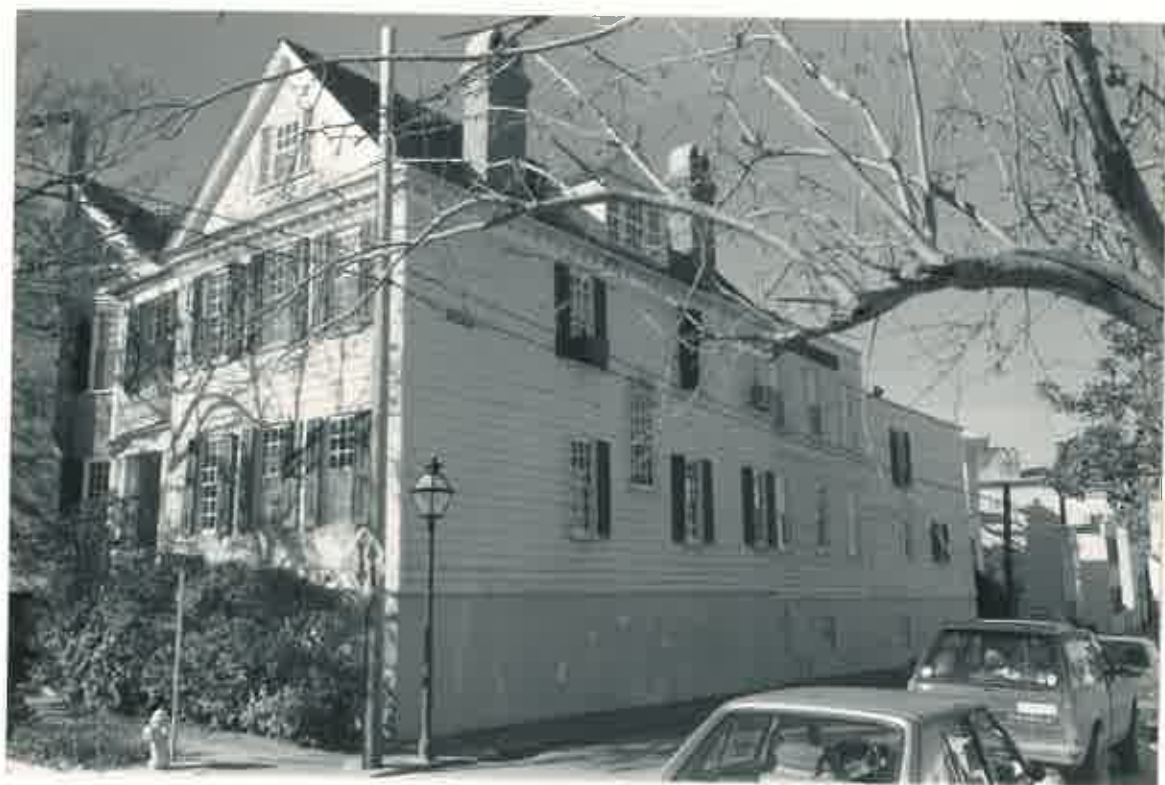
H<sub>2</sub>O damage - foundation - flood area  
chipped paint  
Shutter loss  
Slate loss on roof
