HISTORIC CHARLESTON FOUNDATION  
HURRICANE HUGO DAMAGE ASSESSMENT FORM

Date of Survey: 7/2/90

Street Address: 43 Eliz. St.

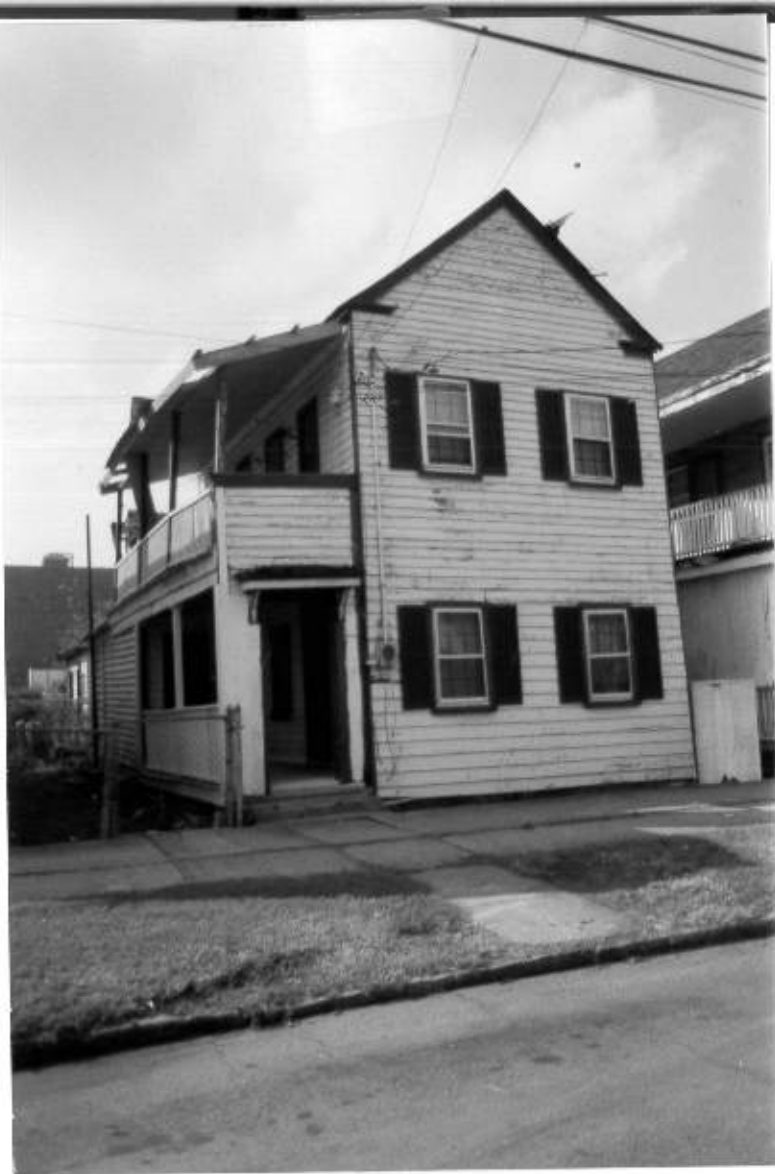
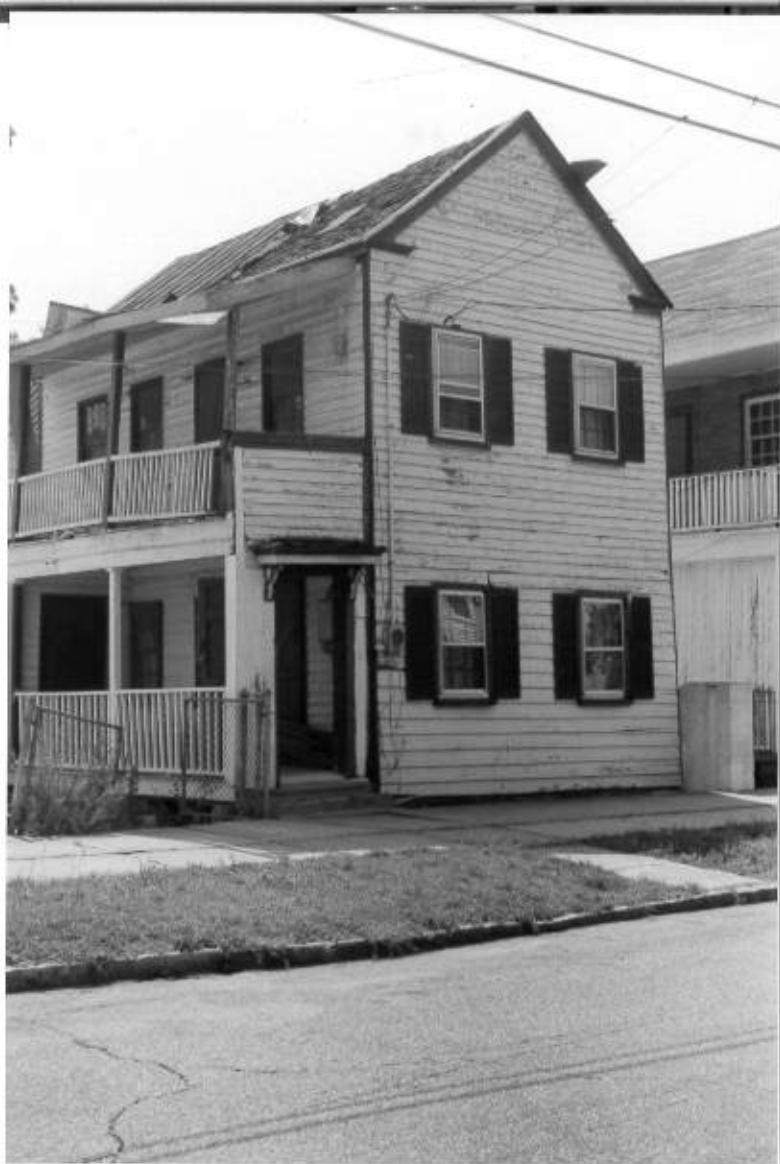
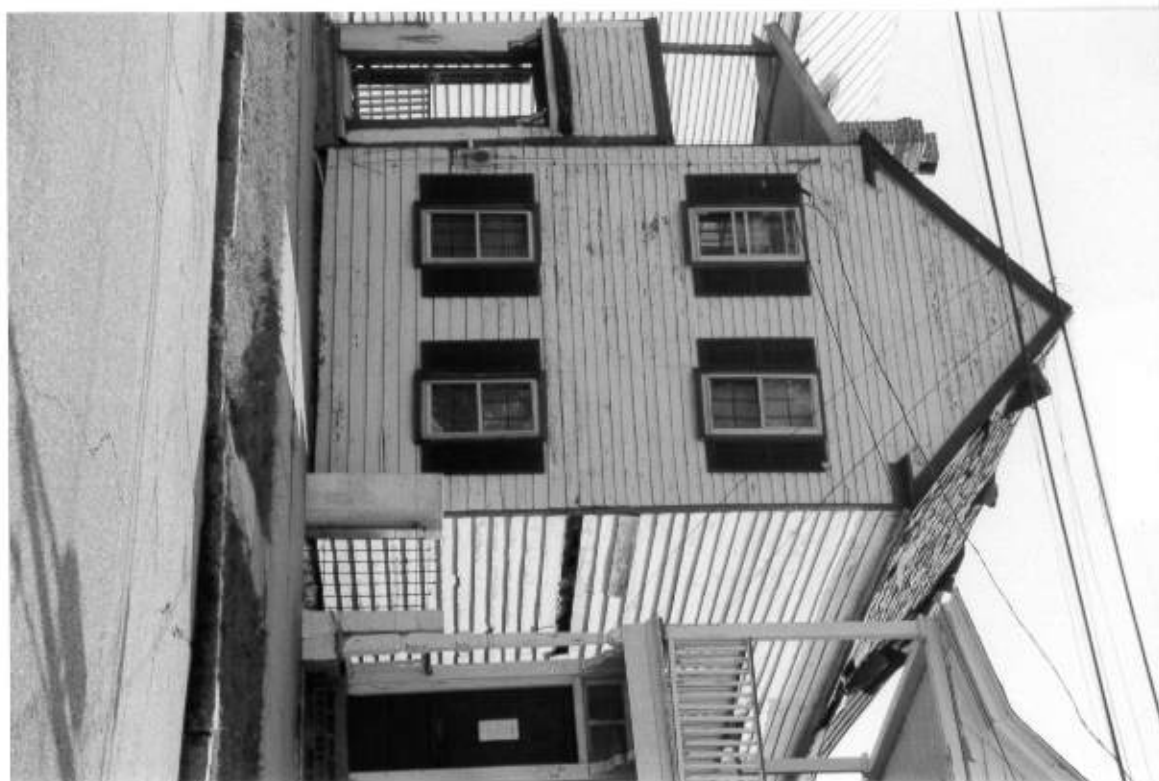
very damaged

[✓] gone 100%
