AIKEN-RHETT INTERIOR PLASTER BLIND STUDY

PREPARED FOR:
HISTORIC CHARLESTON FOUNDATION
40 EAST BAY STREET
CHARLESTON, SC 29401

PREPARED BY:
MEADORS, INC.
PO BOX 21758
CHARLESTON, SC 29413

DATE: 11.13.2014

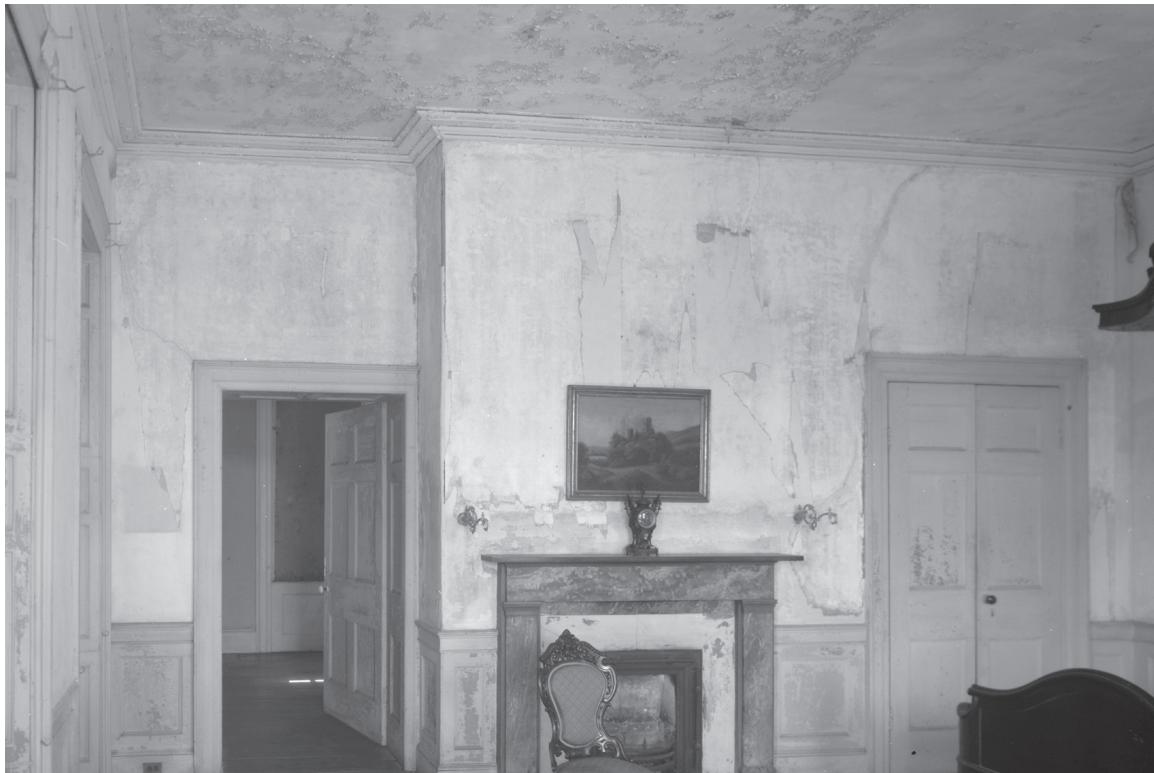
Figure 1: Southwest chamber, north wall ca. 1979.

Analysis of an image taken of the north wall in the southwest bedchamber (Room 202) shows that extensive cracking of the plaster existed in 1979 (**Figure 1**). Comparison of these cracks with a current image indicates little to no growth of a majority of the visible cracks over the last 35 years (**Figure 2**). There does not appear to be any new crack formation on this wall, but two cracks appear to have worsened over time. One crack, directly over the doorway into the northwest dressing room (Room 201) appears to have increased in severity during this time with noticeable vertical separation. Additionally, there appears to be greater separation in the ceiling crack directly over the closet door. The most dramatic change between these two images is the deterioration of the finishes on the woodwork and the removal of the plaster and wallpaper along the casing bead at the fireplace.

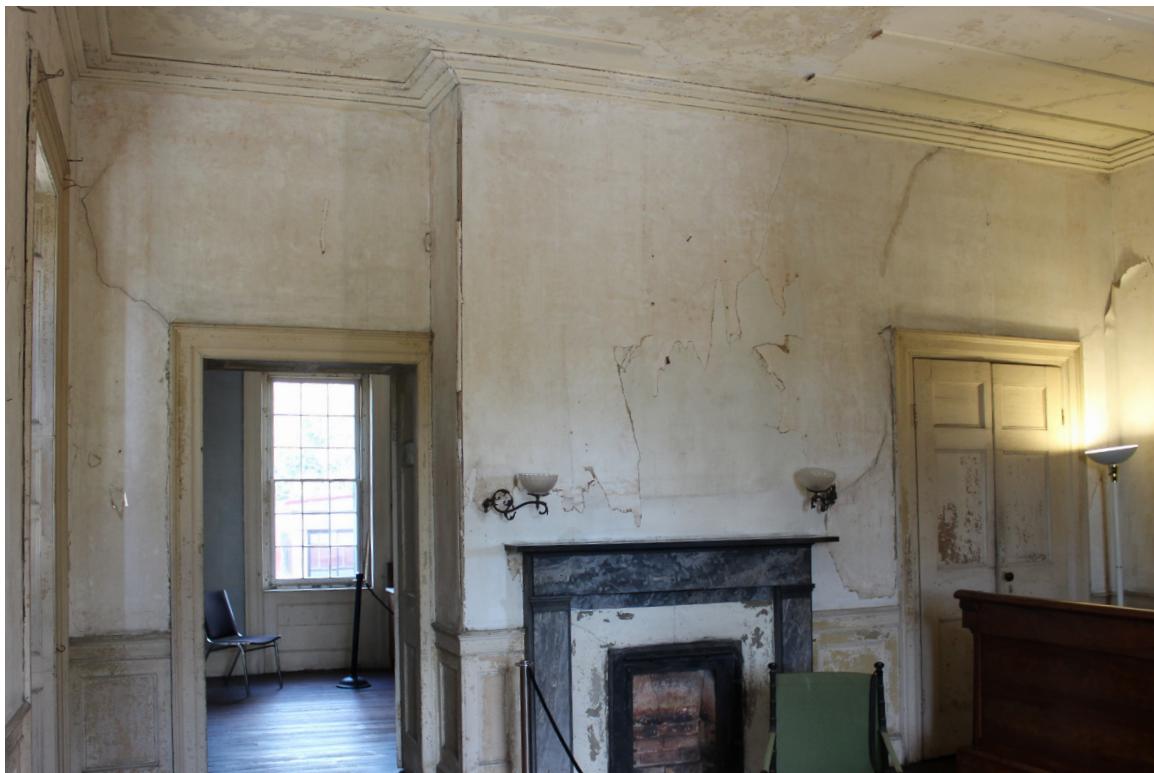
Figure 2: Southwest chamber, north wall ca. 2014.

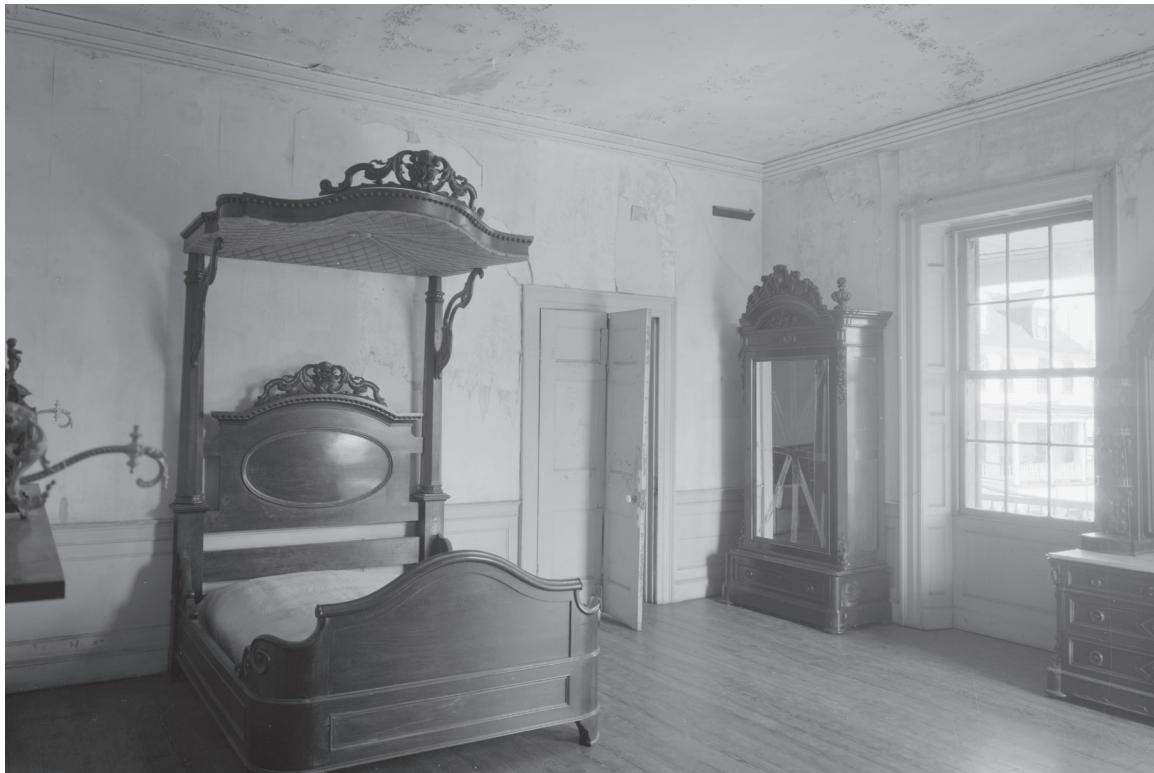
Figure 3: Southwest chamber, east wall ca. 1979.

An alternative view taken in 1979 of the east wall within this bed chamber reveals a similar situation (**Figure 3**). Over the last 35 years, there has been further deterioration of the historic wallpaper, but little to no change in the plaster in this location (**Figure 4**). On the southeast corner, on both sides of the doorway, the wallpaper obscured the presence of cracks in 1979. Areas visible in the original photograph do not appear to have worsened over time.

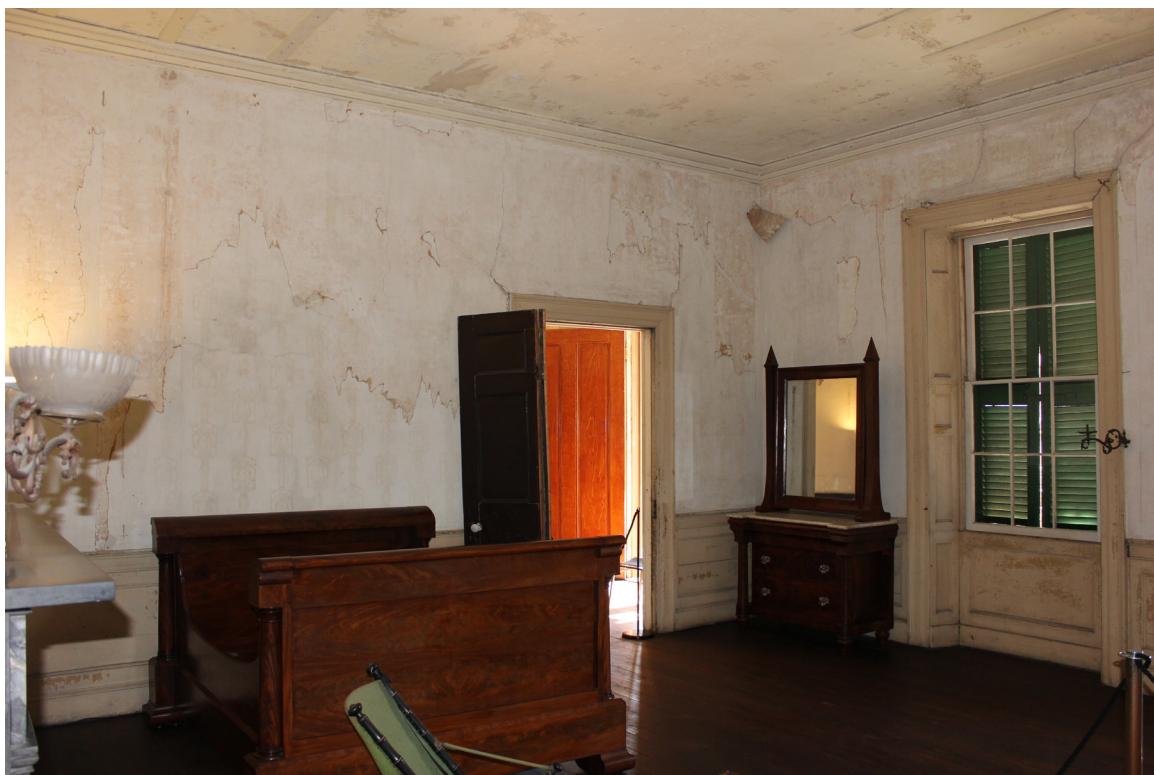
Figure 4: Southwest chamber, east wall ca. 2014.

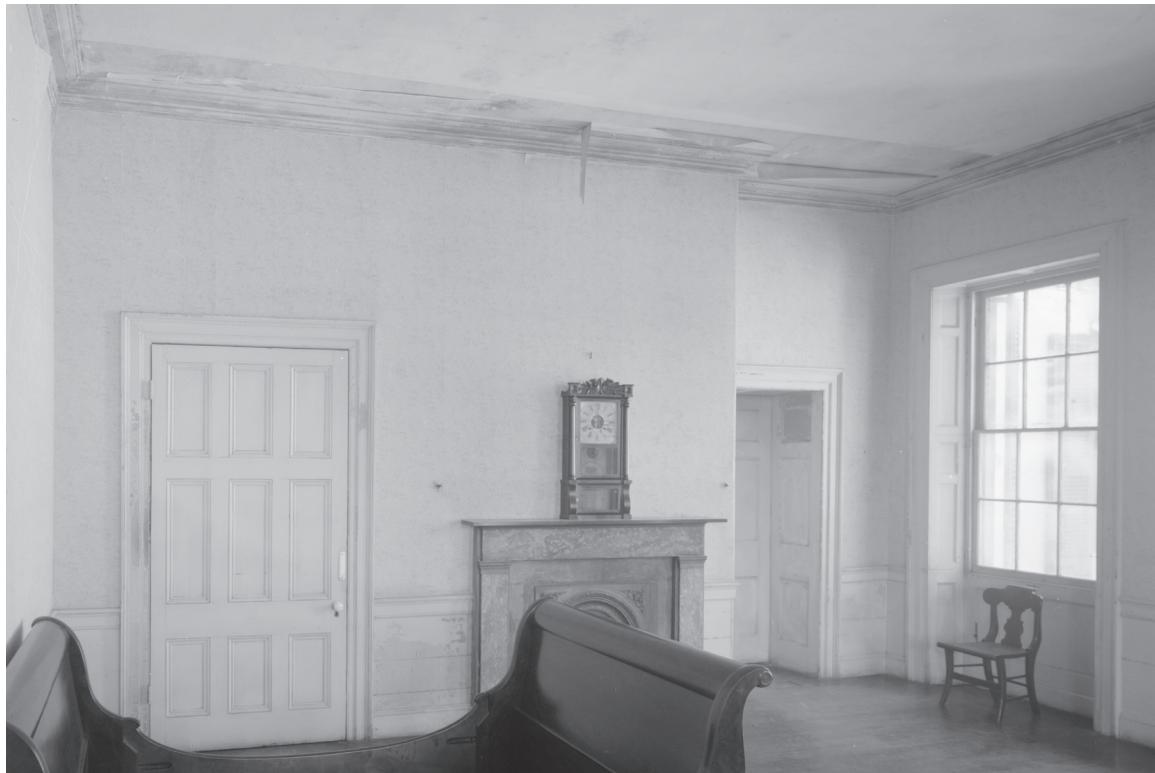
Figure 5: Southeast chamber, north wall ca. 1979.

One image of the north wall in the southeast chamber was taken during the documentation in 1979 allowing for only one comparison with current conditions. The plaster at this location in 1979 has little visible cracking as it is obscured by wallpaper (**Figure 5**). At this time, the wallpaper along the ceiling was beginning to deteriorate while the remaining paper on the walls appears to be in good condition. Comparison with the 2014 image shows there has been increased deterioration of the wall paper as several sheets have begun to detach at the ends and corners (**Figure 6**). One crack visible on the ceiling above the casing bead on the fireplace appears to have increased in separation over the last 35 years. Cracking present within the cornice does not appear to have increased during this time.

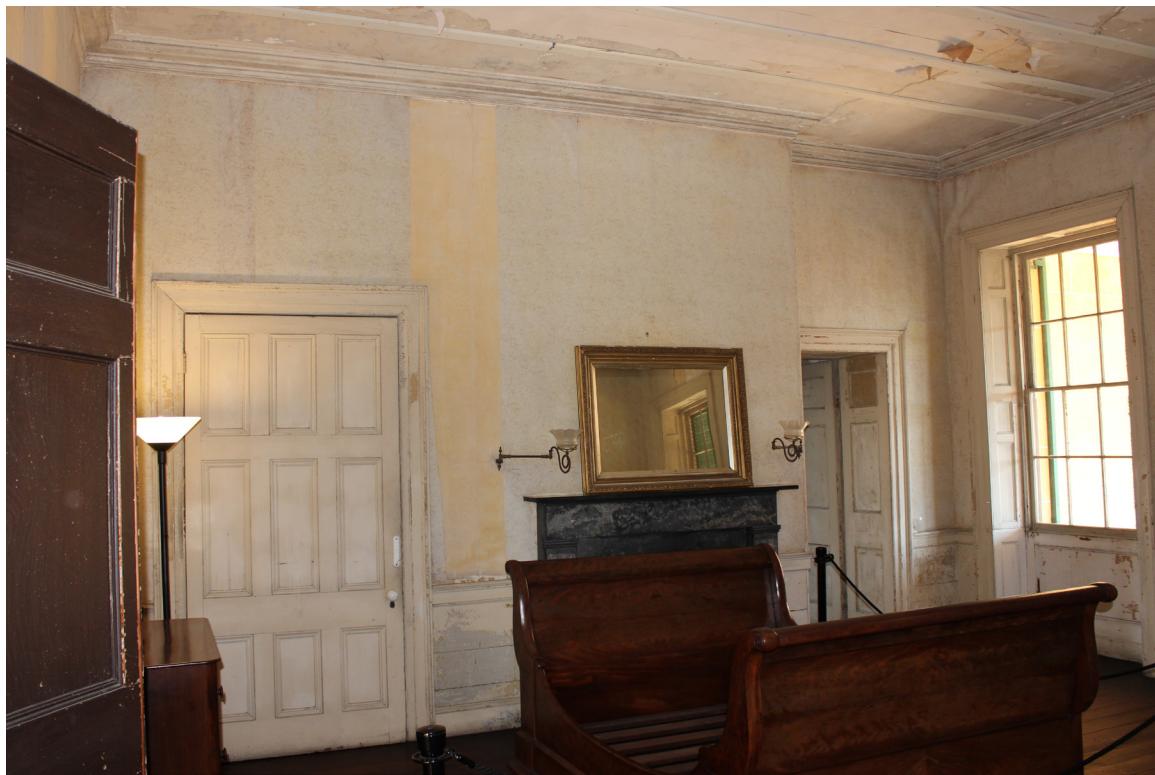
Figure 6: Southeast chamber, north wall ca. 2014.

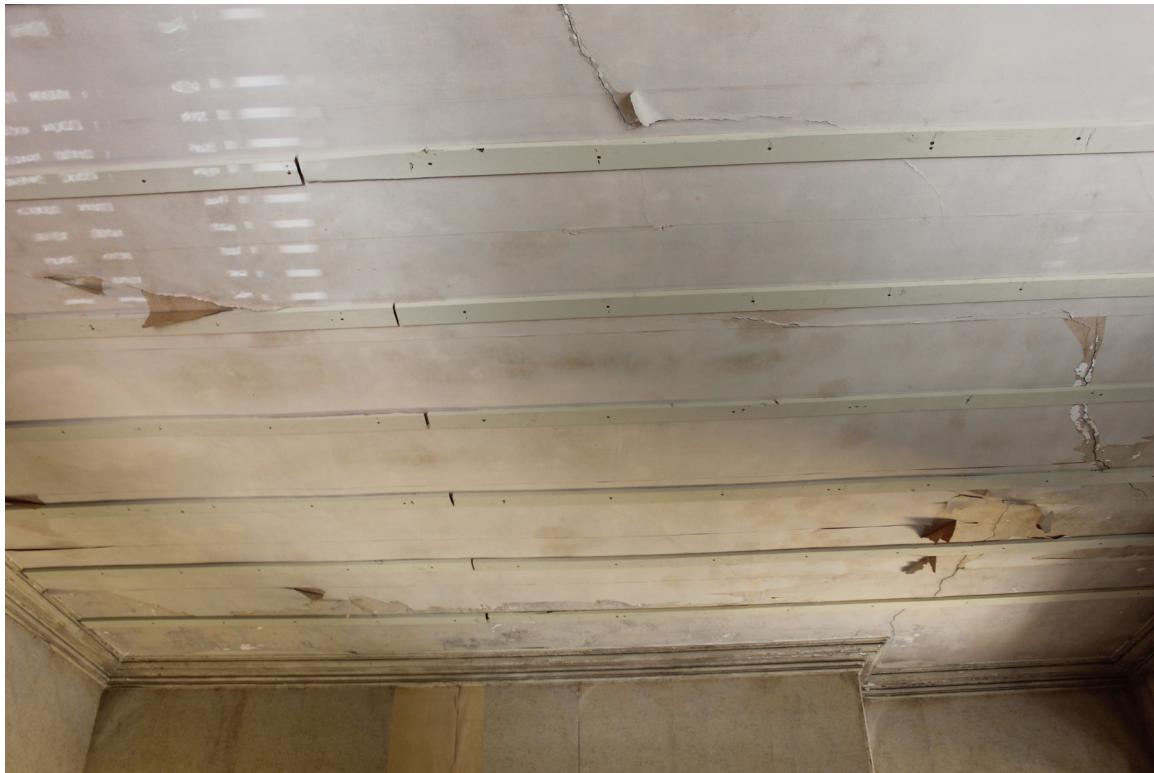
Figure 7: Southeast chamber, facing north: Stabilization installed in 2014 over existing cracks. The battens in this room span the full width of the ceiling.

In order to address potential life safety issues, Historic Charleston Foundation has installed several 1x4 wood battens over the ceiling cracks within both bedrooms (**Figures 7-8**). This has stabilized several areas of detachment and has minimized the life safety risk.

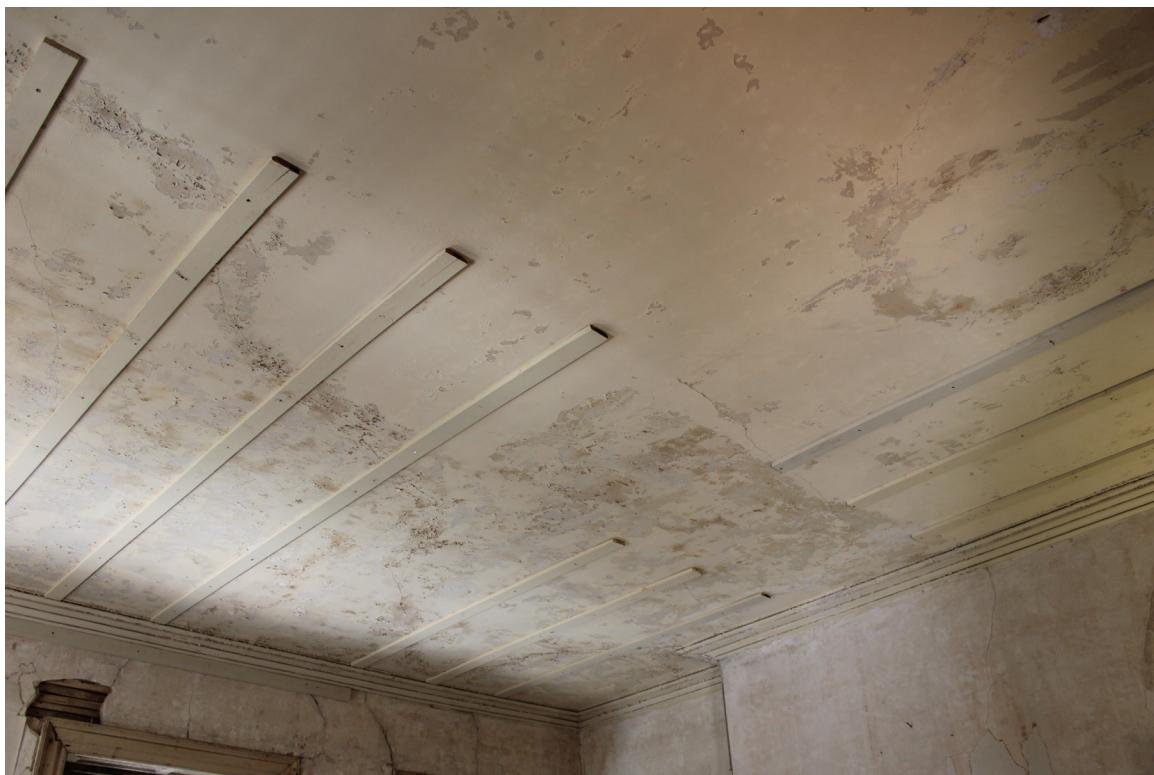
Figure 8: Southwest chamber, facing northwest: Stabilization installed in 2014. The battens in this room only partially span the ceiling.

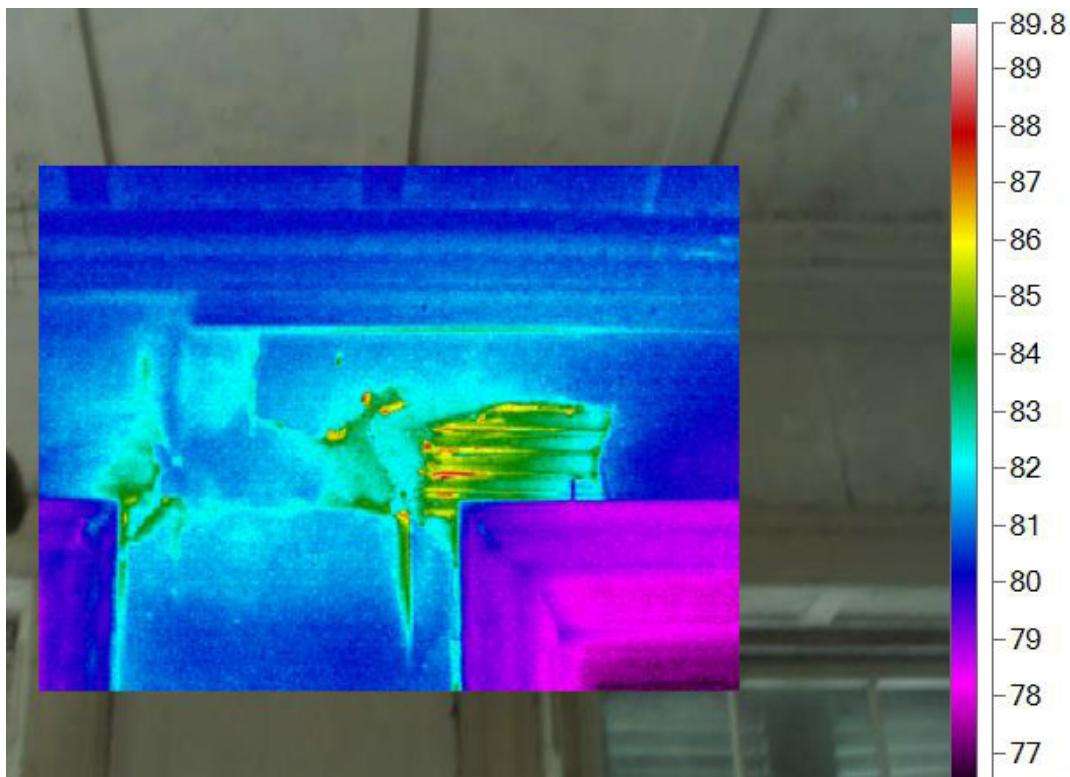
Figure 18: Southwest chamber, west wall: Thermograms taken via active thermography show areas of higher temperature (bright blue) where plaster has been compromised. Areas of complete loss and loose wall paper show higher temperatures (green).

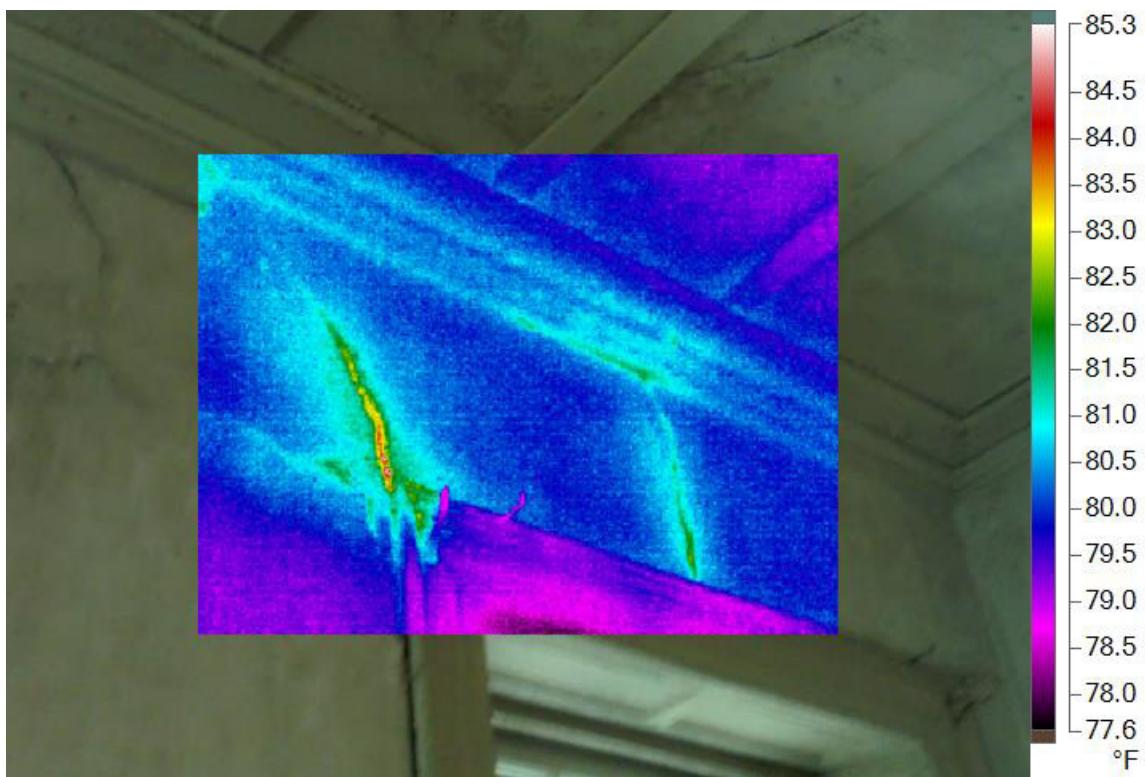
Figure 19: Southwest chamber, west wall: Note: Areas of higher temperatures and presumably detachment along open cracks. Void spaces within cracks correspond with highest temperatures.

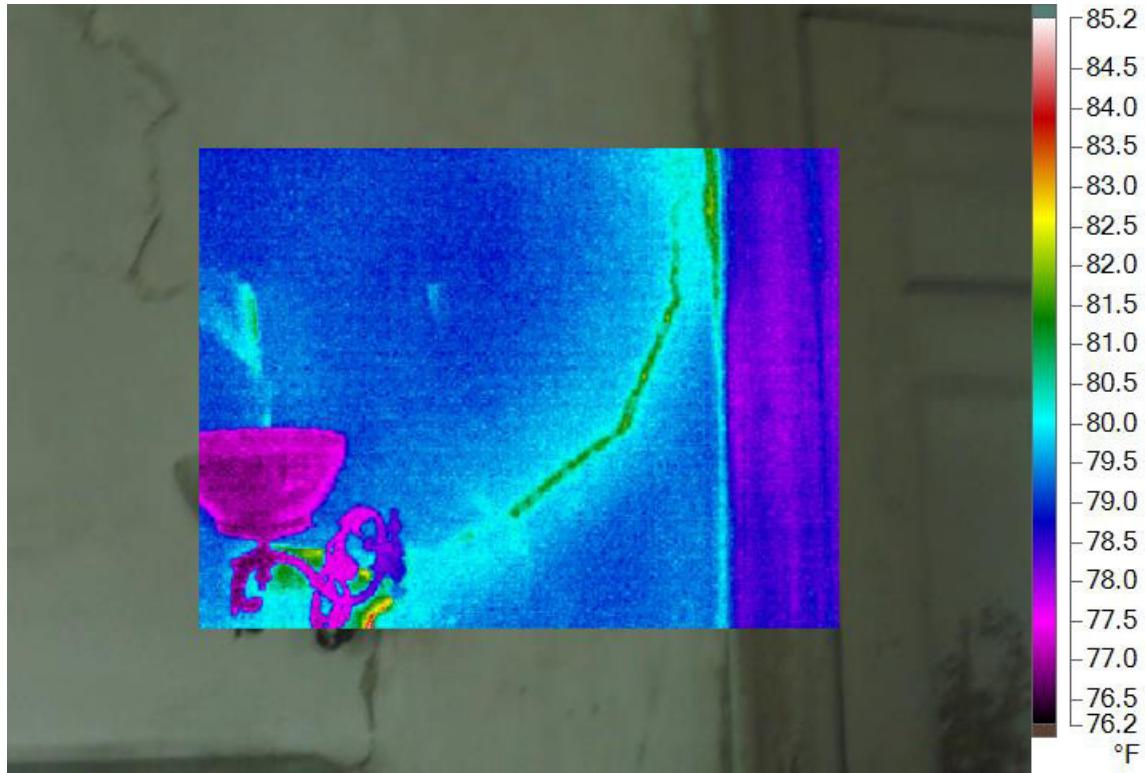
Figure 20: Southwest chamber, north wall: Areas of higher temperatures present along cracking near sconce above the mantel.

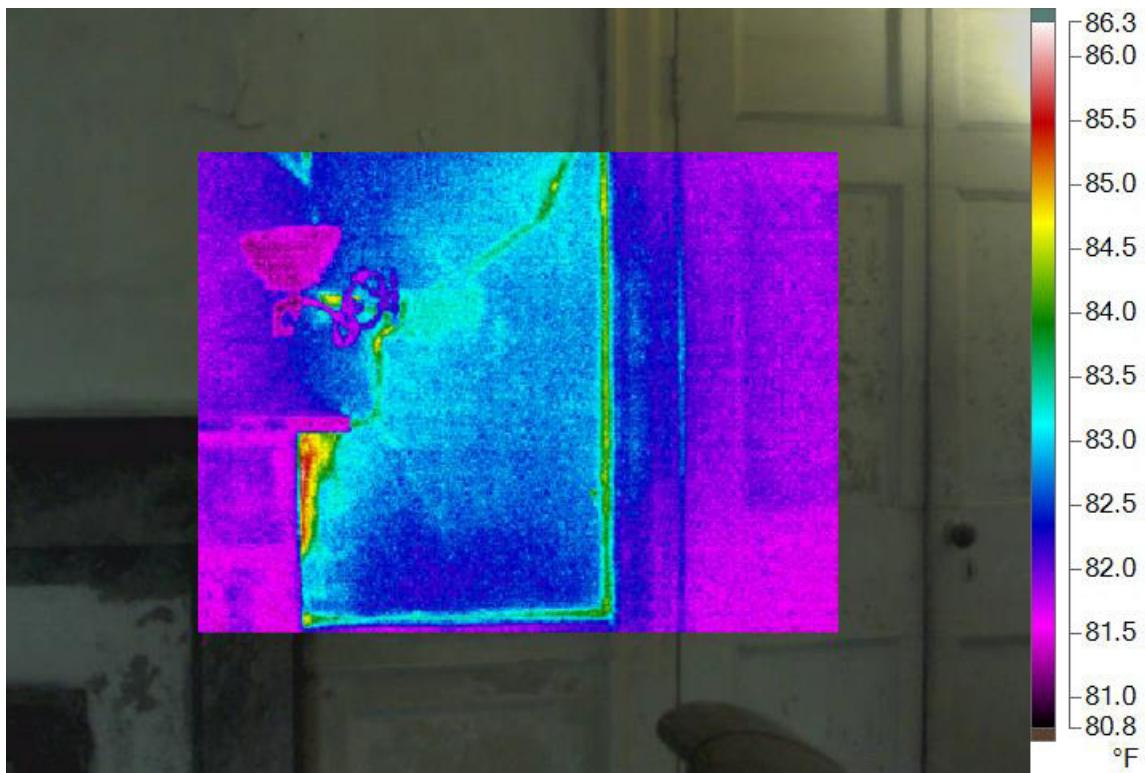
Figure 21: Southwest chamber, north wall: Large view of area adjacent to fireplace sconce, indicating possible detachment (green to bright blue).

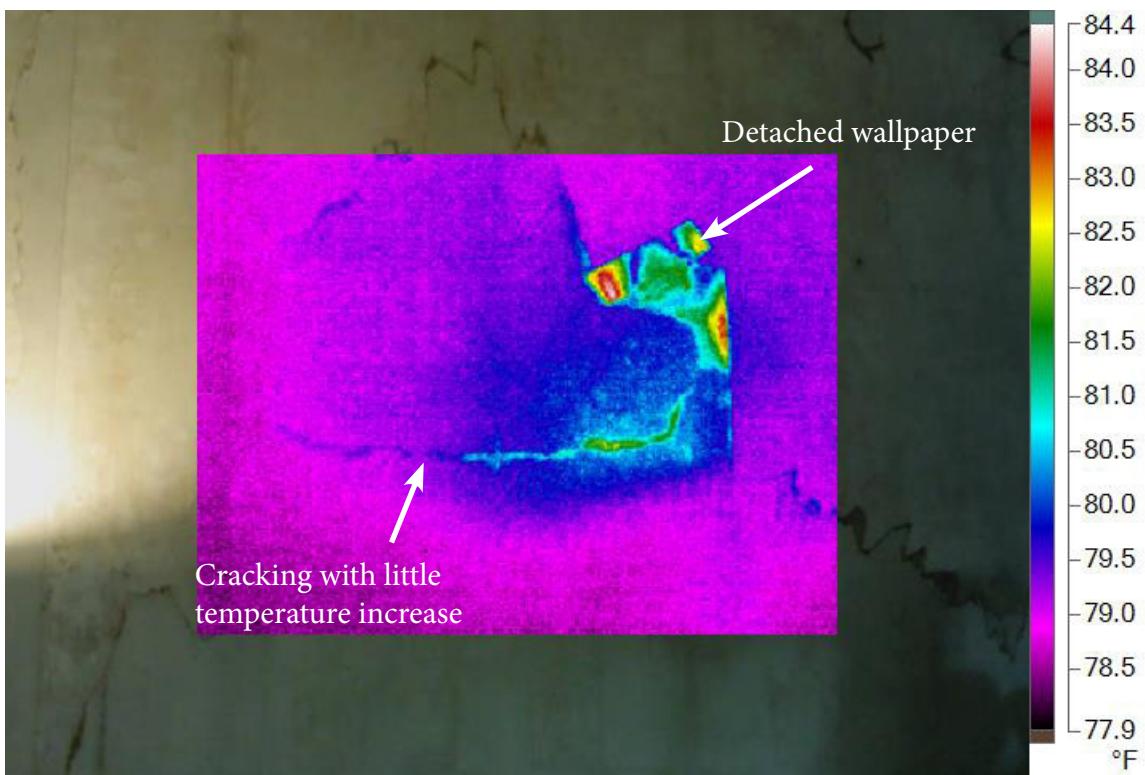
Figure 22: Southwest chamber, east wall: Note: slight temperature increases seen adjacent to the door.

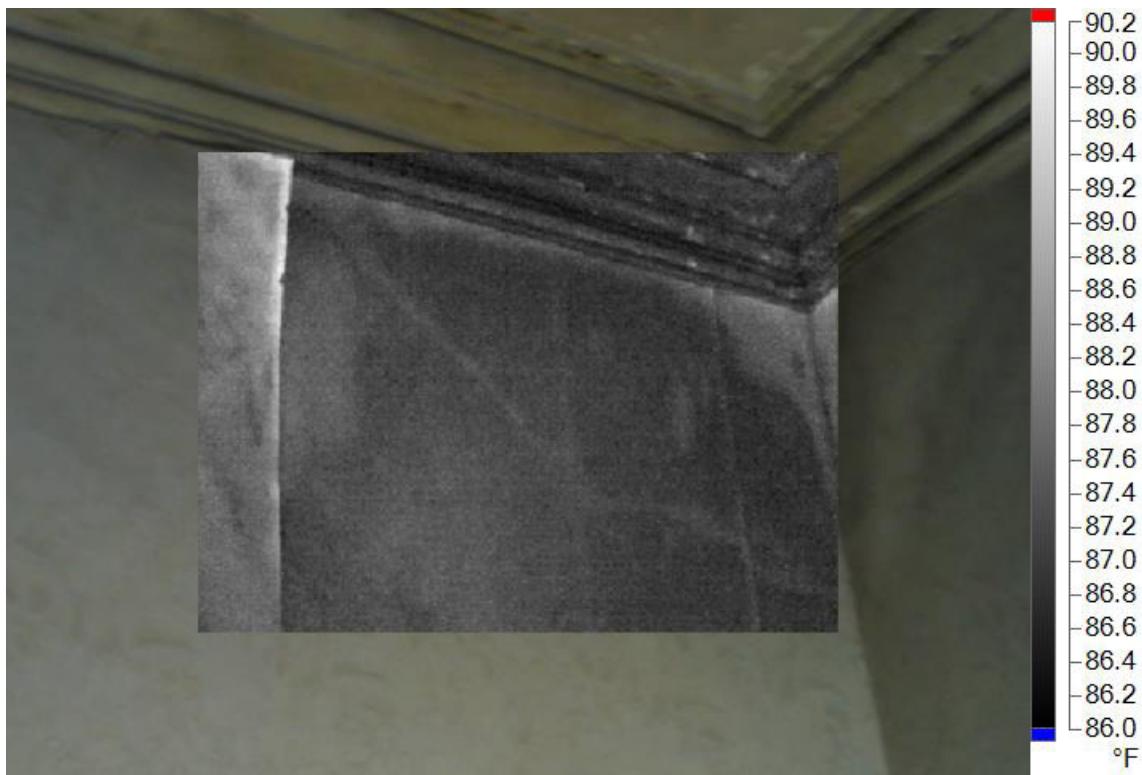
Figure 23: Southeast chamber, west wall: The cracking within the plaster obscured by wallpaper was visible through infrared analysis.

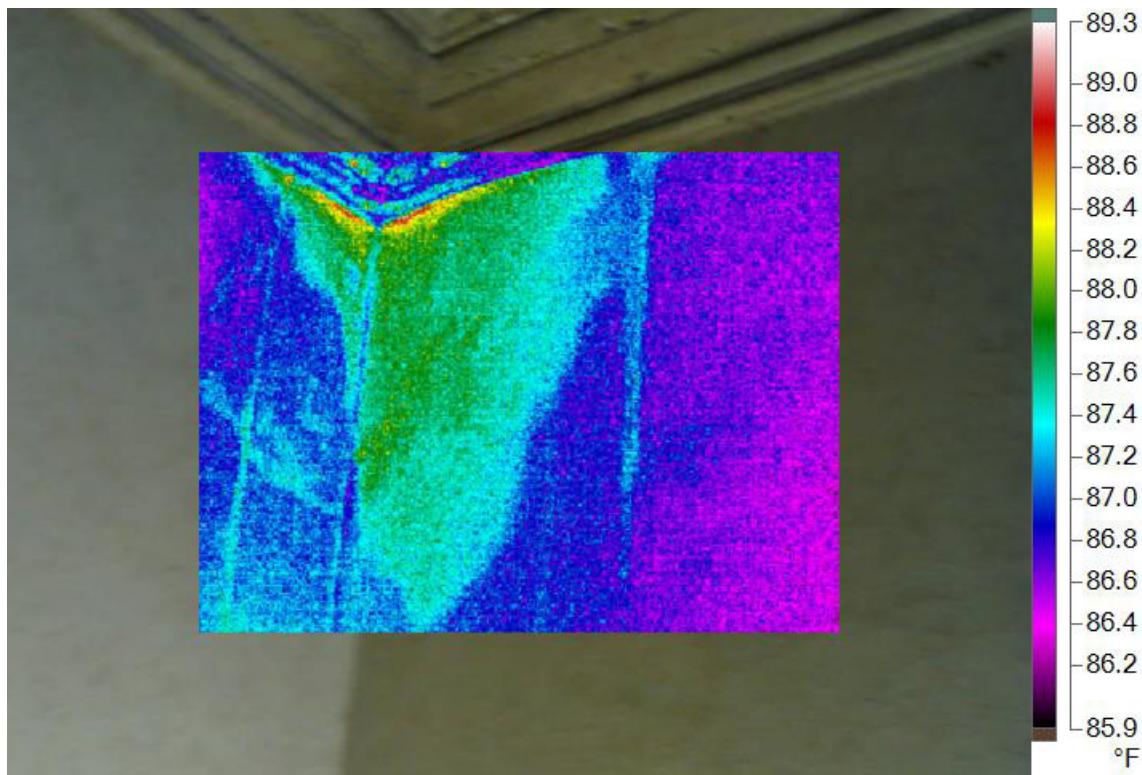
Figure 24: Southeast chamber, northwest corner: Note: Areas illustrating detachment of wallpaper without noticeable plaster damage.

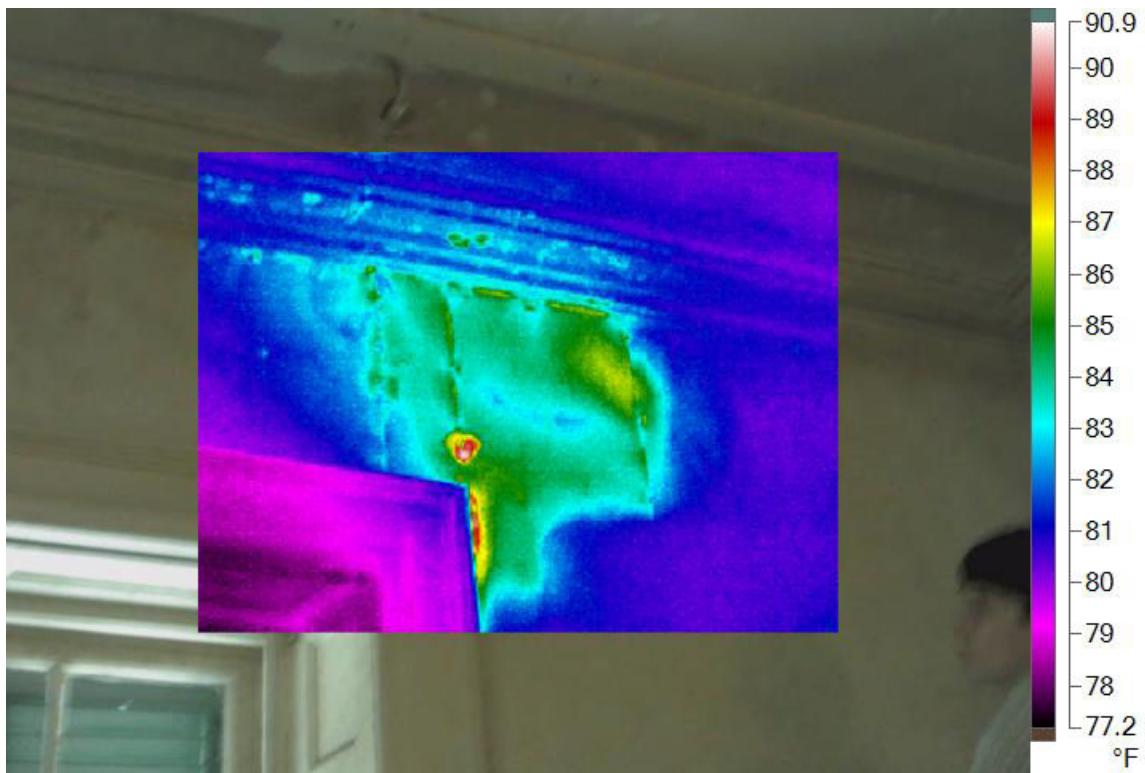
Figure 25: Southeast chamber, south wall: Analysis above window showing visible temperature differences between wallpaper detachment (green) and cracking (blue).

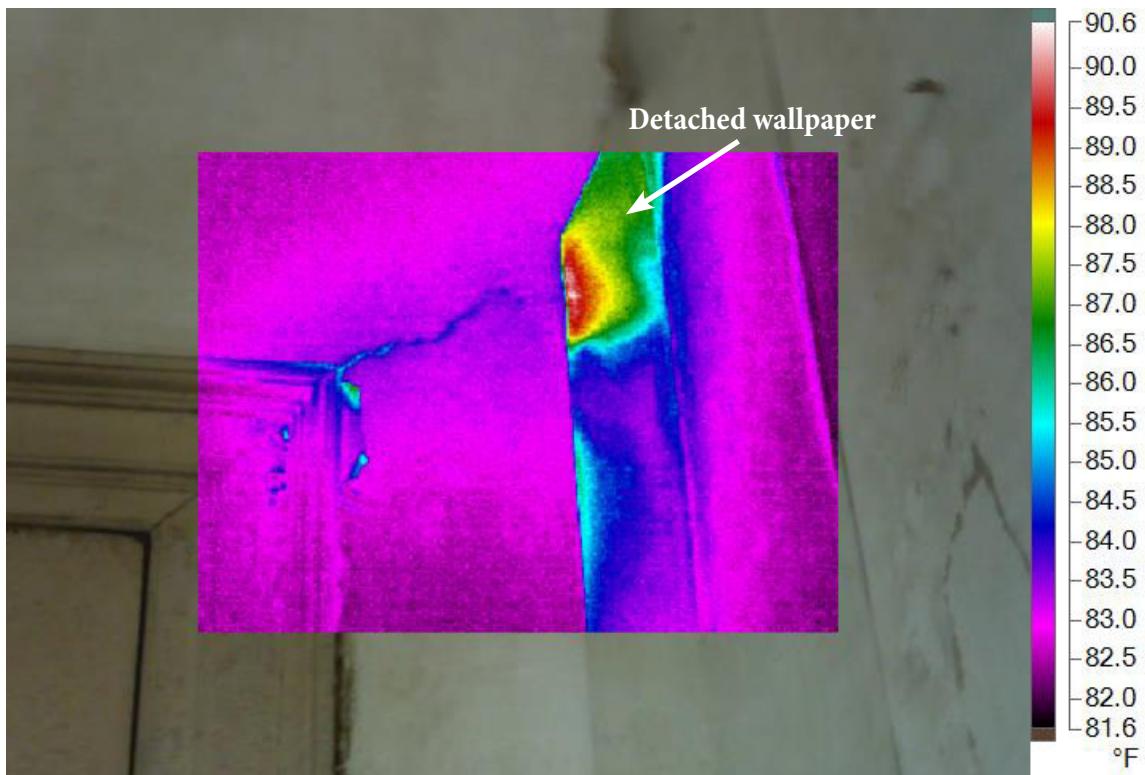
Figure 26: Southeast chamber, west wall: Note: Temperature increases seen adjacent to the door. Areas of detached wall paper display visible temperature differences.

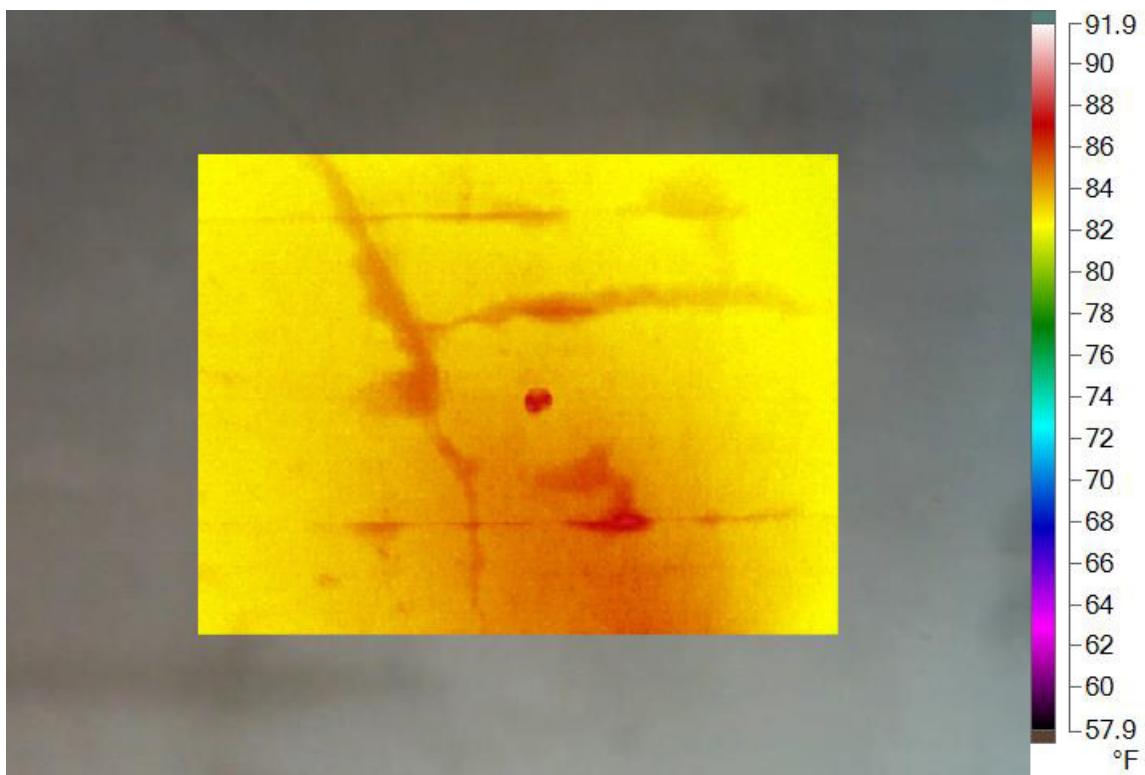
Figure 27: Southeast chamber, ceiling: Analysis of ceiling indicated cracking obscured by wallpaper. Note: Horizontal lines denote edges of individual sheets of wallpaper.

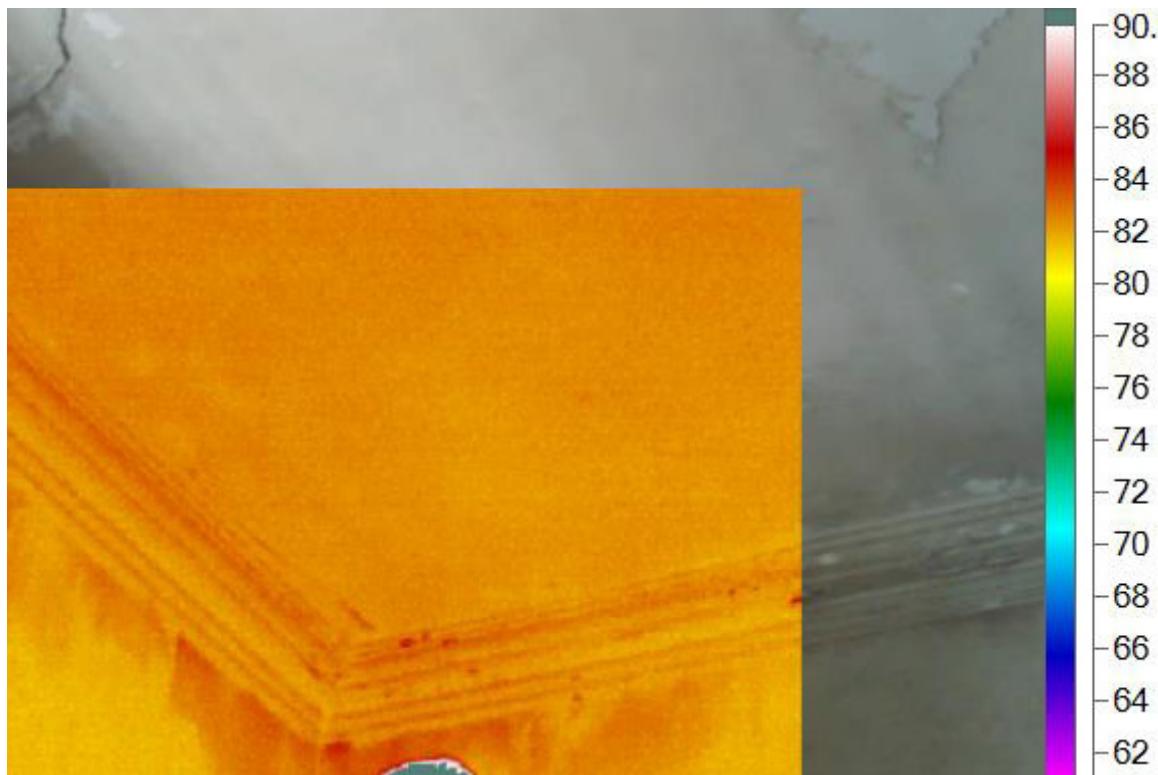
Figure 28: Southeast chamber, ceiling: Area of study where little temperature change was observed, likely indicating sound plaster.

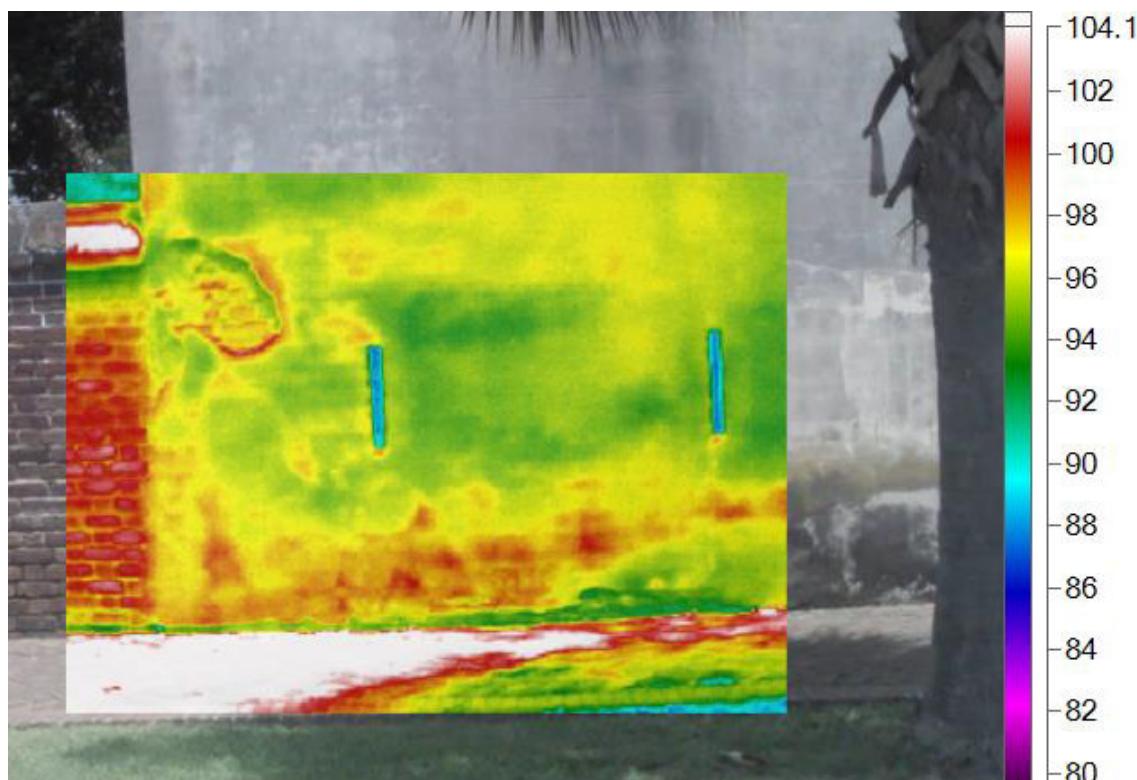
Figure 29: Exterior stucco, west elevation: Red areas on stucco indicate detachment from masonry. Detachment verified in field. Note difference between areas of repair.

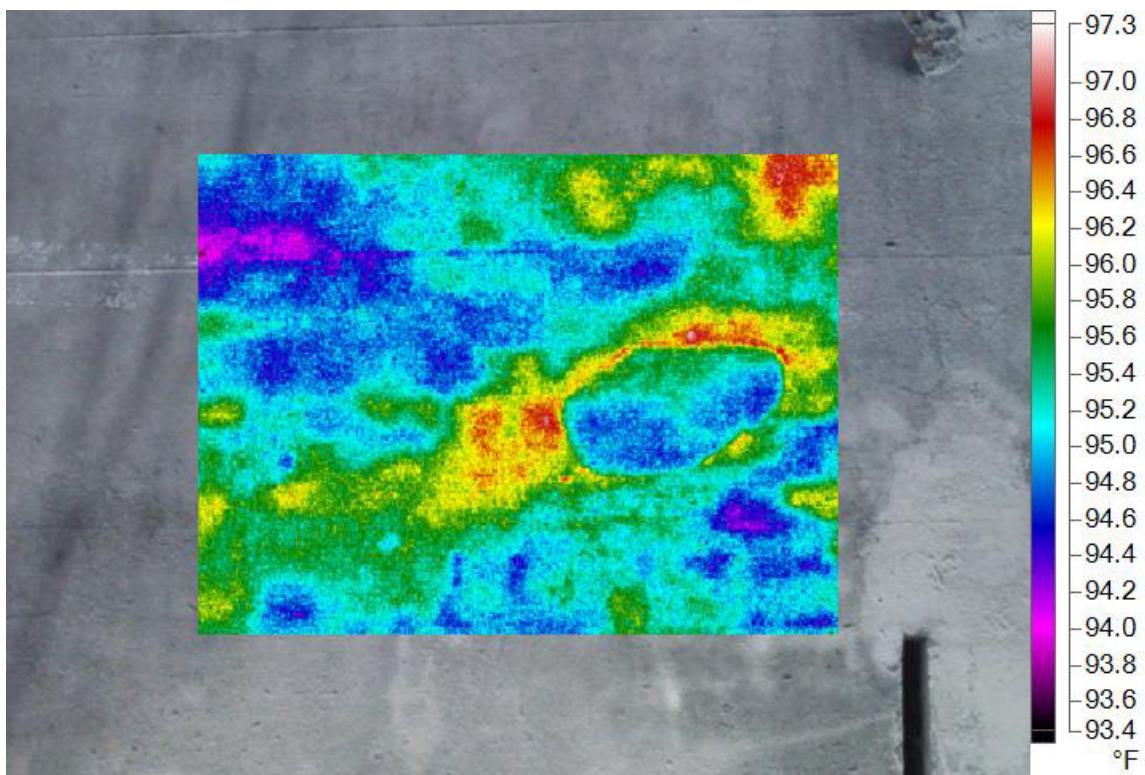
Figure 30: Exterior stucco, west elevation: Detached stucco displayed as red-yellow. The locations of the detachment was verified within the field.

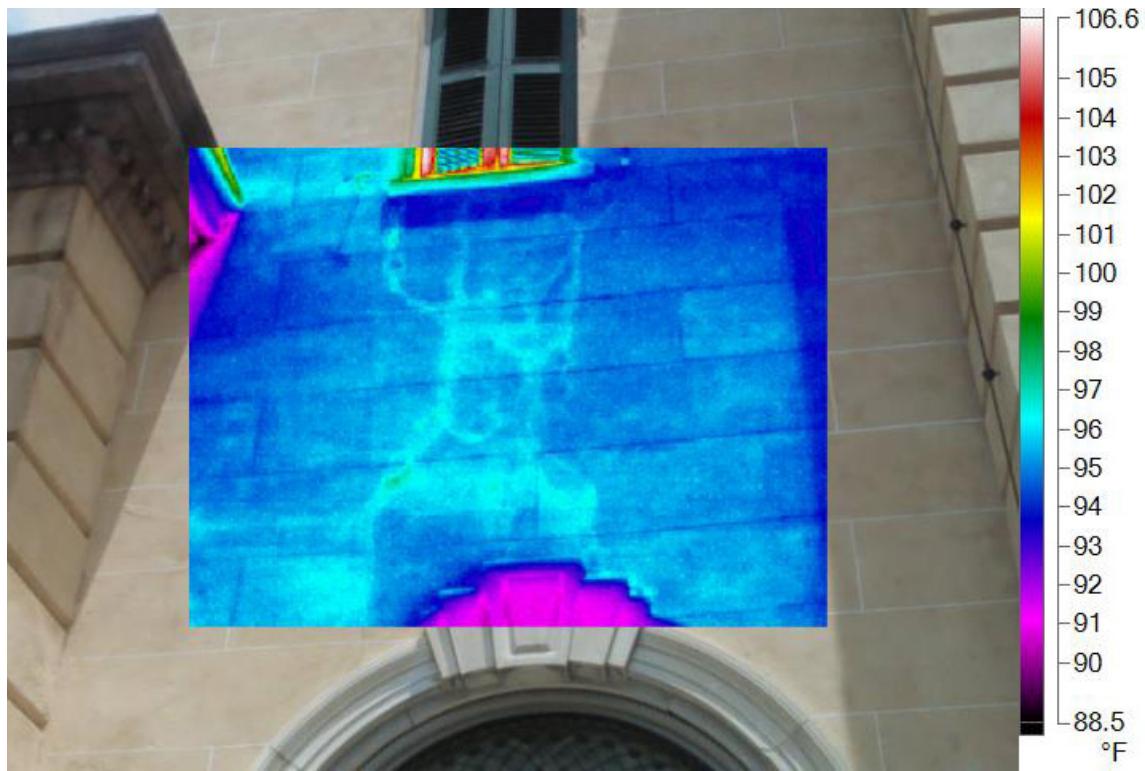
Figure 31: Exterior stucco, west elevation: Additional cracking not seen in visible light viewed in Infrared.
