HISTORIC CHARLESTON FOUNDATION
HURRICANE HUGO DAMAGE ASSESSMENT FORM

Date of Survey: 11/18/89

Street Address: 15 Thomas

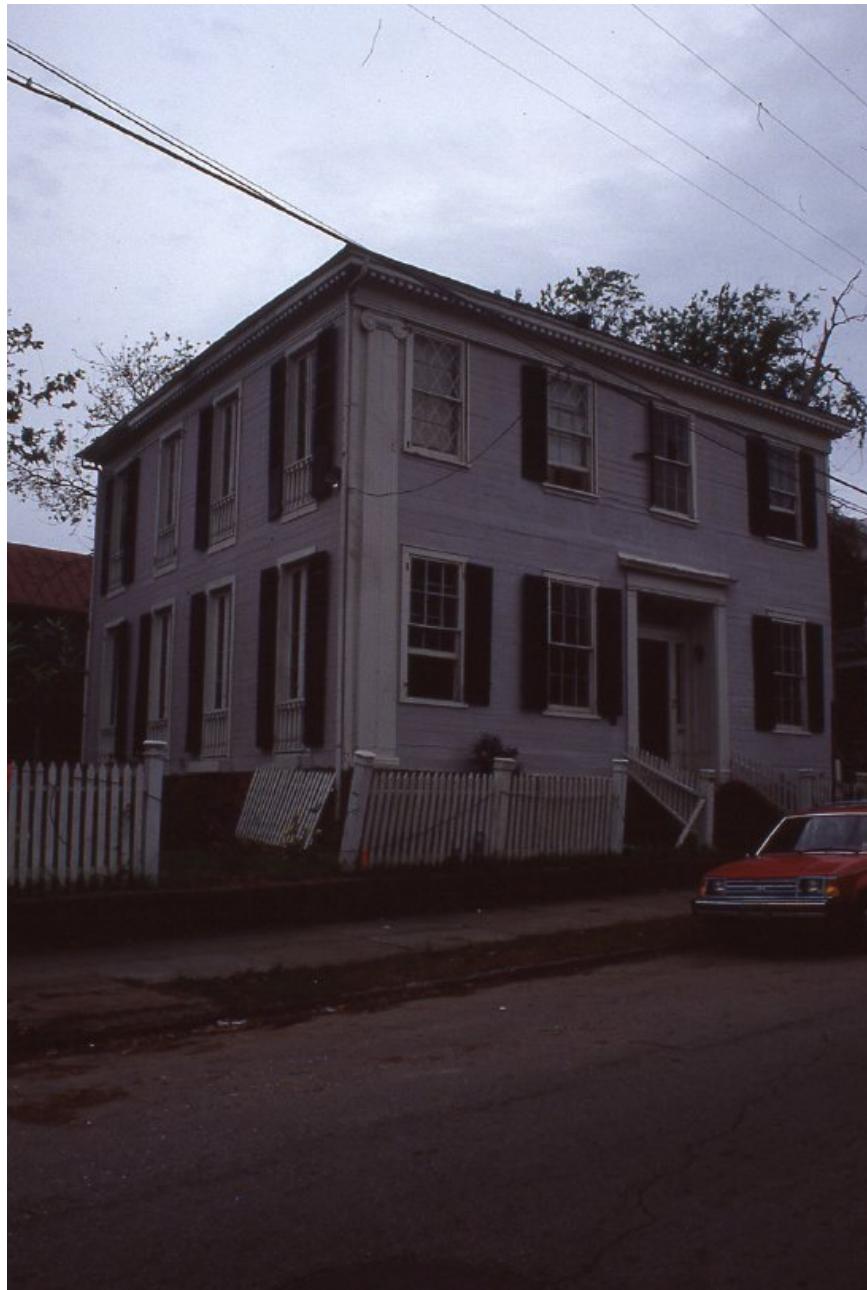
a: Thomas Street (front) elevation.

Comments: Corner lot hill S, E exposure
major tree damage. This house
is on an elevated foundation so it
did not flood.
