HISTORIC CHARLESTON FOUNDATION  
HURRICANE HUGO DAMAGE ASSESSMENT FORM

Date of Survey: 11-28-89

Street Address: 6 ST. MICHAEL'S ALLEY

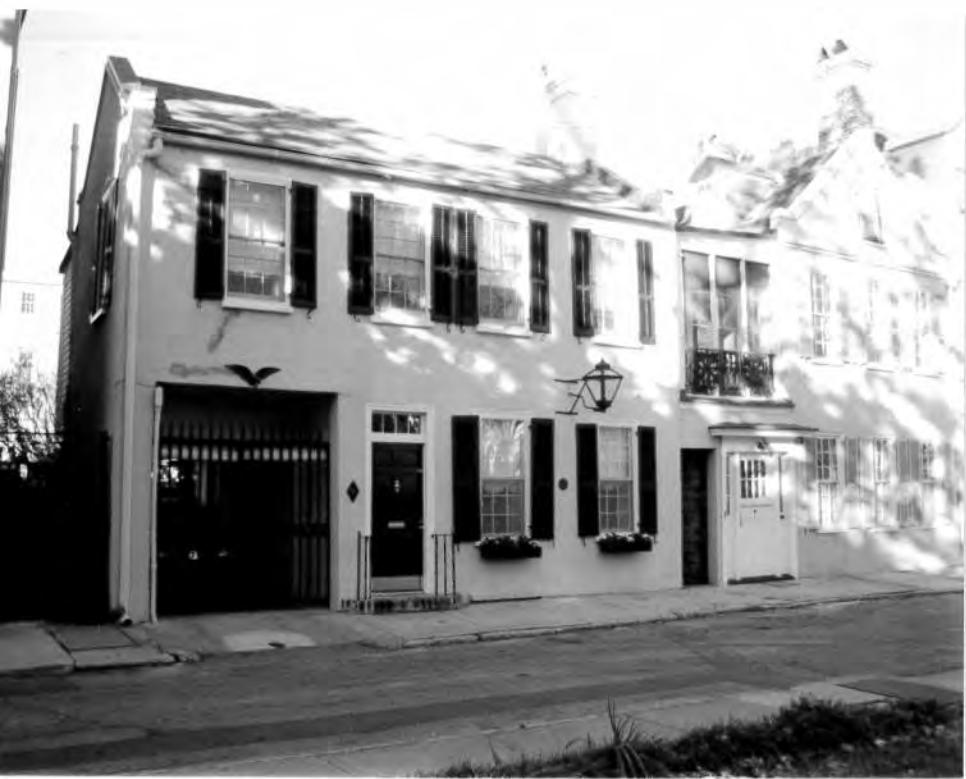
Hugo Survey photograph

Cracks  
in wall

Owner & Occupant	Material		Dimensions			Condition of Walls			
	Building	Roof	Ft. Long	Ft. Wide	Ft. High	North	South	East	West
→ Dingle, Dwelling	Brick	slate	30	16	22	Repair + the gable	Good	Good	Good

Repair and anchor  
the gable and  
north wall.
