HISTORIC CHARLESTON FOUNDATION  
EMERGENCY HURRICANE DAMAGE ASSESSMENT FORM

Date of Survey: 8/21/90

Street Address: 20 Percy St.

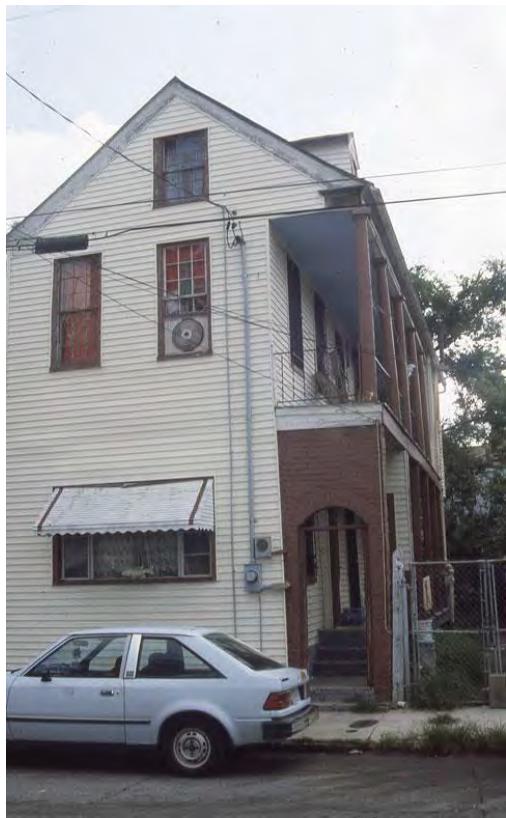
20 Percy Street, August 1990  
Hurricane Hugo Damage Assessment Photo
