HISTORIC PRESERVATION CERTIFICATION APPLICATION  
PART 2 - DESCRIPTION OF REHABILITATION

Address of property: Street 231 King Street

City Charleston County Charleston State SC Zip Code 29401

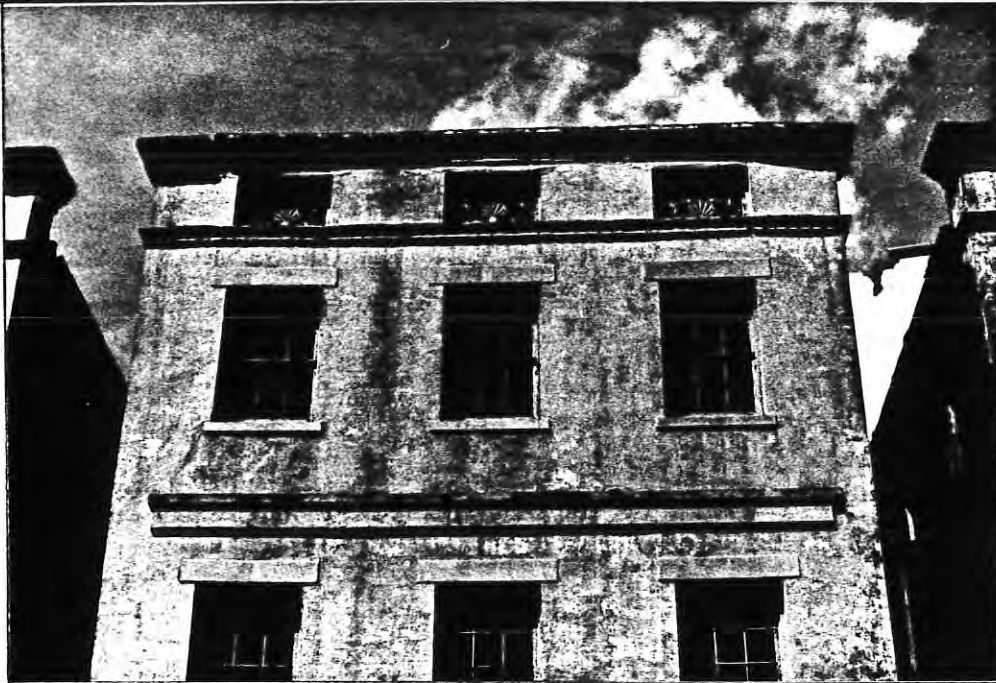
**#5**

**East Facade, Upper Levels**

**Prior to Rehabilitation, 8/84**

Note: Parapet/entablature, decorative grills at frieze, original 6/6 and 9/9 sash windows, molded brick courses

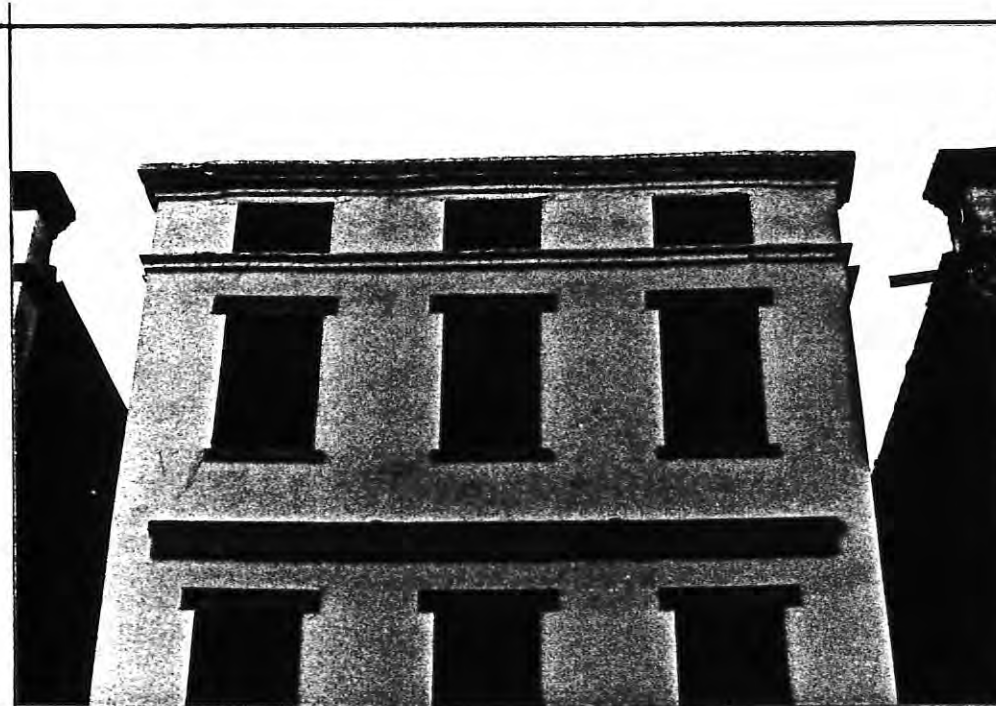
**#6**

**East Facade, Upper Levels**

Note: Parapet/entablature, decorative grills at frieze, original 6/6 and 9/9 sash windows, and molded brick courses retained and repaired as needed

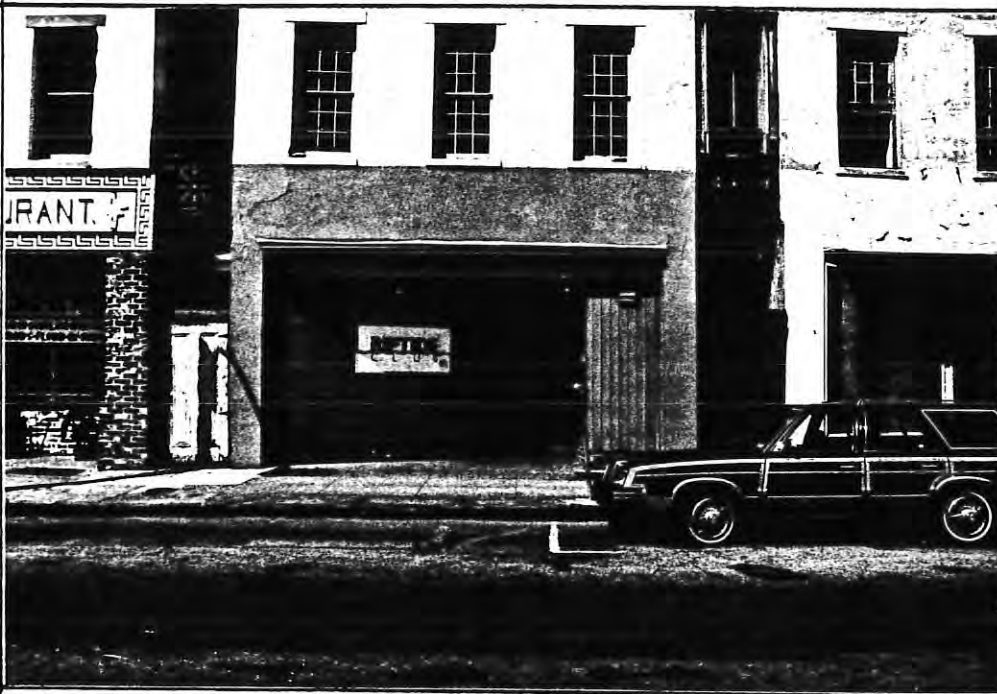
**#7**

**East Facade, Detail of  
Storefront**

**Prior to Rehabilitation, 8/84**

Note: Modern storefront

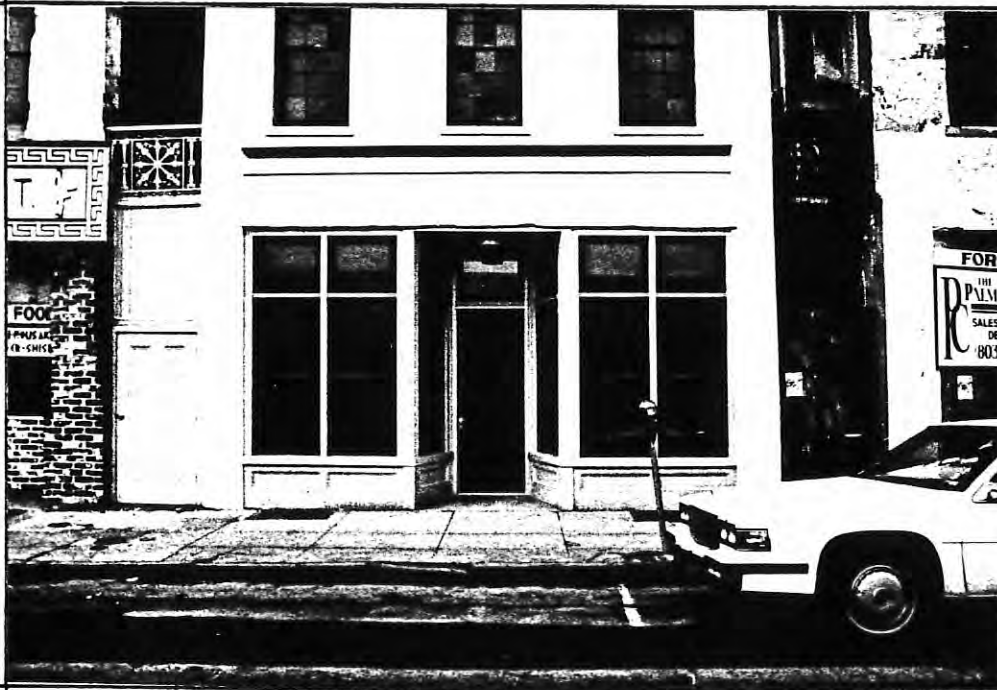
**#8**

**East Facade, Detail of  
Storefront**

Note: Rehabilitated storefront  
based upon a historical  
photograph and the design of  
similar historic storefronts  
throughout Charleston

A new storefront was installed as per plans submitted. The design of the storefront was based upon a historic photograph of the structure (see Photos #68 & 69) and on the design of other similar storefronts found throughout Charleston. The entry screen to the side entry was retained and repaired as per plans submitted. The original cast-iron grill and panelled door were retained and repaired as needed.

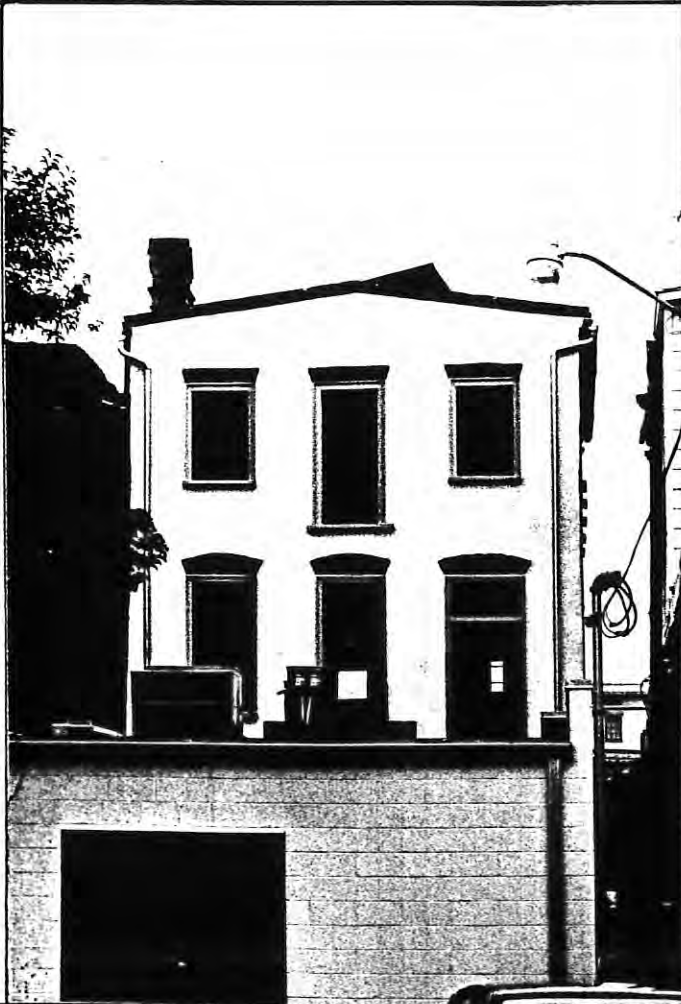
**Prior to Rehabilitation, 8/84**

Note: Deteriorated window sash,  
infilled window and door  
openings

Existing windows were retained and repaired as needed. Repairs were accomplished to match existing adjacent conditions in design, materials, and workmanship in accordance with Preservation Briefs #9. All windows were carefully hand-prepared for new finishes, primed, re-glazed and painted.

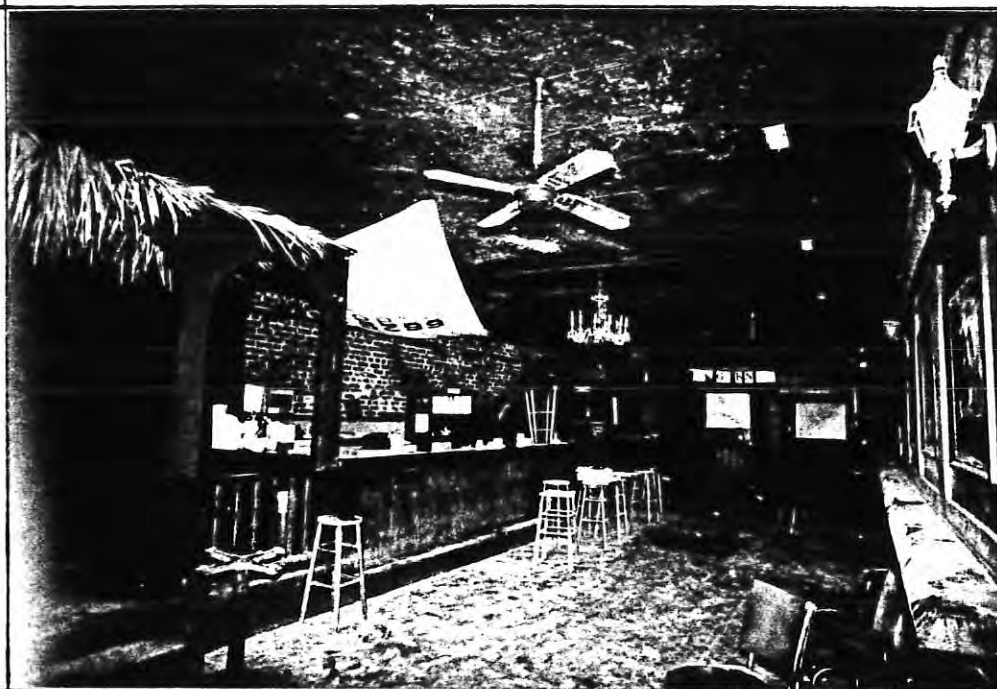
**#21**

**First Floor, Facing  
Southwest**

**Prior to Rehabilitation, 8/84**

Note: Deteriorated pressed metal ceiling, exposed brick walls, composition board flooring

Reinforcement of the existing joists and joist pockets at the first floor level necessitated the removal of the first floor pressed metal ceiling. Efforts to remove the ceiling for storage and re-installation were unsuccessful due to its deteriorated condition. A new pressed metal ceiling of similar design was installed as per photographs submitted.

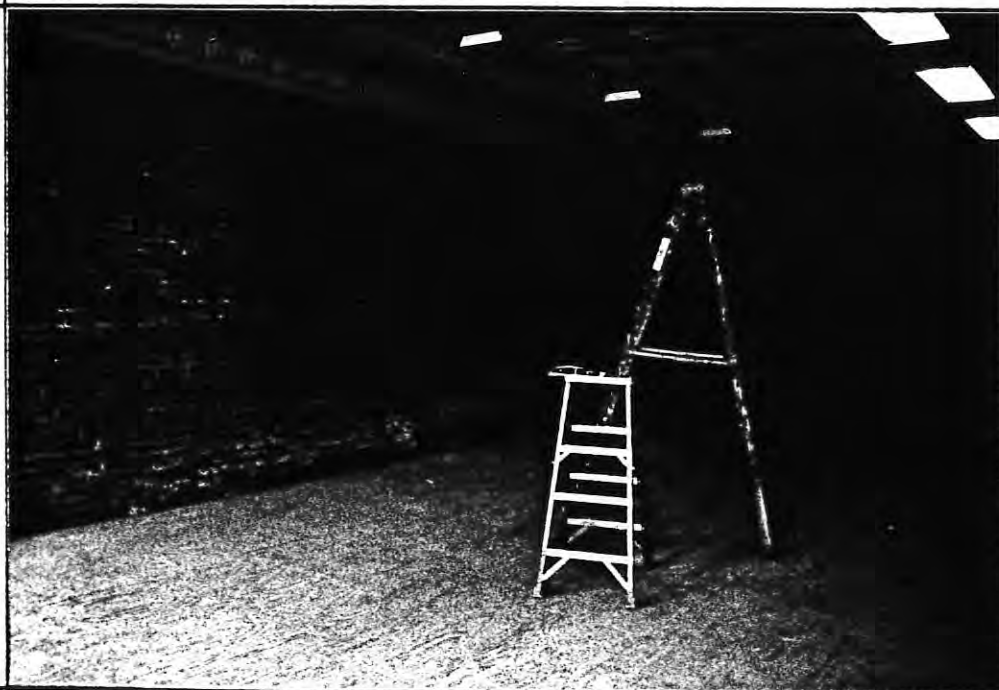
**#22**

**First Floor, Facing  
Southwest**

Note: Deteriorated pressed metal ceiling could not be salvaged and was replaced with a new pressed metal ceiling of similar design, exposed brick walls were retained, composition board flooring was replaced with similar material

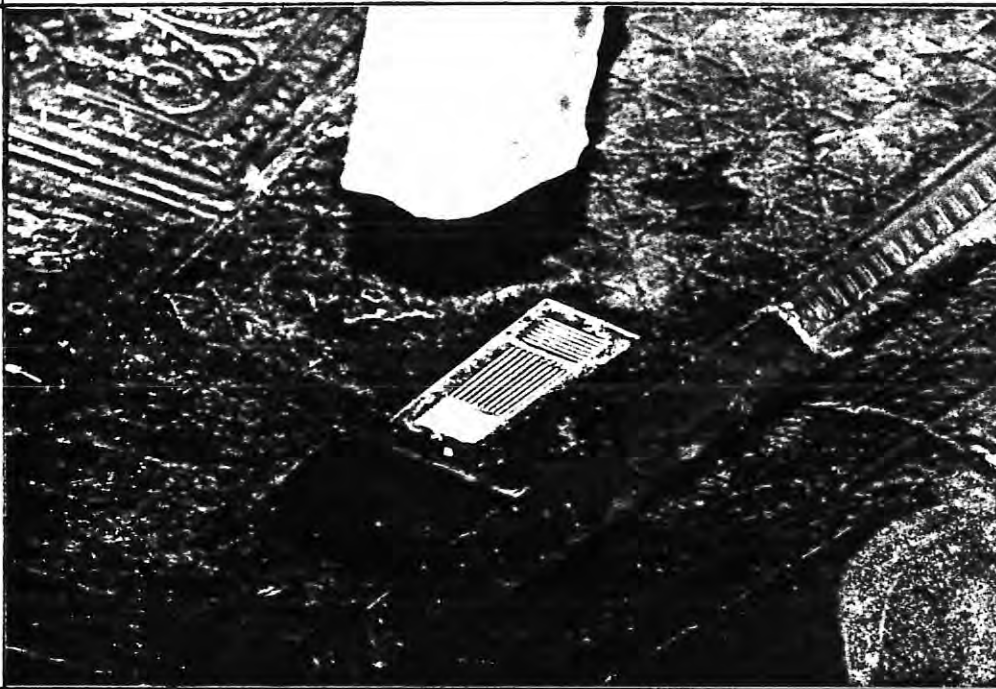
#23

A decorative pressed metal ceiling was located in the first floor of the original structure. The ceiling was in deteriorated condition and had been damaged by poorly executed patches and moisture-related deterioration.

First Floor, Detail of  
Deteriorated Pressed  
Metal Ceiling

Prior to Rehabilitation, 8/84

Note: Numerous patches, ceiling  
could not be salvaged and was  
replaced with a new pressed  
metal ceiling of similar design

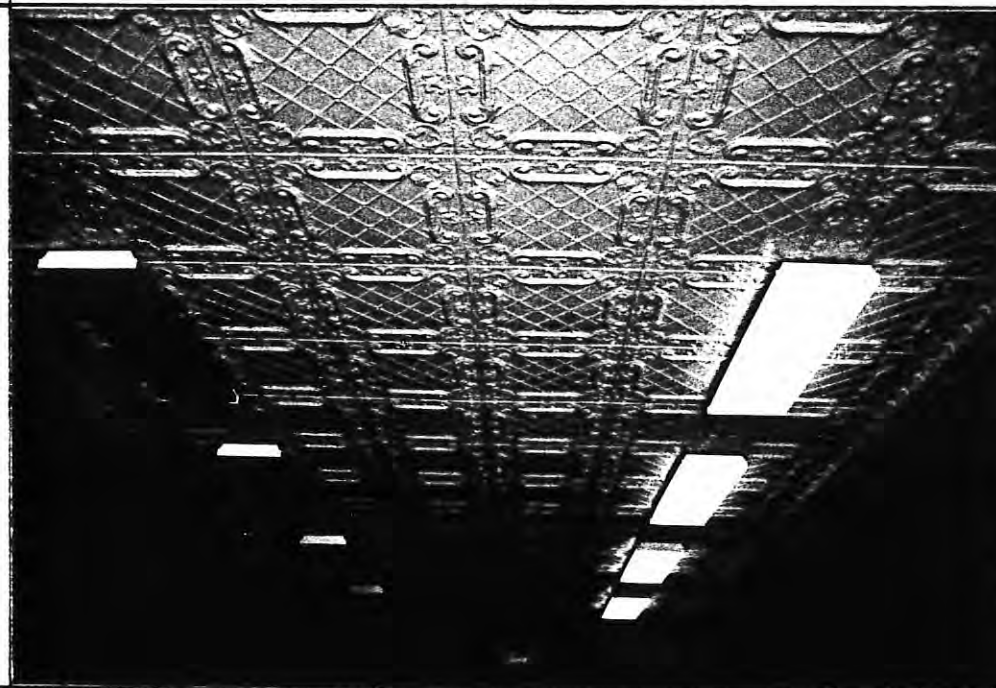
#24

First Floor, Detail of  
Deteriorated Pressed  
Metal Ceiling

Note: New pressed metal ceiling  
was installed

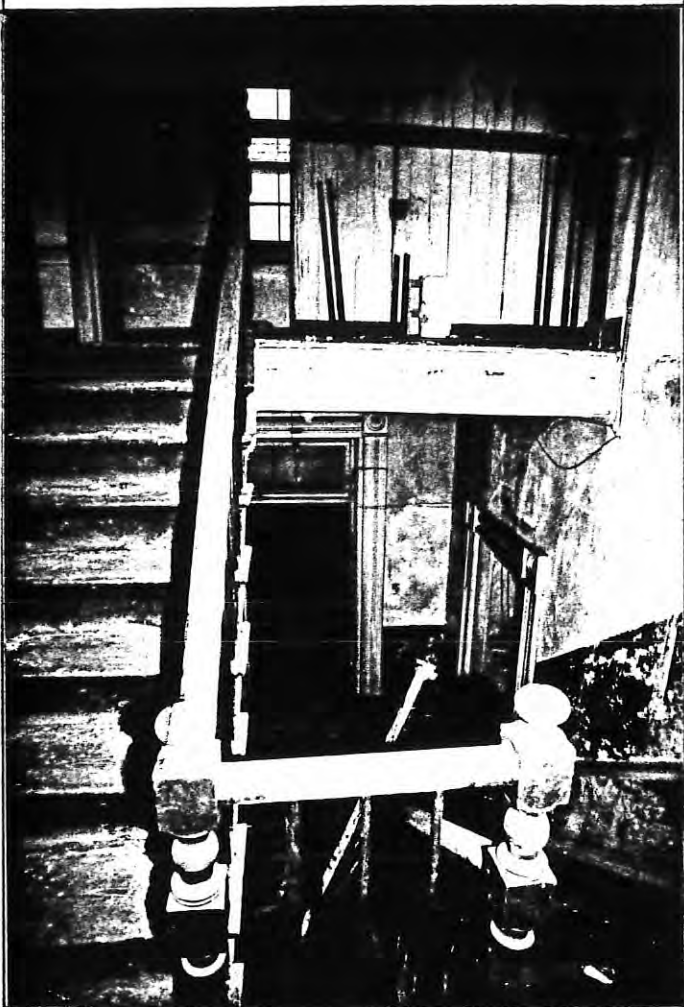
**#31**

**Prior to Rehabilitation, 8/84**

Note: Original ballustrade in  
deteriorated condition

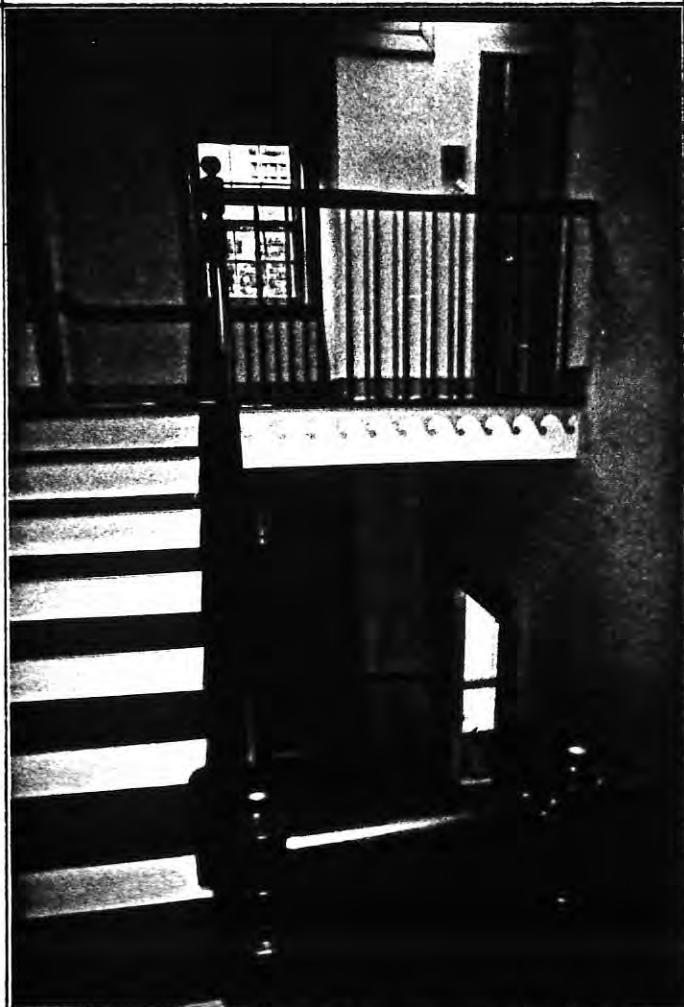
**#32**

**Staircase, Facing  
Third Floor from  
Landing**

Note: Original ballustrade was  
restored to match the appearance  
of surviving sections

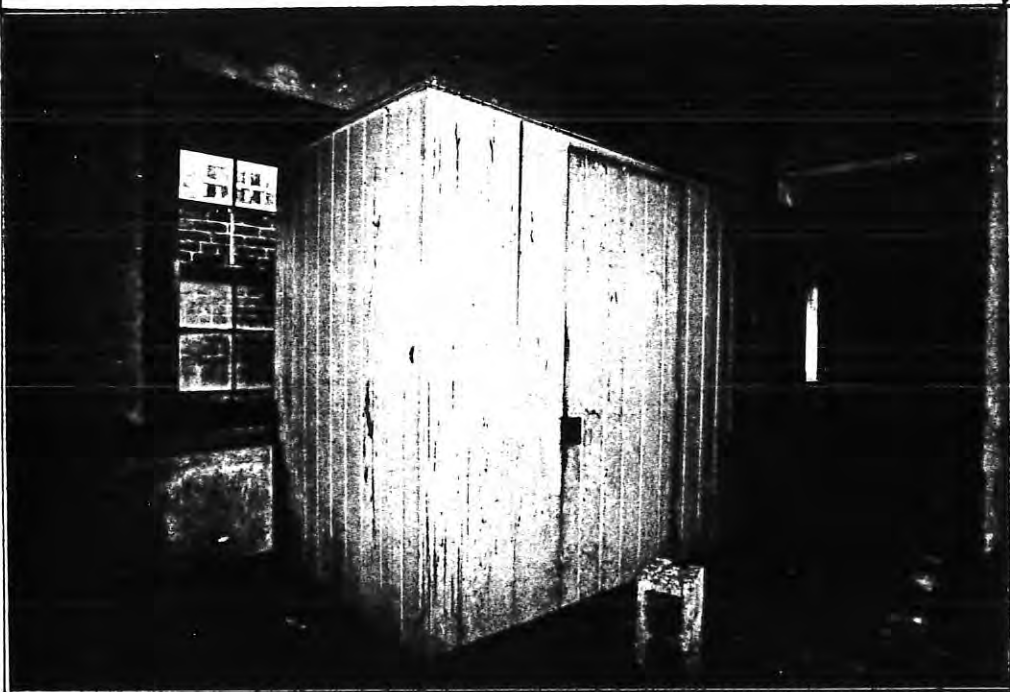
**#33**

**Third Floor Stairhall**

Note: Existing bathroom enclosure obscures window

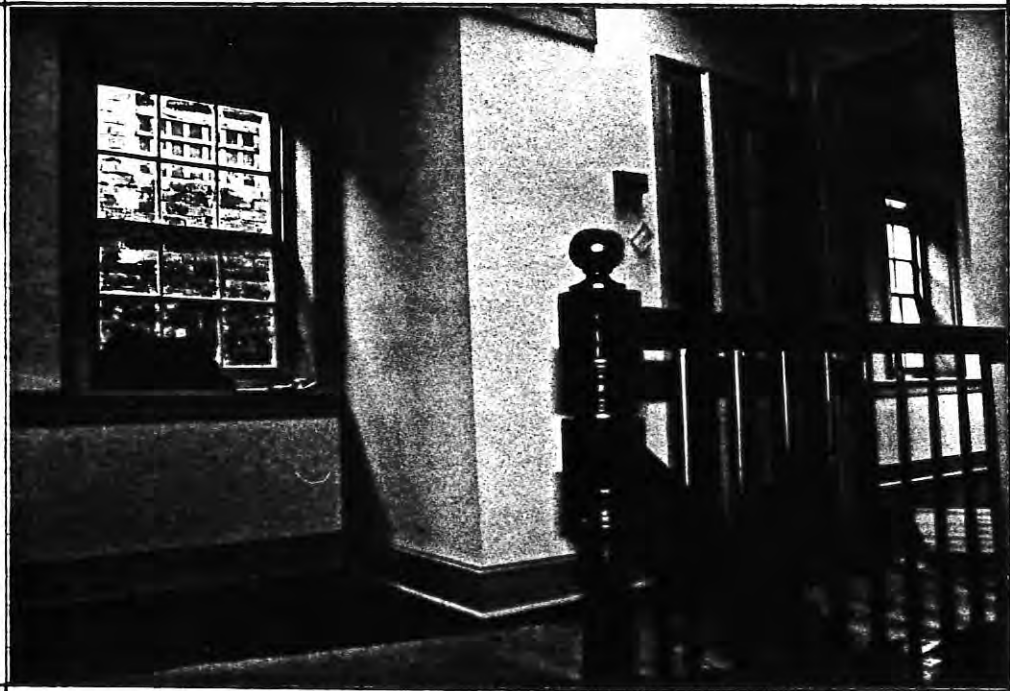
**#34**

**Third Floor Stairhall**

Note: Bathroom enclosure was retained and reworked to open the original window

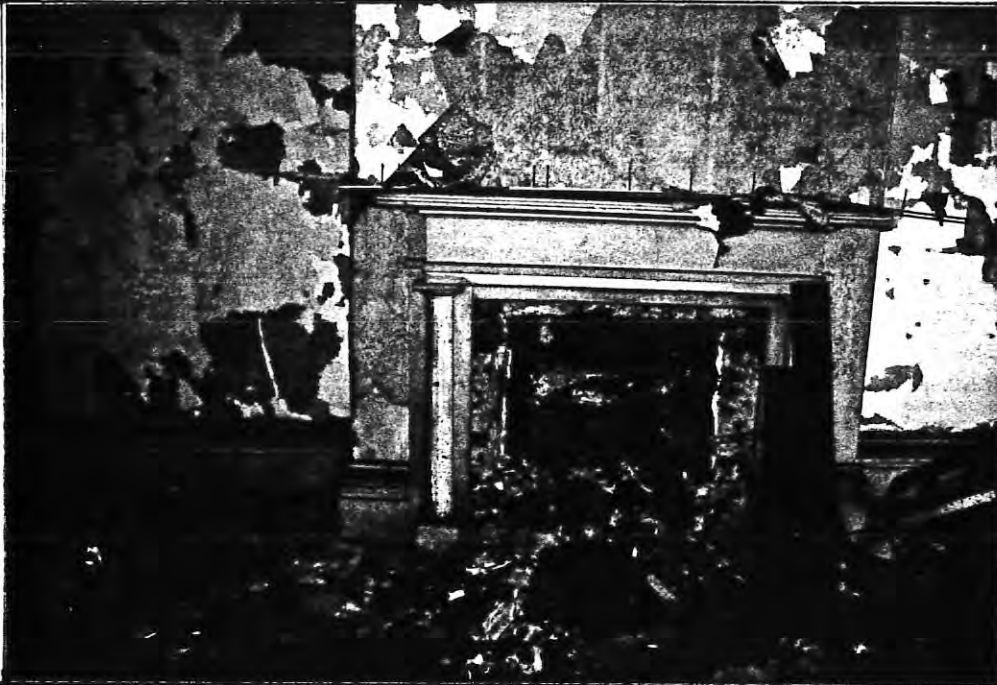
**#40**

Existing fireplaces have been altered for coal burning and are in inoperable condition. Mantels are original and are fine examples of the period.

**Second Floor East  
Parlor, Detail of  
Mantelpiece**

**Prior to Rehabilitation, 8/84**

Note: Firebox converted for coal  
burning, molded baseboards

Existing fireplaces were repaired as needed. Existing mantelpieces were retained and carefully refinished.

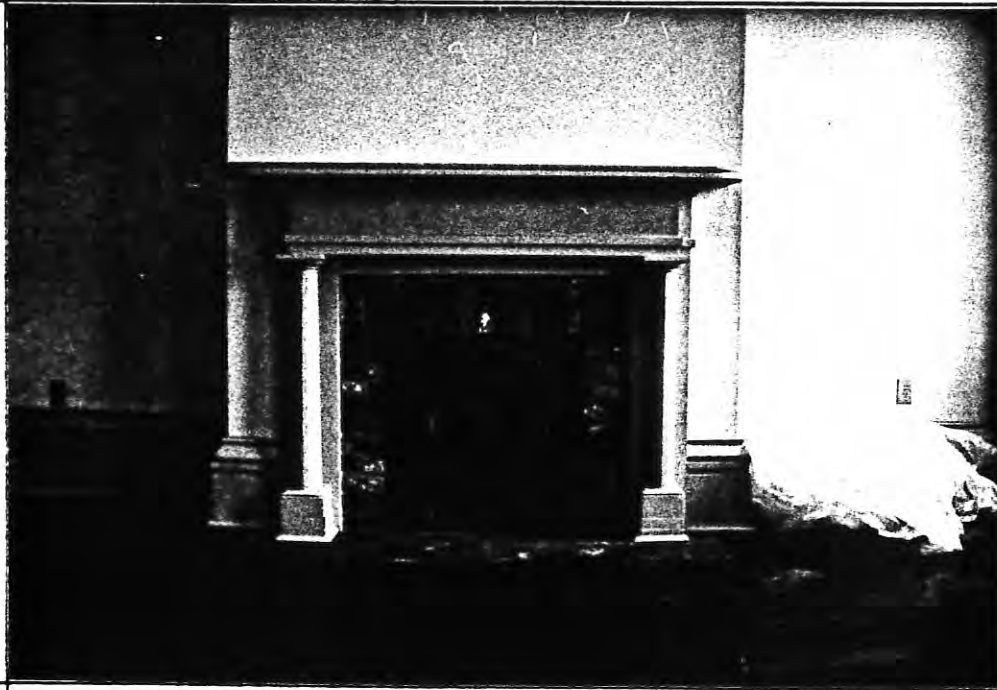
**#41**

**Second Floor East  
Parlor, Detail of  
Mantelpiece**

Note: Firebox restored, molded  
baseboards retained

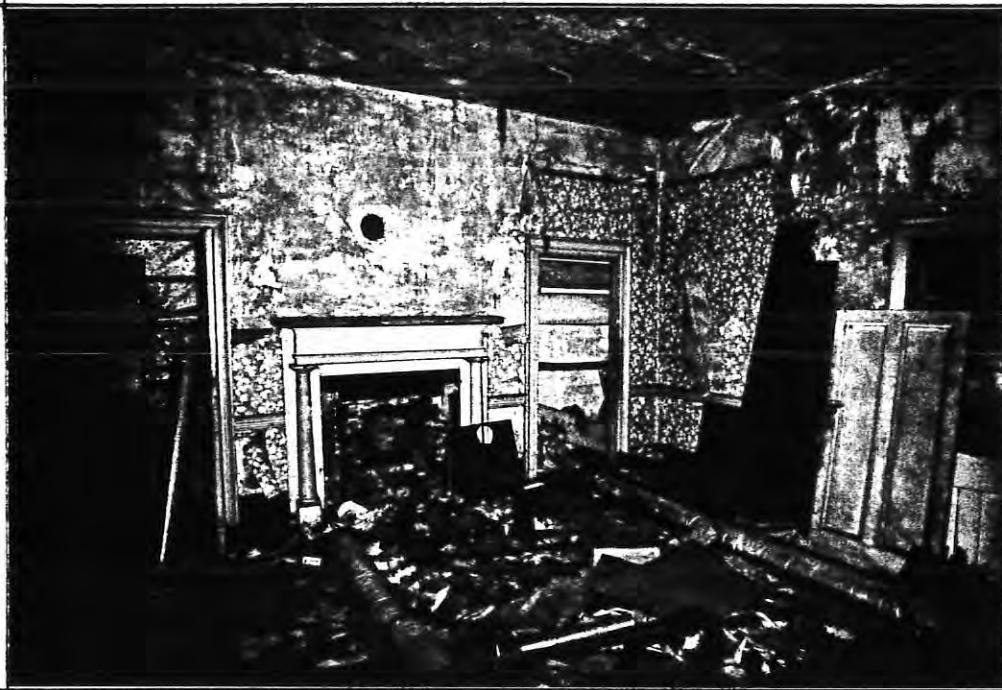
**#46**

Original heart pine floors had been damaged by the existing HYAC system on the second level and by moisture-related deterioration on the third level.

**Second Floor West  
Parlor, Facing  
Northeast**

Note: Original mantelpiece,  
chair-rail, molded door  
surrounds, existing closets,  
exposed HVAC system on floor

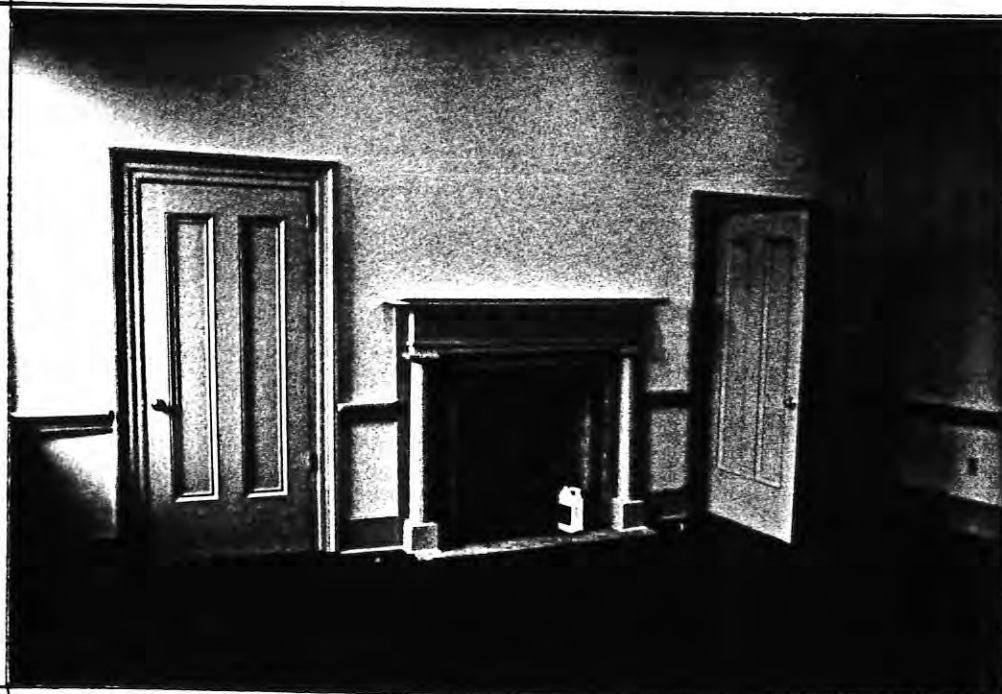
**#47**

**Second Floor West  
Parlor, Facing  
Northeast**

Note: Original mantelpiece,  
chair-rail, molded door  
surrounds, and existing closets  
retained and repaired as needed;  
exposed HVAC system on floor  
removed

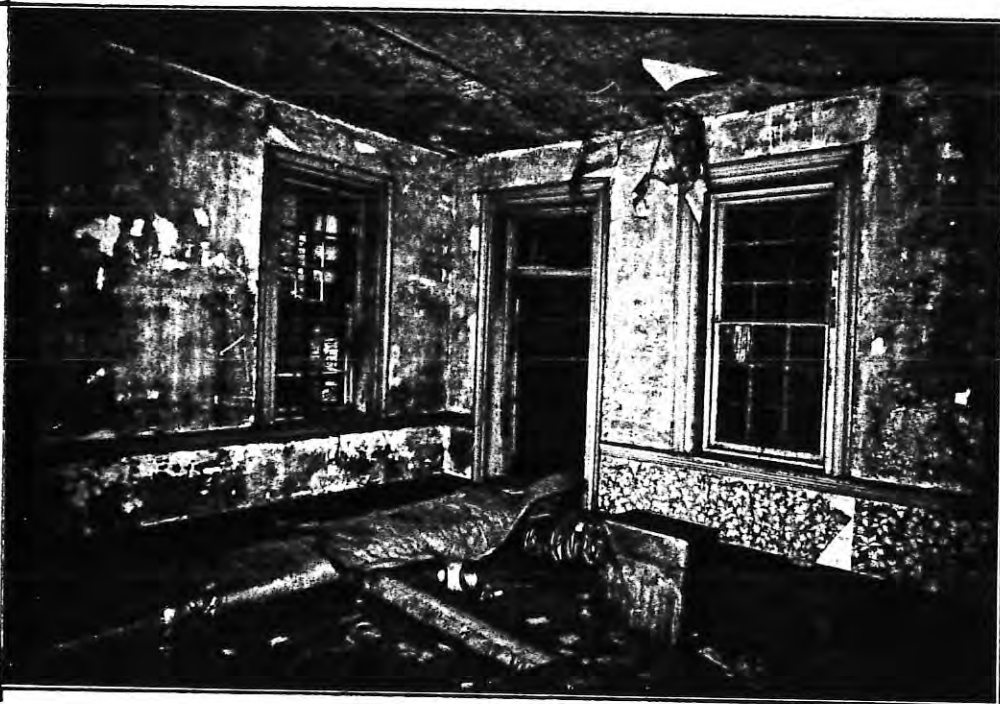
**#48**

**Second Floor West  
Parlor, Facing  
Southwest**

Note: Original chair-rail,  
molded door and window  
surrounds, exposed HVAC  
system on floor

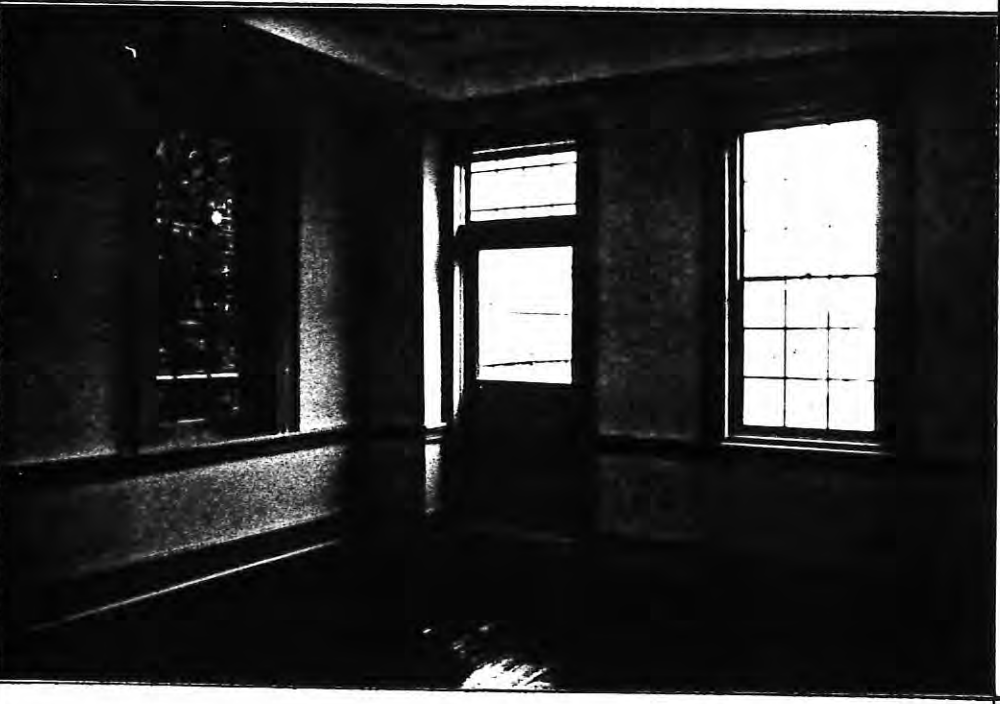
**#49**

**Second Floor West  
Parlor, Facing  
Southwest**

Note: Original chair-rail,  
molded door and window  
surrounds retained and repaired  
as needed, exposed HVAC system  
removed from floor; corner  
alterations are the result of a  
new structural member added  
during the reconstruction of the  
west wall

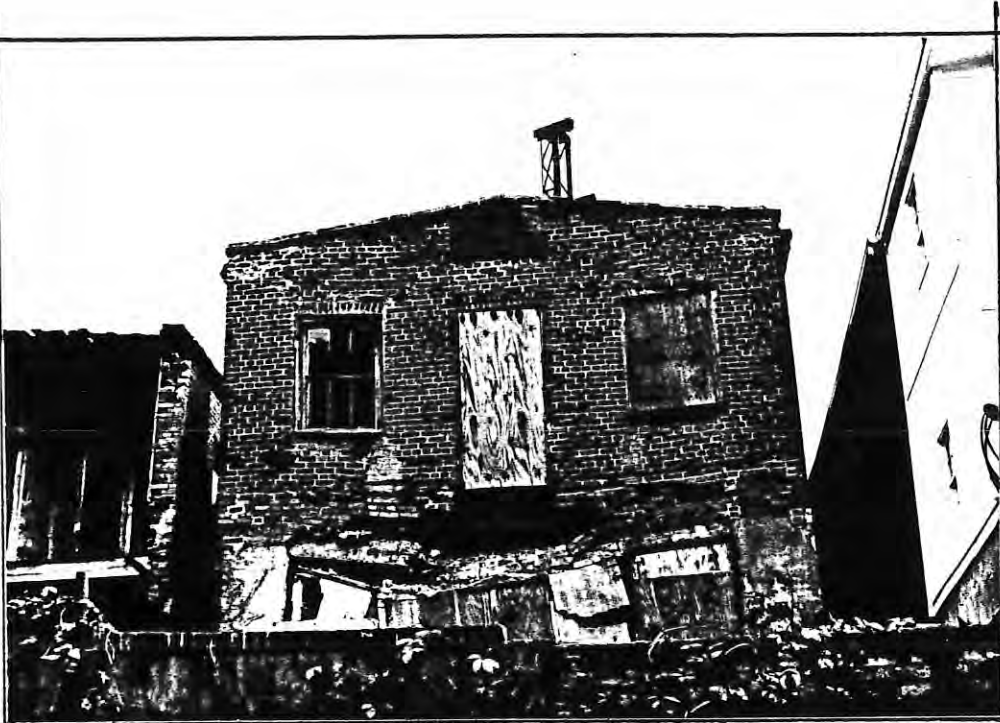
**#70**

**West Wall After  
Collapse, Fall 1984  
(See Photos #17-20)**

Note: West wall could not be salvaged and was reconstructed as per Item #9 and plans submitted

The rear wall was removed and reconstructed as per plans submitted. Original materials, including window sash and interior trim, were re-used wherever possible. Replacement components were constructed to match the original conditions in design, material, and workmanship.

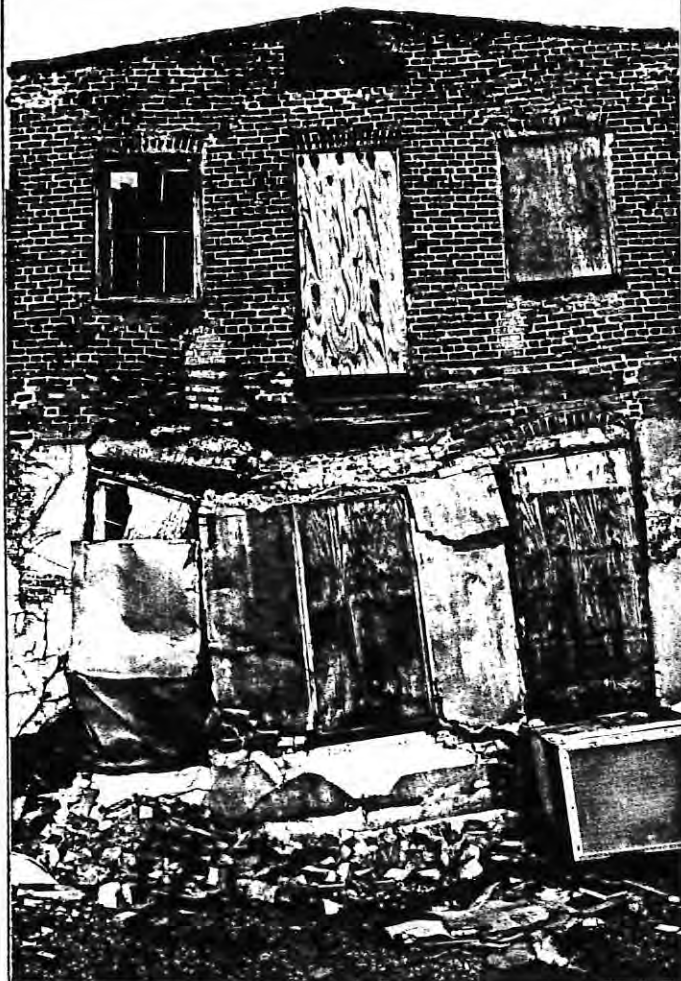
**#71**

**West Wall After  
Collapse, Fall 1984  
(See Photos #17-20)**

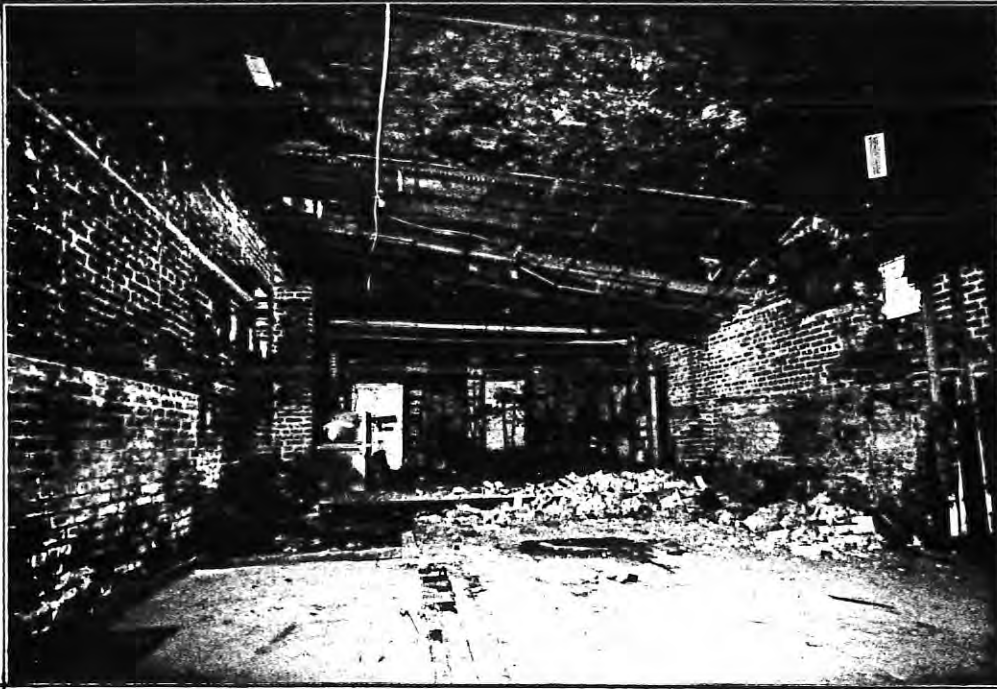
#72

Interior After  
Collapse of West  
Wall, Fall 1984

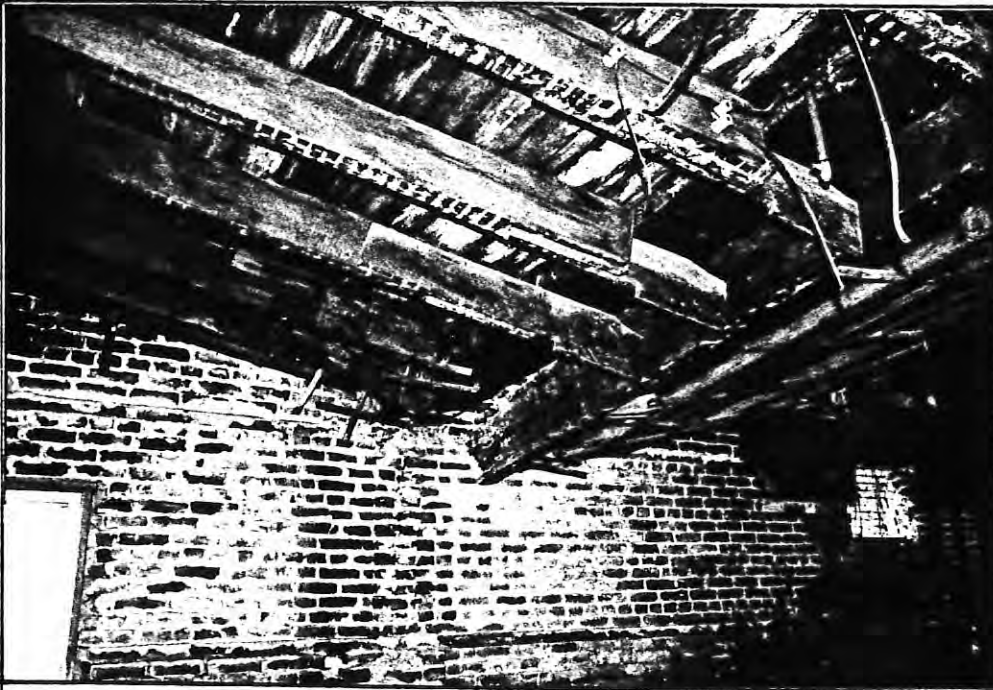
#73

Interior After  
Collapse of West  
Wall, Fall 1984
