August 19, 1991

in re: 22 Charlotte Street
Hurricane Hugo damage

List of possible Hurricane Hugo damage found at 22 Charlotte

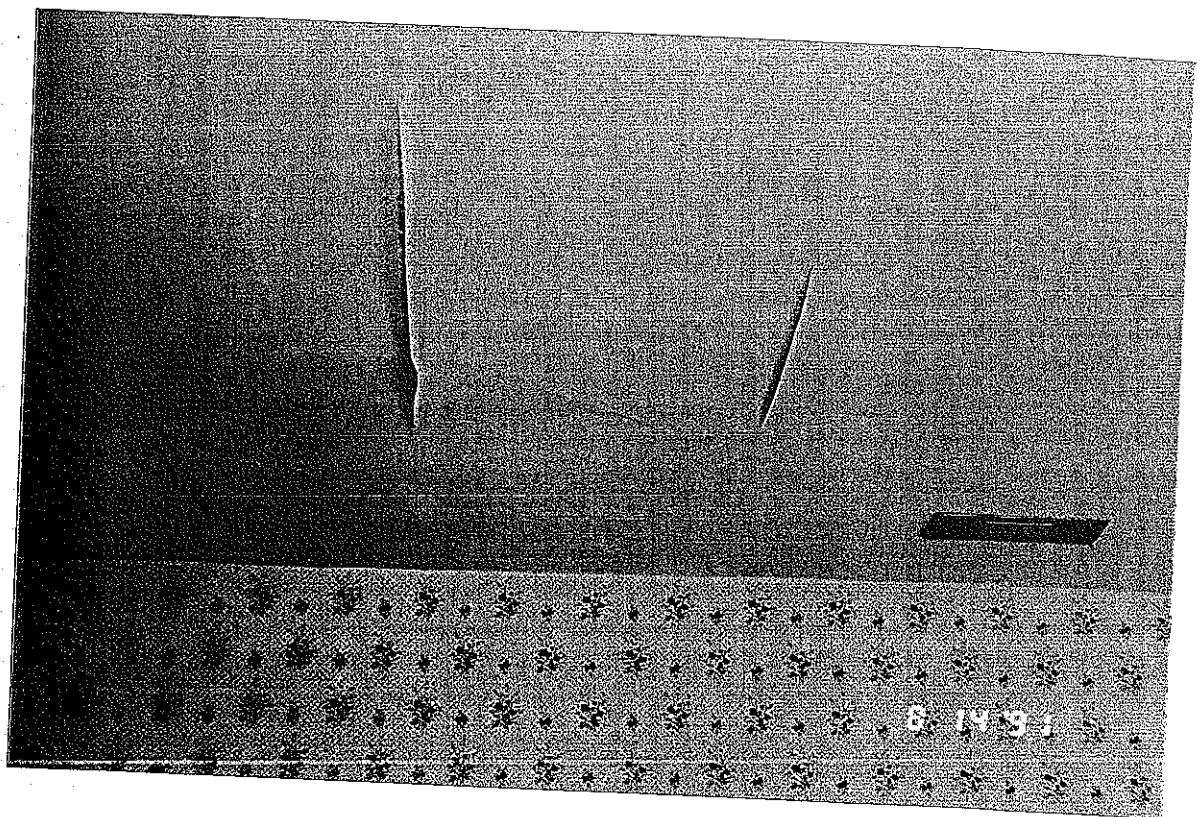
In the Stairwell, the leather wainscoat is peeling.

G. The leather wainscoat peeling at the Stairwell.

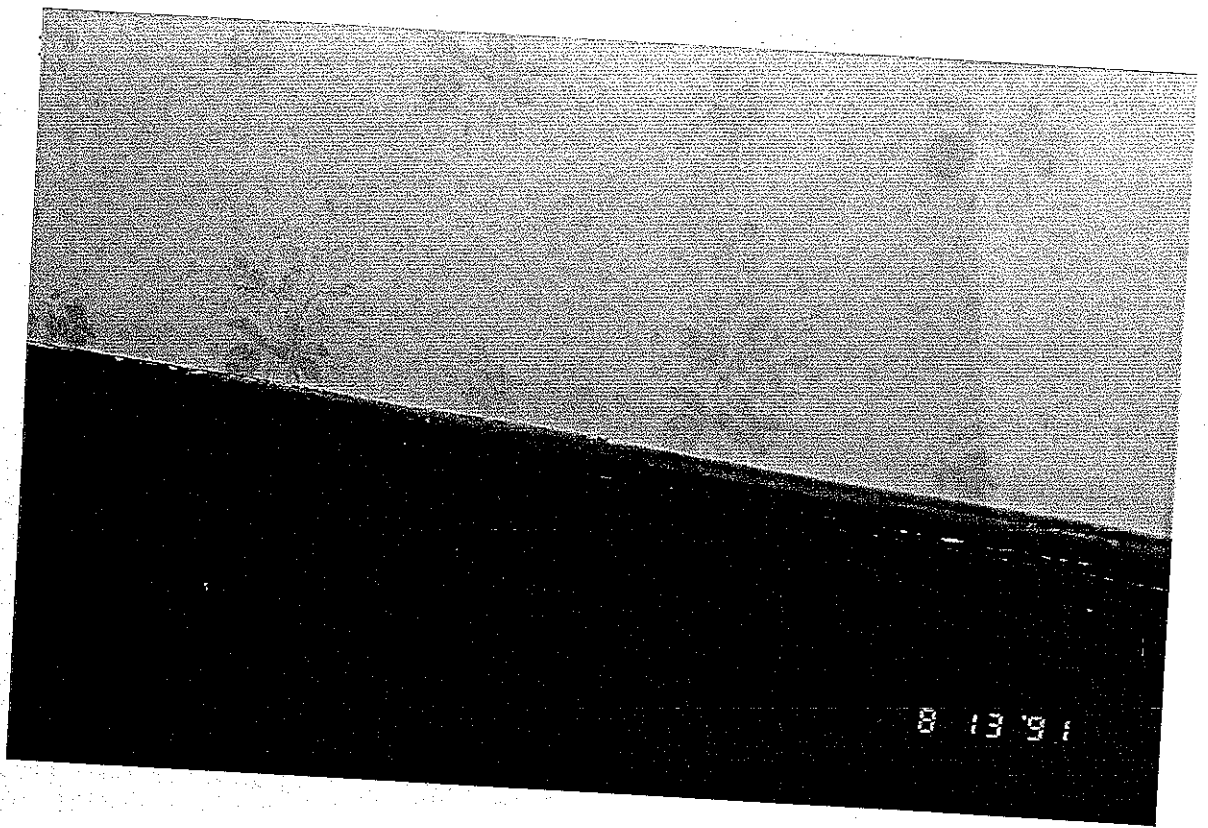
In Bedroom #2, stain mold was found around the entire room. This probably resulted from water entry through the doors to the porch. The wall paper is peeling at the chimney and at the ceiling.

H. Peeling wall paper at ceiling Bedroom #2.

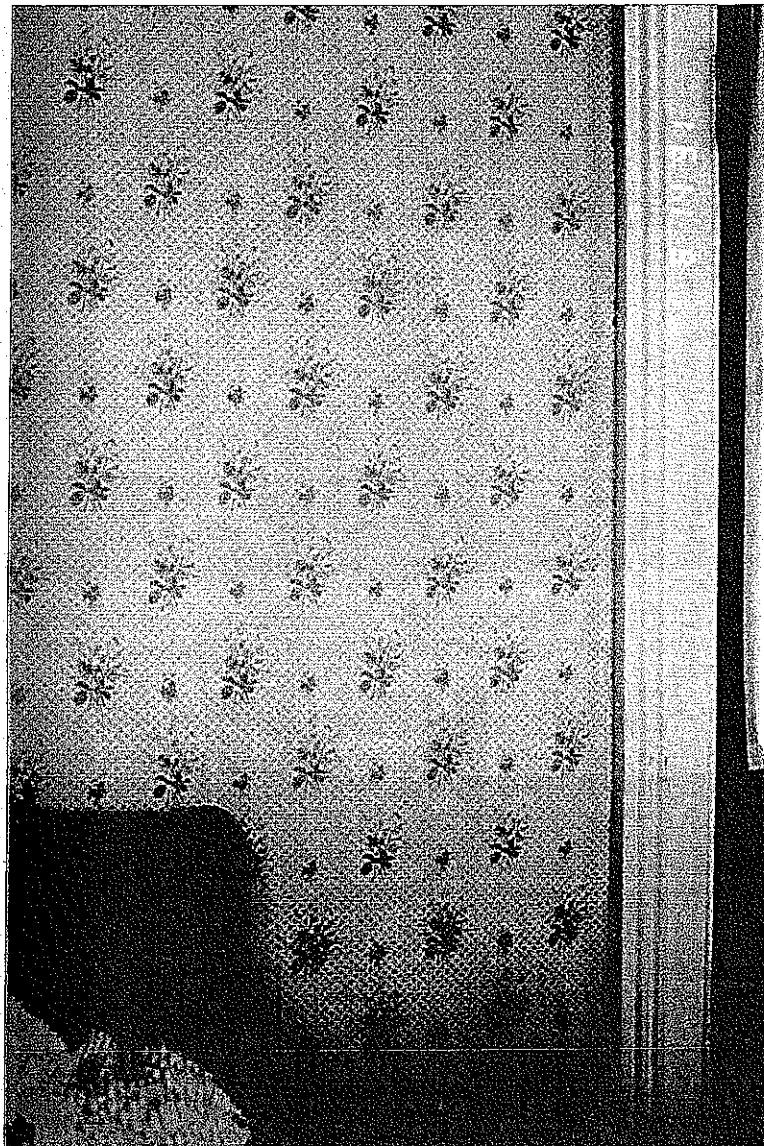
I. Stain mold on the base at the Hallway wall of
Bedroom #2.

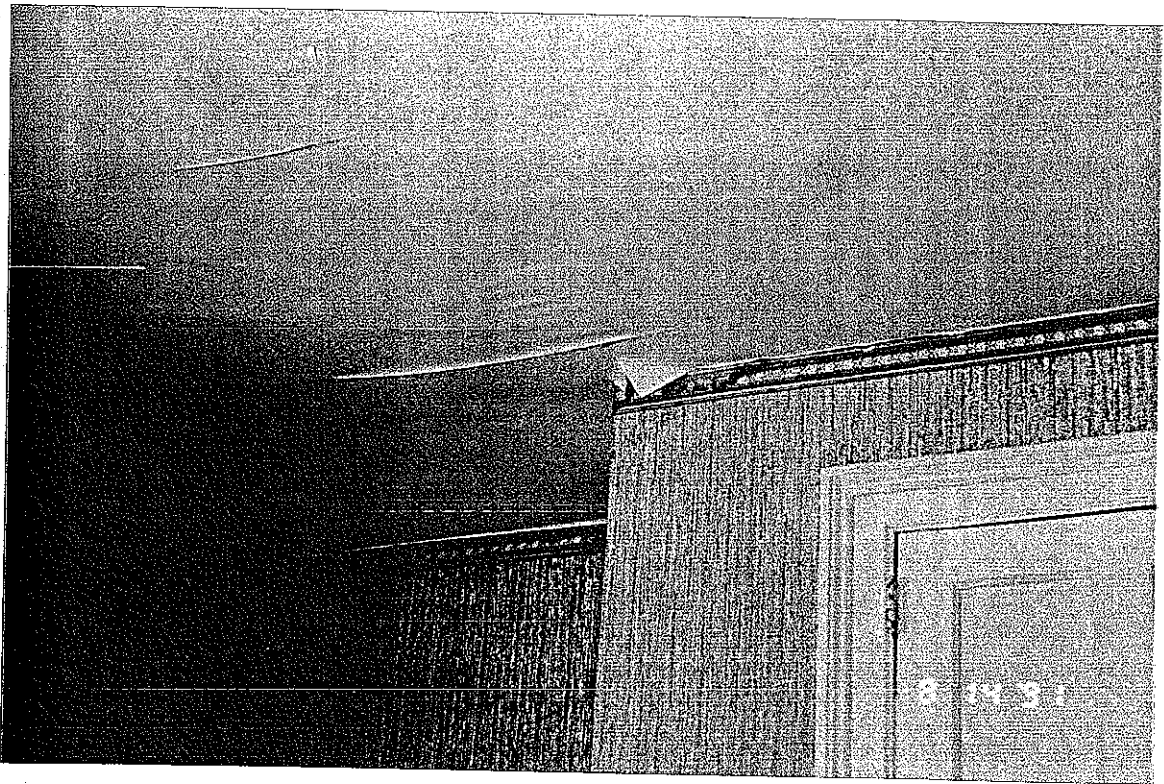
J. Stain mold on the front wall
of Bedroom #2.

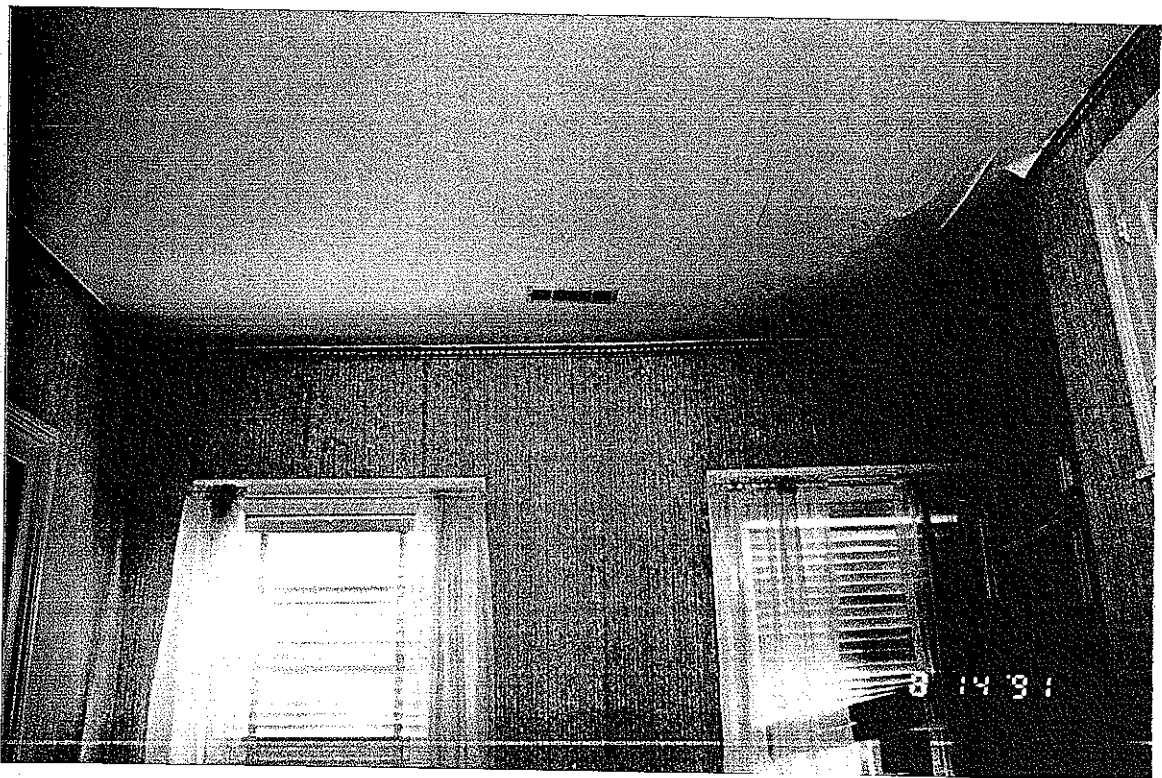
In Bedroom #3, the wall paper is peeling at the ceiling and there are mildew stains on the walls. There are tears in the wall paper in the north east corner. And there are water stains on the wall paper beneath the windows.

K. Peeling wall paper at the ceiling of Bedroom #3.

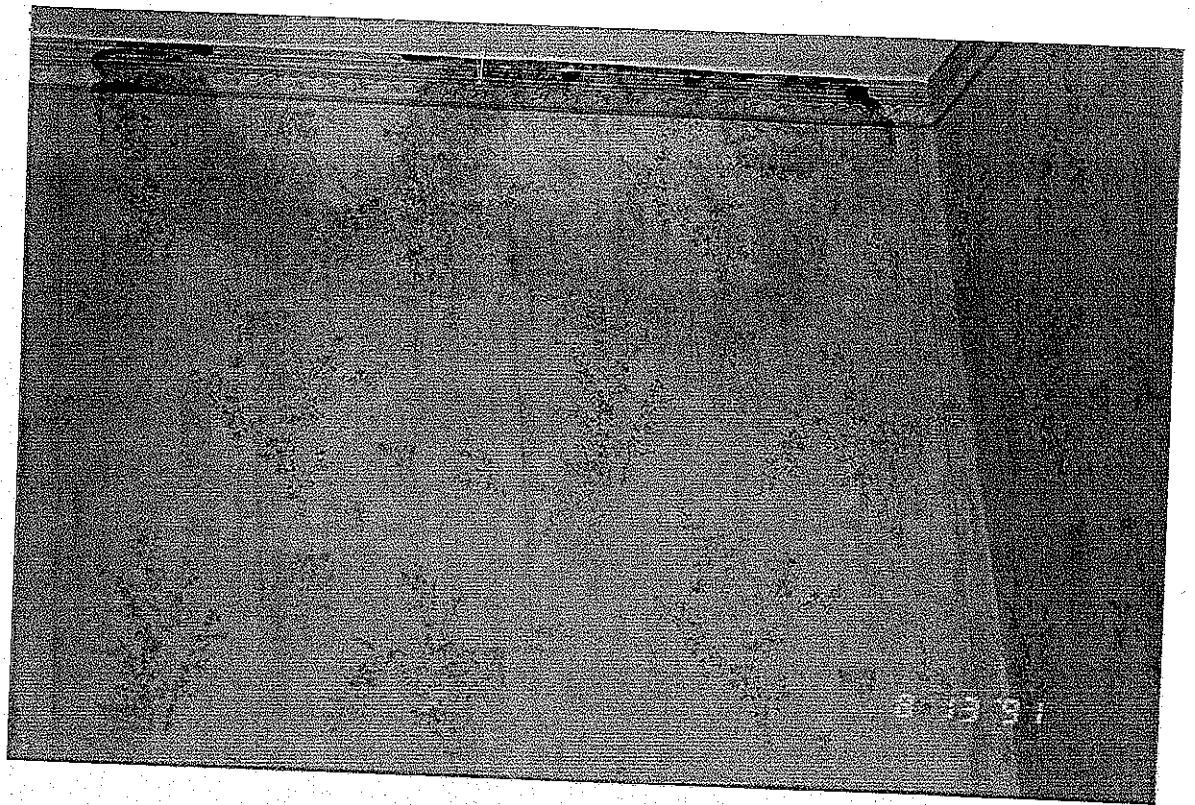
L. Stains on the wall of Bedroom #3.

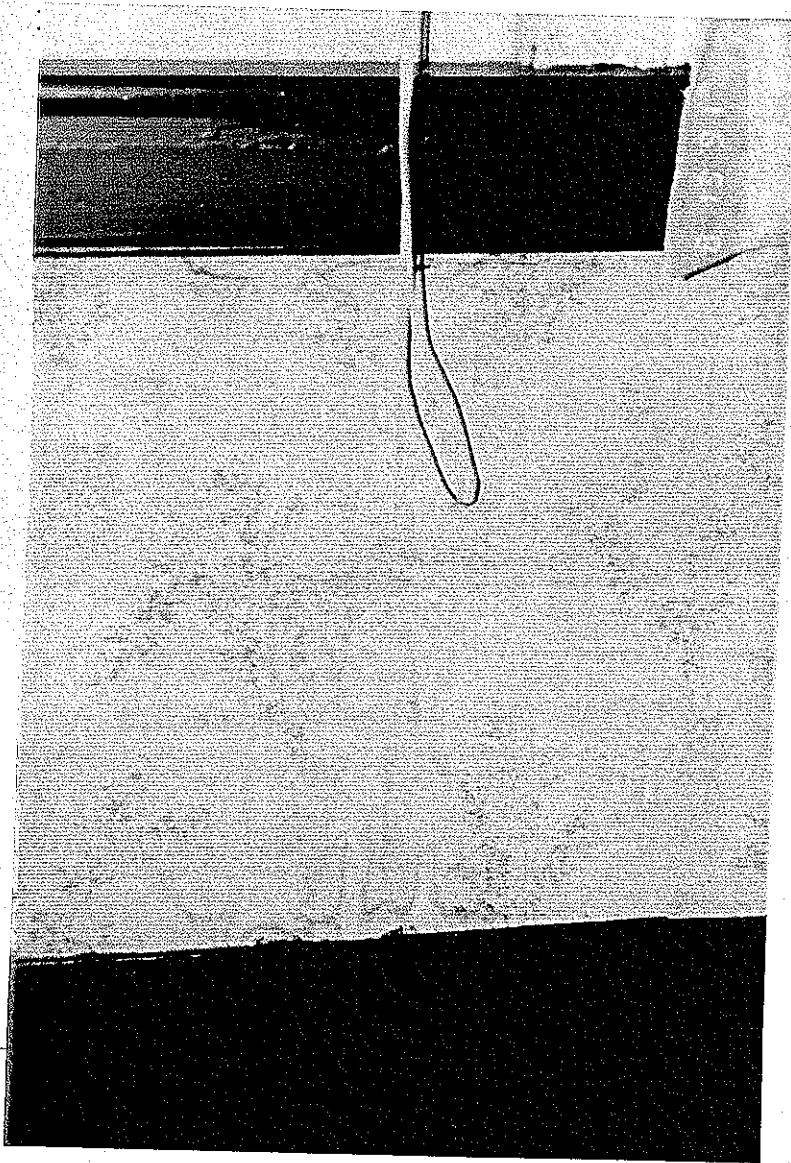
In Bedroom #4, there are water stains next to the ceiling, and stains at the windows at the east side. There are cracks in the back of the closet wall. The ceiling wall paper is peeling.

M. Stains on the rear wall of Bedroom #4.

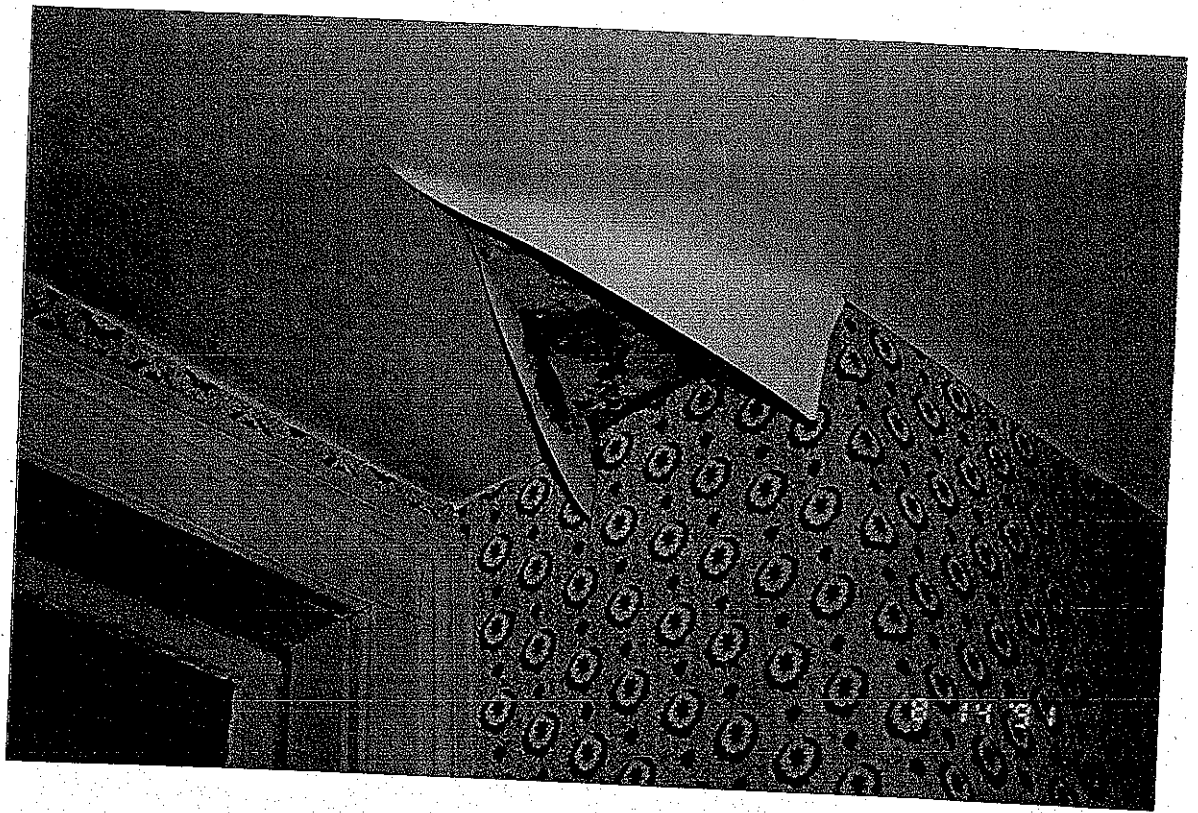
N. Stains on the east wall of Bedroom #4.
