# ST. JOHN'S REFORMED EPISCOPAL CHURCH EDUCATIONAL BUILDING

History, Conditions, and Treatments Report

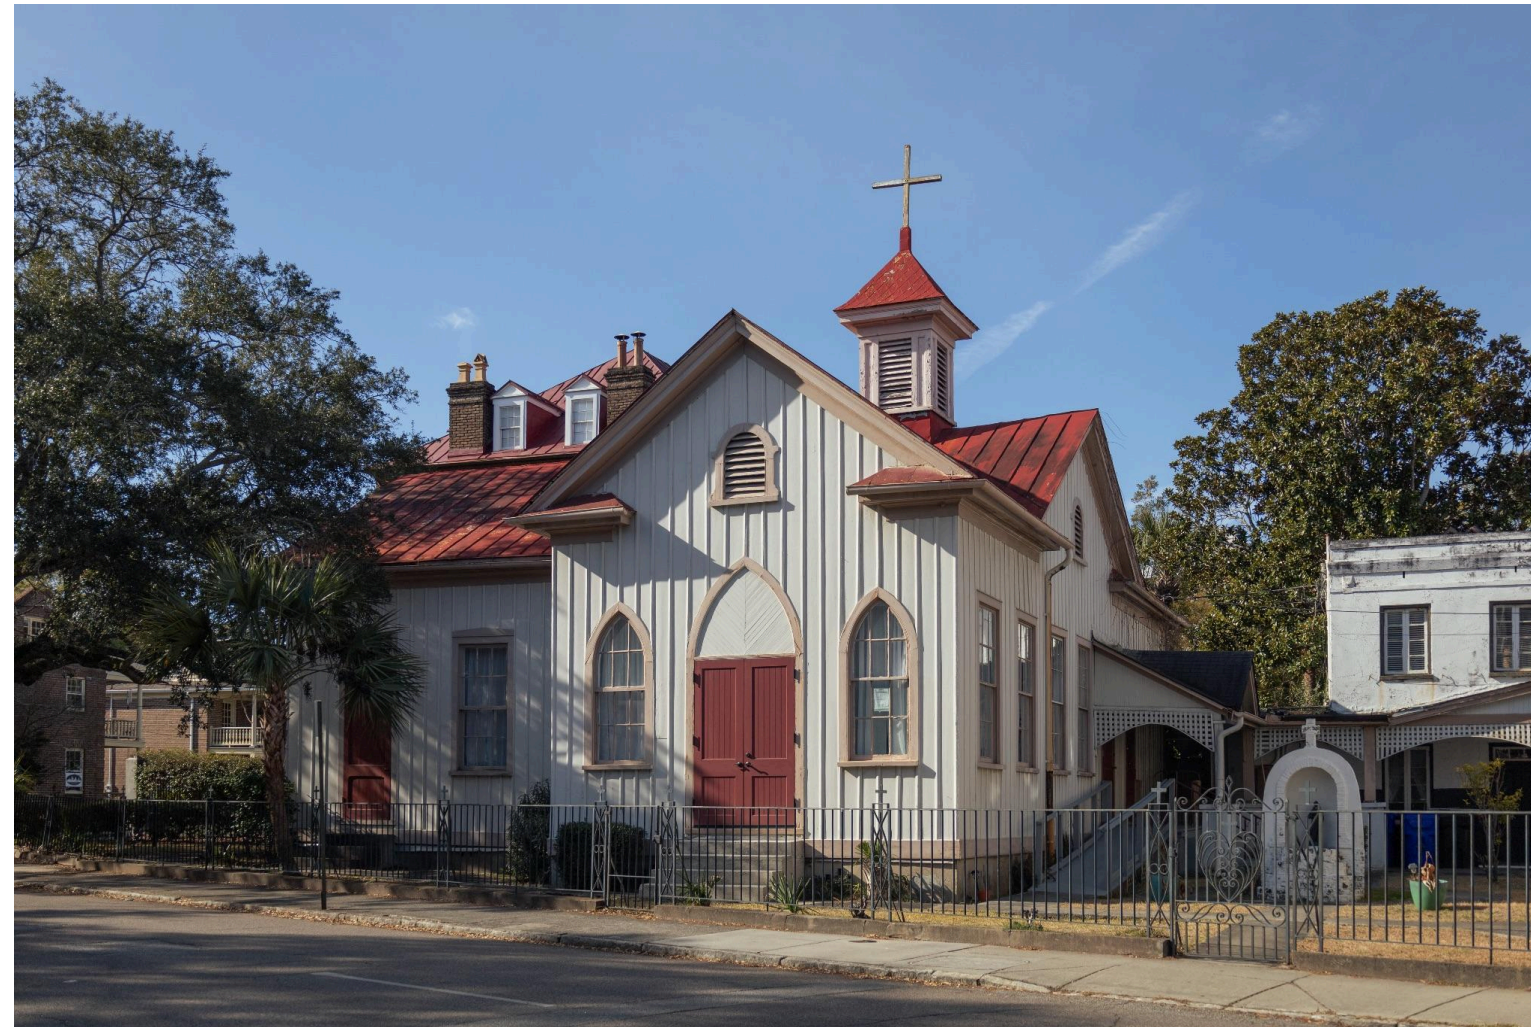
91 Anson Street  
Charleston, SC

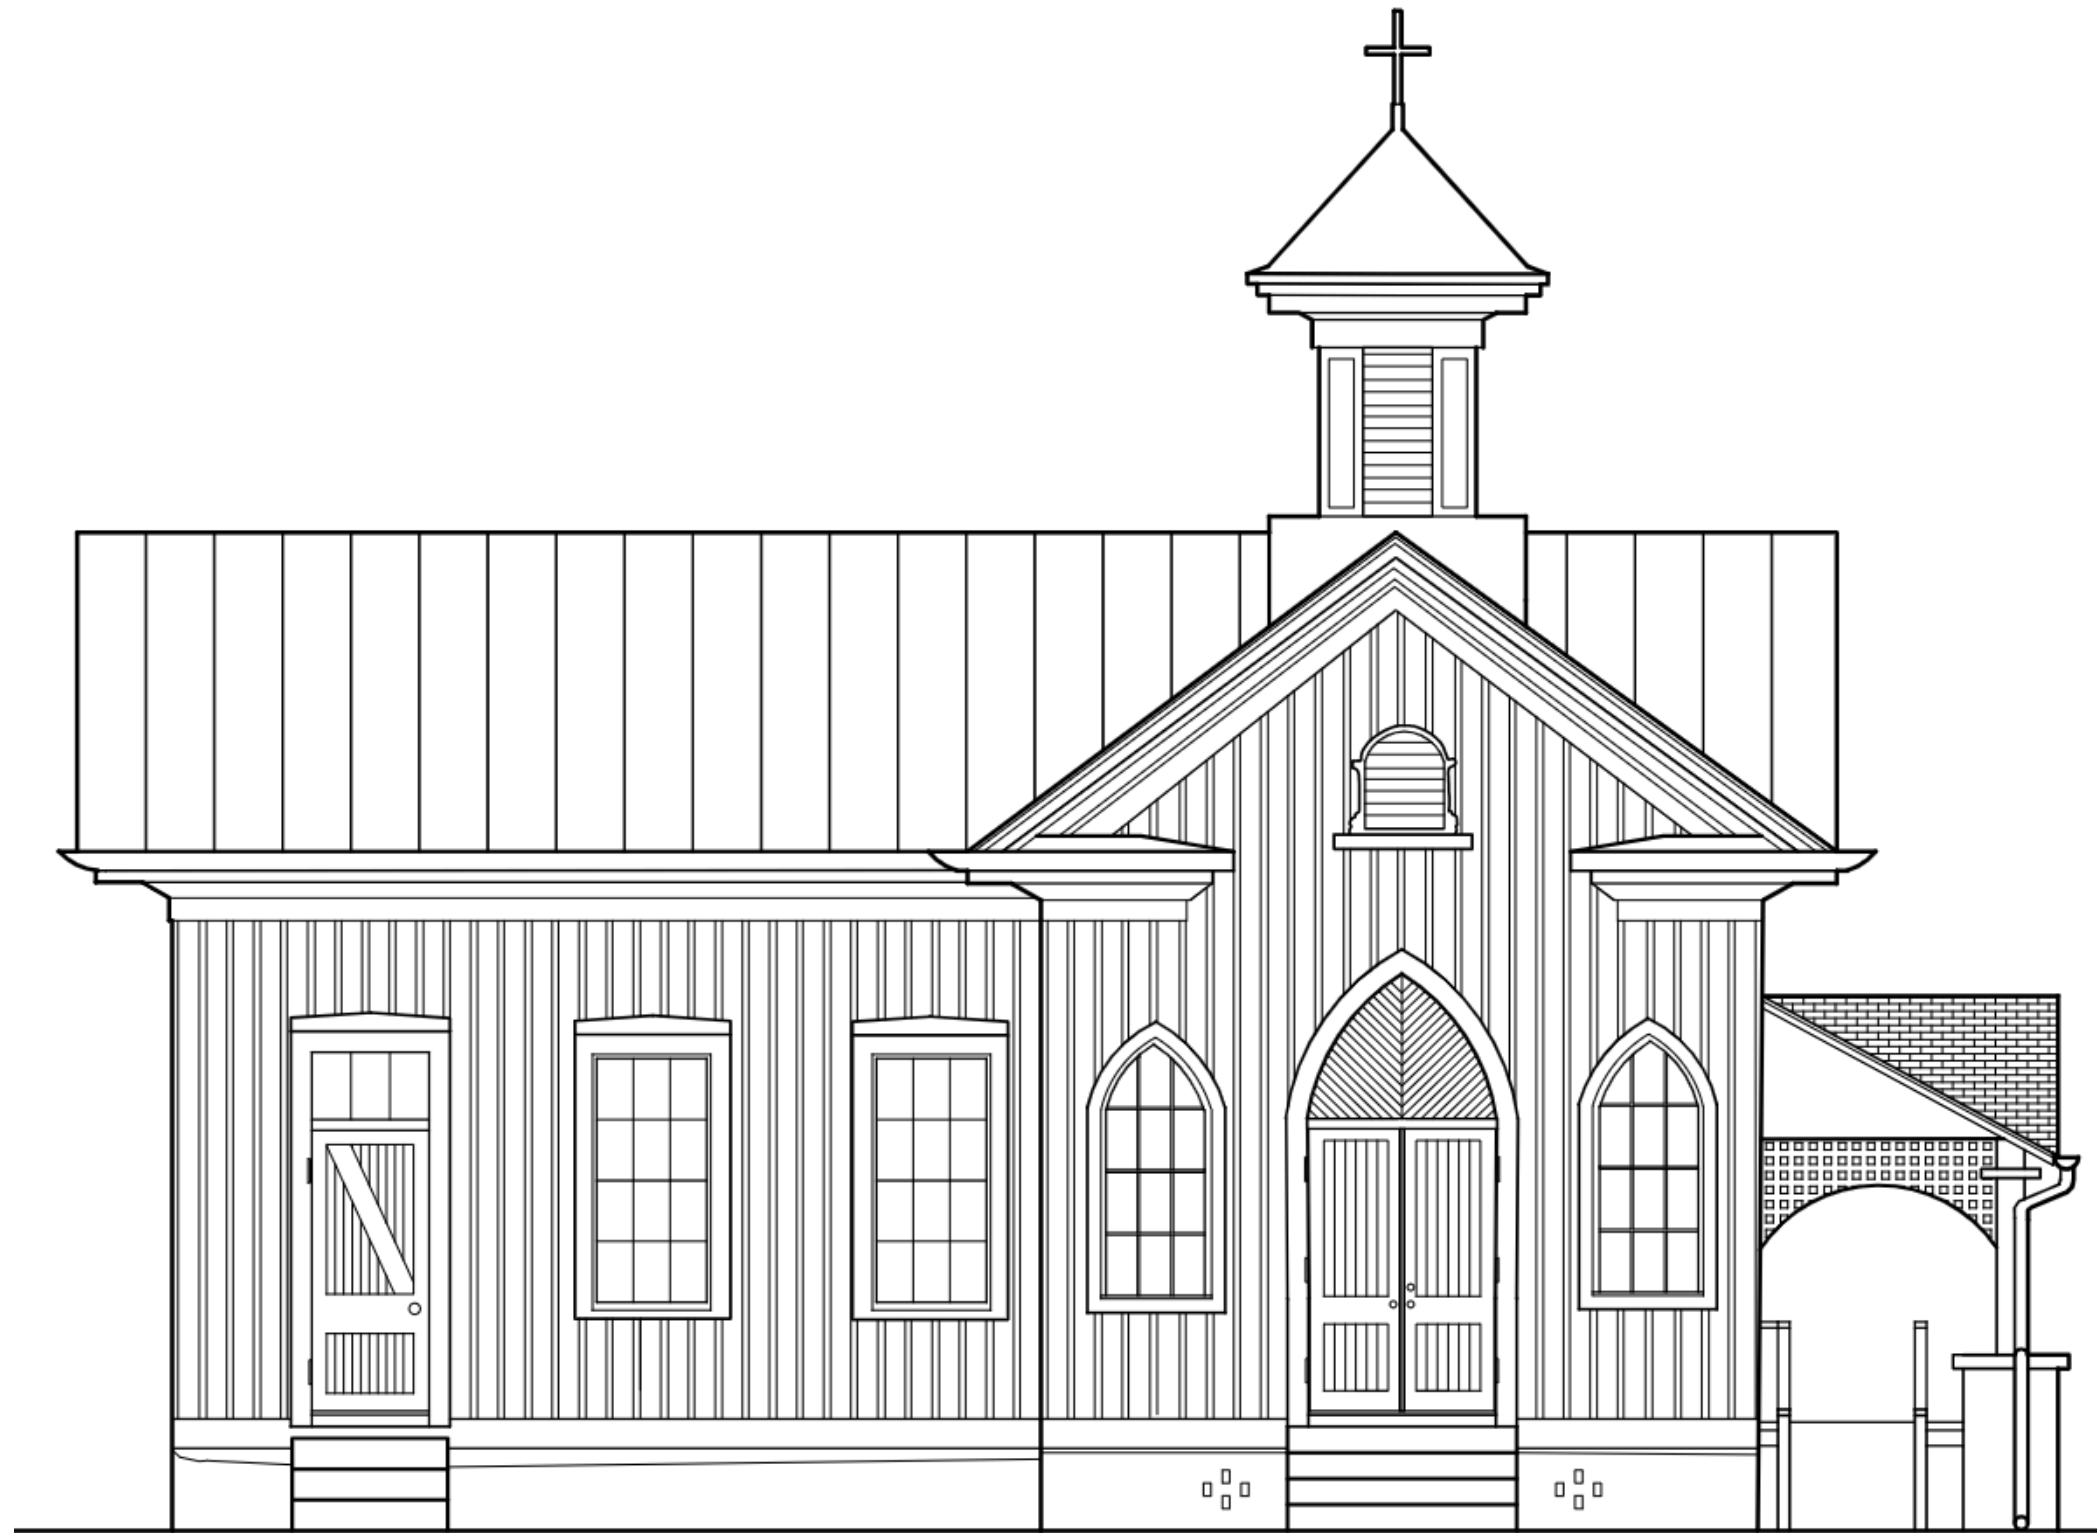
AutoCAD East Elevation Drawing  
By Jacob Mossbrook

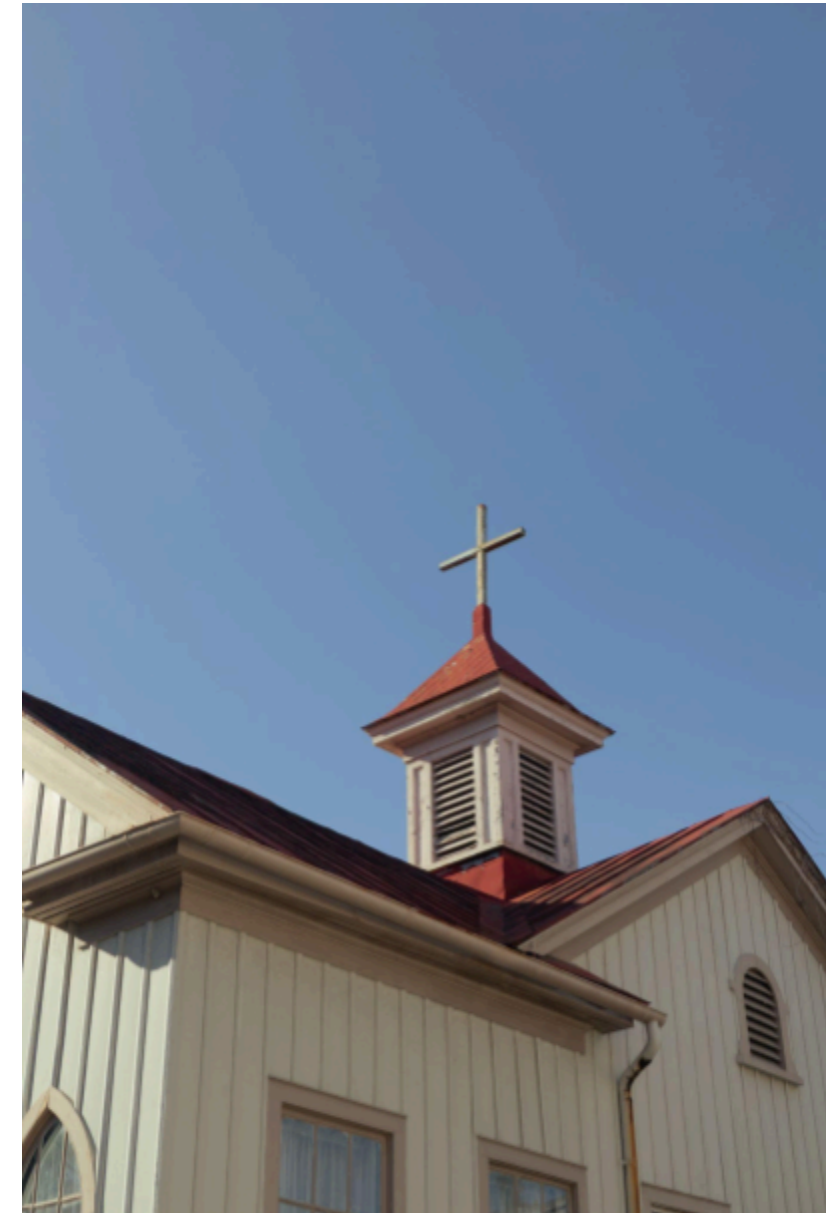
Photograph by Madison Pinion.

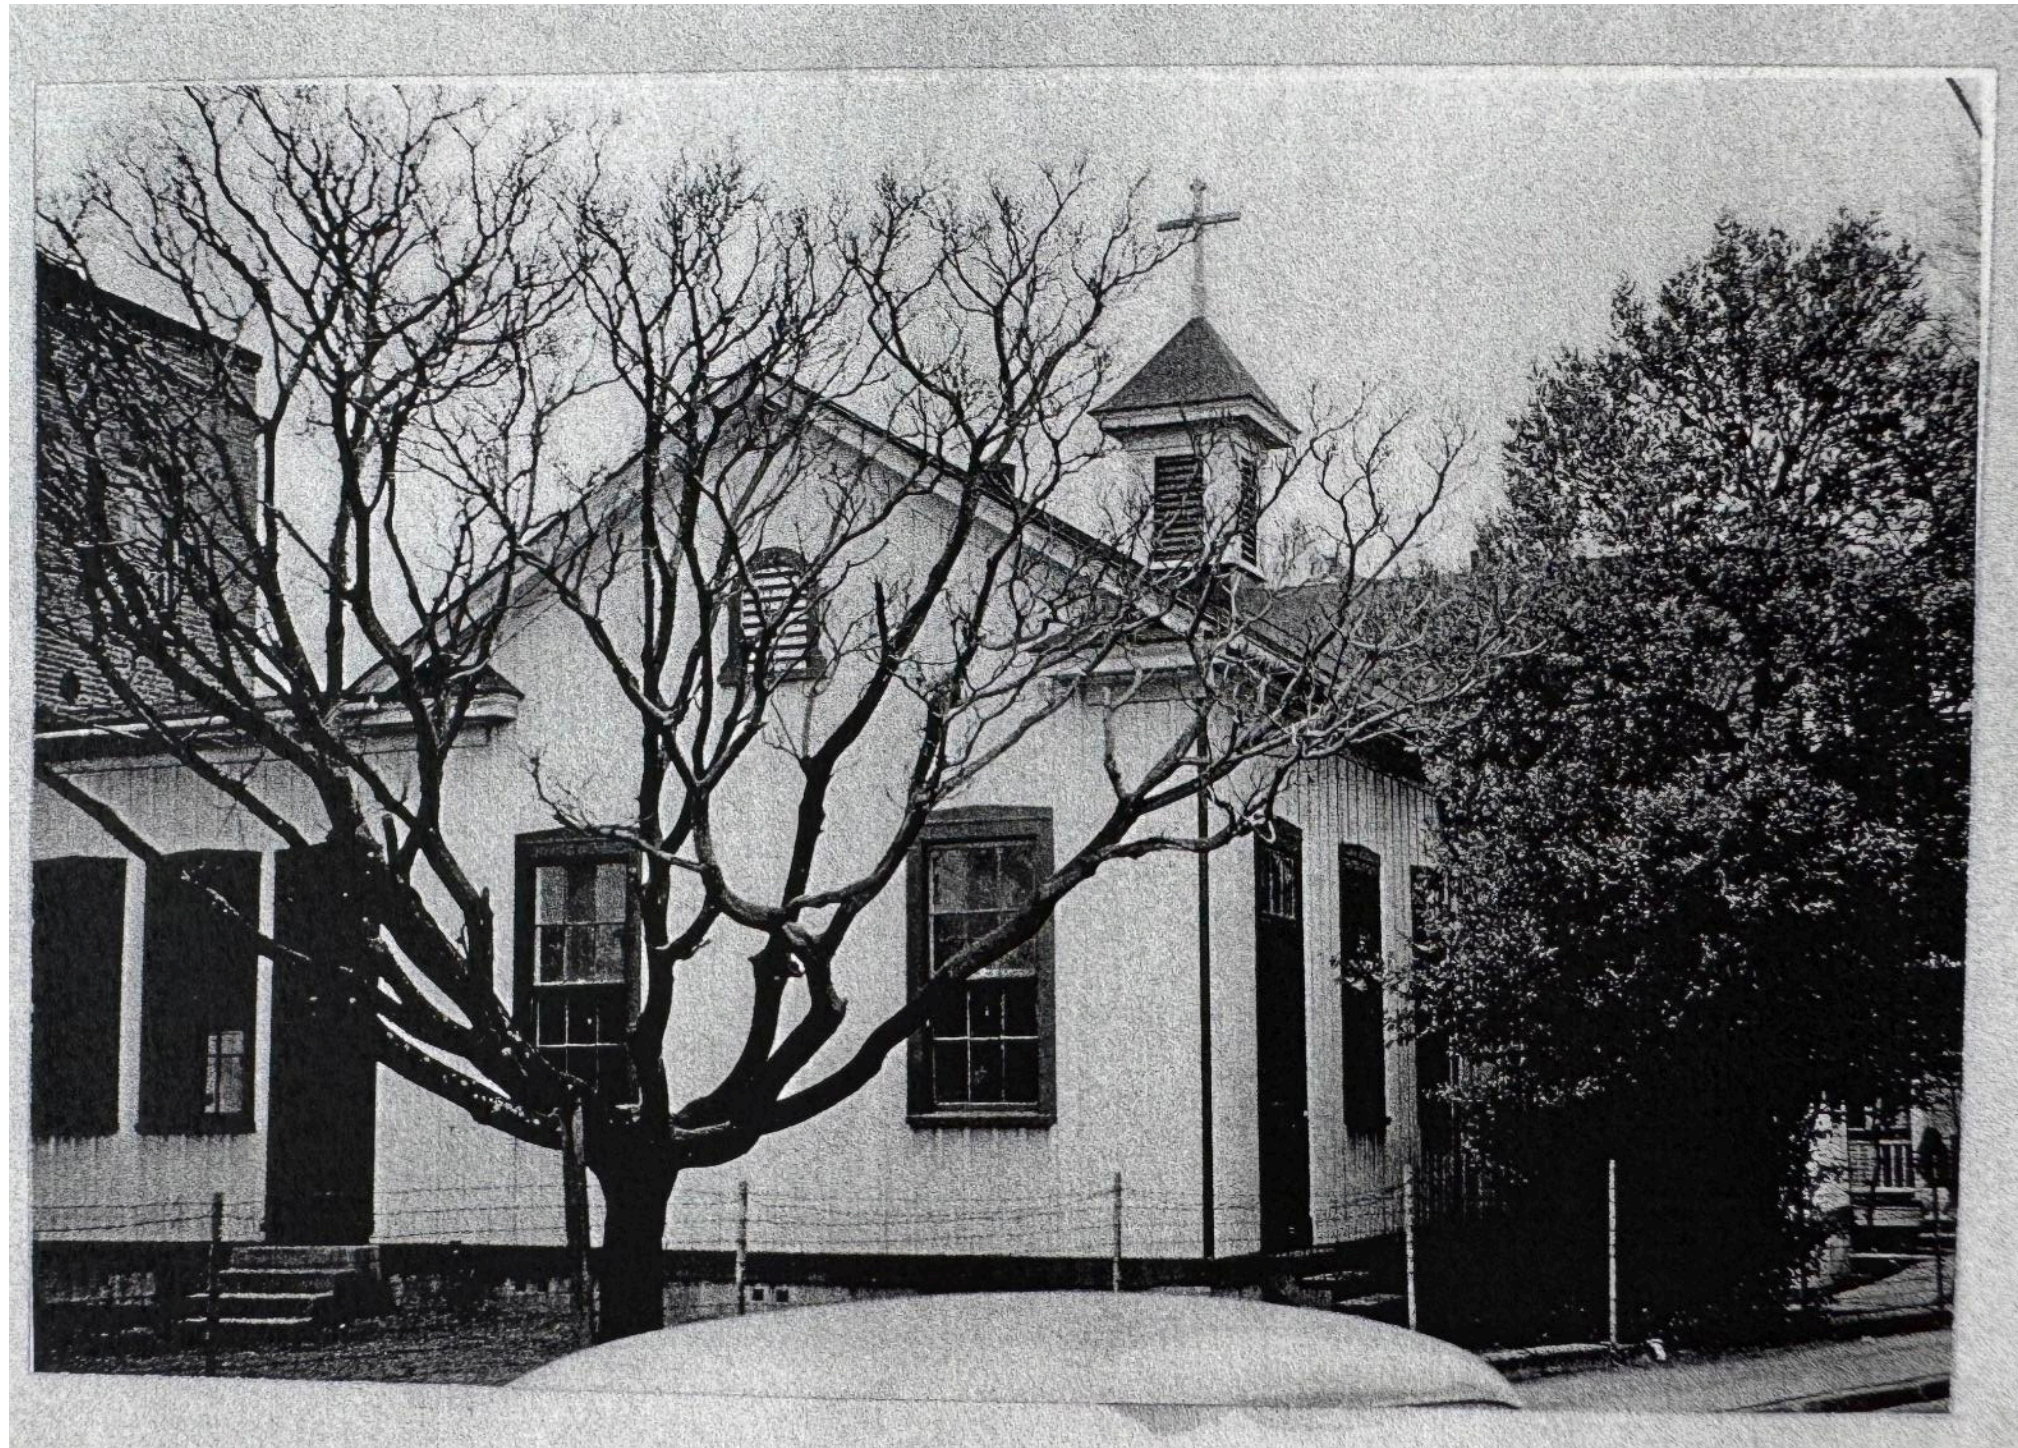
Undated, from Anson Street, Courtesy of The Roman Catholic Diocese of Charleston.

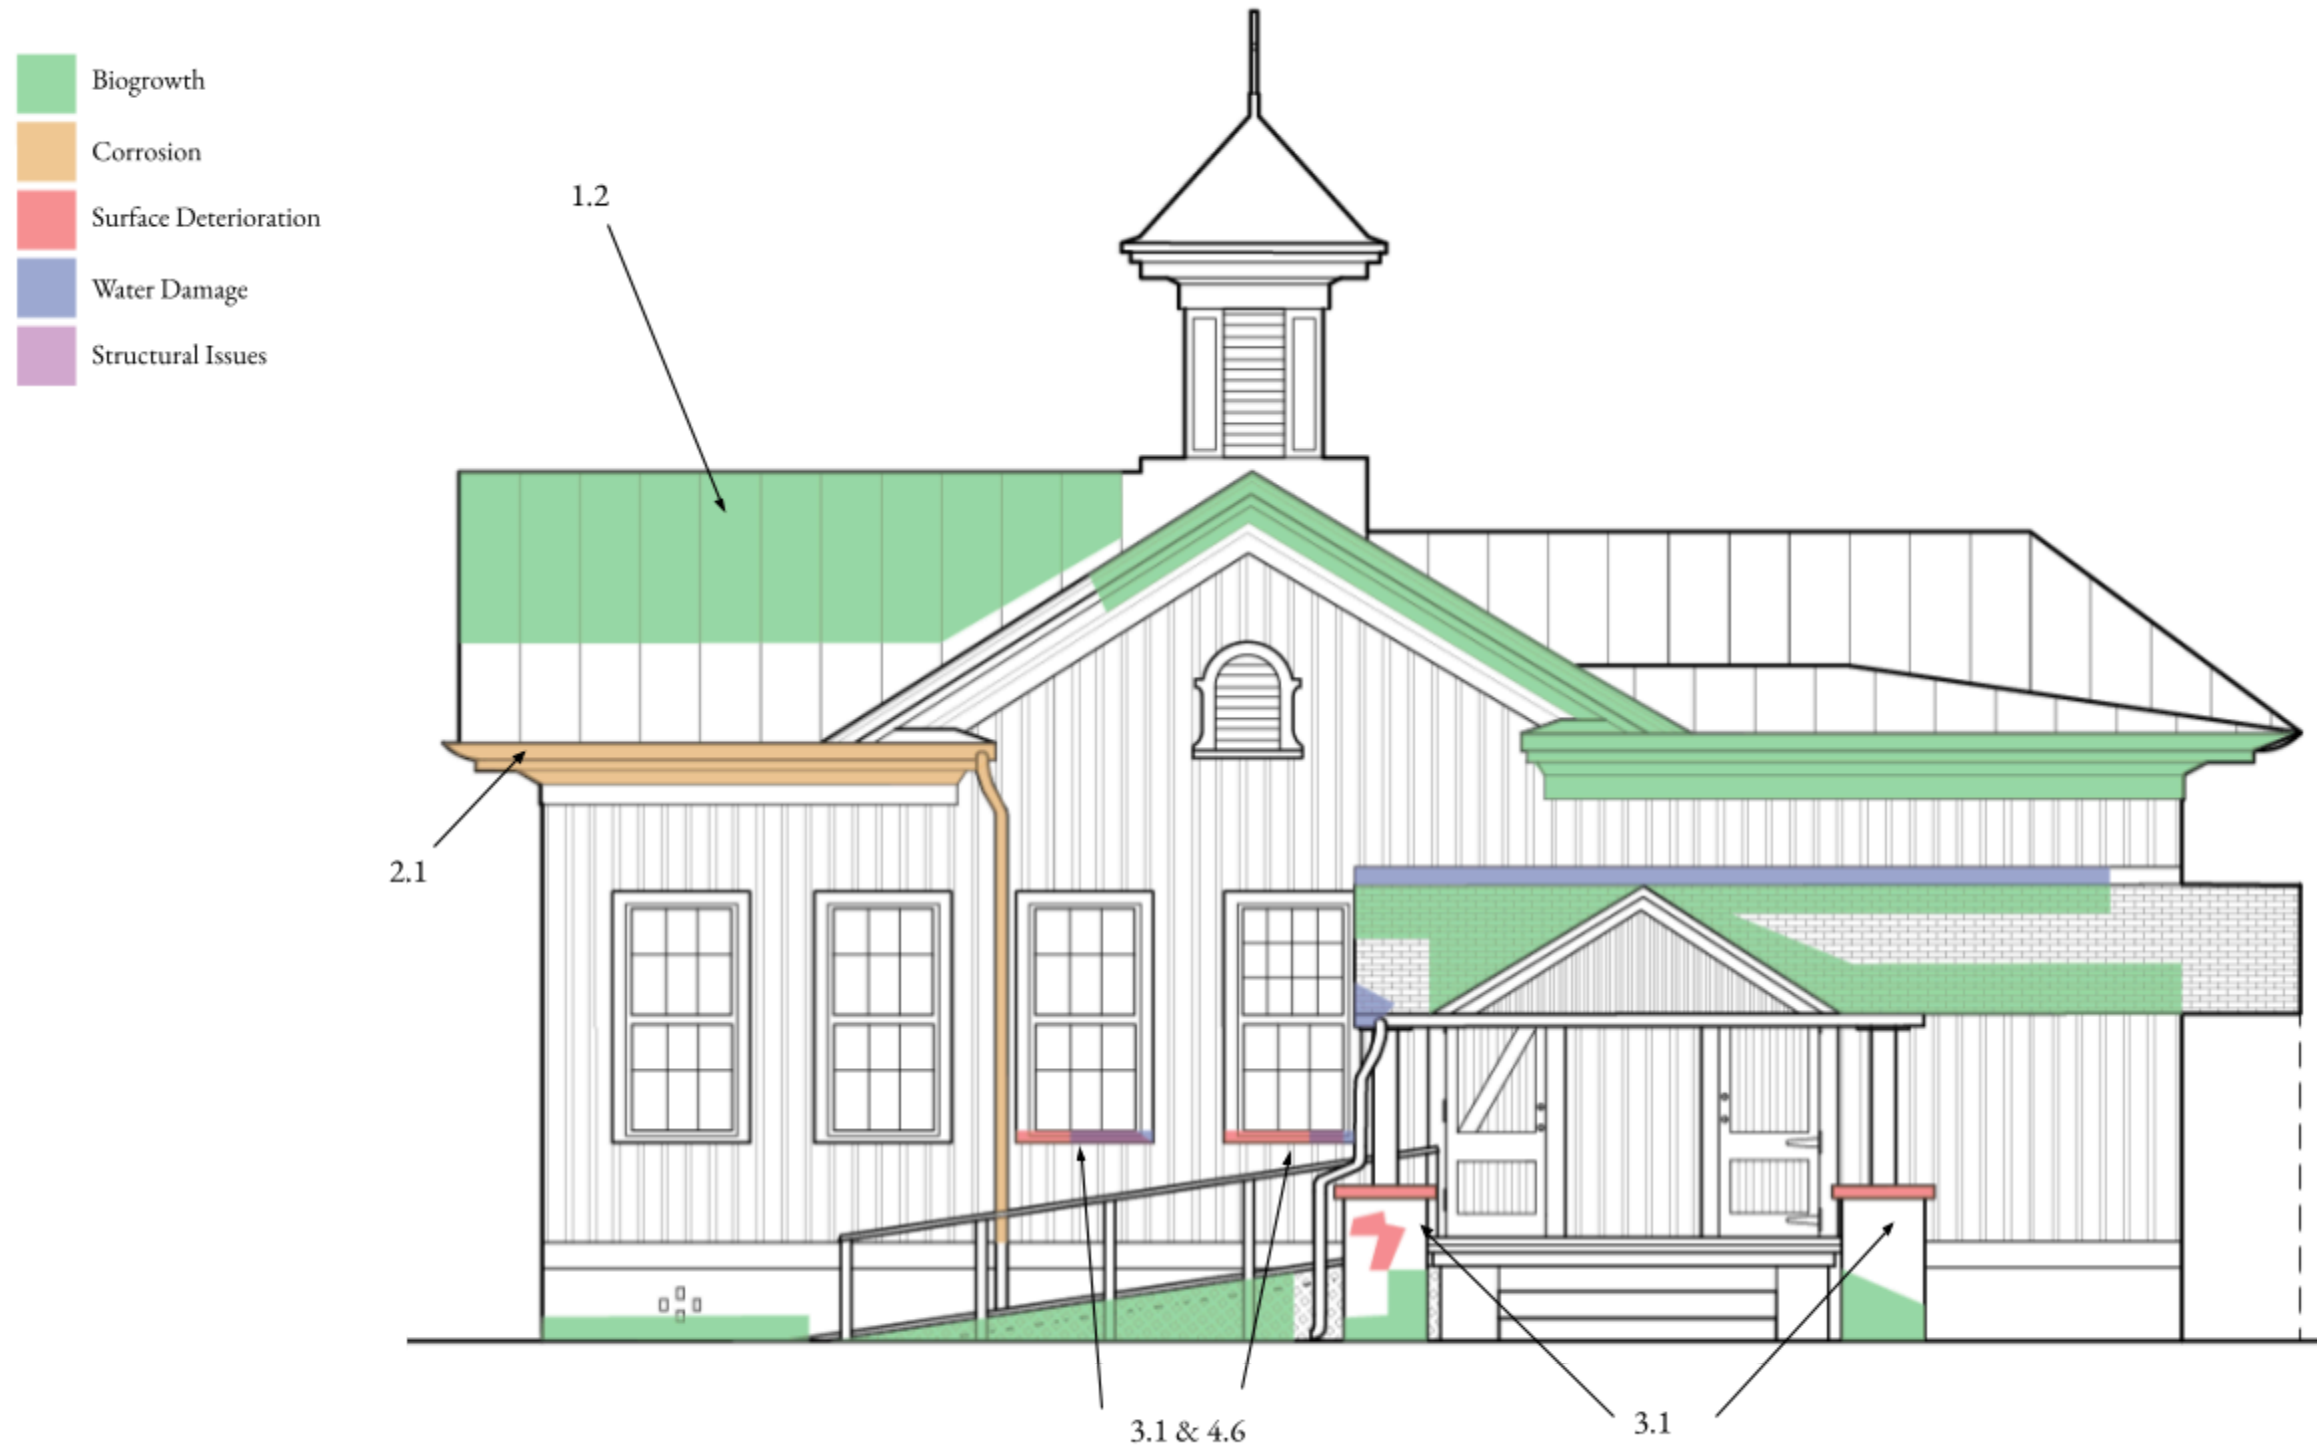
The North facade is in Fair condition. The oxidation on the drainage pipe poses a significant threat to the wood siding over time. Vegetation has spread from the north side of the facade to the peak of the roofline. Both window sills are weathered from water damage.

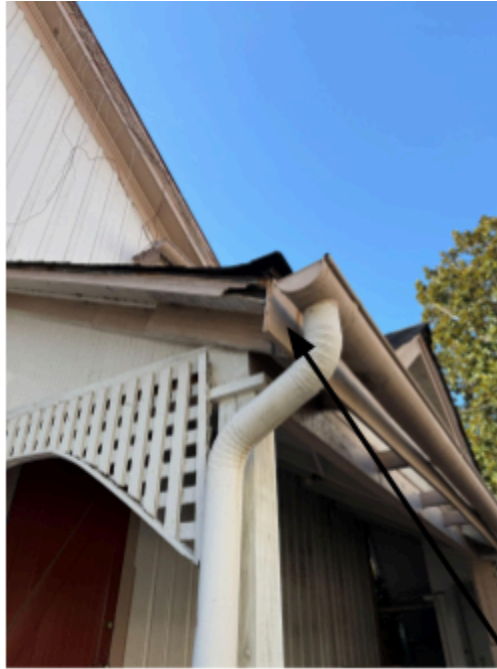
Water intrusion on porch overhang.

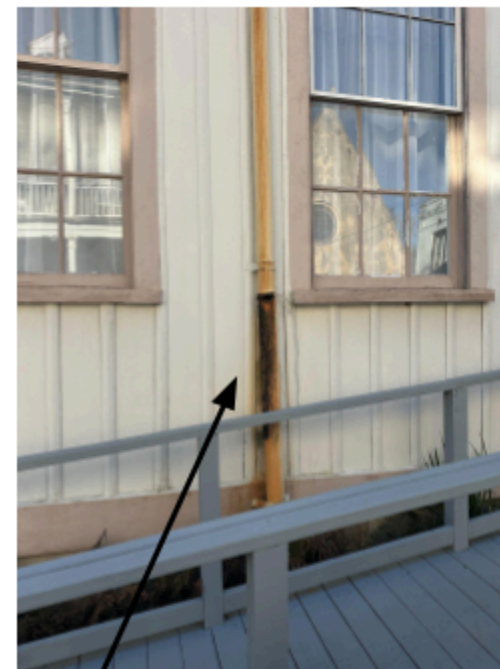
Weathered window sill.

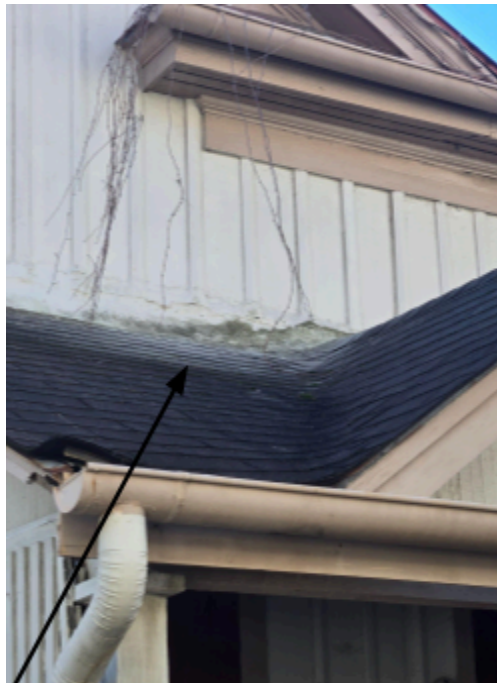
Mold at porch to siding connection.

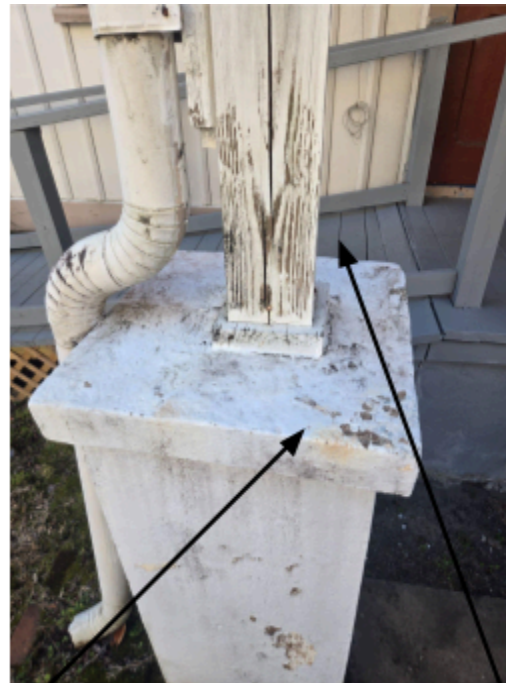
Water damaged support post and base.

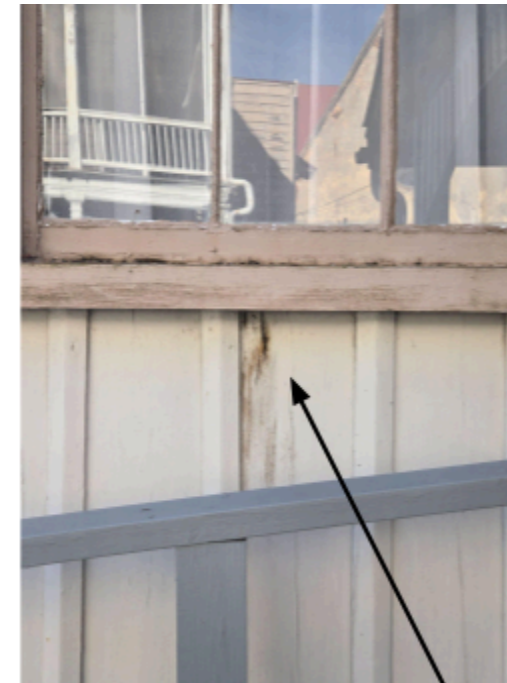
Rot under window opening.

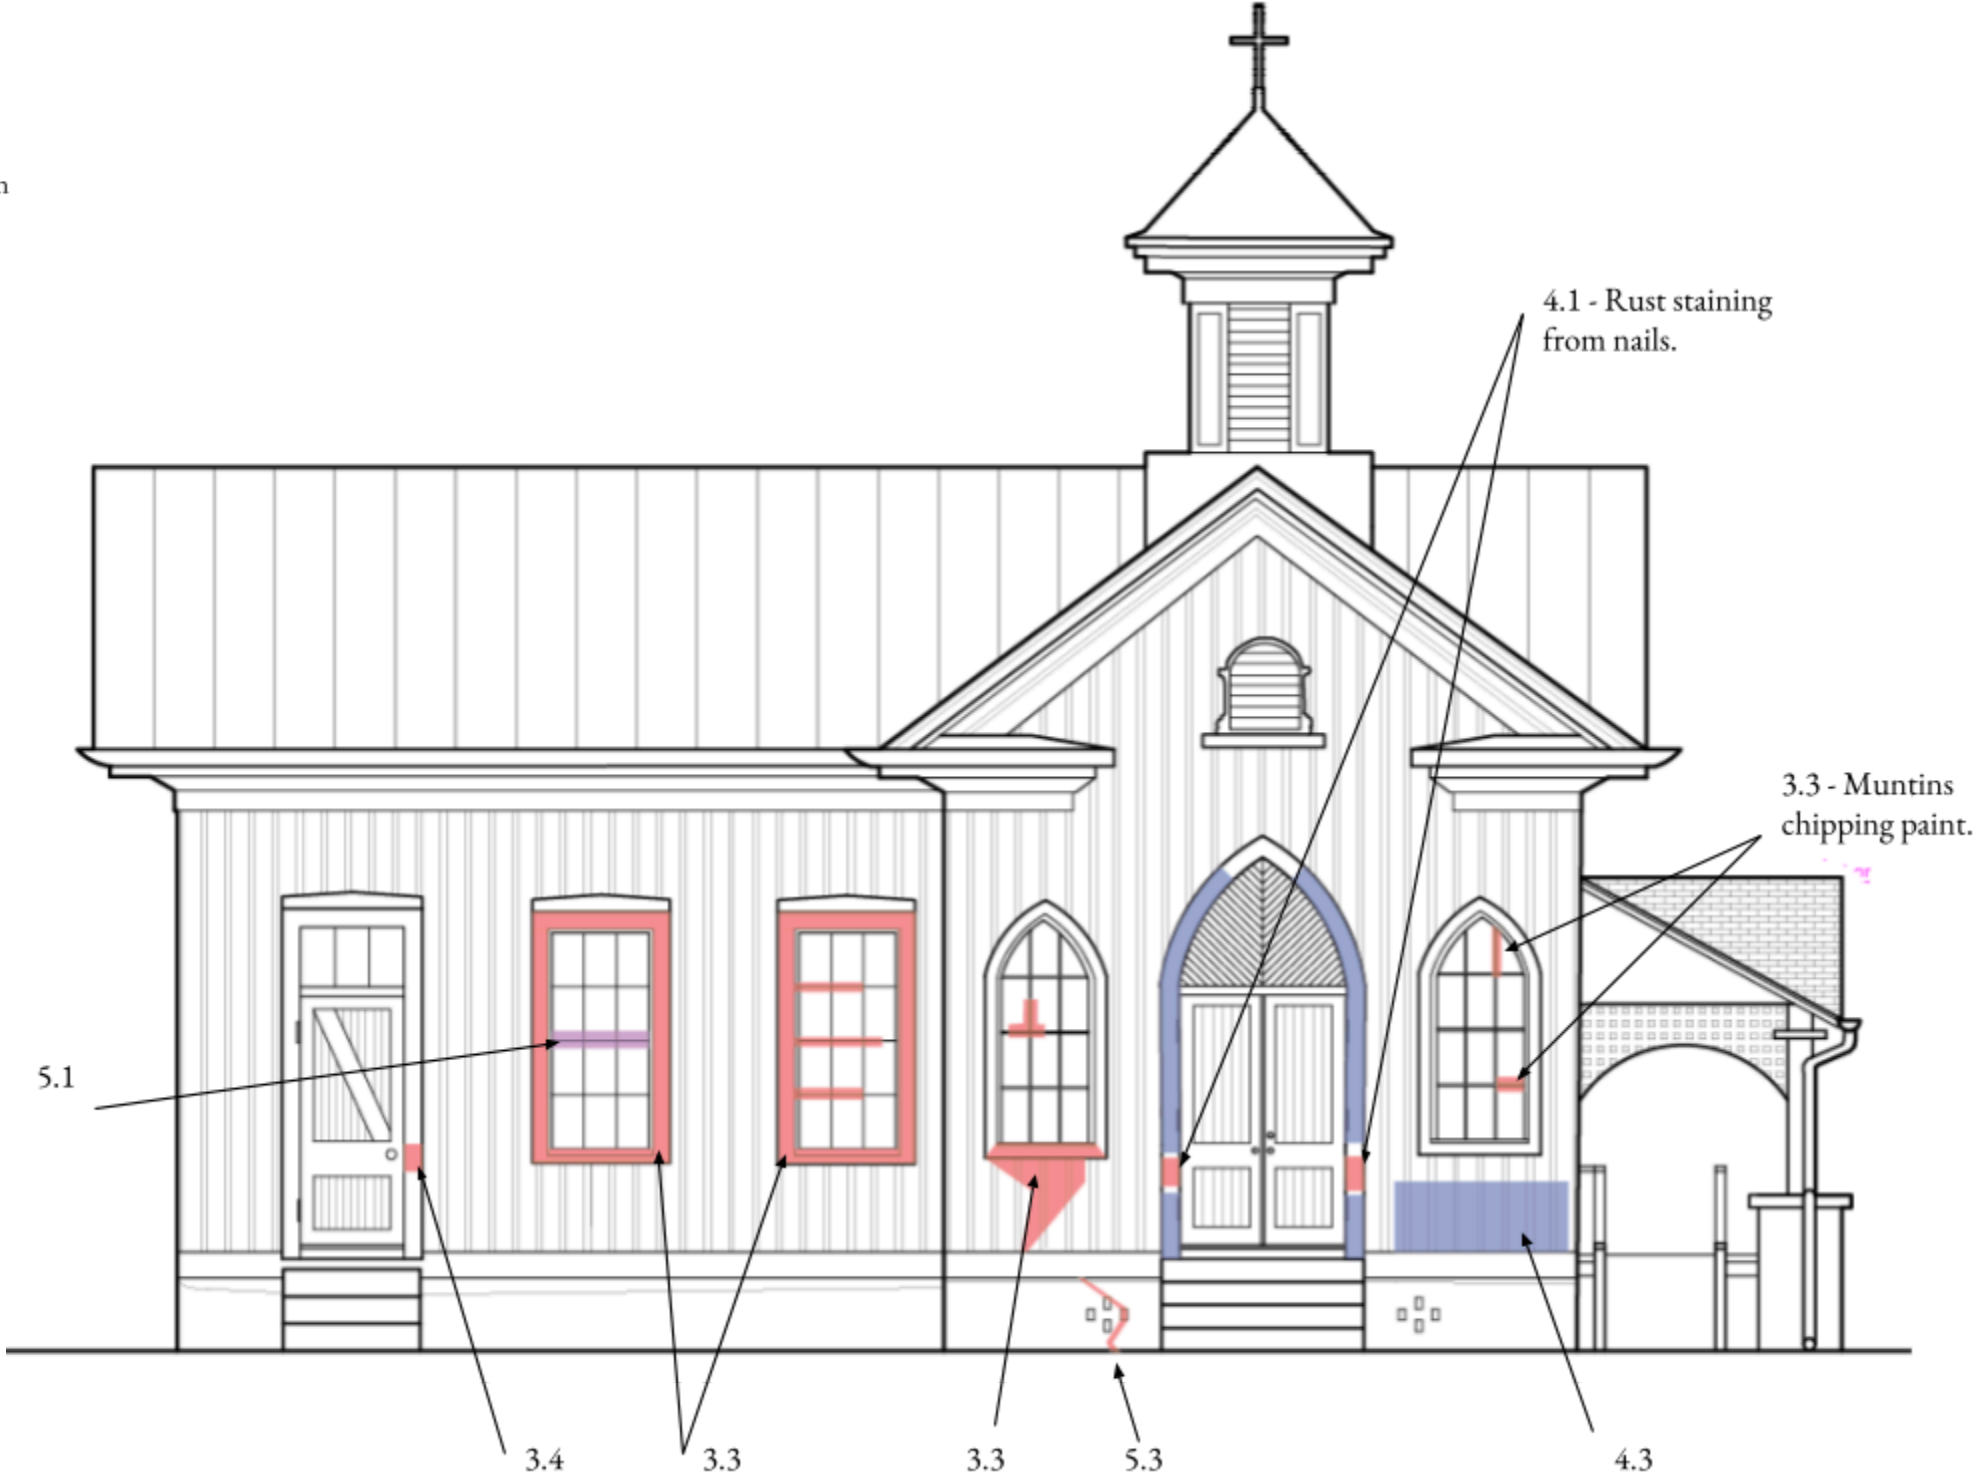
- Biogrowth
- Corrosion
- Surface Deterioration
- Water Damage
- Structural Issues

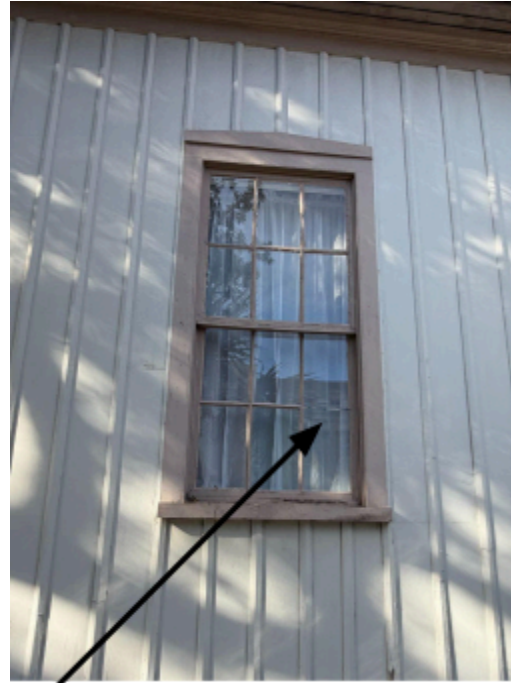
Missing window muntin.

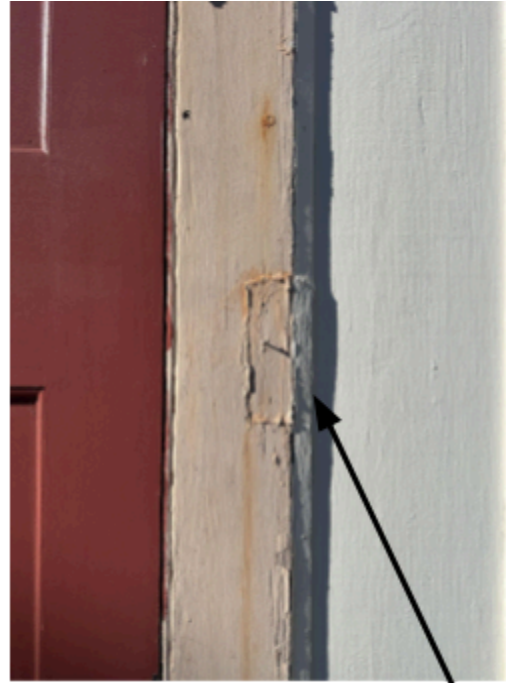
Patching on door frame.

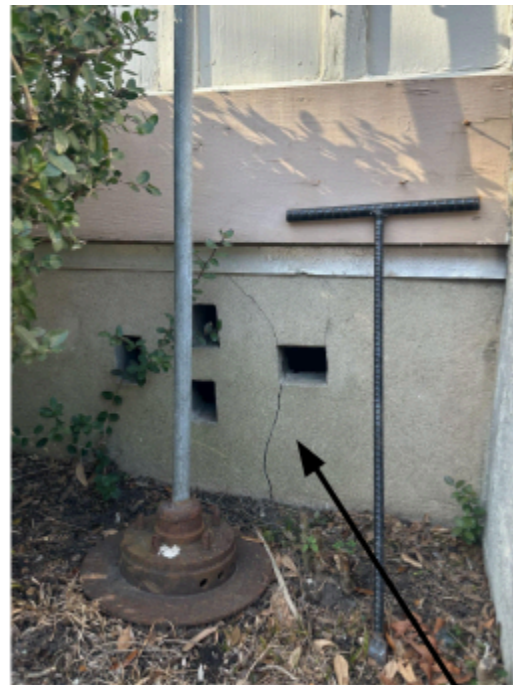
Structural foundation cracking.

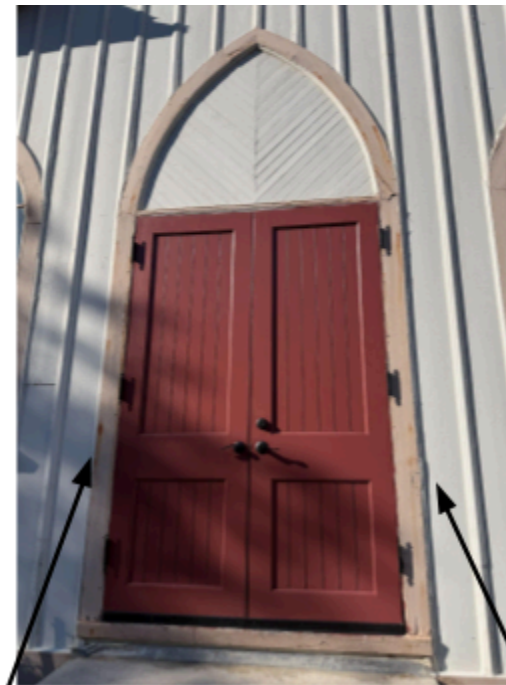
Patina from corrosion on door frame.

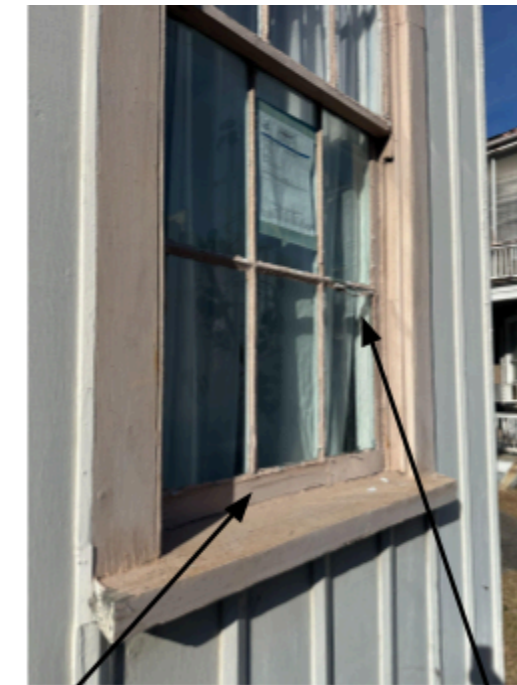
Water damage to window frame.

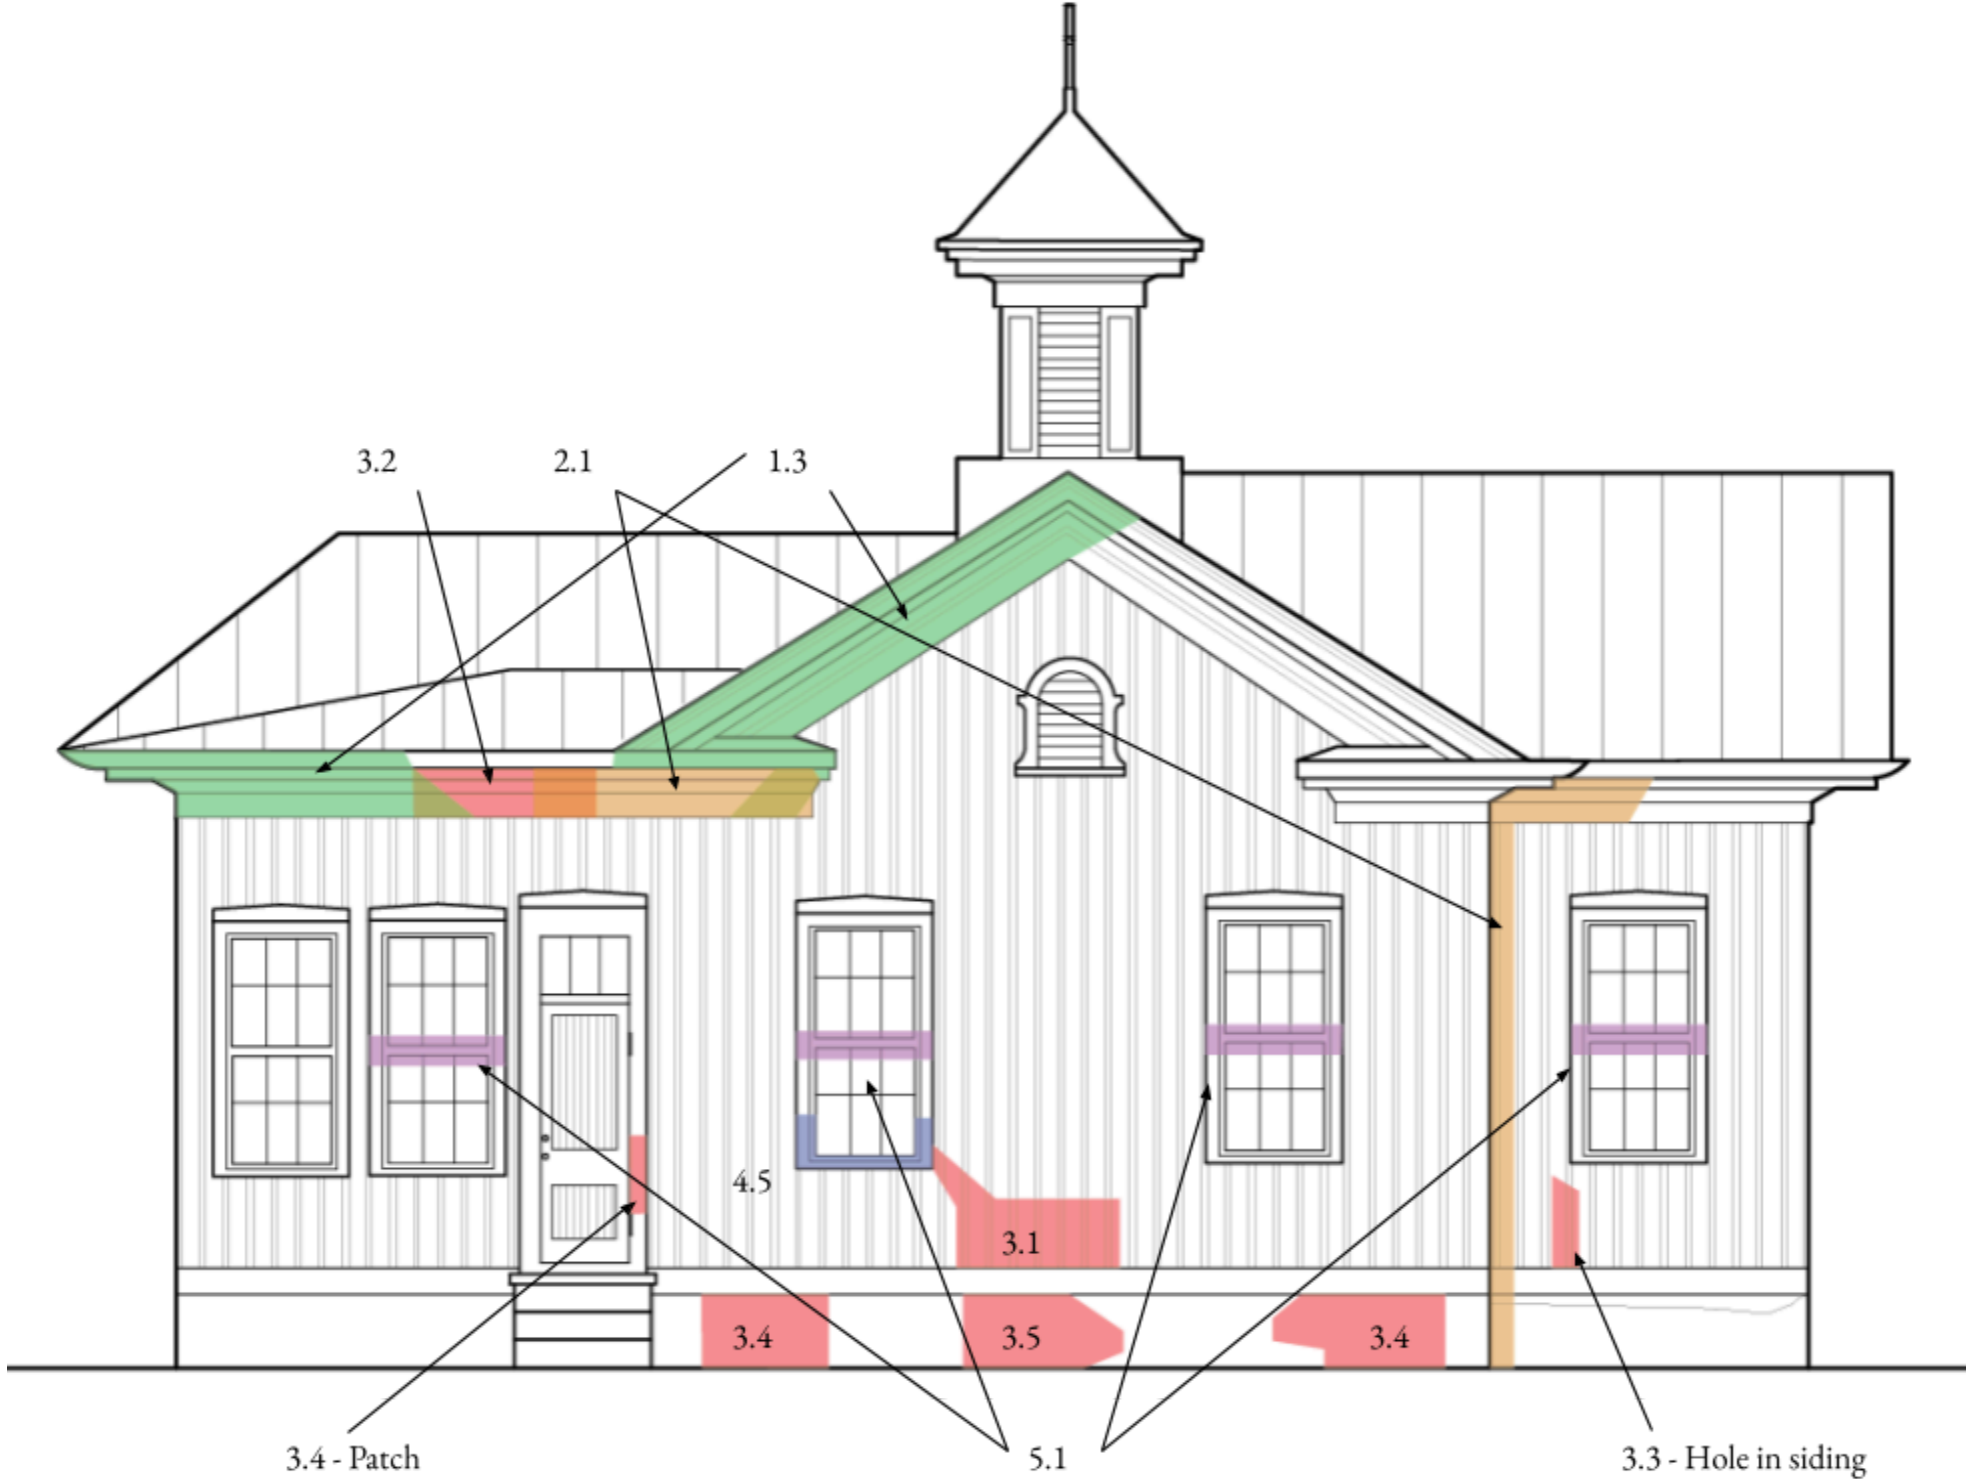
- Biogrowth
- Corrosion
- Surface Deterioration
- Water Damage
- Structural Issues

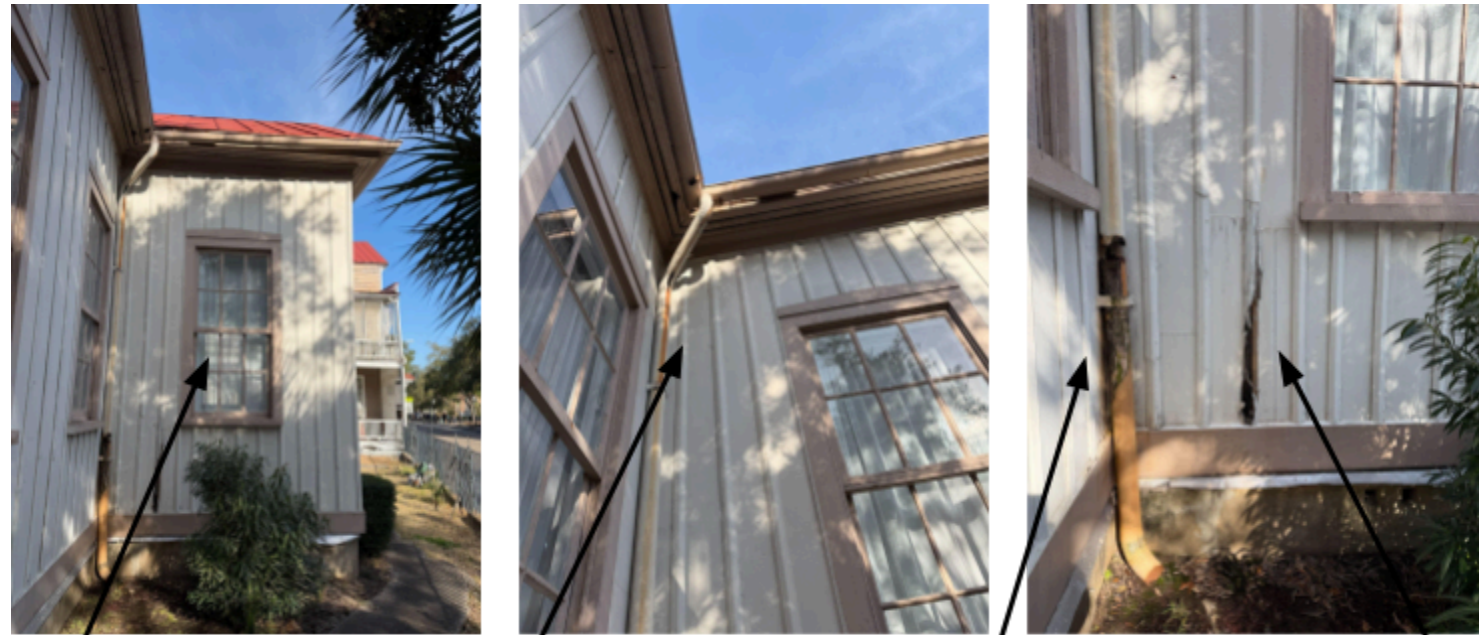
Sagging window sash.
