# ST. JOHN'S REFORMED EPISCOPAL CHURCH EDUCATIONAL BUILDING

History, Conditions, and Treatments Report

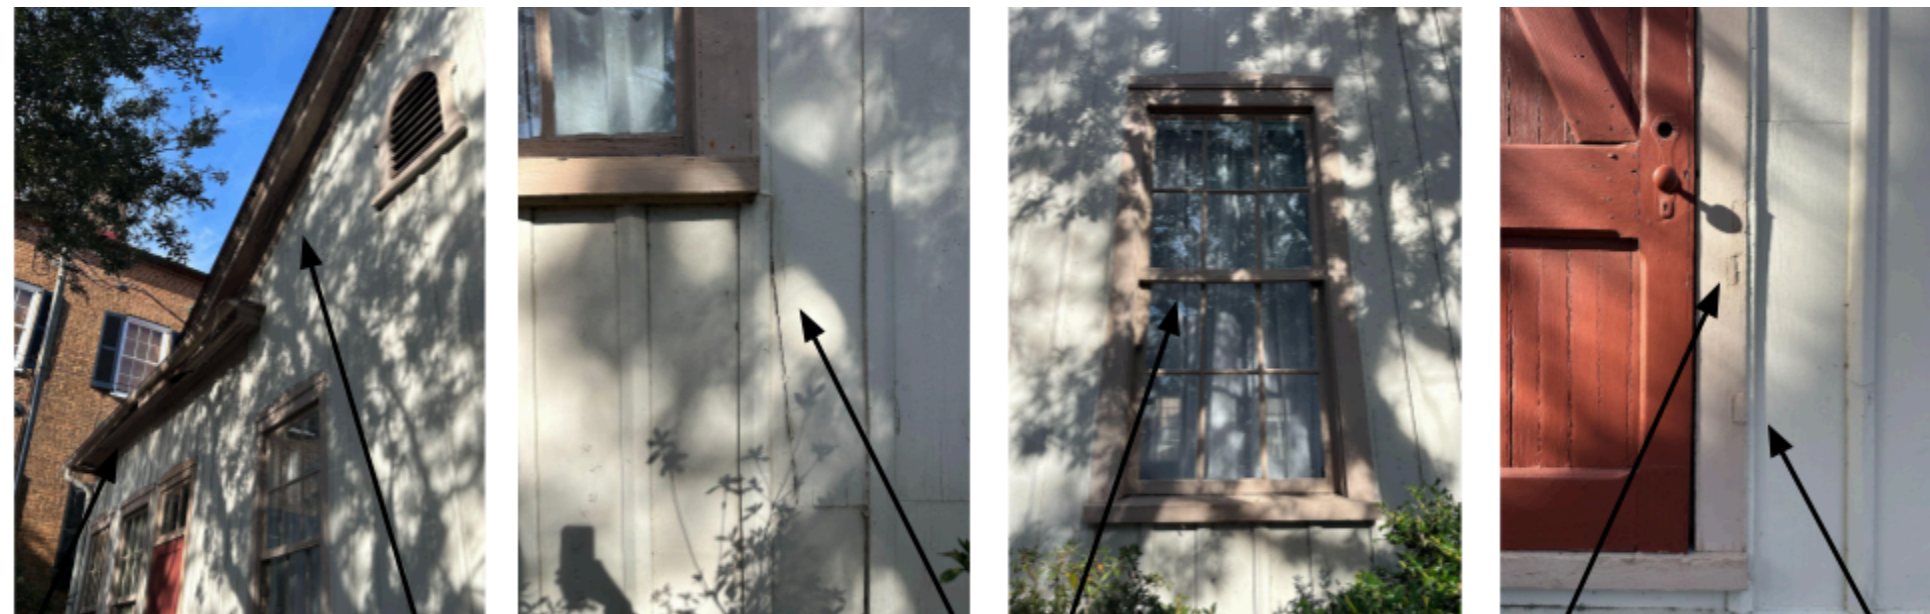
Vegetation on the eaves.

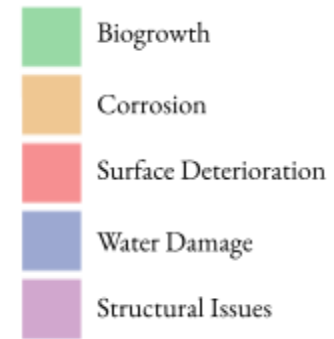
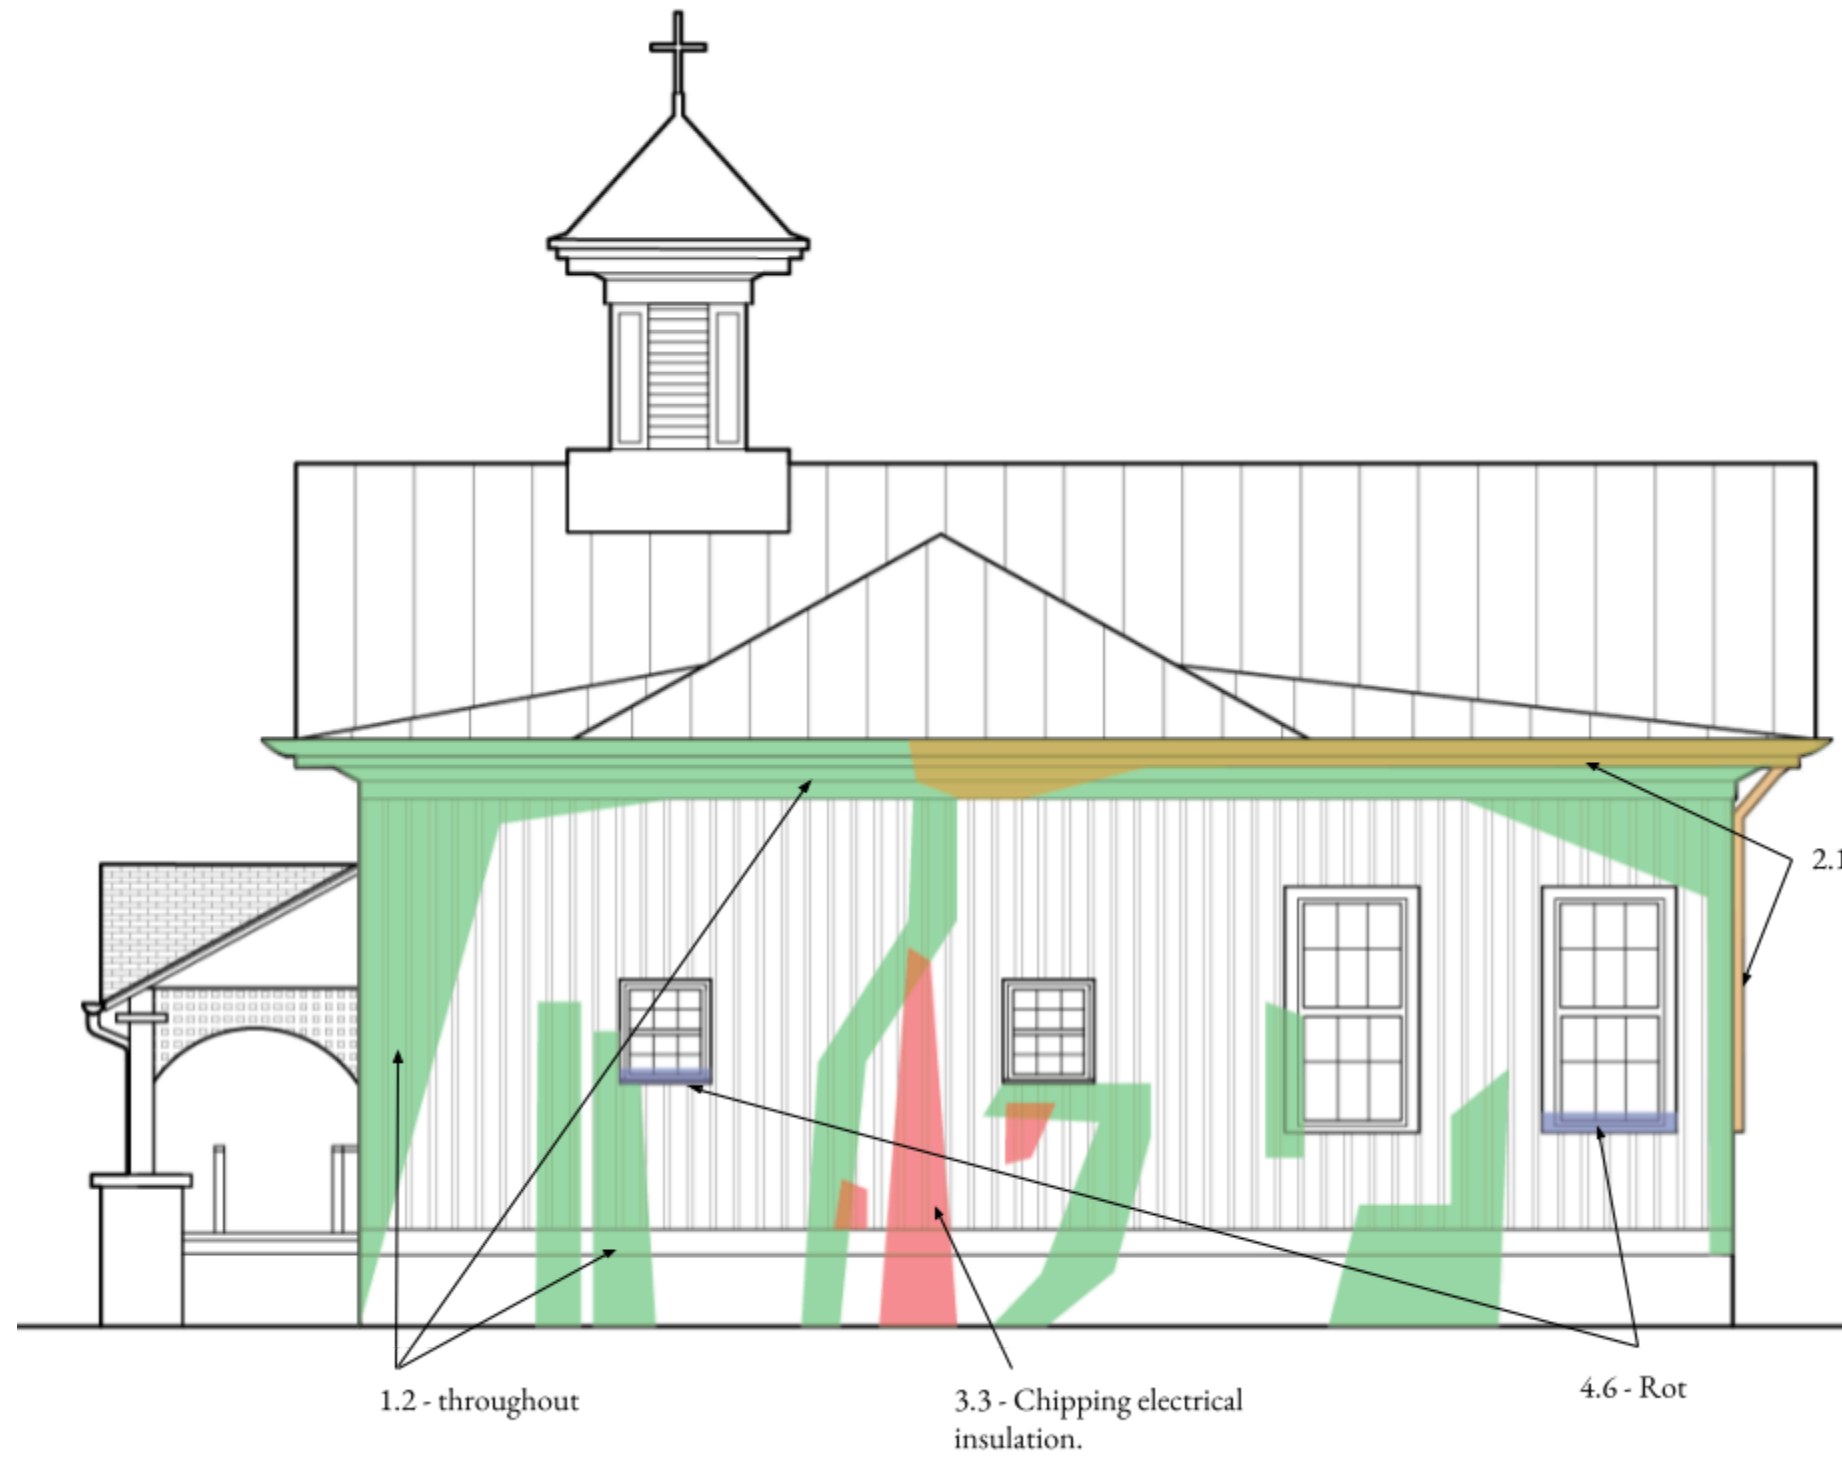
The West facade is in Poor condition. The excess of biogrowth present on this 'back' facade is concerning. The gutter has corroded leaving weaknesses for water intrusion and damage.

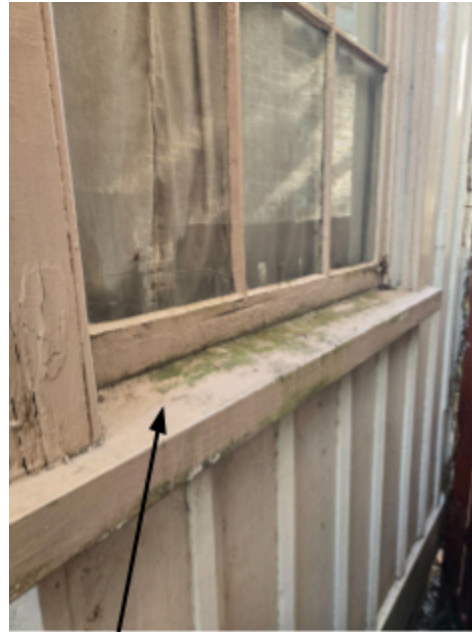
Mold on window sill.

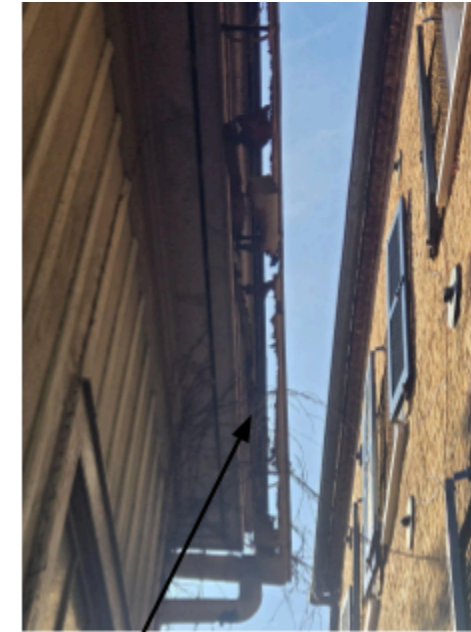
Chipping electrical covers.

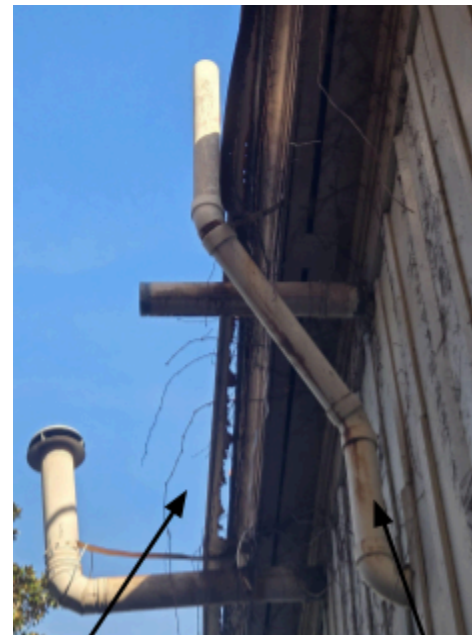
Rust and Patina on Gutters.

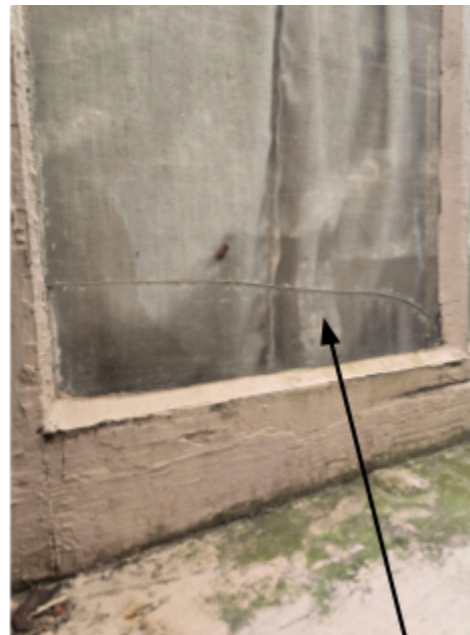
Cracked glass in window.

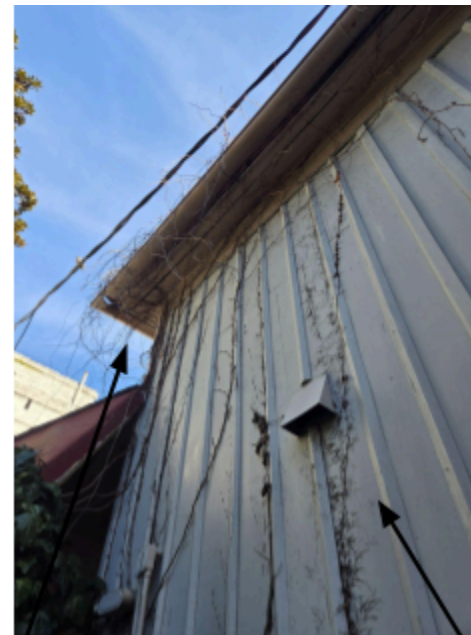
Vegetation on siding and in eaves.

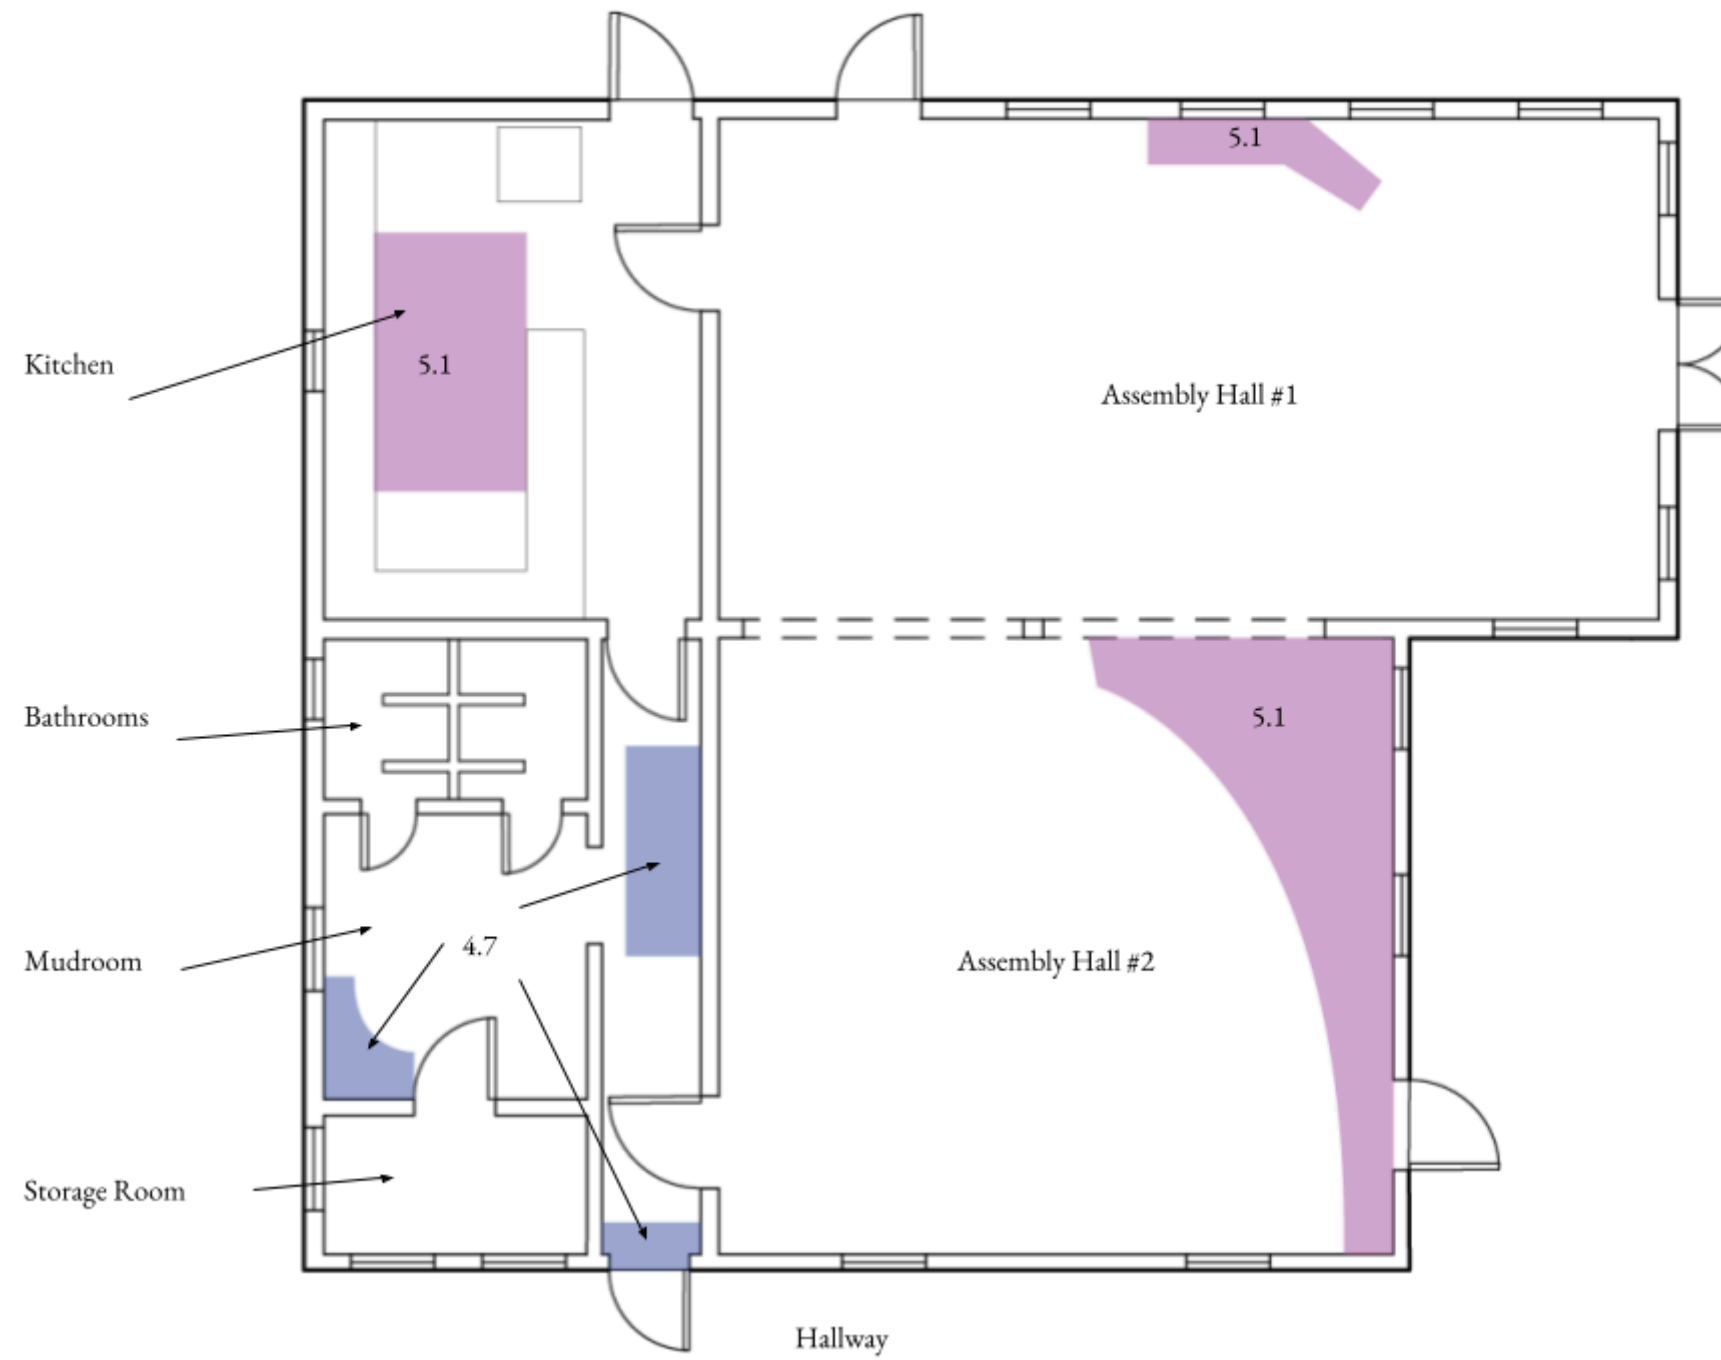
- Biogrowth
- Corrosion
- Surface Deterioration
- Water Damage
- Structural Issues

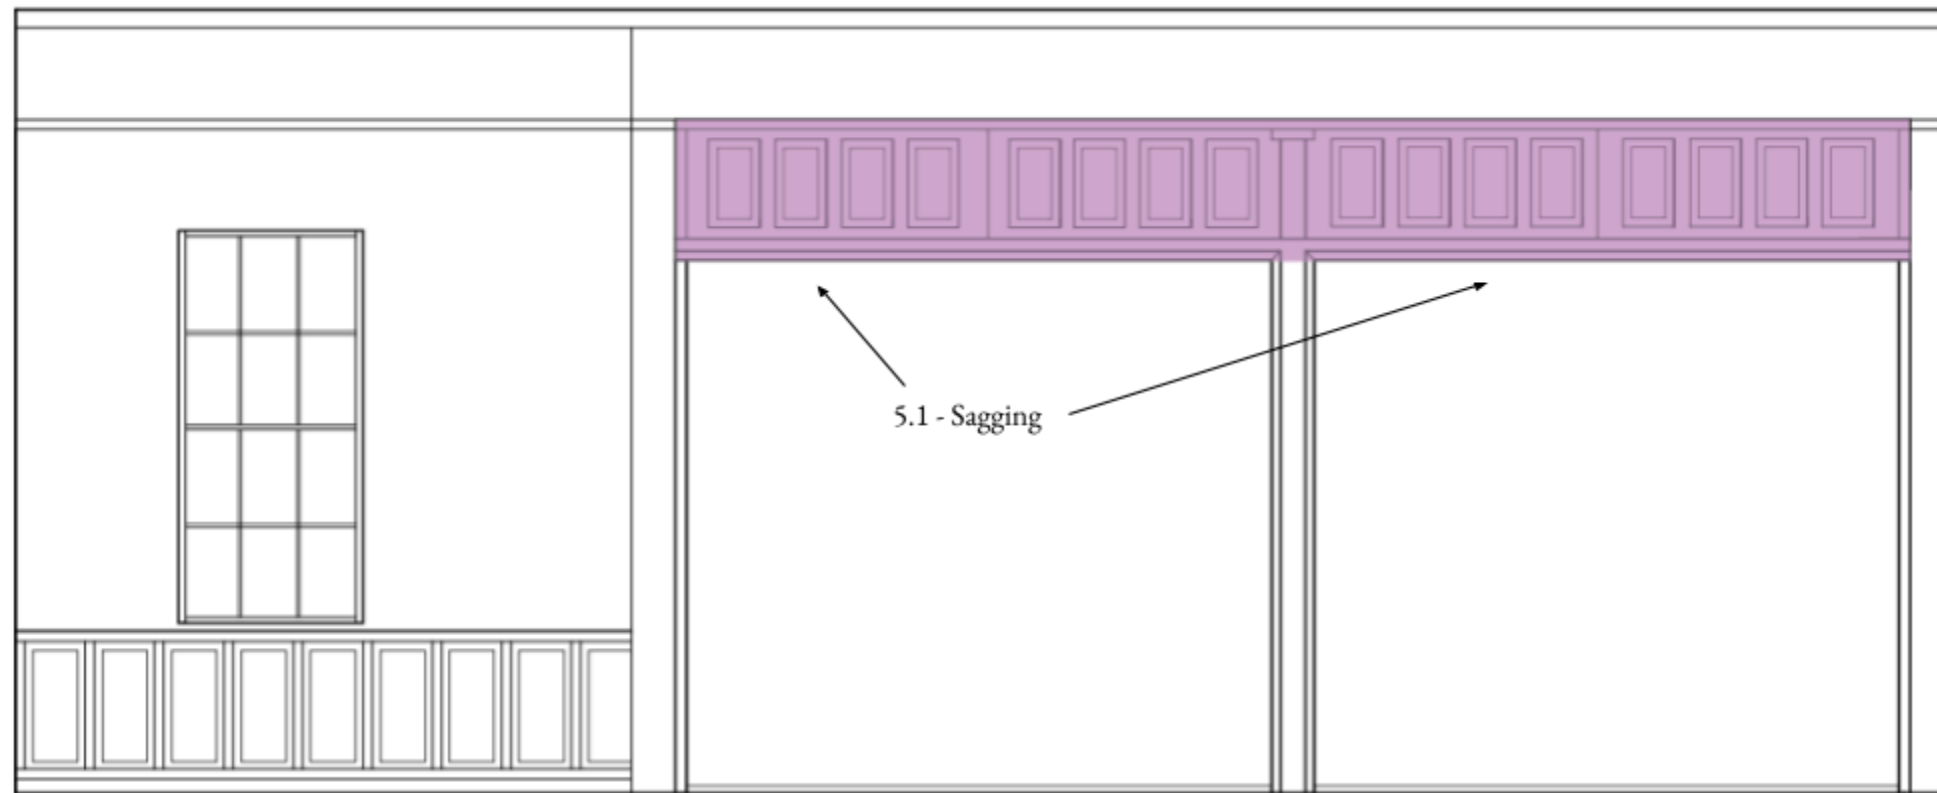
Assembly Hall #1: South Elevation

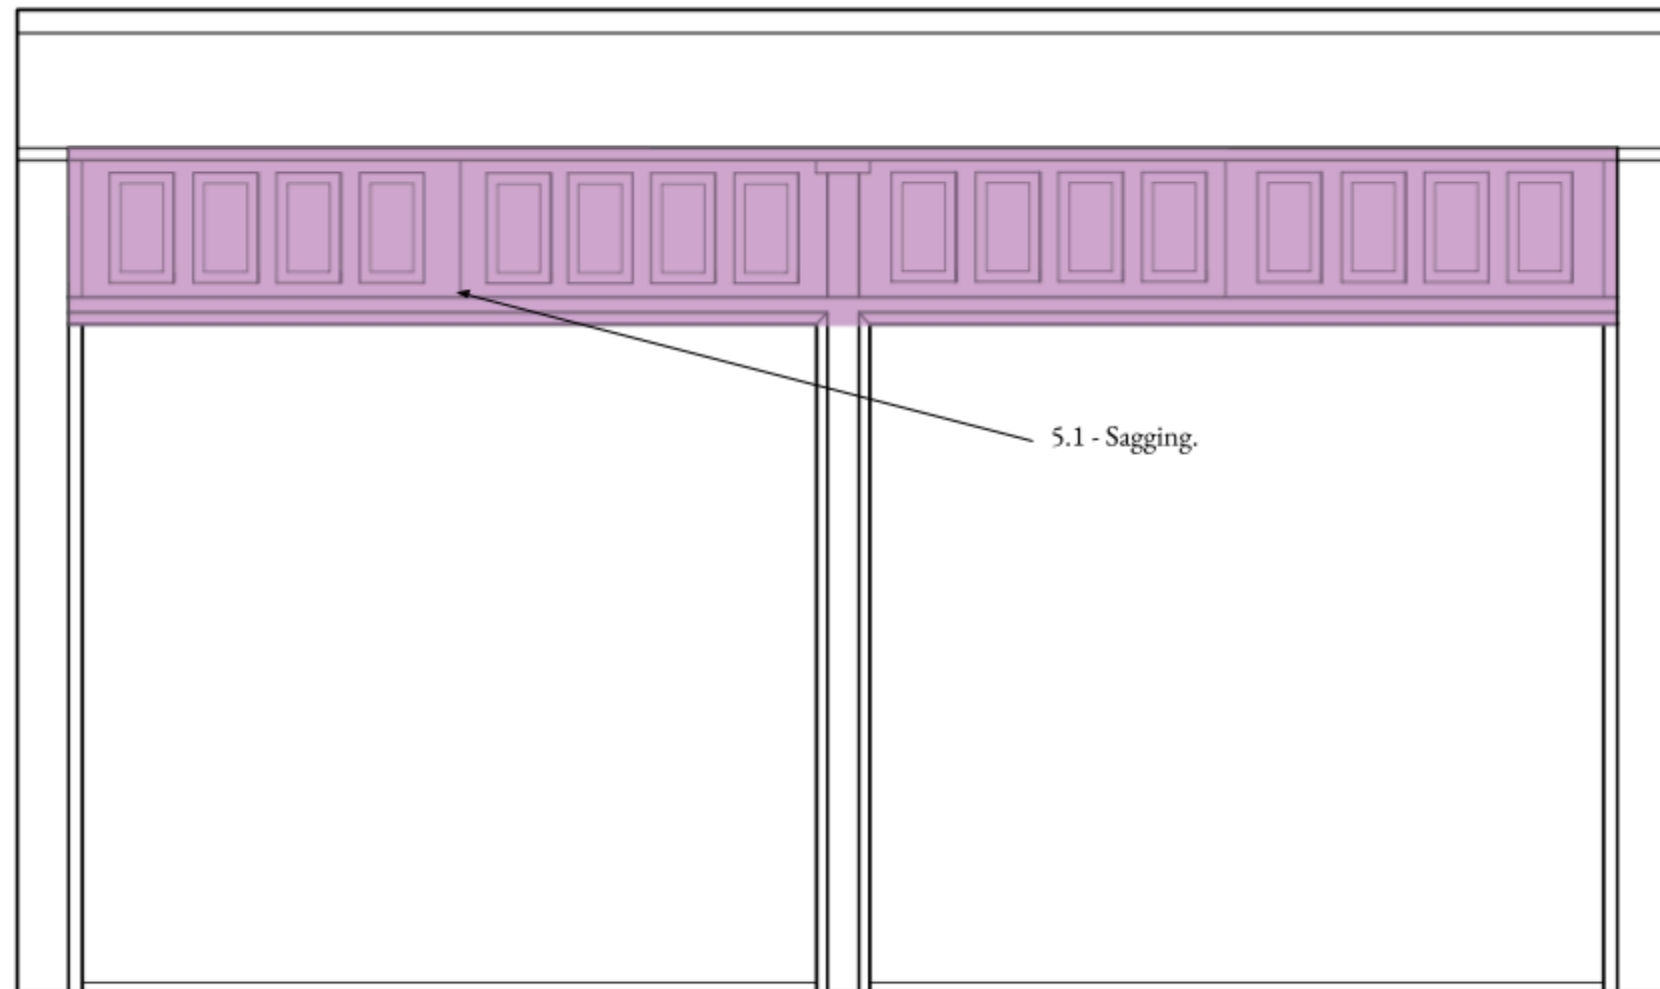
- Biogrowth
- Corrosion
- Surface Deterioration
- Water Damage
- Structural Issues

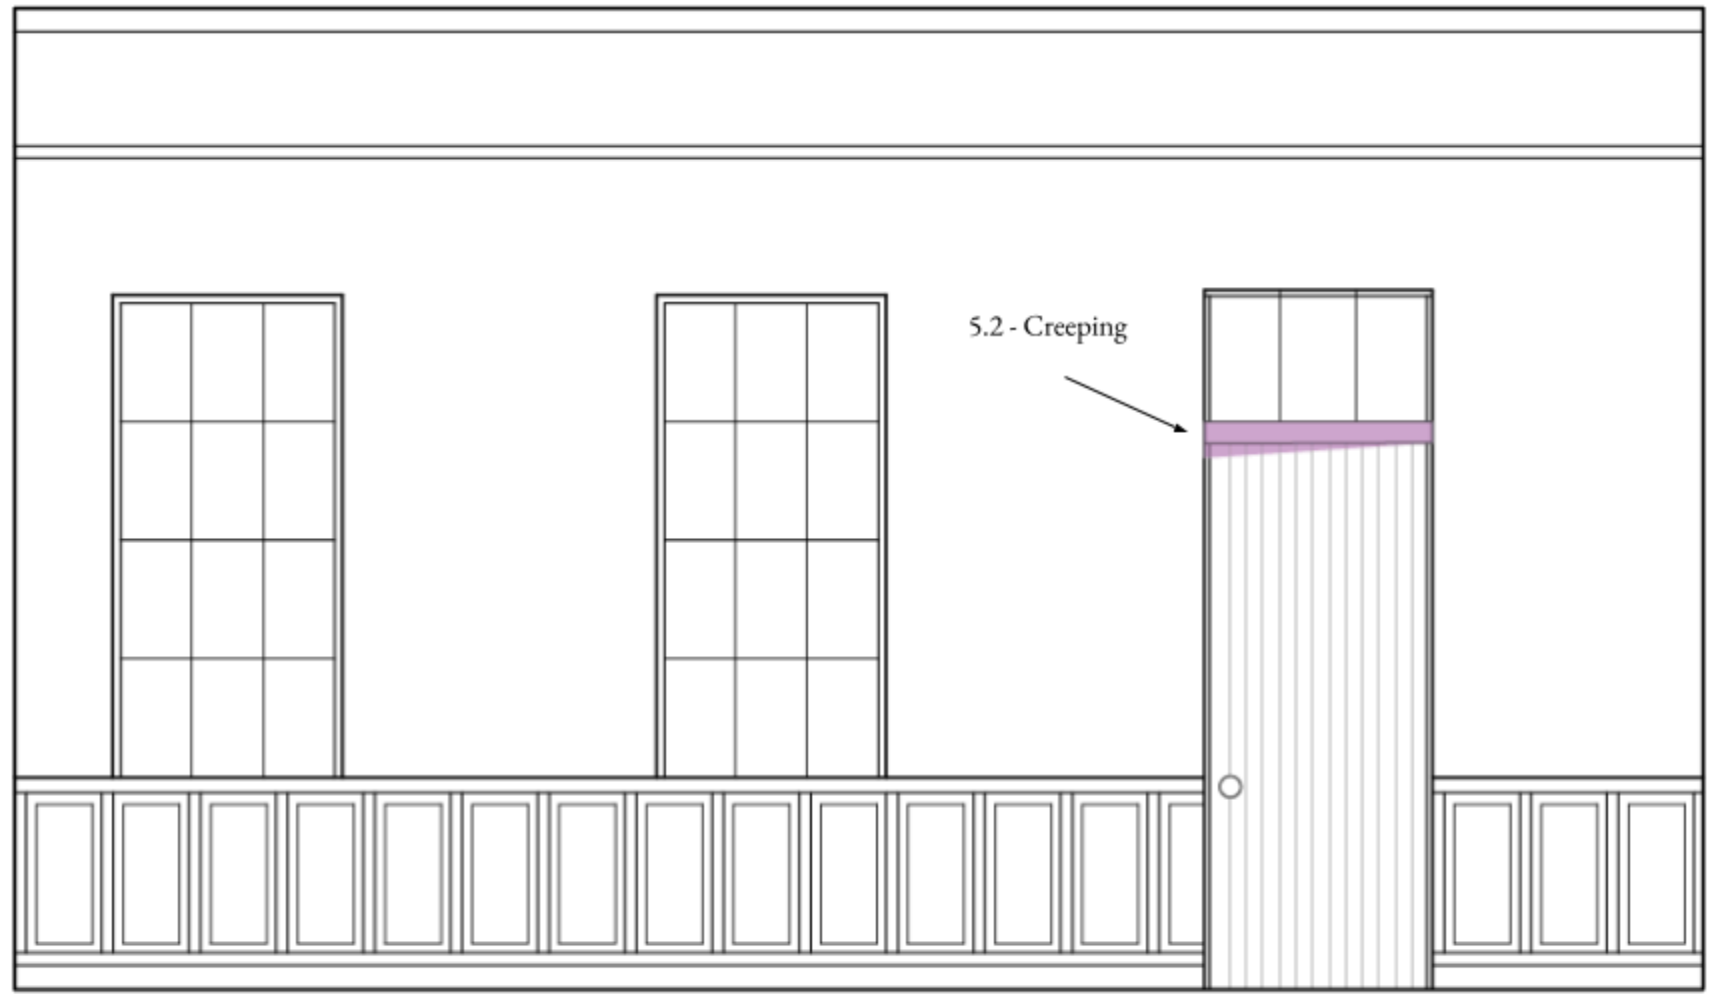
Assembly Hall #2: East Elevation

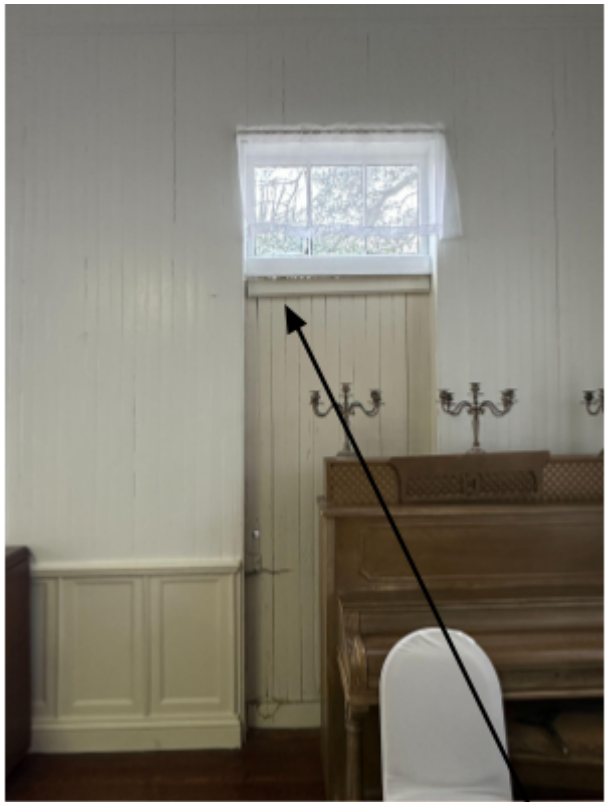
Structural drop above door frame.

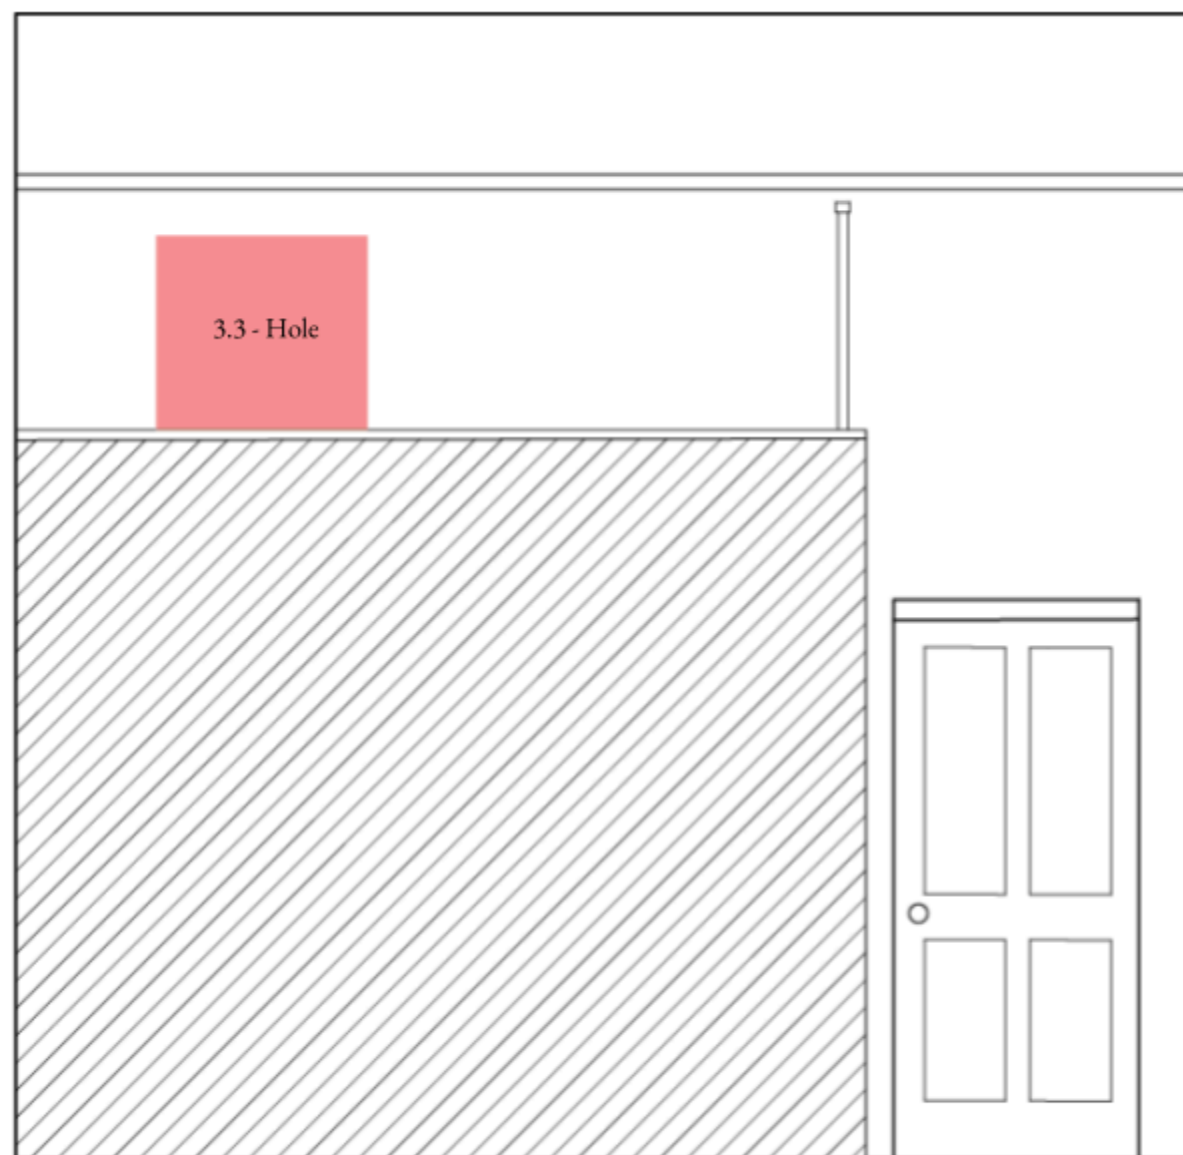
Hallway: North Elevation

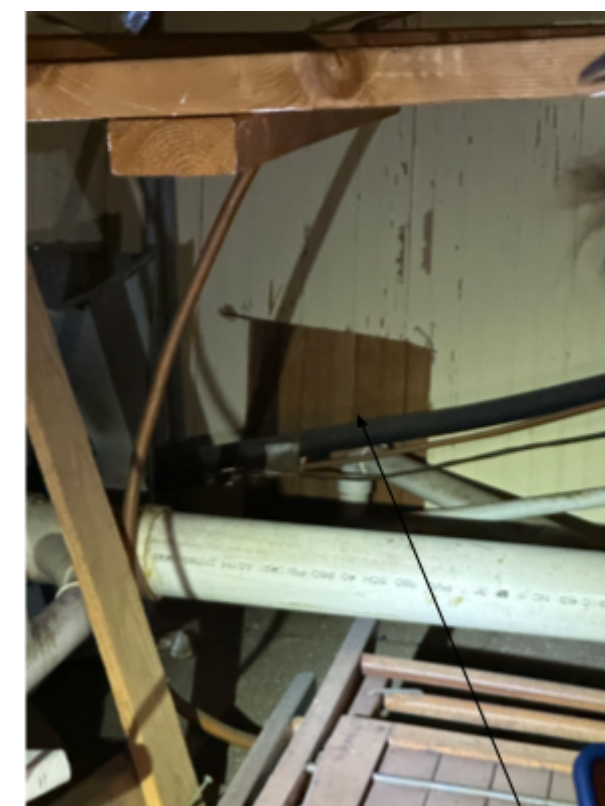
Hole in wall above bathrooms.

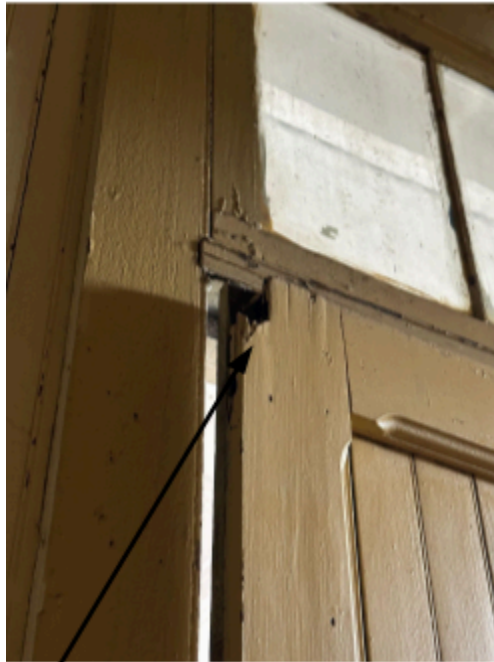
Water damage on door corner.

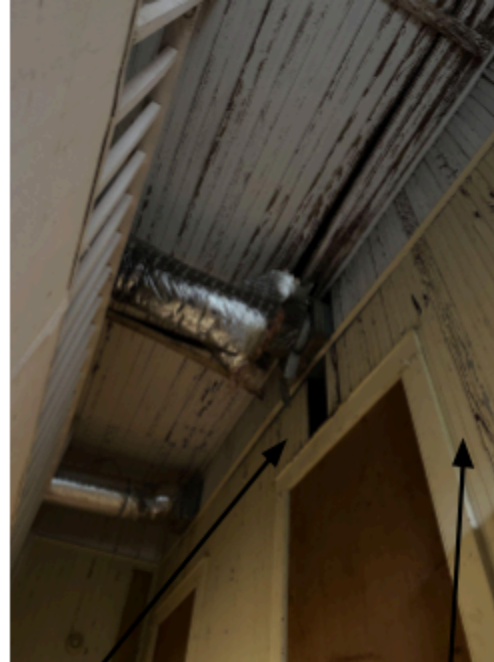
Surface deterioration,  
Hole in wall under HVAC duct.

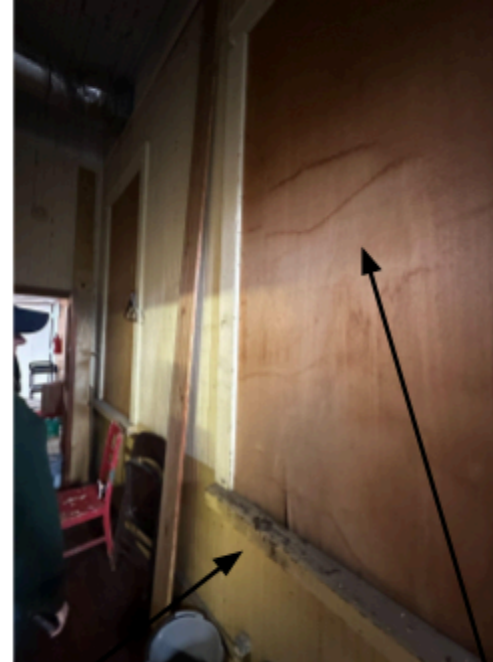
Water damaged sill and infill board.

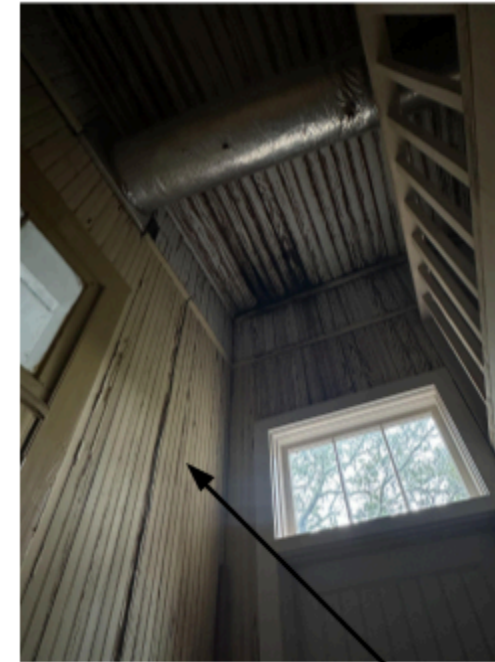
Chipping and breaking  
throughout.

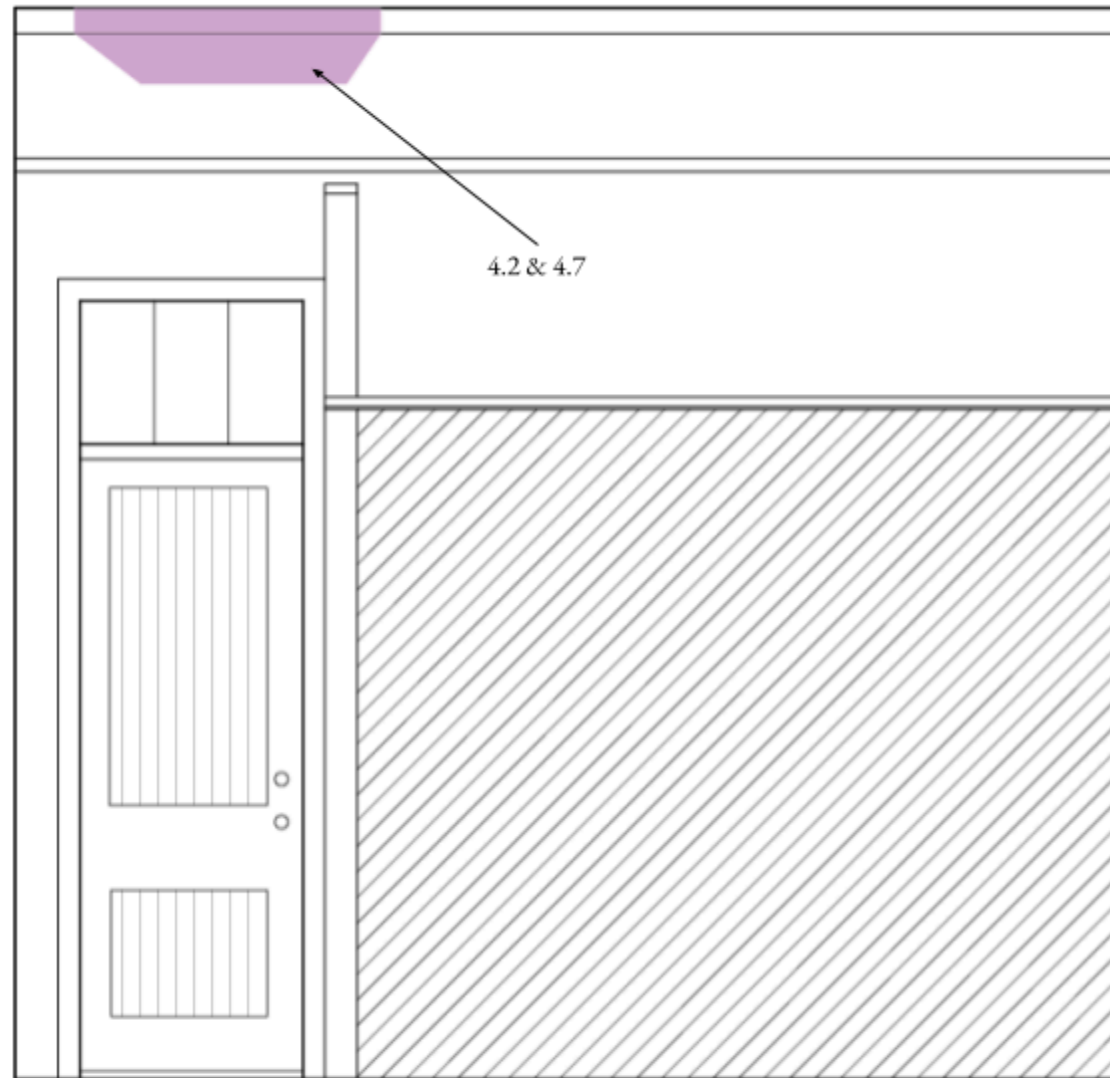
Hallway: South Elevation

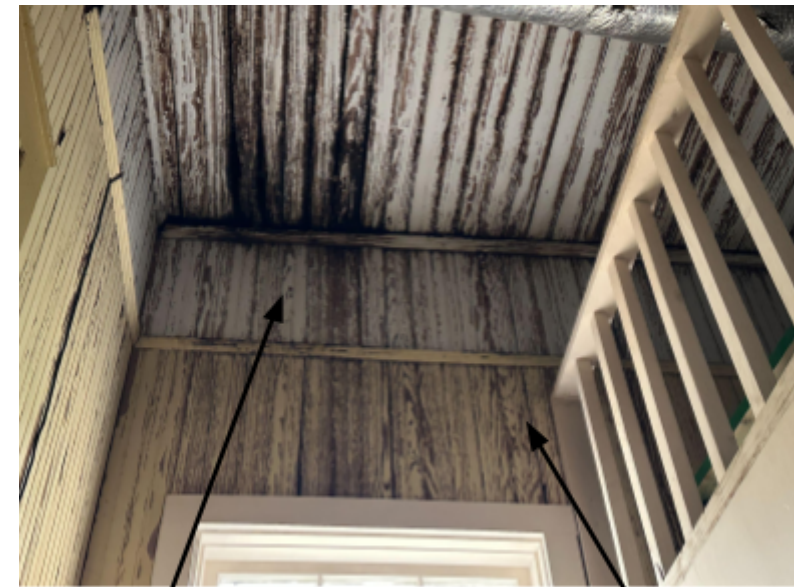
Surface Deterioration throughout, water damage.

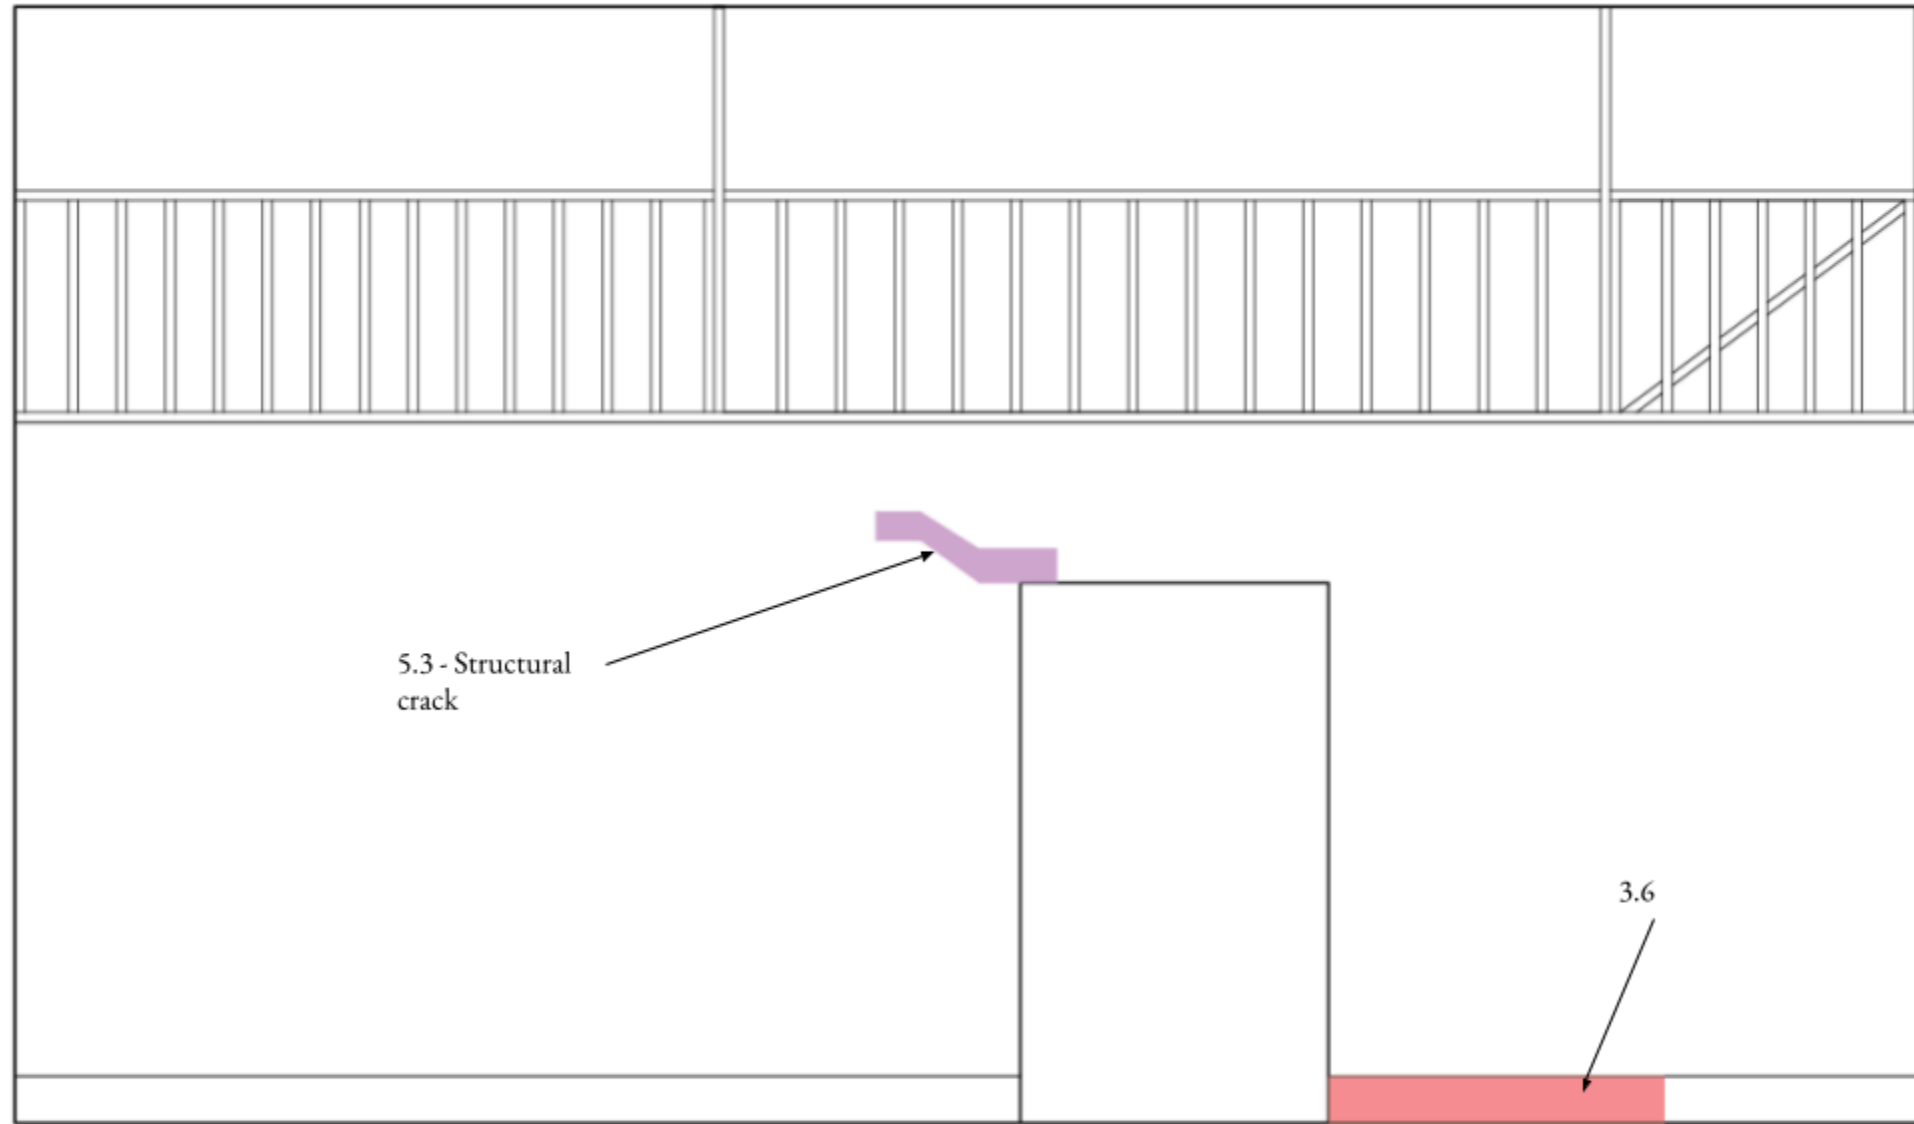
- Biogrowth
- Corrosion
- Surface Deterioration
- Water Damage
- Structural Issues

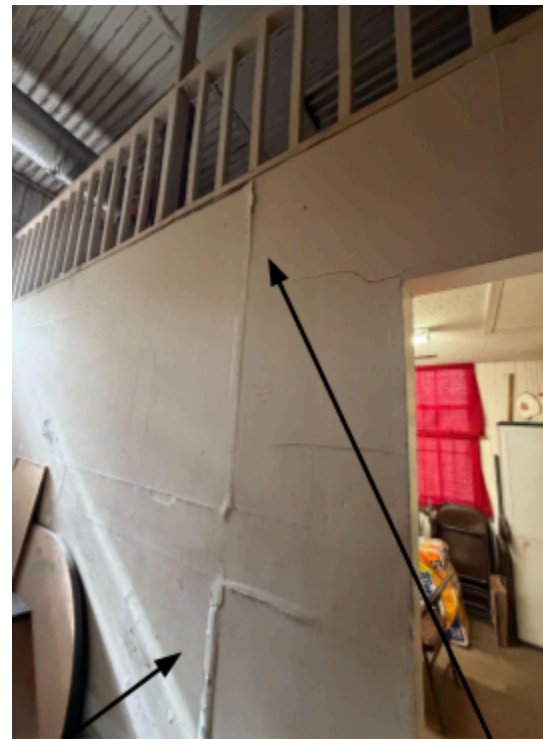
Surface deterioration throughout.

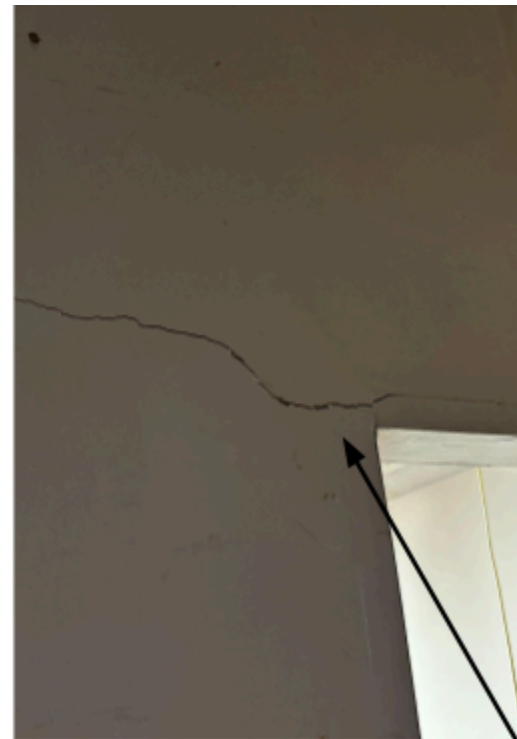
Structural crack near door opening.

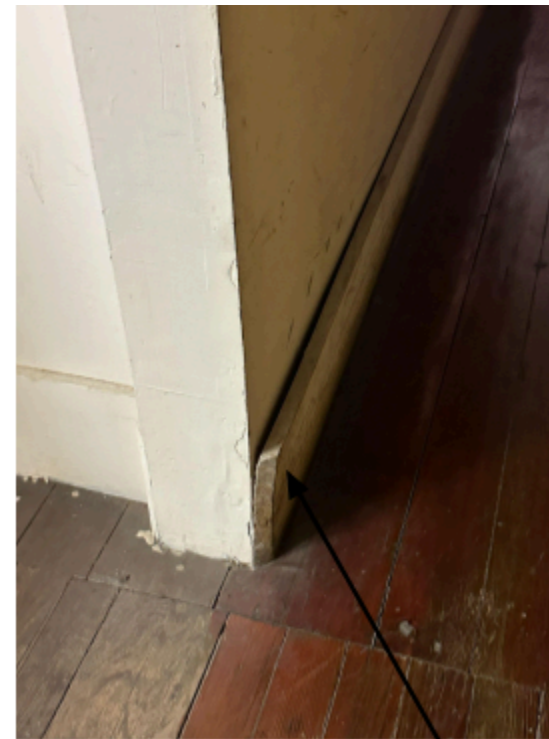
Detaching baseboard.
