# ST. JOHN'S REFORMED EPISCOPAL CHURCH EDUCATIONAL BUILDING

History, Conditions, and Treatments Report

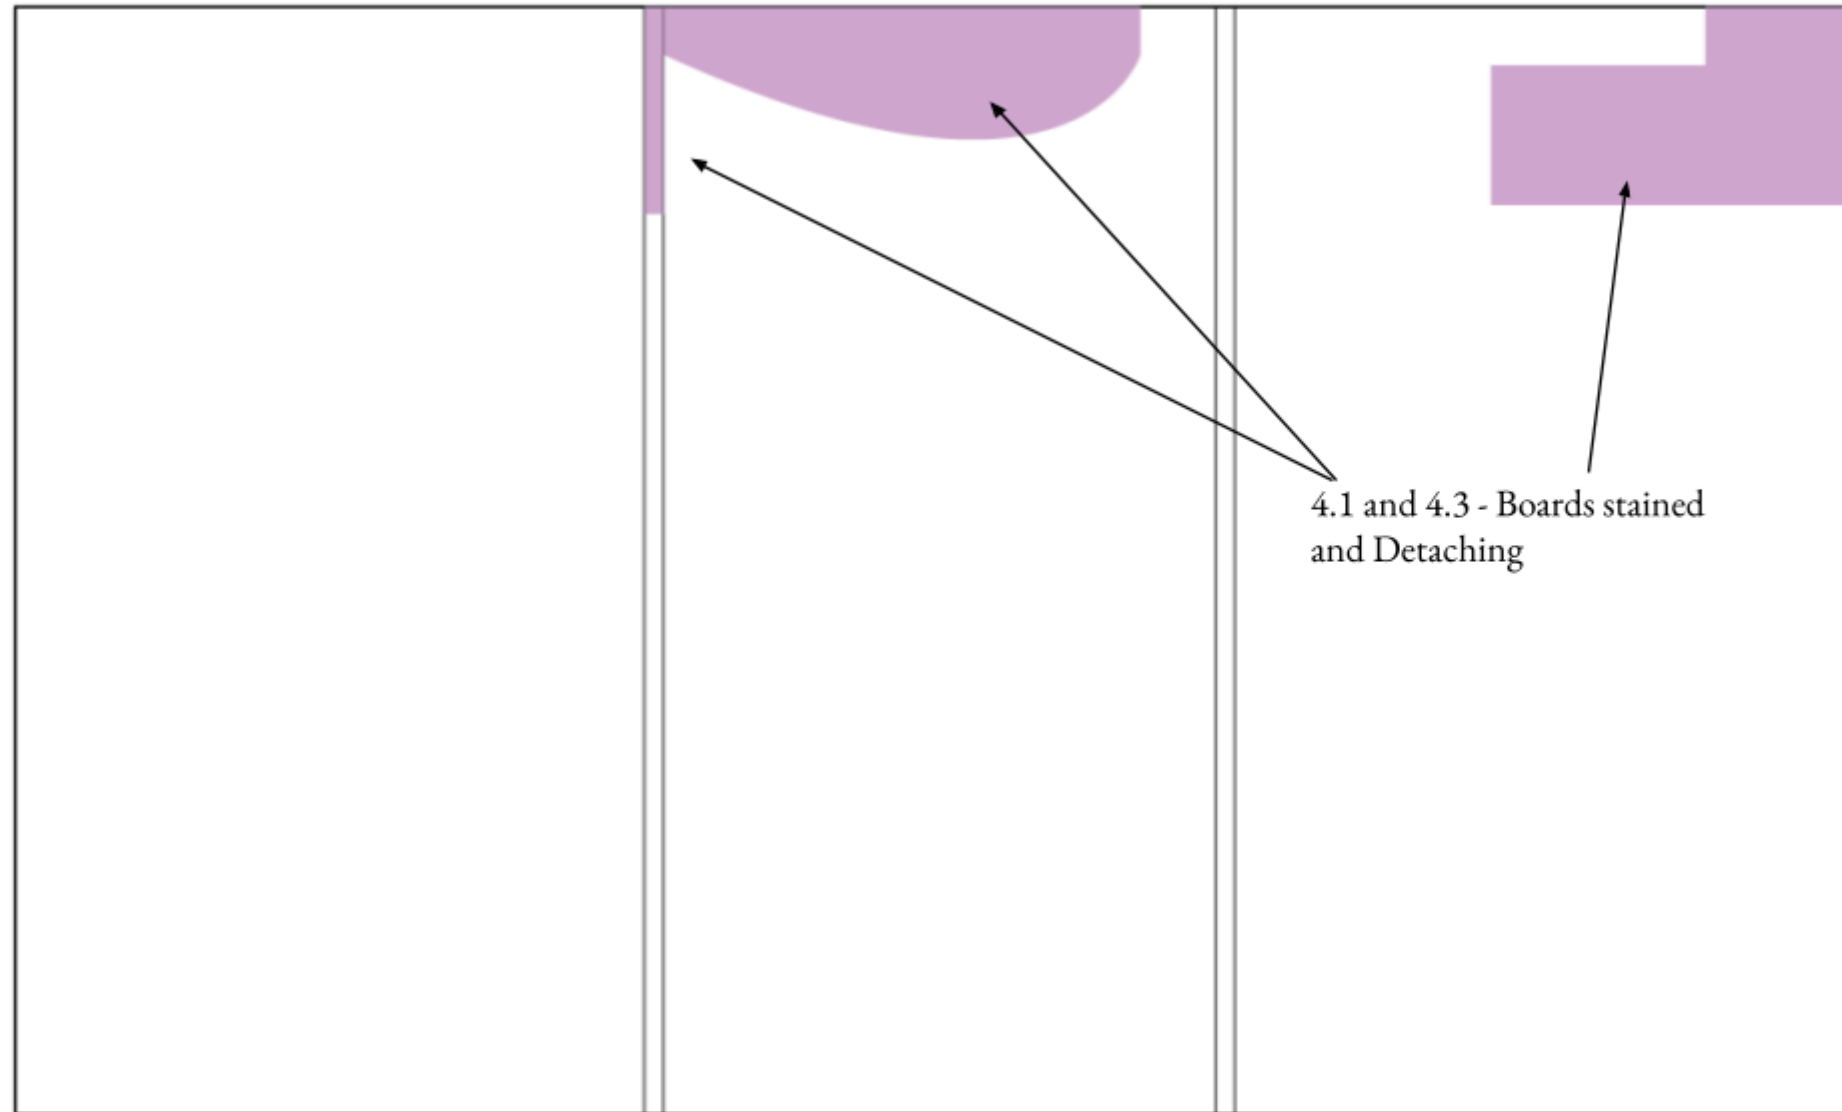
Hallway: Ceiling Plan

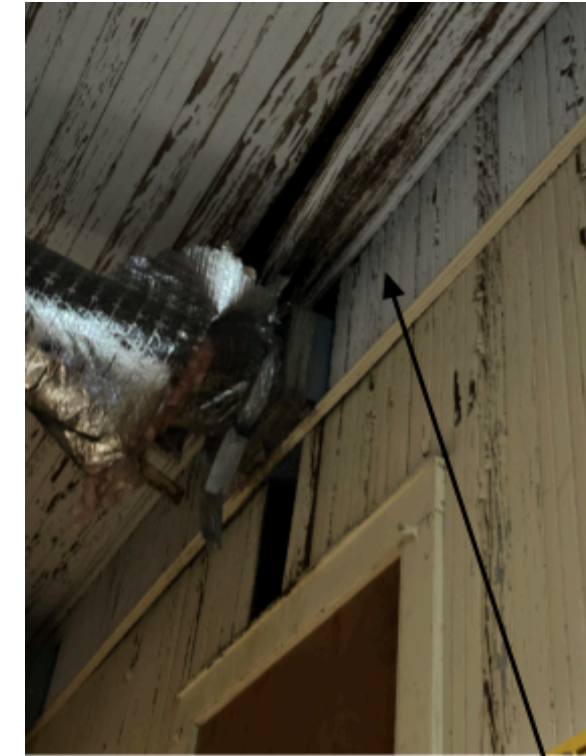
Ceiling boards stained and detaching.

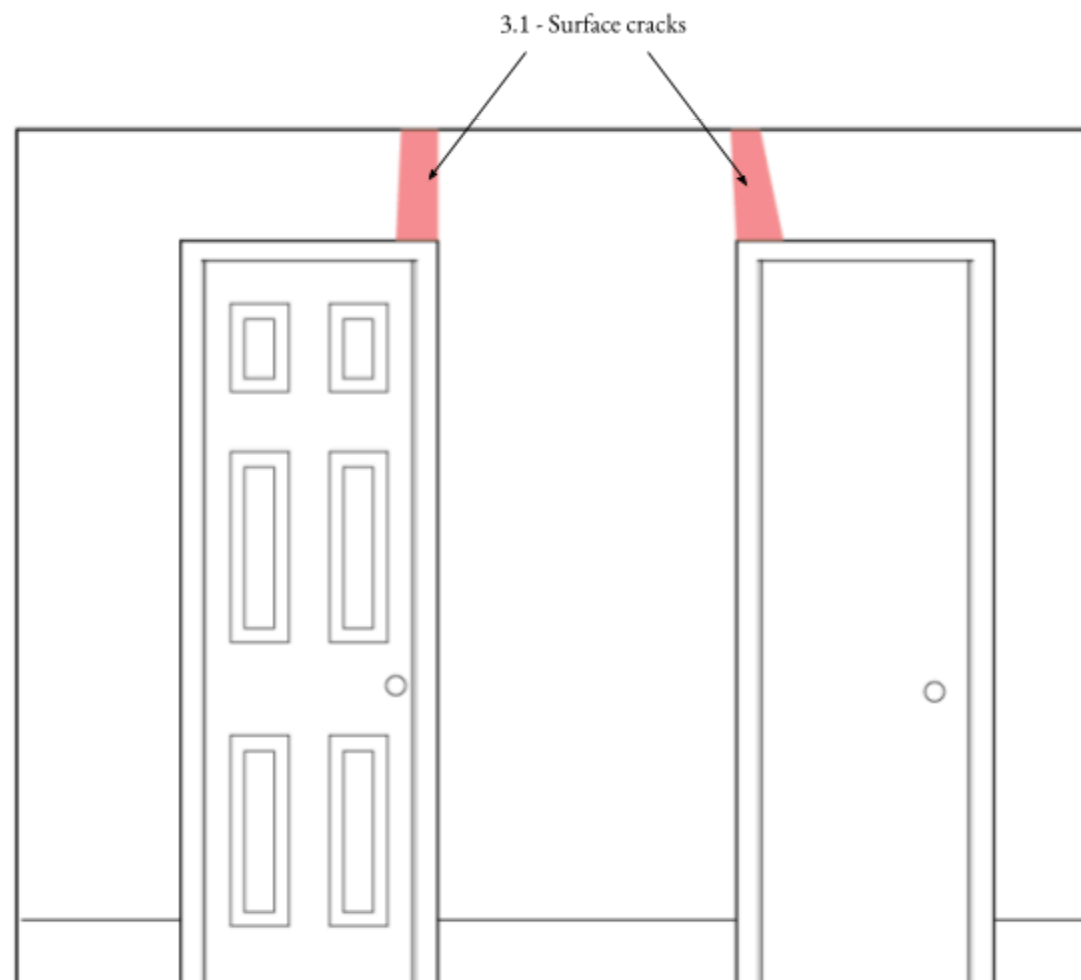
Mudroom: North Elevation

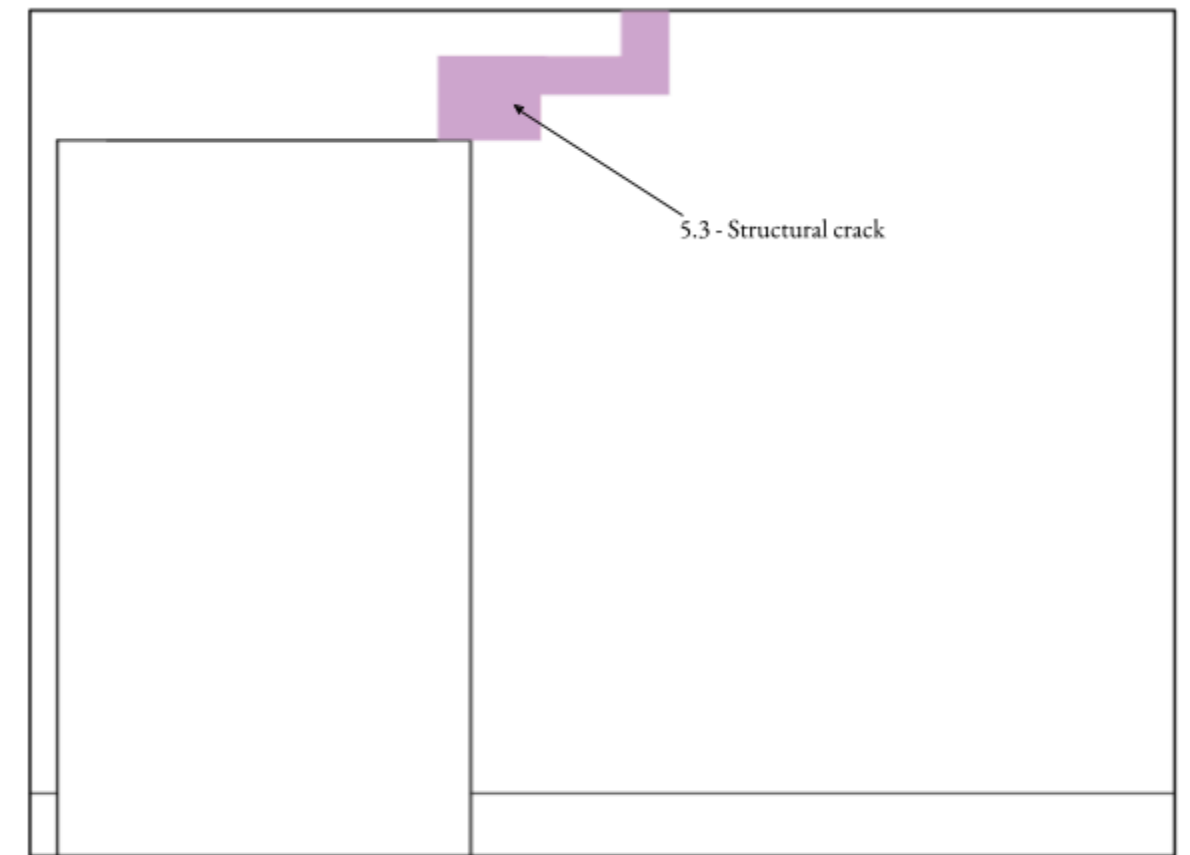
Mudroom: East Elevation

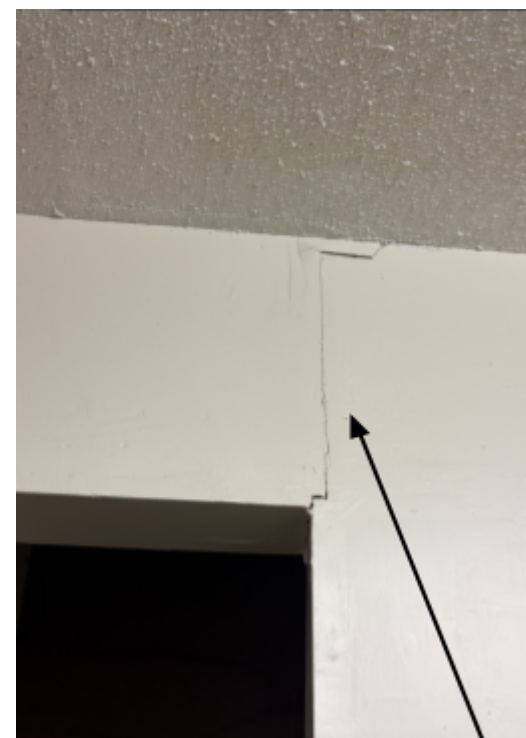
Structural crack over door opening on east elevation.

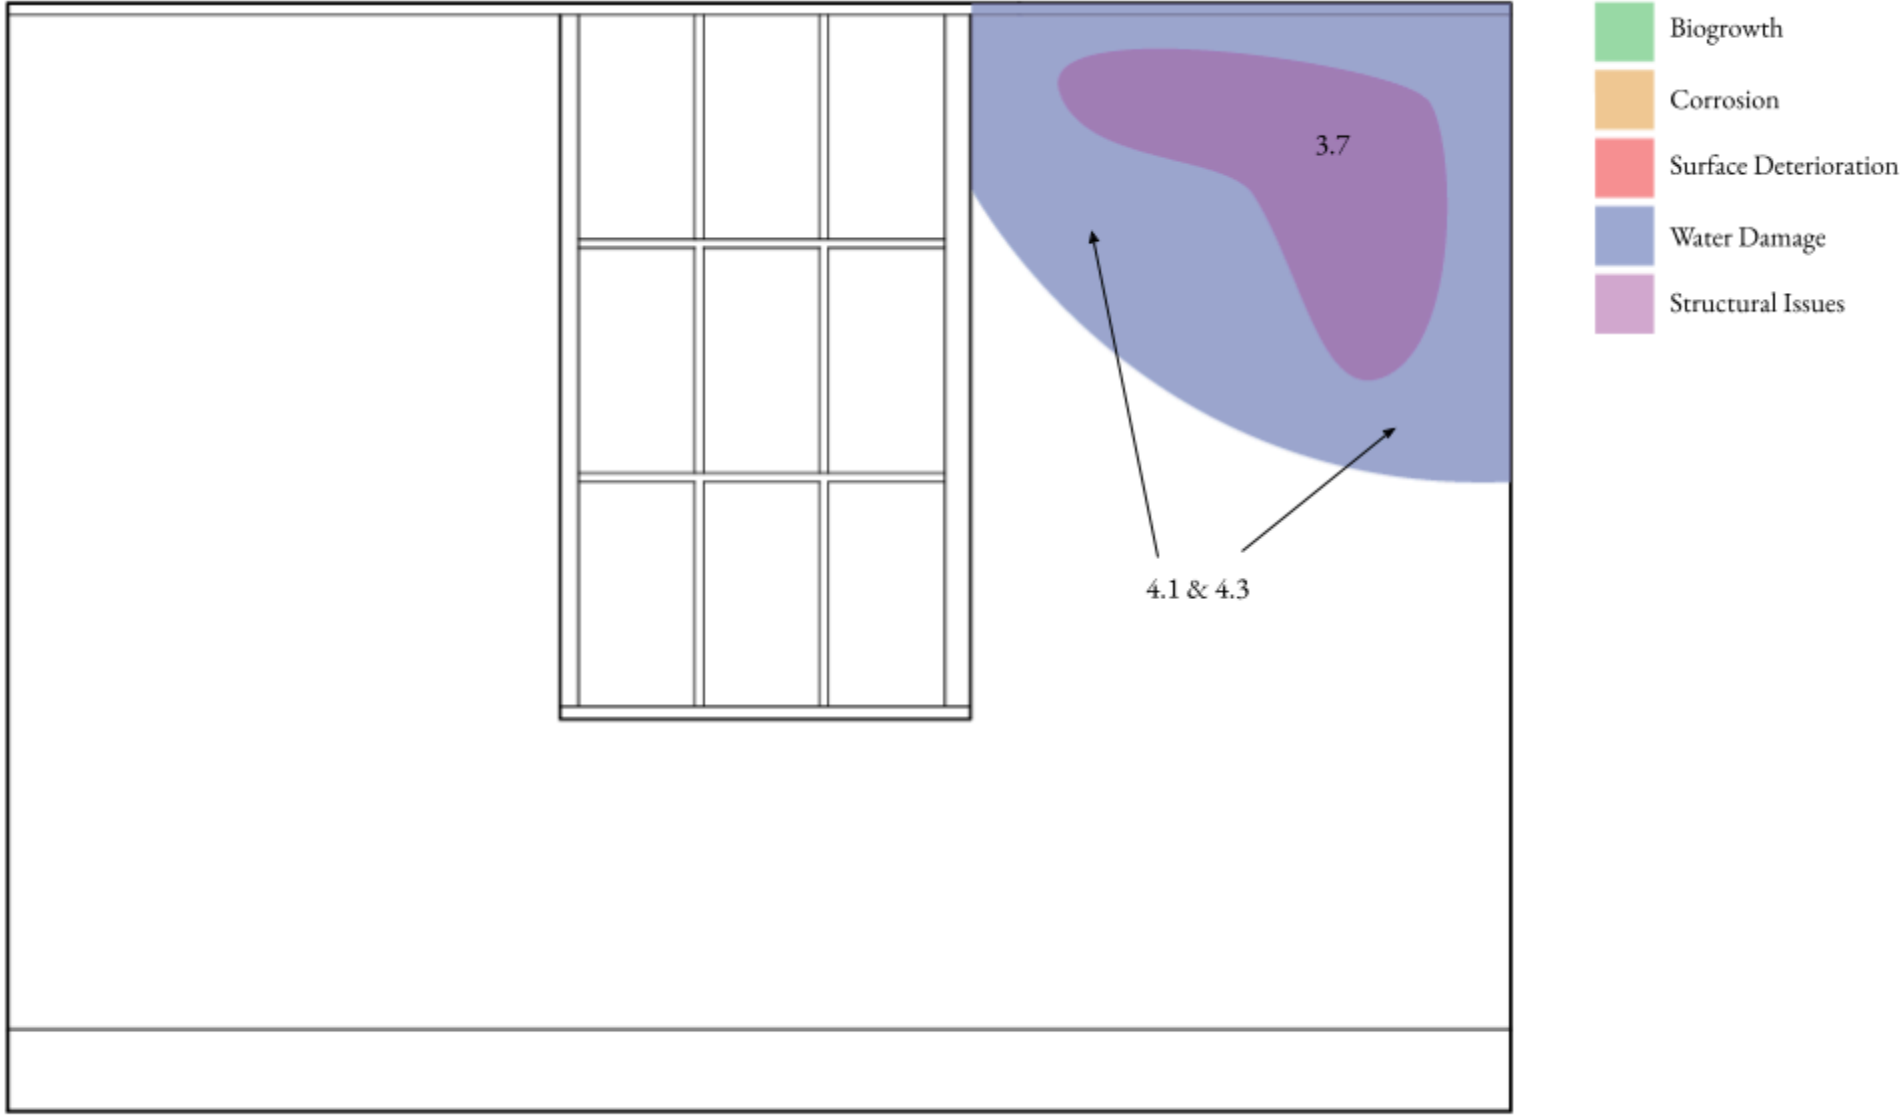
Mudroom: West Elevation

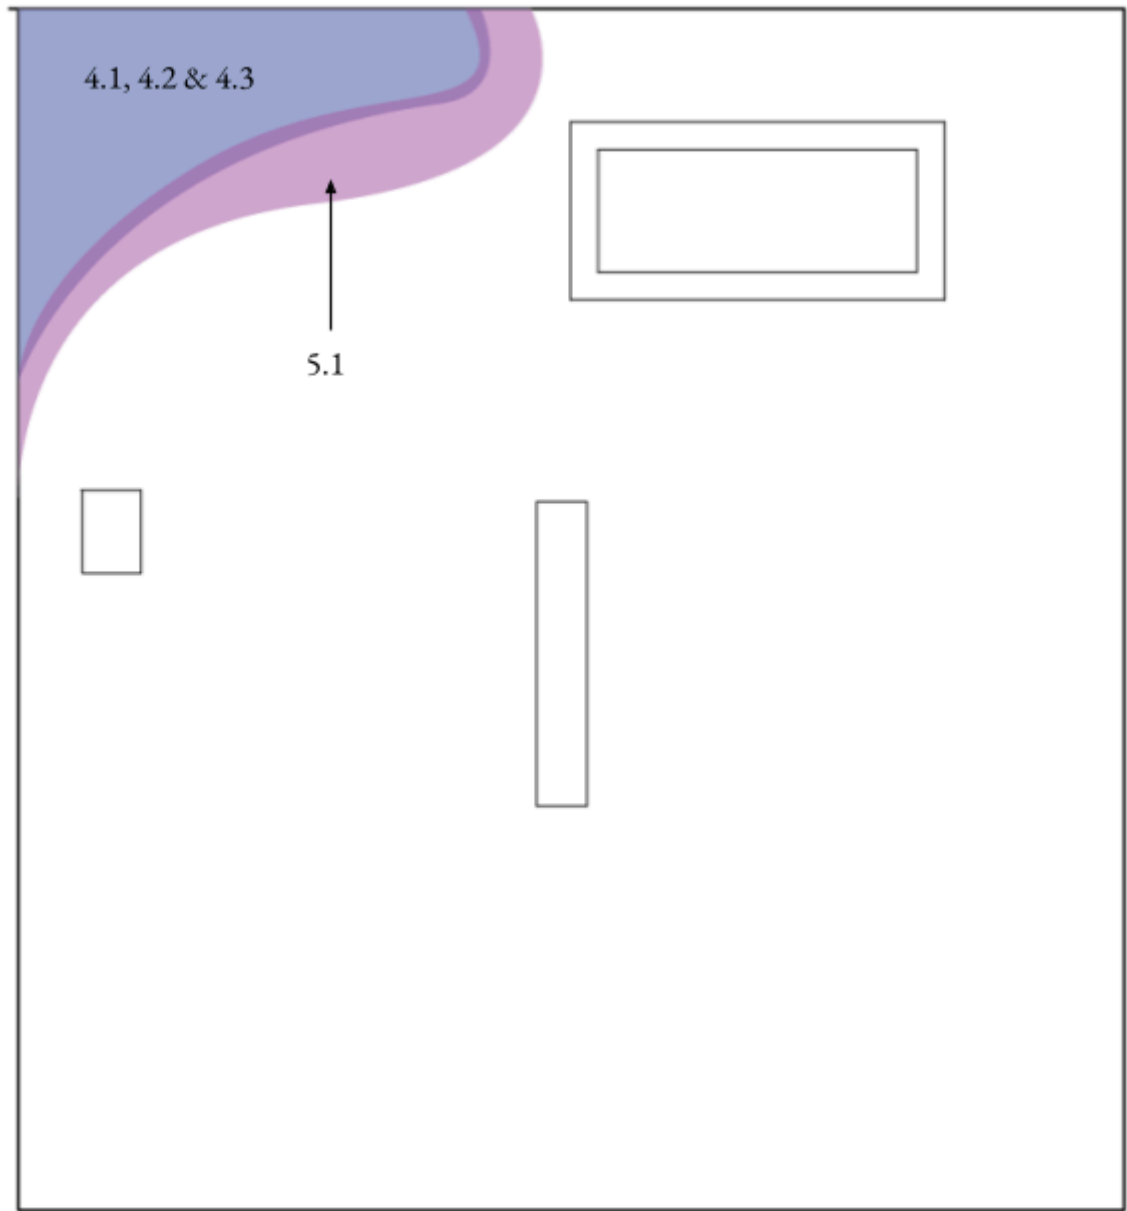
- Biogrowth
- Corrosion
- Surface Deterioration
- Water Damage
- Structural Issues

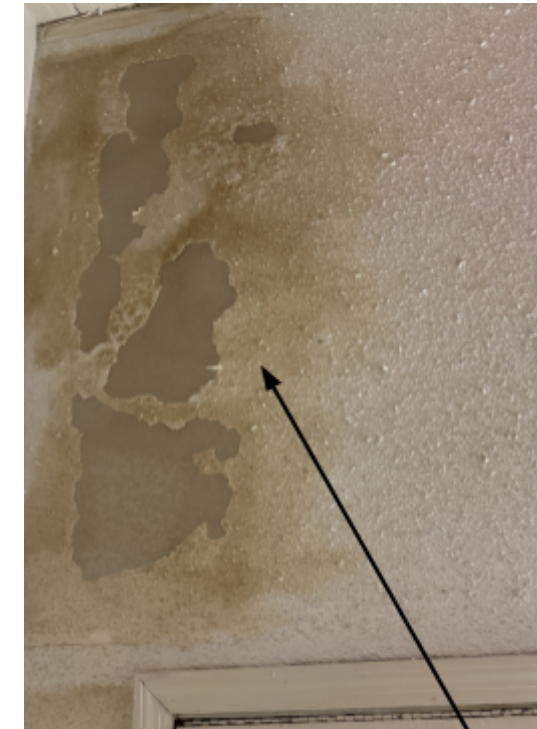
Prolonged surface deterioration.

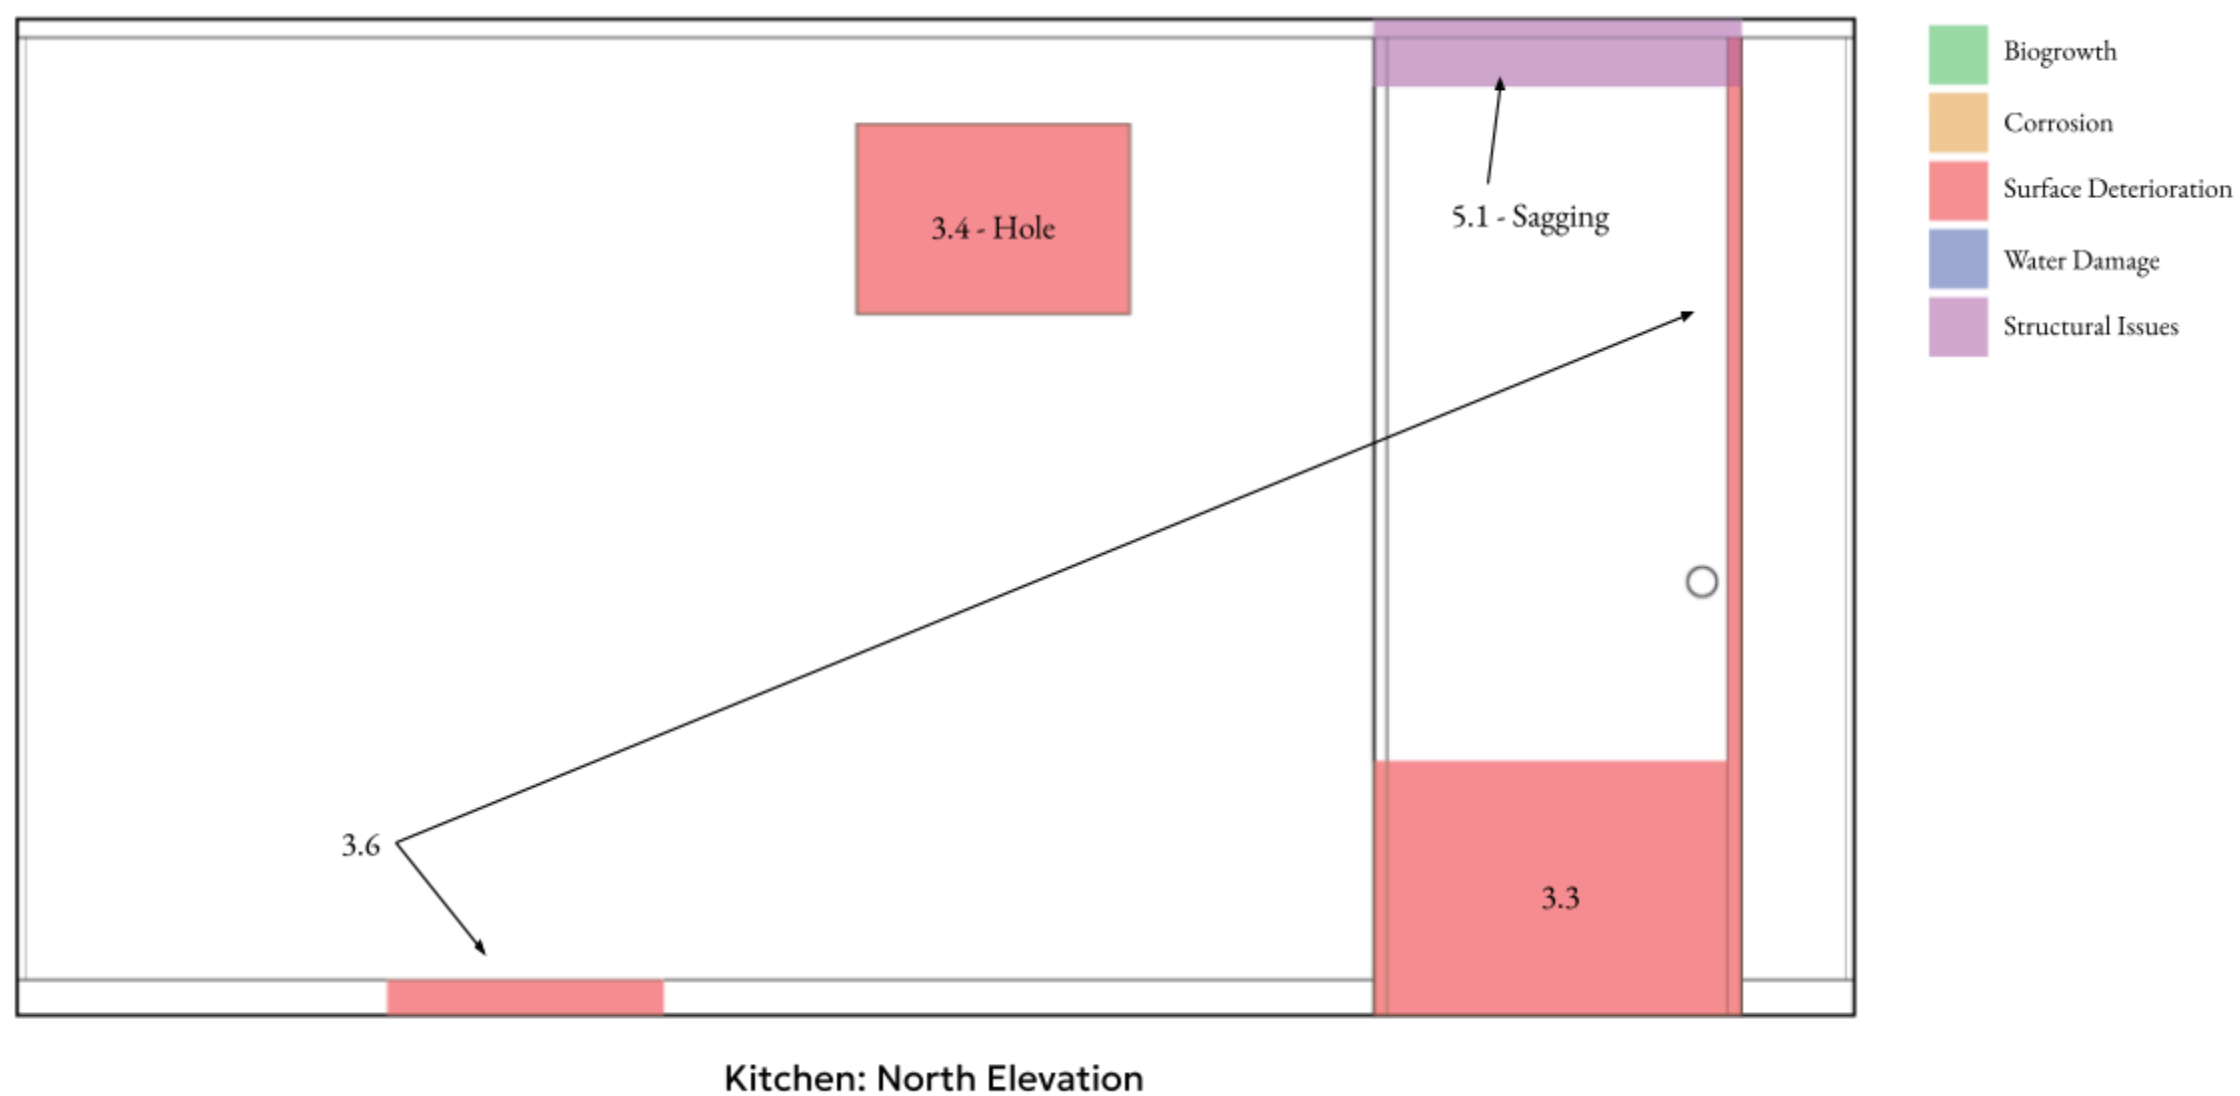
The kitchen is in Critical condition. There is overall surface deterioration across all walls and especially the ceiling. In addition to the surface damage on the ceiling, there are structural issues present due to the detaching drywall from the ceiling joists that are already sagging. This should be remedied immediately and all assessors or visitors should avoid occupying the attic space above the kitchen, as it is unsafe. On the north facade, there is sagging at the top of the door opening, causing a gap to form that will accelerate the already present water intrusion issues.

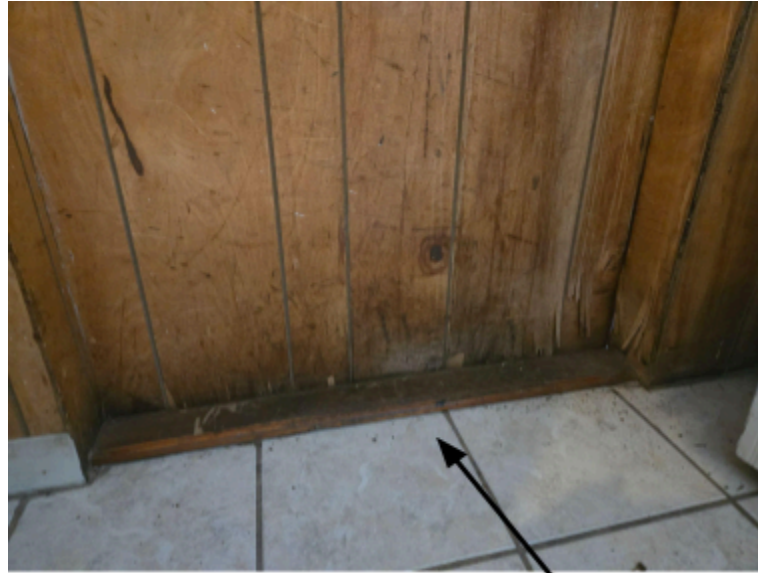
Weathered threshold.

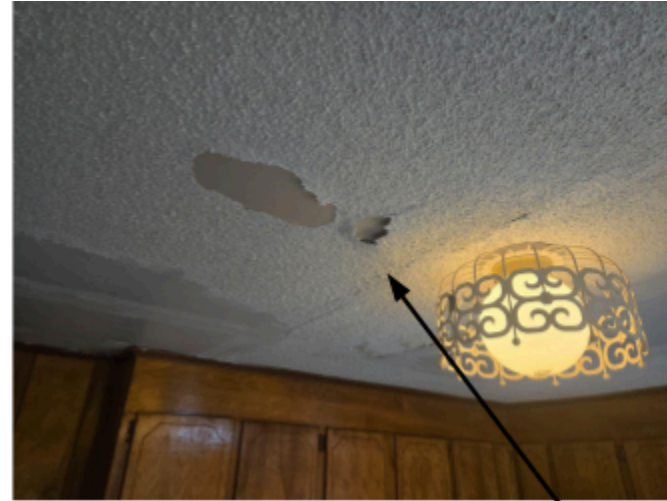
Popcorn surface treatment failing.

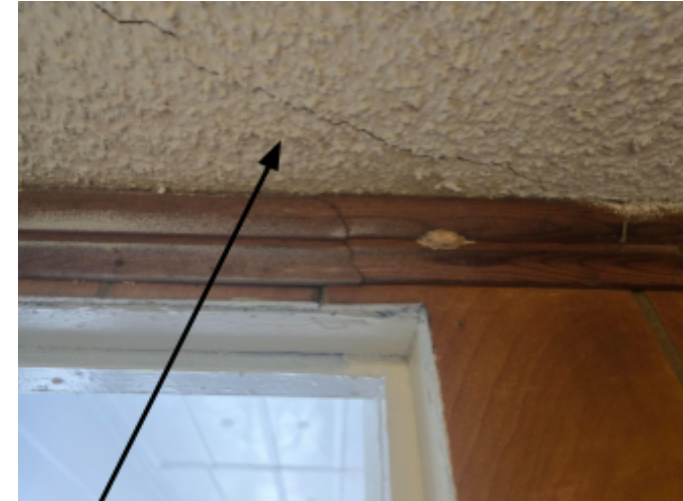
Crack at ceiling and wall connection.

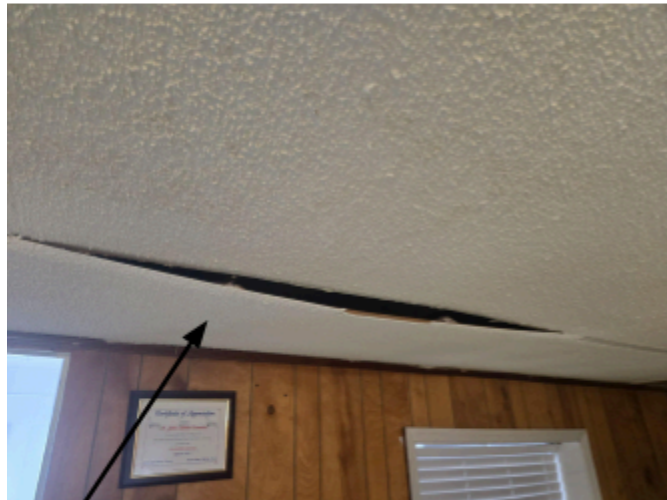
Drywall sheet detaching from ceiling joists.

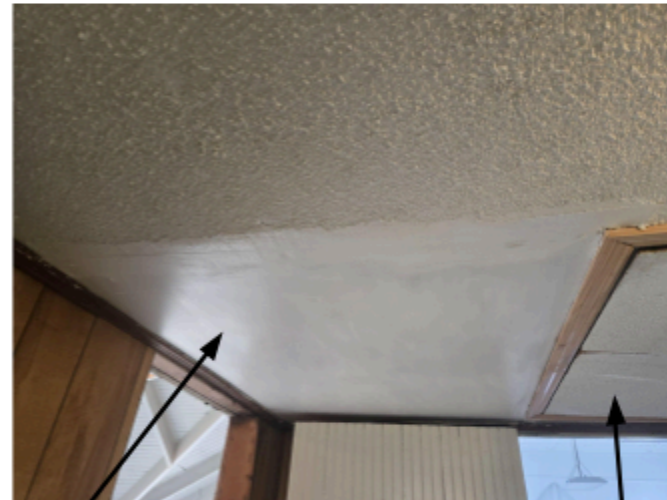
Ceiling patch, and wear on attic door from assembly hall door scratching.

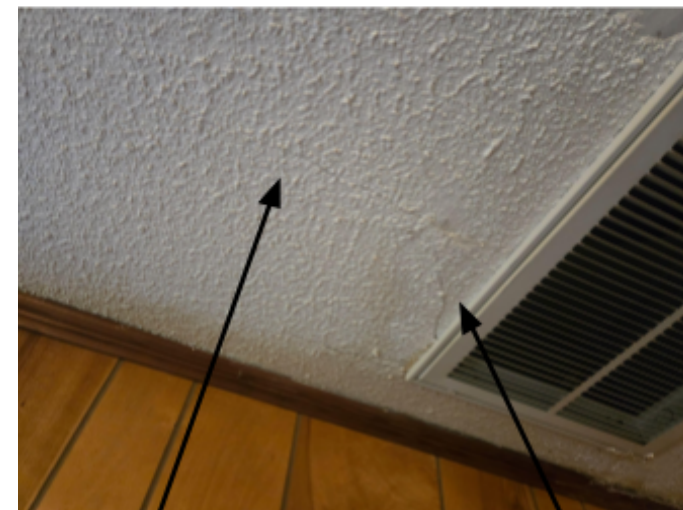
Crack in surface treatment.

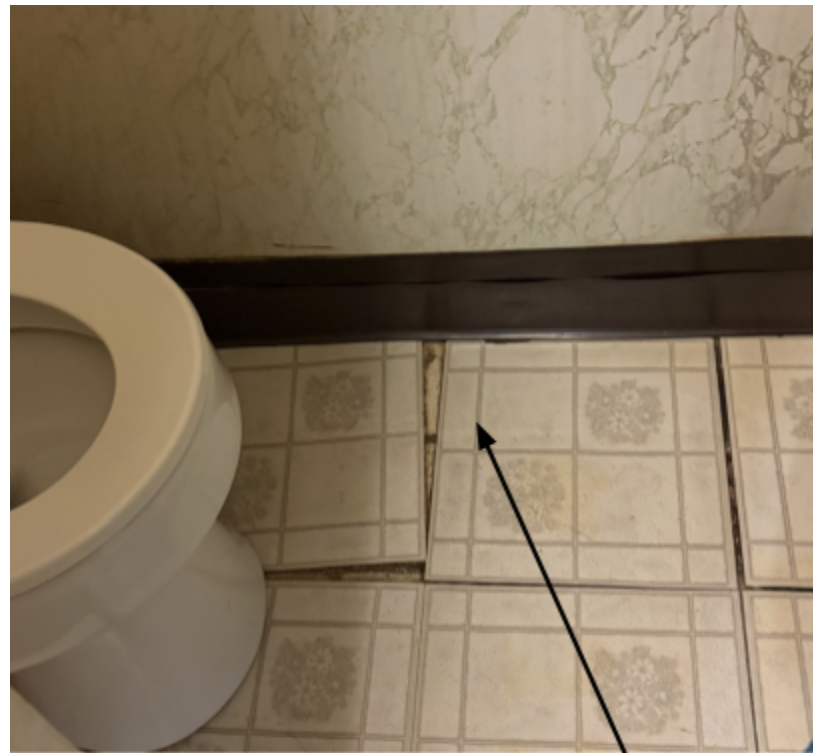
Delamination of laminate flooring.

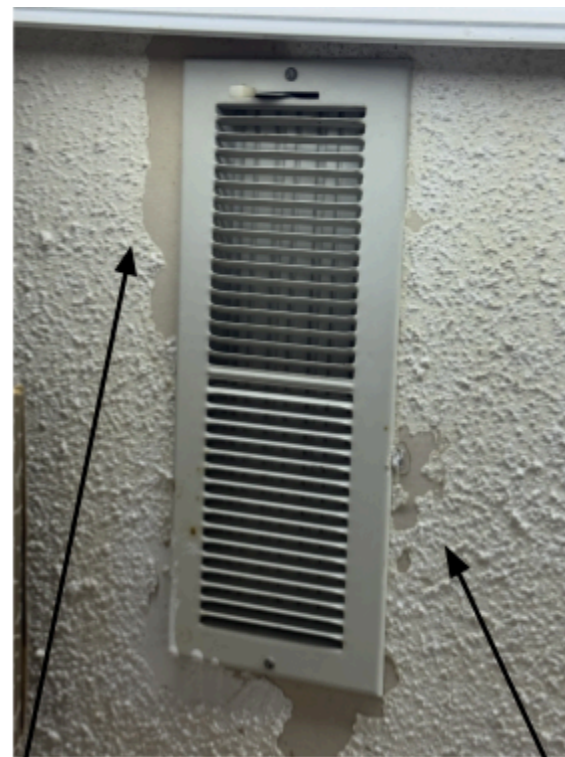
Surface treatment failing around vent.

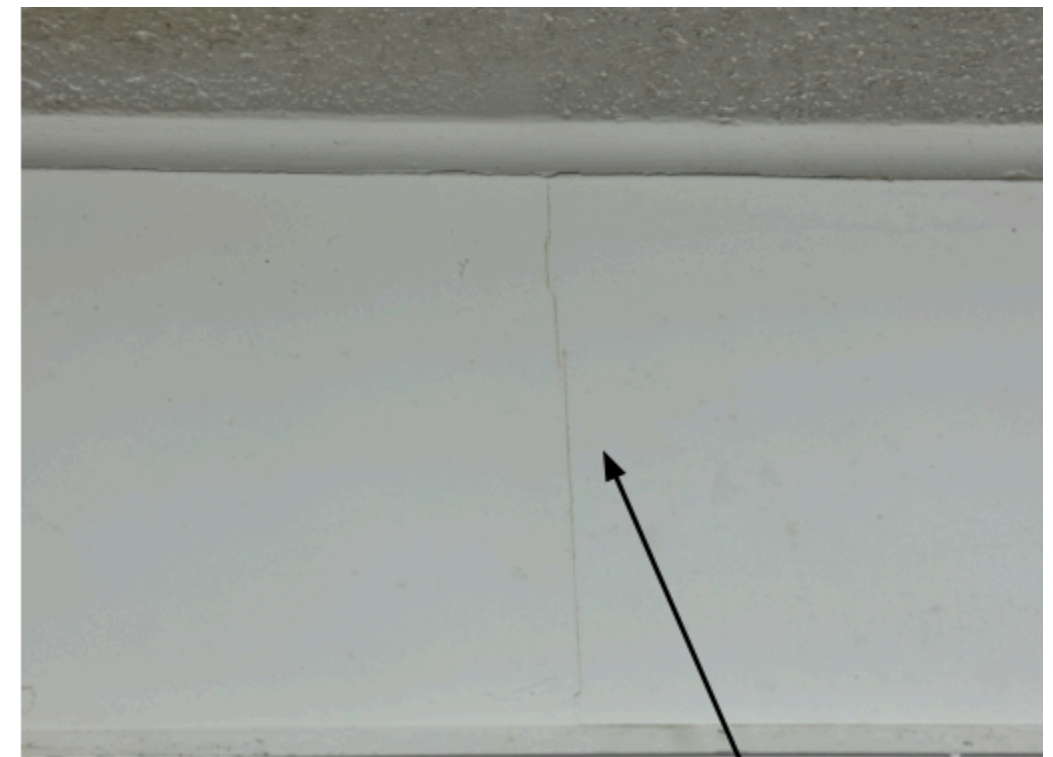
Structural crack near ceiling.

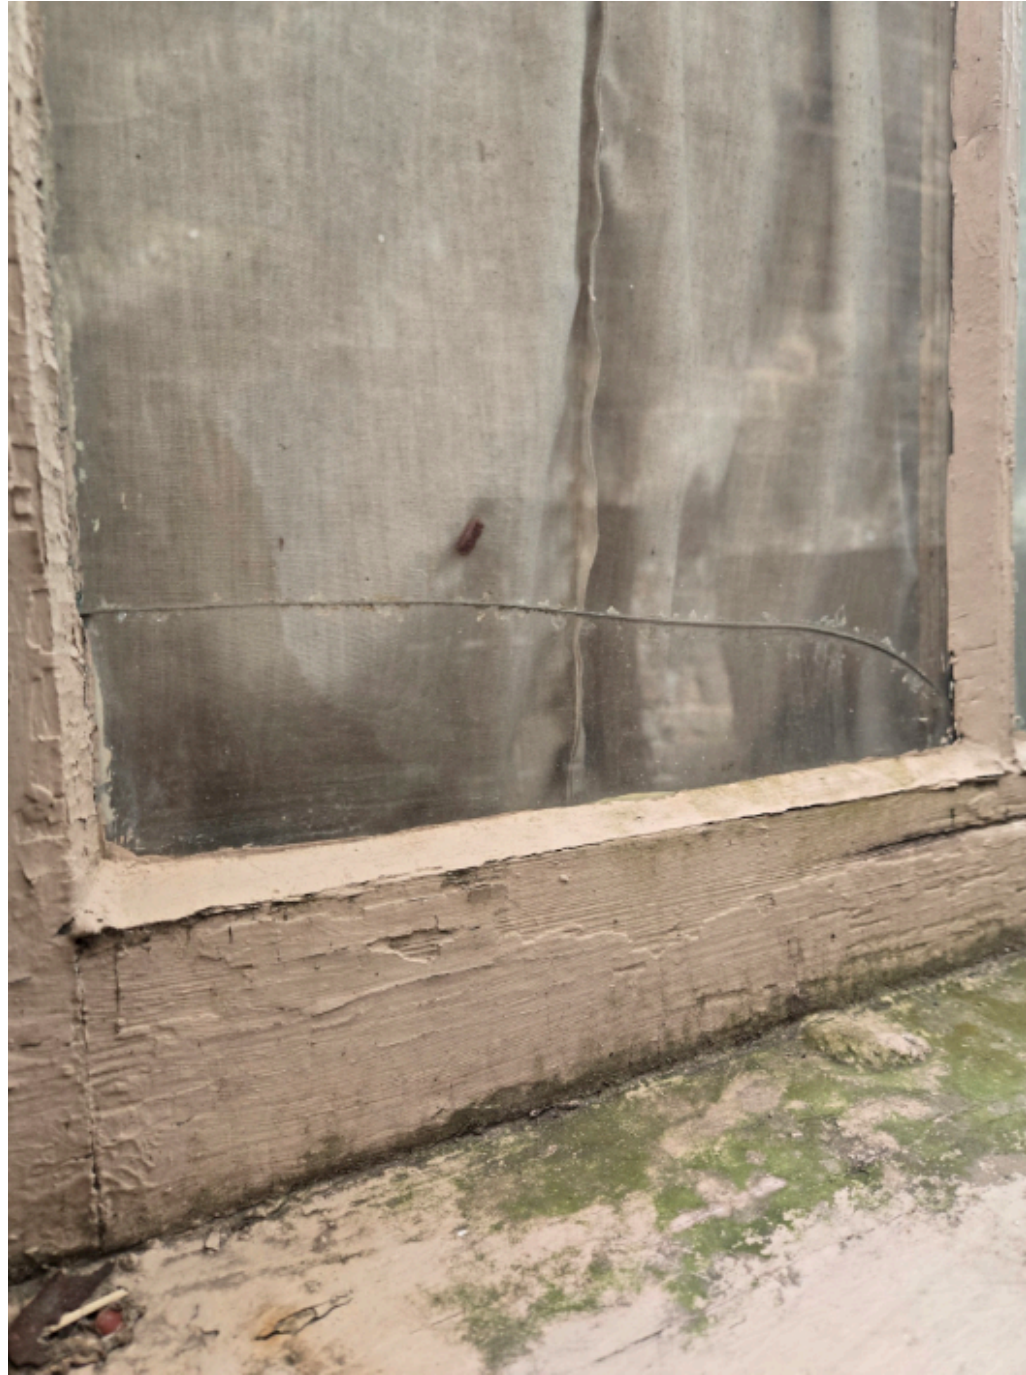
The metals on the exterior of the building are not necessarily important to the historic integrity of the building, but are important to the longevity of the building and its materials. The modern metal roof is already planned to be replaced by the church soon. The most concerning problem with metal materials on the exterior is the corrosion and destruction of gutters and downspouts, as previously noted in the wood section. These gutters and downspouts act as a form of protection in diverting water from the rot-prone wood siding. The most important feature that contributes to the overall historic character is the board and batten wood siding so these materials must be replaced. Proper drainage is required so water does not stand on flat, horizontal surfaces or can accumulate. Replacing in kind with a gutter and downspout system with similar size, scale, material, and color is advised.

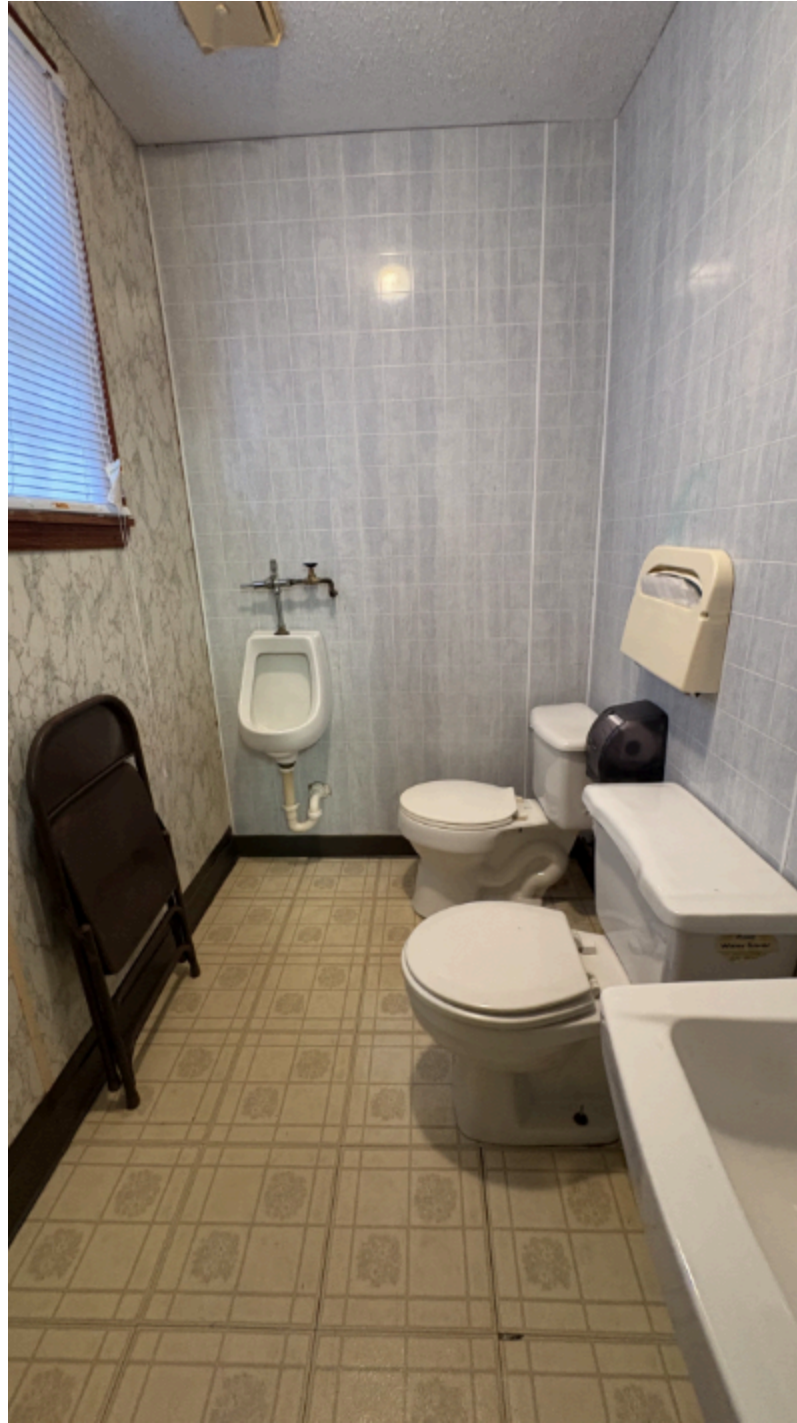
The kitchen floor is covered with extruded ceramic tiles laid with mortar and grout. Tiles should be cleaned with very gentle methods, like a non-soap-based household floor cleaner. Acid-based cleaners should be used with great caution, as they can damage the tiles, but may be useful in removing stains. Natural-bristle or nylon-brushes should be used to remove stubborn dirt. Damaged tiles should be individually replaced in-kind or with a compatible substitute that best matches the appearance of the original. Prolonged exposure to water should be avoided, since it may loosen the mortar underneath the tile and cause it to fail. If the mortar fails, the tile should be relaid.

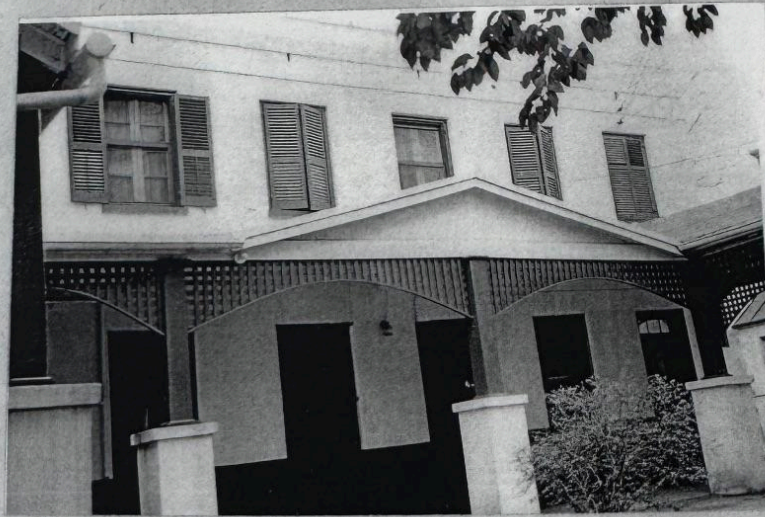
Description: This is a two story brick building of ordinary construction with a wood joisted roof covered with metal. The interior has a concrete floor first and wood joisted floor second, close plastered side walls and ceilings of wood lath and plaster.

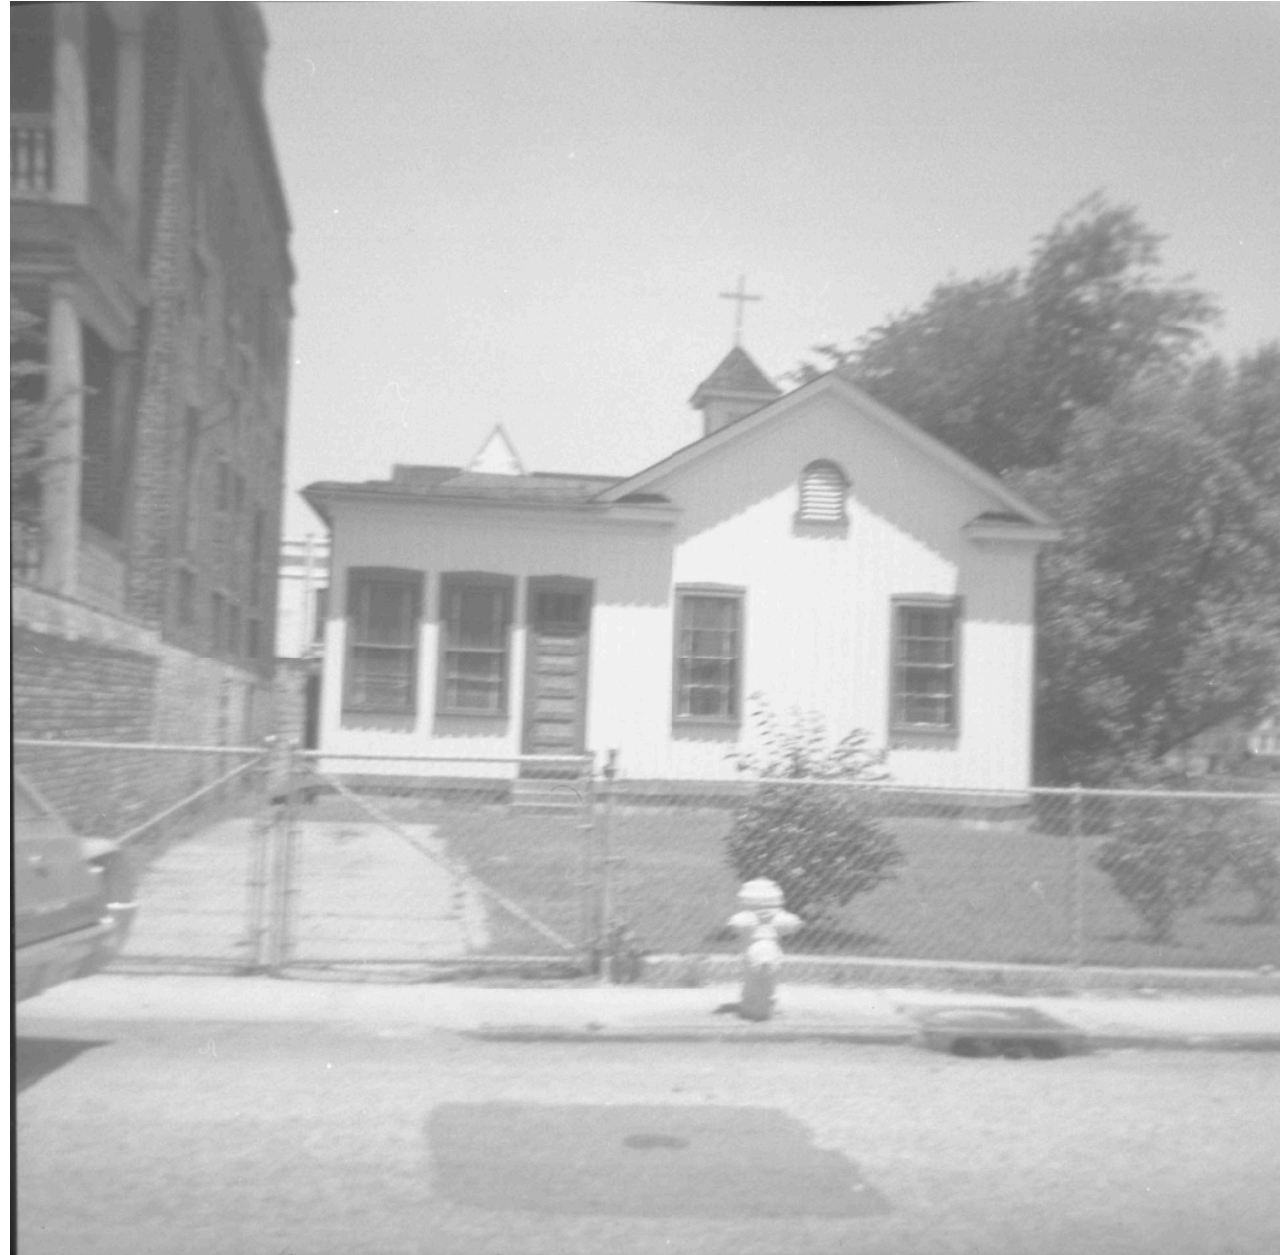
**Figure 13.** “George Street Elevation of 91 Anson Street (St. Johns Reformed Episcopal Church).” 1960. Historic Charleston Foundation Collection, Lowcountry Digital Library.
