# ST. JOHN'S REFORMED EPISCOPAL CHURCH EDUCATIONAL BUILDING

History, Conditions, and Treatments Report

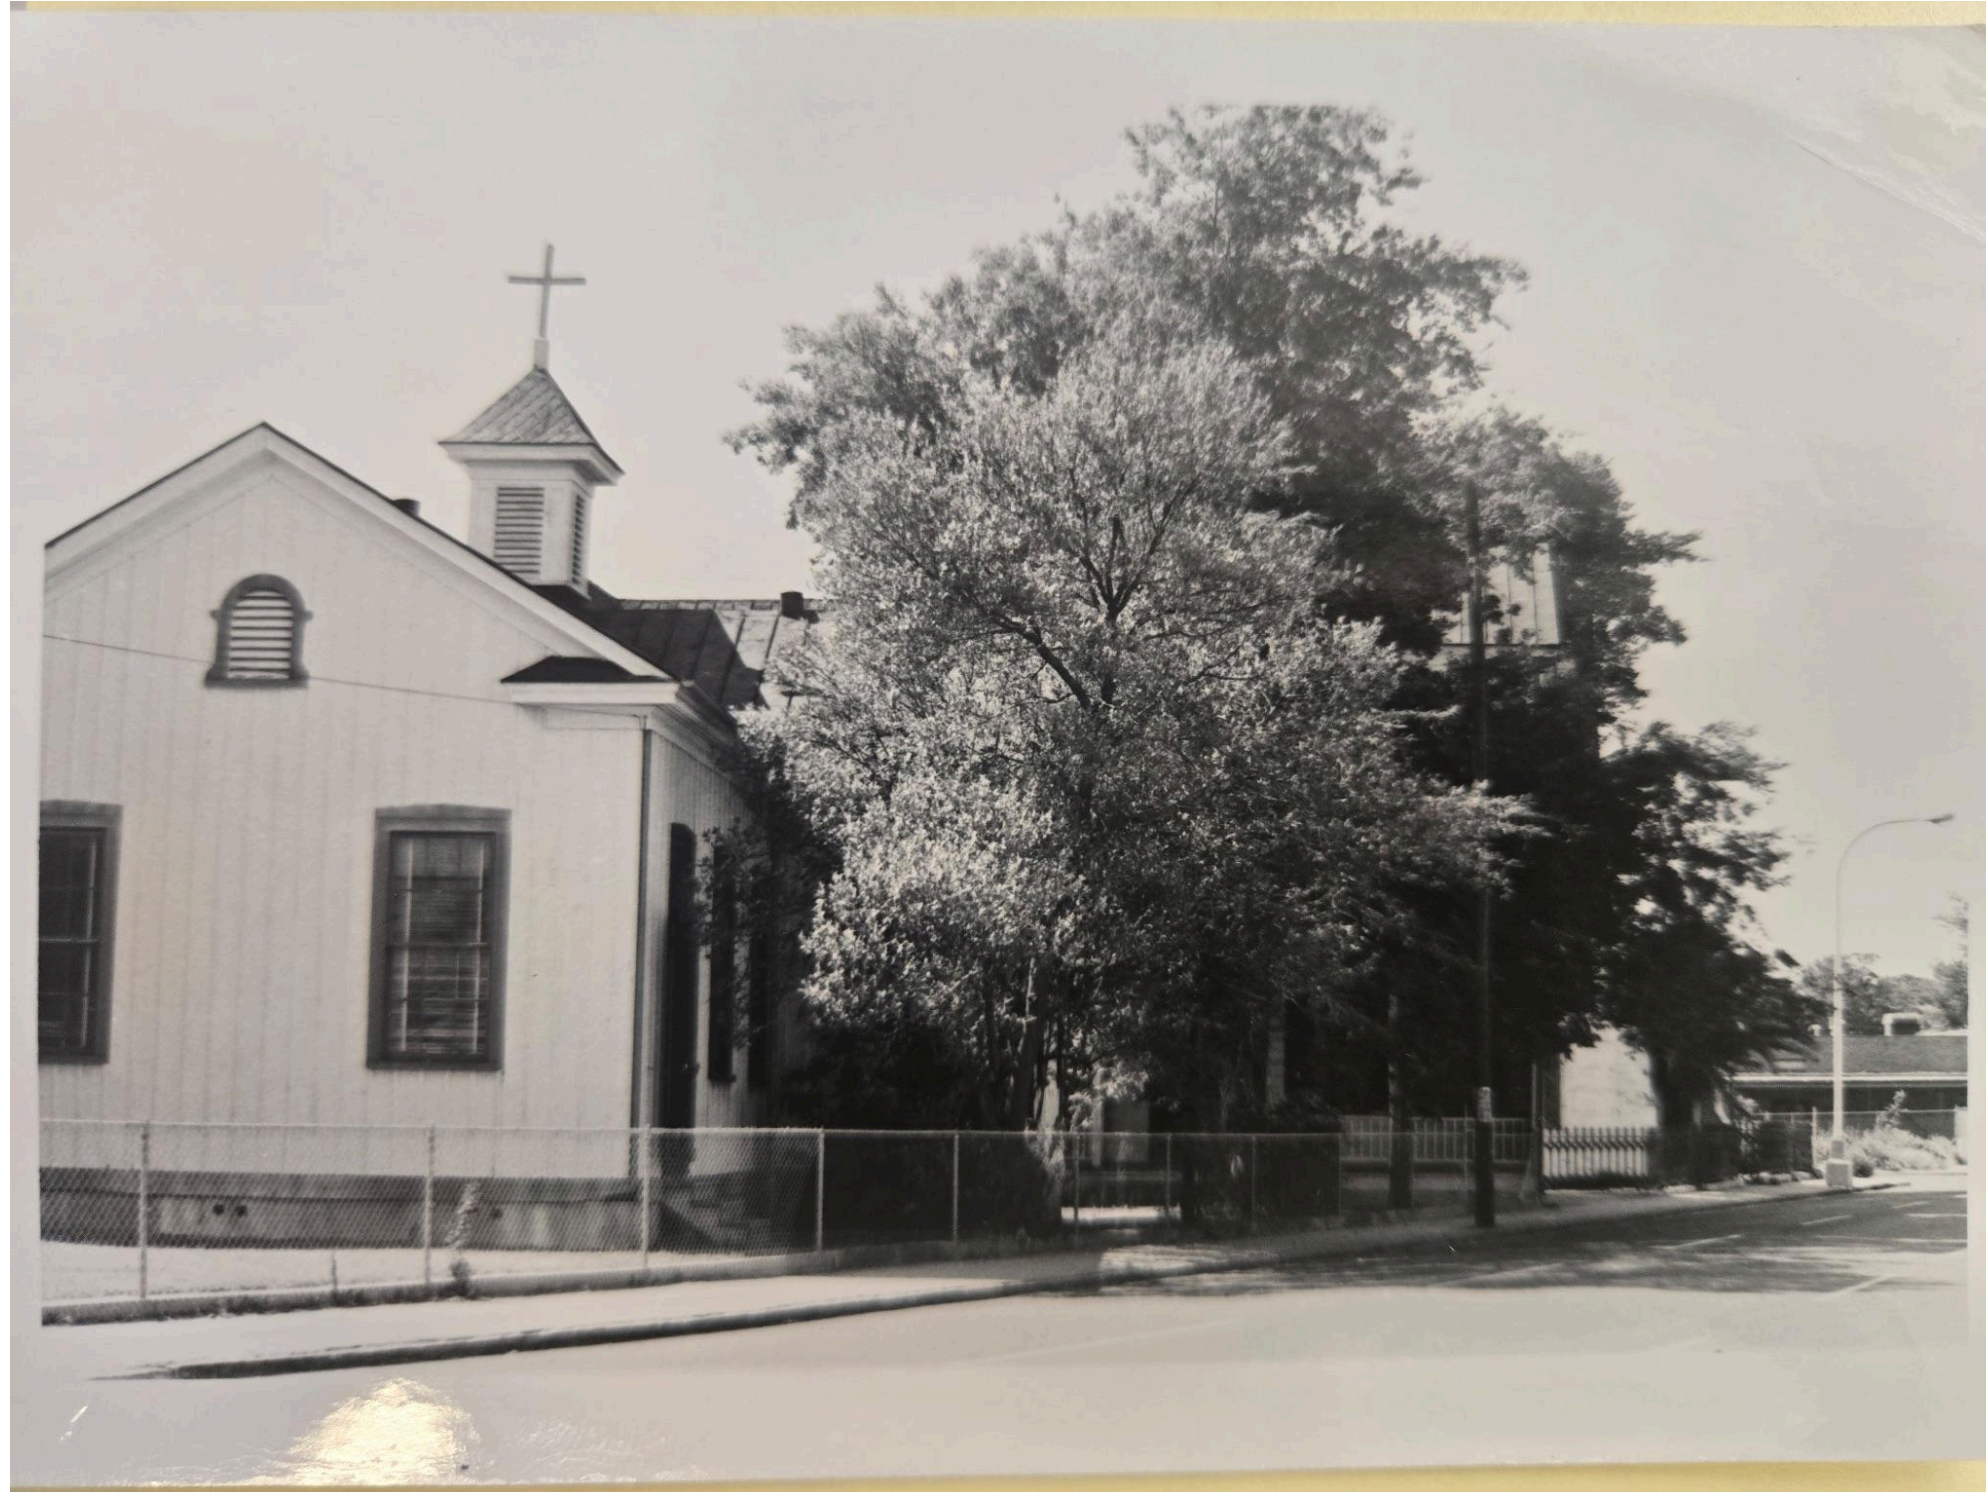
**Figure 14.** August 01, 1968, South and East Elevations Viewed from Anson Street, Roman Catholic Diocese of Charleston.
