**Freedman's Cottage Survey**

**19.5 Line Street**

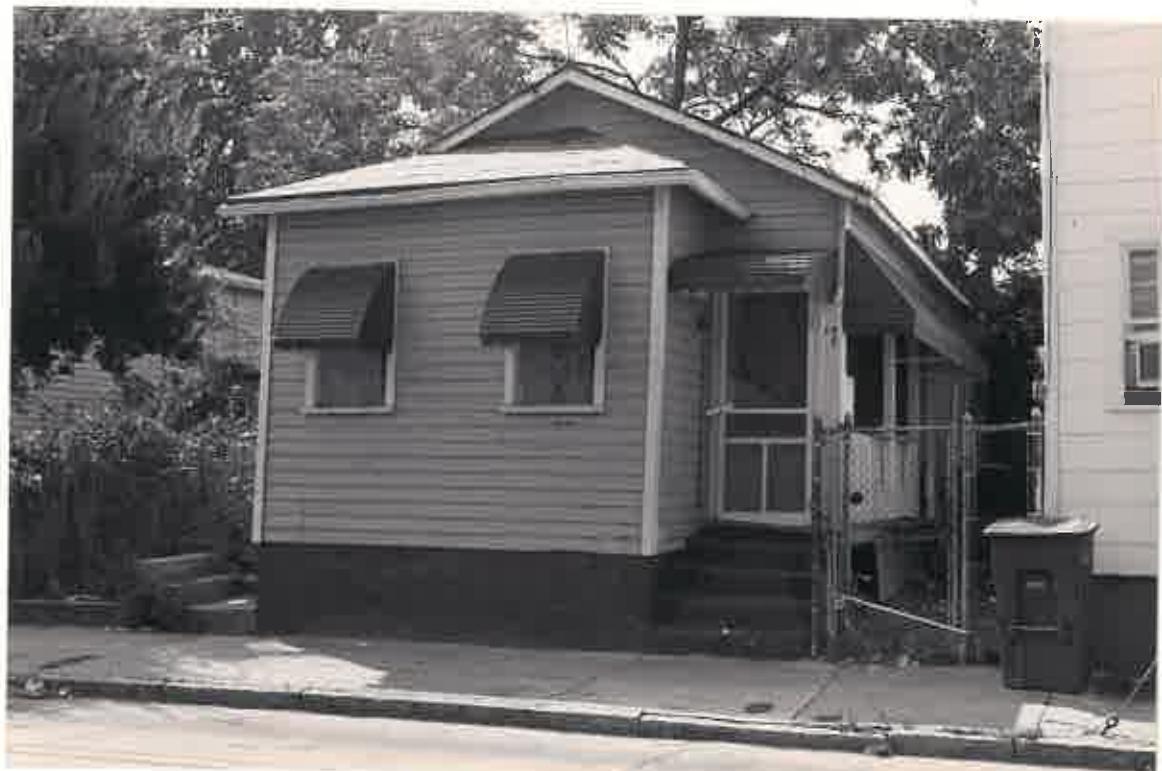
Walls/construction: frame construction, Simple drop siding

Porch: halfway enclosed

Piazza screen: none now, although some evidence of beaded flushboard siding

Gable: minimal gable details and overhang

Windows: addition at front obscures original windows

Openings into main house: entry into first room visible

Foundation: Brick, stuccoed

Chimney: No chimney

Note: Vacant and boarded. Addition at front covers original windows, and house is greatly altered.  
[above house also in Eastside survey]
