**A STRUCTURAL INVESTIGATION OF
36 REID STREET
CHARLESTON, SOUTH CAROLINA**

Submitted to Craig M. Bennett, Jr.
April 26, 2016

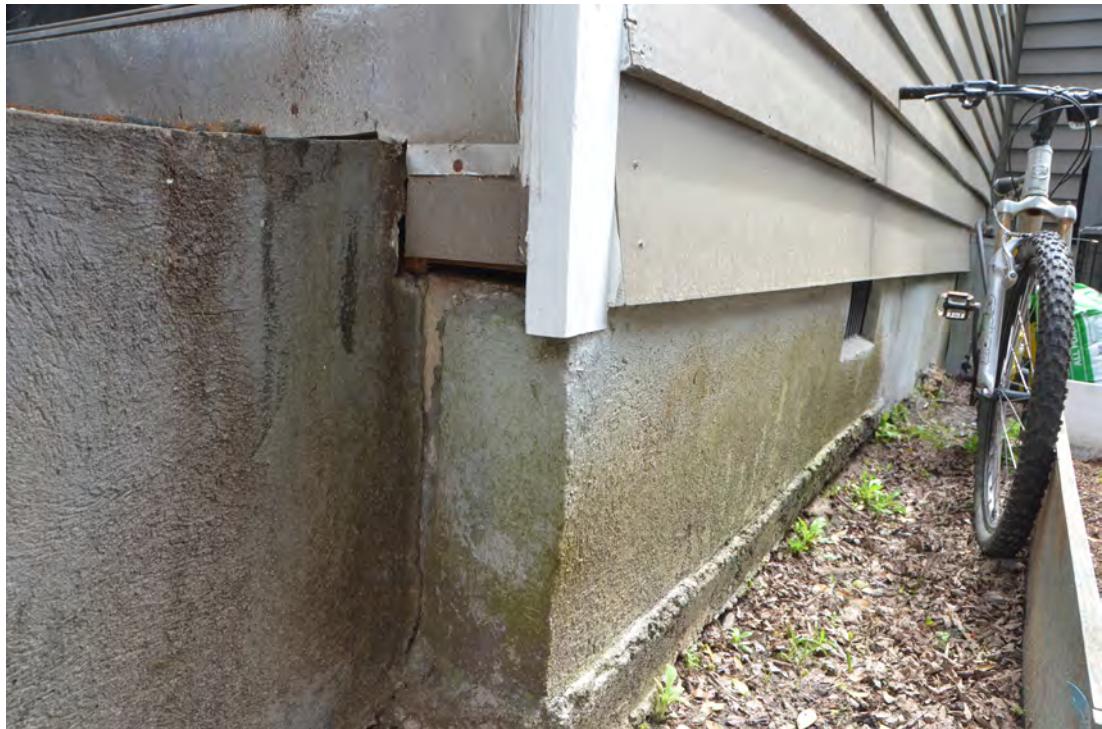
- A significant level of biogrowth and mold/mildew are present on the exterior of the foundation wall on the west side of the hyphen and the kitchen, as well as on the north side of the kitchen. Biogrowth is more prominent near the rear of the house. (Figures 15 and 16)

- Biogrowth is present in areas heavily shaded by trees at the rear of the property. Both the north and west walls – areas affected by biogrowth and mold – do not receive enough sunlight to adequately dry the area. Additionally, without gutters, rainwater runs down the face of the house allowing moisture to sit against the foundation walls fostering an ideal environment for biogrowth.

Figure 19. Biogrowth at the Northwest Corner of the Outbuilding.

- Remove biogrowth and plants against the house and off the foundation. Add gutters and downspouts to the house to migrate water away from the structure and foundation.
- Migrate water away from window and door trim, windowsills and the parapet by installing new flashing. Replace deteriorated wood and repaint where necessary.
- Repair or replace areas of corroded roof material as necessary to prevent water from entering the house, specifically above the hyphen. Ensure that flashing has not corroded at the main house-hyphen junction and at the gable ends.

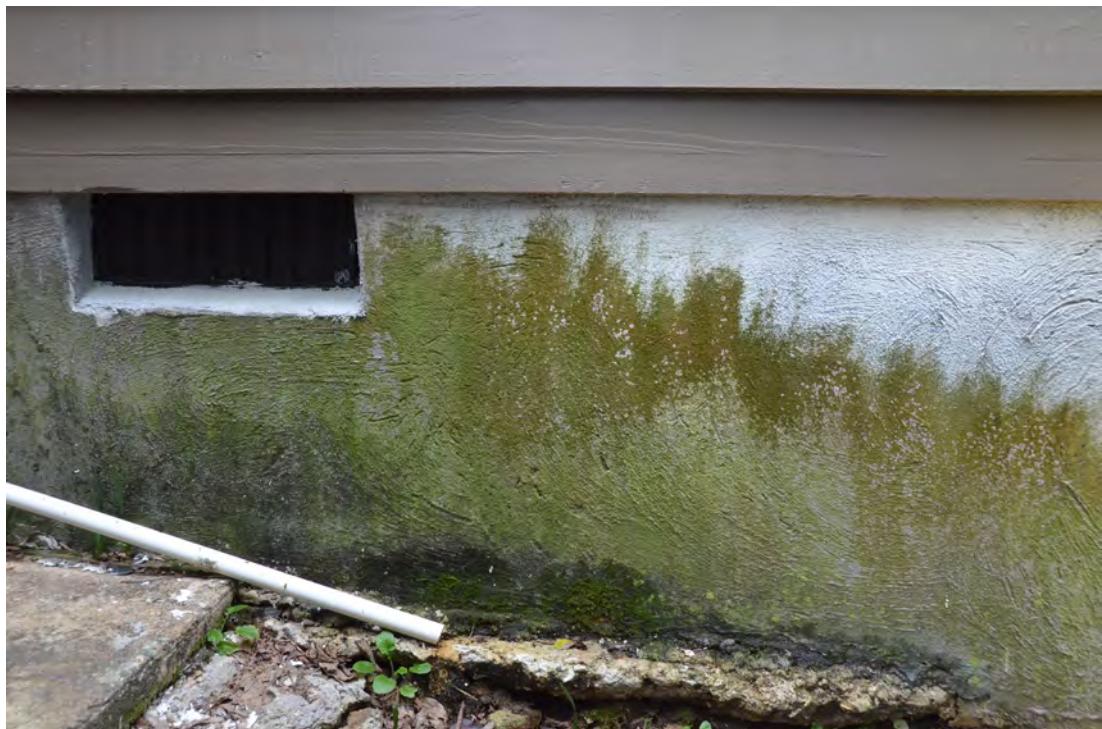
Figure 20. Biogrowth on the West Foundation Wall of the Outbuilding.

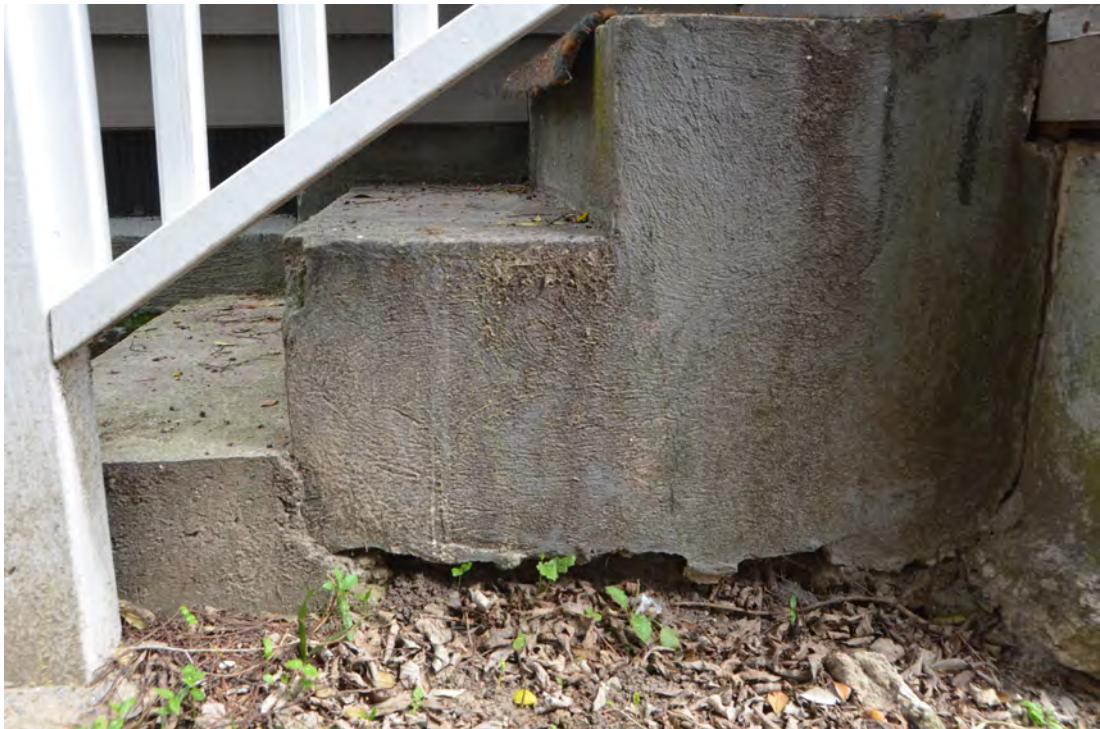
- Soil washout around the foundation and the rear stairs is attributed to the lack of gutters on the house. Without gutters and downspouts, rainwater is not properly migrated away from the structure.

Figure 21. Soil Washout at the Rear Stairs.

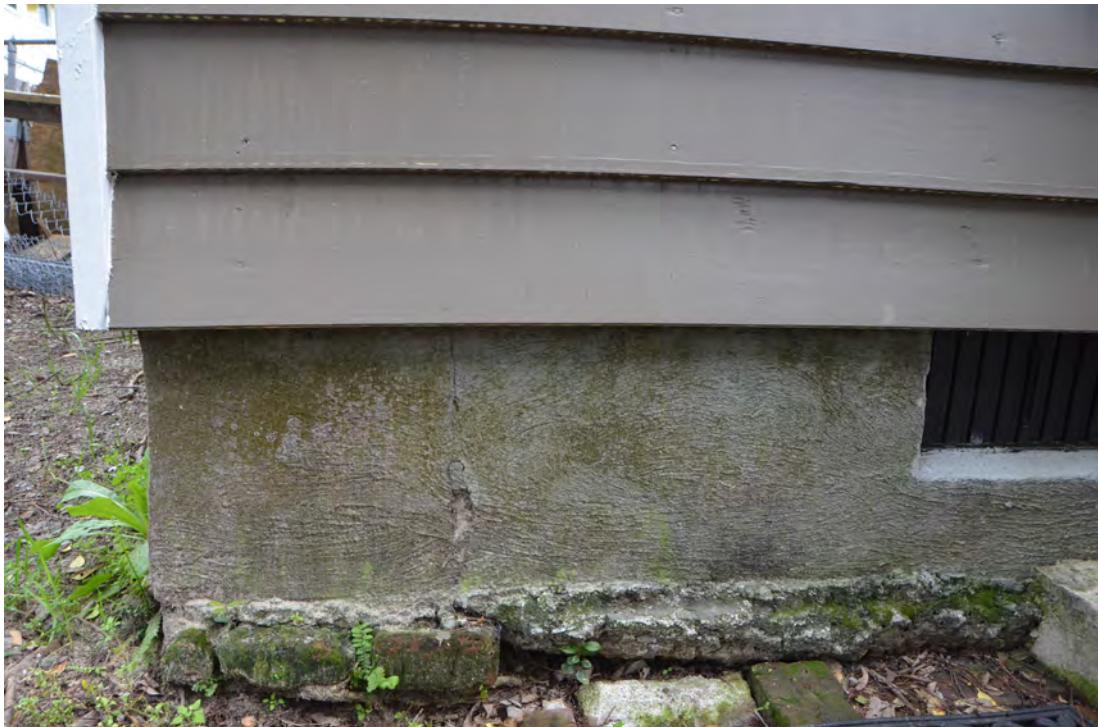
Figure 23. Soil Washout at the West Elevation.

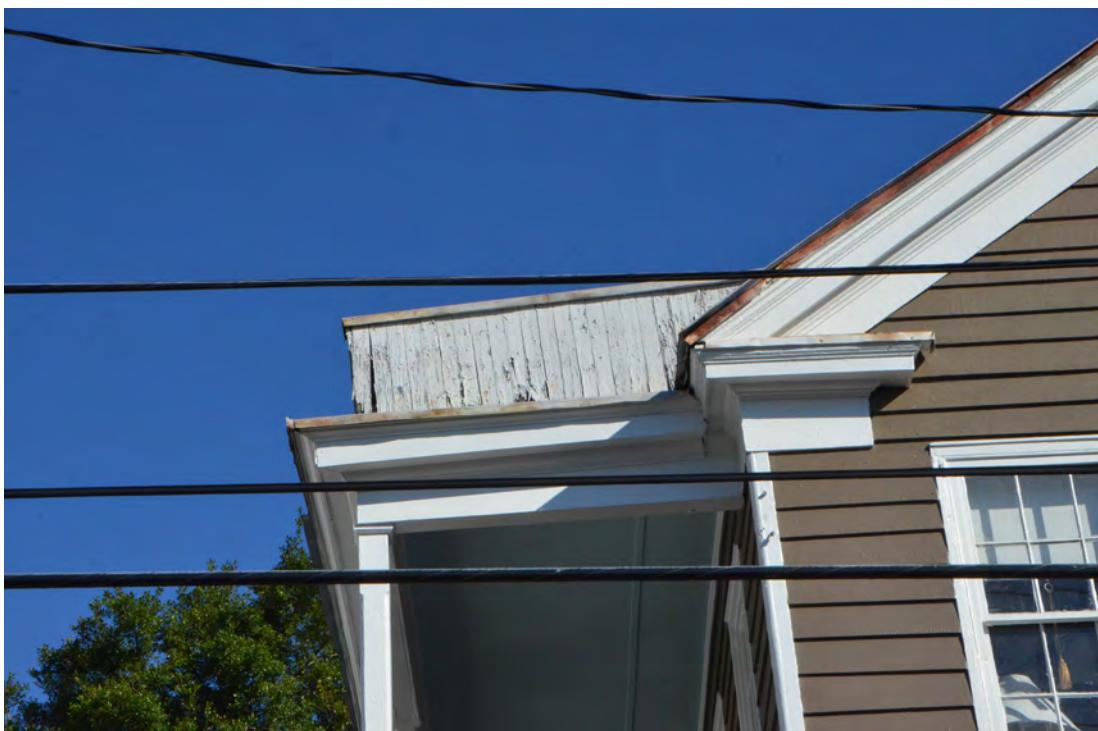
- The vertical wood planks of the parapet are severely deteriorated. The rot is most substantial at the base of the parapet. There is also significant paint loss on the parapet. (Figure 20)

- The parapet has deteriorated due to its prolonged exposure to both moisture and UV light. Deferred maintenance has increased the deterioration process.

Figure 24. Deteriorated Parapet.

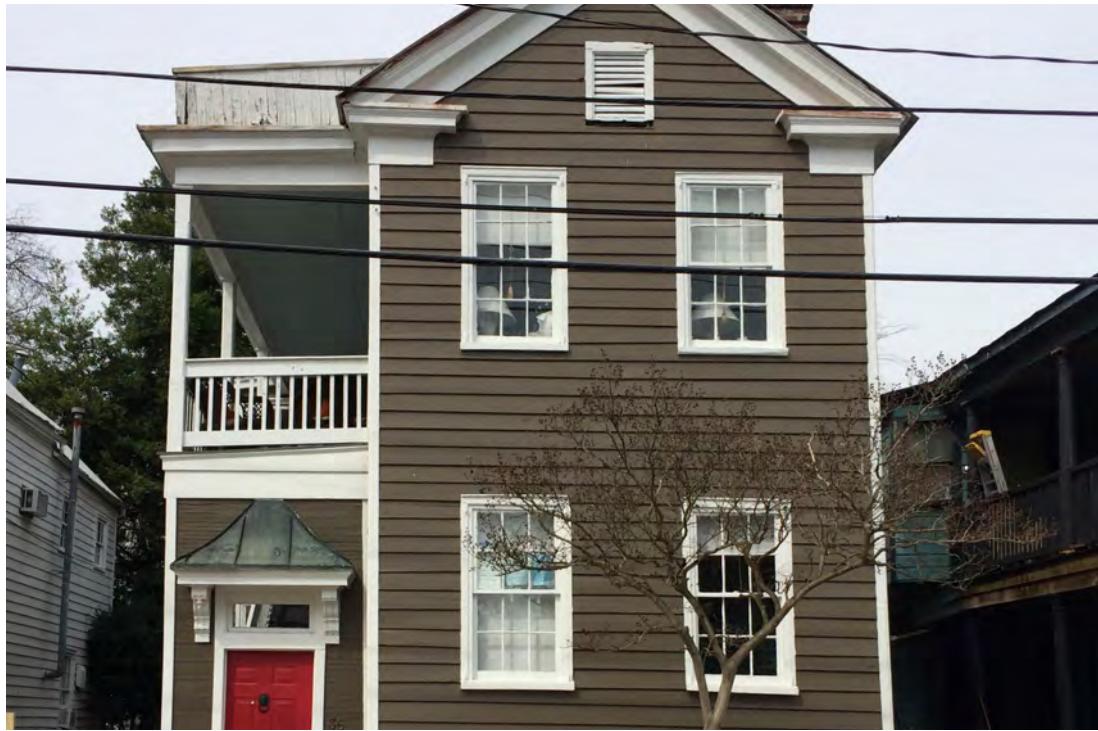
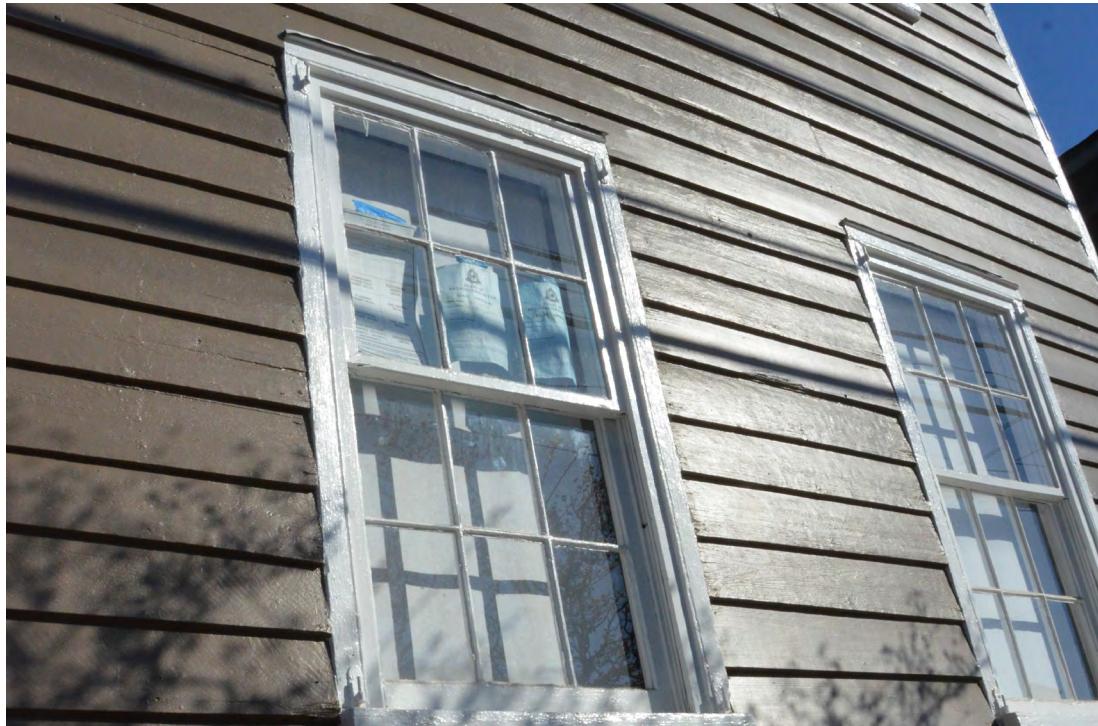
- The shutters on the south (primary) façade of the house are missing. Although the shutter pintles have been recently painted, they still show signs of corrosion and rusting. (Figures 21 and 22)

Figure 25. Missing Shutters on the South Facade of the House.

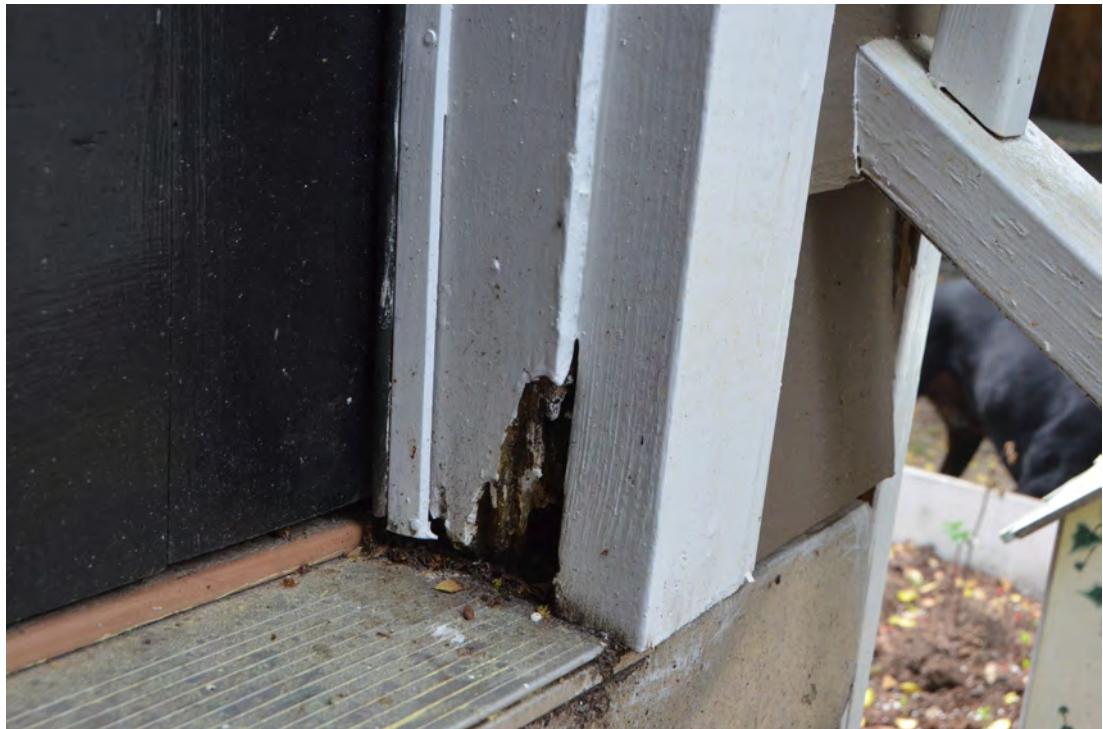
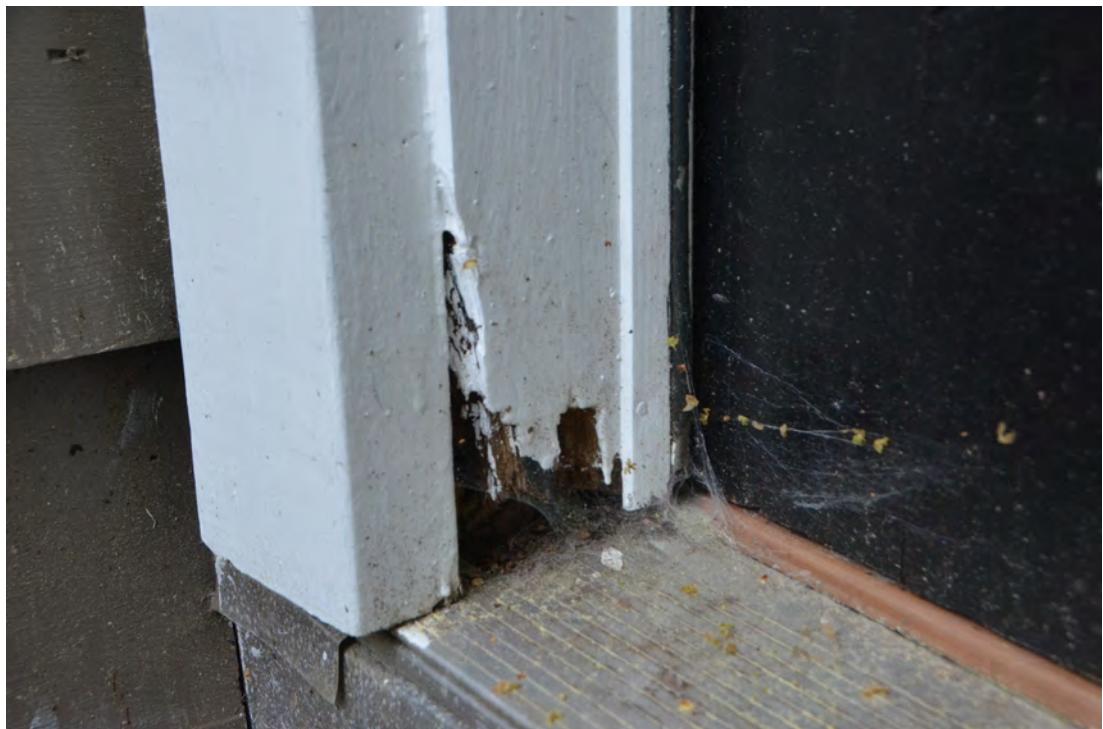
- The wood windowsills, window surrounds and door trim are moderately rotted in several areas. Deterioration is specifically seen at the base of the doorway leading from the rear hallway to the backyard and at the window in the south wall of the kitchen on the first floor. (Figures 23 – 26)

- The shutter pintles, as well as other metal fasteners on the house are corroding due to exposure to moisture.
- Wood millwork on the exterior of the house is deteriorating due to moisture intrusion. Windowsills on the house have begun to deteriorate where their end grain is exposed to water. Door surrounds are most commonly deteriorating where the millwork meets the flashing at the base of the door. The exposed rafters are deteriorating because of a lack of gutters on the house to migrate water away. These areas are all continuously exposed to the weather. Deferred maintenance and a lack of paint has increased the deterioration process.

Figure 27. Wood Rot on an Exterior Door Surround.

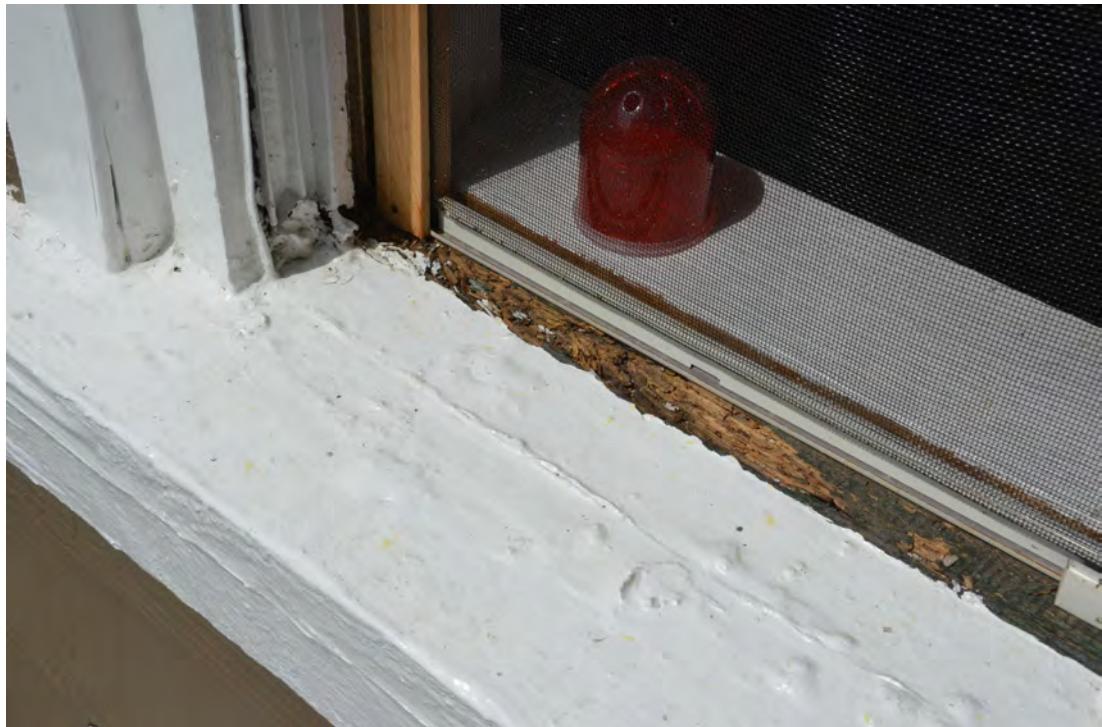
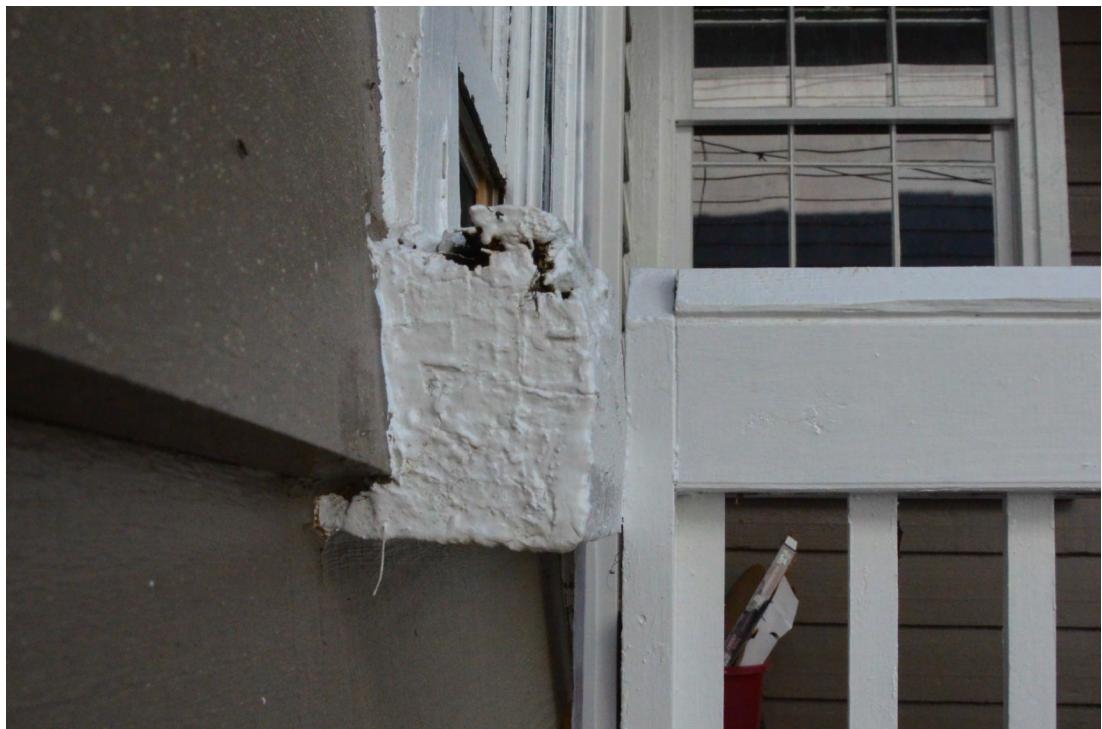
Figure 29. Wood Rot on a Window of the Kitchen Addition.

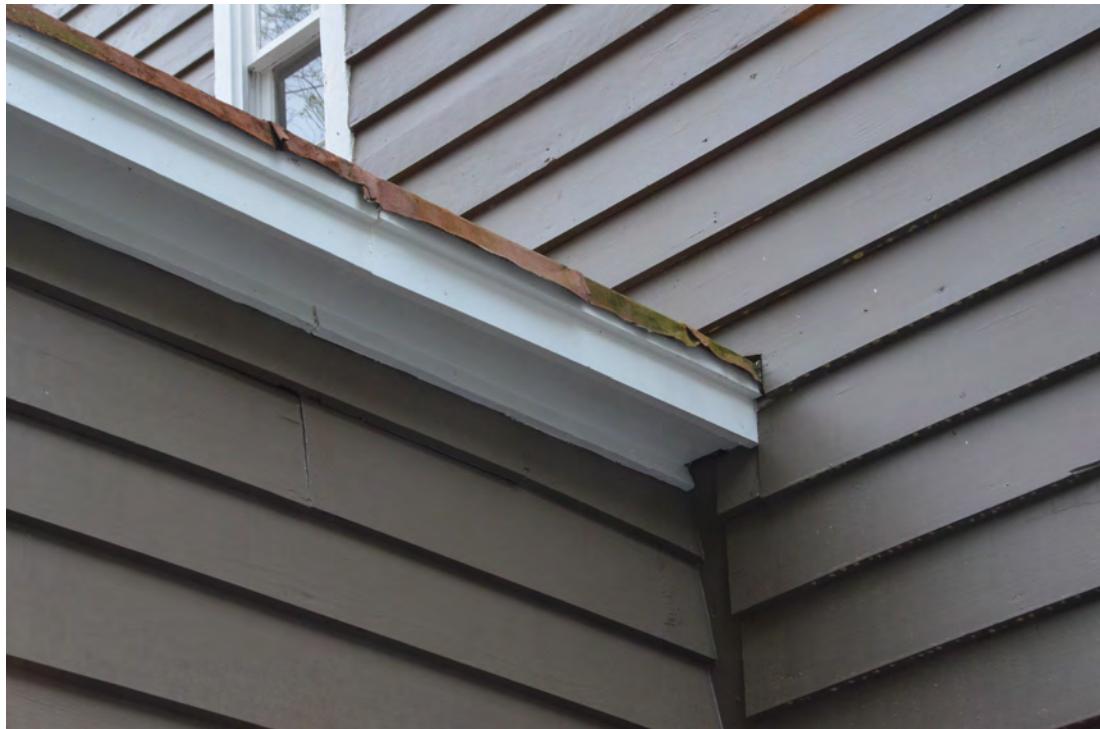
- While the majority of the roof was inaccessible and not visible, the roof over the hyphen of the house showed signs of corrosion and deterioration. The potential for an issue with this roof is reinforced by the presence of water stains on the ceiling of the laundry room. (Figure 27)

- The roofing material is corroding due to age and deferred maintenance.
- The appearance of millwork deformation around the windows on the south wall of the kitchen is attributed to the settlement of the west façade of the kitchen addition and the piazza.

Figure 31. Corroded Roofing Material Over the Hyphen.

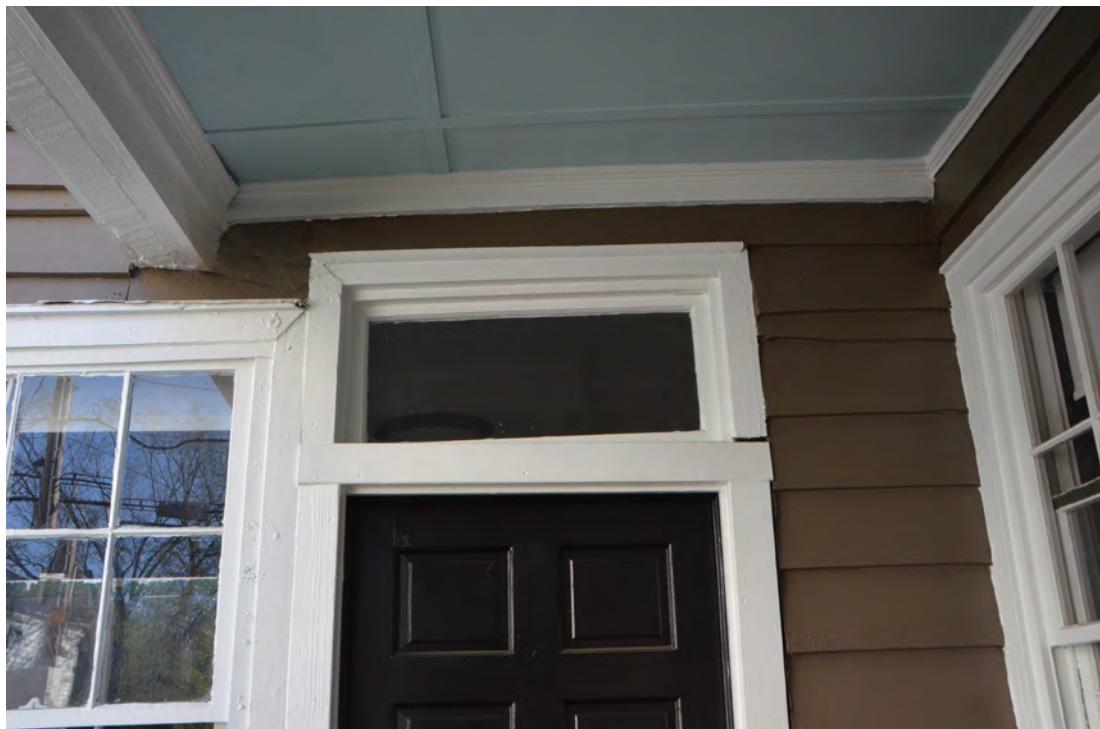
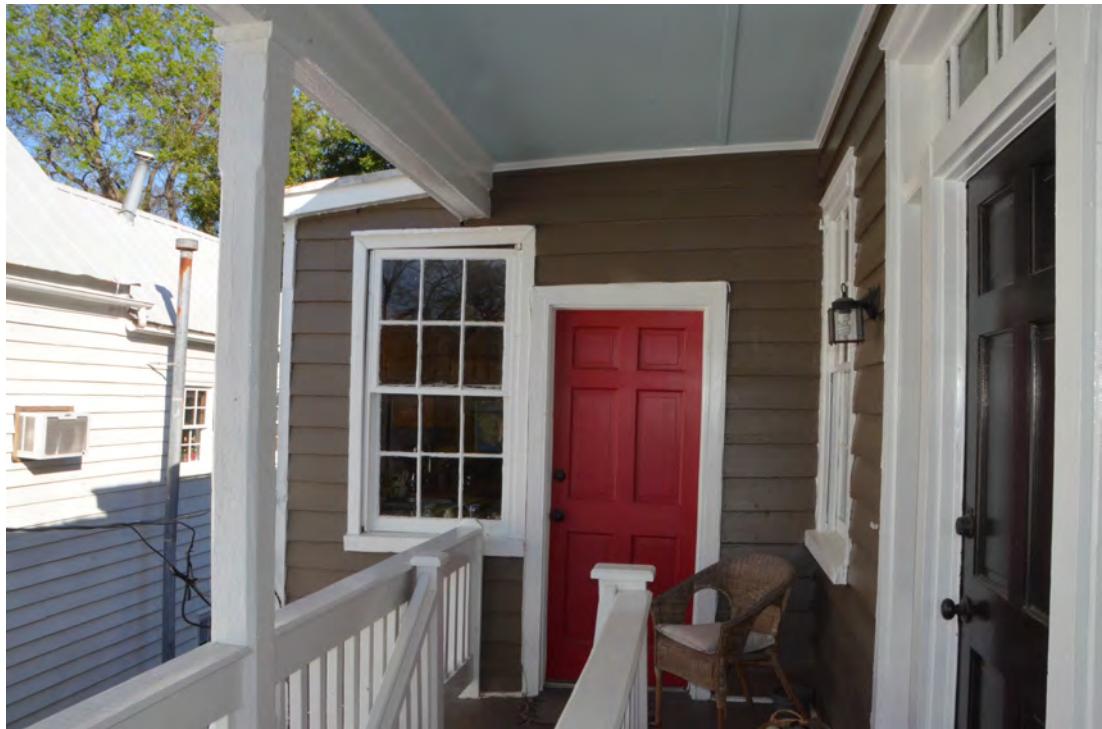
Figure 32. Shifting of Fenestrations on the 1st Level.

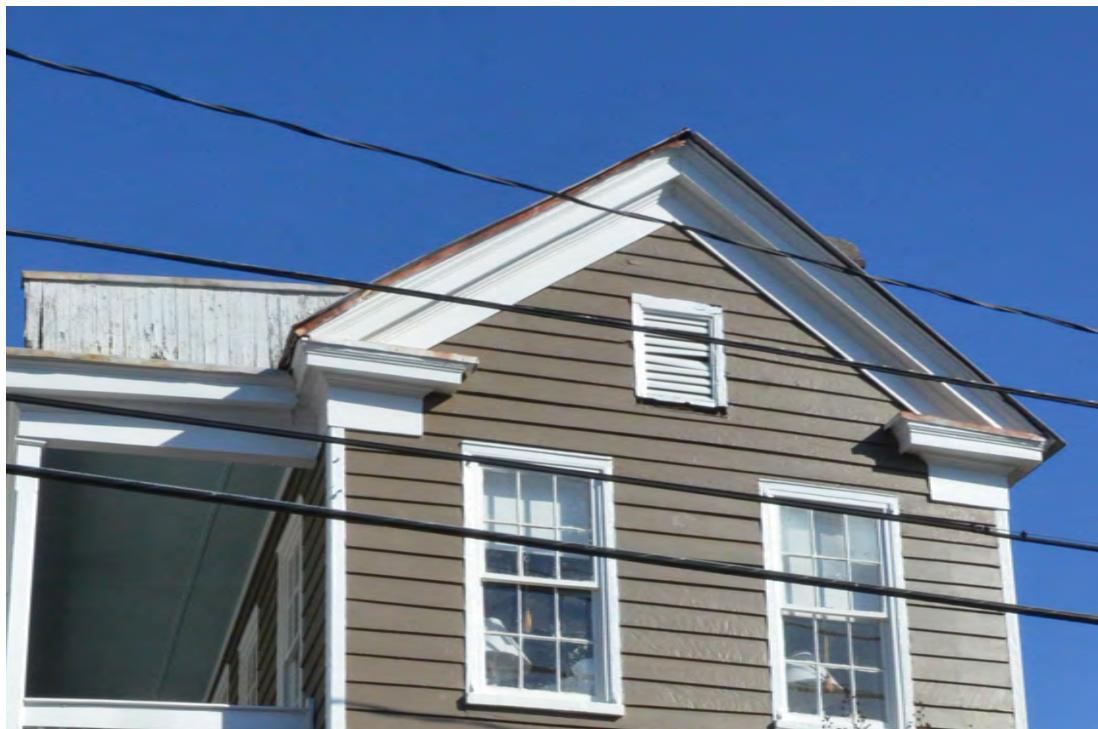
- Flashing around the house, specifically at the south gable-end is corroding due to exposure to moisture.

Figure 36. Corroded Flashing at the South Facade Gable.

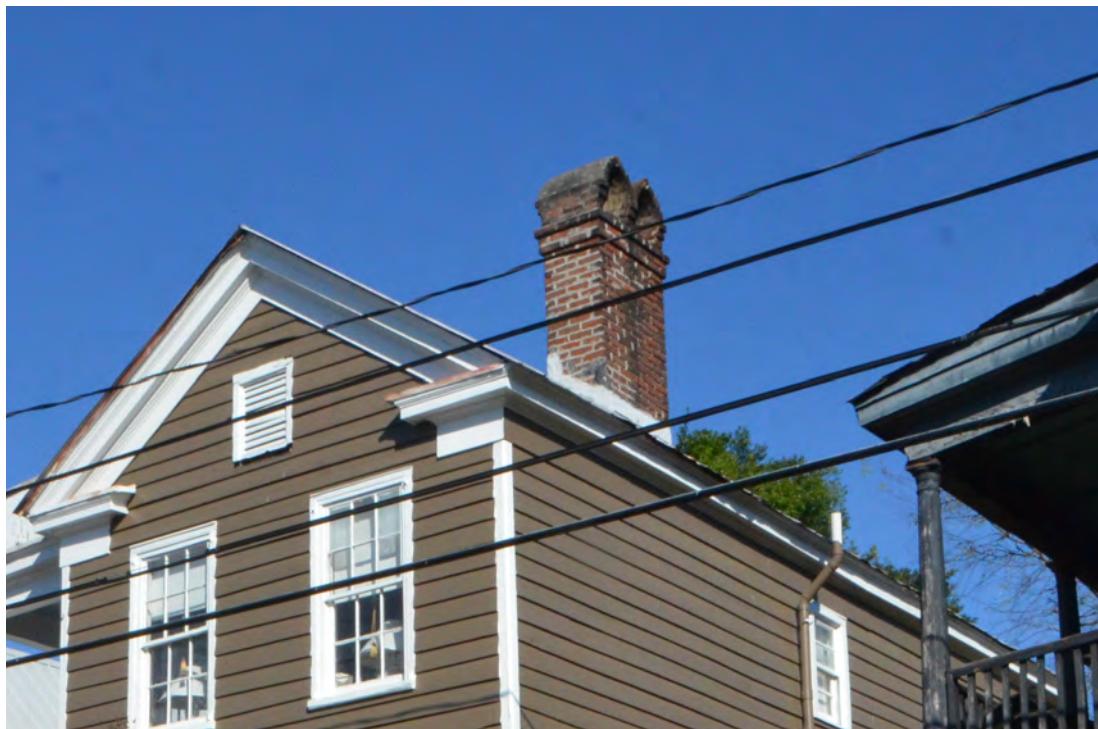
Figure 37. Loss of Mortar on the Chimney.

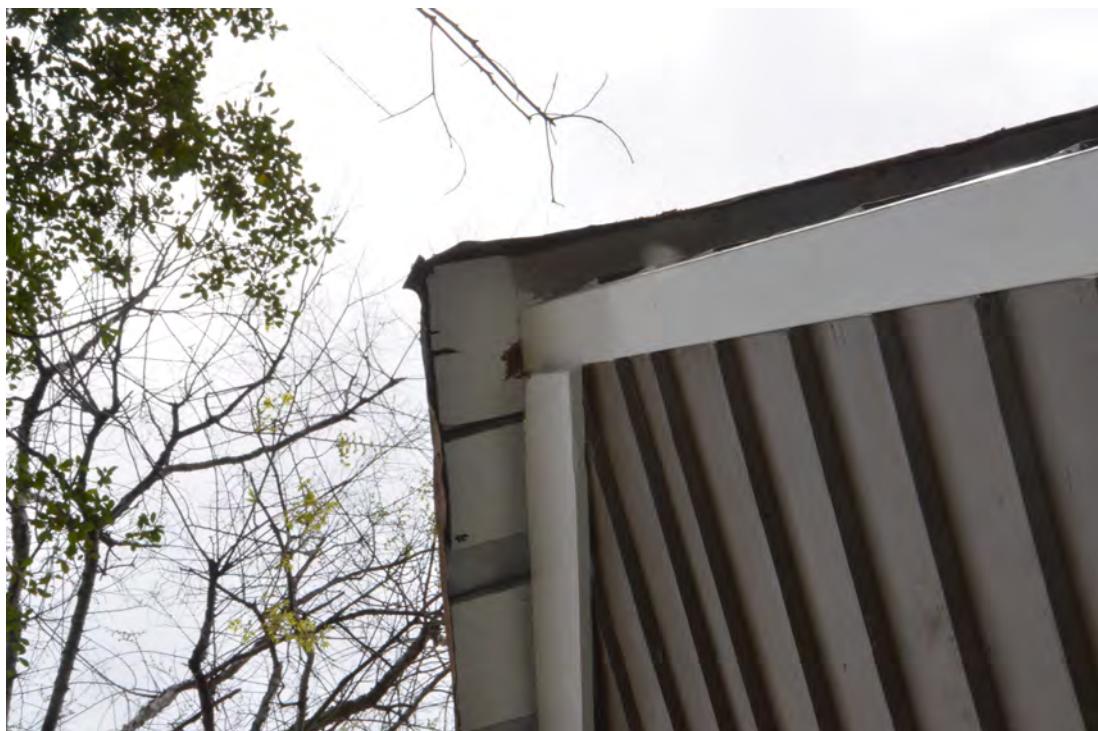
Figure 38. Deteriorated Rafters Beneath the Gable of the Outbuilding.

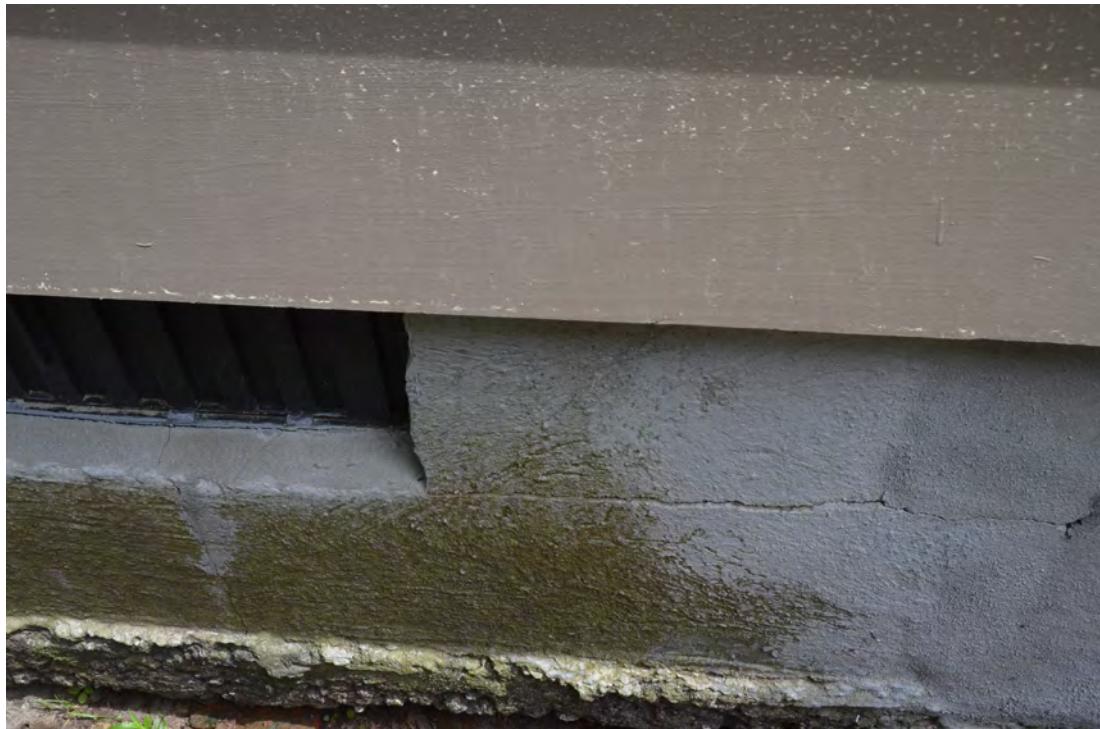
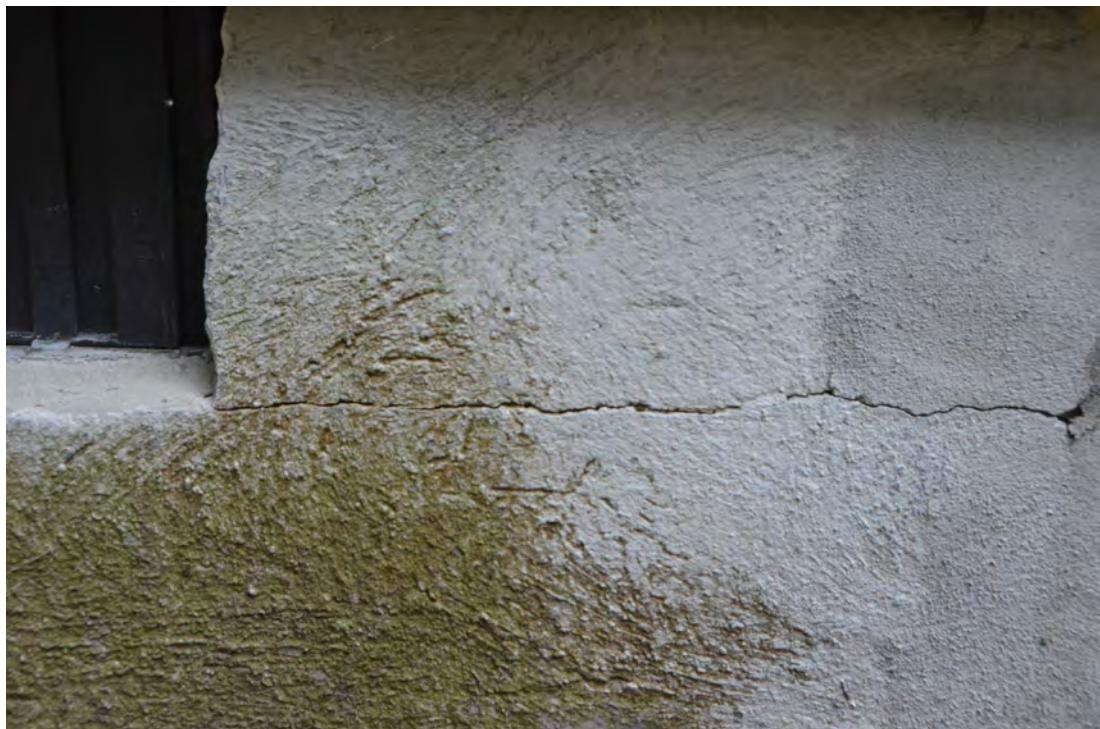
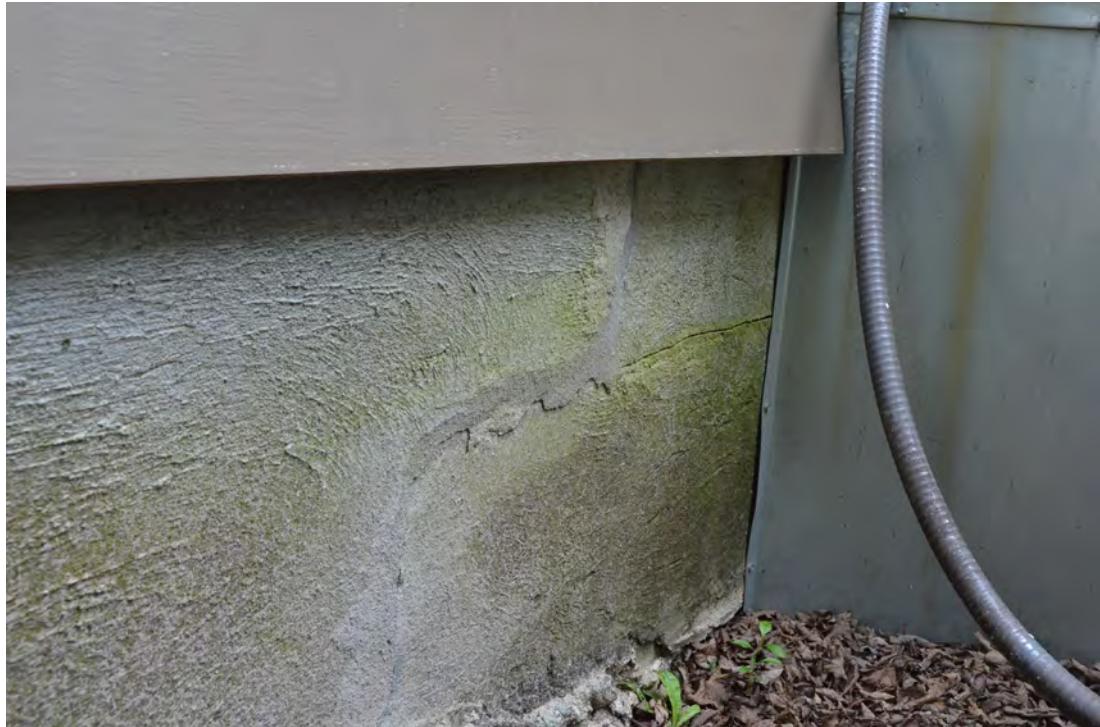
- There are several horizontal cracks on the west elevation of the dependency (now connected to the main house) and the hyphen. These cracks are located near the crawl space ventilation grates and the HVAC system units. There are also several vertical cracks, however, horizontal cracking is more prevalent. It is unclear if the cracks are through-wall or only present in the stucco veneer. Past repairs with Portland cement are visible at some of the cracks. (Figures 35 – 37)
- The west masonry wall of the kitchen addition is bowing outward where the top of the foundation meets the wooden structure. (Figure 38)

- The addition of pipes through the foundation walls to serve modern utilities and the HVAC units has caused the horizontal cracks seen in the stucco veneer of the masonry foundation. Settlement of the masonry walls and prolonged exposure to moisture may also be causing cracking.

Figure 39. Foundation Cracks.

- Monitor the cracks in the foundation to determine if they are active. The cracks do not appear to be through-wall and do not pose an immediate threat to structural stability.

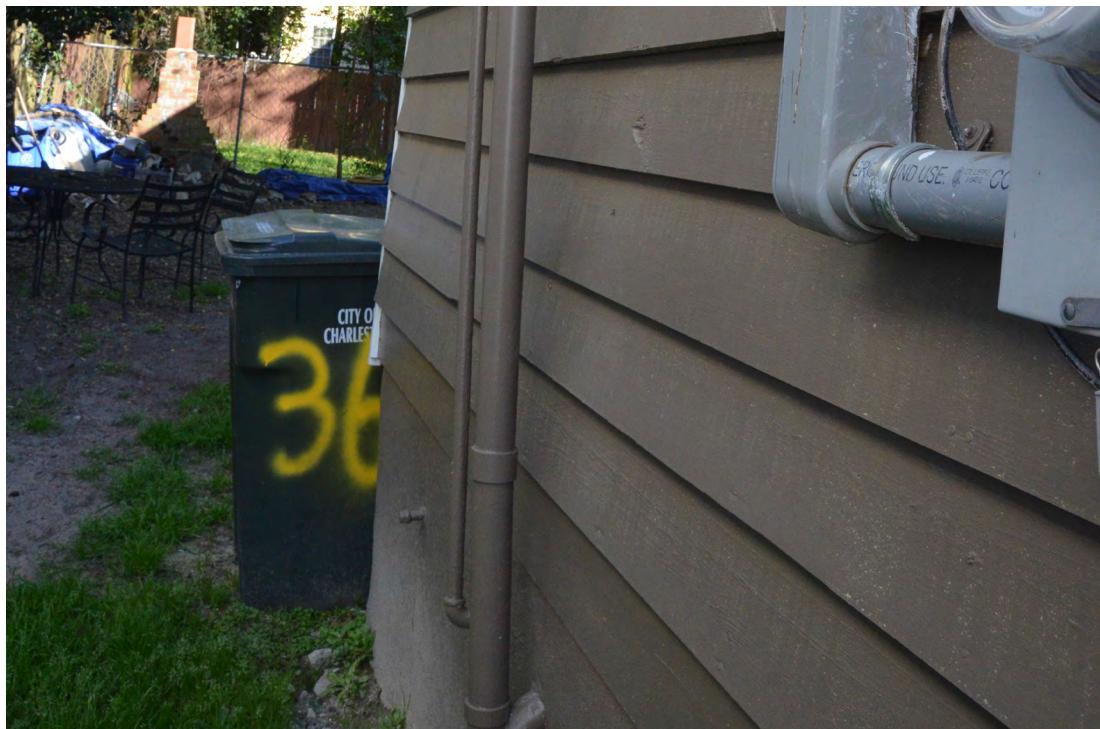
Figure 42. Bowing of the Northwest Corner of the Kitchen Addition.

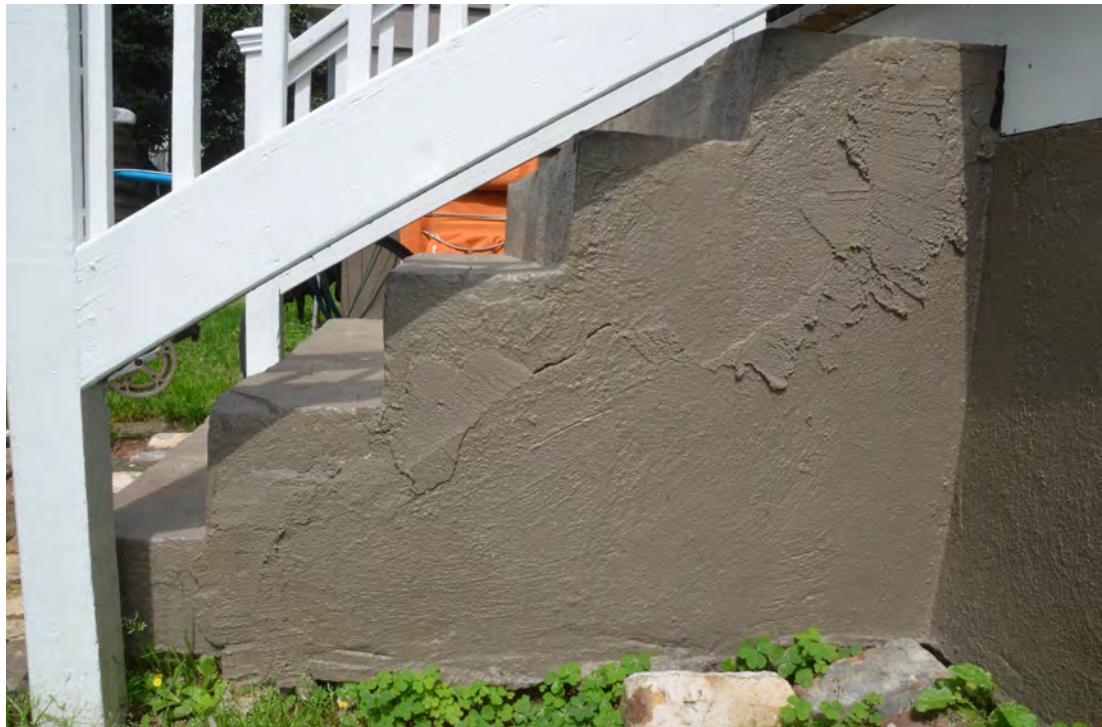
- There is a diagonal crack running the length of the south side of the concrete stairs leading from the side yard up to the piazza. It appears that this crack was previously repaired. (Figure 39)
- On this same stair leading from the side yard to the piazza, there is an area of material loss on the top step where the concrete meets the piazza decking. (Figure 40)
- The two columns on the first level of the piazza appear to be splitting. There are vertical cracks along the west and south sides of both columns. These cracks start at the capital and run two-thirds the length of the column. The columns were painted in the past year and the cracks do not appear to be active. (Figures 41 and 42)

- The diagonal crack on the south side of the stairs in the side yard does not appear to be active. The crack was likely caused by settlement. The missing concrete on the top step was likely caused by an incorrect concrete mixture or inadequate time to set.

Figure 43. Diagonal Crack in the Side Concrete Stairs.

- Repair the area of missing concrete on the side yard stairs and patch the crack on the stair's south face.
- Remove and replace steps that have deteriorated or split on the exterior piazza stair. These steps should be replaced with a pressured treated wood and painted to keep moisture from entering the exposed end grain.

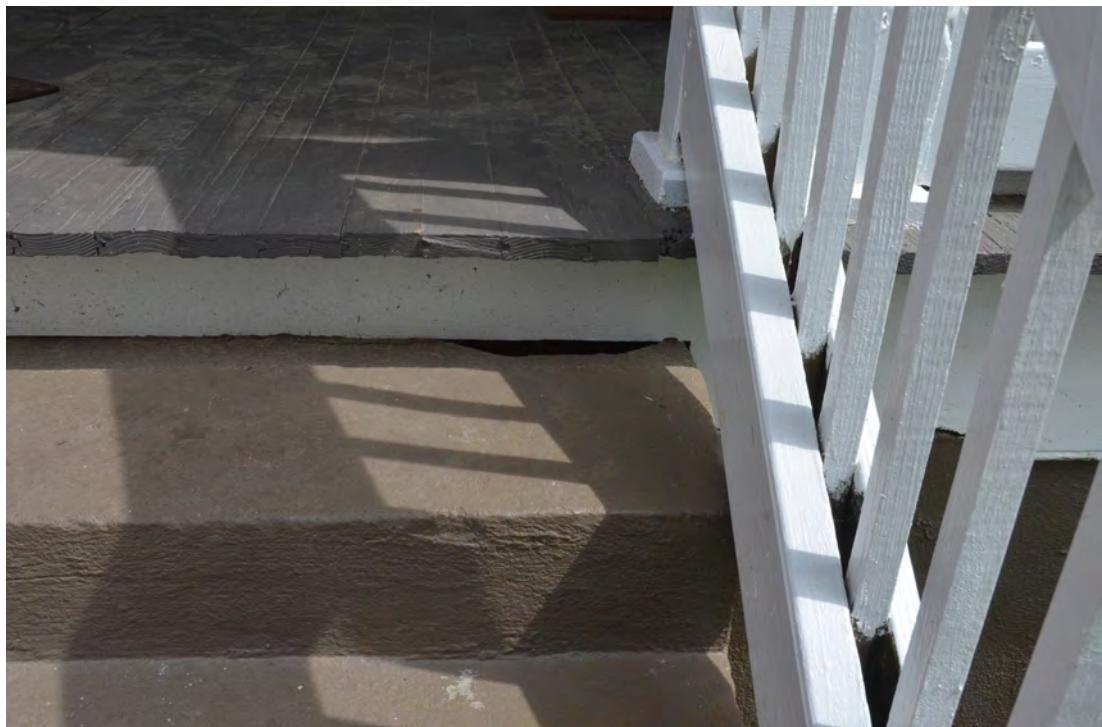
Figure 44. Loss of Material (Concrete) on the Side Stairs.
