**A STRUCTURAL INVESTIGATION OF
36 REID STREET
CHARLESTON, SOUTH CAROLINA**

Submitted to Craig M. Bennett, Jr.
April 26, 2016

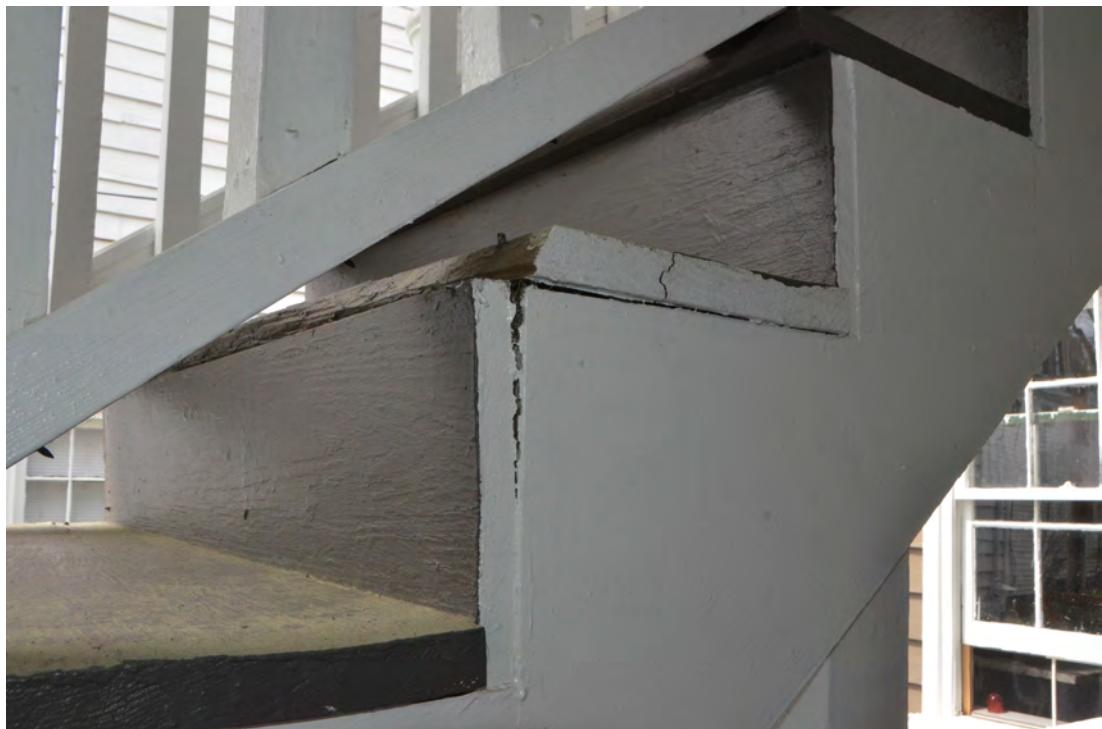
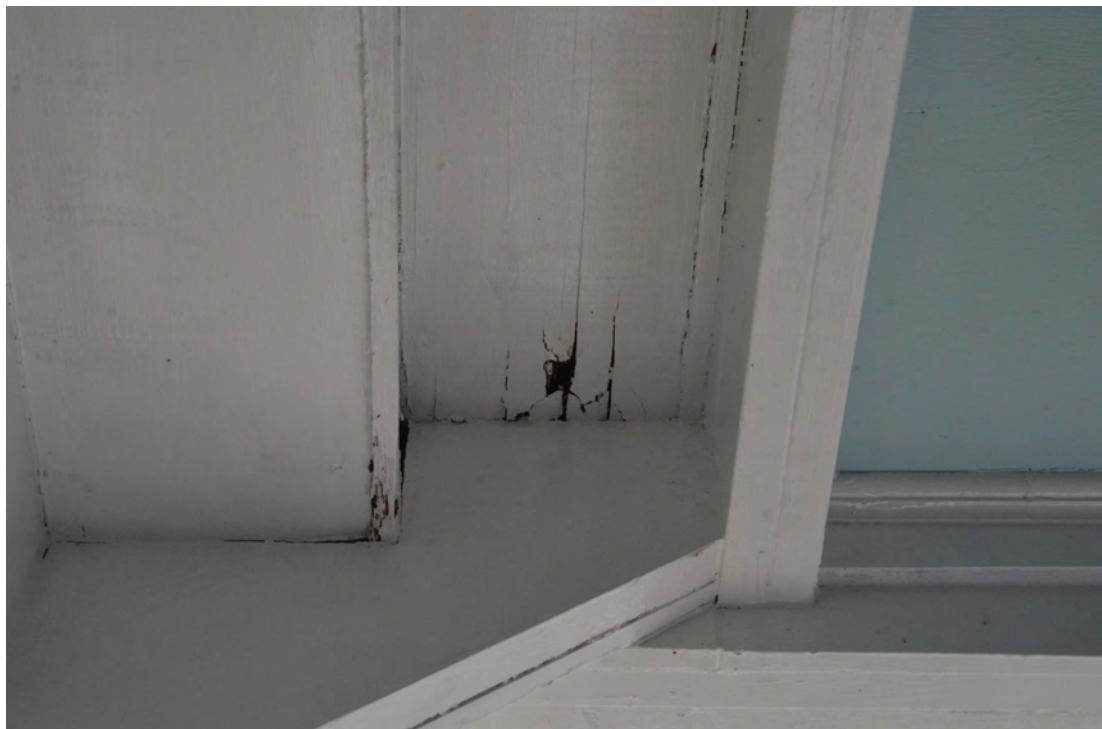
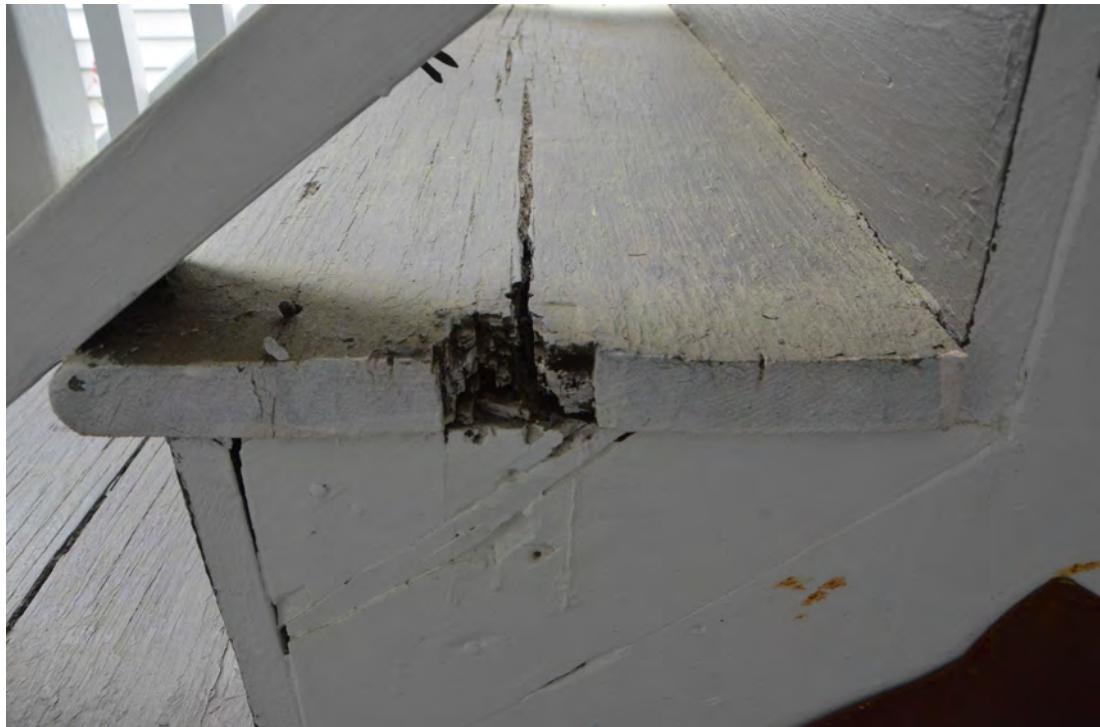
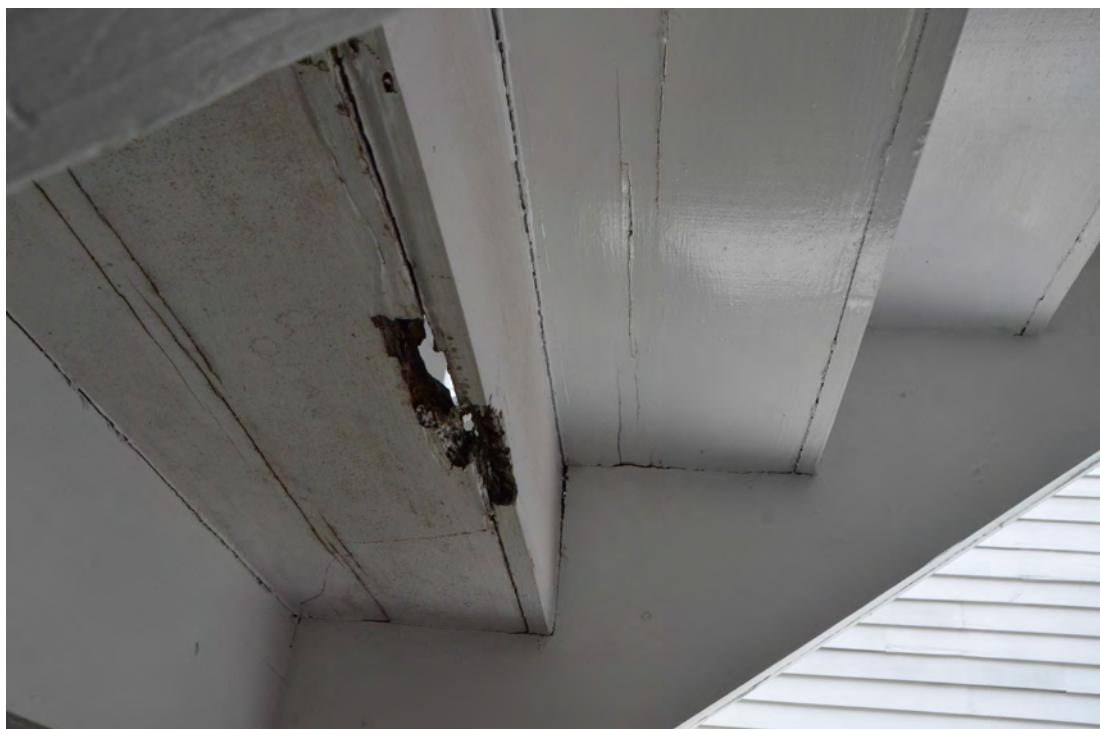
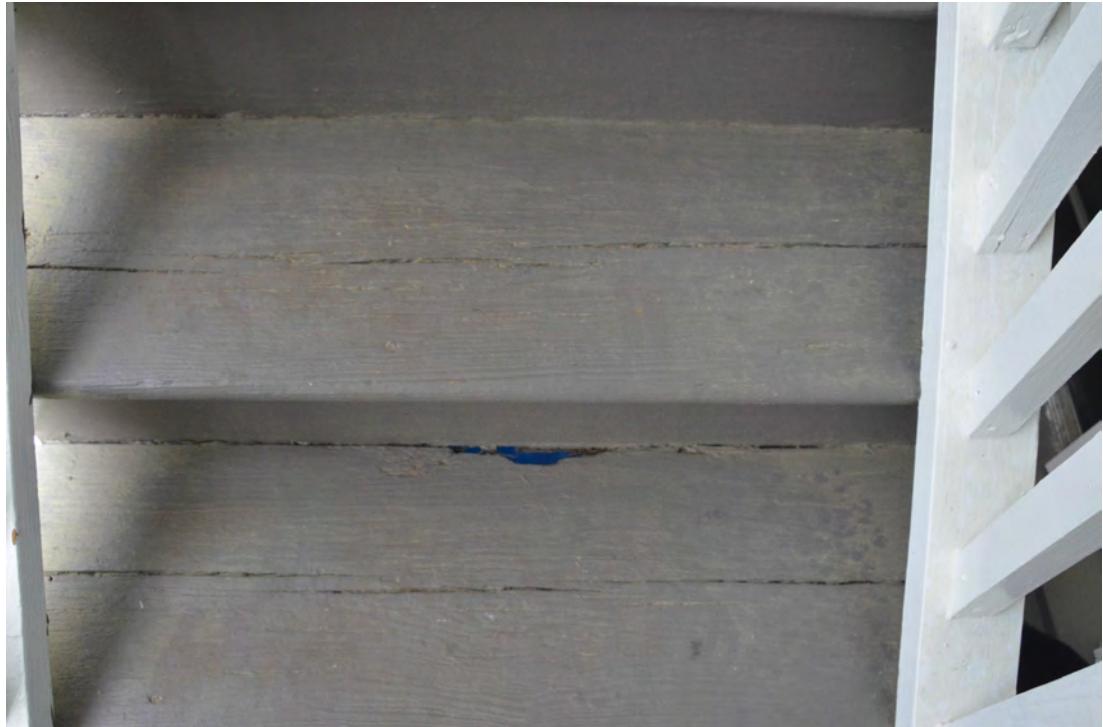
- The exterior stairs leading from the first level of the piazza to the second level are severely deteriorated in several areas. The wood on several of the steps has split parallel to the grain and along the length of the step. Additionally, there are several small areas of the stairs where the wood is severely deteriorated and has resulted in material loss. Material loss is typically located near the ends of the individual steps or at the center where the riser meets the tread. Areas of deterioration appear to be related to the horizontal fractures. (Figures 43 – 47)

- The exterior stairs on the piazza are deteriorating due to general wear-and-tear, exposure to weather and deferred maintenance. The steps are splitting along their grain due to stresses. These cracks allow for water infiltration, accelerating the deterioration process of the wood, especially at the exposed end grain.

Figure 47. Splitting Wood on the Exterior Piazza Stairs.

- Repair the area of missing concrete on the side yard stairs and patch the crack on the stair's south face.
- Remove and replace steps that have deteriorated or split on the exterior piazza stair. These steps should be replaced with a pressured treated wood and painted to keep moisture from entering the exposed end grain.

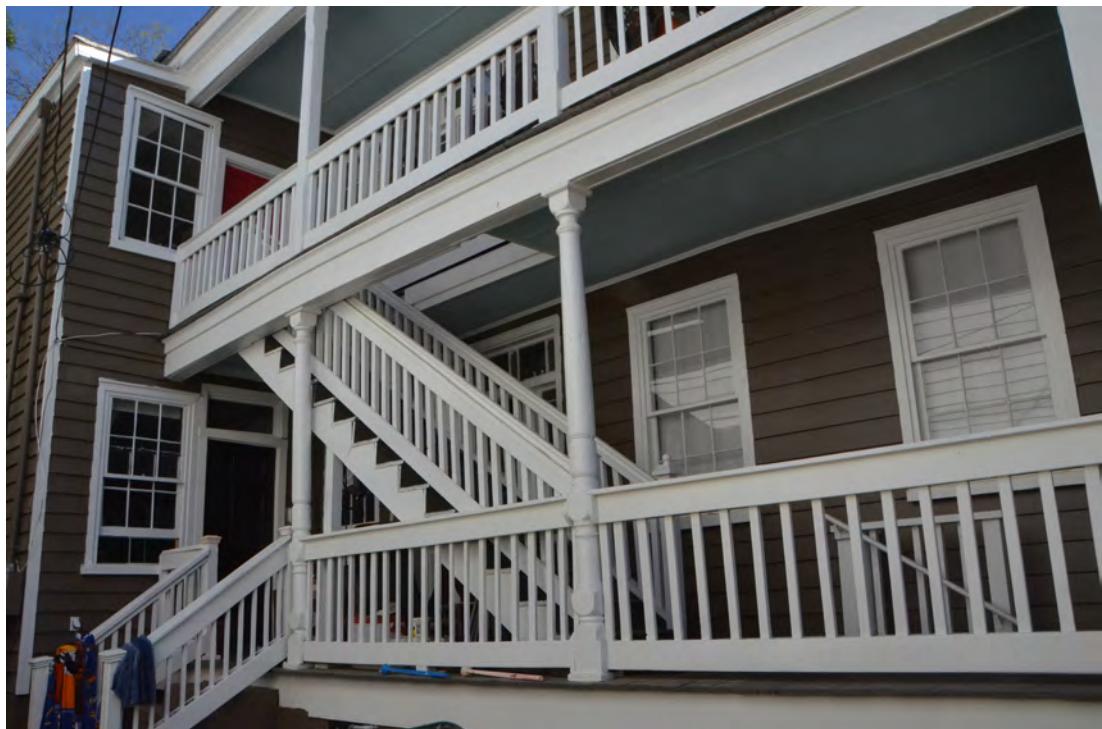
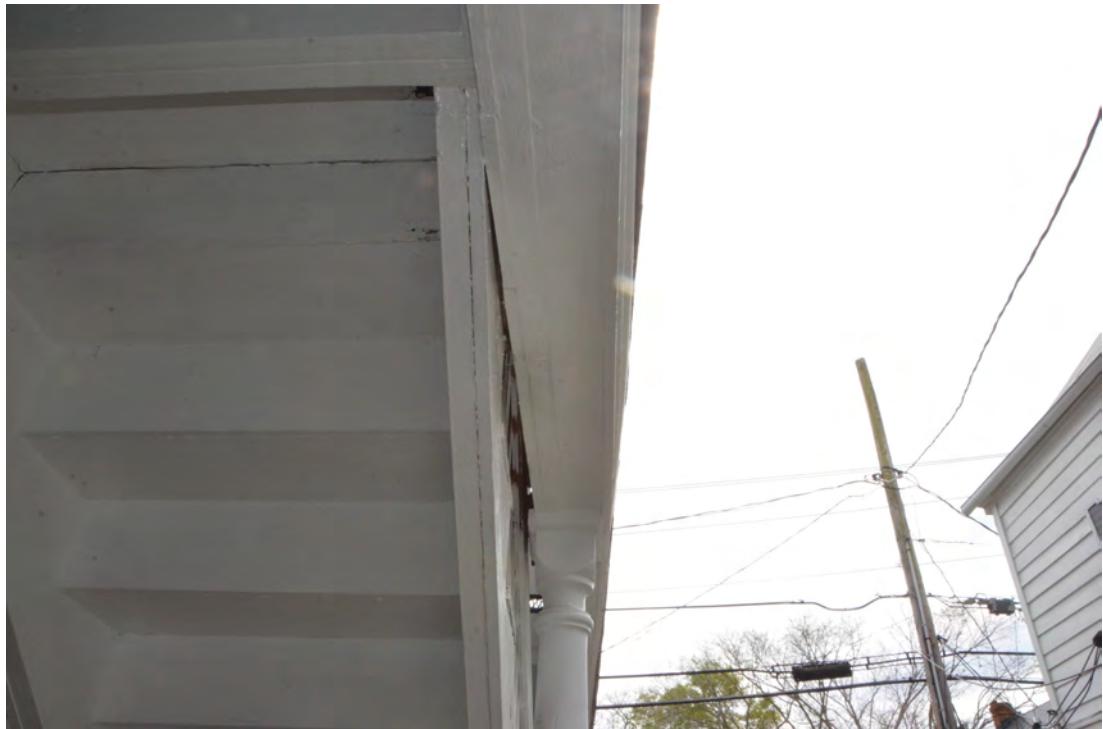
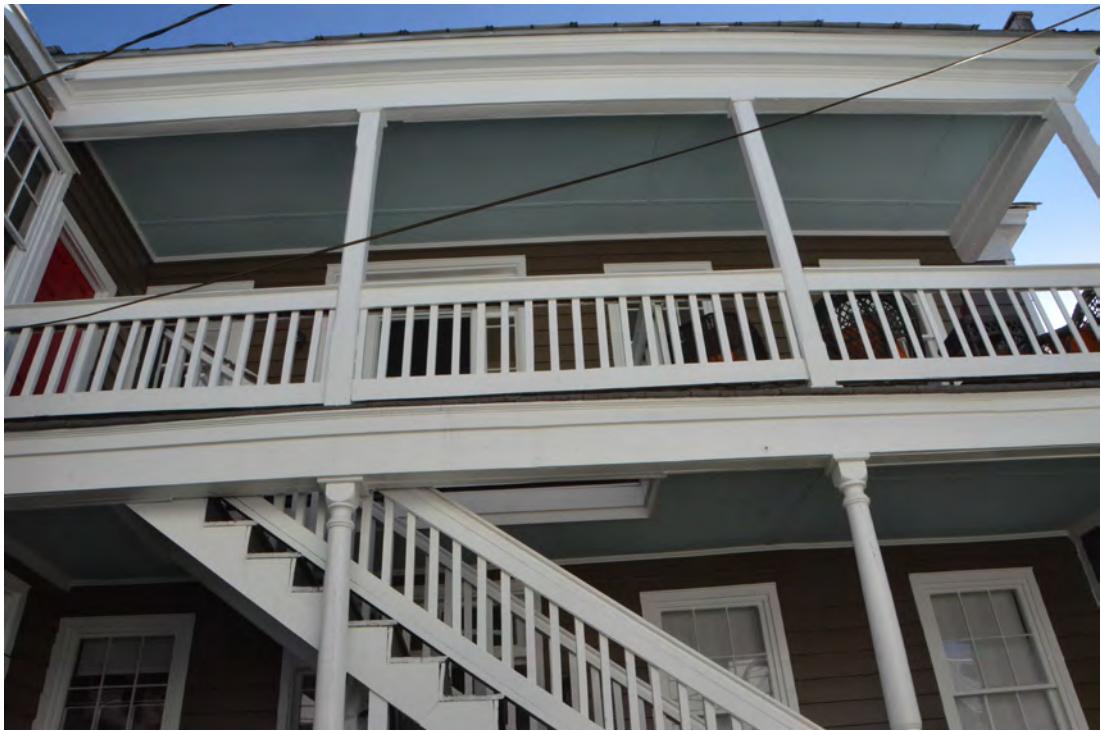
- The outward bowing of the columns on the first level of the piazza is likely related the deformation of the piazza edge beam at the second level. The rotation and deformation of the beam suggest unusual stresses on this structural member. The deformation may be caused in part by settlement on the west elevation of the piazza. Additionally, when the exterior stairs were added to the piazza, cutting into and removing structural material, additional loads from the second floor and roof were added to the two columns and the corresponding regions of the edge beam. This change in framing has caused the edge beam to bow upward on the north end, rotating where the beam meets the kitchen addition, and deflect downward at the south end.

Figure 54. Deformation of the 2nd Floor Framing Edge Beam.

- Monitor the edge beam deformation and bowing of the columns. Monitor the cracks in the first floor columns of the piazza to determine if they are active. Check both the first and second floor framing of the piazza to determine if the structural integrity of the porch was compromised when the exterior stair was added. Additional framing or shoring may be necessary to account for framing members removed at the stair opening and to mitigate the deformation of the edge beam.

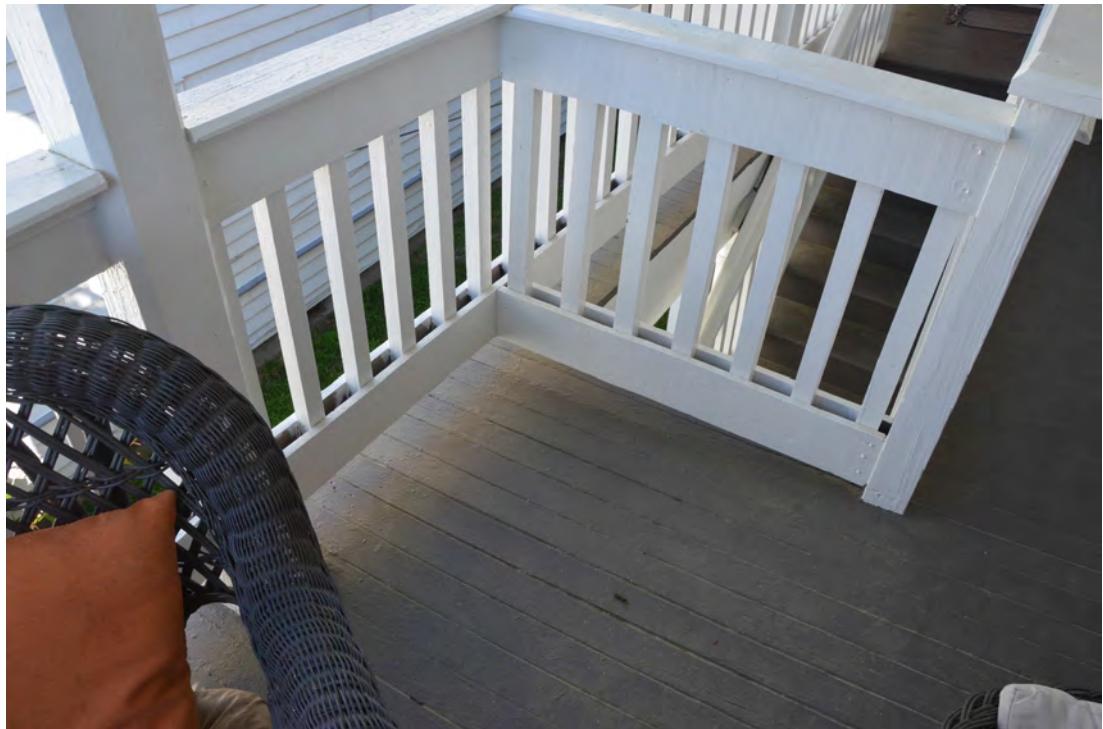
Figure 61. Settlement of the Floor on the 2nd Level of the Piazza.

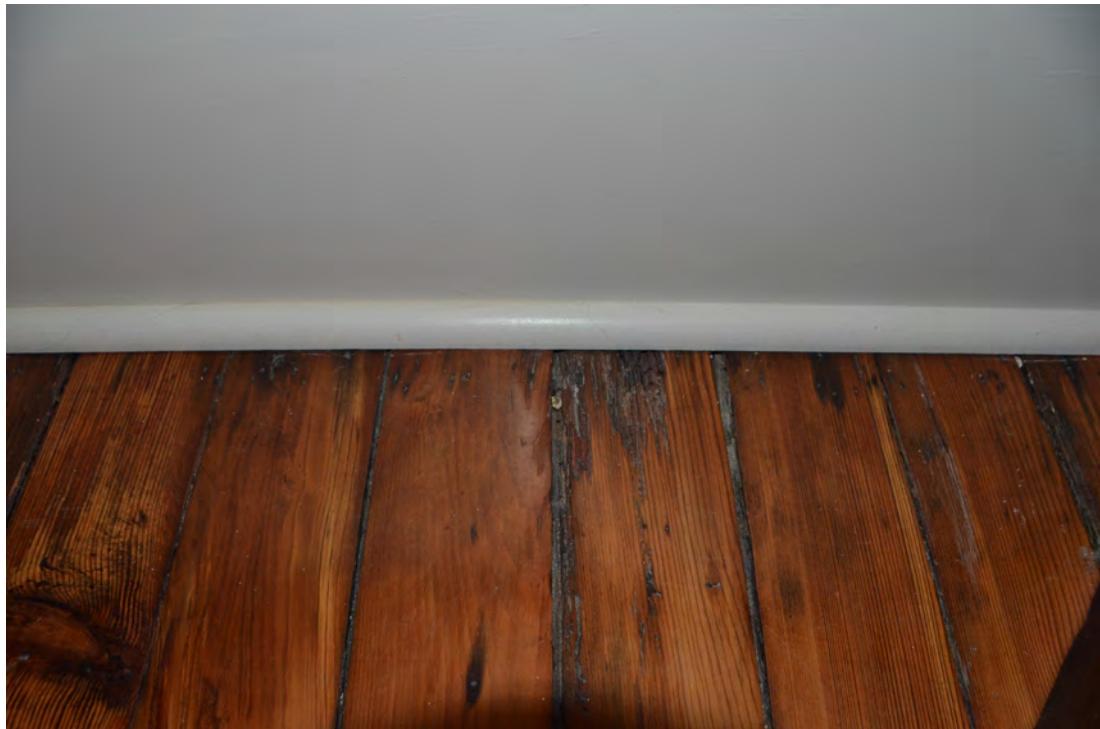
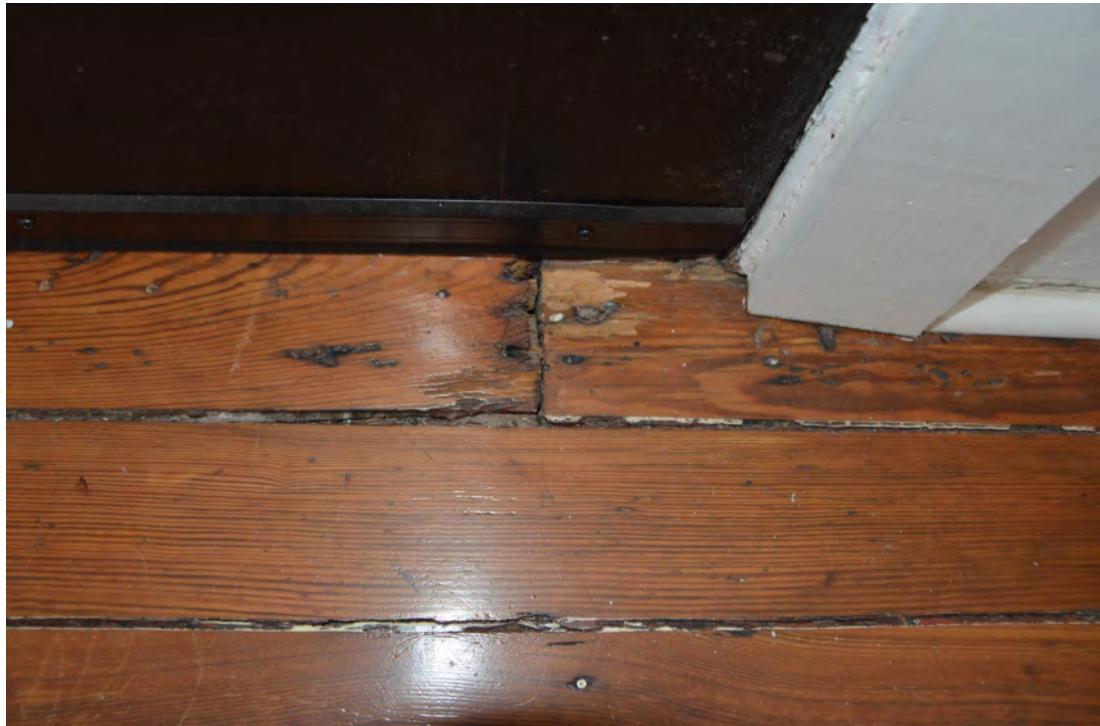
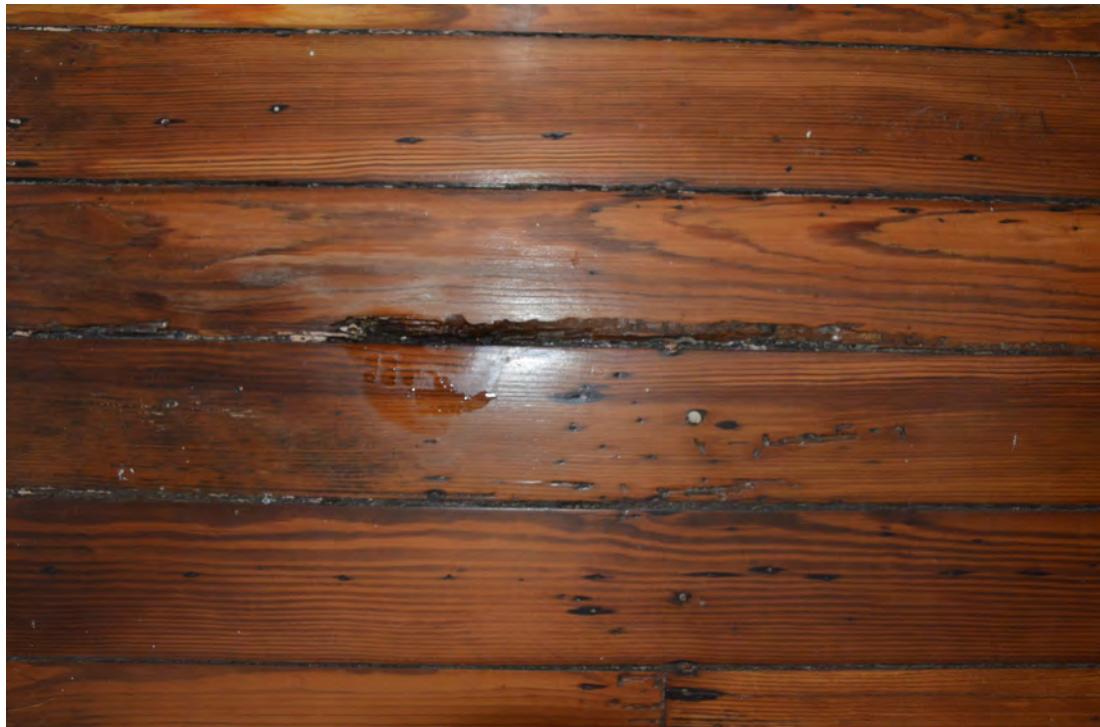
- There are areas of minor deterioration in the wood flooring. This deterioration is confined to the original main house and can be seen in the present-day front bedroom, entry hall and living room. The flooring in these spaces was not replaced during the recent renovations and is attributed to the original nineteenth century construction. Areas of the flooring with minor wood rot are typically located near the exterior walls of the

- Areas of deterioration in the wood flooring are relatively minimal and localized. The deterioration is caused by general wear-and-tear, as well as age. Past problems with termites and moisture – during the house's vacancy – may also have caused some of the wood rot.

Figure 63. Deterioration of the Wood Flooring.

- Repair severely deteriorated areas of flooring with an appropriate wood epoxy or consolidant. Remove areas of failed wood consolidant and replace with an appropriate wood epoxy or consolidant.
- Patch and repair the cracked plaster in the front bedroom and the area of plaster failure in the living room. The area of soft plaster in the rear bedroom should be checked for moisture and repaired.
- Framing should be sistered or replaced as necessary beneath the kitchen and bathroom if the flooring slope in these areas has been caused by deterioration.

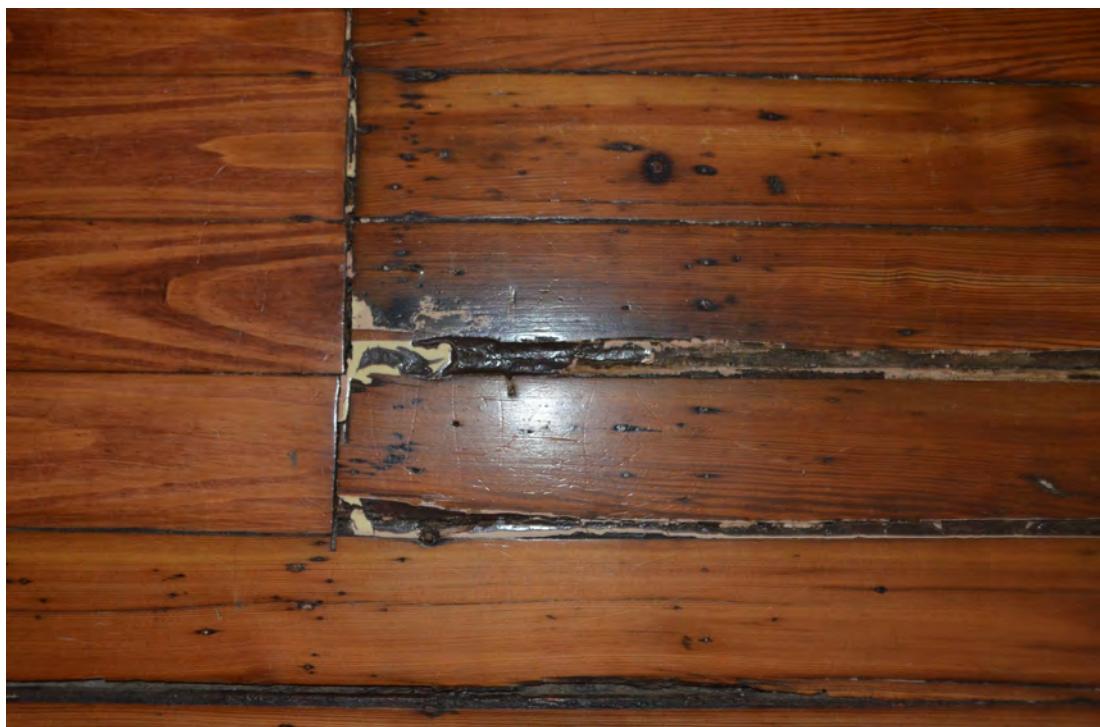
house. In some instances, there are regions where a past repair was made with a wood consolidant. These repairs are now failing. (Figures 59 – 62)

Figure 66. Failed Wood Consolidant Repairs.

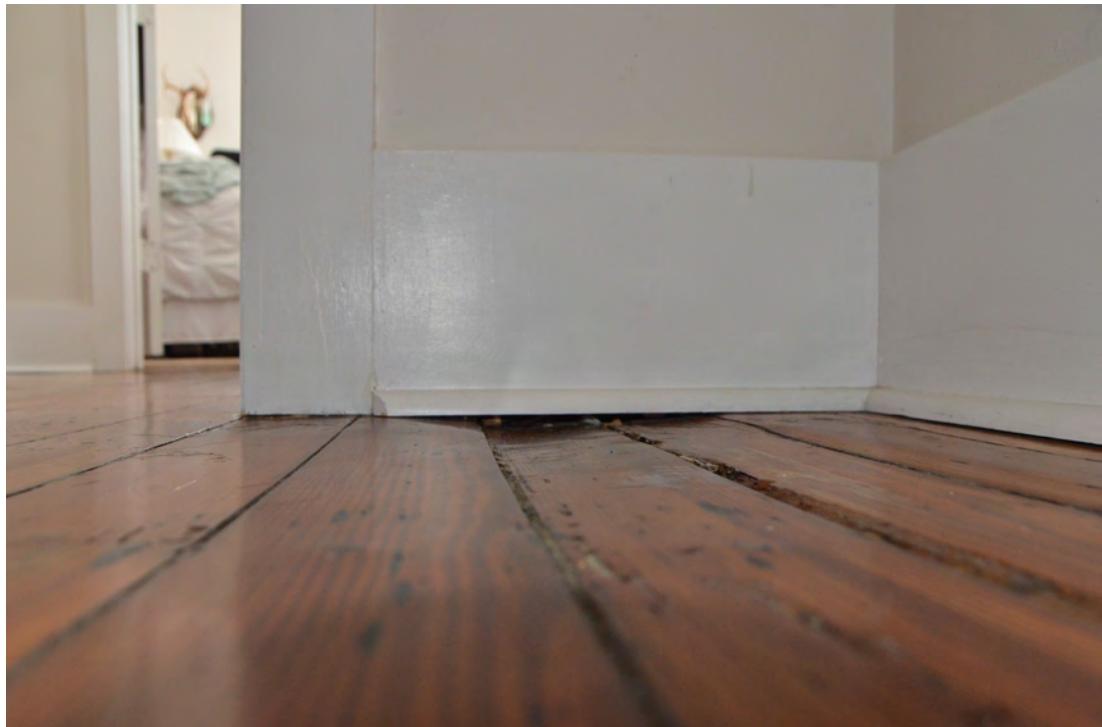
Figure 67. Deformation and Settlement of the Wood Flooring.

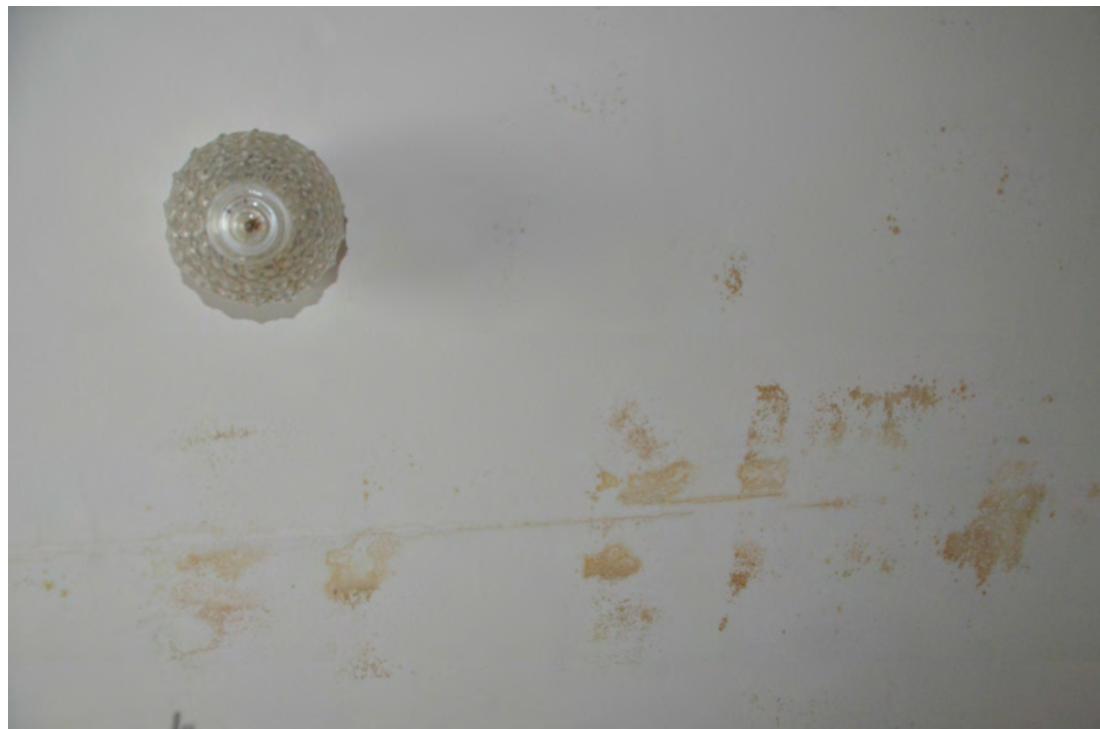
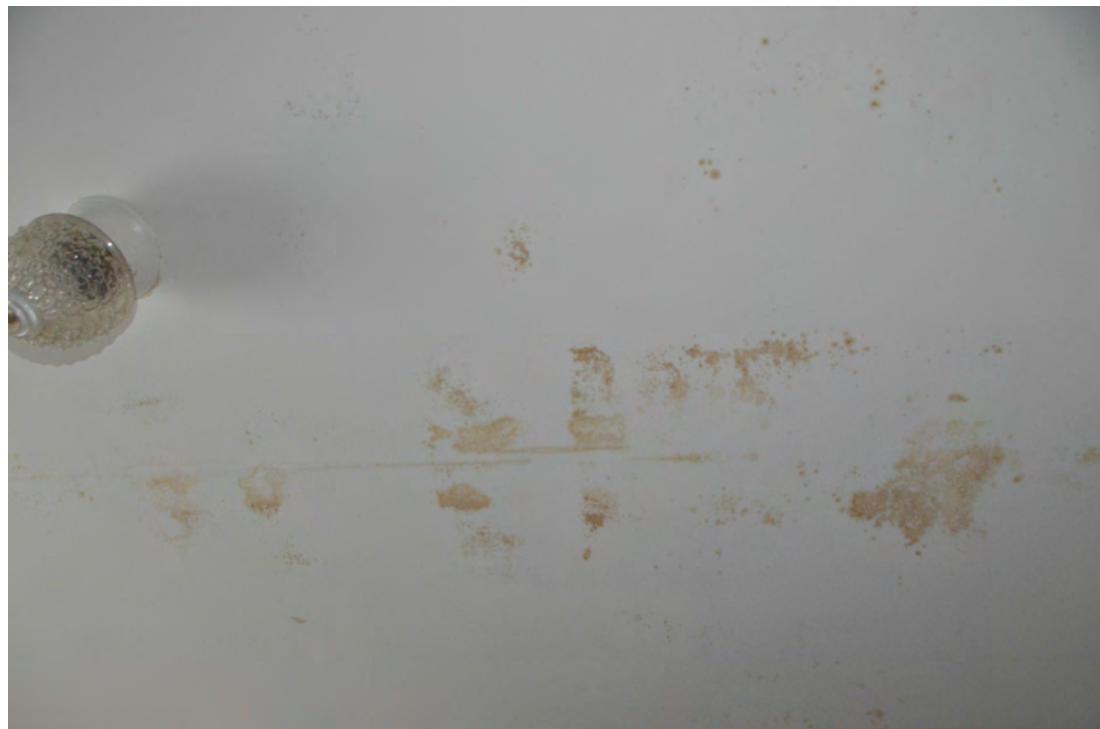
- Water stains are present on the laundry room ceiling. This area corresponds with the one-story hyphen connecting the main house to the dependency. From the exterior, the roofing material in this area appears to be corroded and in need of replacement. (Figures 69 and 70)

- A roof leak in the hyphen of the house has caused staining to appear on the laundry room ceiling. The water stains developed in the Fall of 2015 following several days of inundating downpours. The roof above this portion of the house is older and from the ground appears to be significantly corroded. Corrosion of the roof material is allowing rainwater to seep into the hyphen's attic area. It may also be possible that the flashing between the main house and hyphen has corroded, no longer effectively serving its purpose of migrating water away from joints.

Figure 73. Water Stains on the Ceiling of the Laundry Room.

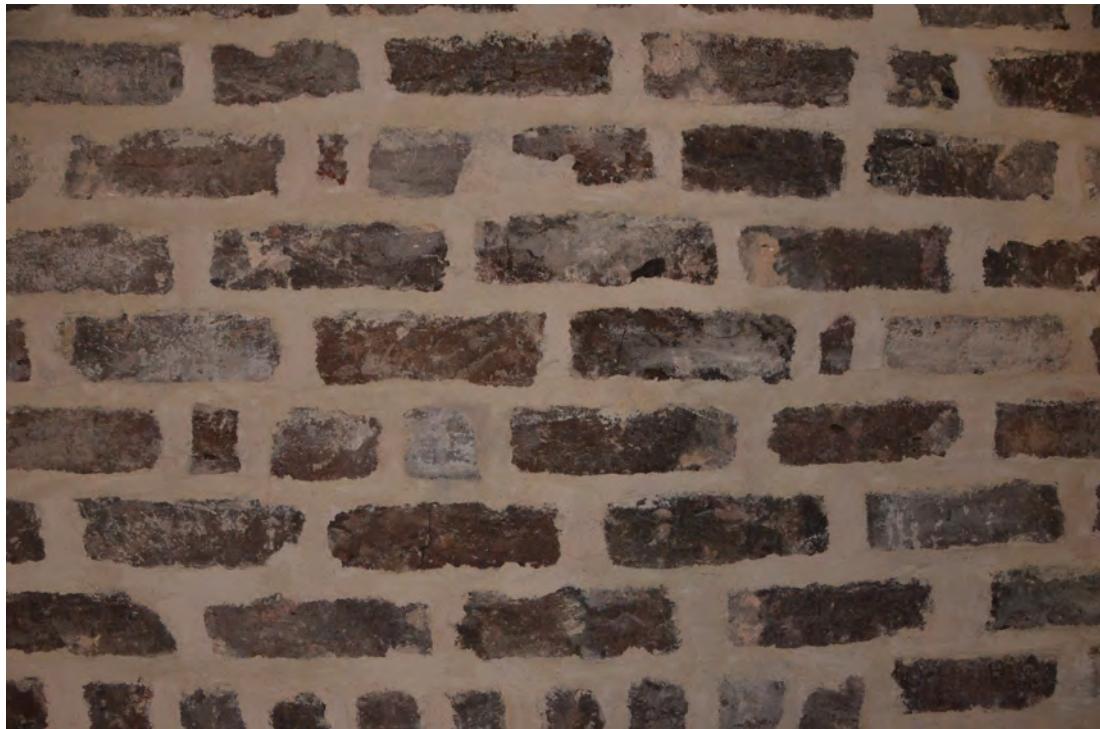
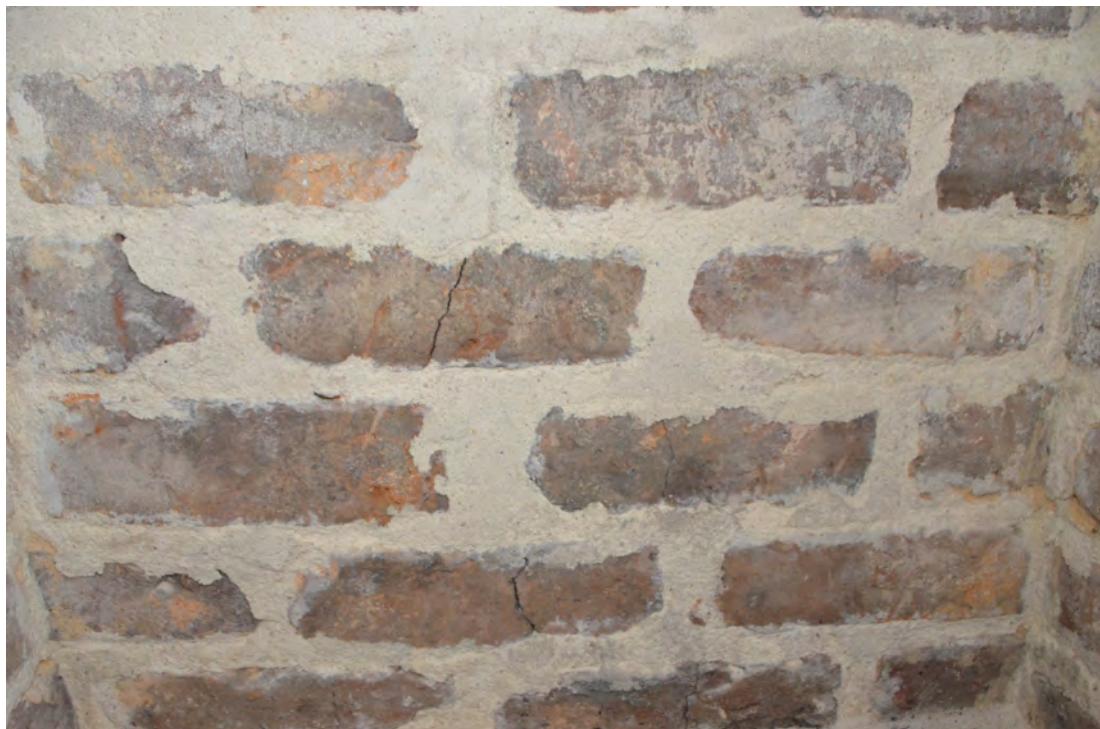
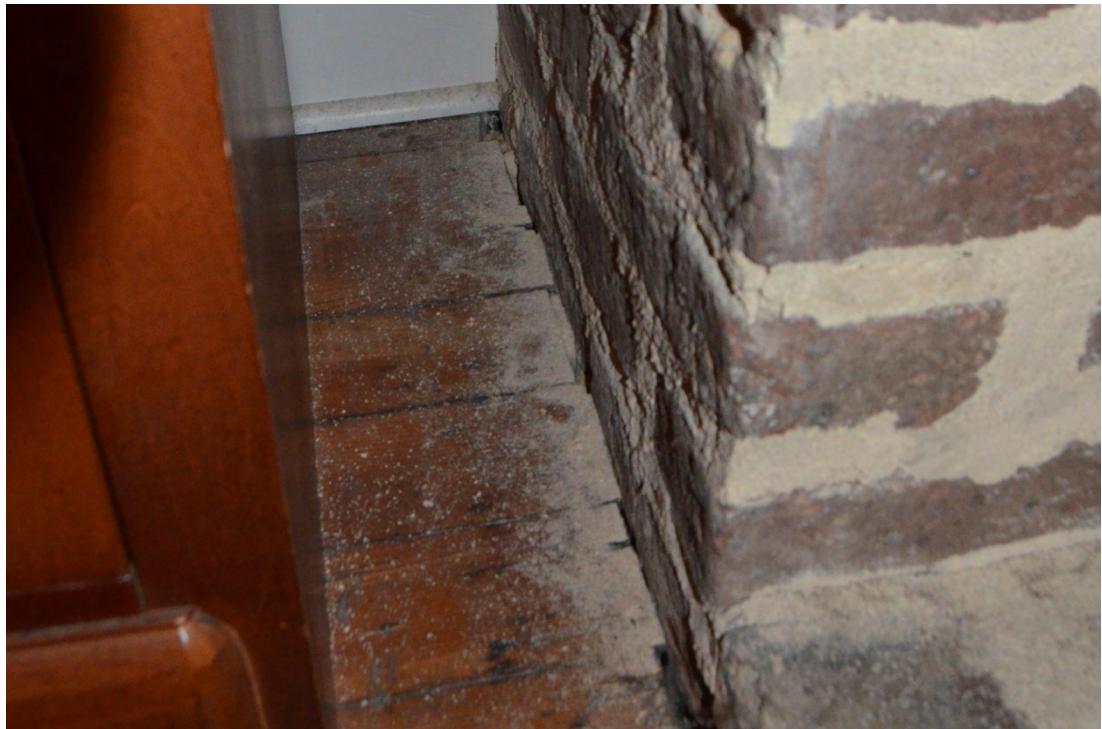
- In recent years, likely during the 2013-2014 renovation, the fireplace in the front bedroom was repointed. The mortar is now disintegrating leaving a fine sand on the floor surrounding the fireplace. Several bricks on the fireplace and within its box have cracked vertically. Additionally, an appropriate mortar joint was not used. (Figures 71 – 73)

- An inappropriate mortar was used to repoint the fireplace in the front bedroom. While this does not appear to have structural implications, the mortar has caused several bricks to crack vertically. Additionally, the mortar is disintegrating, leaving a sandy powder at its base. The presence of moisture in the chimney may be causing the mortar to disintegrate.

Figure 75. Inappropriate Mortar Repair on the Fireplace.

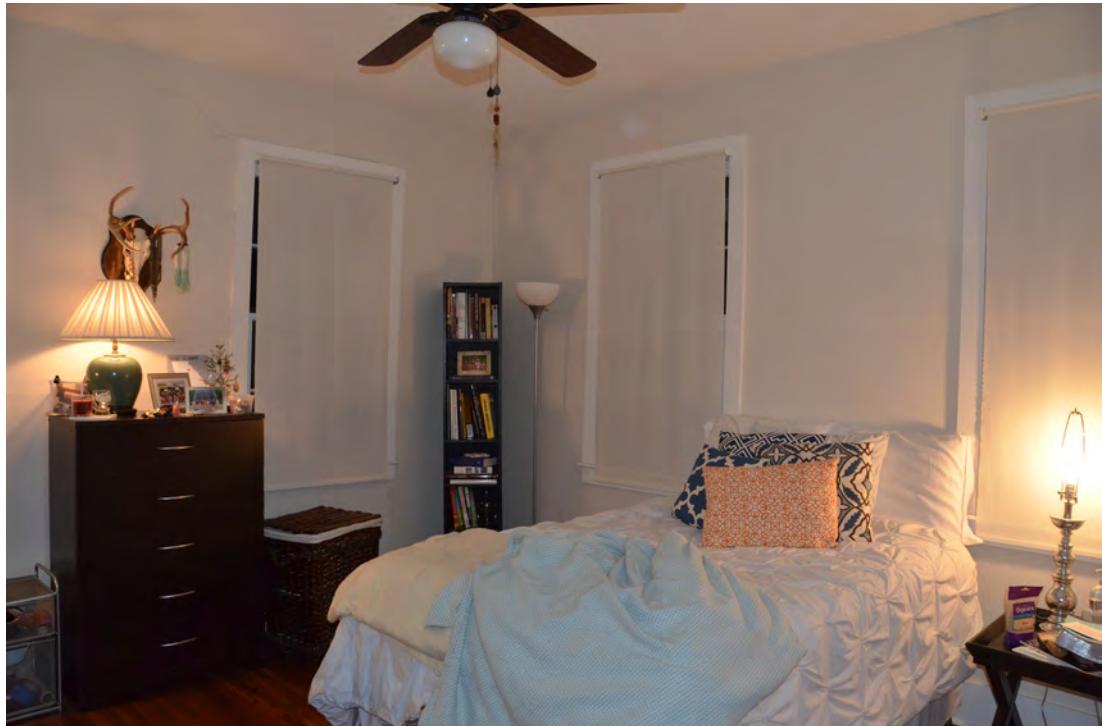
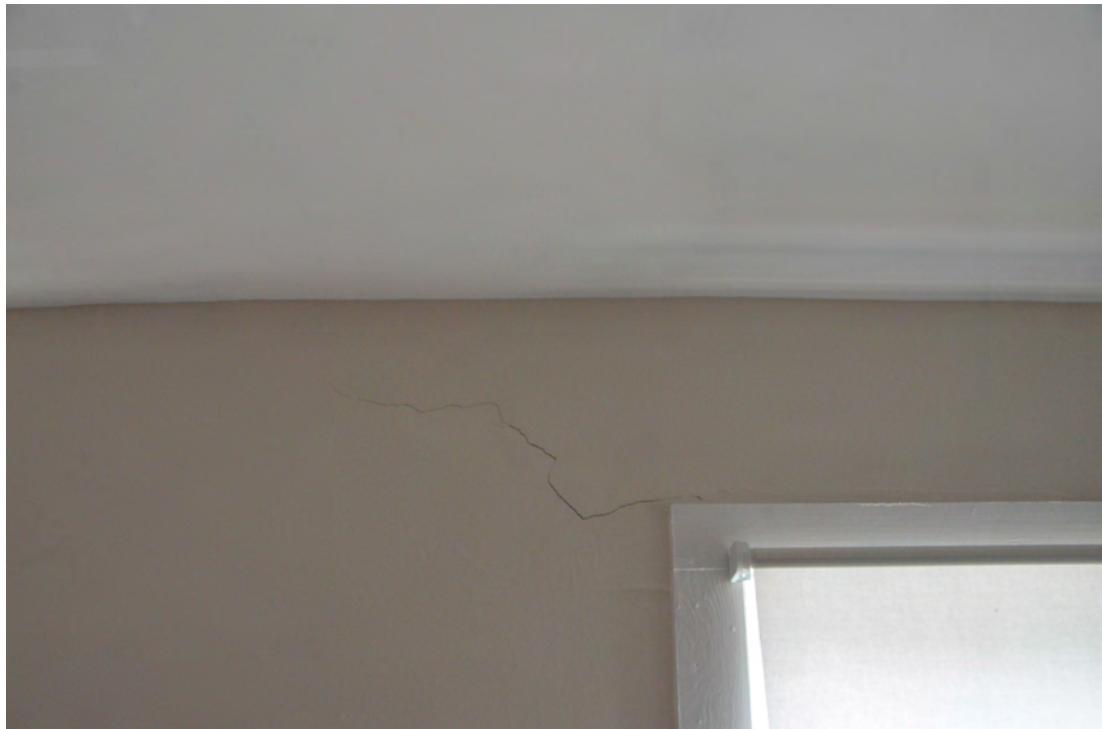
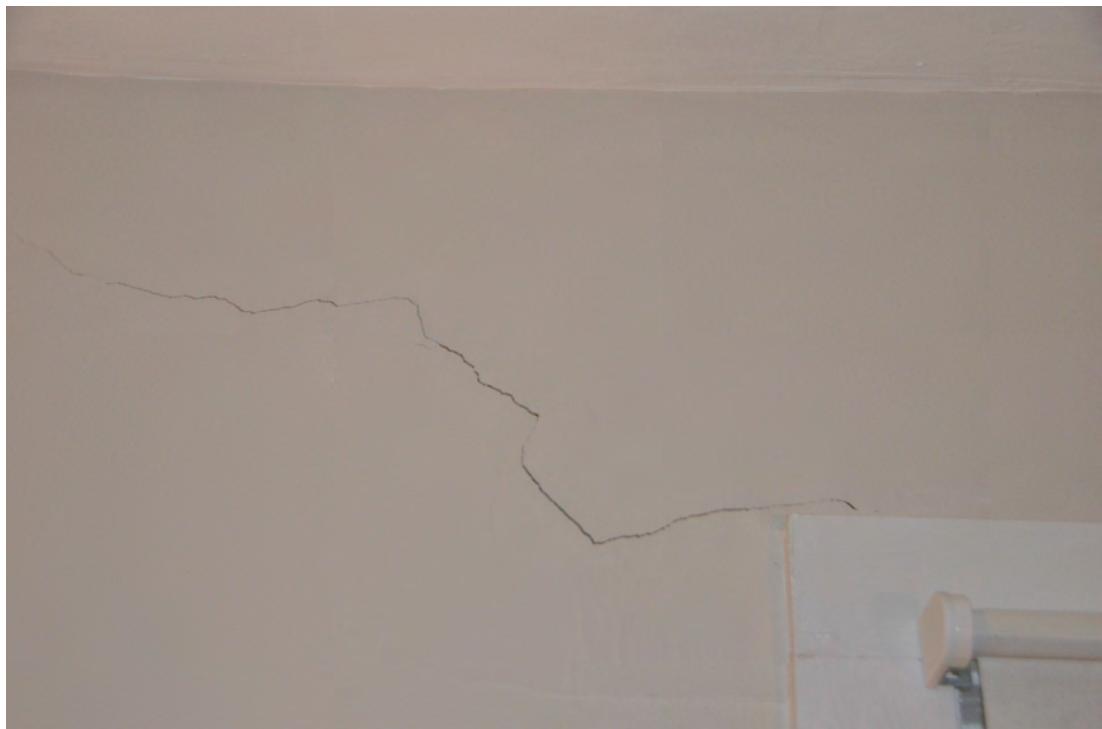
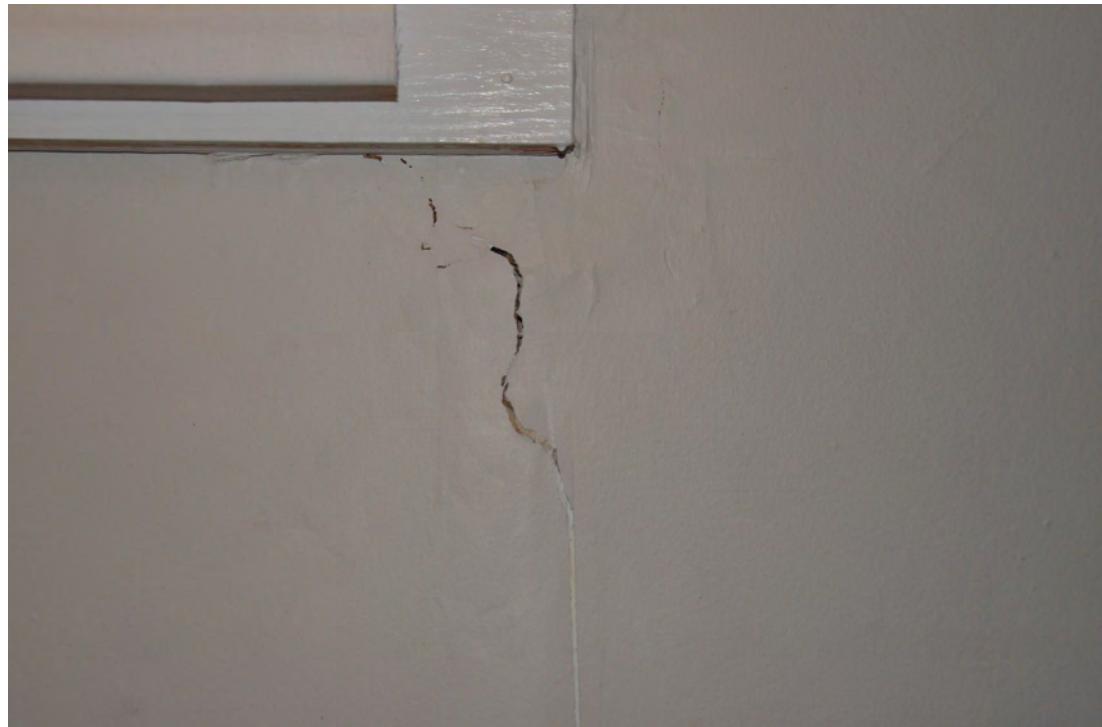
- There are diagonal cracks in the plaster both above and below one of the windows in the south wall of the front bedroom. The cracks extend from the upper left corner and the lower right corner of the window. At the lower right corner, the crack transitions into a vertical crack extending to the baseboard. (Figures 74 – 77)

- The diagonal cracks in the plaster above and below the window in the southwest corner of the front bedroom appeared when structural work was recently performed on the house. During this renovation, the stucco veneer was removed from the south wall of the foundation, revealing brick masonry. This portion of the foundation had to be completely rebuilt as all of the mortar had disintegrated. Additionally, the edge beam sitting on the

foundation wall was severely deteriorated. The beam was removed and replaced. During this procedure, the cracks appeared on the interior of the wall. Movement of the façade during construction and settlement after the renovation caused the cracks.

Figure 79. Diagonal Crack in the Plaster at Corner of the Window.

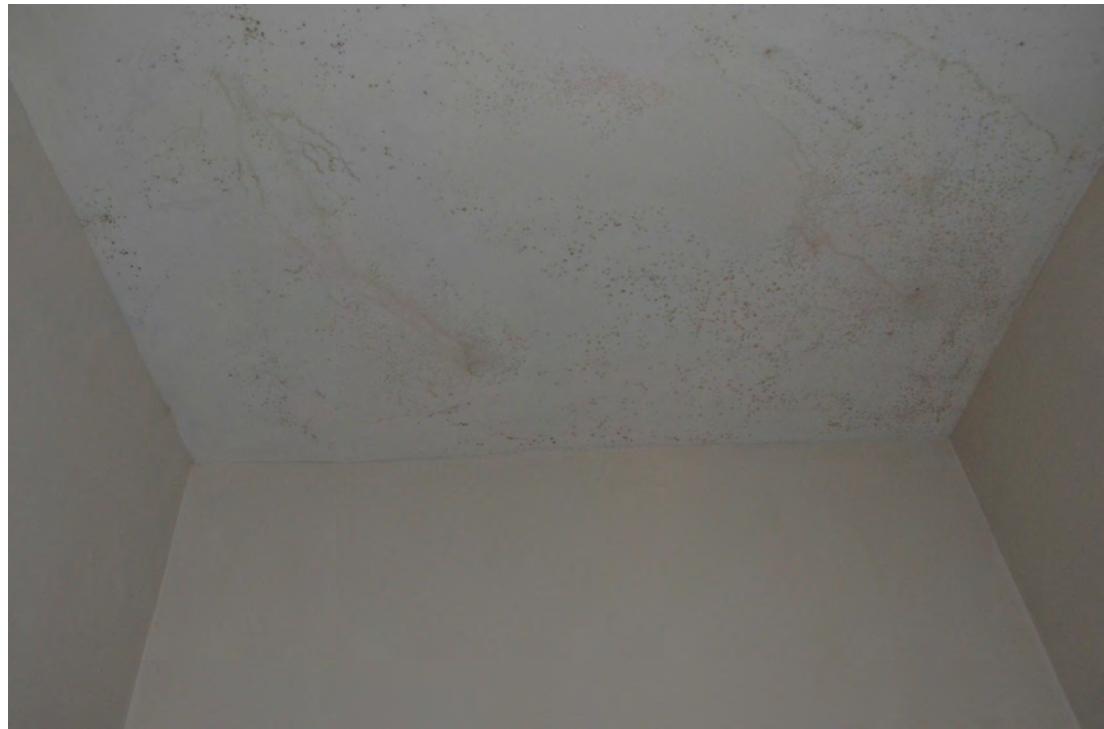
- The bathroom does not have a ventilation or exhaust fan. Excess moisture from the shower has caused mold to grow on the ceiling.
- The area of plaster fail in the living room beneath the east window was caused when the siding and studs on this wall were replaced in the Summer of 2015. When the rotted framing was removed, the window dropped causing the plaster to crack and fail. The area of soft plaster in the rear bedroom is attributed to moisture intrusion.

Figure 85. Mold in the Bathroom.

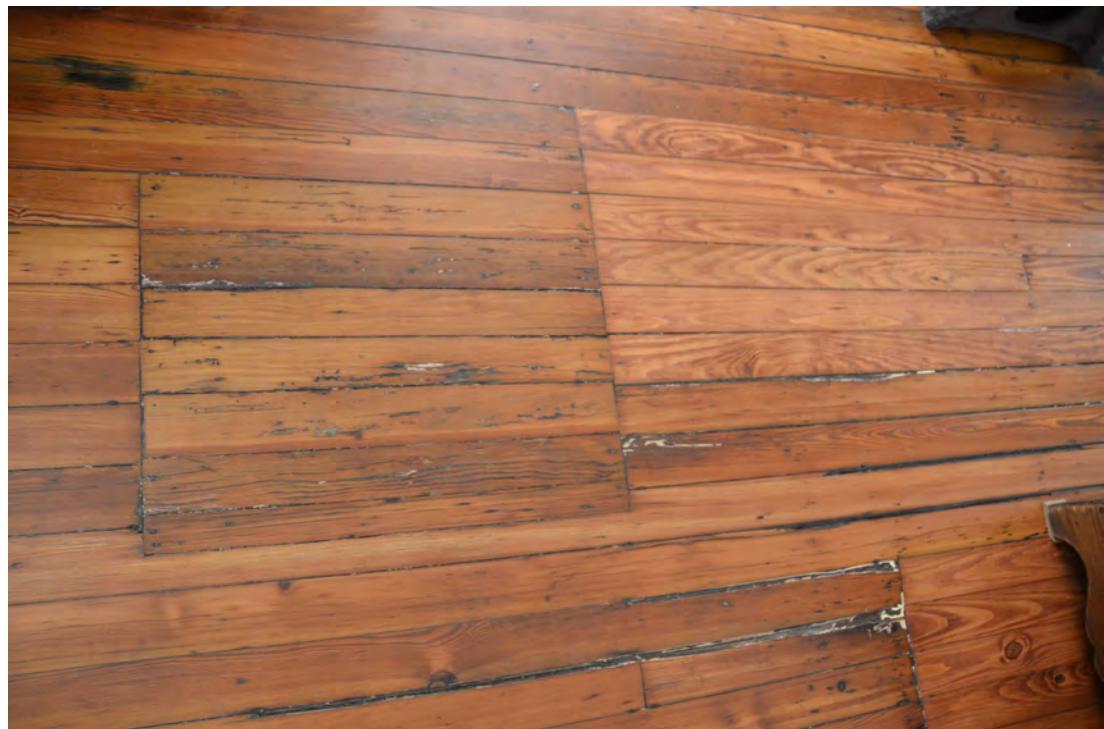
Figure 86. Living Room Flooring Campaigns.
