**A STRUCTURAL INVESTIGATION OF
36 REID STREET
CHARLESTON, SOUTH CAROLINA**

Submitted to Craig M. Bennett, Jr.
April 26, 2016

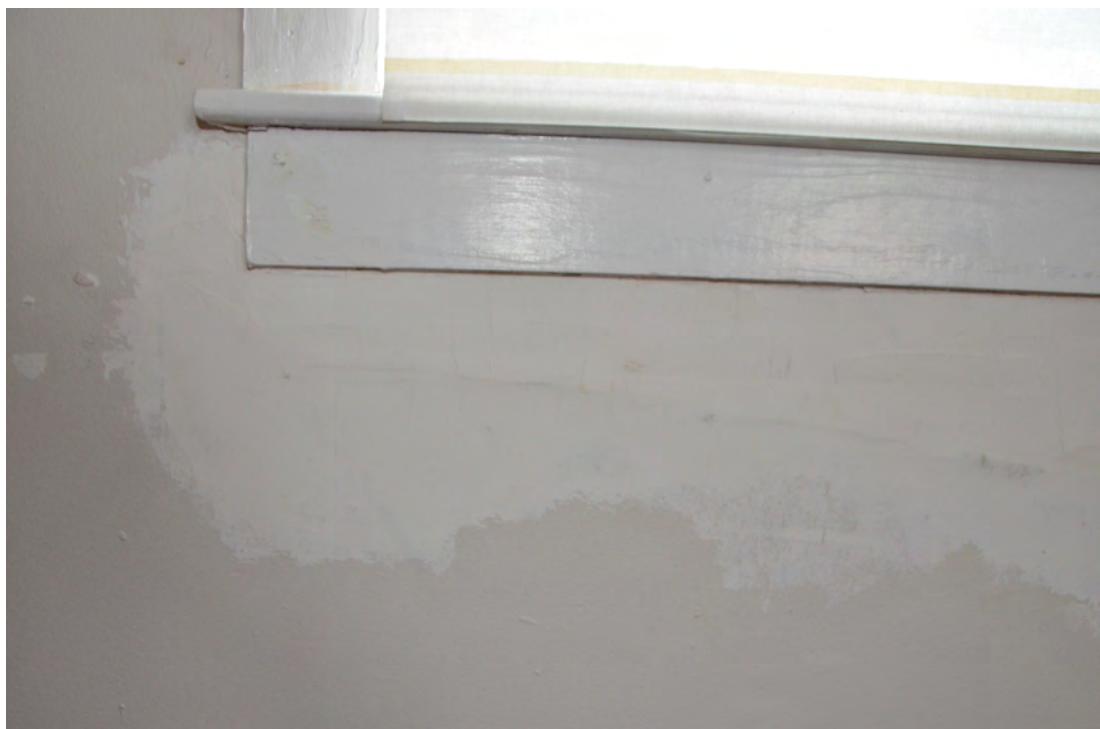
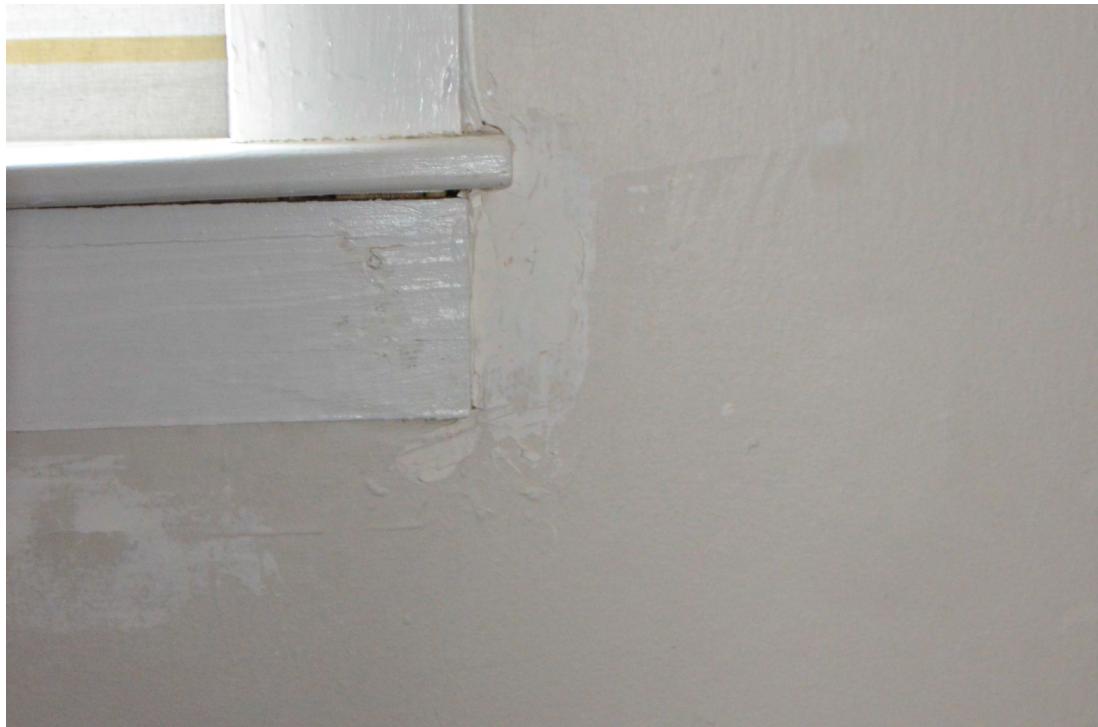
- The bathroom does not have a ventilation or exhaust fan. Excess moisture from the shower has caused mold to grow on the ceiling.
- The area of plaster fail in the living room beneath the east window was caused when the siding and studs on this wall were replaced in the Summer of 2015. When the rotted framing was removed, the window dropped causing the plaster to crack and fail. The area of soft plaster in the rear bedroom is attributed to moisture intrusion.

Figure 88. Plaster Failure in the Living Room.

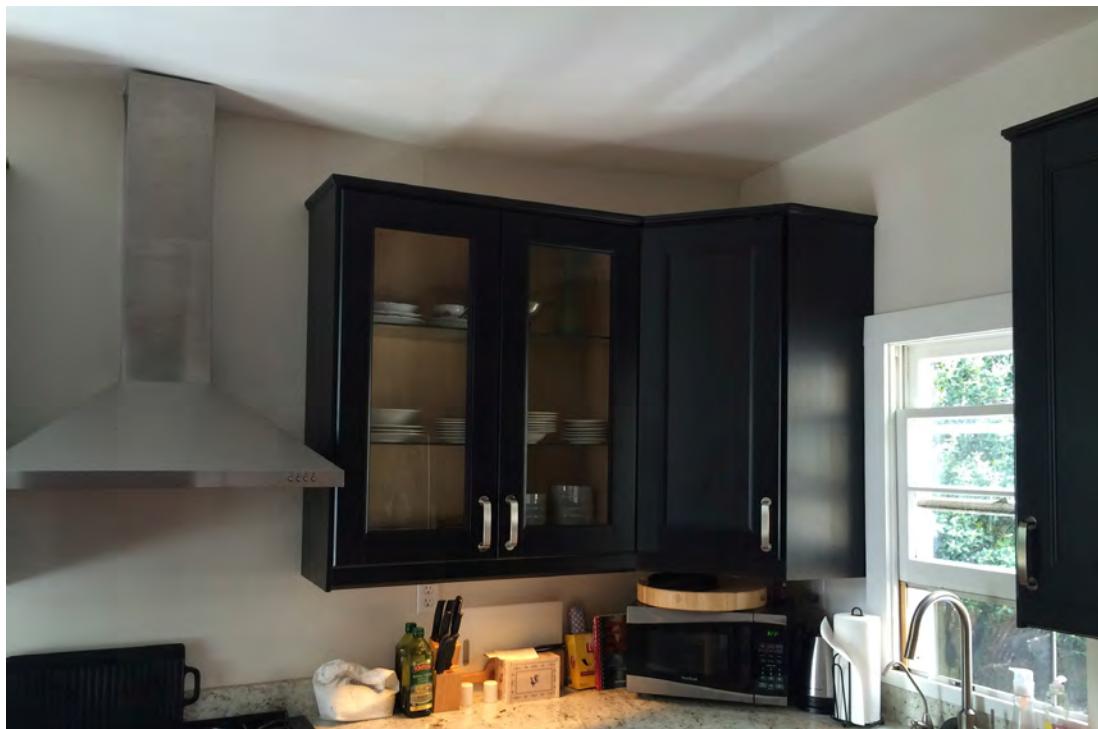
Figure 90. Ceiling Deformation in the Kitchen Addition.

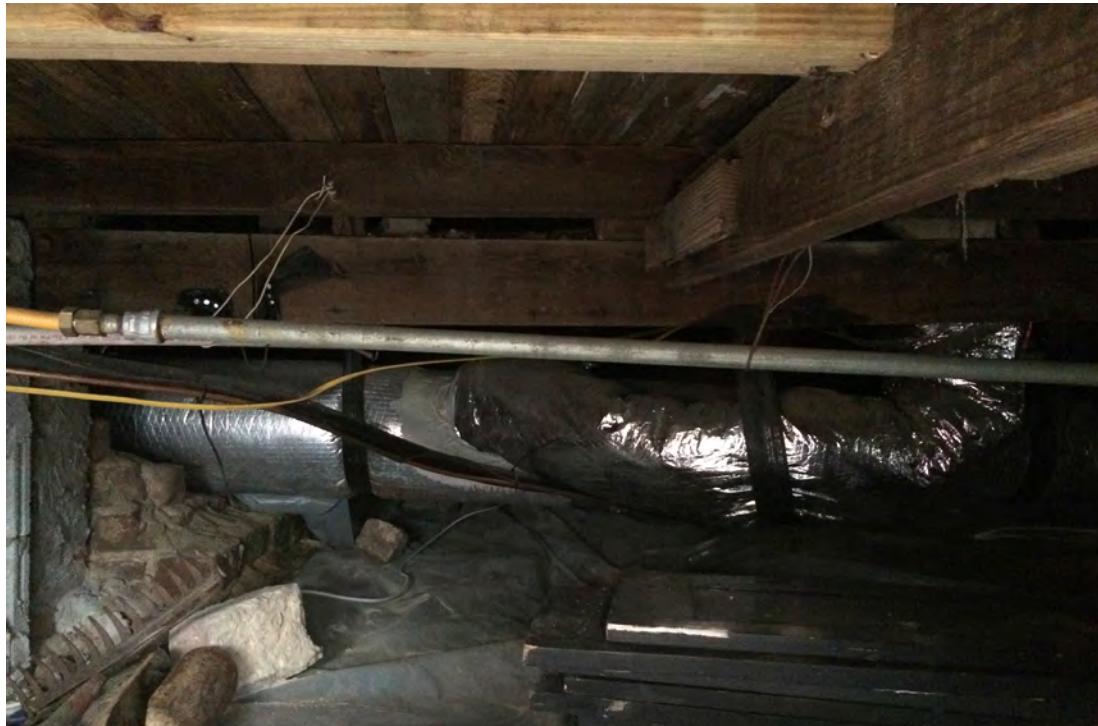
- At some time after the Earthquake of 1886, a fireplace on the north wall of the living room was removed. The foundation of the fireplace is visible beneath the house, as are remnants of the bricks, now stacked in the abandoned cistern. When constructed, the fireplace served as a structural member of the house. Without the fireplace, the structural integrity of the north wall may have been compromised.

- Chimneys act as structural members of the building and help to carry the load of the roof and upper stories down to the foundation. Not rebuilding the fireplace on the north wall of the living room compromised the vertical and lateral loading of the house.
- Many of the structural members were replaced within the past three years due to deterioration from moisture and termites. The framing of the piazza likely received the most significant repairs due to its constant exposure to weather.
- Joists and girders were sistered for additional strength where the members had been cut to accommodate modern utilities.
- Modern concrete masonry units were added to strengthen the framing. In some cases, the CMUs were placed specifically where the floorboards tend to bounce and lack support.

Figure 94. Evidence on the left for the foundation of the former fireplace.

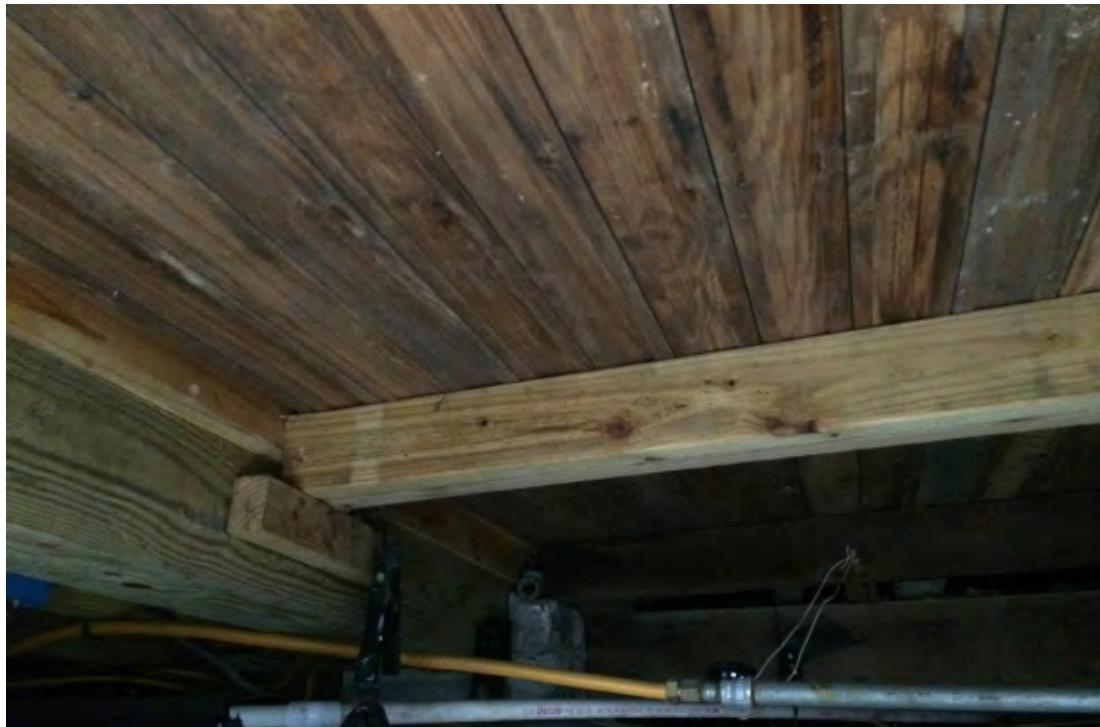
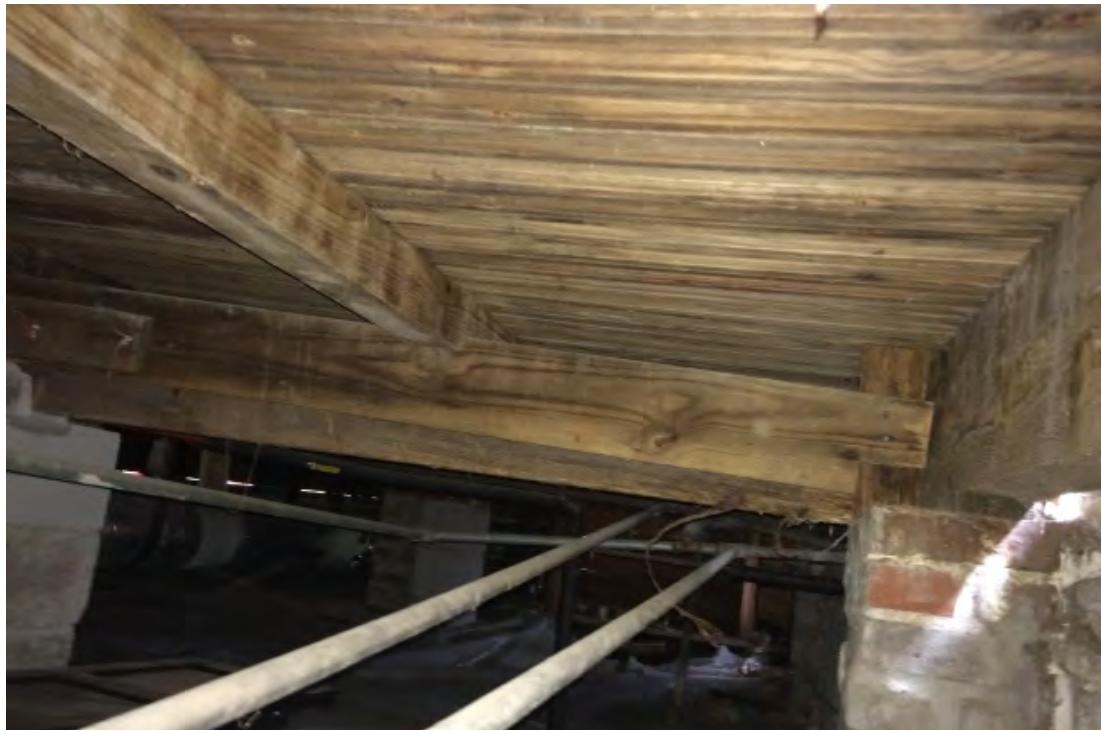
- By observing the framing in the crawlspace from the west elevation of the piazza, it appears that a significant amount of the joists, girders and decking has been replaced with new wood. Additionally, some of the girders and joists have been sistered. This observation is restricted to the piazza framing as the structural framing of the main house was difficult to observe due to ductwork.

Figure 95. New framing beneath first level of the piazza.

- More thoroughly check wood members and their structural capacity in the crawl space to address areas of deformation at the piazza.
- Venture further beneath the structure to check the condition of the girders, joists and beams looking specifically for areas of deterioration due to moisture or termites. Specifically look at the structure where the south wall of the living room meets the entry hall and the floorboards have begun to twist. This location may need additional framing or strengthening with a new masonry pier.
- Sister members where the structural integrity has been compromised, and replace severely deteriorated members as necessary.
