# St. John's Reformed Episcopal Church

# Conditions Assessment

Our investigation and documentation of the church includes a report of systems and architectural features observed to be in need of repair.

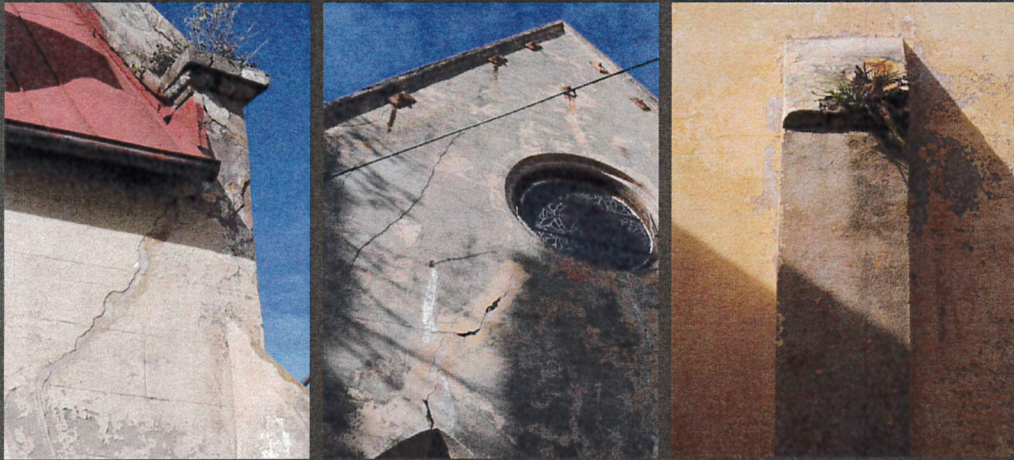
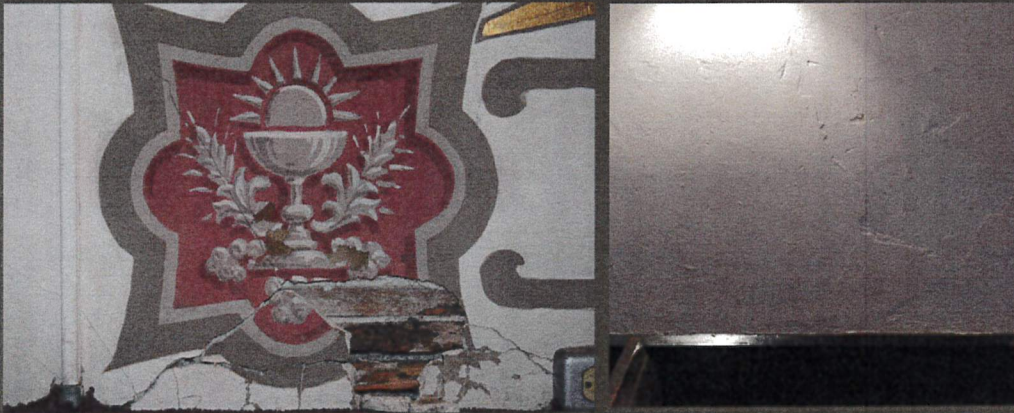
## Walls - Finish & Structure

### Overall Exterior Finish

#### Condition: Poor

- Paint discoloration
- Stucco cracking
  - Some cracks penetrate to—possibly through—masonry
  - Concentration around & above window arches
  - Slight bowing outward of nave walls
- Masonry integrity
  - Over time, vegetation can cause damage to brick
  - Loss of exposed brick & mortar—water table & apse

### Overall Interior Finish

#### Condition: Fair

- Plaster cracks observed throughout church
- Unpainted plaster repairs
- Holes in plaster to substrate—balcony & apse

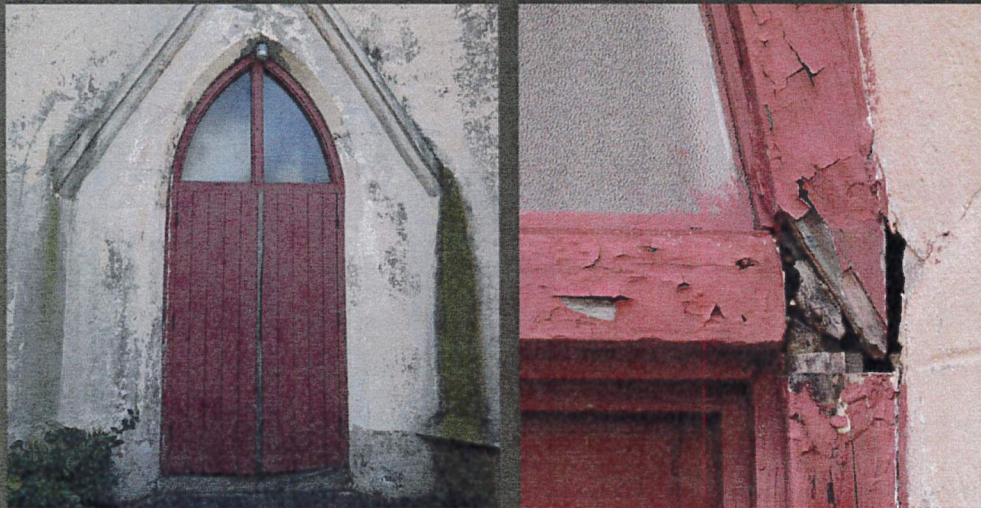
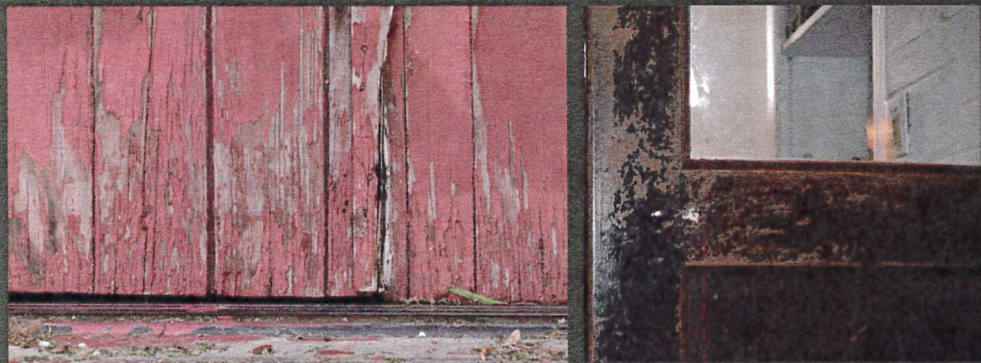
# Doors

## Transept Vestibule Doors

### Condition: Poor

- Paint delamination
- Damage to frames
  - Southern hole & leveling
  - Northern difficulty in operation
- Damage to bottoms of doors
  - Weatherstrips

## All Other Doors

### Condition: Fair

- Paint delamination
- Balcony half-landing door

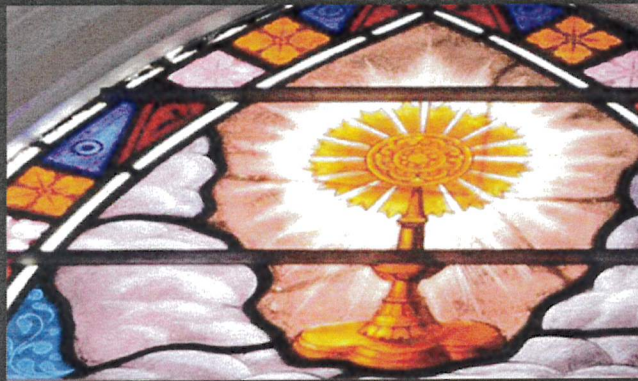
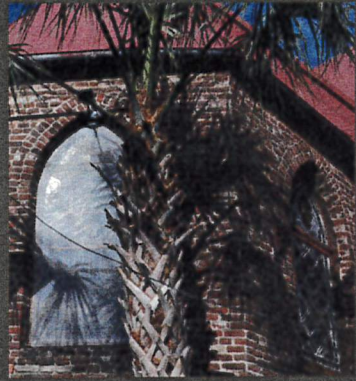
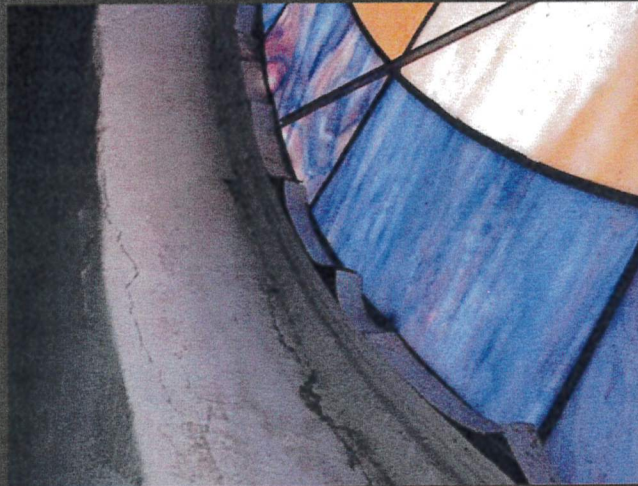
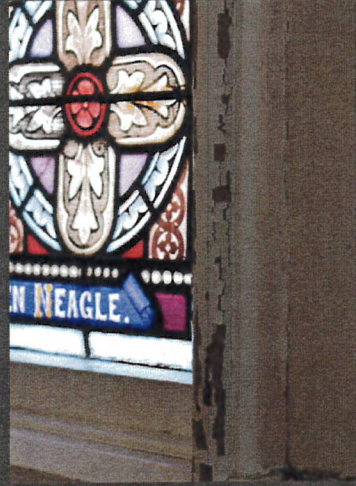
# Windows

## Stained Glass

### Condition: Good

- >140 years old
  - Morgan Bros., New York, NY
- Glass secure within lead frame
- Compositions remain intact
  - Intricate hand-paintings in good condition
- Some protective panes are broken

## Window Frames

### Condition: Fair

- Paint delamination
- Deterioration of exterior sills—metal & wood
- Primary facade rose window trim

- Mold remediation and water damage mitigation of areas affected by water intrusion.
- Restoration of interior and exterior finishes (guided by historic paint stratigraphy).
- In-kind repair, replacement, or conservation of doors and windows throughout the building.
  - i.e. Transparent polycarbonate (aka Lanex) to protect stained-glass windows.

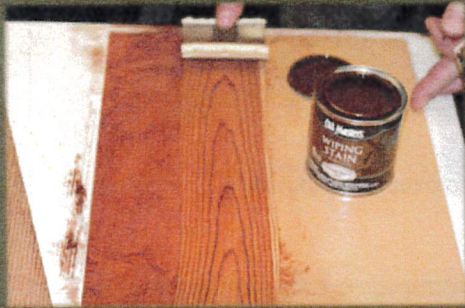
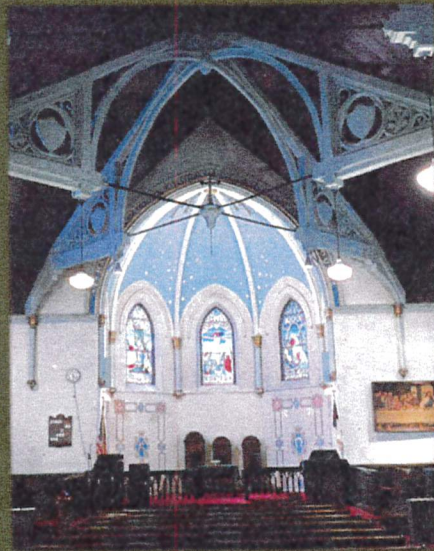
# Paint Sampling Findings

- Use of darker colors and browns in earlier layers
  - heavy implication of graining in baseboards and paneling, but also seen in wall paintings with dark reds and browns in thin layers
- Shift to lighter colors, especially light yellows and blues
  - heavy use of turquoise is consistent with an earlier photo of the church
- Some samples match those of the ancillary buildings
- Multiple hints towards decorative painting

- Some samples from the same areas display very different layering patterns
  - Two adjacent window frames had different color histories : brown and orange vs greens and teals
- Walls in the same general areas had different color histories : layers of browns vs layers of blues
- Some samples give insight to conditions assessments

Further investigation by way of more exposure is highly recommended
