HISTORIC CHARLESTON FOUNDATION  
HURRICANE-HUGO DAMAGE ASSESSMENT FORM

Date of Survey: 10-18-89-

Street Address: 27 TRAD

Tax Map Number: 458-13-1-39

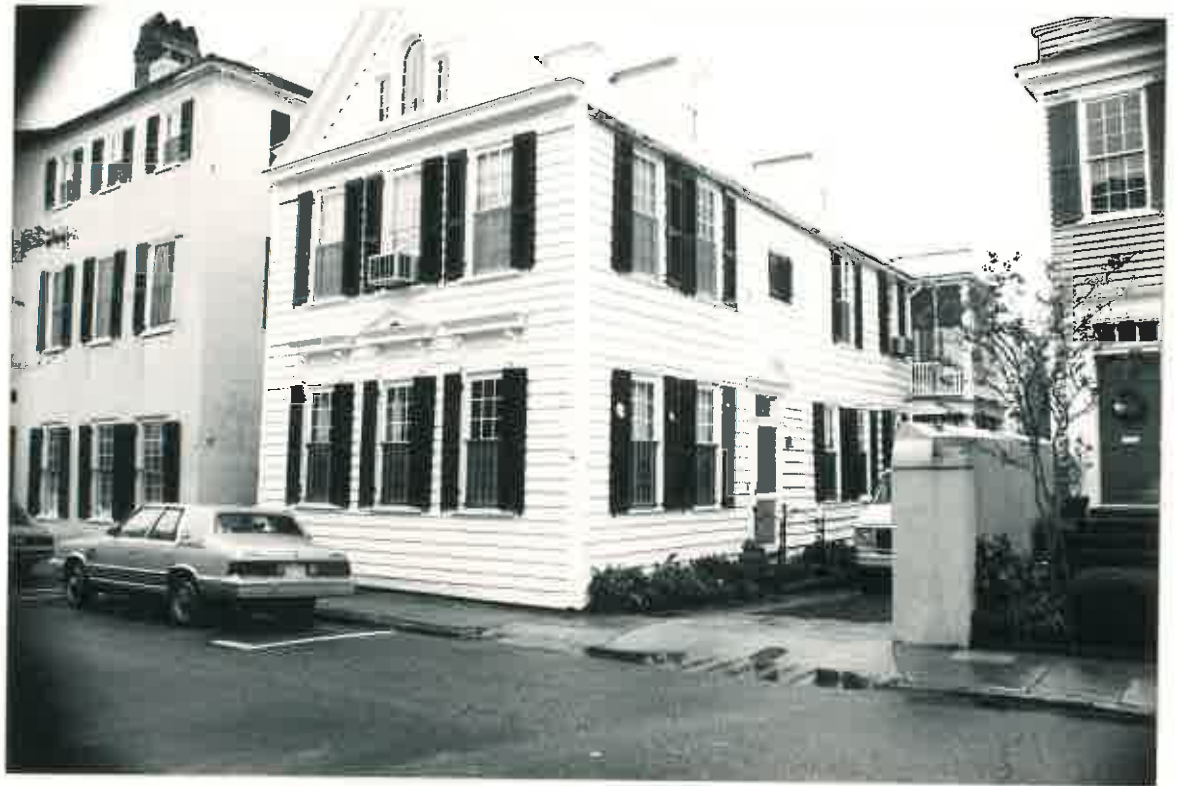
Comments: 20% damage to siding on s. elevation. Already repaired

*20% to  
20% back  
wa*
