HISTORIC CHARLESTON FOUNDATION  
HURRICANE HUGO DAMAGE ASSESSMENT FORM

Date of Survey: 17 Oct 1989

Street Address: 35 Chapel St.

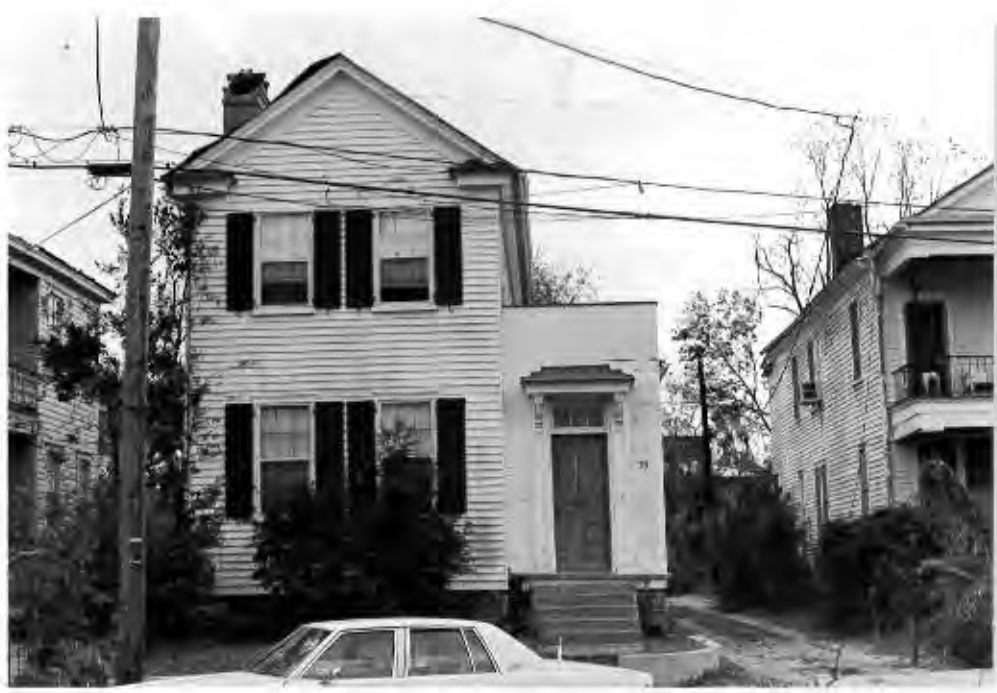
| Downspouts | [ ] | [X] | [ ] | 5% |
| Gutters | [ ] | [X] | [ ] | 5% |
| Roof Covering | [ ] | [X] | [ ] | 15% |
| Chimneys (Number: 2) one w/ [X] | [X] | [ ] | [ ] | 15% |
