Richard Marks
Richard Marks Restorations, Inc.
12A Vanderhorst St.
Charleston, SC 29403

September 17, 2012

This letter report details the archaeological monitoring that took place between September 10 and September 12, 2012. Archaeological monitoring is required by the Historic Charleston Foundation at Medway Plantation if excavations are needed below surface grade at depths exceeding 6" inches. Plans for a drain pipe that would tie in the downspouts of gutters off the south elevation of the Medway house called for excavations in the south yard that would reach depths of 1.0' feet below surface (bs). Archaeological consultant Andrew Agha was present for all ground breaking and completion of this drain system.

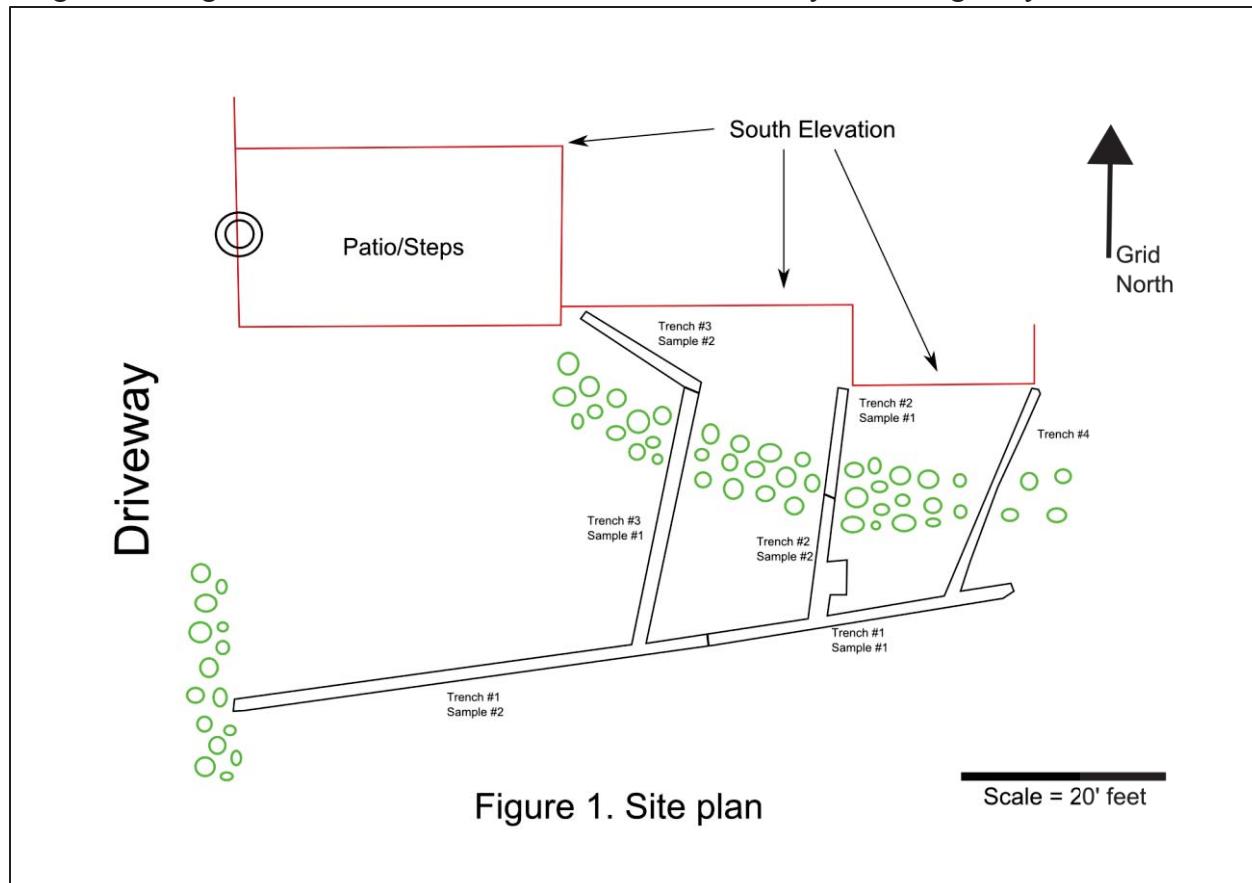
The plans for this drain system included a 6" PVC pipe that would run roughly southwest to northeast across the south yard of the house at a slightly diagonal angle to the south elevation. Figure 1 displays a plan view of all ditches excavated for this drainage system. Additionally, three trenches were excavated from the three downspouts that would tie 4" PVC pipe into the 6" master drain pipe. These three trenches run roughly south from the south elevation to the main trench. The 6" pipe trench is designated Trench #1. This trench is 83' feet long from its eastern edge to the edge of the flower bed that delineates the driveway from the grass yard. Since the

The other three trenches that are for the 4" PVC pipes are labeled Trench #2, Trench #3 and Trench #4 (see Figure 1). Trench #4 runs from the southeast corner of the house to Trench #1. Trench #2 runs from the next corner west of Trench #4 to Trench #1, and is basically in line with the projected wall of the 17th century house. Trench #3 is the western most trench that runs south from the house. It ties in to a gutter downspout adjacent to where the back steps meet the core of the house. This trench turns an angle to mirror the angles of Trenches #2 and #4. Stratigraphy in Trench #3 and Trench #4 is very similar to Trench #1: Zone 1 followed by Zone 2 without Zone 2a.

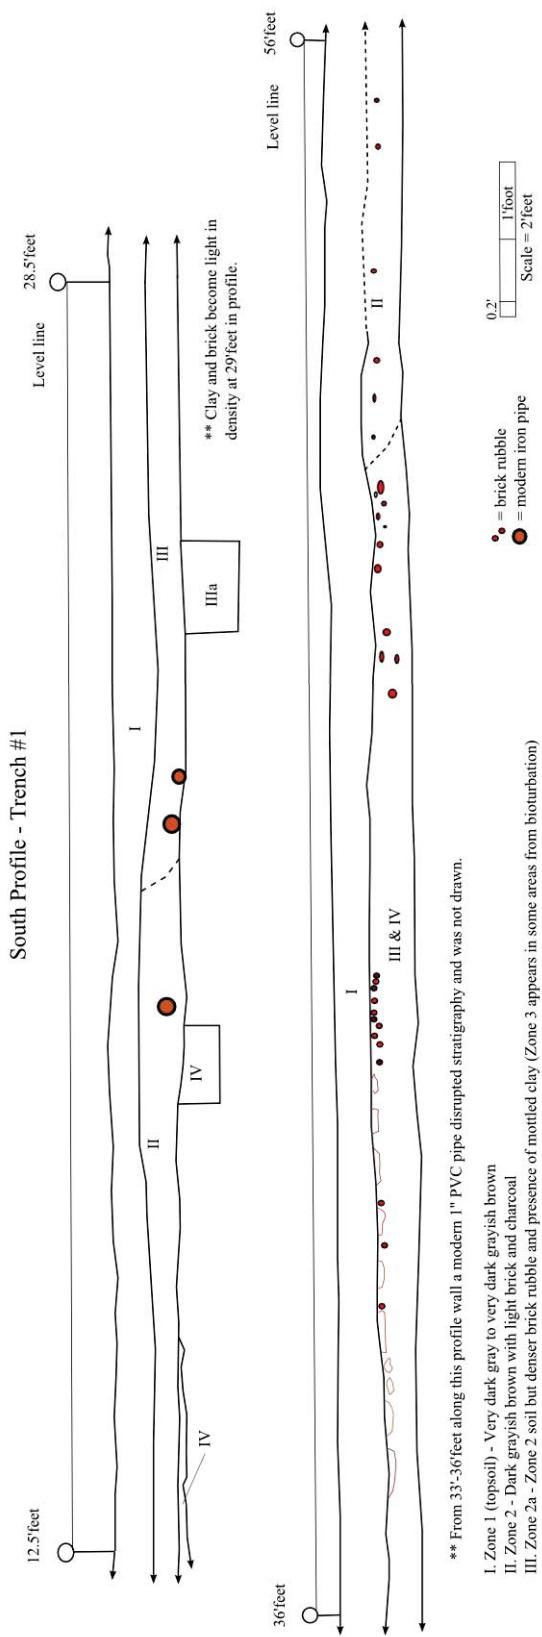
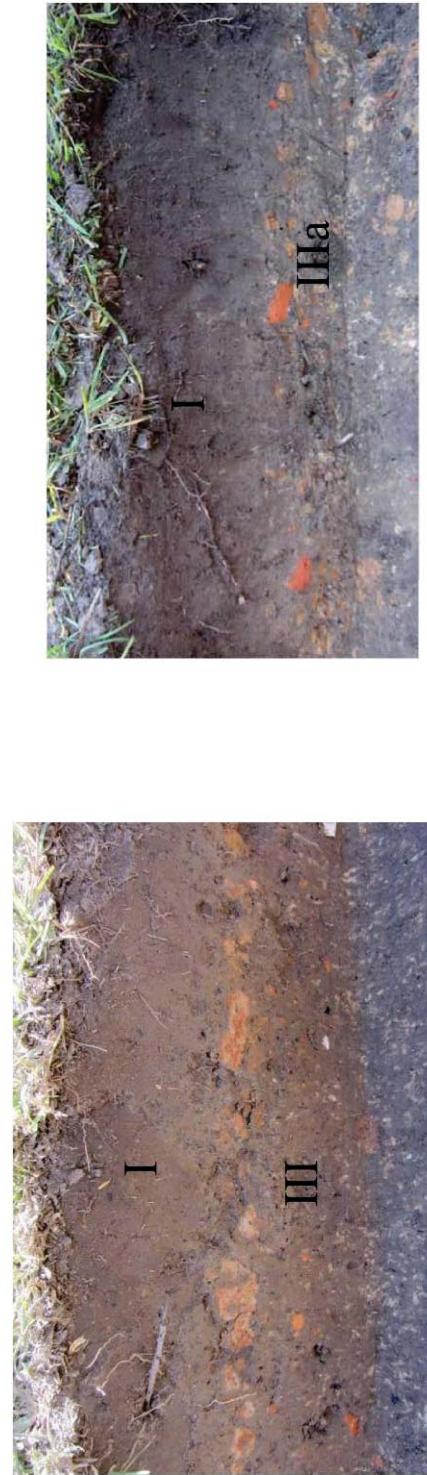
The stratigraphy presented in Trench #1 shows a history of the south yard that had minimal impact from activity and management. Figure 2 displays south profile drawings of the two mapped sections of this trench. Root mat, roughly between 0.1-0.15' thick, was carefully removed as it was to be laid back in place after work was finished. Below this lays Zone 1, a homogenous very dark grayish brown sandy loam that overlays the entire yard. Minimal brick rubble and diagnostic artifacts were found in this fill. Beginning at 21' from the east edge of the trench, larger brick fragments and balls of mottled clay were seen along with larger ceramic sherds and bottle glass fragments. These artifacts increase in density towards the west and form a lens or horizon that delineates Zone 1 from intact soils below it. Zone 2 has more brick rubble and charcoal flecks than Zone 1, and is a gray brown sandy loam. In areas, subsoil sand appears to leach upwards from bioturbation. A portion of Zone 2 has more brick rubble, mottled clay,

Figure 2. Portions of Trench #1 south profile, with a photo of clay lens (left) and intact Zone 2a with heavy brick and clay inclusions (right).

and mottled soils than other areas and is designated Zone 2a. Rubble and artifact density that defines Zone 2a continues to 50' feet west of the east end of Trench #1. From this point to the flower bed, there are thin and light sections of possible ash and/or water deposited silt that helps separate Zones 1 and 2. If the walls of the center of Medway—the portion and location in the current house believed to be the oldest structure—is projected into the south yard from the south elevation, the span of Zone 2a occurs only within this space that may have been related to the 17th century house. Zone 2a is roughly 24' feet wide across the yard. As seen on the profile drawing, a clay lens between 37.4' and roughly 44' feet separates Zones 1 and 2. Zone 3 is the transition soil between Zone 2 and subsoil, and is mottled from bioturbation.

To investigate soils below the 1.0' excavation, two deep tests were dug in the base of Trench #1. Deep Test #1 was placed between 18' and 19' west of the east end of the trench (see Figure 2). This window tested to 1.35' feet bs and was terminated at clear pale yellow subsoil sand. Zone 3 soil continued throughout this window but became more mottled with subsoil the deeper the test went. Deep Test #2 was placed between 24' and 25' west of the east end of the trench (see Figure 2). Excavation of this window went 0.7' feet below the base of the trench and was terminated at slightly mottled light yellowish brown subsoil sand, which is 1.6' feet bs. The soil matrix is Zone 2a, but with less mottled clay. The soil from both Deep Tests was screened separately.

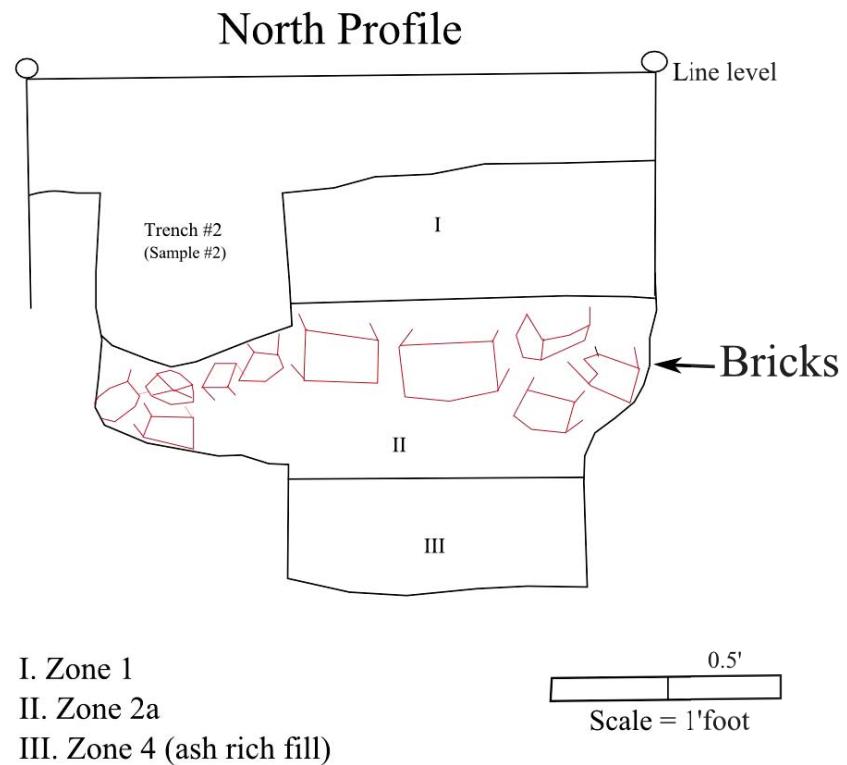
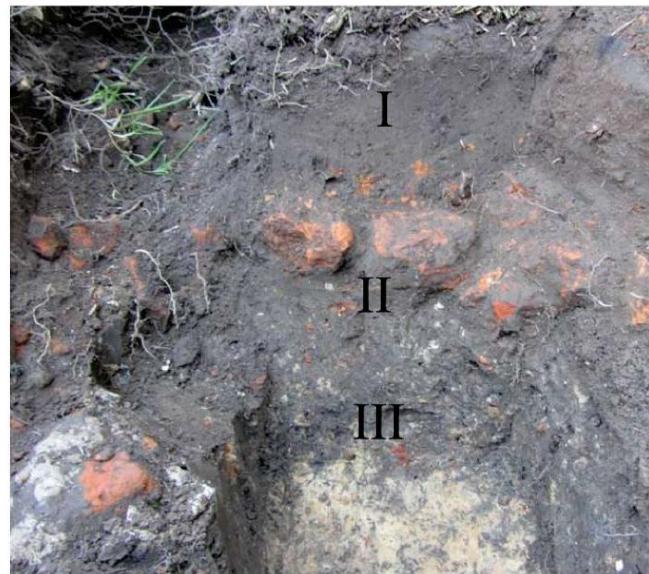
Figure 3 displays a north profile drawing of this test window excavation. Zone 1 was encountered and was 0.6' deep. Below Zone 1 lies the heavy rubble layer that is 0.4-0.6' feet thick. Little soil fill was excavated from the brick matrix but a trowel could be pushed between the brick bats. Below the brick lens was Zone 2a. Underlying Zone 2a here is the similar to the soil encountered in Deep Test #2 but with very little mottled clay in the fill. The soil, designated as Zone 4, was ash rich and had moderate charcoal/cinder content. Evidence of a fire is clear through the severely molten/melted iron and glass lumps and large blobs that were recovered.

Figure 3. A north profile drawing and view of Feature 1 window excavation.

This soil deposit was excavated to a depth of 1.9' feet bs, with the ash-rich fill being 0.45' feet thick. The intact brick lens, which mirrors the clay and brick lens seen in Trench #1 at the base of Zone 1, is a cap for intact and undisturbed soils that are evidence of the c.1701 fire that destroyed the original Medway manor house. If the brick rubble was thicker and was sitting on top of subsoil, it could have been evidence of a robbed wall. Feature 1 was not investigated to the east or west beyond the 2.4' foot width of the test window so that edges of it could be found. It is possible that this heavy brick rubble is in this location because Trench #2 is nearly on-line with the projected old eastern Medway house wall, and could be demolition evidence of such a wall. More excavations would be needed to evidence this theory further. Brick rubble similar to Feature 1 was not seen in either Trench #3 or #4.
