HISTORIC CHARLESTON FOUNDATION
HURRICANE HUGO DAMAGE ASSESSMENT FORM

Date of Survey: 10.18.89

Street Address: 36 COMING

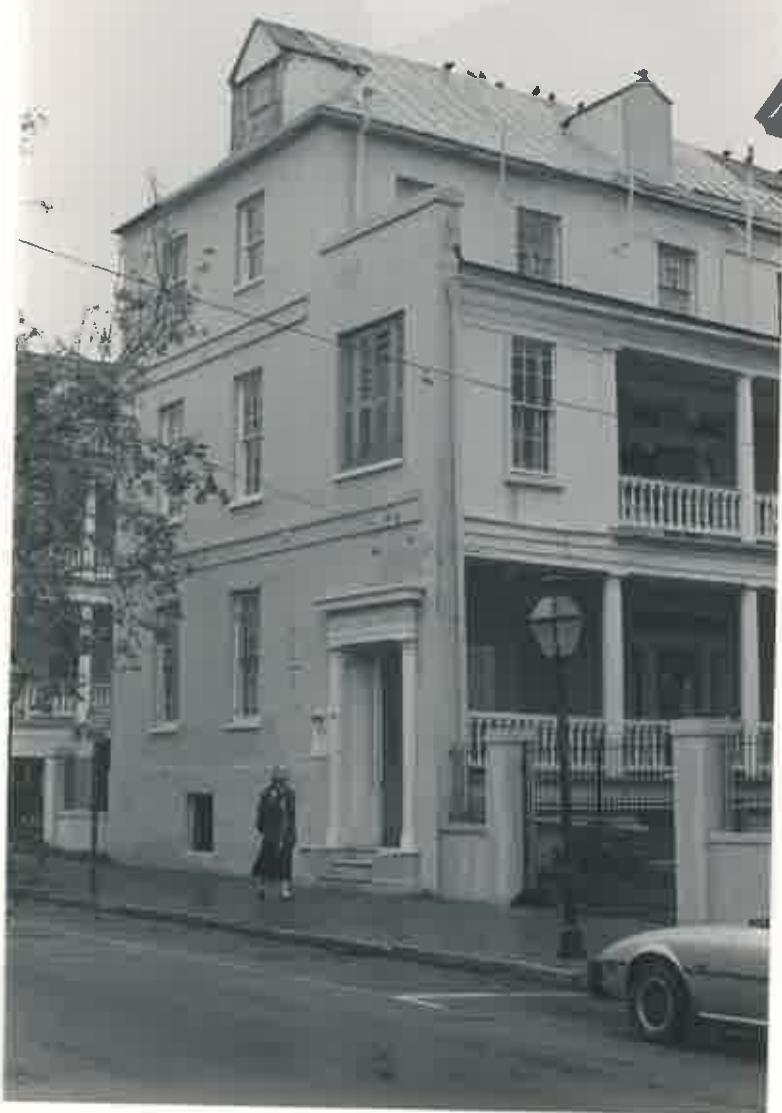
36 Coming Street After Hurricane Hugo; photo by Historic Charleston foundation
