HISTORIC CHARLESTON FOUNDATION
ENDANGERED STRUCTURES REPORT
1999

Endangered Structures Survey

Purpose: The object of this survey is to create an inventory of structures at risk by 1) neglect, 2) decay, or 3) development and to protect these vulnerable buildings and monuments and to set priorities for their future care.

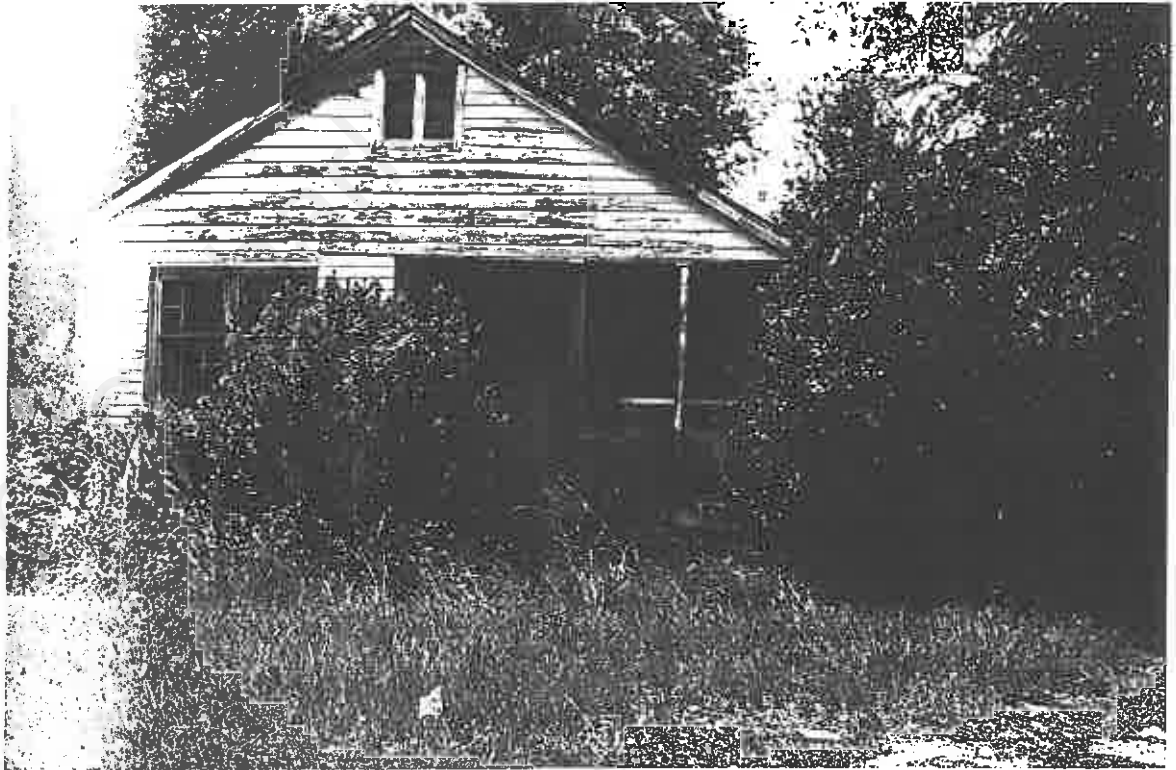
Condition: Very Bad

Summary: The structure is vacant and decay is accelerating. The roof has failed and the fascia is rotting as well as the clapboards, windows, and door. There is differential settlement suggesting foundation failure. There is organic growth infiltrating the structure. The structure is in Crisis, and very near Loss.

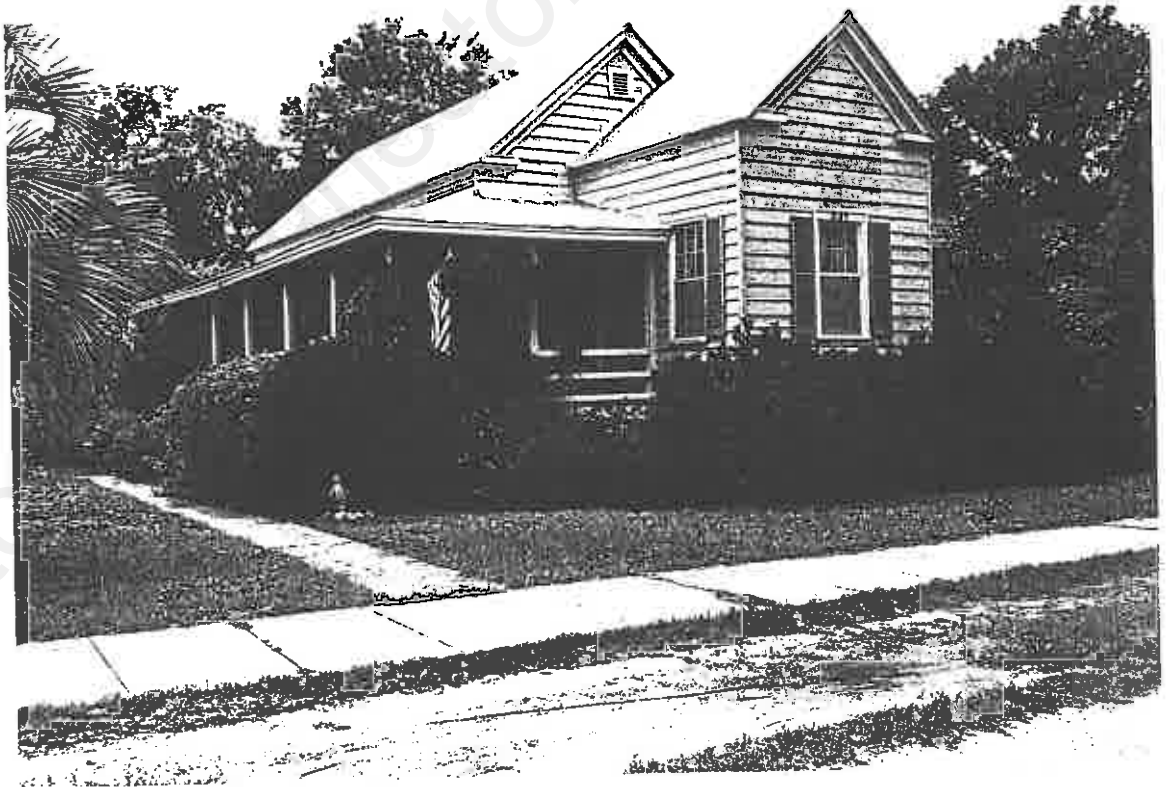
Condition: Fair

Summary: This structure is in fair condition. Evidence of rot on porch. Evidence of deflection on porch and roof suggests water penetration within the structure. Flashing is poor and roof reaching end of its usefulness. Building is becoming Vulnerable

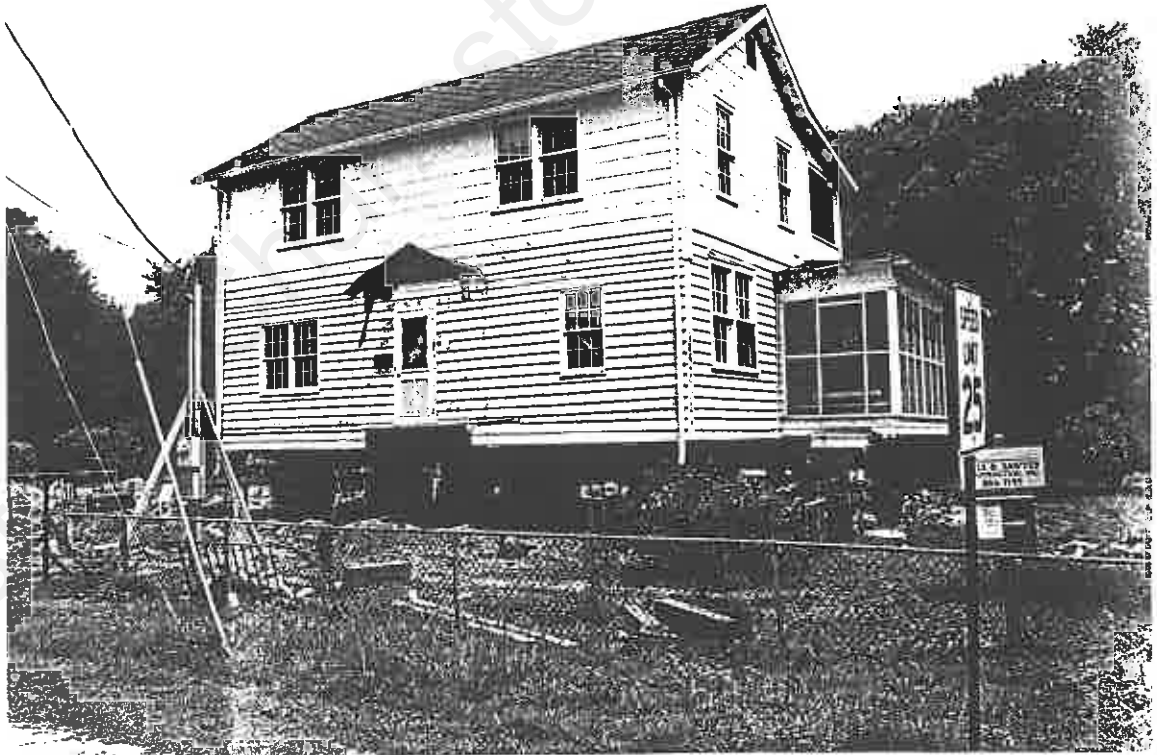
Condition: Poor

Summary: This structure appears to have been sided and subsequently damaged areas. Evidence of window flashing shows water penetration localized to joints in siding and causing rot. Significant water damage and rot evident on structural beams of the first floor (exposed b/c of foundation work). Suggests that prior foundation rotted and failed. Roof in poor condition and projecting portico removed showing poor quality of interior wood. Structure being repaired, but as is: Risk/Crisis

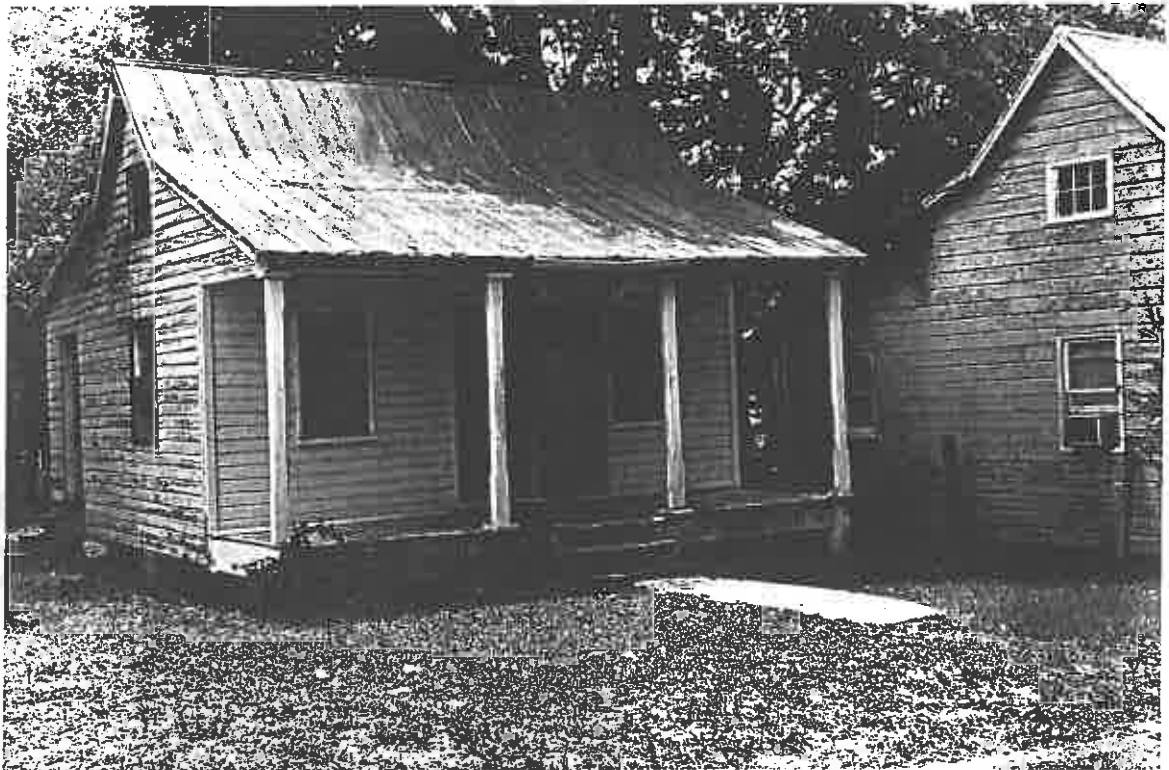
Condition: Poor

Summary: The structure shows general lack of maintenance evident in wood rot and failed gutters. The roof barrier looks functional, but overall condition is poor. There is evidence of wood rot on the roof joists. There is differential settlement, and the entire structure is sliding down on its left side. The structure is at Risk.

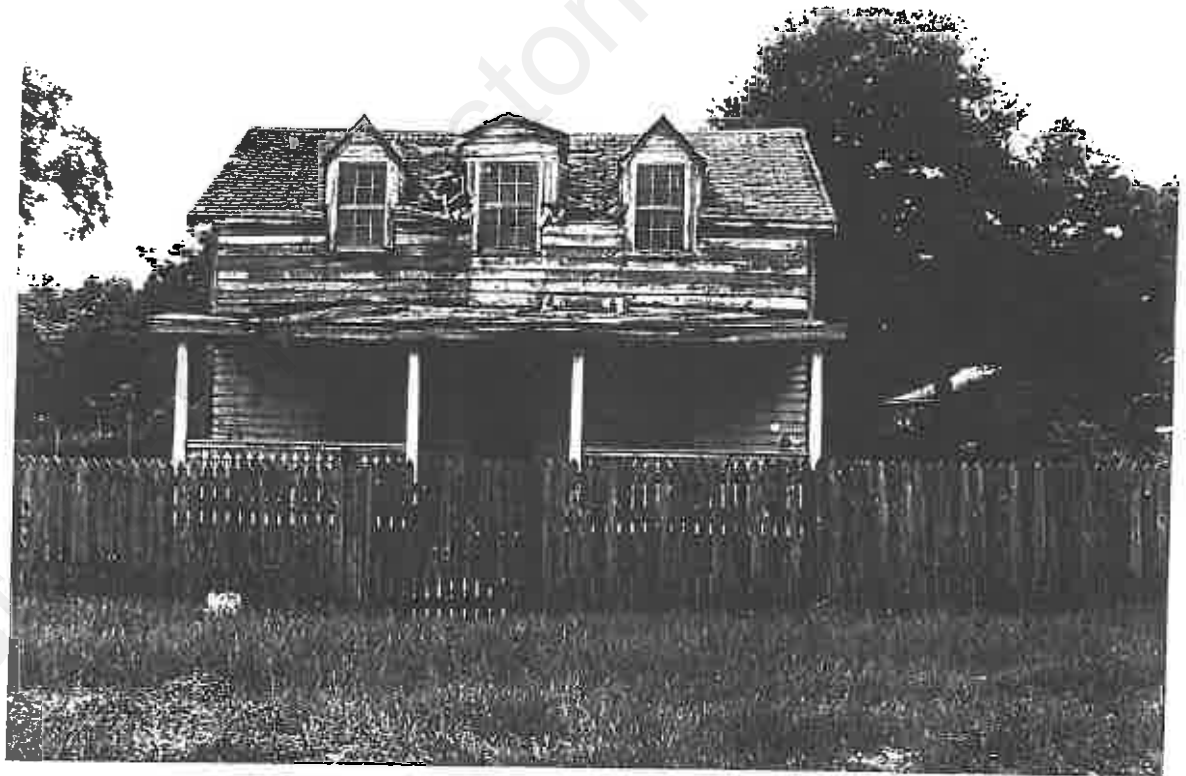
Condition: Very Bad

Summary: The structure's condition is Loss. The roof has failed exposing the interior and structural wood to water damage. The exterior wood is extensively rotted. Foundation is failing. Windows and doors are very bad.

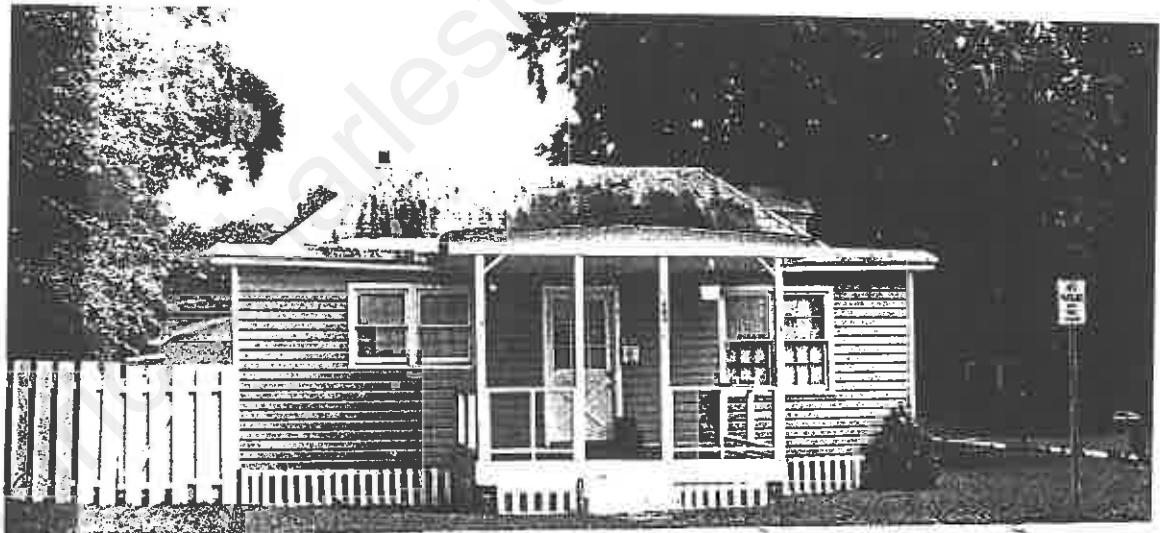
Condition: Fair

Summary: The structure is in fair to good condition. Evidence of poor maintenance schedule. Roof beginning to show preliminary signs of structural damage ie. Slight deflection evident in roof ridge. The structure has recently been sided with vinyl. Suspect structure to be **VULNERABLE**

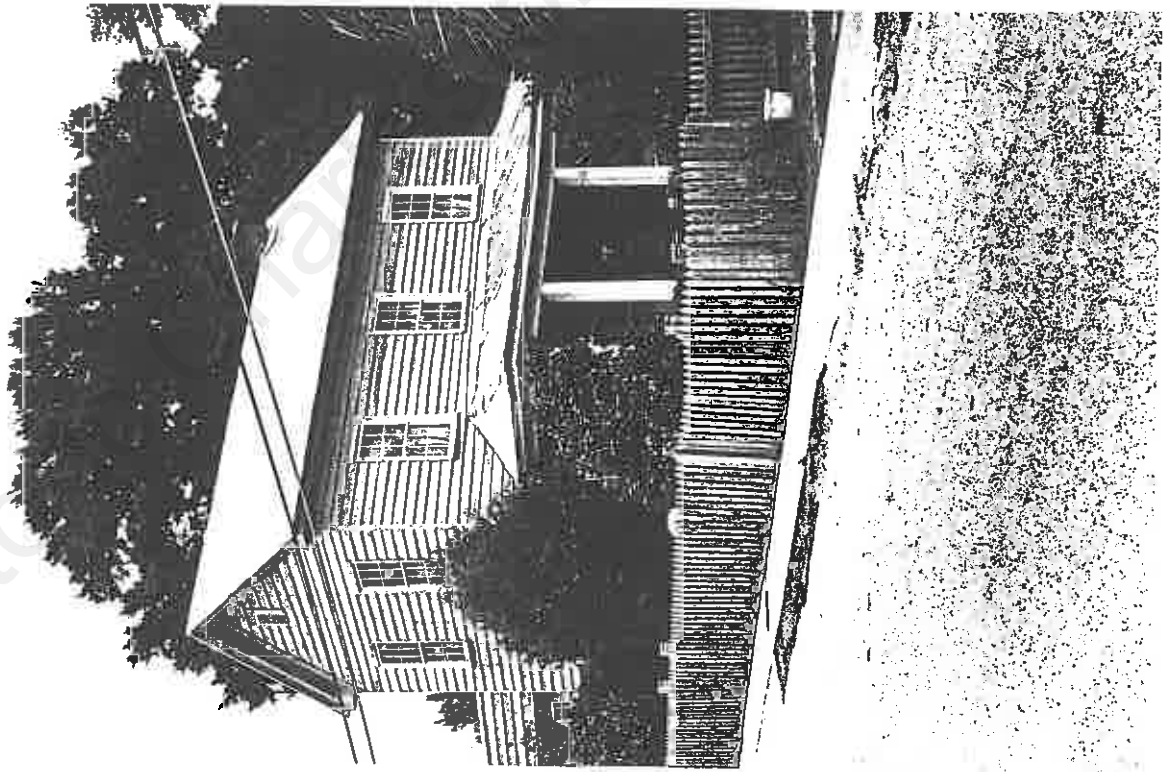
Condition: Fair

Summary: Structure beginning to display evidence of a poor maintenance schedule. Clapboard beginning to become susceptible to water damage and rot b/c not painted. Deflection in porch roof.

Structure is threatened by market demands. The majority of sites on this street are commercial extension of Coleman Blvd. Street has lost ability to support residential use.

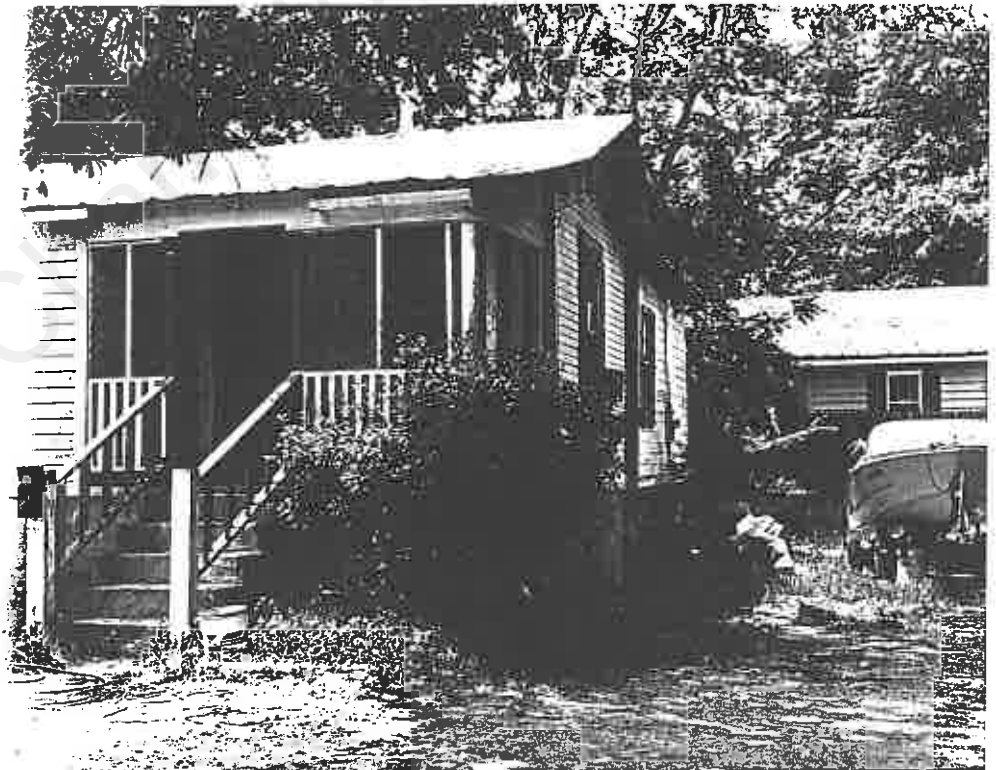
Condition: Poor

Summary: The roof of the structure is in very poor condition. There are defective gutters with notable rot occurring on roof eaves. The windows are in very poor condition. The structure is at Risk.

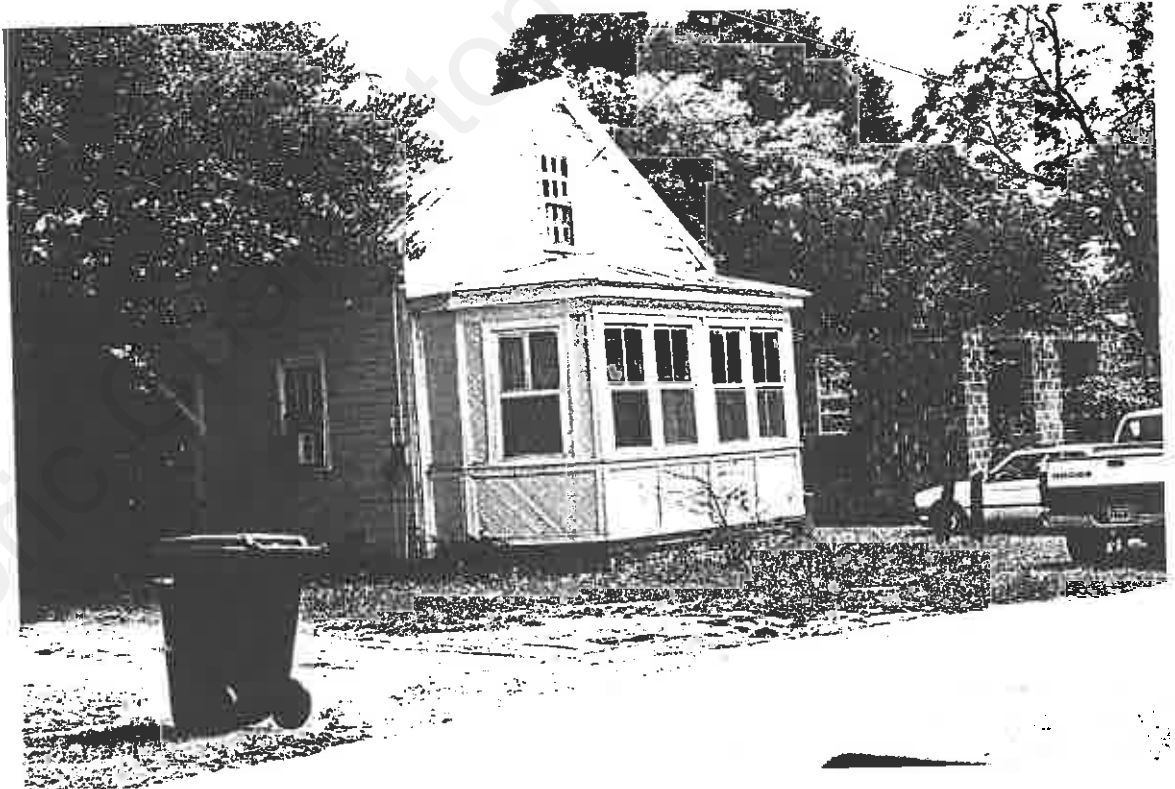
Condition: Fair

Summary: Roof is in poor condition displaying some rot. Wood rot evident on clapboard and on the first floor floor plate. Overall the structure is Vulnerable.

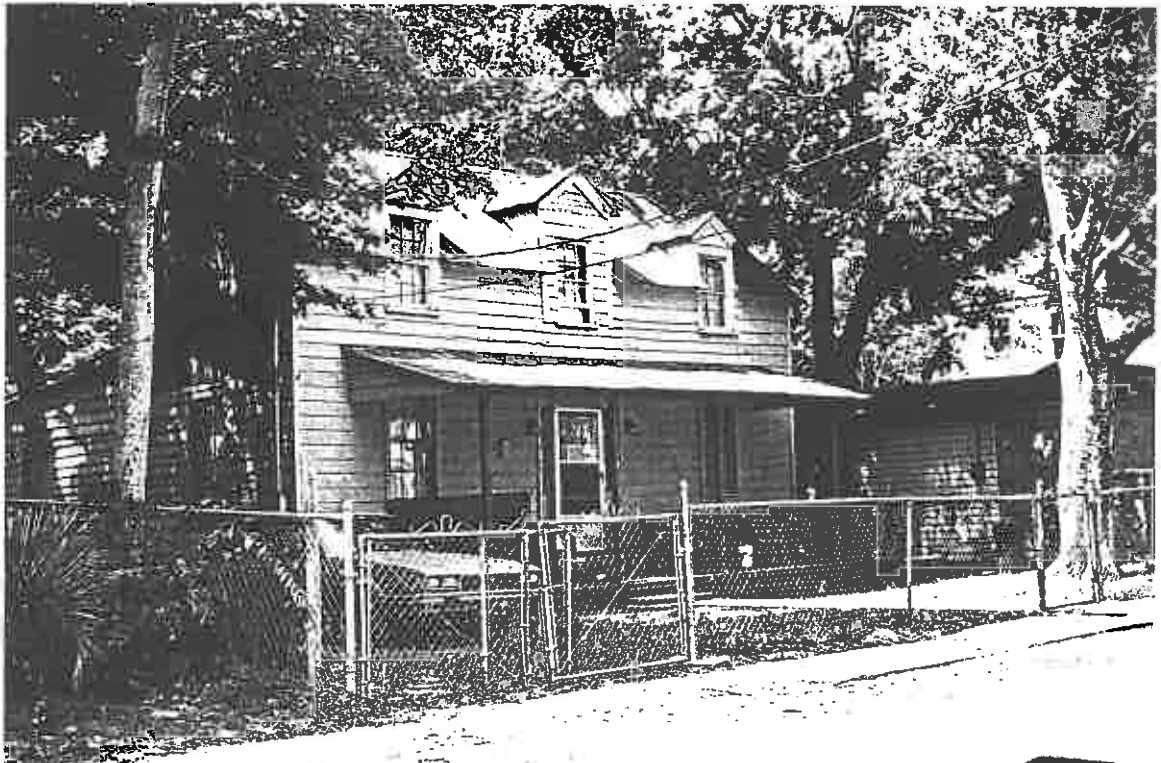
Condition: Fair

Summary: Roof is in poor condition with rust and very poor joinery and flashing.
Evidence of rot on clapboards (very poor condition on sides of house)
Suspect water penetration. Structure is Vulnerable

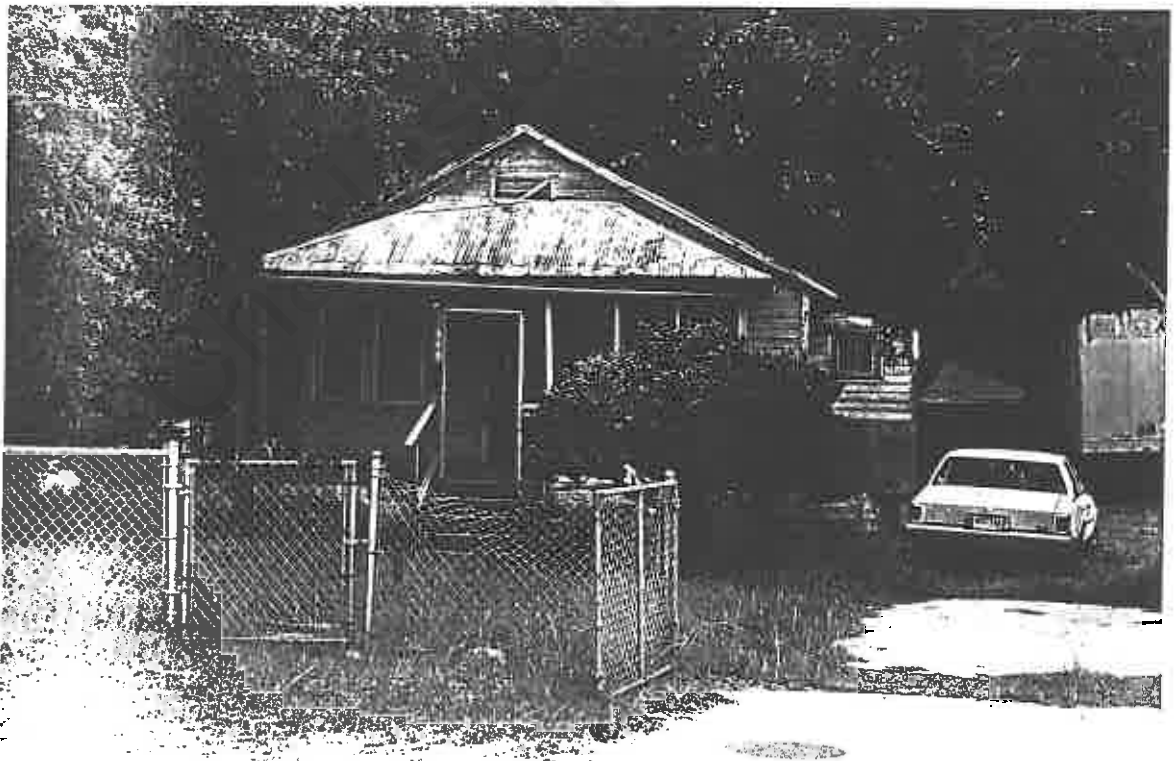
Condition: Poor

Summary: The structure is in poor condition displaying minor failure of the roof barrier. The roof is deteriorated, rainwater goods are defective. There is considerable wood rot evident in the clapboards, windows, and door. There is no evidence of maintenance. The structure is at Risk.

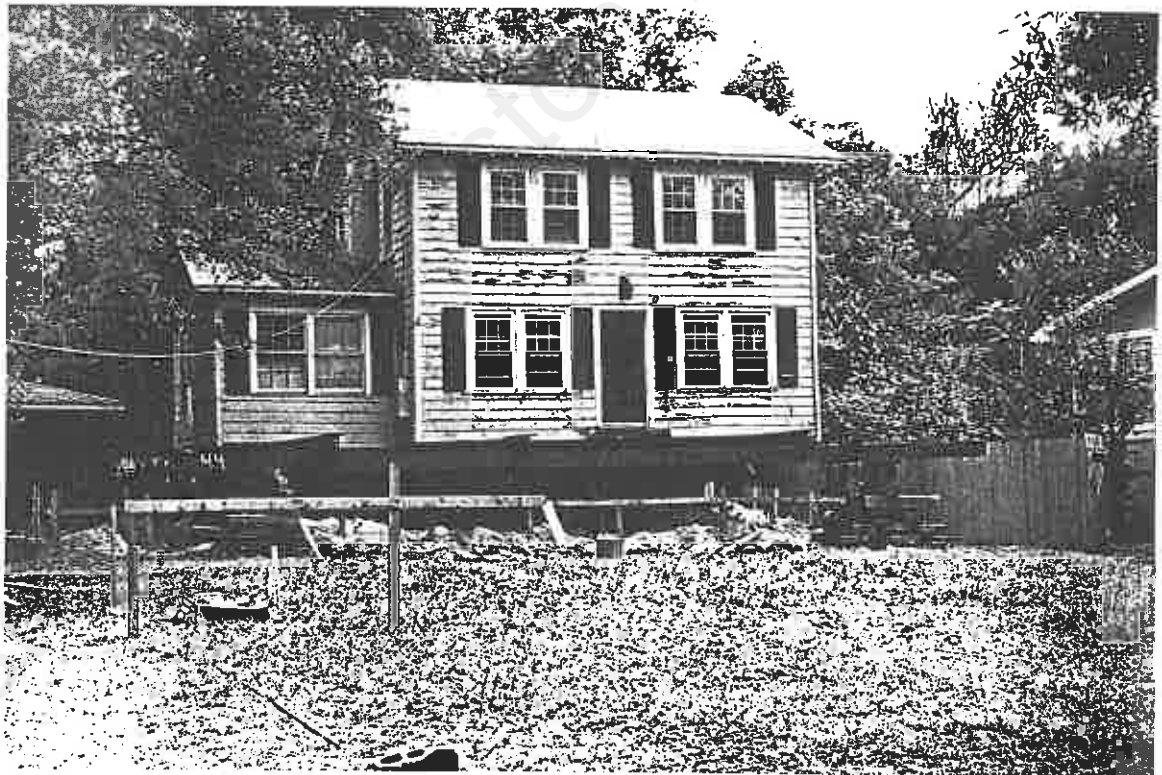
Condition: Poor

Summary: This house shows signs of little to no previous maintenance. Foundation completely rotted away, but being fixed. Clapboards are in poor condition and are rotting on lower courses. Many of windows frames are warped and windows don't seal. Suspect poor grading and drainage around foundation have caused water penetration and damage. Building at Risk

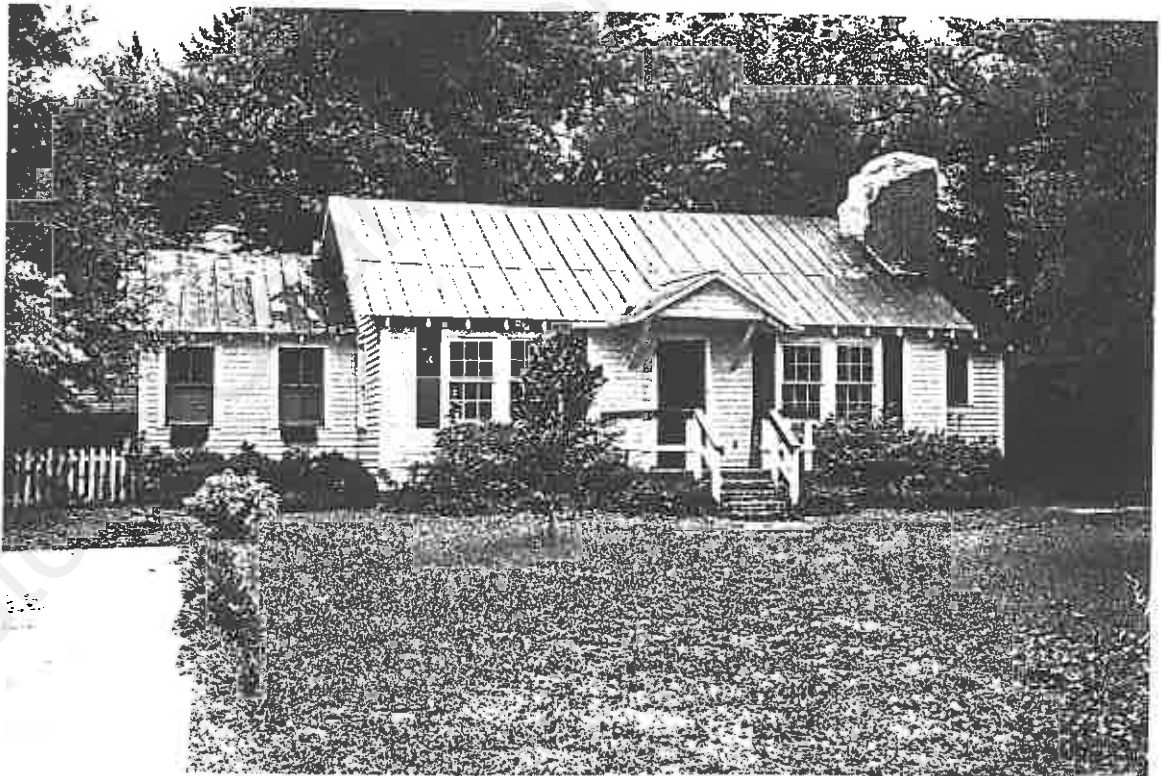
Condition: Fair

Summary: There is severe damage to the chimney which is currently covered. The roof of the addition is in poor condition and sheets of main roof are beginning to separate. This structure is Vulnerable.

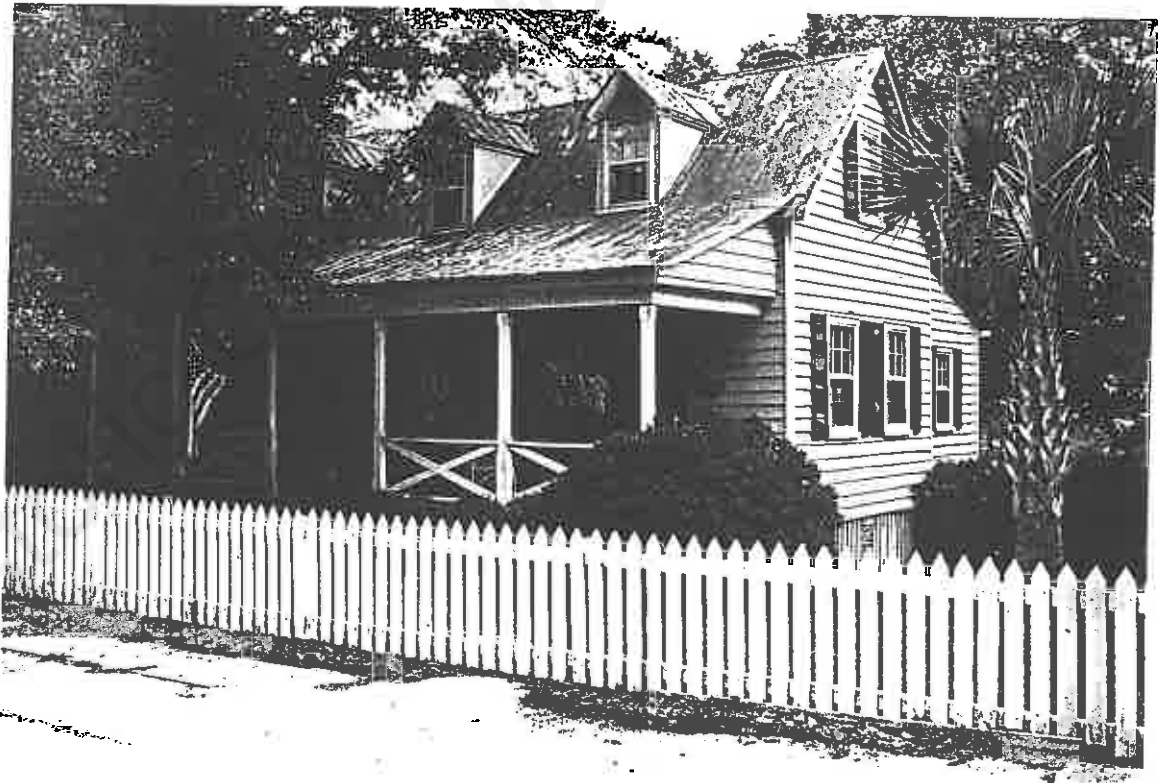
Condition: Fair

Summary: This house displays signs of deferred maintenance. Shutters are rotted and broken. Paint peeling off of clapboards with evidence of rot forming. Roof is in poor condition and is separating. House is at Risk. Chimney in poor condition with crude cap. Water penetration occurring.

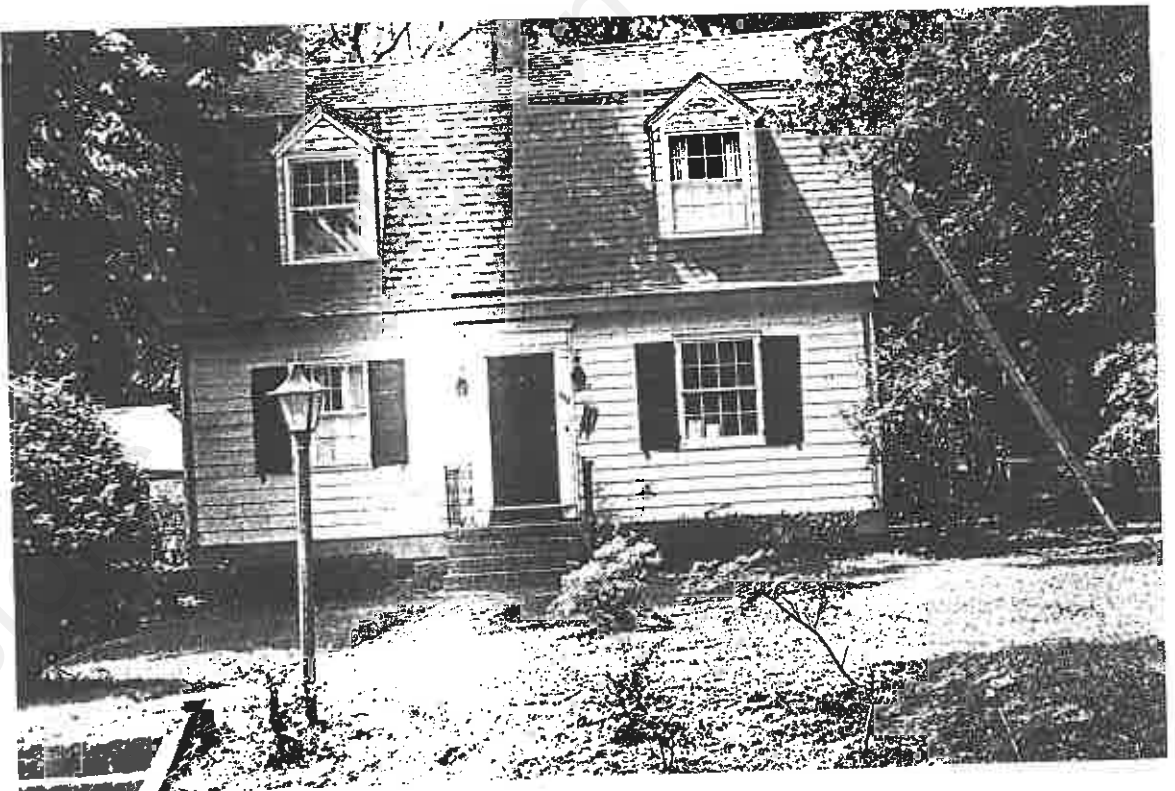
Condition: Fair/Poor

Summary: Roof is new, but deflection on front gambrel. Rot evident on all wood elements especially clapboard which also has holes. There is a new baseboard and porch. Very nicely detailed door, but condition poor. Windows are new. Entire structure displays differential settlement. Overall the structure is at Risk.

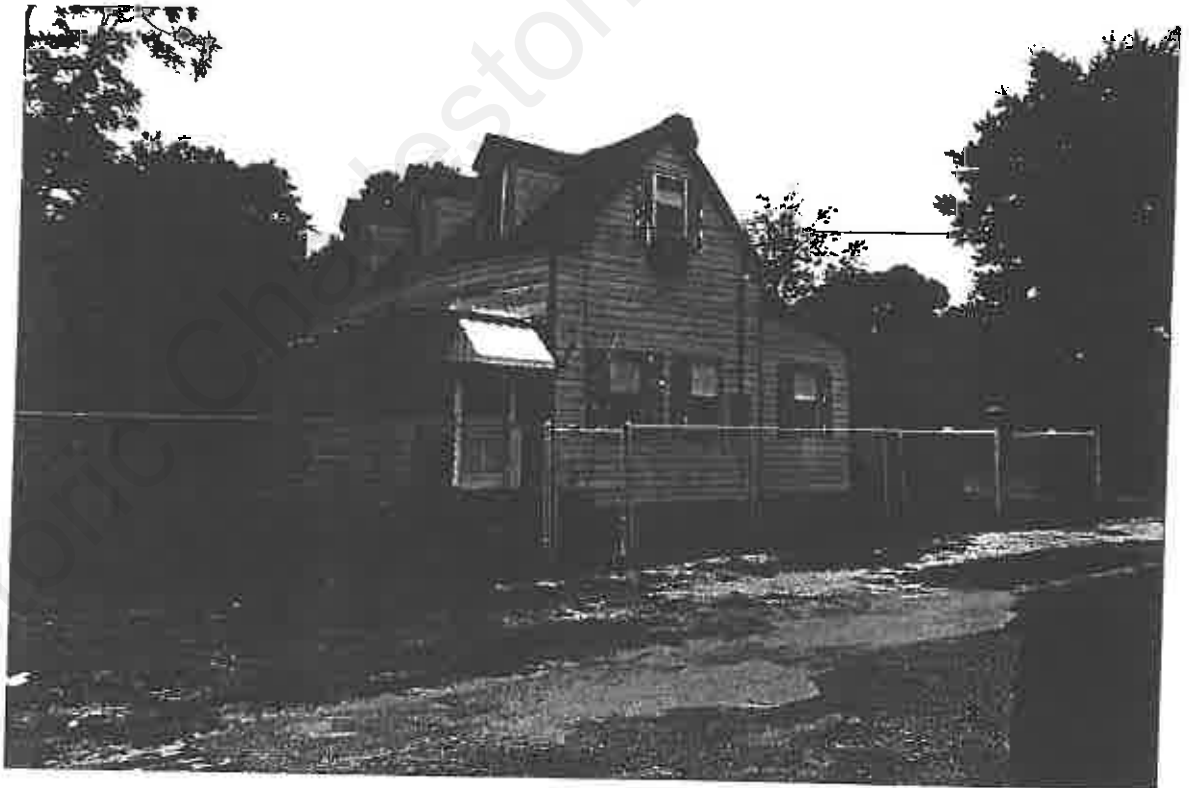
Condition: Poor

Summary: There is visible deflection occurring along the roof ridge. The roof is in poor condition and suspect to water penetration. The flashing is very poorly done and in bad condition. There is settlement occurring along the side wall suggesting deeper structural damage. The shutters and windows are in very poor condition. The structure is in Crisis.

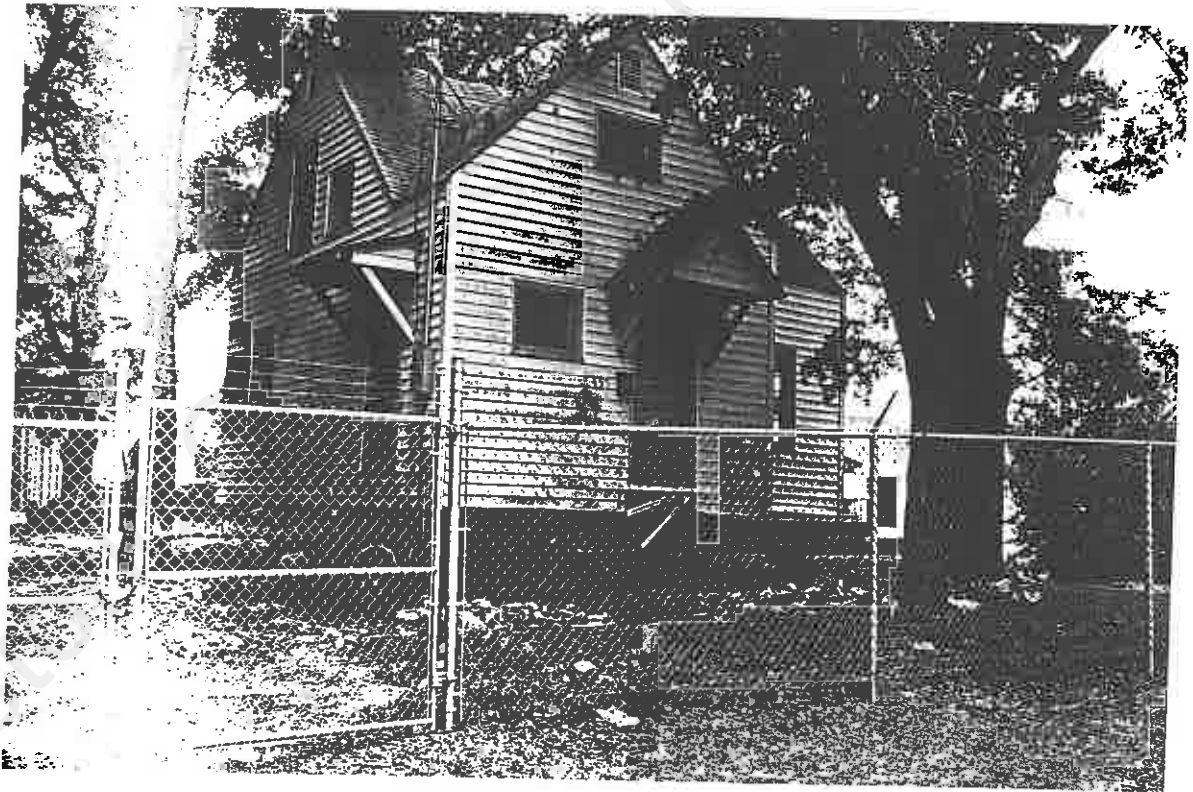
Condition: Poor

Summary: Currently the structure is underpinned and raised off the ground. The roof is crudely patched and suggests a poor barrier. There is considerable rot on the clapboard and the foundation. The structure is at Risk in its present condition.

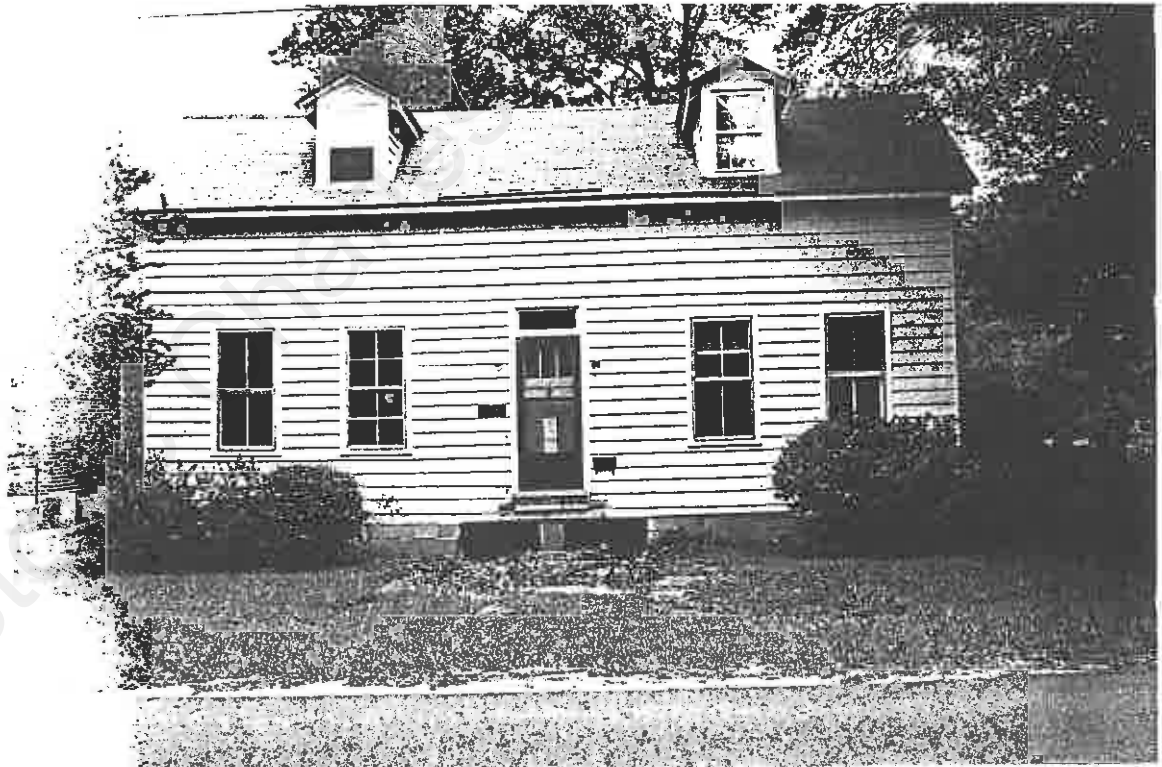
Condition: Fair/Poor

Summary: There is considerable sag in the eave of the roof evident in the fascia. Except for visible opening of removed stairs there is no crawlspace ventilation suggesting possibility of interior wood rot. Deflection of the roof ridge corresponds with sag in eaves suggesting structural failure. Roof has poor flashing. Evidence of minor rot in exposed framing. Clapboards recently repainted. Shutters still removed

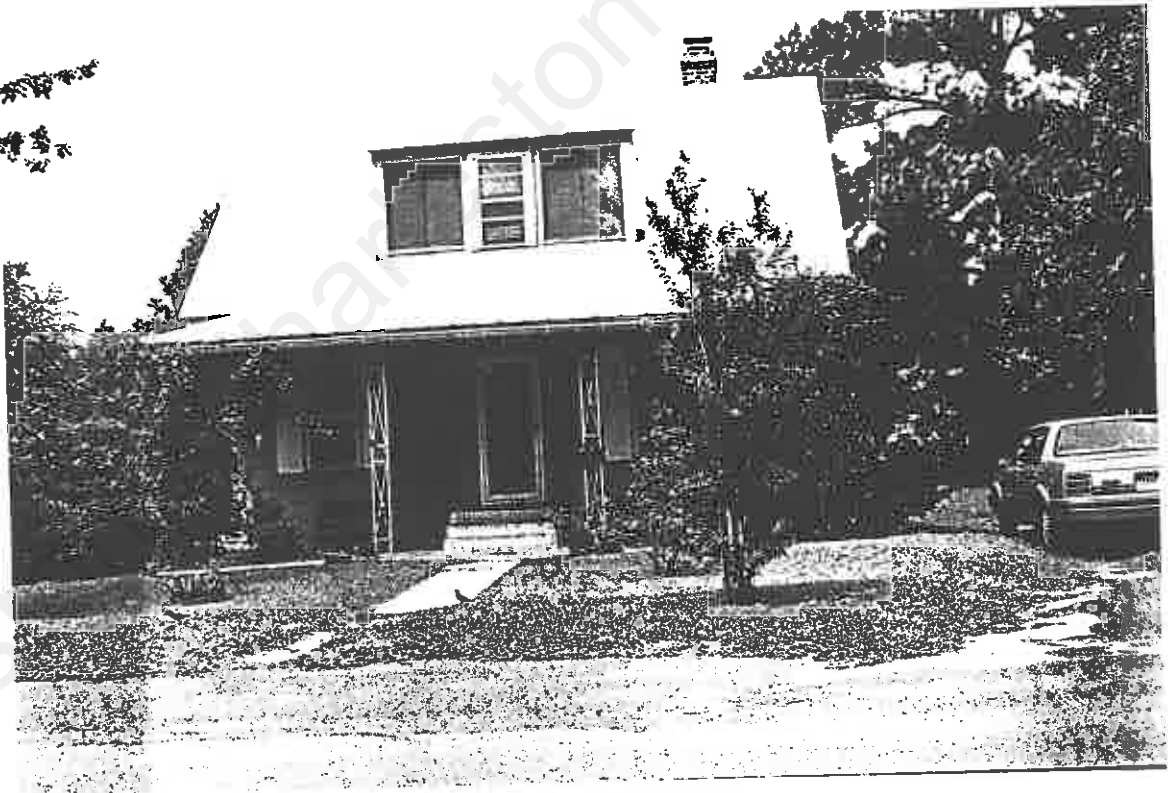
Condition: Fair

Summary: Roof is beginning to deteriorate. Very poor flashing on shed dormer.
Gutters have failed.

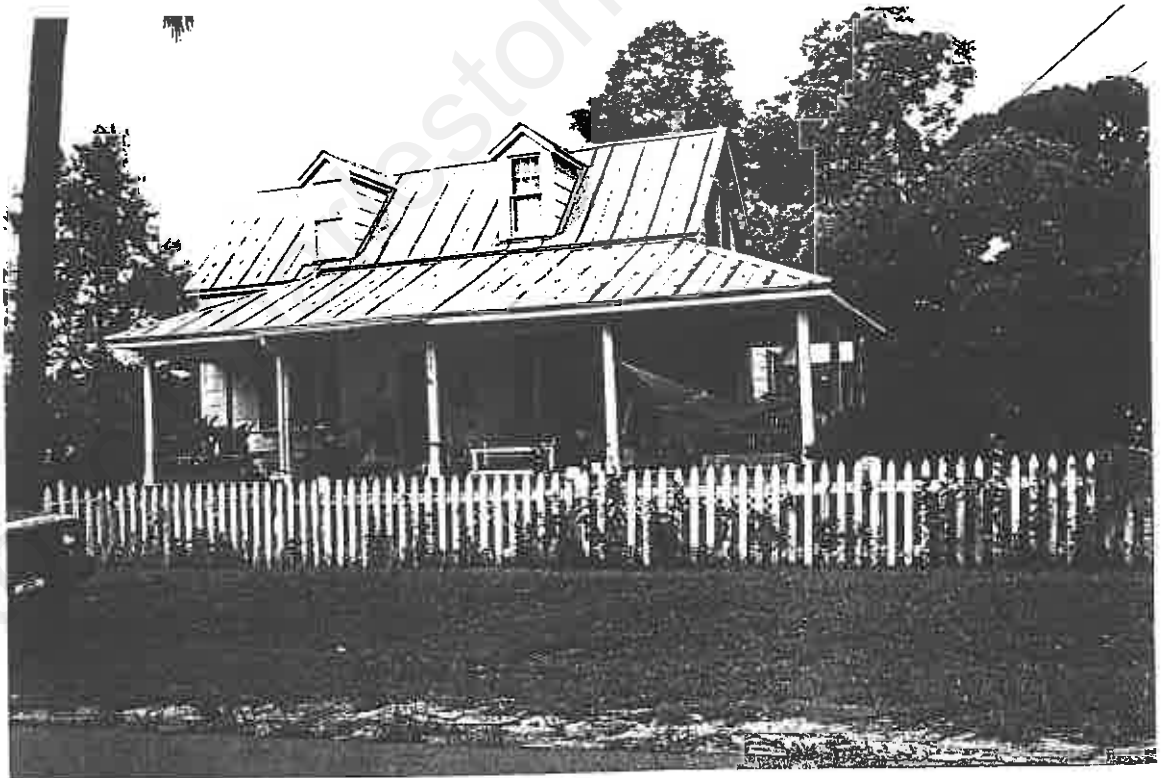
Condition: Fair

Summary: Roof is deteriorated and beginning to display minor along roof eaves and as well as window sills. Not adequate flashing along dormers and suspect water intrusion at dormer crickets.

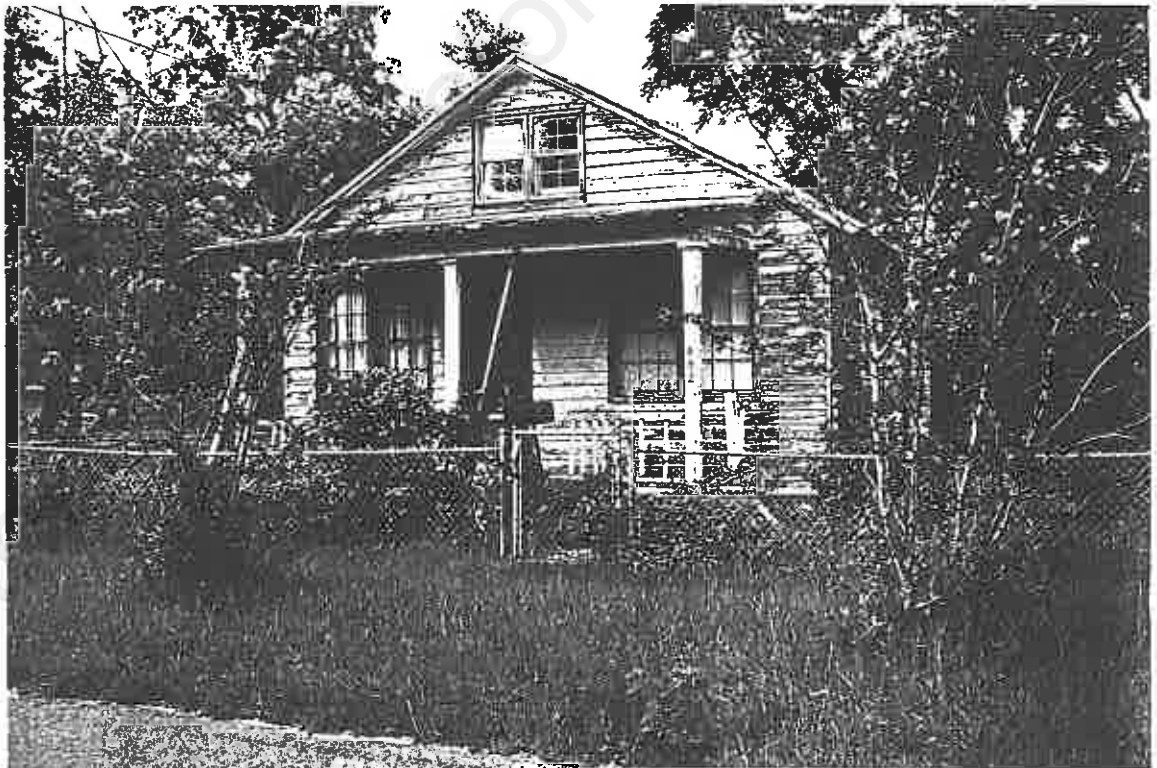
Condition: Poor

Summary: The structure appears to be vacant. Roof has extensive rust and is beginning to fail. Advanced wood rot evident on all clapboard, and suggests structural damage as well. Boards supporting failed porch roof. Thus structure is currently at Risk, possible Crisis stage of decay.

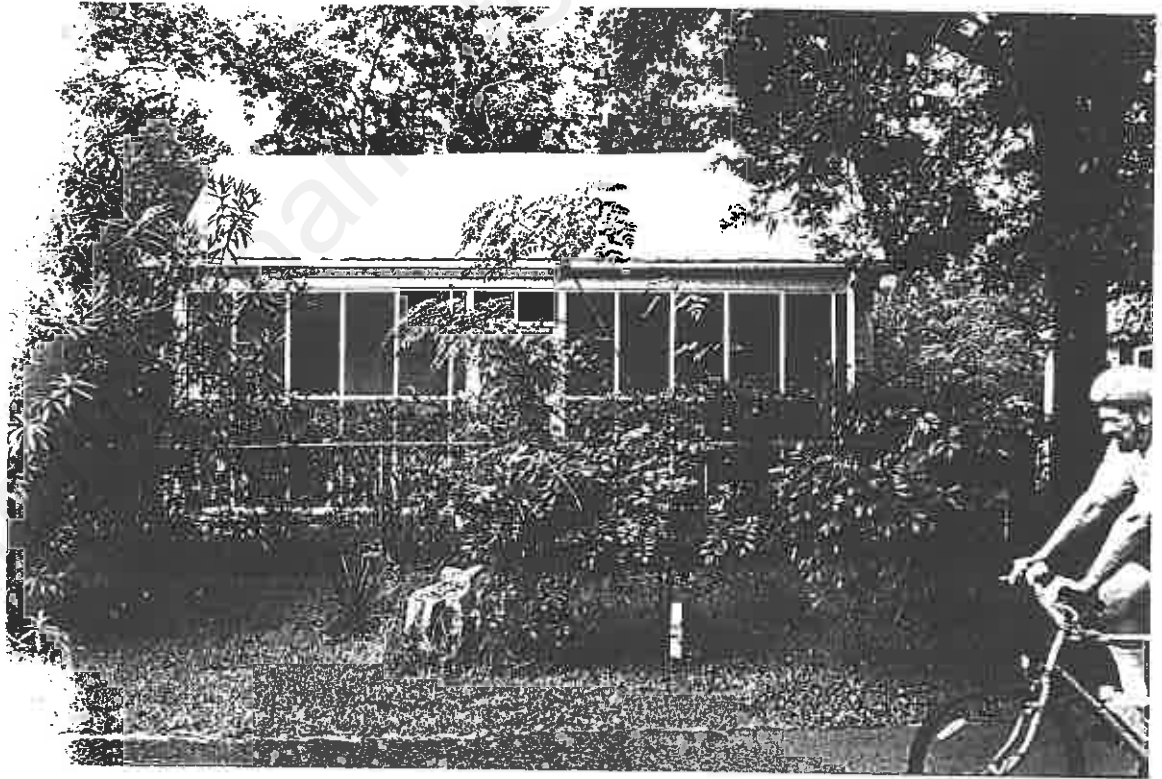
Condition: Fair

Summary: Roof is in poor condition with areas of rust and evidence of deflection on ridge of roof. The windows sills display differential settlement and don't seal properly. Overall condition of wood is poor and suggests interior wood rot. Structure is vulnerable

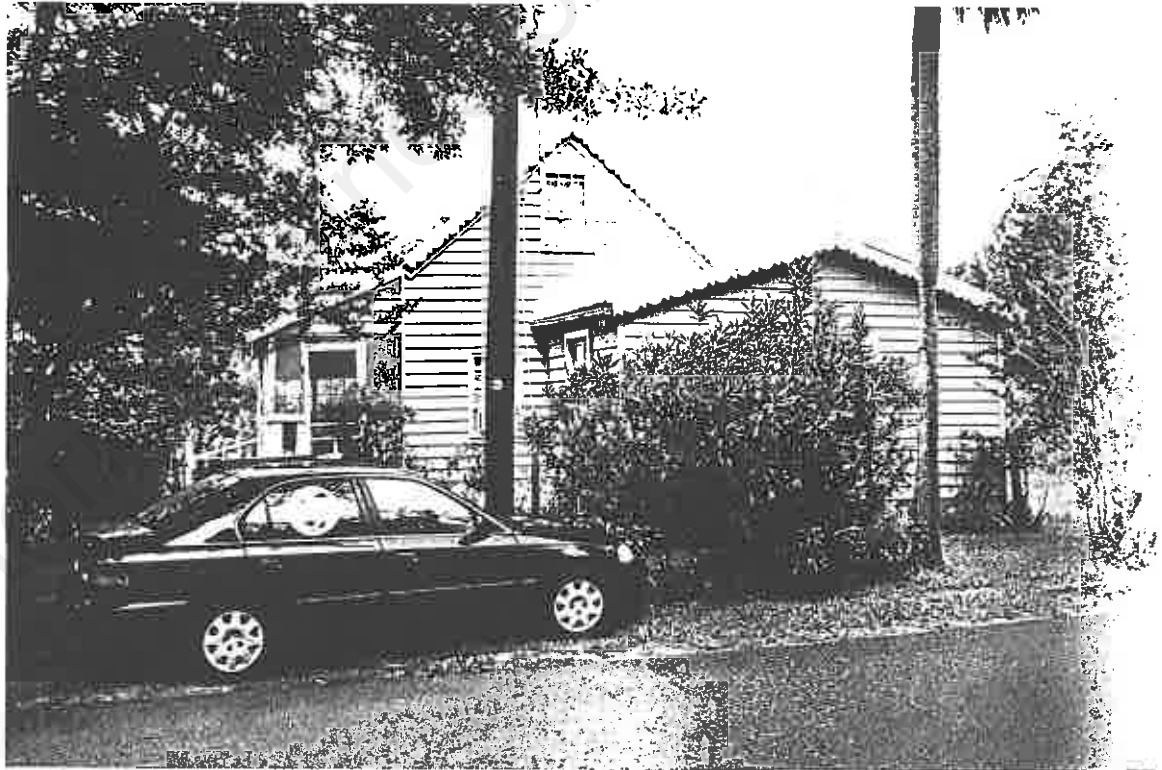
Condition: Fair/Poor

Summary: Evidence of roof barrier failure. Rust on roof and evidence of sag along fascia of the gable. Suggests structural water damage. Windows have notable sag and rotted sash. Wood clapboards in poor condition. Overall decay: risk
