HISTORIC CHARLESTON FOUNDATION
ENDANGERED STRUCTURES REPORT
1999

Endangered Structures Survey

Purpose: The object of this survey is to create an inventory of structures at risk by 1) neglect, 2) decay, or 3) development and to protect these vulnerable buildings and monuments and to set priorities for their future care.

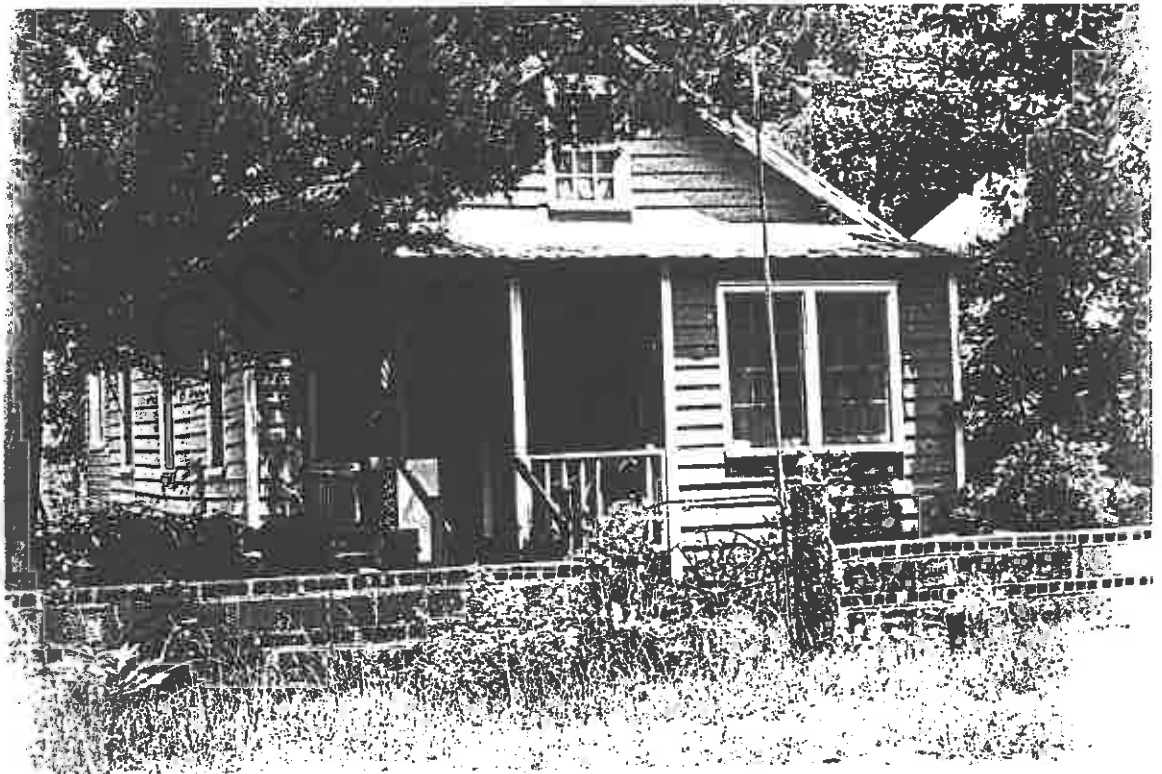
Condition: Poor

Summary: Roof is rusted. There is considerable wood rot, notably on clapboards, and structural failure noticeable along side wall. Serious differential settlement. Windows in very poor condition
Structure is in Risk, near to Crisis.

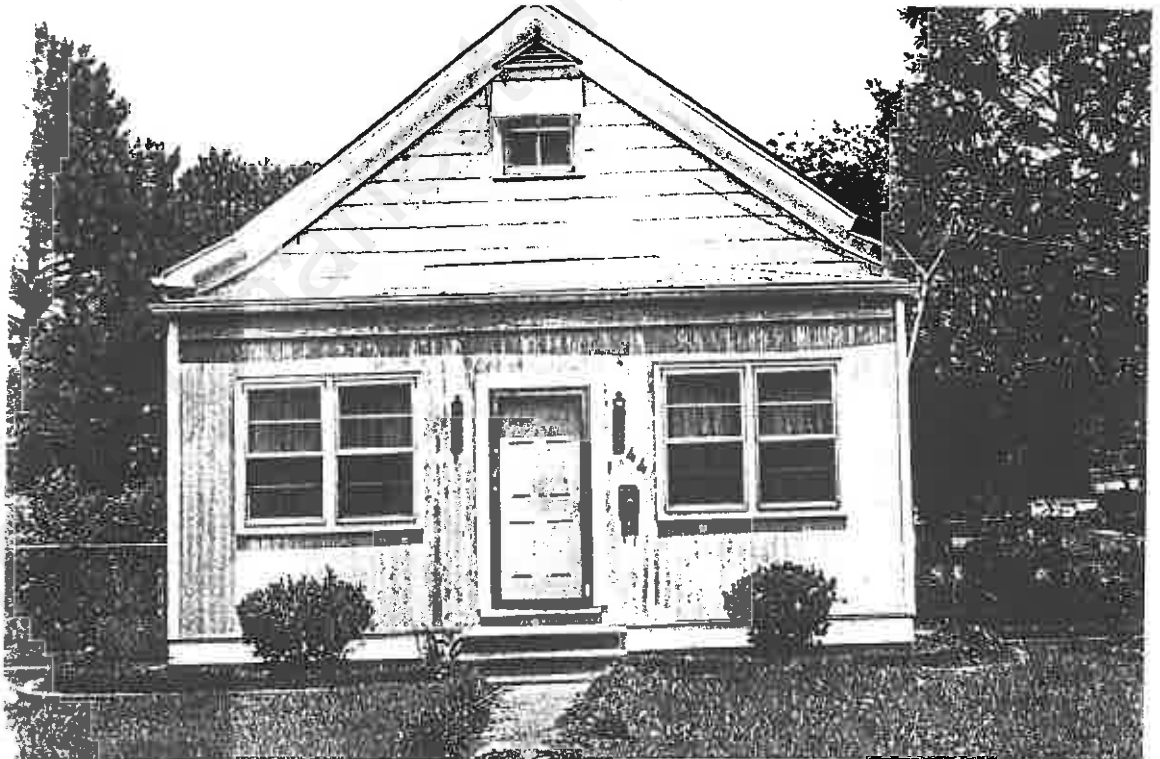
Condition: Fair/Poor

Summary: This structure appears OK, but suspect problems. The right roof eave is gone exposing wood roof plate. The roof is in poor condition, suggesting a poor barrier. The front porch has been sided over and noticeable rot is noted along door sill and under the eave. Suspect structural condition to be at Risk and possibly Crisis without more preventative maintenance.

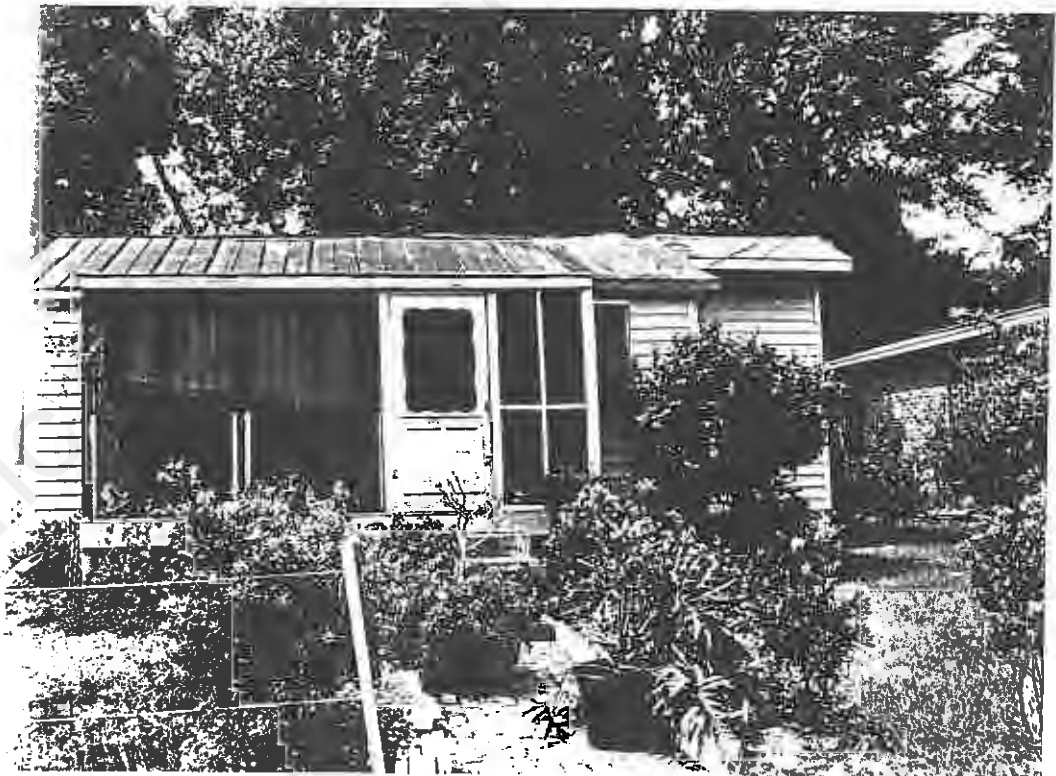
Condition: Fair/Poor

Summary: The roof ridge is separating exposing the joint. The roofing material (Tin) in poor condition and settlement is evident. The fascia displays rot along the gabled ends. The structure is at Risk.

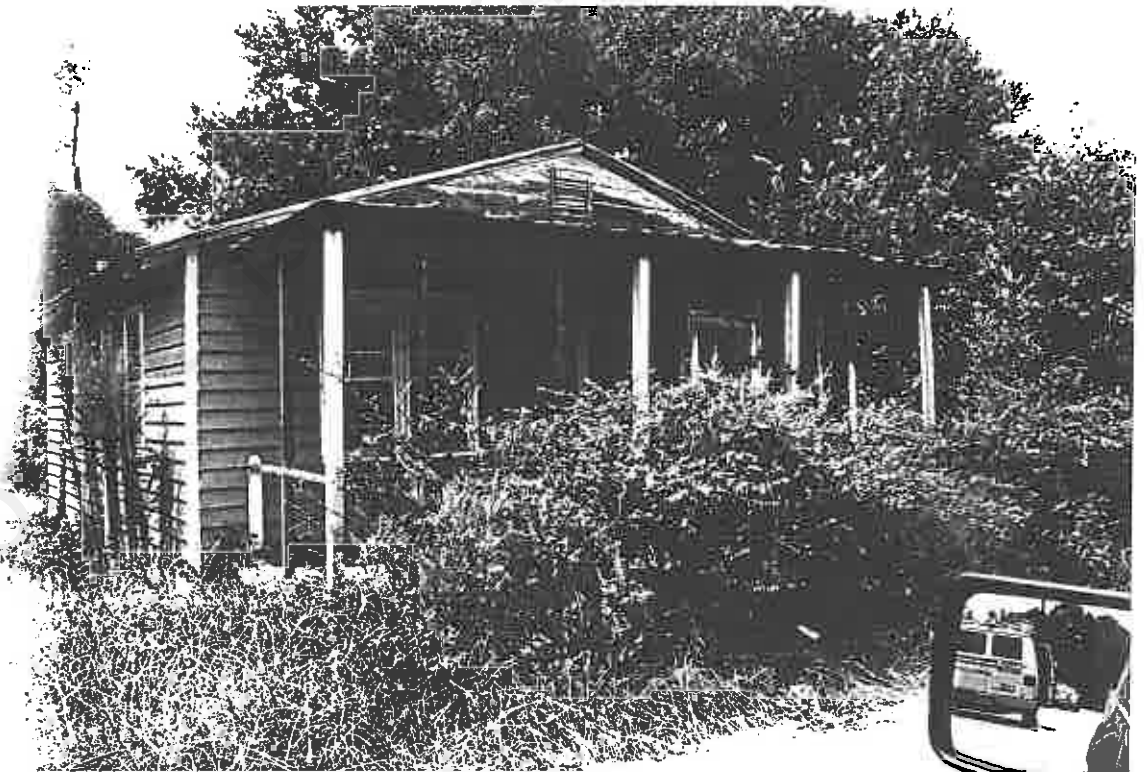
Condition: Poor

Summary: The roof is failing along the ridge, noticeably towards the rear of the structure. The porch roof is very unstable. All of the roofing material is rusting and rot is evident along the undersides of the eaves, fascia, and trim. There is extensive rot on the clapboards. The structure is in Crisis.

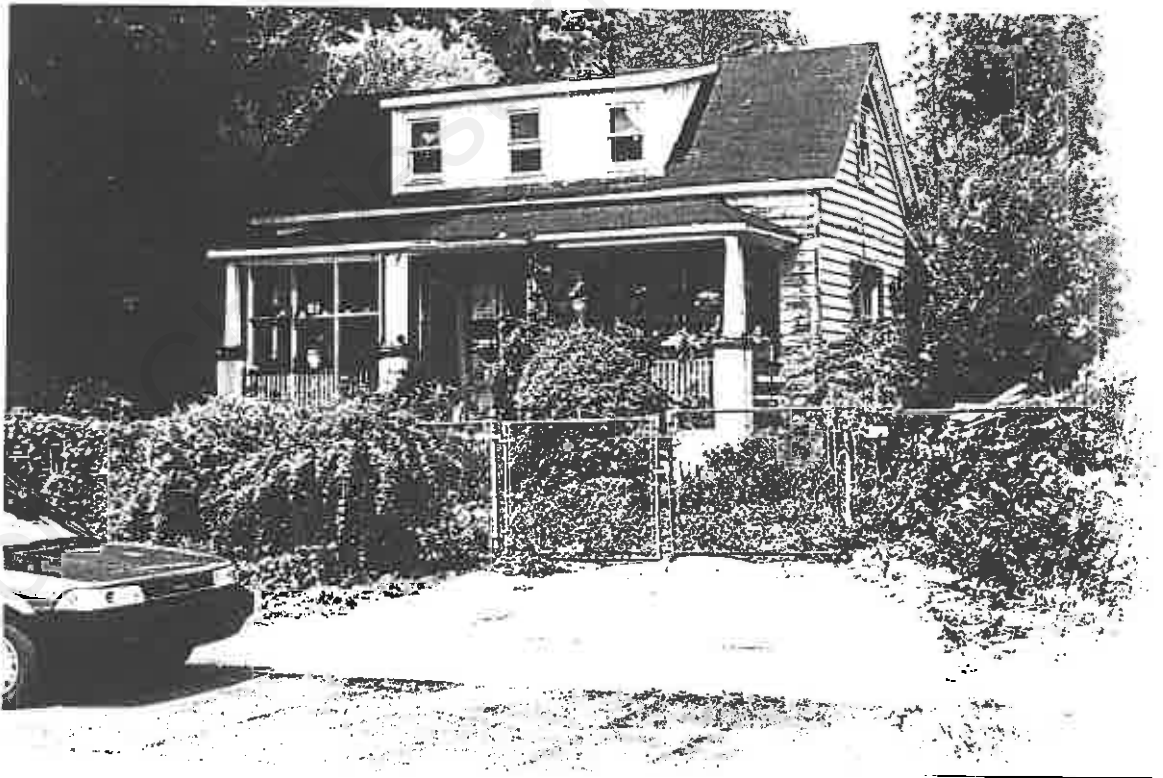
Condition: Fair

Summary: Asphalt shingle appear to be relatively new, but flashing and joints are very poor. Clapboards in poor condition, displaying evidence of rot. Suspect serious water penetration. Excessive organic growth on walls which appears to penetrate roof eaves, window frames, and foundation. Overall the structure is Vulnerable.

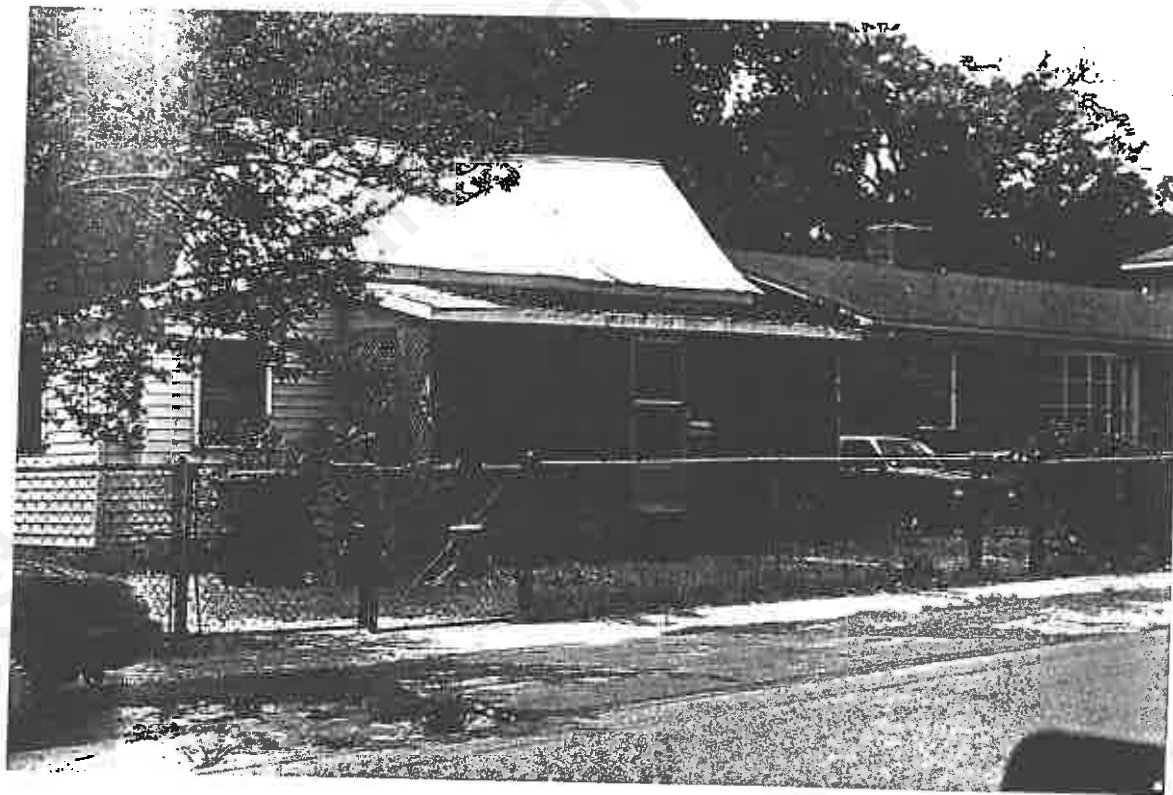
Condition: Poor

Summary: There is severe deflection of the roof. The roofing material of the porch is completely deteriorated. Suspect water penetration. The windows and door are in very poor condition. The structure is sided, but suspect serious rot to be occurring within structure. No sign of maintenance. The structure is at Risk, approaching Crisis.

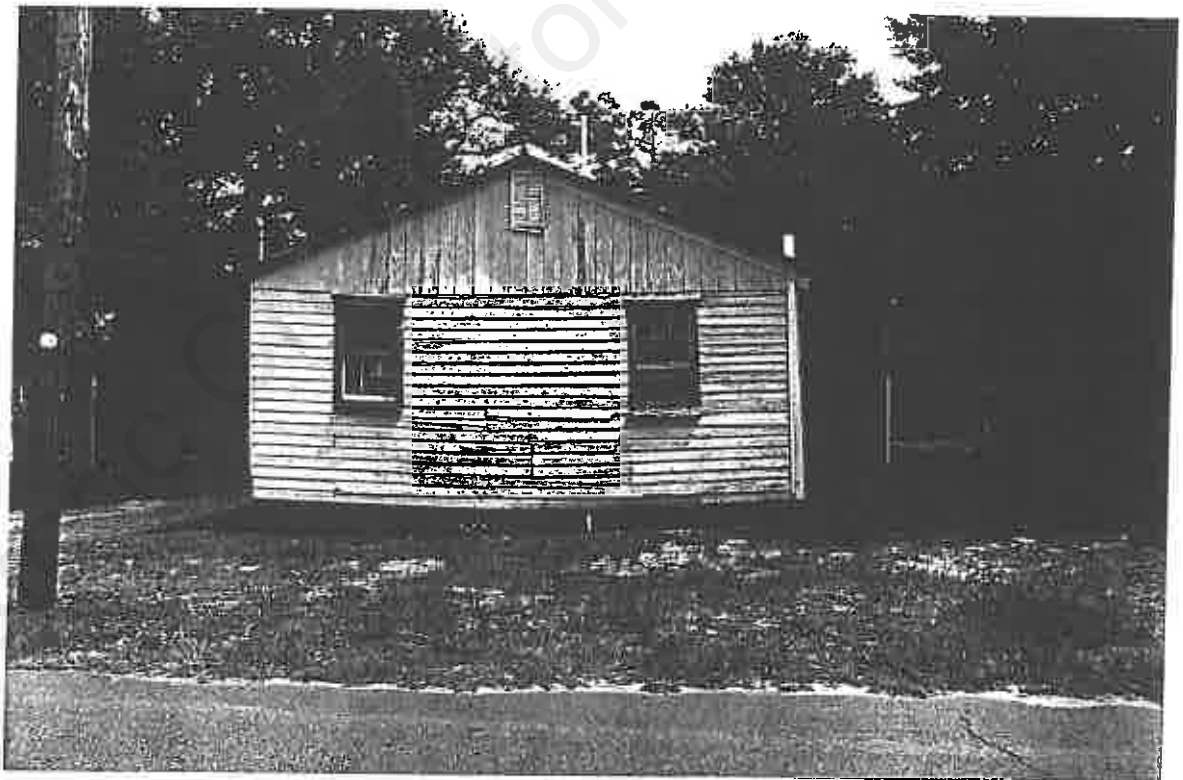
Condition: Poor

Summary: The structure is displaying accelerated settlement. The windows subsequently don't function. The structure appears vacant, but unsure. There is advanced wood rot occurring on the clapboards, windows, and floor plate. The roof is sagging and very near to failing completely. The structure is in Crisis.

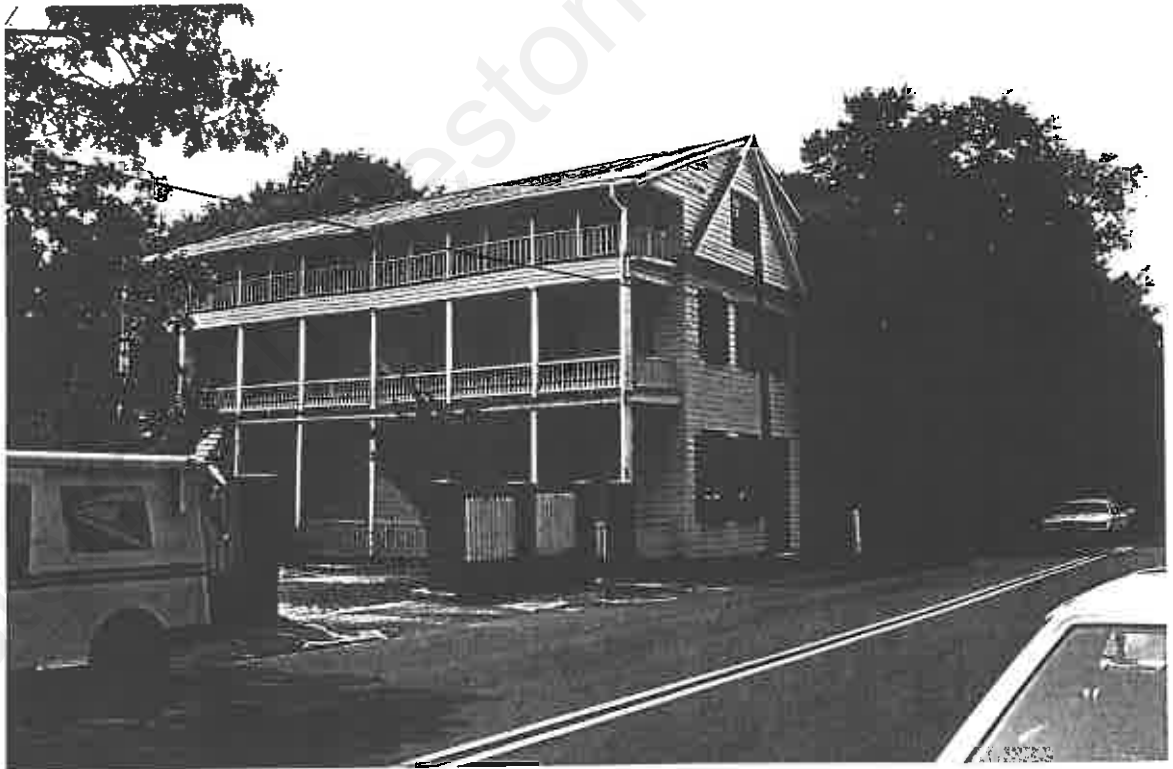
Condition: Fair/Poor

Summary: Structural failure occurring. Note differential settlement concentrated at center. Very noticeable sag at center of porch. Evidence of rotted wood. Extensive rot to clapboards. Roof in poor condition with very crude patches. Suspect water penetration. Building at Risk.

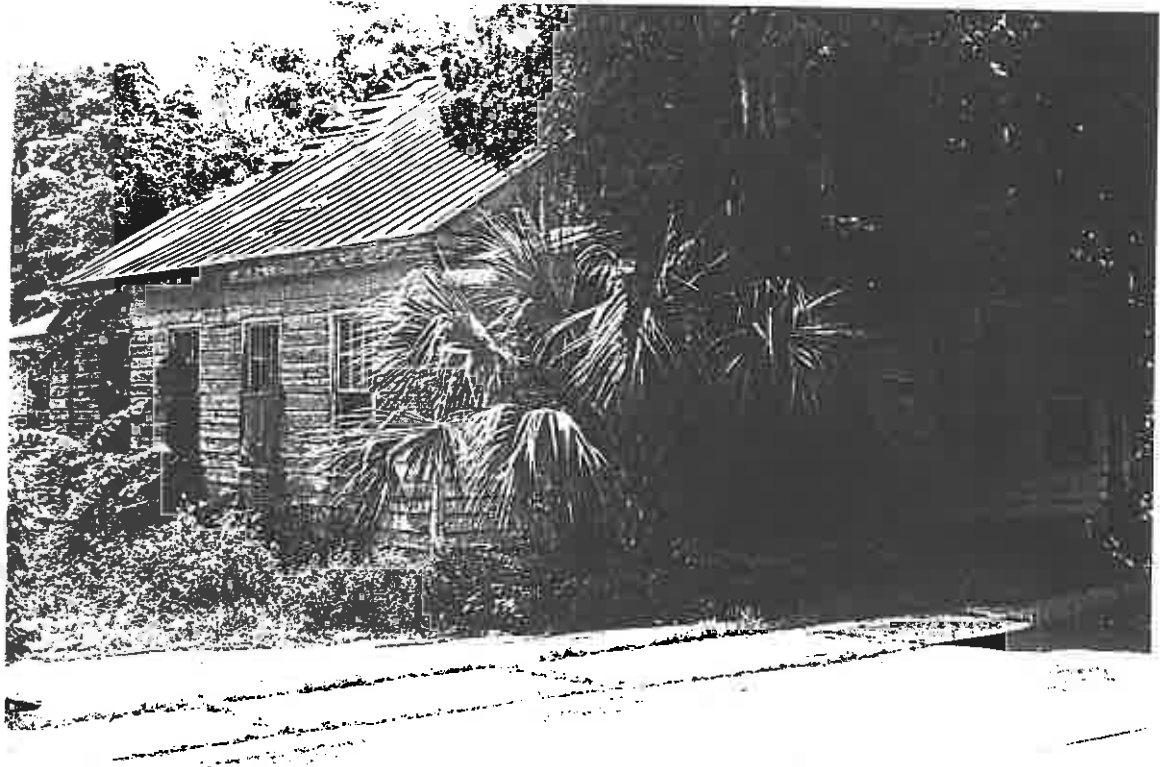
Condition: Very Bad

Summary: This structure is a Crisis, possibly Loss. The roof has failed causing severe interior damage. The eaves are rotted out. All windows have failed and rotted. Organic growth penetrating windows, walls, and the roof. The foundation appears to be beginning to fail, suggests total rot.

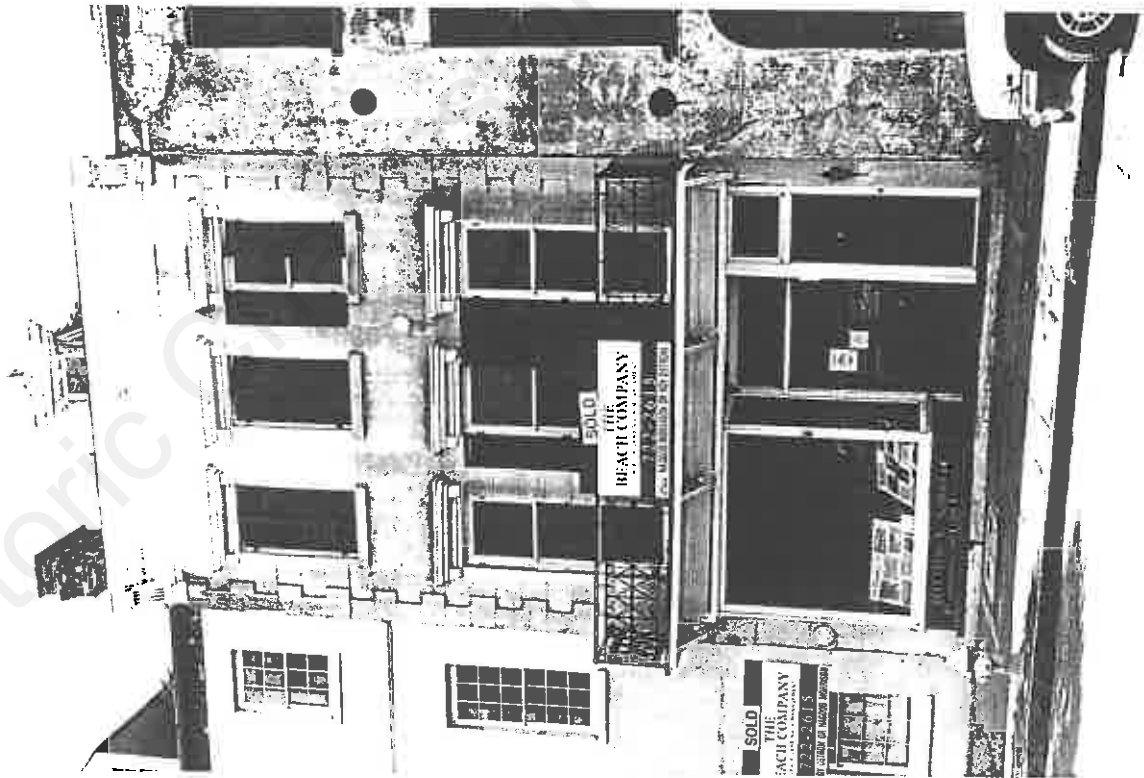
Condition: Fair/Poor

Summary: This structure appears fair on the exterior. But the interior is completely deteriorated on the third and fourth floors. The roof has failed exposing the interior to the weather. The front porch displays some deflection in the middle. The fourth floor dormer is rotted and the window has failed. The structure is vacant. The structure is at risk as is.

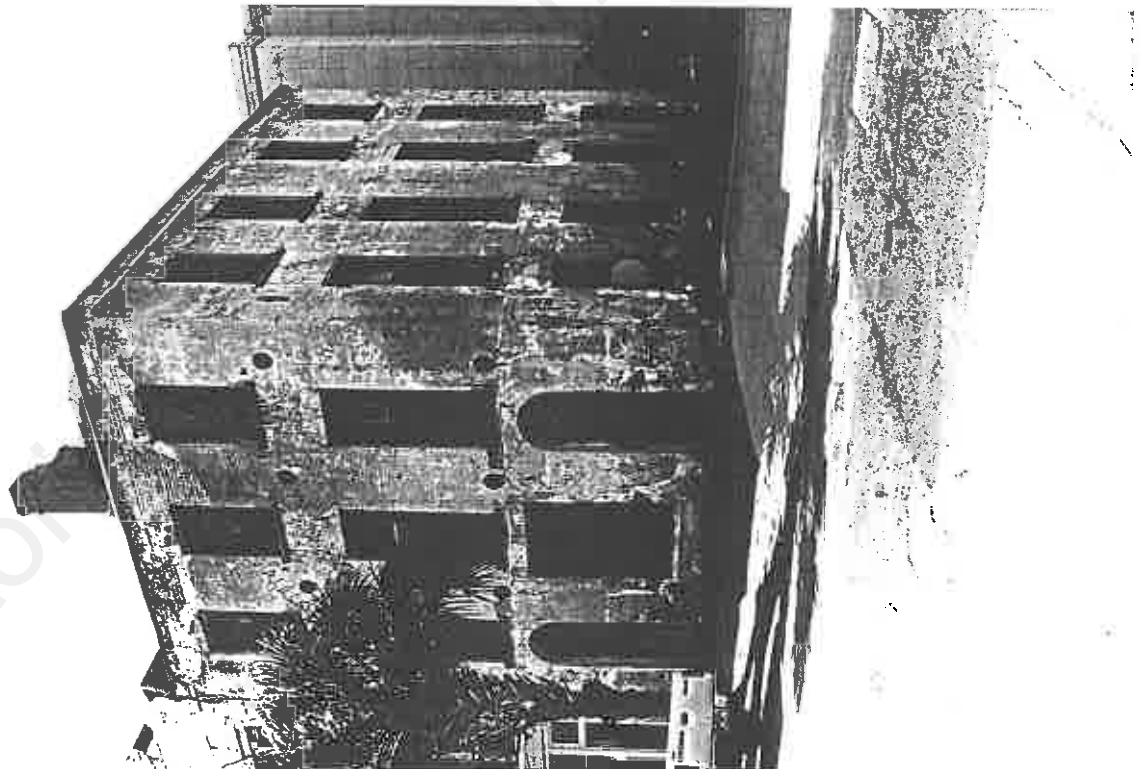
Condition: Poor

Summary: There is a temporary roof on the structure, but evidence of considerable water penetration. The masonry is severely deteriorated under the eaves of the roof and is crumbling off. The window lintels are cracking, spalling, and sagging. The windows and doors are rotted and no longer functional. The building is vacant and as is it is in Crisis.

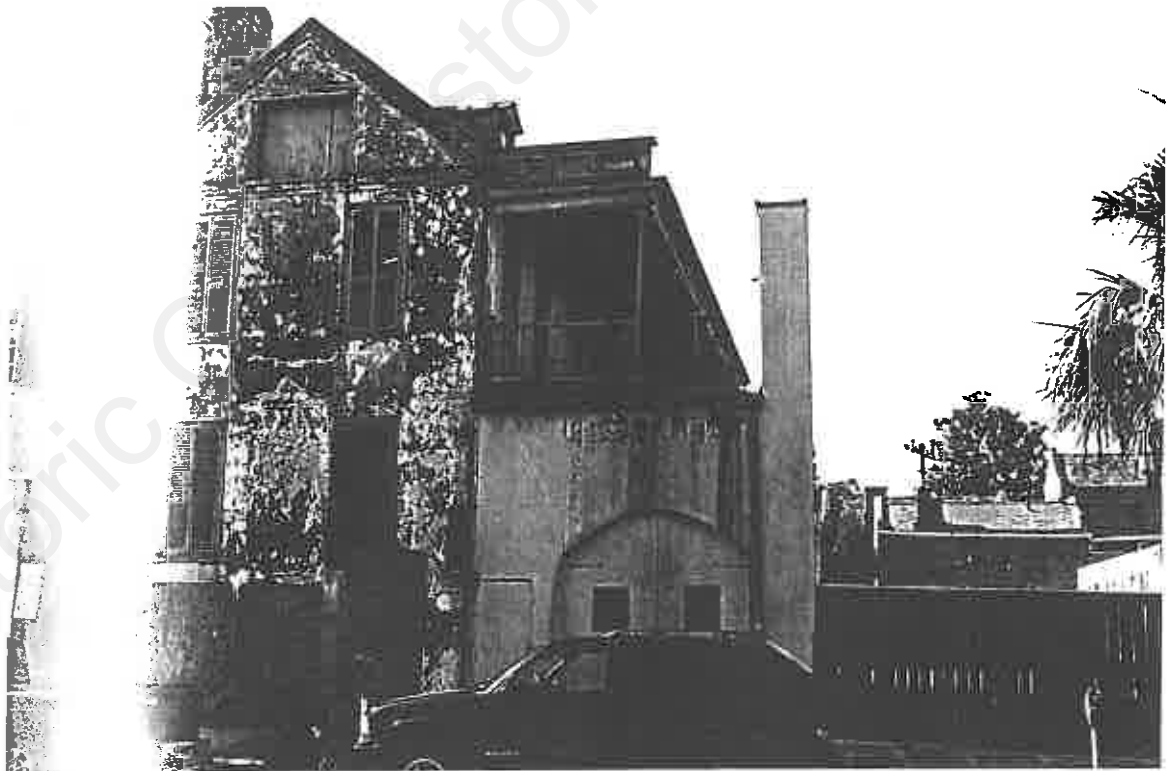
Condition: Very Bad

Summary: The roof has failed completely and the interior is exposed to direct water and weather. There are cracks in the masonry above the doors and windows suggestive of differential settlement. All remaining wood displays advanced rot. The windows and doors are missing. The structure has a section demolished and is threatened by the courthouse construction. The structure is in Crisis, approaching Loss.

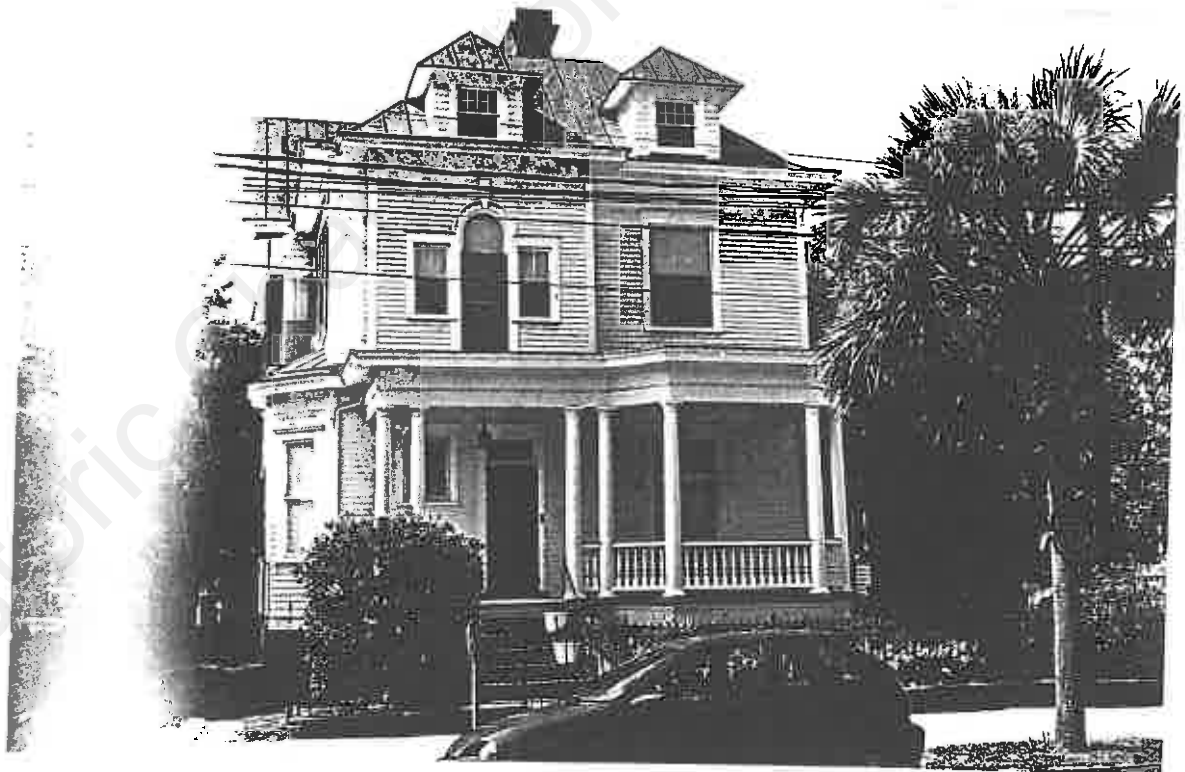
Condition: Fair

Summary: Over all the structure is in fair condition, but close examination reveals that the rot visible under the eaves of the roof is very deep and probably effecting the joists and roof plate. The roof in fair to poor condition, and overall maintenance appears to be low. The structure is Vulnerable.

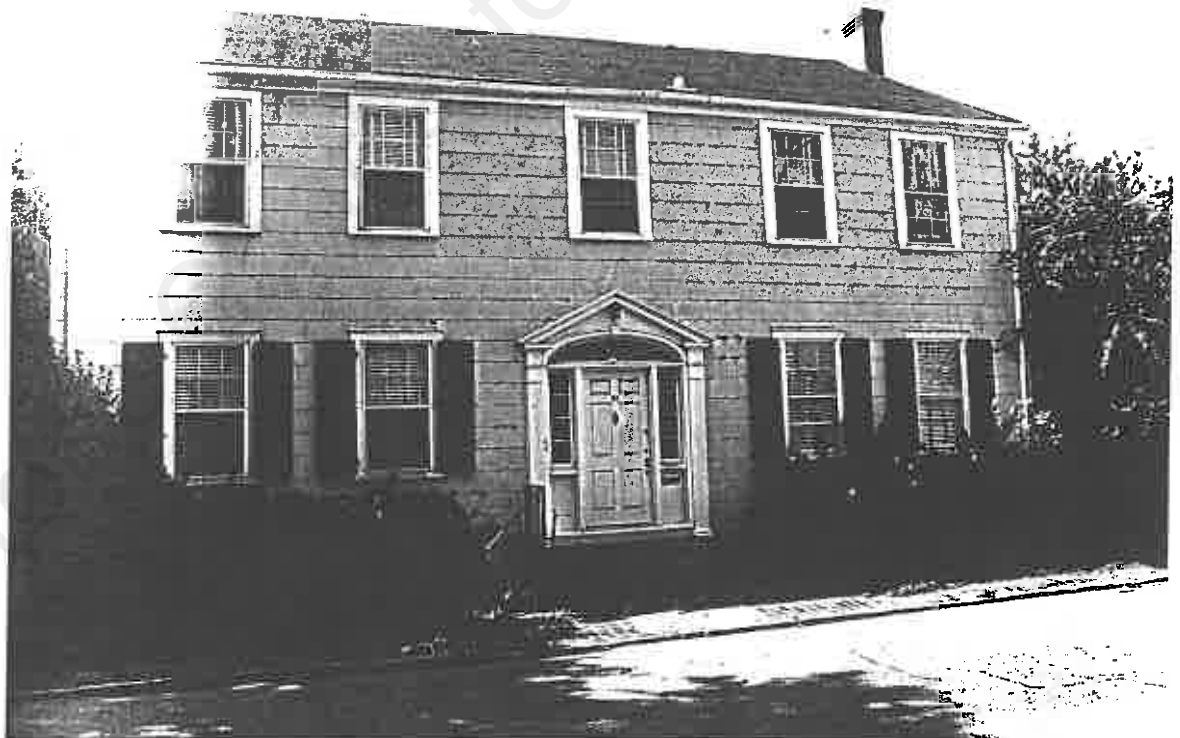
Condition: Fair

Summary: There is slight deflection on along the roof line, and overall the roof is in poor condition. The gutters have failed, and the shingle condition is poor. Inspection suggests possibility of internal dry rot within the walls. The windows are in poor condition and the lintel are rotten. There is iron railing missing, and excessive biological growth penetrating the shingle and roof. The basement ventilation is blocked up. Overall the structure is Vulnerable.

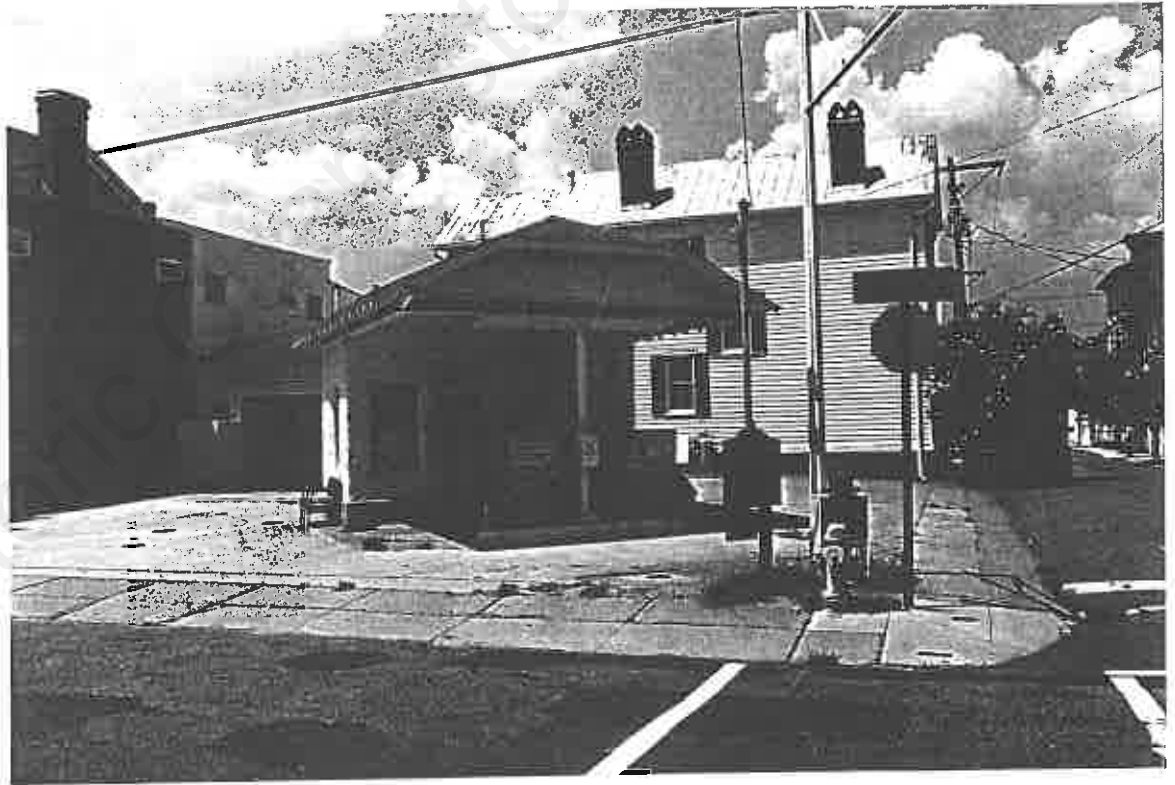
Condition: Good

Summary: This property is under serious threat of development due to poor revenues as a gas station. Plans and proposals for the demolition and construction of apartments have been submitted. The lot is a double lot and can create higher income as apartments. The structure is in good condition with a very sound roof, no signs of rot or deterioration, and in working condition.

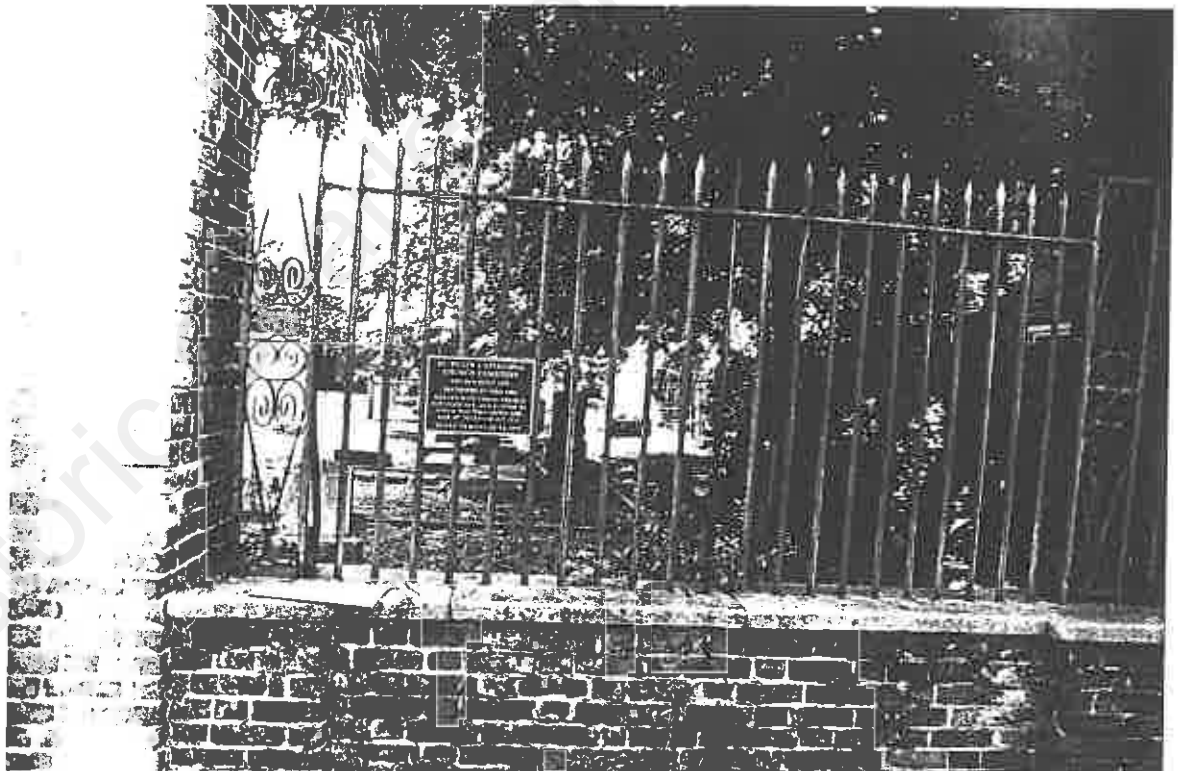
Condition: Fair/Poor

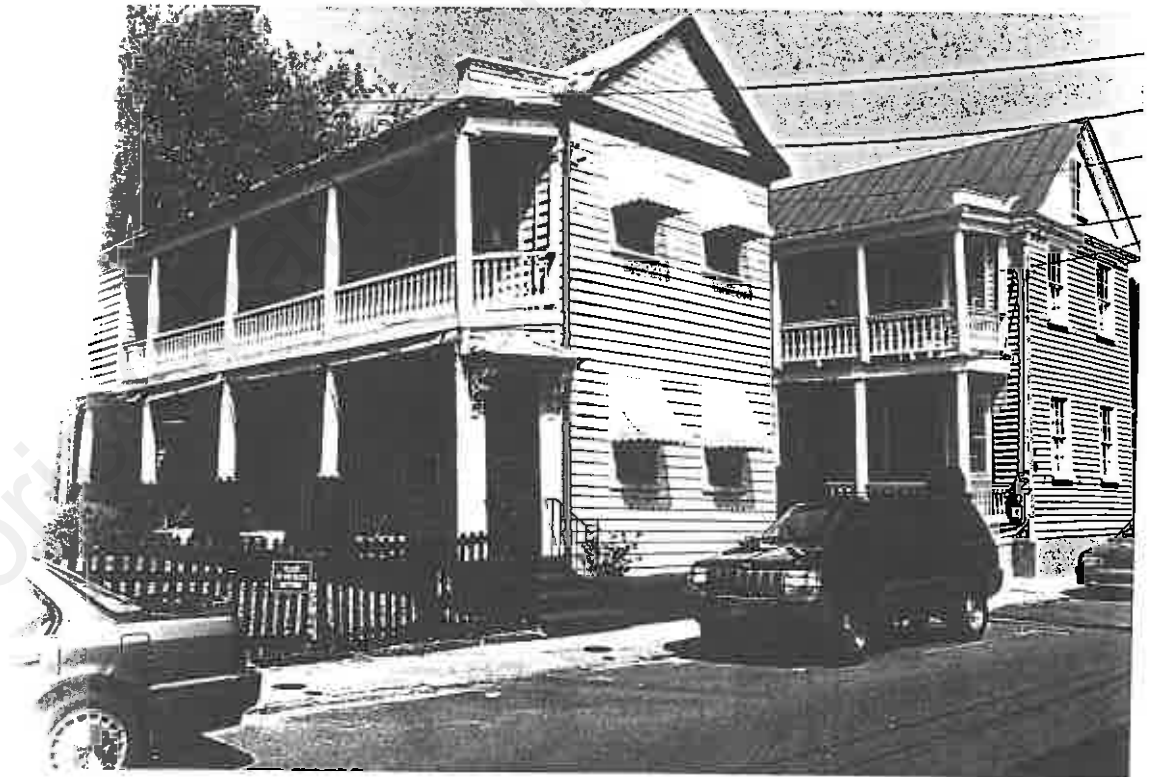
Condition: Poor

Summary: There is a new asphalt roof, but the eaves of the roof are rotted and joists are exposed. There is advanced deflection on the porches. The clapboards are in poor condition with evidence of rot occurring in isolated section and primarily on the porch, door, and details. There is noticeable differential settlement. Overall the structure is Vulnerable

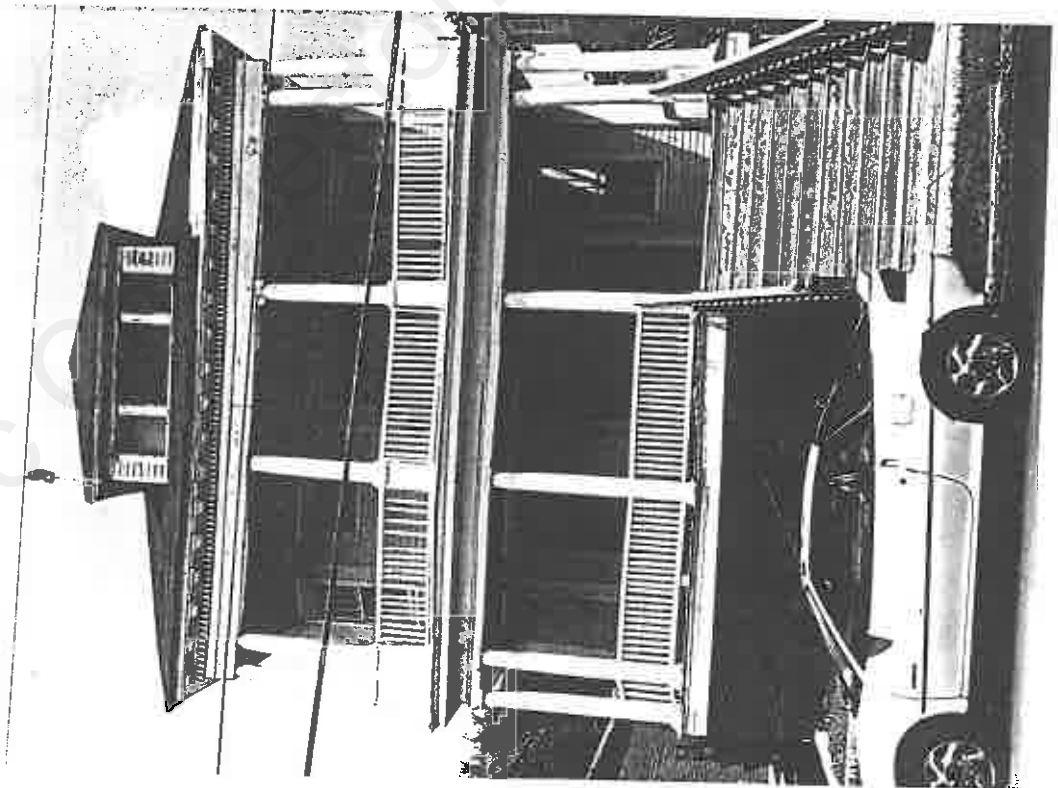
Condition: Poor

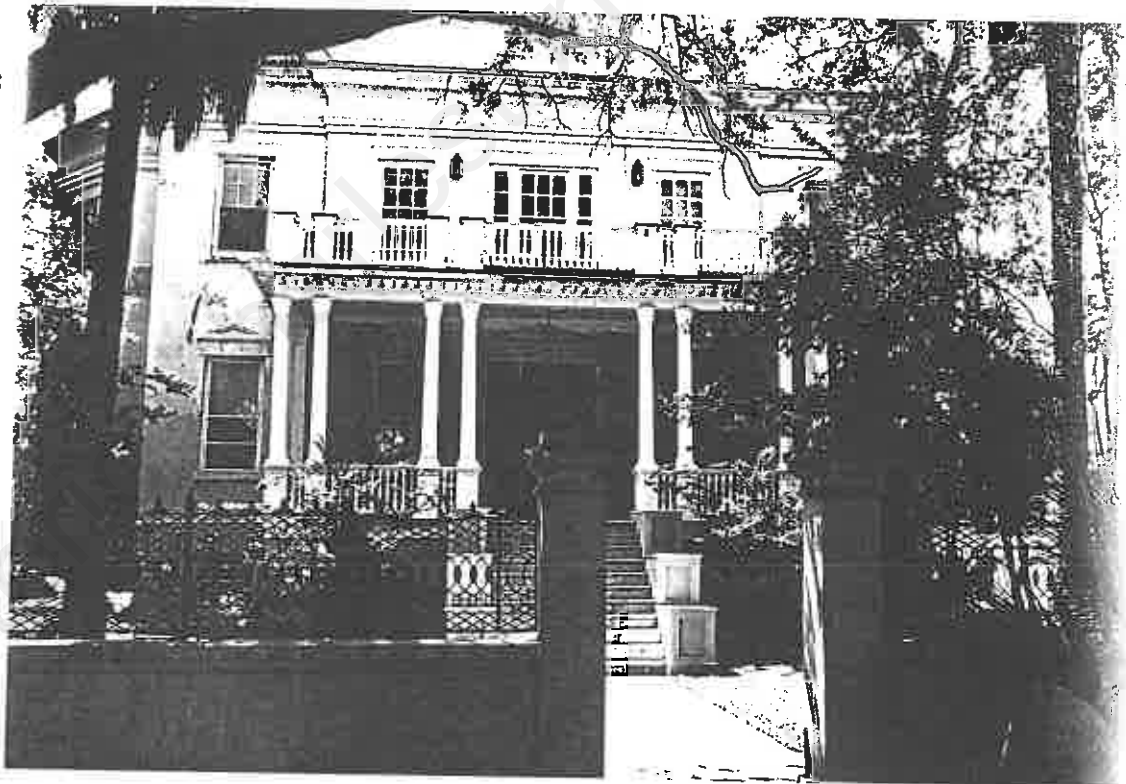
Condition: Fair/Poor

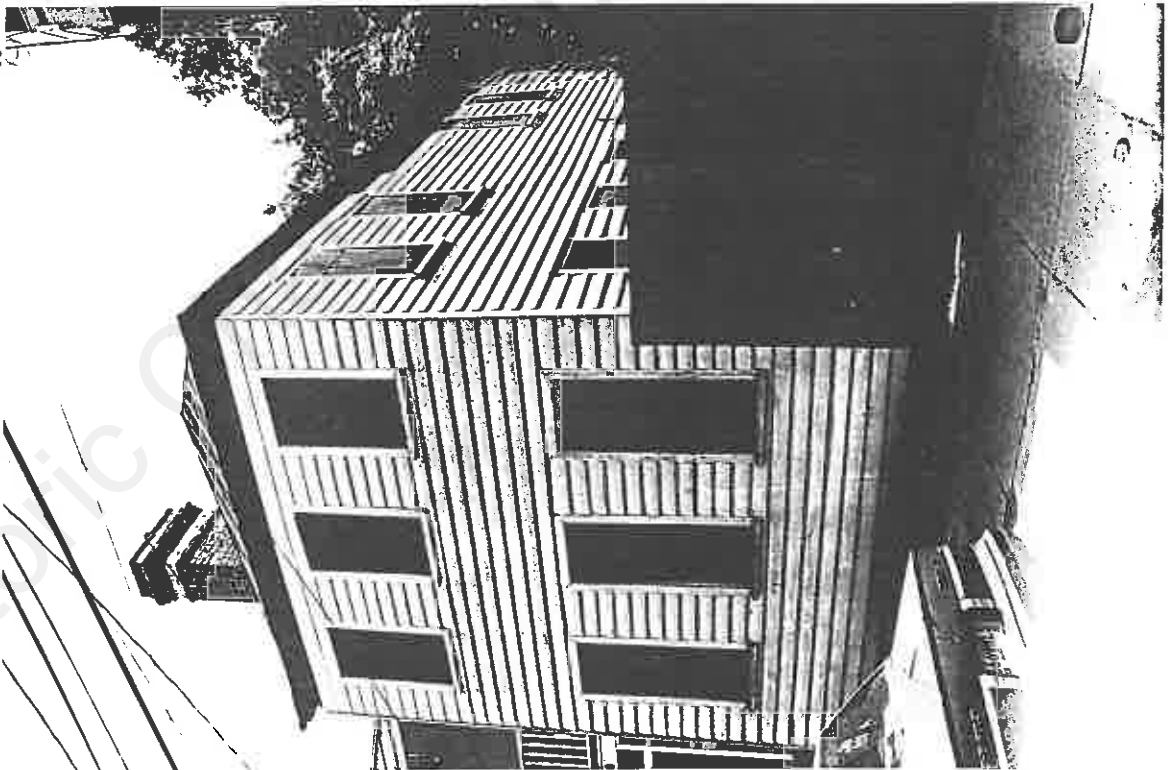
Condition: Poor
