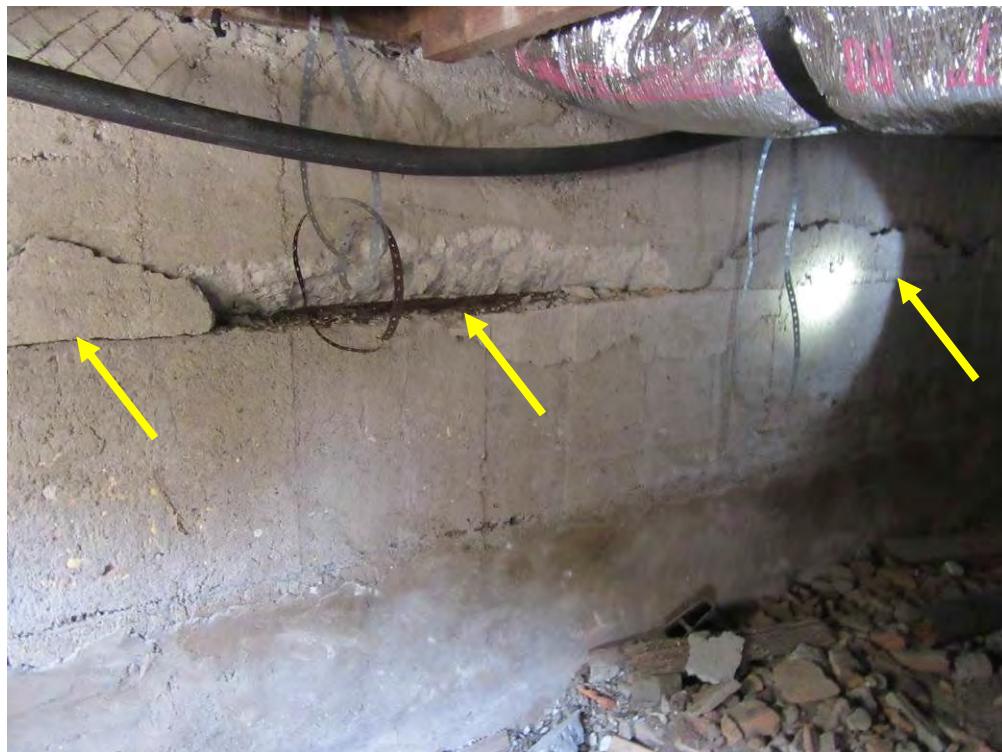
Photo 2: Typical horizontal crack caused by rebar corrosion at an interior foundation wall. The corroded rebar is visible at the center of the photo.

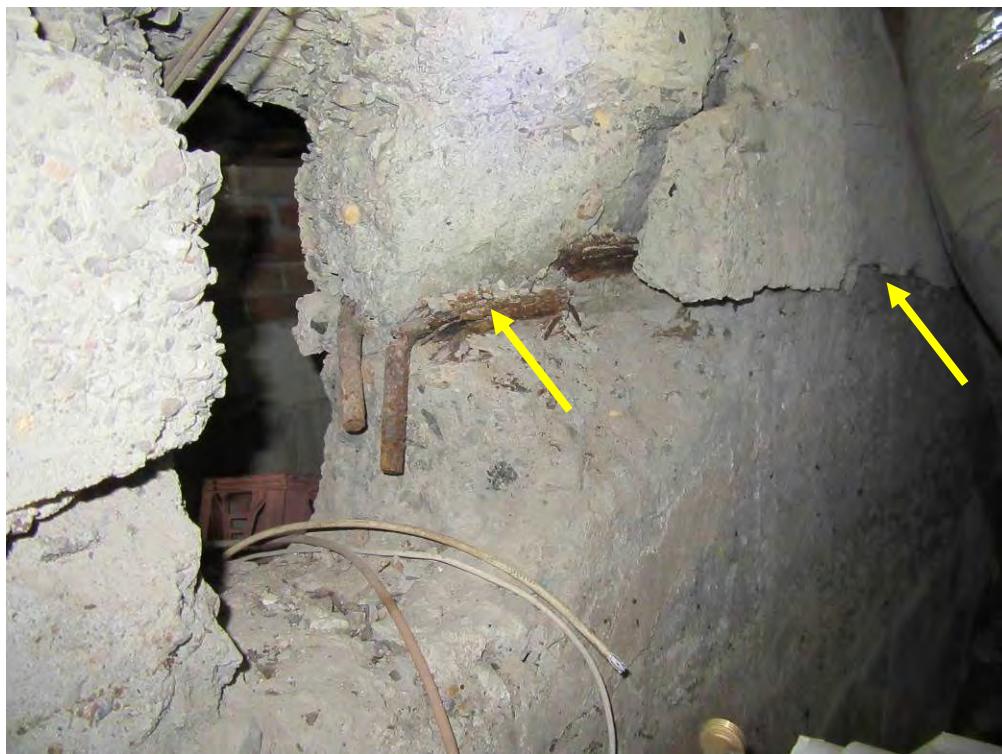
Photo 3: Opening through an interior foundation wall. The horizontal rebar is visible at the spalled concrete and horizontal crack.

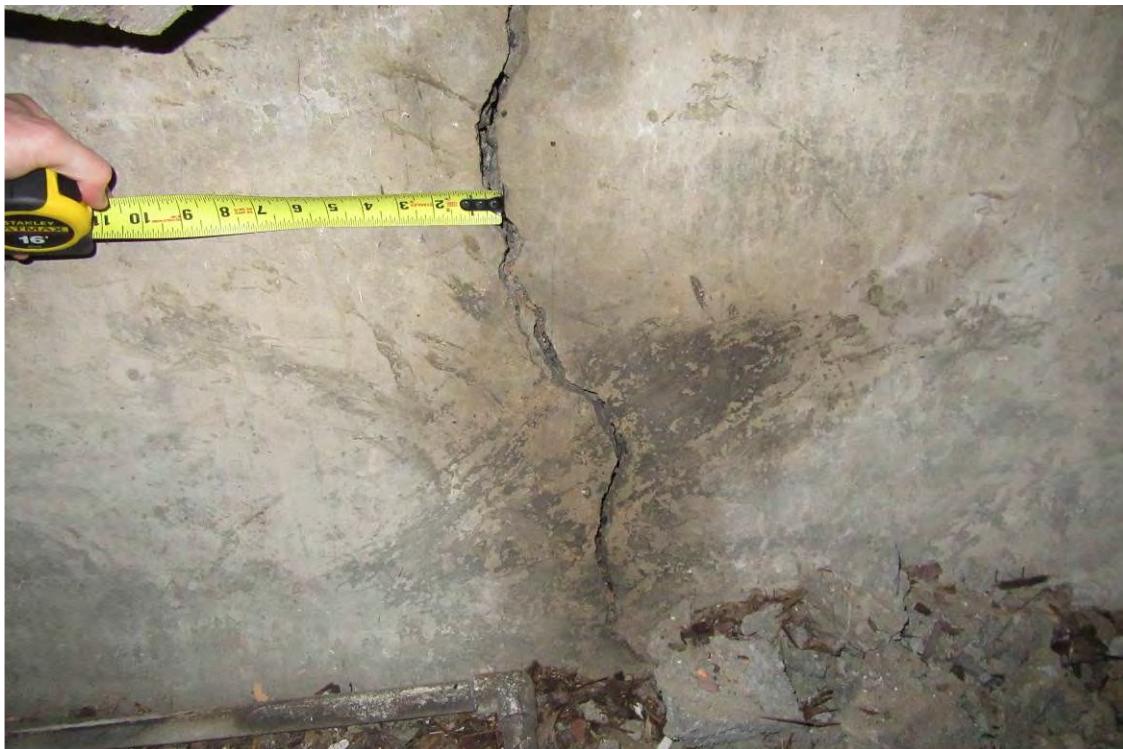
Photo 4: Vertical through-wall crack in the west exterior foundation wall below Unit 1.

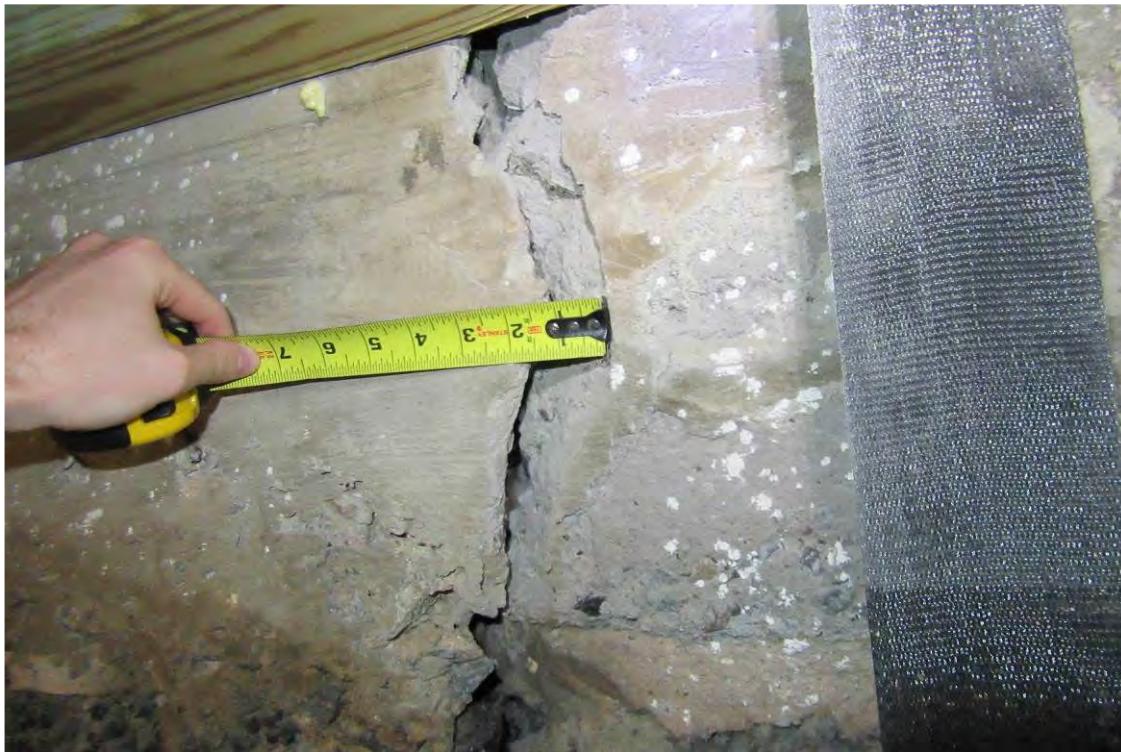
Photo 5: Through-wall crack in the south exterior foundation wall below Unit 1.

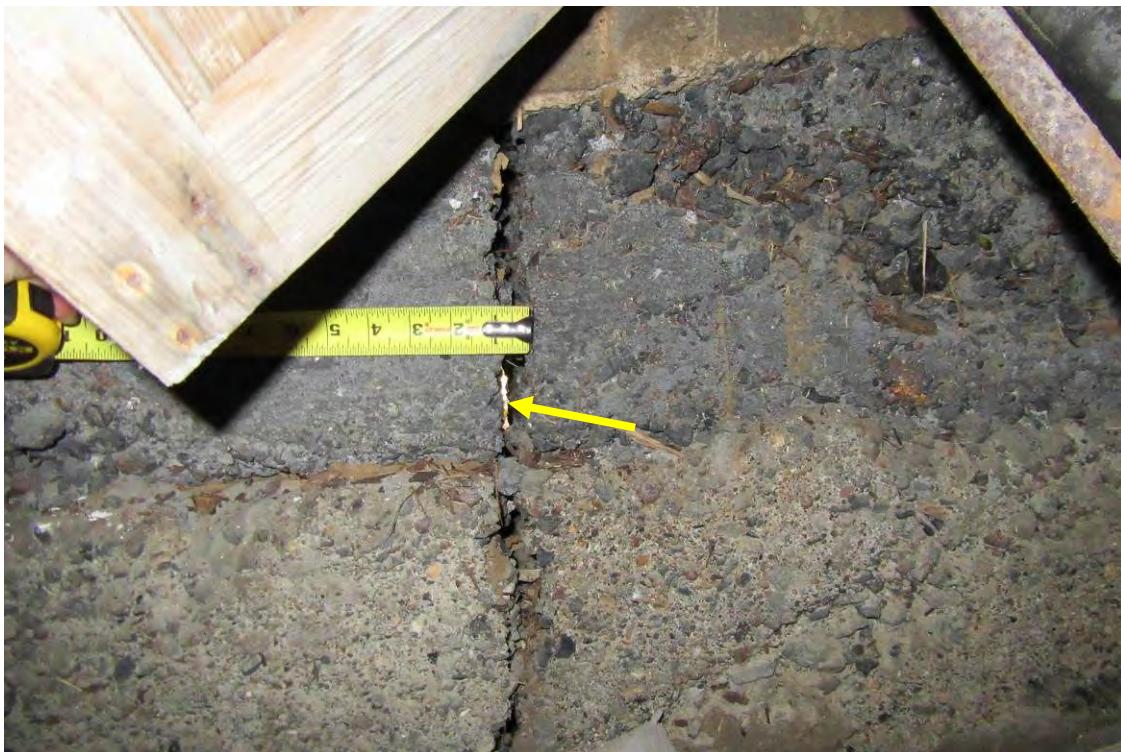
Photo 6: Through-wall crack in the east exterior foundation all below unit 1. Daylight can be seen through the crack (arrow).

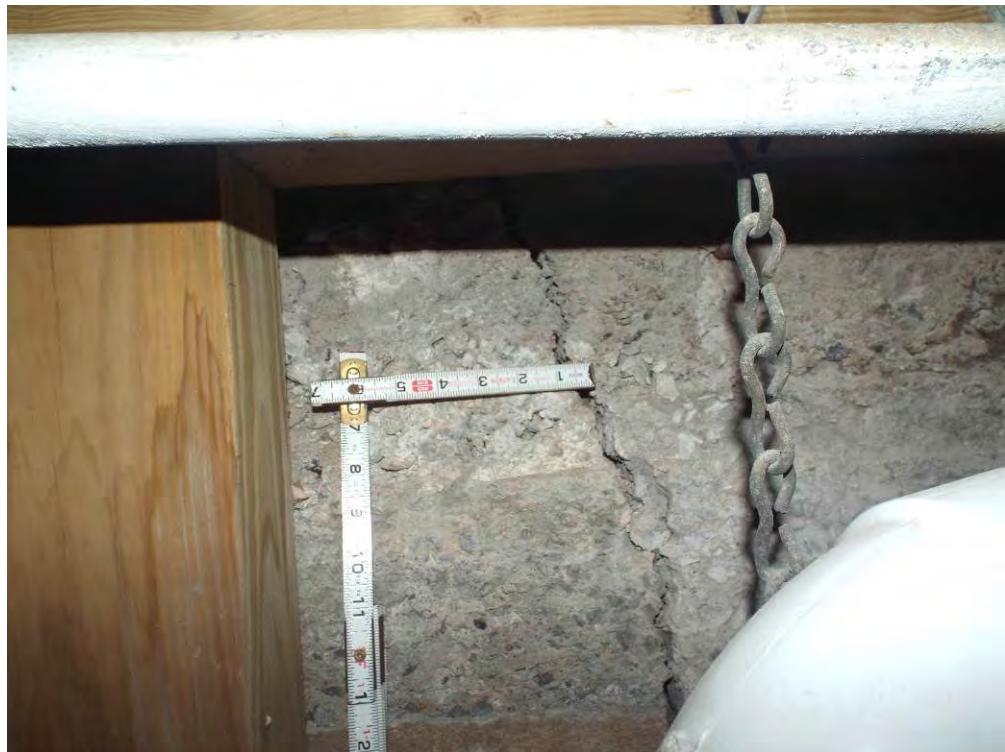
Photo 7: Through-wall crack in the north exterior foundation wall below Unit 11.

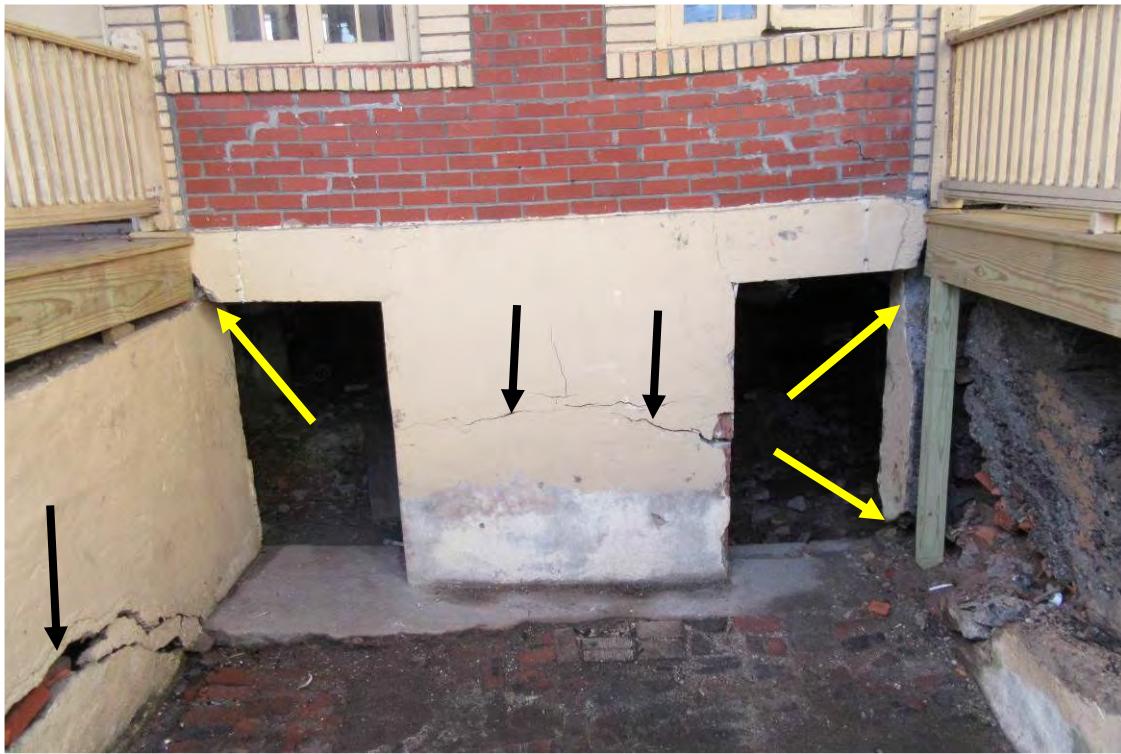
Photo 8: Foundation wall segment between Units 5 and 7. Note the horizontal crack in the foundation wall; the large fracture in the foundation wall to the right of the rightmost access door adjacent to the concrete stoop; the spalled concrete above the leftmost access door, and the large crack in the concrete knee wall on the left of the photo.

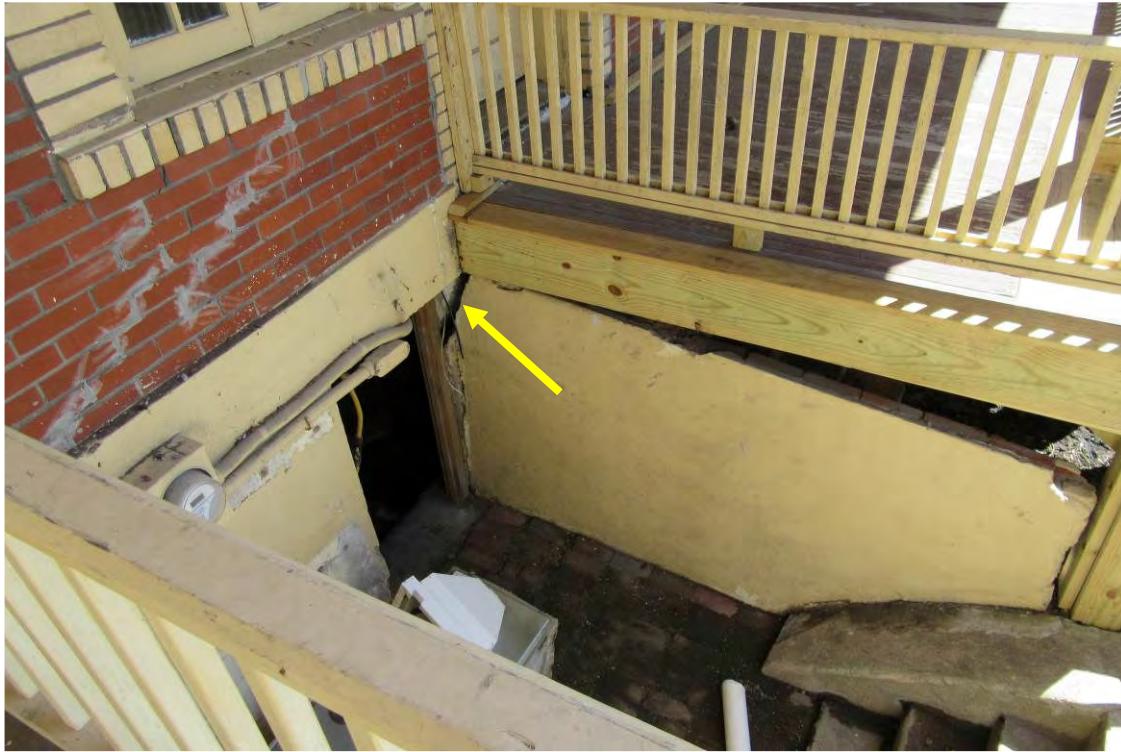
Photo 9: Concrete wall segment between units 9 and 11. Note the typical foundation wall fracture at the adjacent knee wall (arrow).

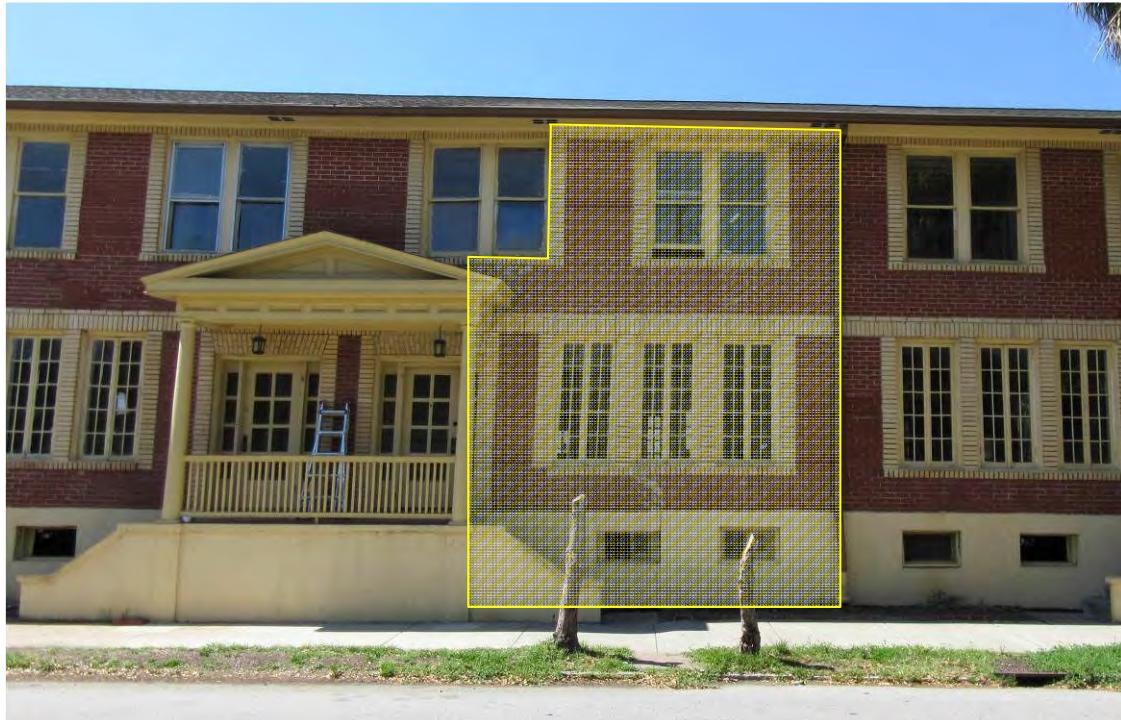
Photo 10: Front elevation of unit 7. The hatched wall section will need to be removed and rebuilt.

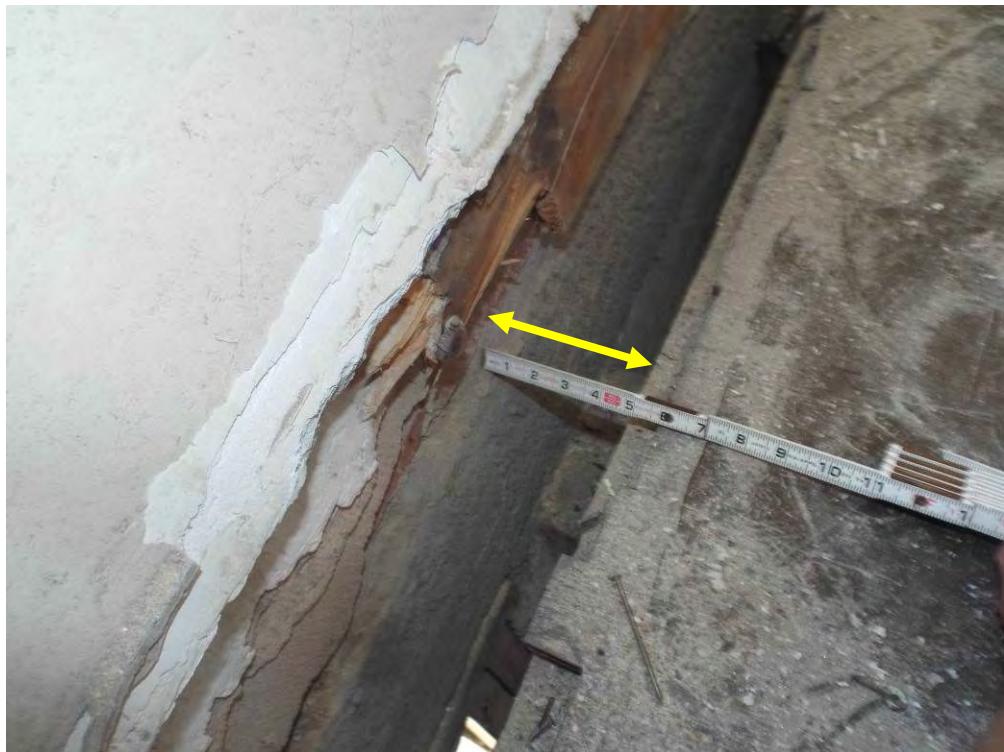
Photo 11: Unit 7 – The exterior wall has pulled approximately 5 inches away from the first floor framing in this location (arrow). The floor support girder below is at risk of losing support if the wall shifts closer to the street.

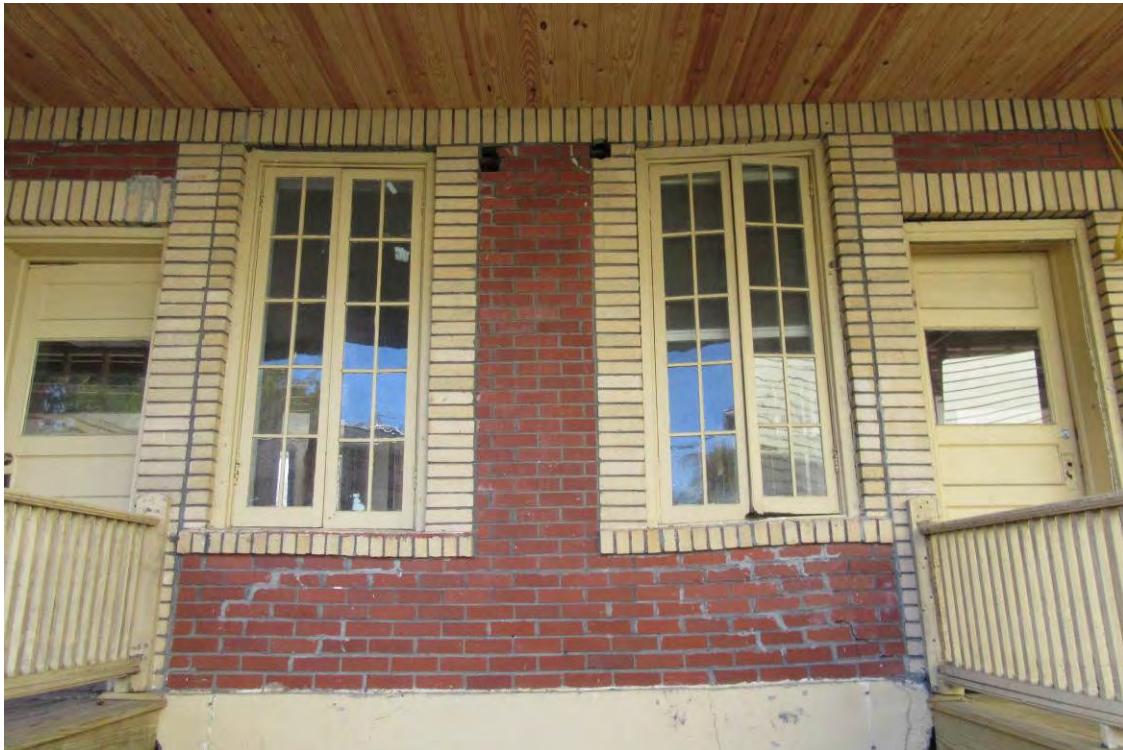
Photo 12: Rear wall section between units 5 and 7. Foundation damage below this wall (see photo 8) will require the wall to be removed and rebuilt up to the roof.

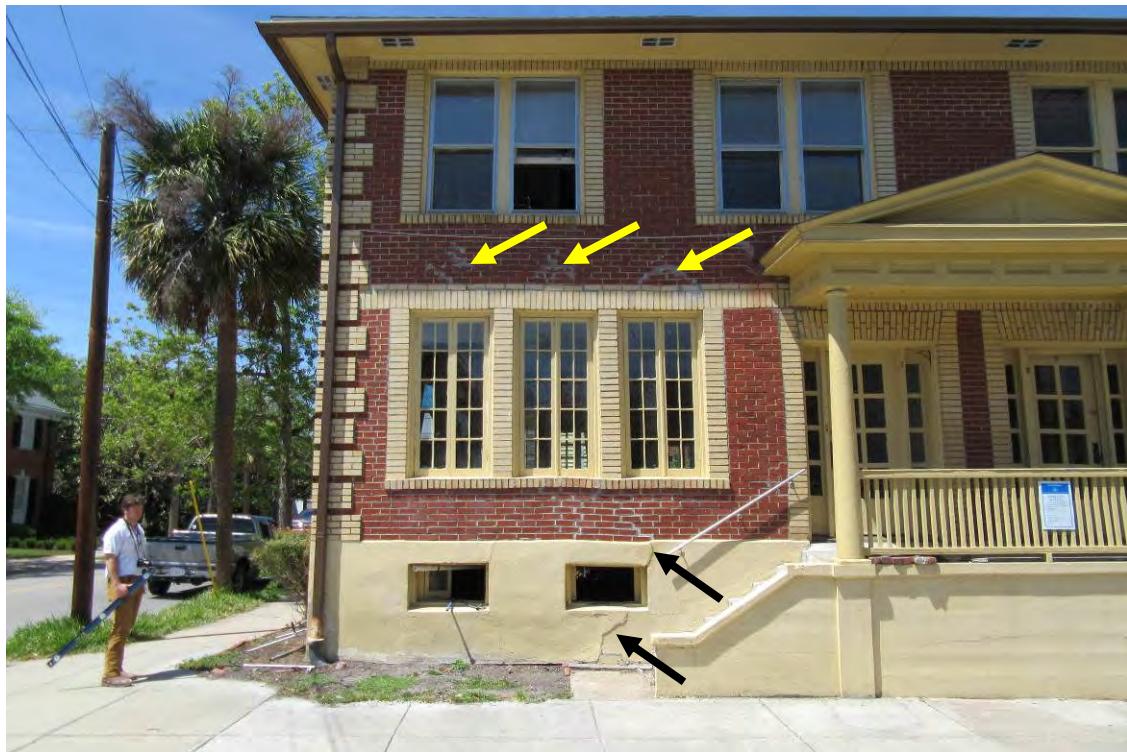
Photo 13: Front elevation of Unit 1. Note the typical cracks above the failing window headers. Note the through wall foundation crack and header failure above the crawl space vent.

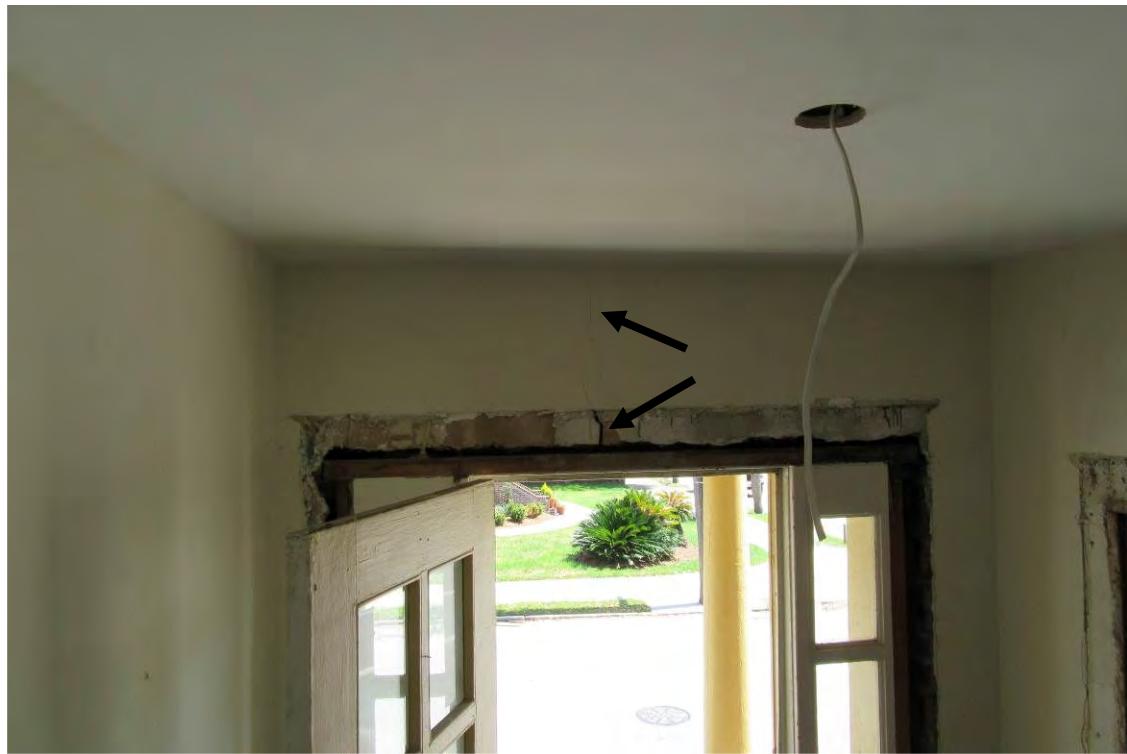
Photo 14: Crack in the HCT load-bearing wall header above a front door (arrow).

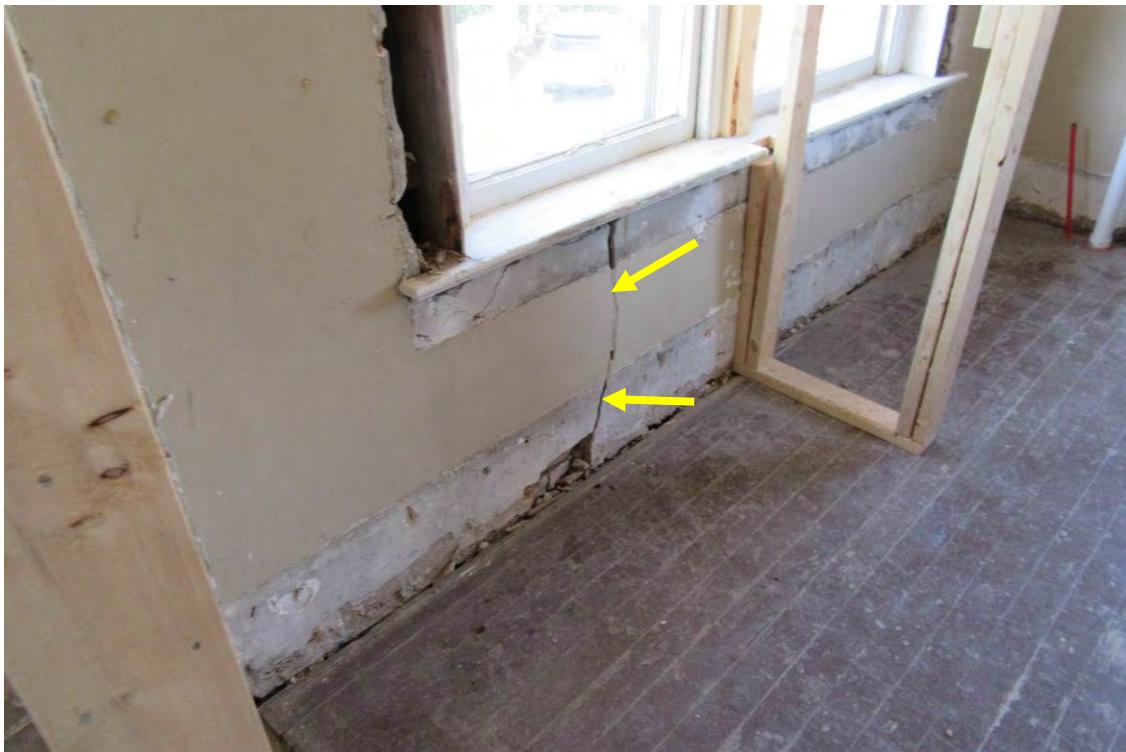
Photo 15: Typical crack in a second floor HCT wall due to a window header failure below.

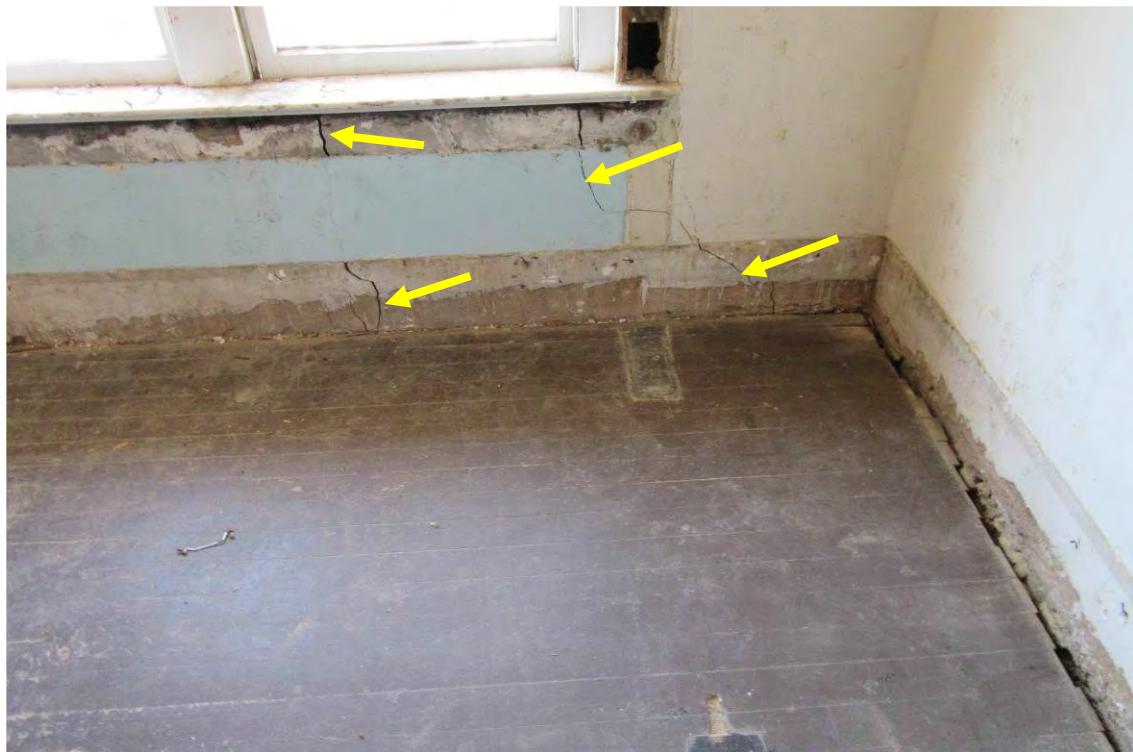
Photo 16: Typical crack in a second floor HCT wall due to a window header failure below.

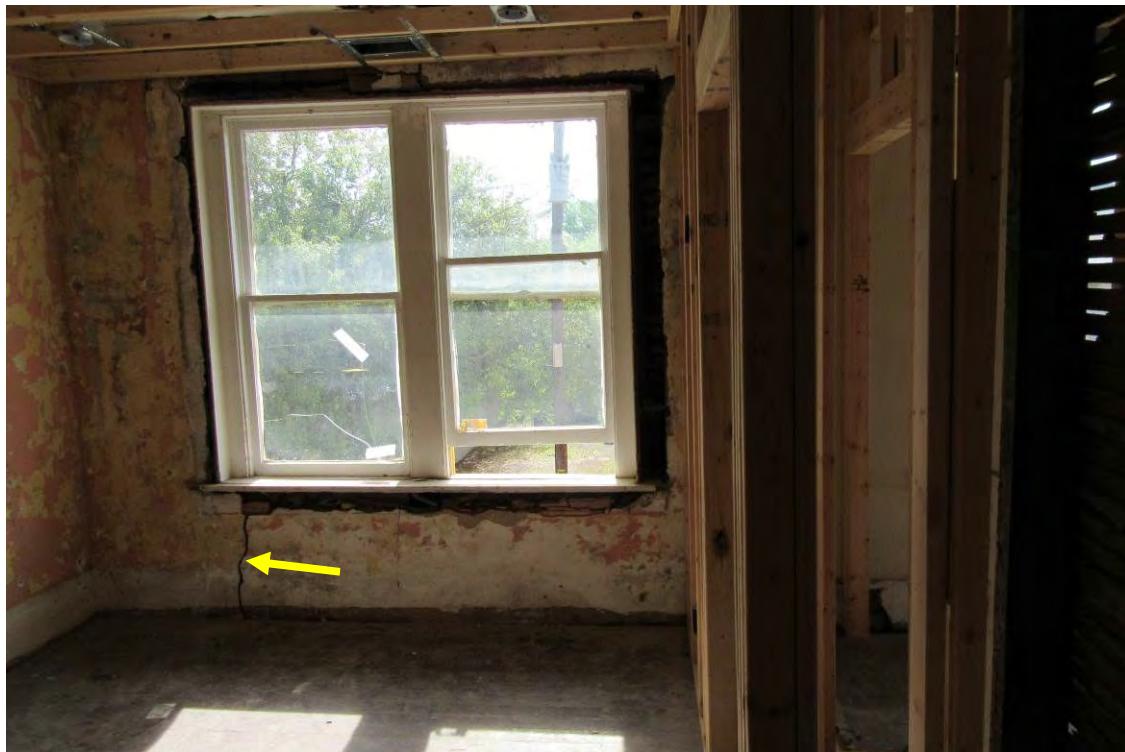
Photo 17: Typical crack in a second floor HCT wall due to a window header failure below.

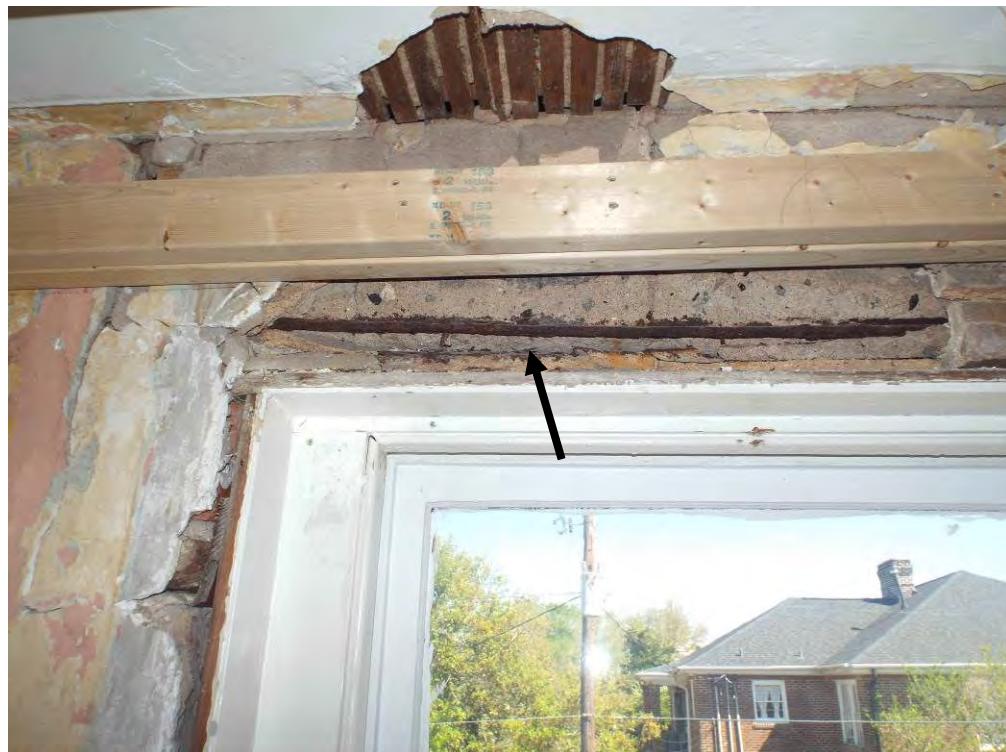
Photo 18: A reinforced masonry header was observed in one location. The rebar was exposed, corroded, and section loss was observed (arrow).

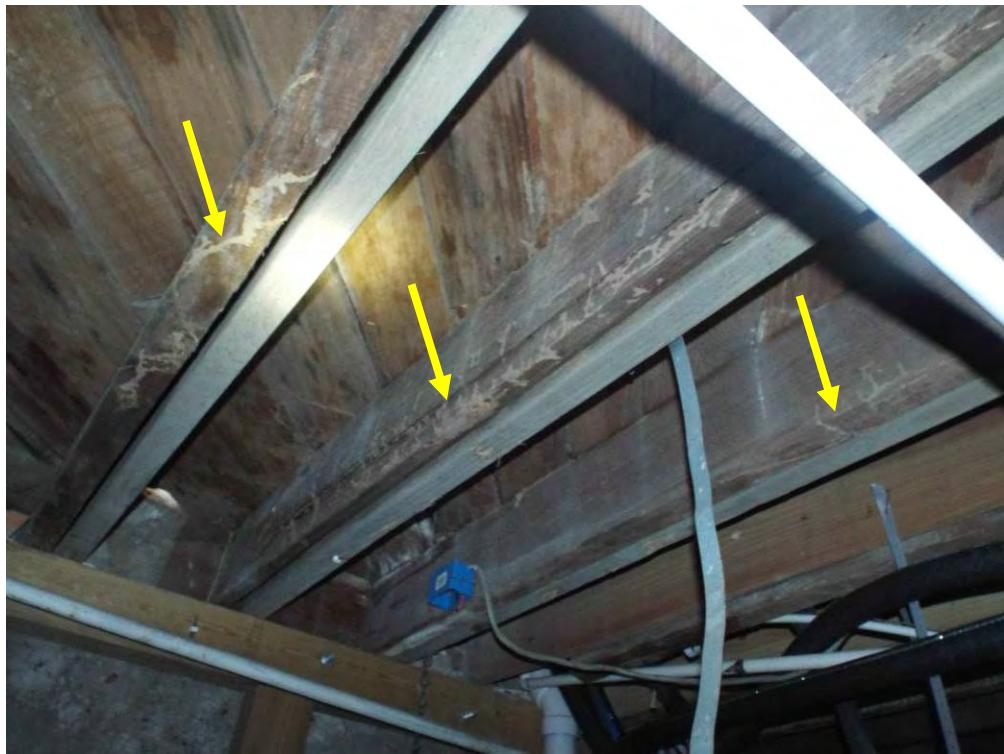
Photo 19: Evidence of termite infestation and damage was observed in some locations. Termite tubes are visible on three floor joists in this photo (arrows). Note the recent addition of a bolted ledger and post in the background, presumably repairs to damaged joists in this location.

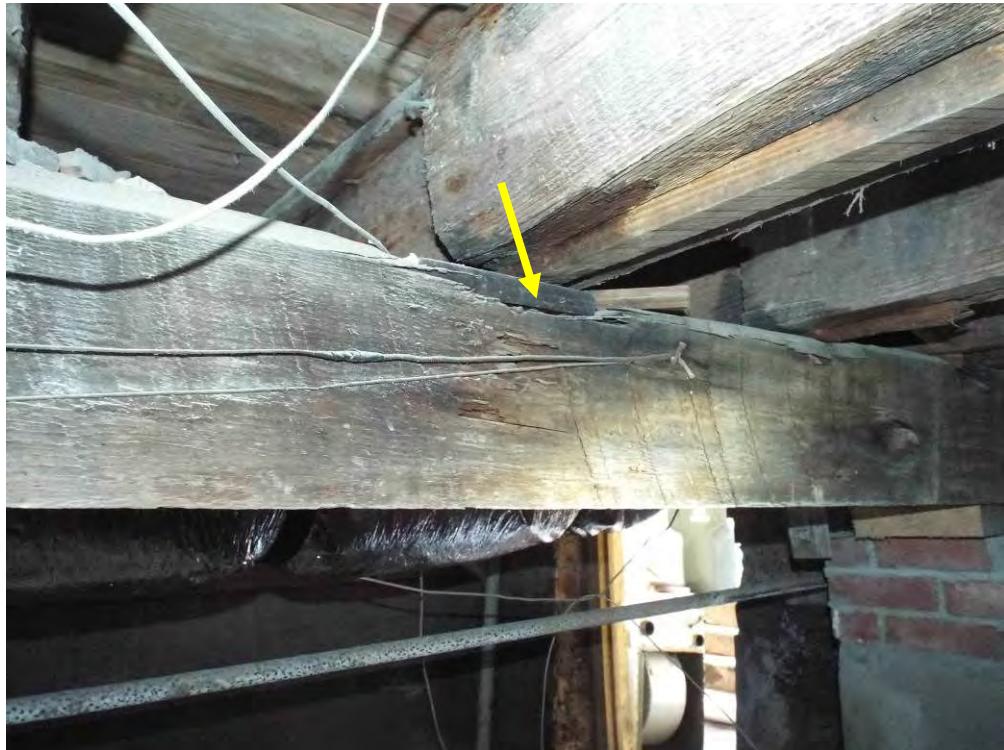
Photo 20: Typical example of moisture and possible insect related damage to a first floor drop girder (arrow).

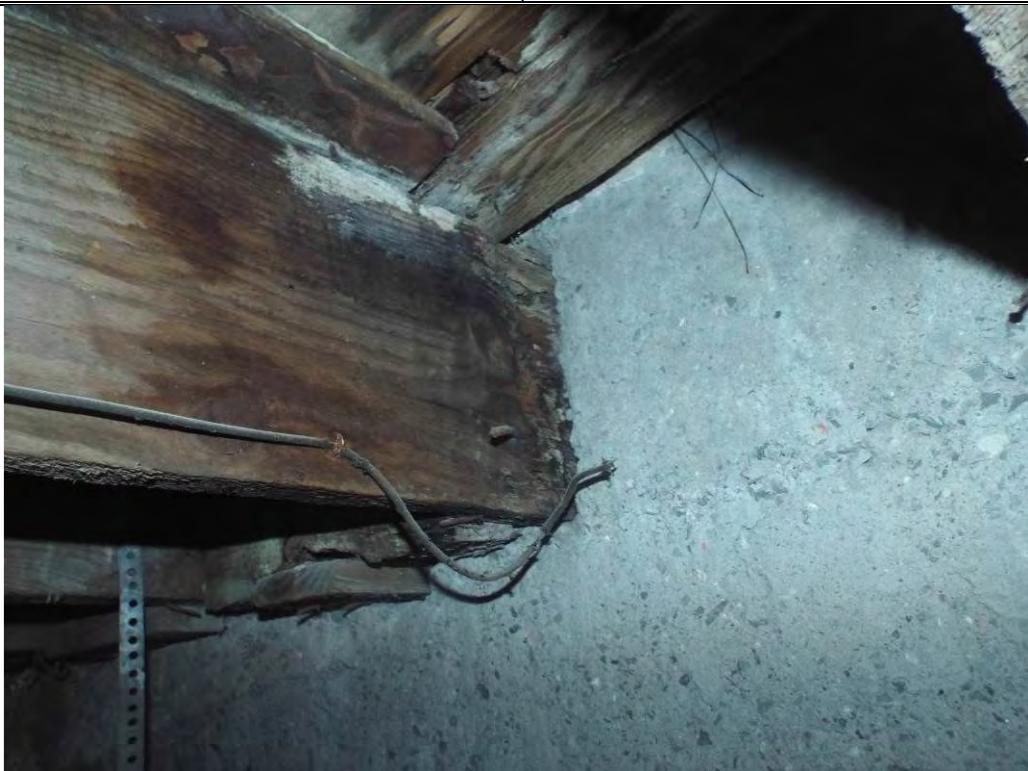
Photo 21: Typical example of moisture damage where a floor joist is embedded into the concrete foundation wall.

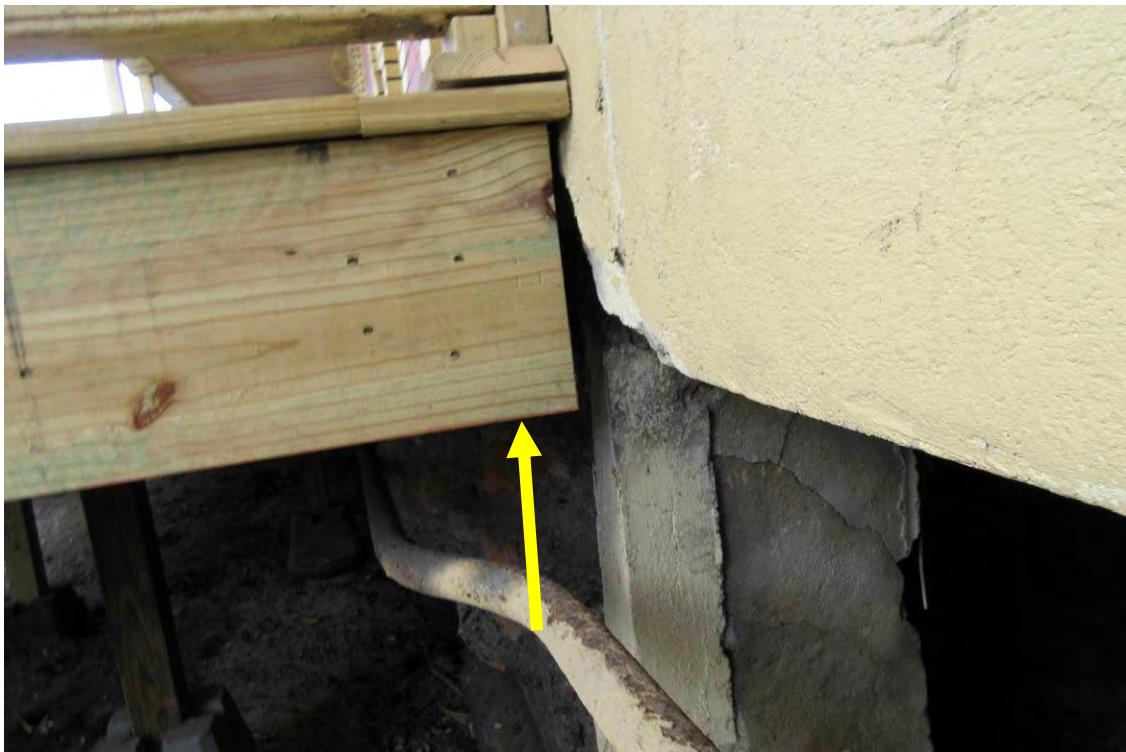
Photo 23: No support was provided for the deck band beam in this location.

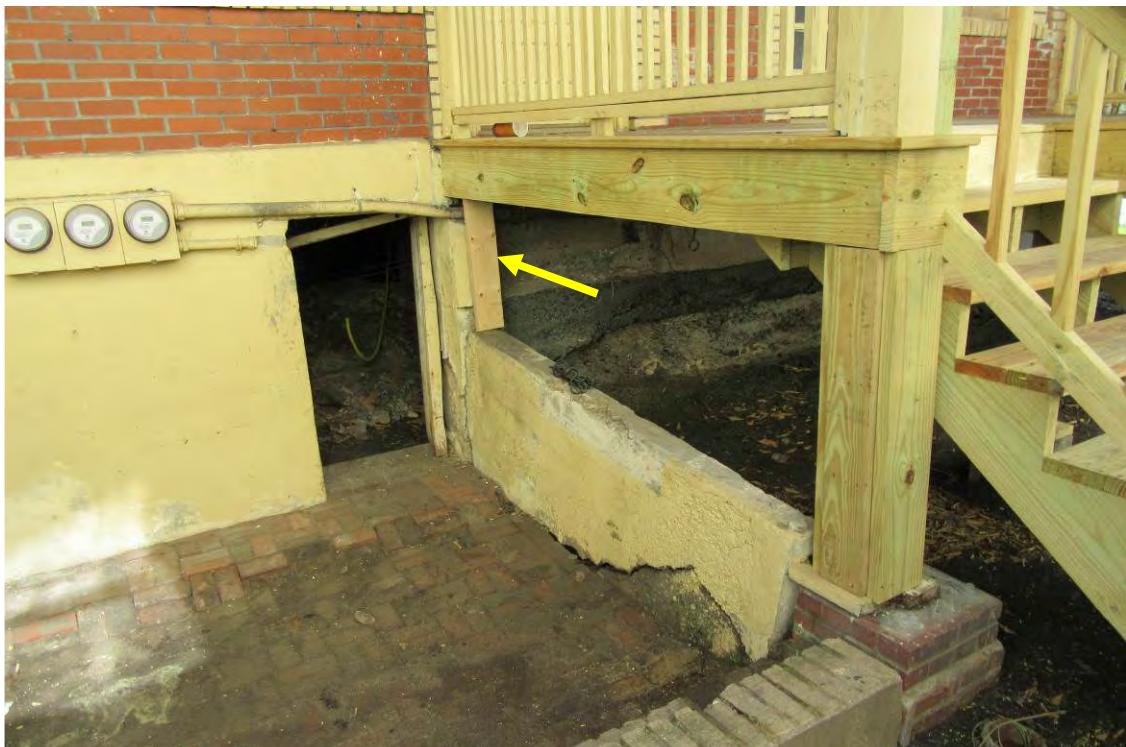
Photo 24: New rear deck framing supported by a single 2x member on unstable knee wall (arrow).

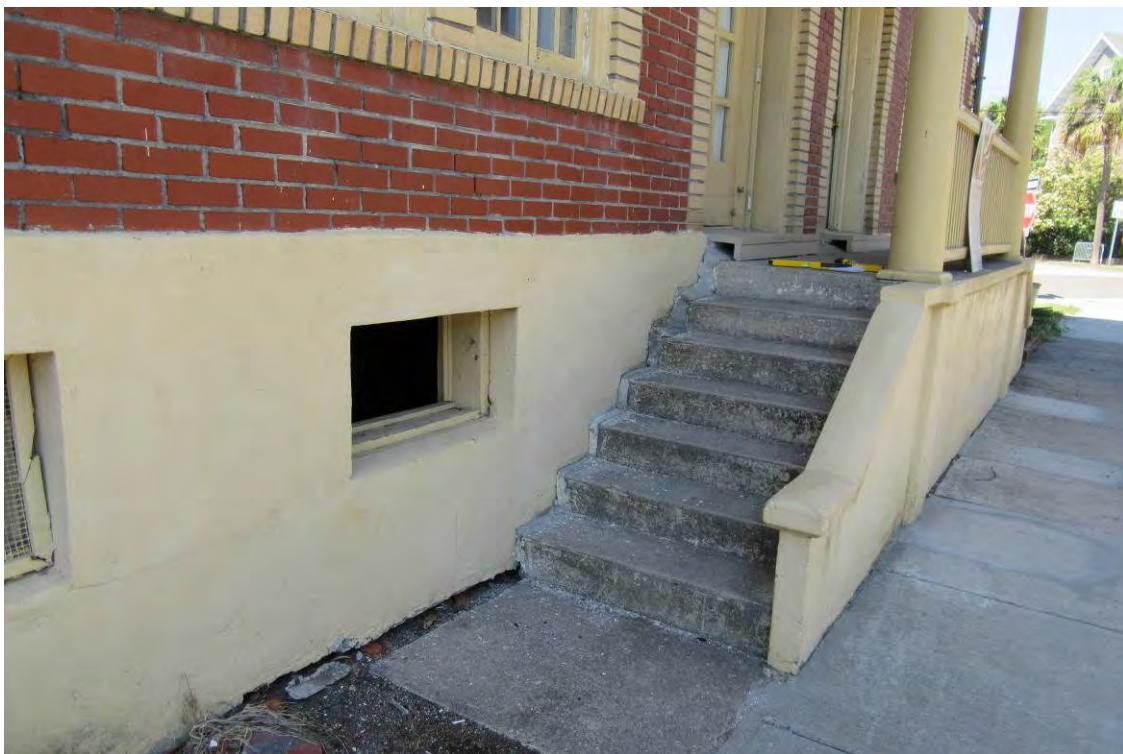
Photo 25: Grout or repair mortar was noted between the front stoops and the building foundation wall. It was reported that this cavity was filled as the stoops settled.

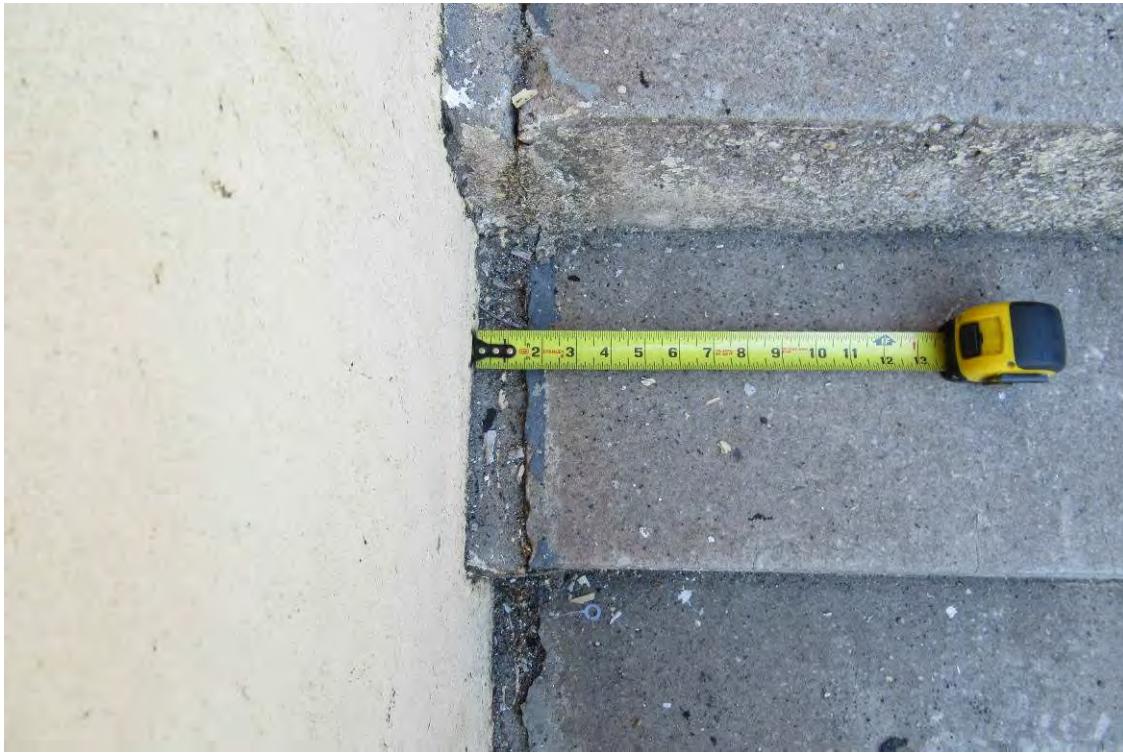
Photo 26: Grout or repair mortar was noted between the front stoops and the building foundation wall. It was reported that this cavity was filled as the stoops settled.
