Cross-section Microscopy Report

54 Hasell Street Charleston, South Carolina

Investigation of the Interior Paints

Date: August 19, 2018

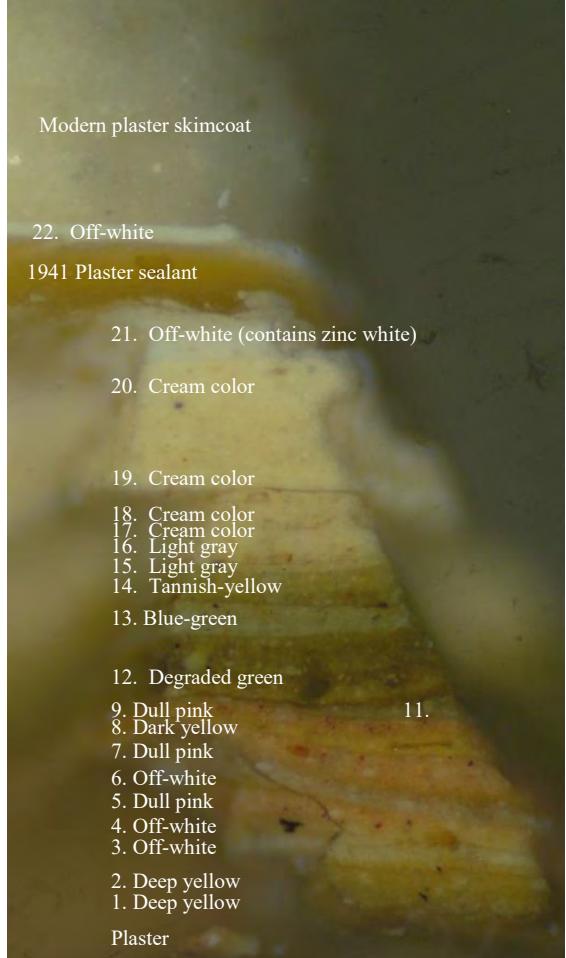
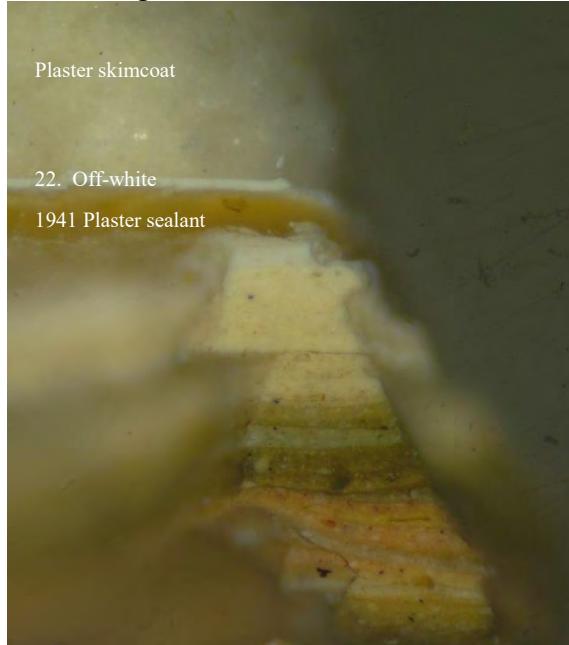
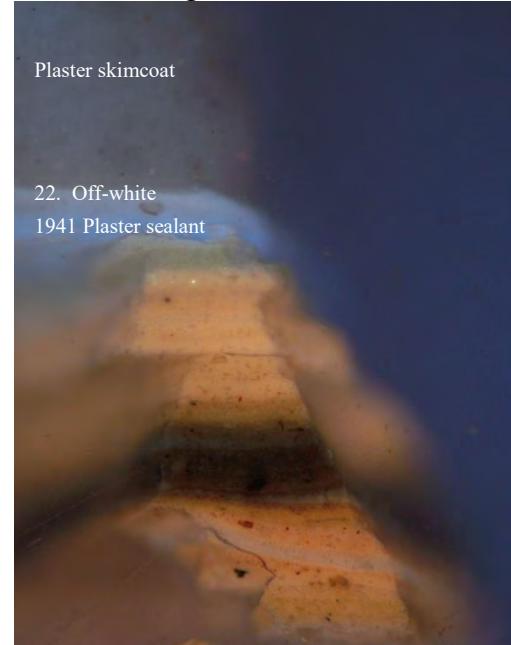
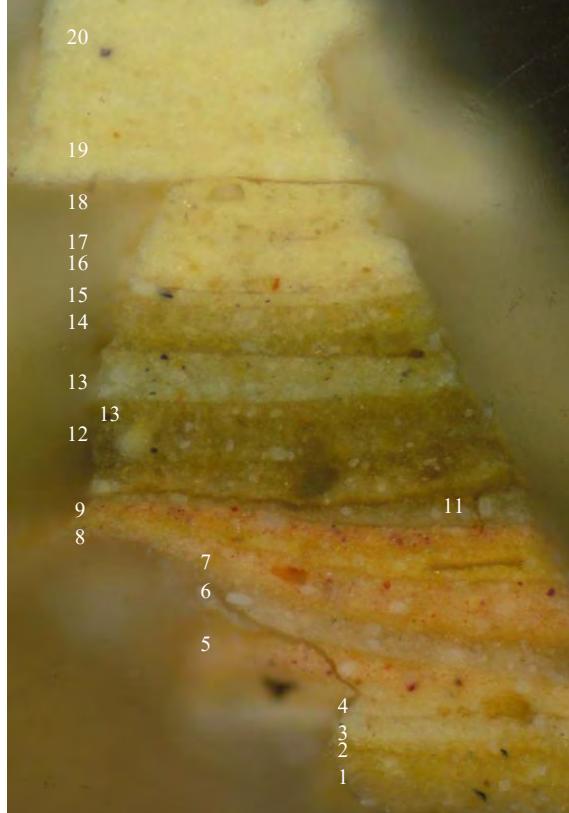
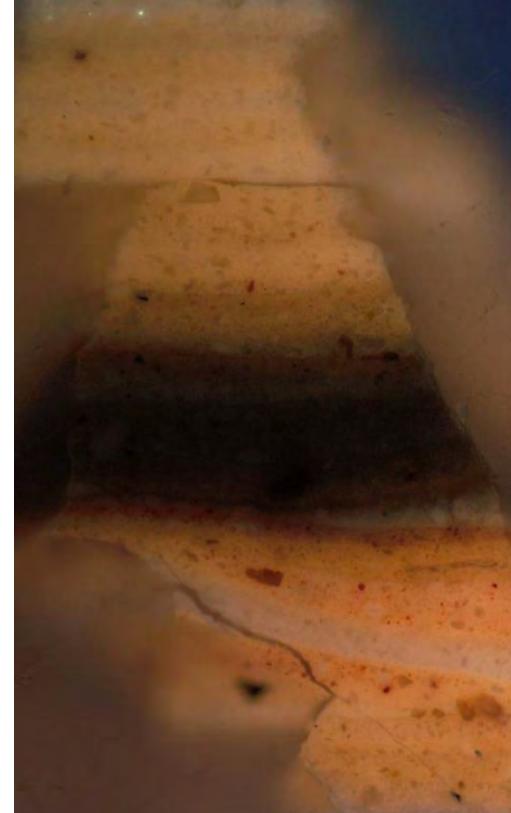
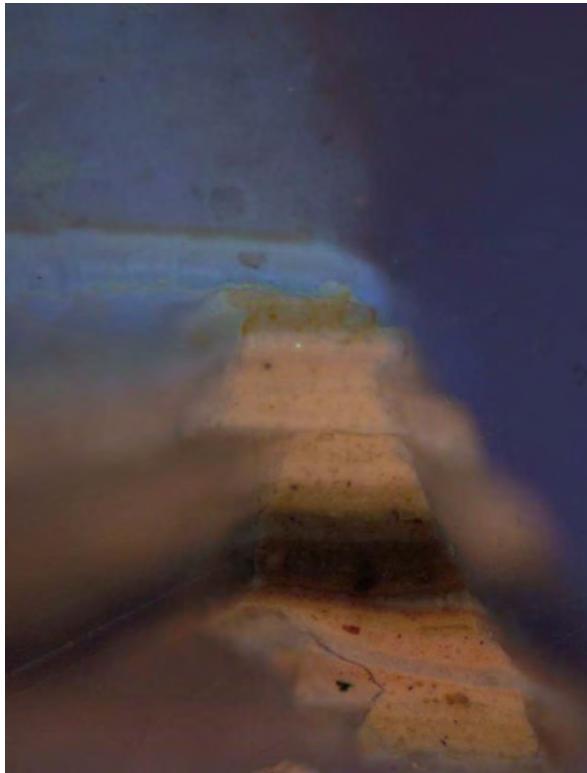
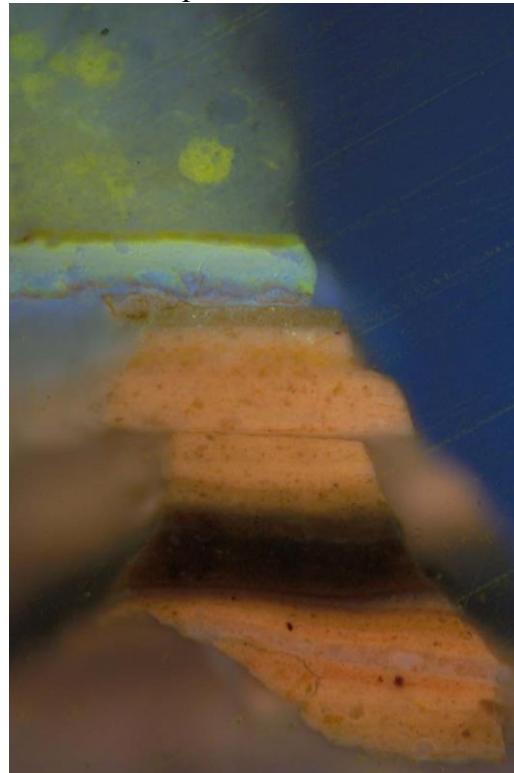
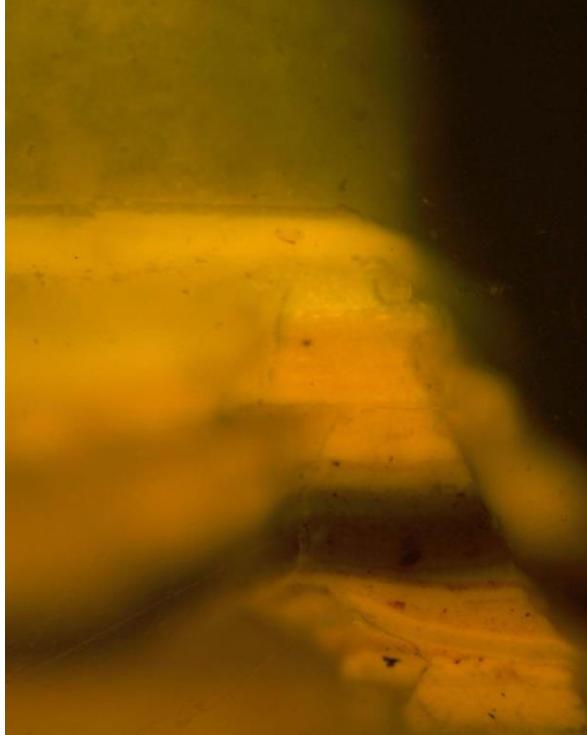
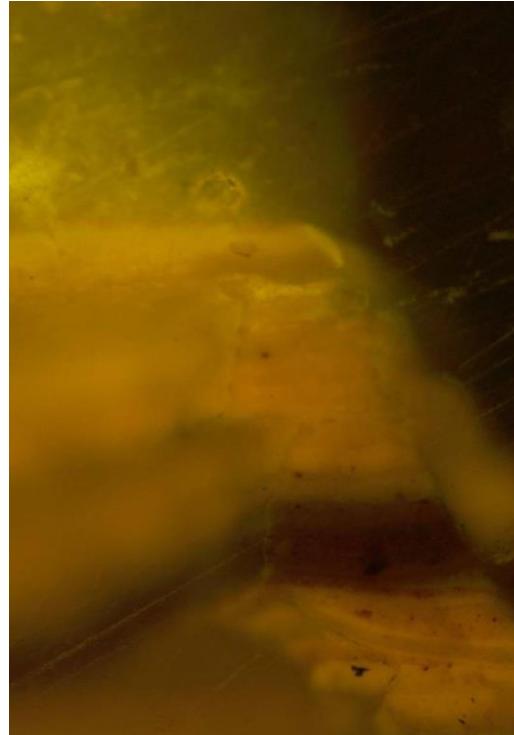
SW-3. East wall, over north door, plaster below lower right swag.
Visible Light 100X

The paints in samples SW-3 from the wall and sample SW-4 from the applied plaster leaf form can be neatly aligned from generations 1 through 20. Sample SW-3 is missing the off-white paint that appears in generation 21. That particular layer contains the pigment zinc white which dates it to after 1845 when zinc white became commercially available. The comparative plaster stratigraphy can be reconstructed to show that 21 generations of paint were applied to the west wall plaster and the raised plaster paneling before the clear sealant layer that marks the 1941 plaster was applied. This sealant layer has a distinctive

The comparative evidence in SW-3 and SW-4 suggests that the applied decorations were most often painted the same colors, beginning with deep yellow in the first two generations of paint, followed by off-white in generation 3. In generation 4 the plaster wall was off-white while the decorations were tan. Then in generations 5, 6 and 7 the plaster and raised decorations were all dull pink, then off-white, then dull pink again. The films of dirt between some of the paint generations, and the subtle darkening of the paint surfaces, help to distinguish the paint generations. These long and intact sequences of paints, with notably coarsely ground pigments from generations 1 through 15, suggests the proposed third quarter of the eighteenth century date for the wall plaster is plausible.

Binding media analysis of the plaster paints in SW-3 suggests that all the early paints are bound in oils (with the fluorochrome DCF), with no other organic additives.

The plaster substrate for SW-3 is a coarse off-white color with clear and tannish sand particles. This plaster matches the plaster substrate in samples SW-1 and SW-2 from the raised paneling on the south wall, helping to confirm that the east wall plaster is the same period as the raised paneling on the south, west and north walls.

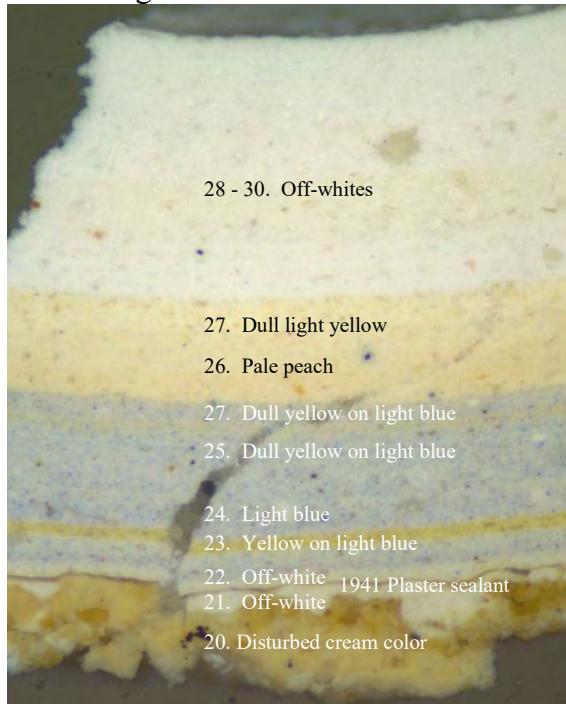
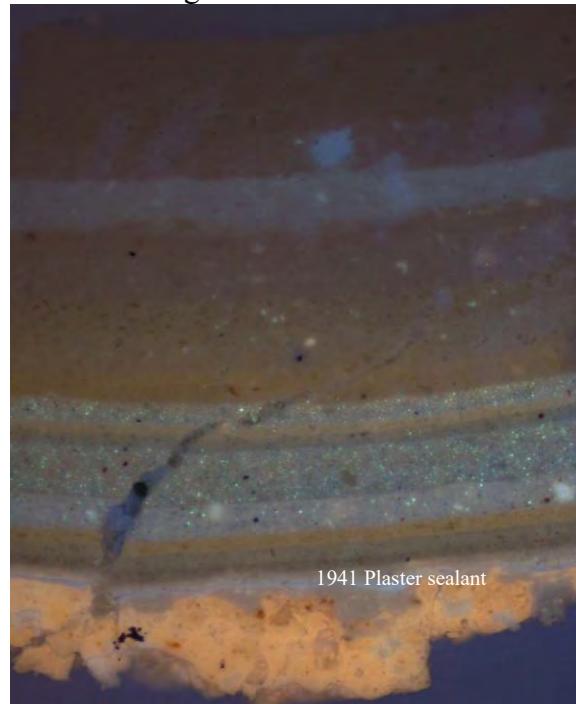
SW-1. South wall, southeast corner, at right lower edge of raised plaster panel, in chamfer.

Four samples from different areas of plaster paneling provide compelling evidence that most of the wall plaster was aggressively stripped at least once before 1941, as well as again during the 1941 restoration. Sample SW-1 from the chamfer for the raised paneling in the southeast corner of the south wall retains just remnants of the cream-colored paint identified as generation 20, followed by the off-white paint in generation 21 that flowed over and around the disrupted cream-colored paint below. The 1941 plaster sealant is on top of this off-white paint, and it is followed by generations 22 through 30. Sample SW-2 from raised panel surface retains the off-white paint applied on top of the coarse plaster in generation 21, followed by the 1941 plaster sealant, and then all the paints applied from 1941 onwards.

The colors applied just after the 1941 restoration are light blues in generations 23 through 27, and in two generations – 23 and 25 – the chamfers for the panels were picked out in dull yellow, while the panels were light blue. Generation 26 was pale peach and generation 27 was dull light yellow. The most recent paints on the chamfers were whites while the panels were painted in beige or tan colors. Sample SW-1 (below) came from the chamfered section while sample SW-2 came from the raised panel. The evidence in sample SW-2 shows that in some areas the earliest paints were complete scraped away to expose the plaster substrate before repainting.

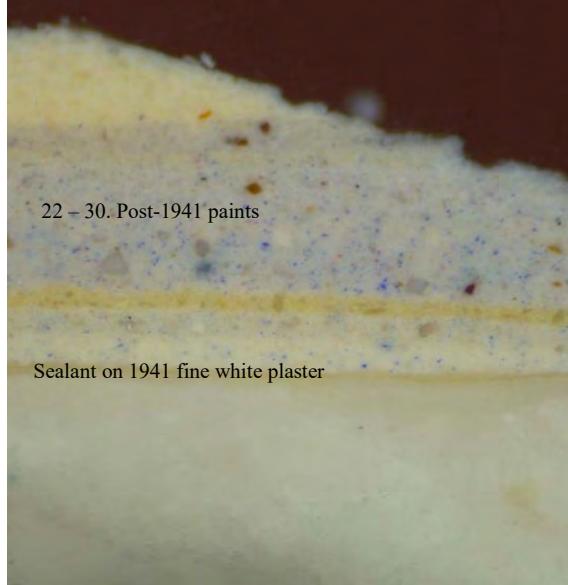
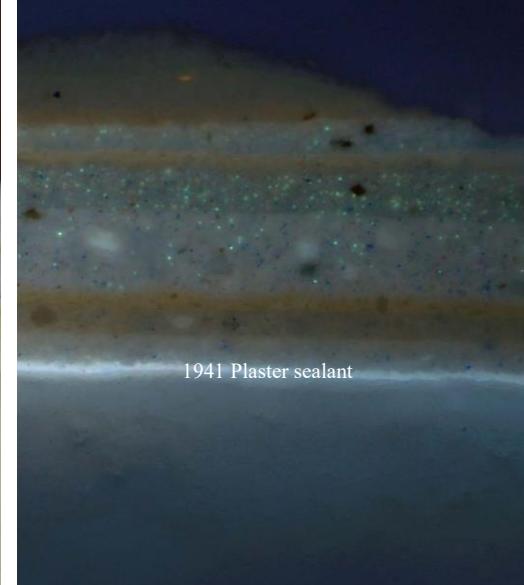
SW-5. West wall, replacement section of plaster, chamfer of plaster panel.

The evidence in sample SW-5 from the 1941 plaster paneling is important as it provides a reference for the plaster and paints applied in 1941. The plaster sealant is quite obvious in the reflected ultraviolet light image, and the plaster finish coat is smooth and bright white.

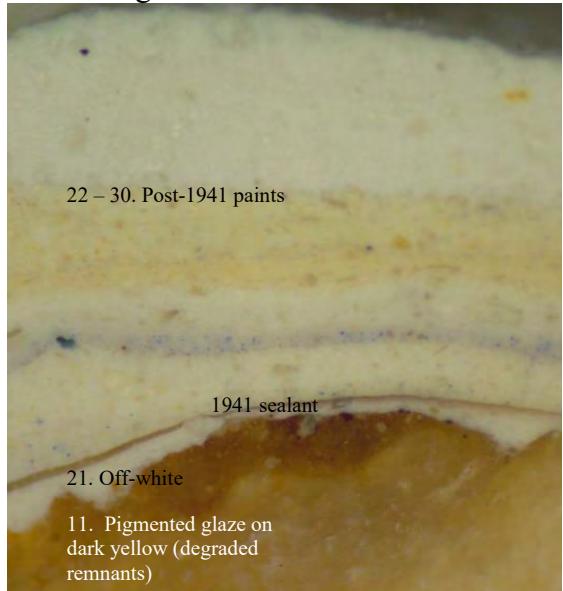
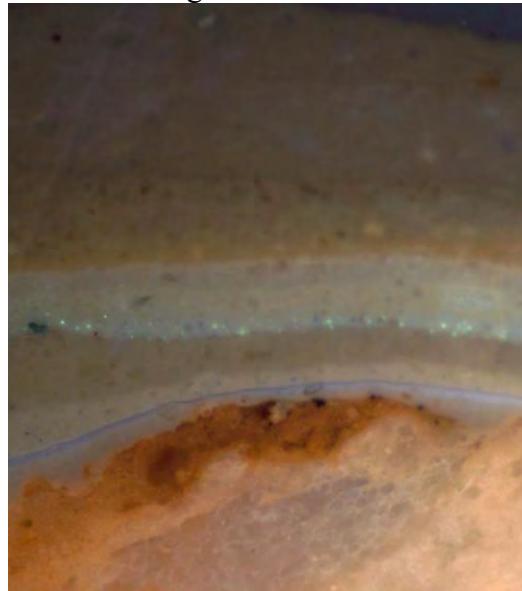
SW-9. West wall, swag above door, edge of top left bellflower.

One cross-section from the decorative swag about the north door on the west wall retains remnants of degraded paint that appears to be generation 11 – a pigmented glaze on a deep yellow base coat. Uncast portions of from this same area retain remnants of the first deep yellow distemper paint found in samples SW-3 and SW-4. This is followed by the off-white paint identified as generation 21 and then the 1941 coatings. While the early paints in this cross-section are fragmentary, the presence of early hand-ground paints suggests this swag and ribbon decoration is the same date as the more exuberant leafy rococo decoration above the north door on the east wall.

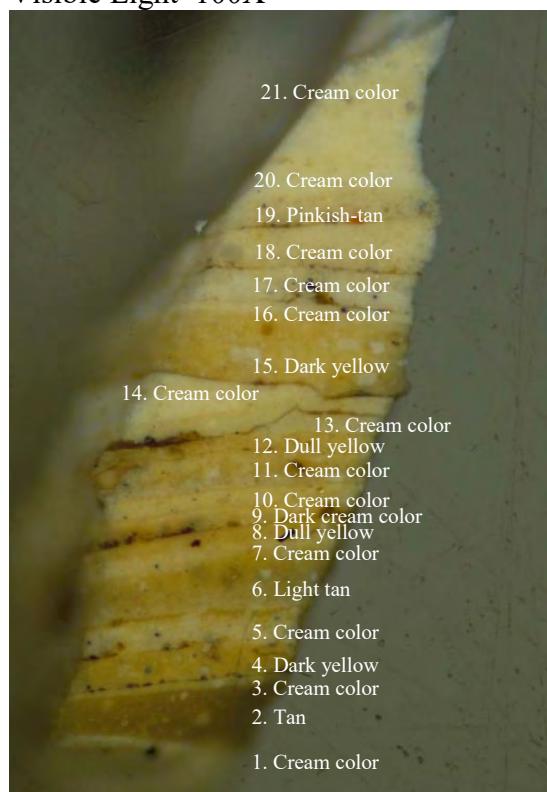
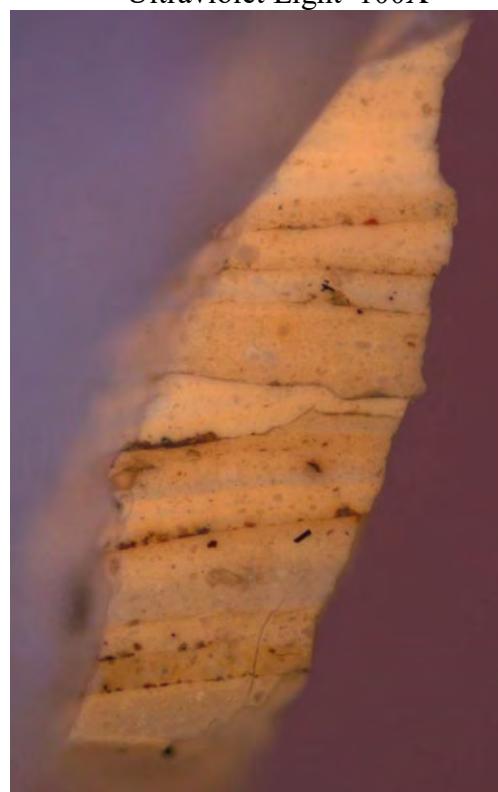
SW-8. North wall door architrave, pediment, edge of fluting.

Paint Evidence on Southwest Room Woodwork. The only early paint evidence on the woodwork in this room was found in sample SW-8 from the north wall door architrave. There are approximately 21 generations of aged, grimy, white lead-based paints in this cross-section, beginning with cream color, followed by glossy tan paint (which contains a varnish component) in generation 2. Most of the woodwork colors are variations of creams and dull yellows, as shown in the photomicrographs below.

The most recent trim paints cleaved off when this sample was removed, but the paints in uncast portions of SW-8 match the finely ground off-white paints identified on the north wall door in sample SW-7. The comparative evidence suggests that the woodwork in this room was repainted as frequently as the walls, and that the applied ornaments, raised plaster paneling, door and window architraves were installed in the same period. The exceptions are the woodwork and plaster in the center of the west wall which date to 1941. So, the combined evidence suggests that the earliest palette on the plaster and woodwork in this room consist of matte dark yellow walls and cream-colored woodwork.

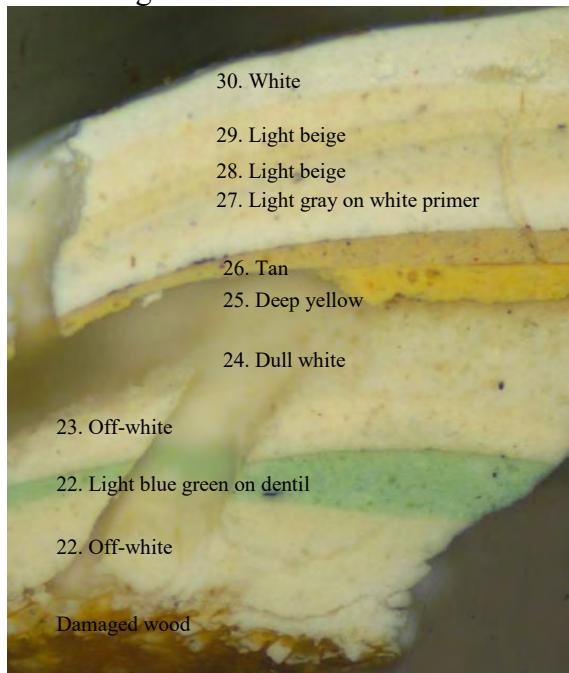
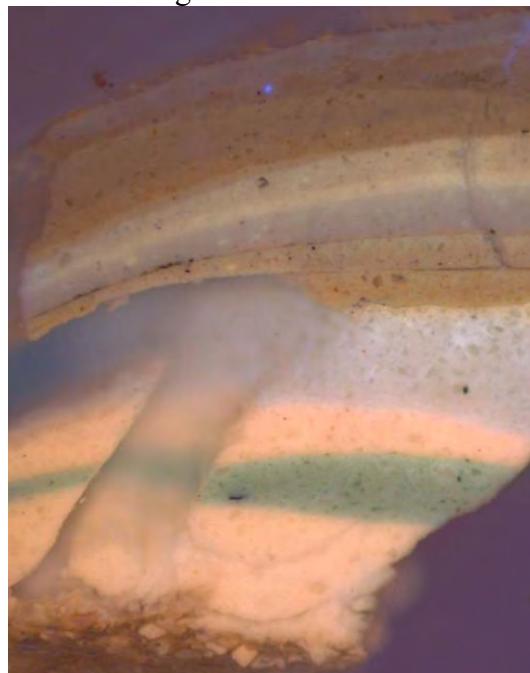
SW-6. East wall, cornice in northeast cornice above door, edge of dentil molding.

The wood substrate in SW-6 from a cornice dentil is fibrous and disturbed, which is likely the result of aggressive paint stripping. This stripping may have been done in 1941, which would date the off-white primer directly above the wood and the light blue-green finish coat to 1941. It is possible that in 1941 certain elements of the cornice, like the dentils, were picked out in light blue-green, while the rest of the cornice was white. Other elements, such as the north wall door trim, seem to have been off-white in 1941. No early paints were found on the cornice, but stylistically it fits with the rest of the woodwork, and the evidence of thorough paint stripping suggests it was treated harshly in the 1941 restoration.

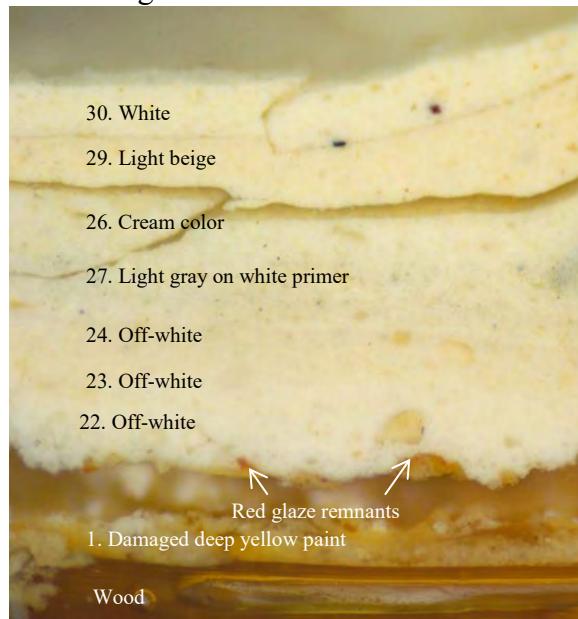
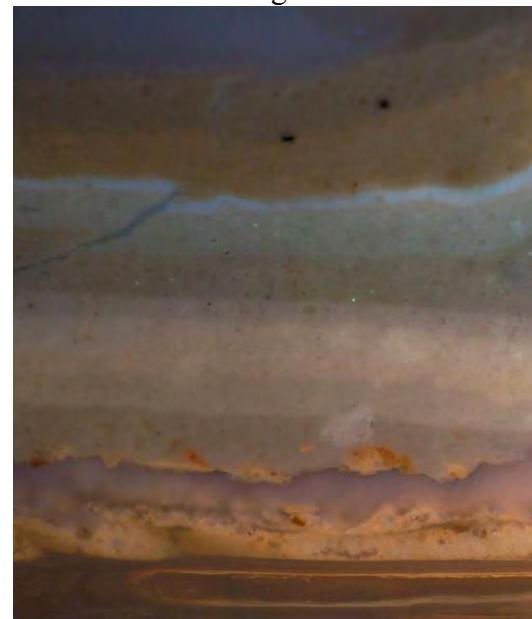
SW-7. North partition wall door. Top left corner, top right panel.

The door leaf for the north partition wall was also sampled to search for early paints. Like the other woodwork in this room it has been quite thoroughly stripped. But, there are remnants of the original paint treatment remaining on top of the wood. The earliest layers are fragmentary, but there is a coarsely ground deep yellow paint on the wood, and remnants of a reddish glaze on top of the deep yellow. It is possible that this represents a graining treatment to replicate a figured wood like mahogany. This type of decorative painting is common for doors in entertaining rooms in Charleston from about the third quarter of the eighteenth century into the early nineteenth century.

The graining fragments are followed by finely ground, nonfluorescent paints that are consistent with the post-1941 woodwork paints found in this room.

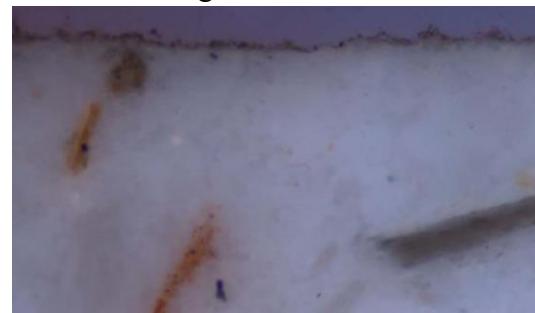
NE-4. East wall, exposed plaster left of closed-up window opening.

Paint Evidence on the Northeast Room Plaster. Only two samples were taken from areas in the northeast room that might be early plaster. Sample NE-4 came from a section of coarse white plaster on the east wall which was revealed when an opening was made in the southeast corner to reveal the staircase and the closed-up window. This plaster was applied directly to the brick and there is defined edge on its right side where it met some type of vertical element. It consists only of coarse white plaster with large shell and wood fiber inclusions, and there is a thick film of soot on its surface. This plaster does not match any of the plaster exposed on the north wall of the stair passage. This plaster clearly never had any sort of paint or wallpaper on it, so it remains a puzzle.

White plaster with shell inclusions
Does not match plaster in samples
SP-1, SP-6 or SP-7 from the two
periods of exposed plaster in the stair
passage

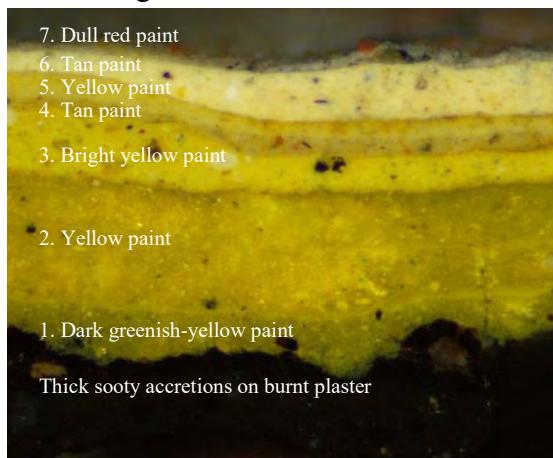
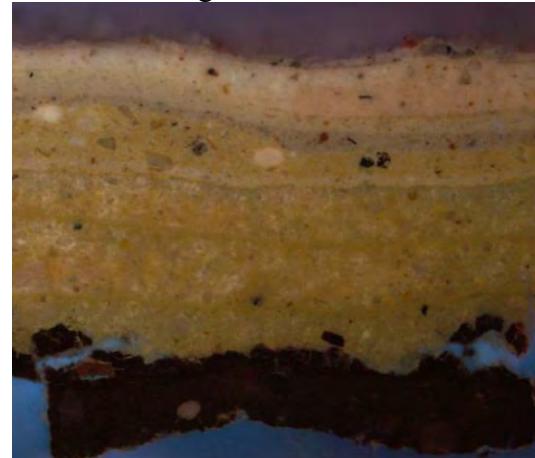
NE-5. Fireplace, multiple coatings on left side of interior of firebox.

The interior of the firebox has a thick accumulation of darkened materials, and there are many patchy colored coatings present. In cross-section there is a darkened plaster or stucco at the bottom of the sample, followed by a thick black layer of burnt plaster, soot and oily materials. There are seven generations of opaque, oil-bound paints on top of the blackened substrate which are mostly variations of yellows. The most recent coating is a thin dull red paint. None of these paints can be dated by composition or context, but the absence of soot between most of the layers suggests that they were applied after the fireplace stopped being used on a regular basis. These paints could all date to the twentieth century.

1. Dark greenish-yellow paint
2. Yellow paint
3. Bright yellow paint
4. Tan paint
5. Yellow paint
6. Tan paint
7. Dull red paint

Thick sooty accretions on burnt plaster

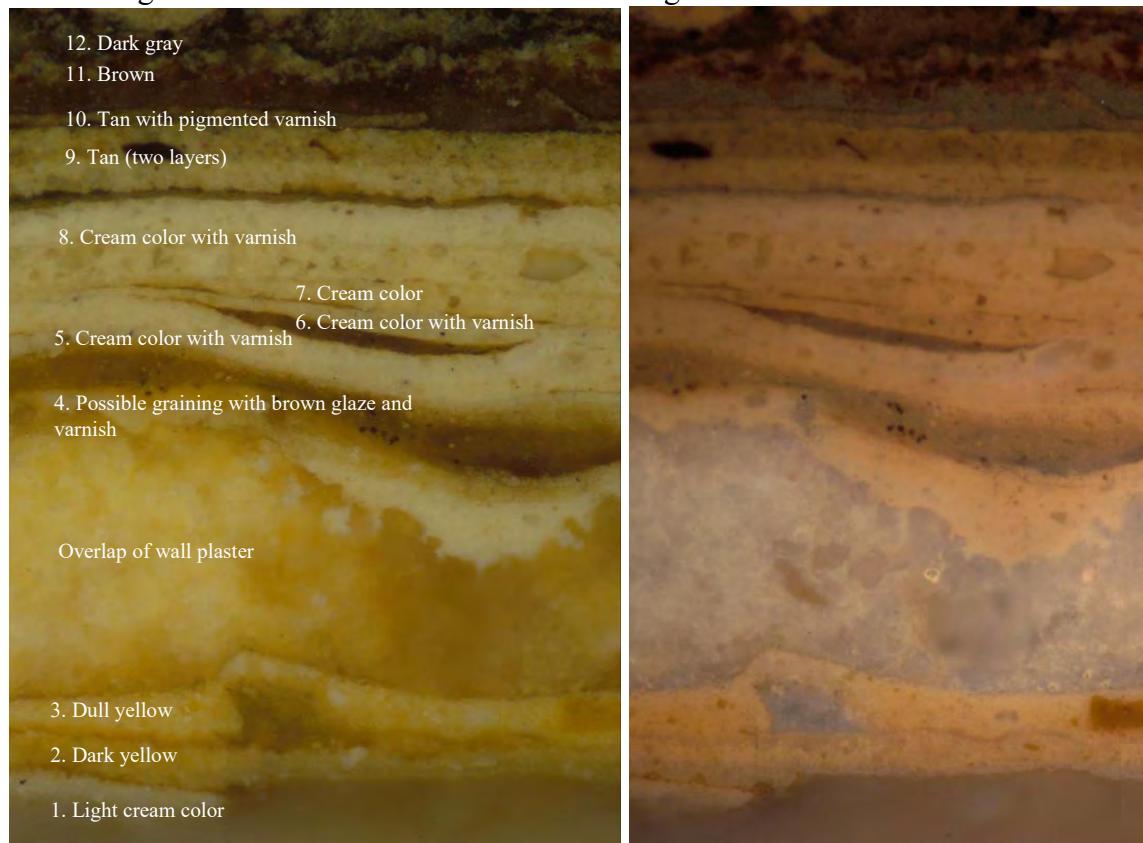
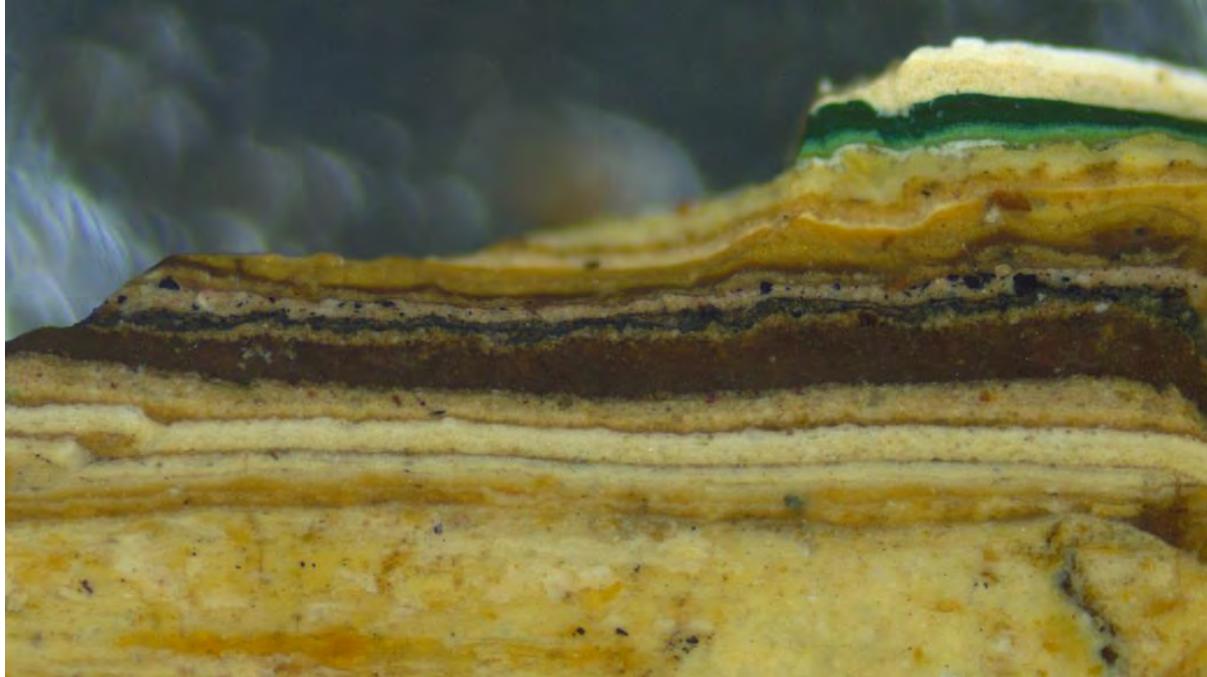
NE-1. West wall, cornice about fireplace.

Paint Evidence on the Northeast Room Woodwork. An extraordinarily complete stratigraphy of early paints was found on the cornice, which remains undisturbed and could date to the first period of the house. There are 20 generations of coarsely ground, white-lead-based paints on top of the wood in sample NE-1, beginning with a thinly applied cream-colored paint, followed by deep yellow in the second generation. Most of the earliest colors are creams, tans and dull yellows, as shown in the detail images of NE-1 at 200X magnification below. The most recent green paints, followed by bright whites, cleaved away when the samples were removed, but they are shown in separate photomicrographs on page 23.

Binding media analysis with the fluorochrome DCF confirms that all the paints in this woodwork paint sequence are oilbound.

The complete stratigraphy of paints on the cornice can be reconstructed from the layers that cleaved apart. There are approximately 29 generations of paint. Generations 21 through 29 can be aligned with the paints found on the wainscoting and chair rail. An uncast portion of this sample was also photographed to help put this complex paint sequence into context.

Uncast sample photographed at 40X to show all the paints, from the original cream color at the bottom to the most recent white at the top.

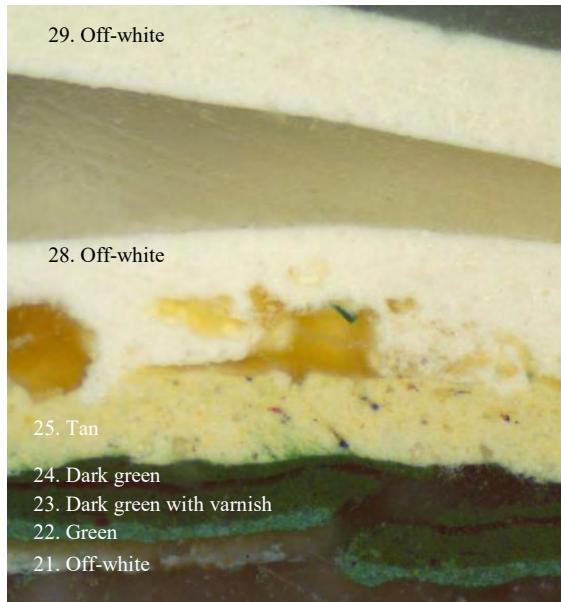
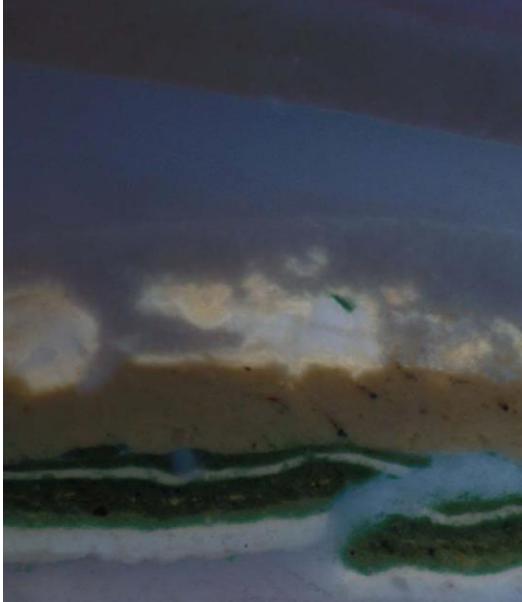
NE-2. North wall, northeast corner, wainscot just below chair rail.

The paints on the wainscot (NE-2) and chair rail (NE-3) retain paint histories that only seem to date to 1941, with an off-white paint labeled generation 21 on top of blackened and fibrous wood. These elements cannot be comparatively dated based on their paints.

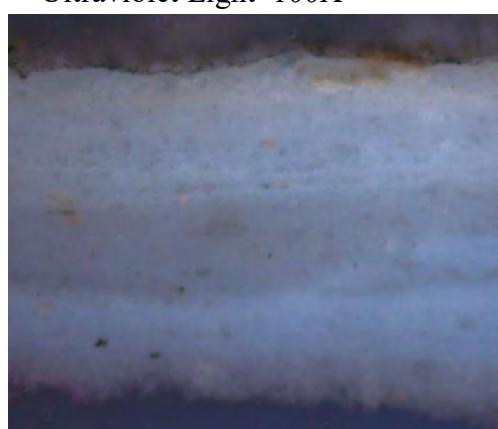
SP-6. North wall, plaster directly on brick face exposed above wainscot in opening.

There are six generations of unpigmented limewash on top of the coarse light tannish plaster substrate in sample SP-6. This suggests this plaster was exposed for a number of years before the second layer of plaster was applied.

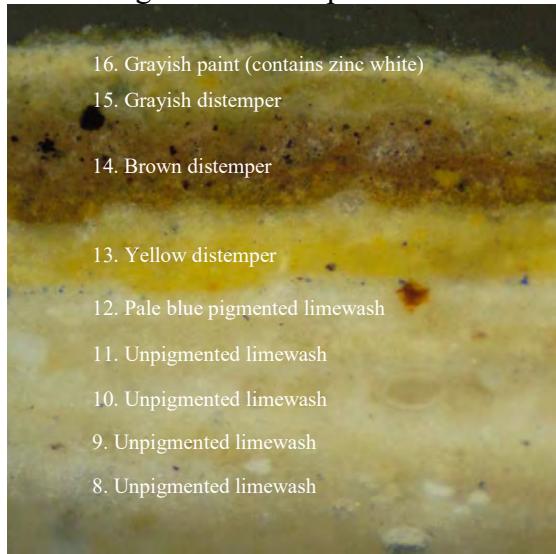
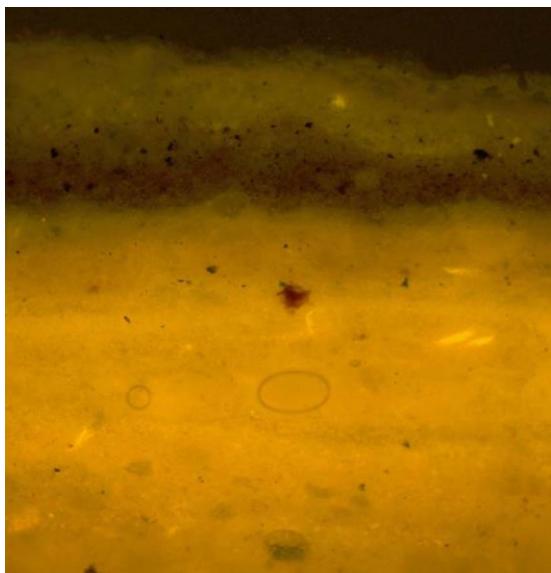
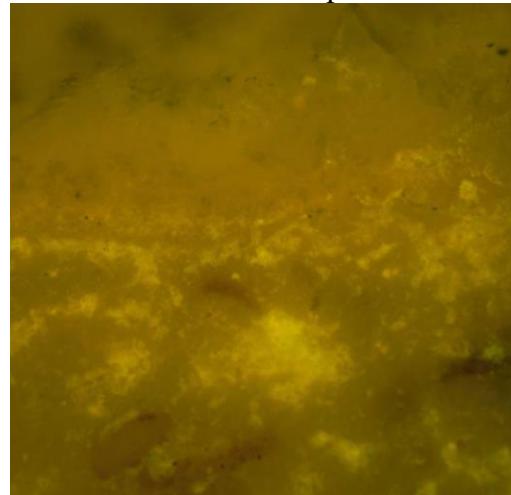
SP-7. North wall, second plaster layer in exposed section.

There are many coating layers in sample SP-7 which was taken from the second generation of plaster. The whitish plaster substrate is finer than SP-6 and has clear sand, brownish hair, and brick dust inclusions. It does not resemble the plaster exposed on the east wall of the northeast room where an opening was made to reveal the closed-up window. The coating layers in this sample have been labeled sequentially as 7 through 16 as this plaster is directly on top of the first plaster which retains six generations of unpigmented limewashes. Generations 7 through 11 are unpigmented limewashes, followed by a light blue-pigmented limewash is generation 12 and a yellow distemper in generation 13. Generation 14 is an opaque brown paint which may be distemper, followed by a gray distemper in generation 15 and an opaque gray paint in generation 16 that contains zinc white. The presence of zinc white means this layer could not have been applied before about 1845 when zinc white became commercially available. It also means that the earliest date that the plasters on the west wall of the northeast room could have been cut through was well after 1845.

Staining with biological fluorochrome stains suggests that generations 13 through 15 are traditional distemper paints (bound in dilute hide glue) because of the strong positive reactions with the fluorochrome FITC. Generation 16 must be an oil-bound paint as it reacted strongly positive when DCF, a fluorochrome tag for oils, was applied. Limewashes and distempers were traditional wall paints which were chalky, slightly translucent, and not very durable. Their advantages are that they were inexpensive, easy to apply, and easily painted over.

If the two layer of plaster do, in fact, relate to the northeast room, the evidence indicates that the walls in the northeast room were initially repeatedly coated with inexpensive limewashes. No distinctive color was applied to the walls until generation 13, a yellow distemper. The walls were repainted three more times with brown and gray distempers, then a gray oil-bound paint, before it was somehow trapped by alterations to the staircase or the northeast room.

Strong + for proteins in generations 13 - 16

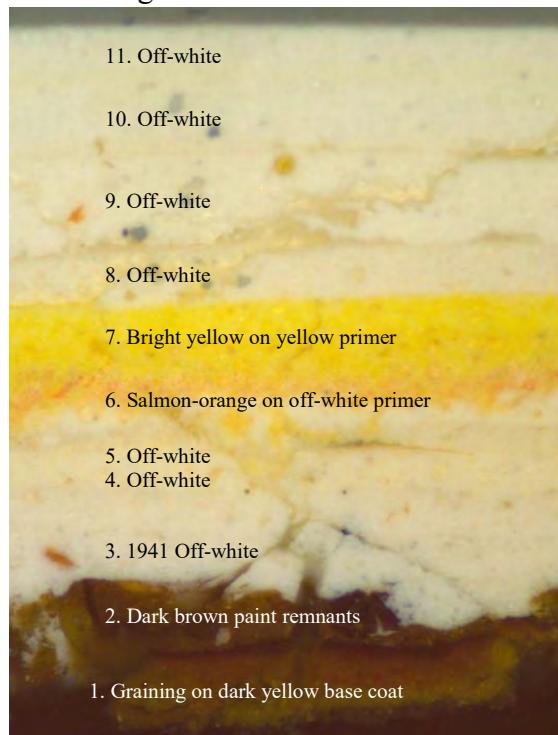
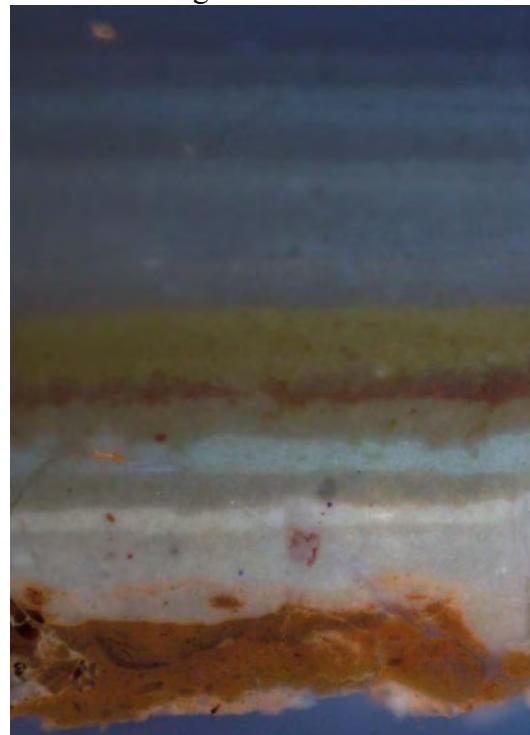
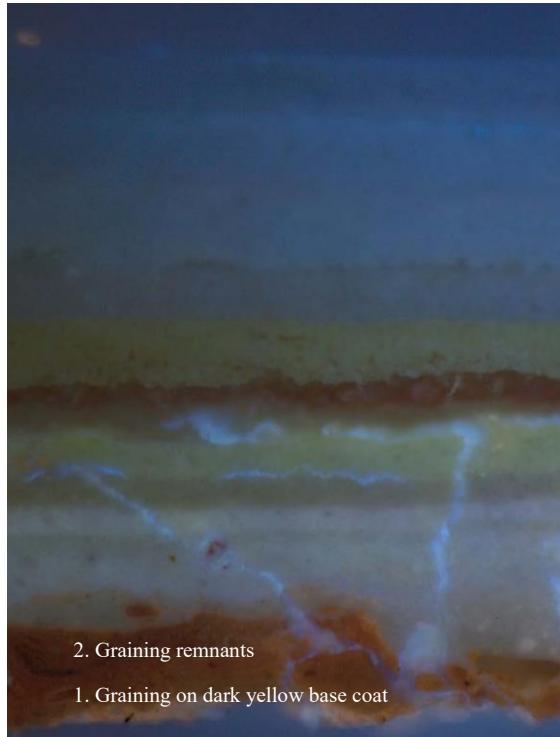
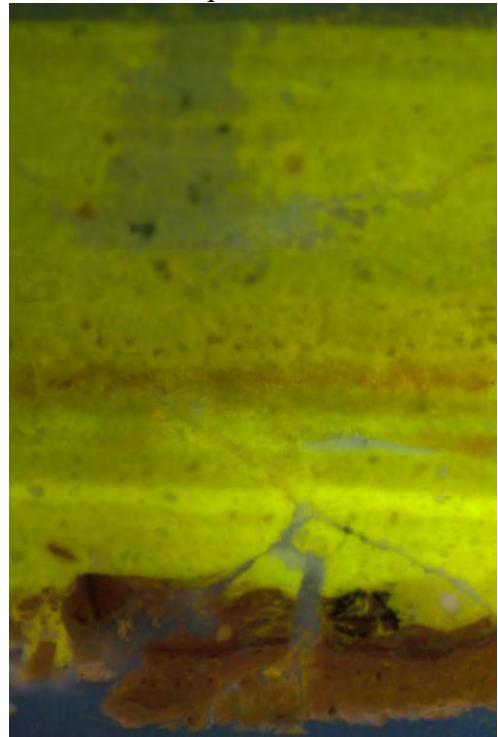
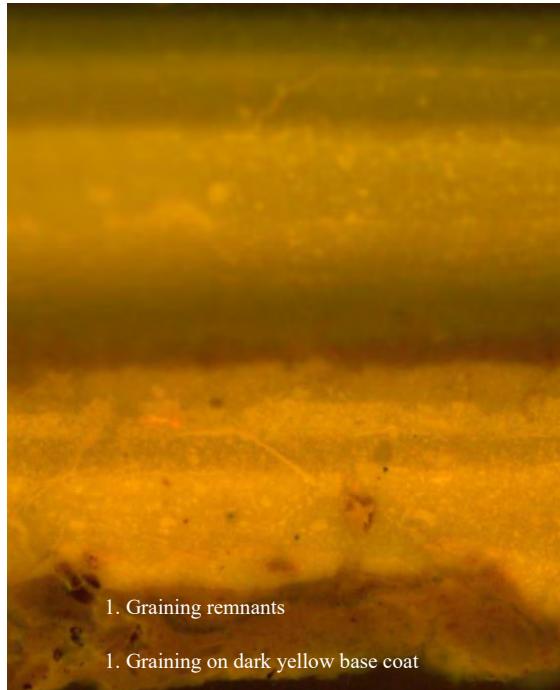
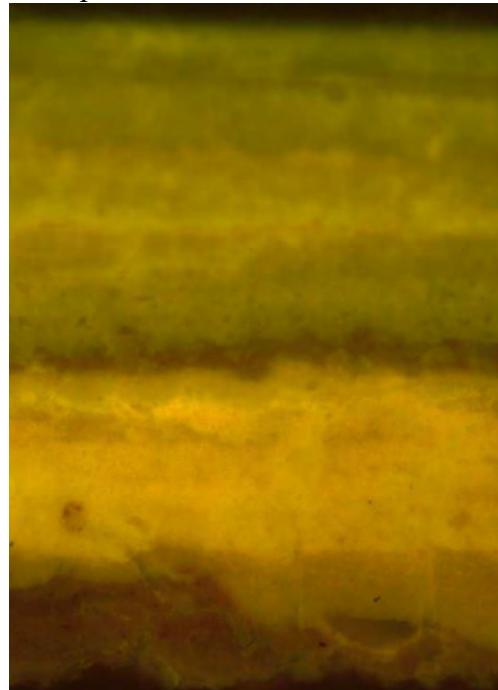
SP-8. North wall, curved end block below stair, tenth step up.

The most intriguing paint evidence was found in sample SP-8 from a curved block below a staircase step. There is less early evidence remaining in SP-4 from a different flat block. The oil-based paints on the curved block are compromised by stripping, but there are still remnants of what seems to be a grain-painting sequence remaining below the post-1941 paints. The graining consists of a dark yellow base coat, a dark red glaze and a darkened varnish. This original decorative treatment became cracked and damaged before it was painted over with a dark brown paint. This second-generation was mostly scraped away and painted over with off-white paint which is likely the 1941 layer. There are eight more generations of paint on this curved block, including a salmon color in generation 6 and bright yellow in generation 7.

The grain-painting evidence is significant because it suggests that when the staircase was first painted the blocks were grained to match mahogany balusters. Unfortunately, the limited paint evidence remaining on the woodwork in the stair passage means that the paint chronologies cannot help to decipher the evolution of this space, nor can it help to date the current staircase.

UV Light & DCF for oils 200X
+ for oils in all paints

Ultraviolet Light 200X
+ for proteins in the most recent off-whites

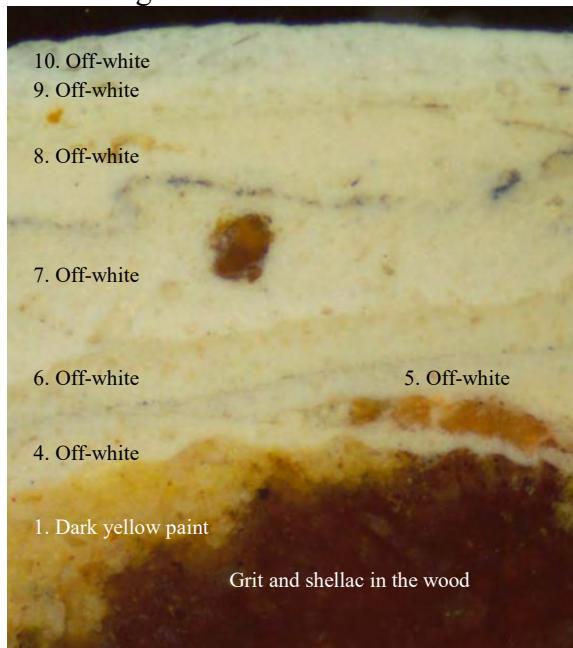
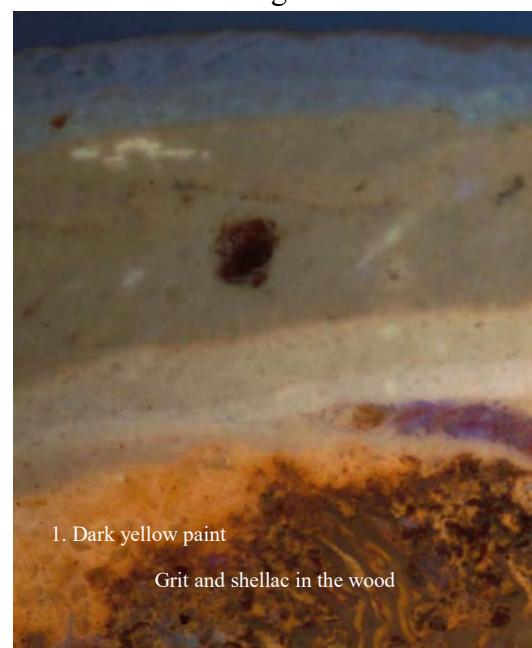
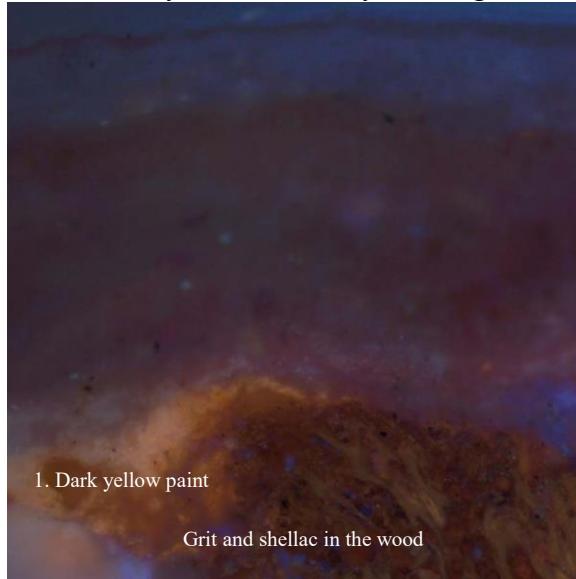
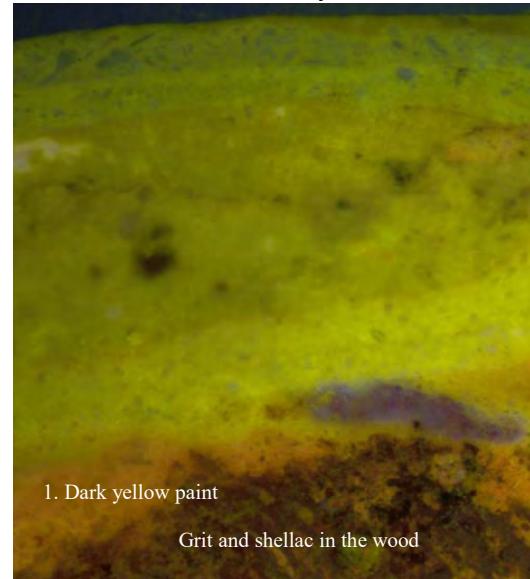
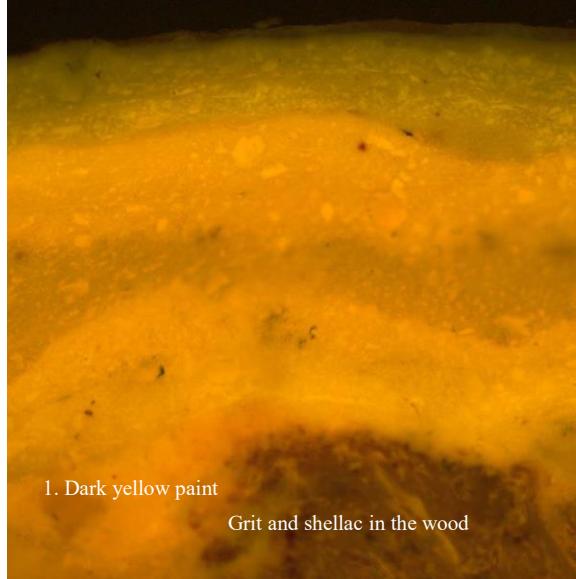
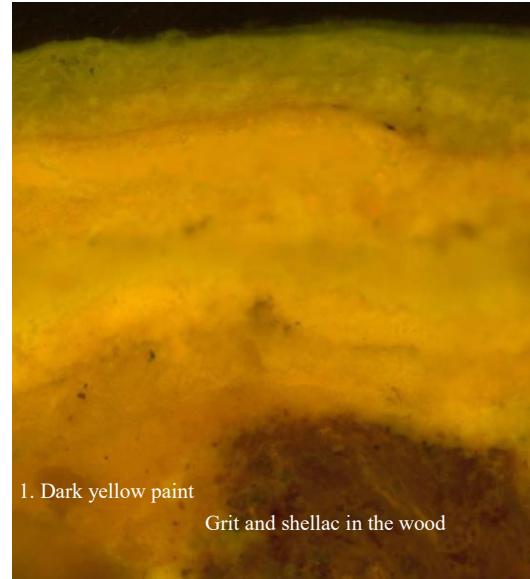
SP-5. North wall, inner surface of hinged door, left corner of top rail, at left stile.
Visible Light 100X

The exterior face of the hinged door did not yield any early paint evidence. It clearly had been completely stripped, as shown in sample SP-2. However, the interior surface of this door does retain remnants of early material. Sample SP-5 was taken from protected area of the inside of the door, and while interior door had also been stripped, there are remnant of shellac trapped in the wood (identified based on its characteristic orange autofluorescence in reflected ultraviolet light). There is grit and dirt trapped in the wood as well, so perhaps in the interior of this door was first shellacked, not painted. Then after considerable amounts of grit and soot was trapped on the wood. The door was painted with a dark tan oil-based paint. The paint on top of this dark tan paint is the finely ground, nonfluorescence off-white paint that seems to be the 1941 trim paint in the stair passage.

UV Light & TTC for carbohydrates 100X
+ for carbohydrates in all layers but generation 1

UV Light & DCF for oils 100X
+ for oils in all layers

B-2A filter & FITC for proteins 100X
Weak + for proteins in the post-1941 paints

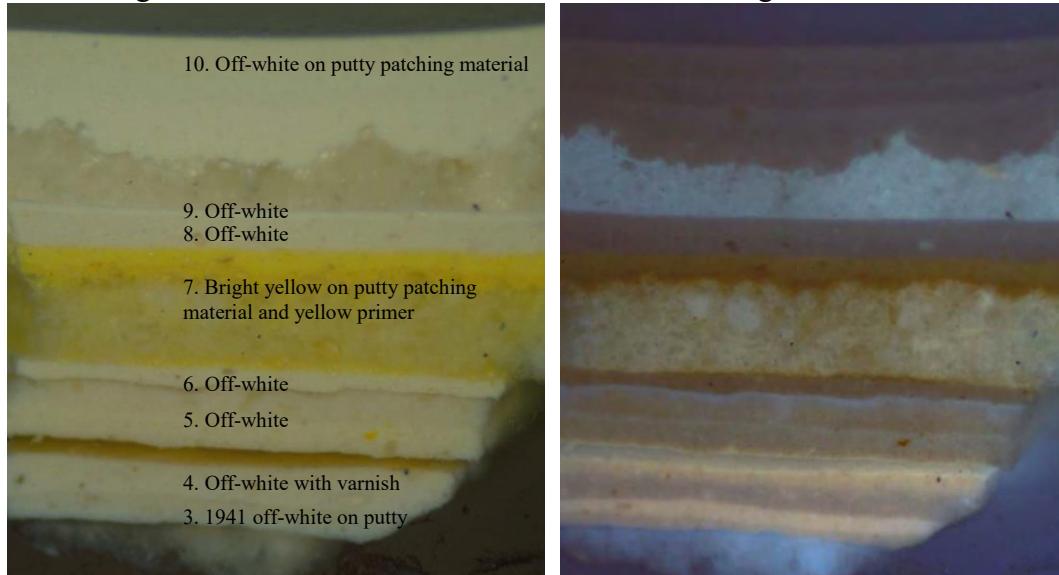
When the surfaces of the horizontal paneling under the stairs were examined at low magnification it was apparent that there are many white putty patches on the paneling, and at the horizontal joins of the boards. The joinery was extensively patched after the woodwork was stripped and before the 1941 off-white paint was applied, and then it was patched again when the woodwork was painted bright yellow in generation 7, and again before the most recent repainting. The chronology in SP-3 from the paneling shows that only coatings dating to 1941 and after remain on this woodwork.
