Cross-section Microscopy Report

54 Hasell Street Charleston, South Carolina

Investigation of the Interior Paints

Date: August 19, 2018

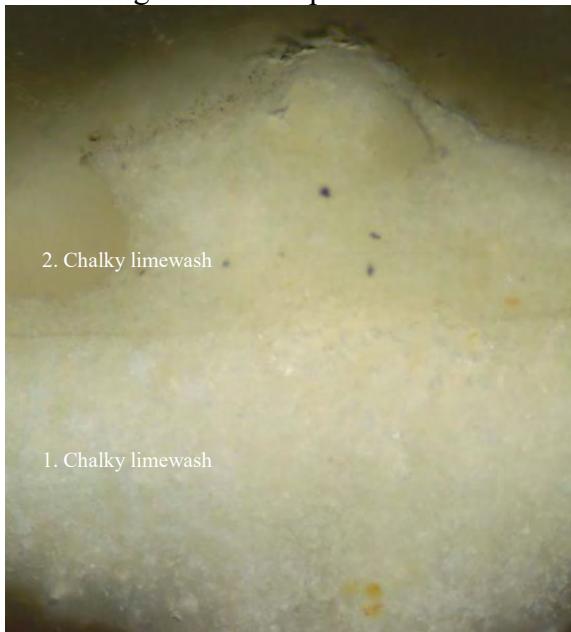
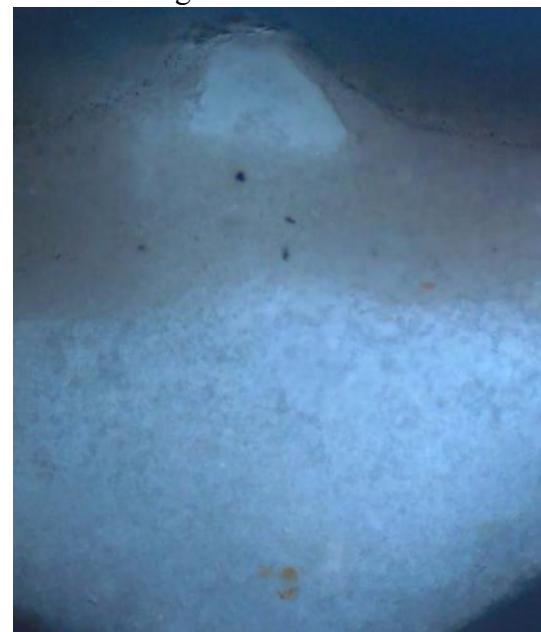
C-2. Central west room, south side, underside of exposed floorboards in ceiling.

There is only one layer of unpigmented limewash on top of the dirty wood substrate in sample C-1, and in sample C-2 there are two similar layers of unpigmented limewash. There is very little dirt on the surfaces of these limewashes, and they are not notably discolored or damaged. The combined evidence in these two cross-sections indicates that the joists and ceiling (underside of the flooring) were originally left unpainted and the limewashes might not have been applied until later in the nineteenth century. It is more typical to find many, many layers of limewashes on kitchen, cellar, laundry and dairy spaces in the eighteenth and nineteenth centuries as these alkaline limewashes were considered hygienic coatings.
