PAINT INVESTIGATION

Middleton Chair

Object: Middleton Chair
painted wood, c. 1800
2019.002.001

Date: November 30, 2023

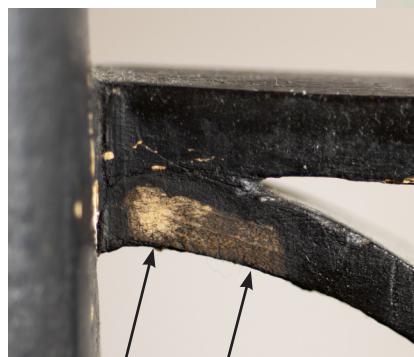
(Back of lower ringed slat)
Traces of white primer layers survive close to stiles (where they were missed by sanding?) but original paint is now mostly gone here. The front of the slats do not appear to retain any early paint. Microscopy of the inner ring (2019.002.001-5) suggests the protected areas of the inner rings retain some original paint.

abraded white primer

bare wood

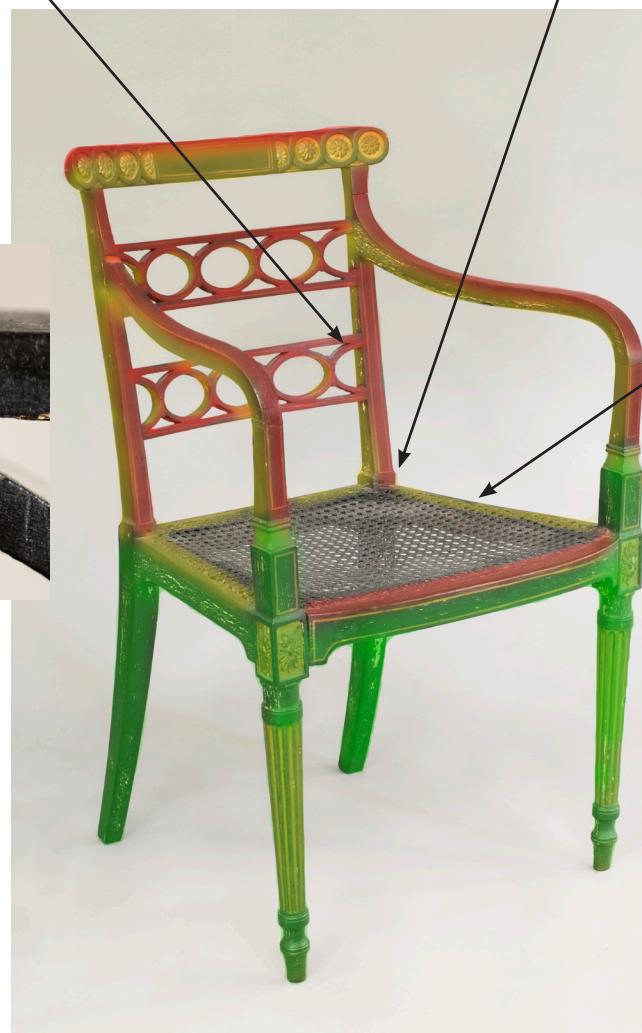
Below, the photograph of the chair has been digitally colored to illustrate the estimated condition of the original paint.

Green: The original paint scheme appears to be present under several layers of overpaint, though some loss and wear is expected.

Yellow: Some original paint layers may survive, but because of use, wear, and abrasion from repairs, the presentation surface may be missing.

Red: Examination and testing suggest that there is little to no original paint surviving under the current black paint scheme.

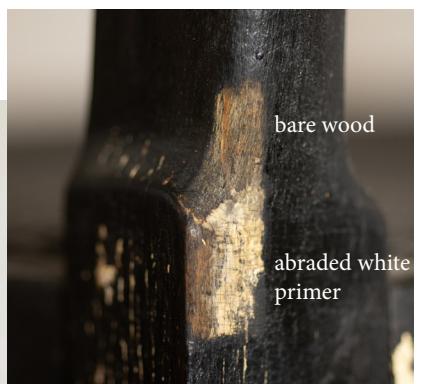
(Back of PR stile) Traces of original paint appear at the start of the leg, but above the seat, early paint layers appear missing on the back of stile. Condition: heavily abraded, black overpaint retained in wood pores.

bare wood

abraded white primer

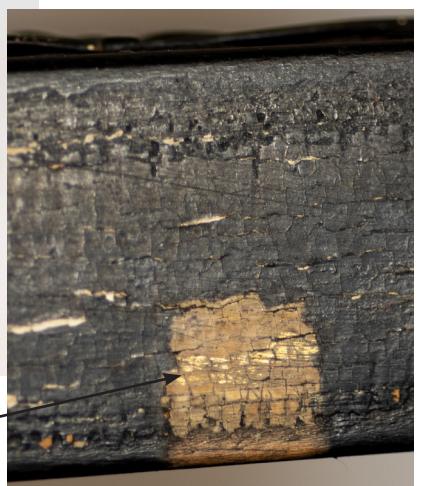
(PR seat apron) Original paint scheme is present under black and brown overpaint. There is surviving gilding that suggests linear decoration over a yellow-tan paint (this may be the bole serving as the base color). Condition: area is generally intact, cracked paint, abraded gilding, scratches on surface (from mechanical abrasion such as sanding)

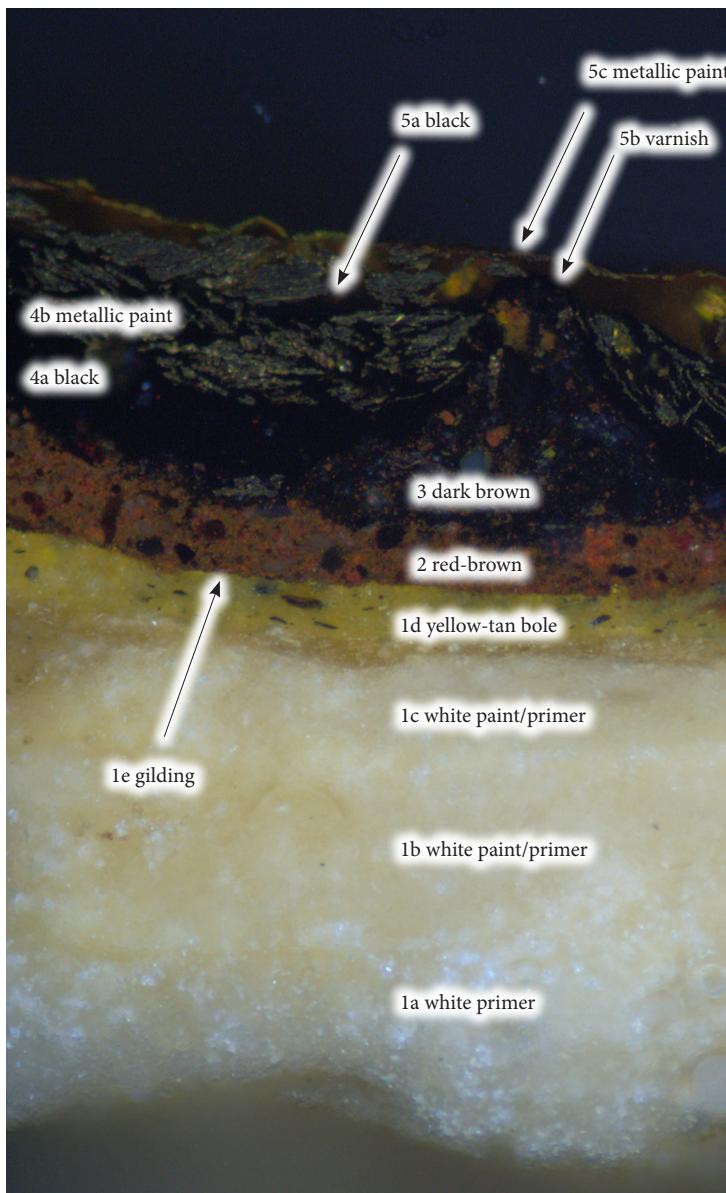
2019.002.01-1, visible light, 200x

Notable Observations: This sample is a good representation of how the current scheme differs from the original scheme. Originally, the chair was prepared with three layers of white primer, followed by a yellow-tan colored bole/paint and gold leaf decoration.

Generation 2 red-brown paint has a matte appearance almost like a filler when examined at the macro level. It also appears to be present in areas of previous paint loss. It may have not been intended as a presentation finish. Also, sometimes the sequence of brown paints can indicate a graining scheme but this is not the case here (see photomicrographs on next page).

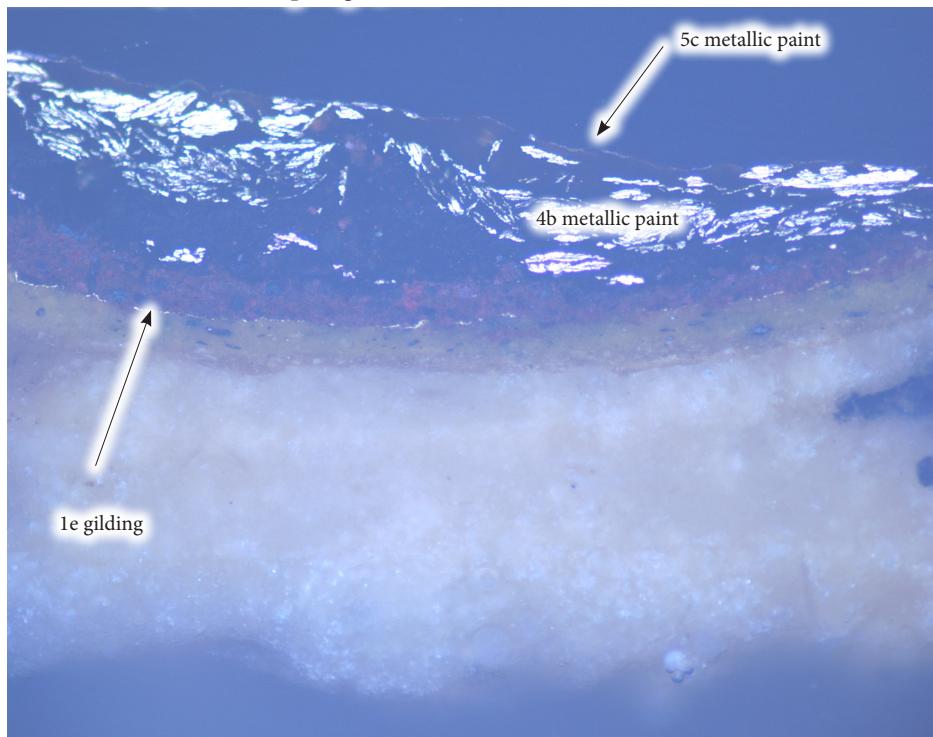
2019.002.01-1, visible oblique light, 200x

[Oblique light helps to identify gilding]

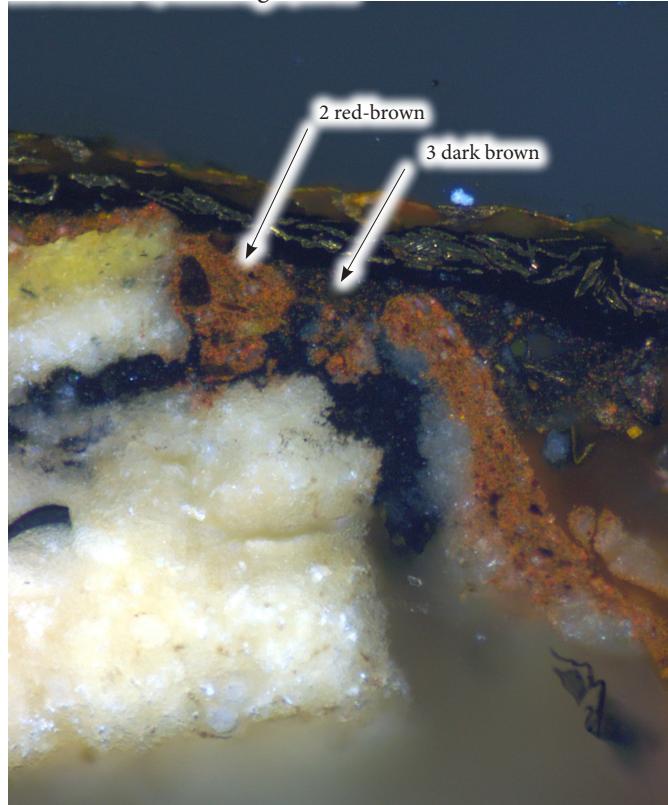
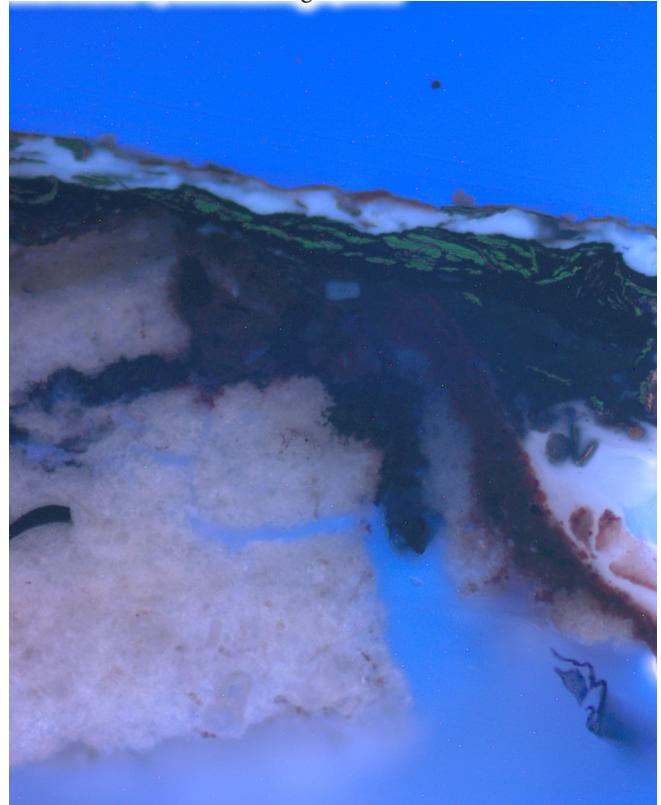
2019.002.01-1, visible light, 200x

In this section of the sample, the red-brown paint can be seen flowing in and around cracks in the original paint generation. Next, the dark-brown paint can be seen flowing into cracks in the the red-brown paint, which confirms that these two layers were not applied at the same time.

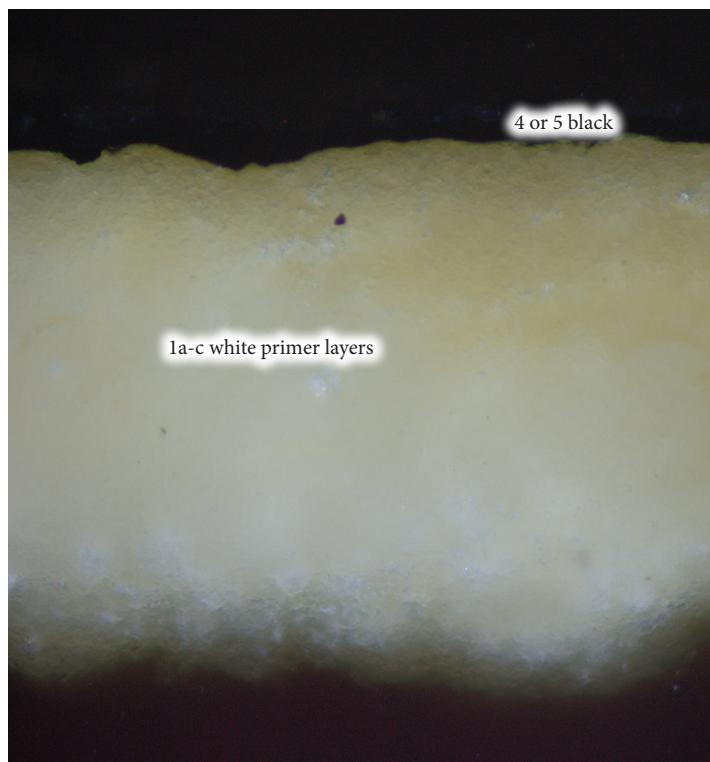
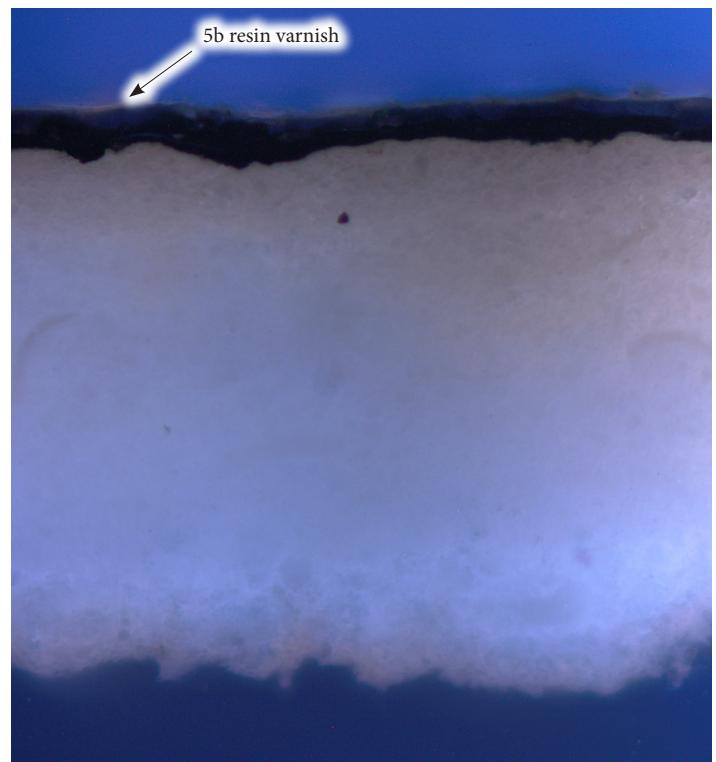
2019.002.01-2, visible light, 200x

Notable Observations: The early white primer layers are present here, in part. The top surface of the white layer looks uneven, suggesting that it has been abraded. The black paint appears to be two thin layers of Generation 4 and 5.

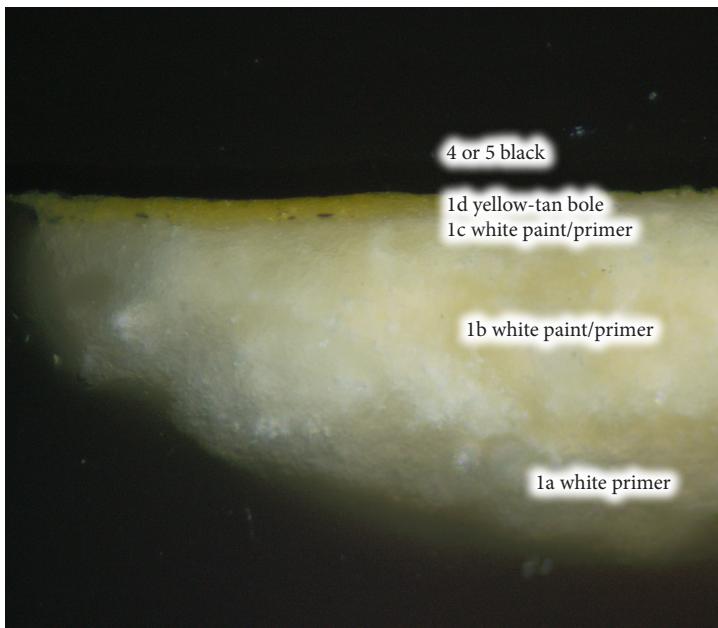
2019.002.01-3, visible light, 200x

Notable Observations: This area of the arm showed some paint build-up so it was thought that the original scheme may be intact. The early layers are present but compromised. In one part of the sample, the yellow-tan bole survives (no gilding), and in another part of the sample, Generation 1 is abraded and incomplete.

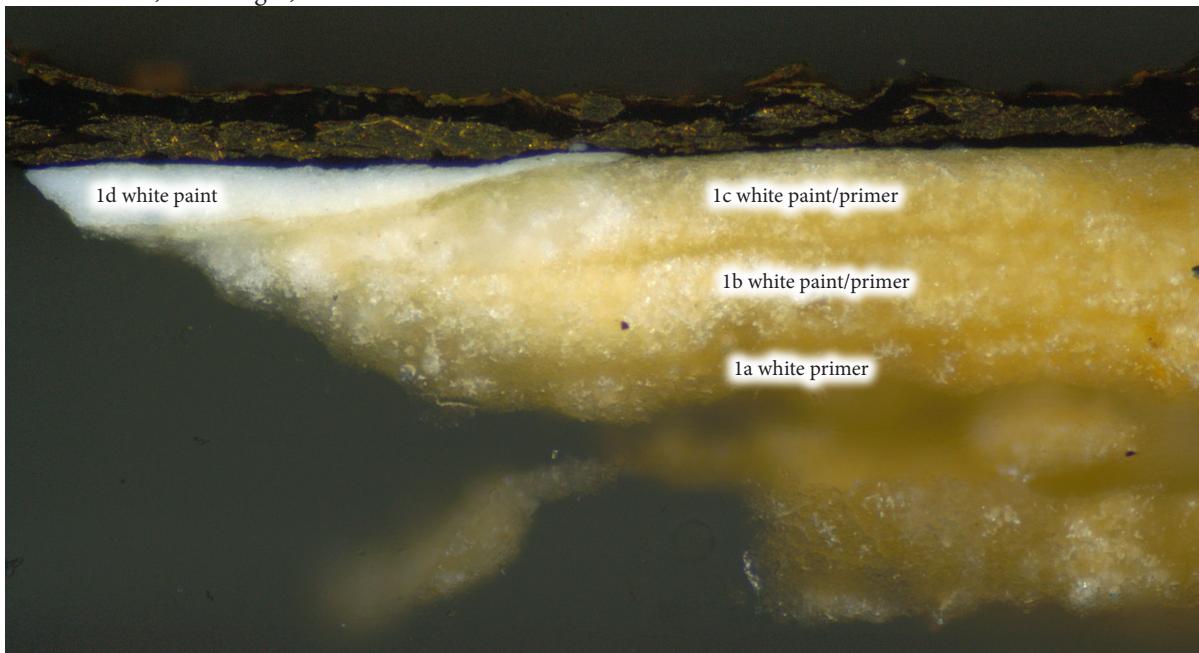
2019.002.01-4, visible light, 200x

The white paint in this sample is not fully understood. It is likely that the white paint is part of the original paint scheme, such as white-painted background or highlights. The paint evidence does point in this direction: there is no dirt accumulation or signs of age between the white primer and the white paint. Or, it could be part of a repainting campaign (Generation 2). Further sampling or reveals could inform on this.

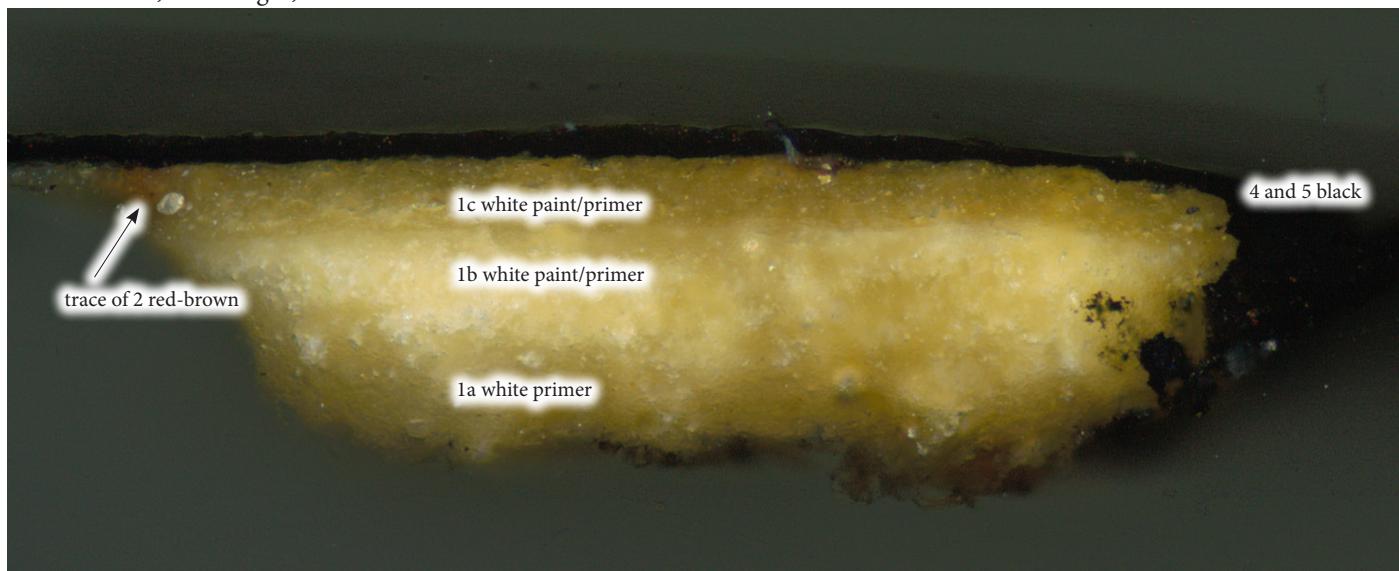
2019.002.01-5, visible light, 200x

Notable Observations: The early white primer layers are present here, though the original scheme does not survive on the front of the ringed slat. The black paint appears to be two thin layers of Generation 3 and 4. This sample also contains a thin layer of shellac, as indicated by its orangish autofluorescence in UV light.
