NATIONAL PARK SERVICE
Washington D.C. 20240HISTORIC PRESERVATION CERTIFICATION
APPLICATION — PART 2

Part 2 DESCRIPTION OF REHABILITATION

1. NAME OF PROPERTY: Railroad Car Shop
 Address of property: Street 44 Line Street
 City Charleston County Charleston State SC Zip Code 29403

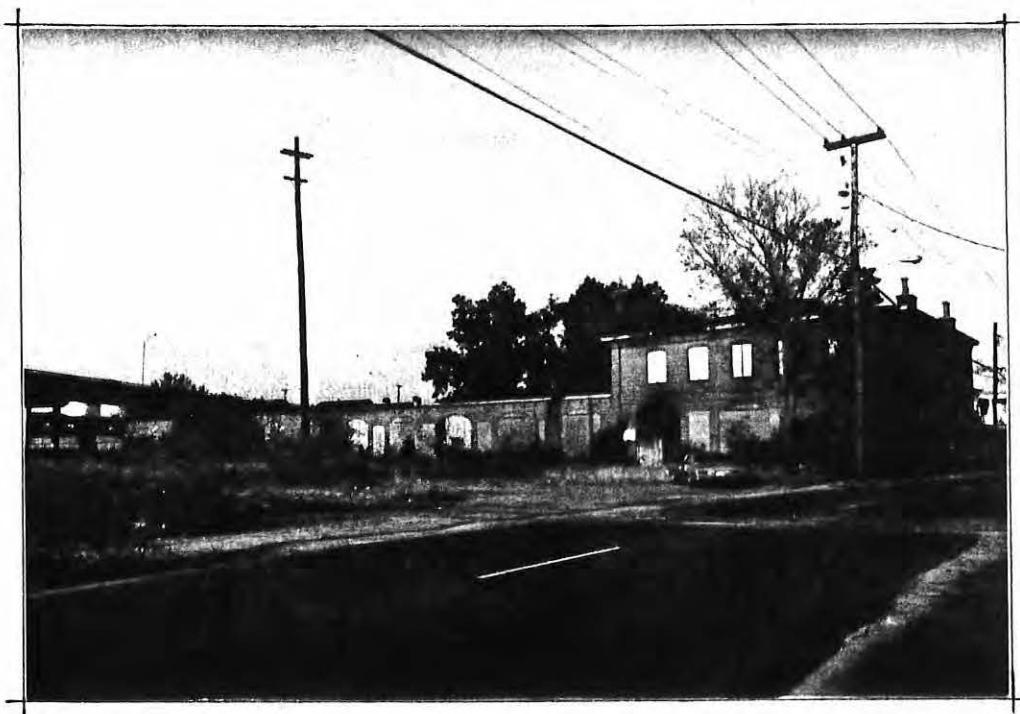
#1

Exterior Site:
West Elevation

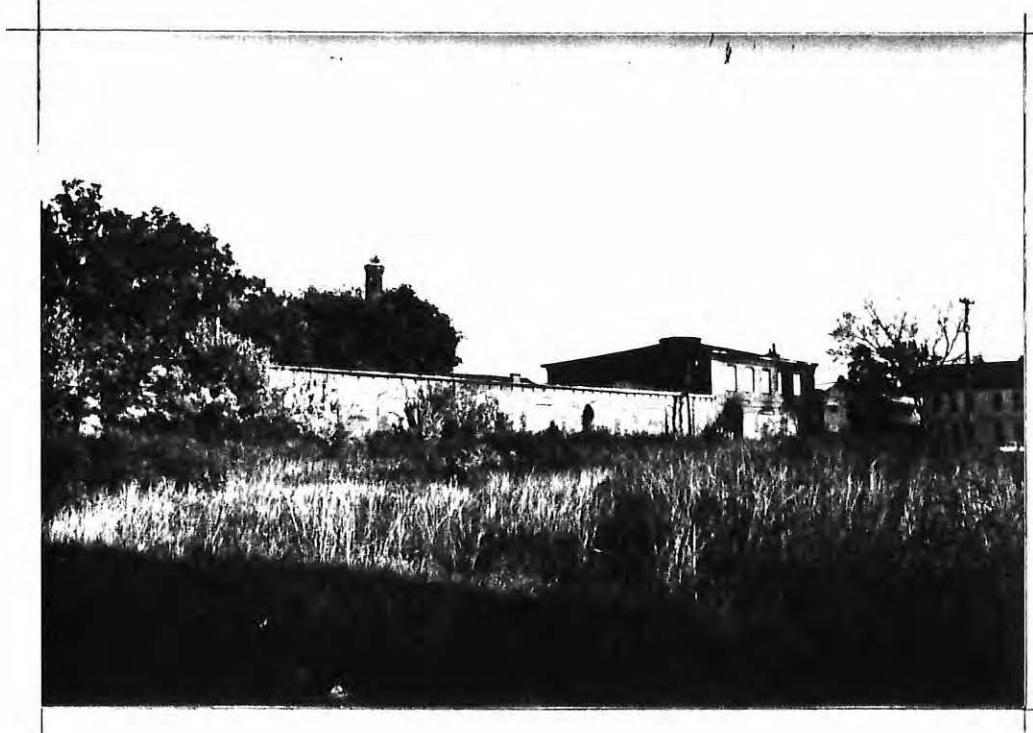
#2

Exterior Site:
From northwest with view
of train yard area

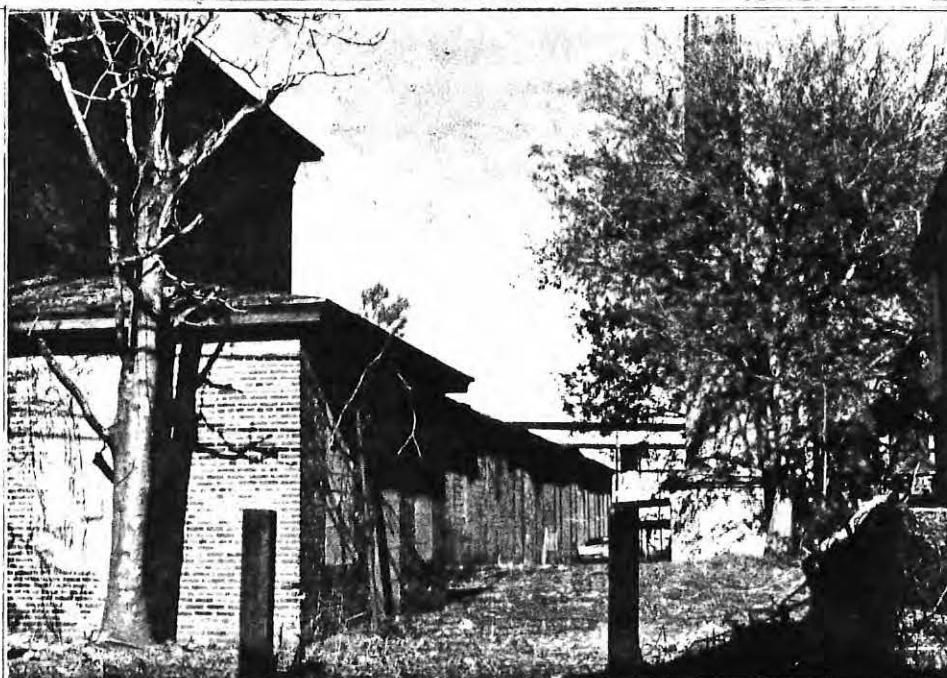
#6

Small 1-story brick addition to east elevation with asphalt roof. Interior and roof structure were completely destroyed by fire in December 1981. Window and door openings are infilled with CMU.

East Elevation: Small
1-story brick addition

Note CMU blocks in window

Addition to be rehabilitated for use as a small office/apartment. Interior partitions of modern design will be installed. All walls to be sheetrocked. Roof structure to be rebuilt to original configuration. Roofing to match new roof over warehouse (see # 7).

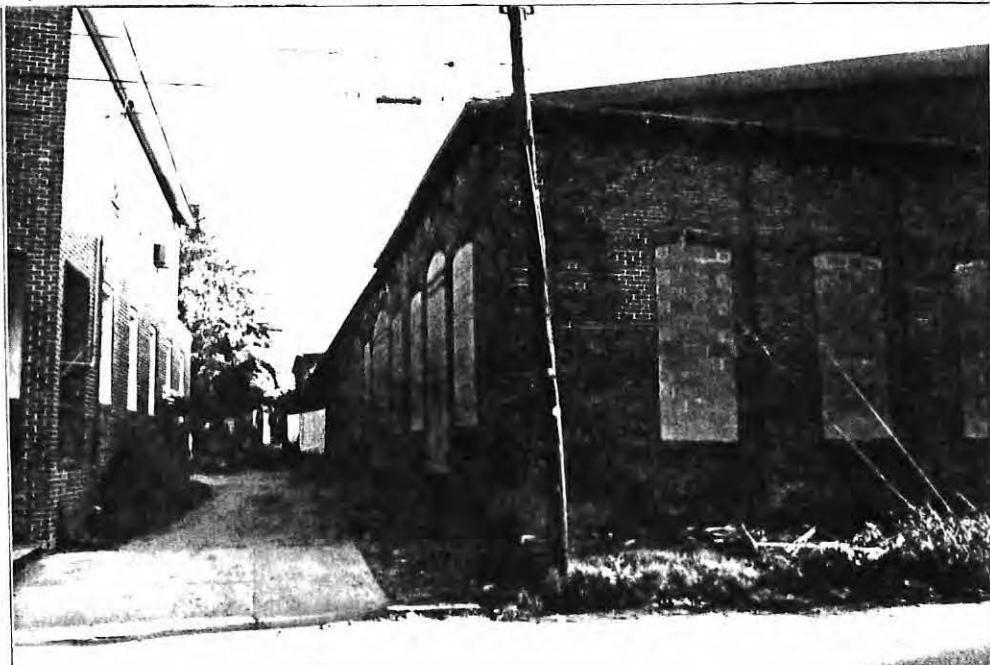
#7

1-story Train Shed
viewed from the northeast

Note CMU infill in window
and cargo openings

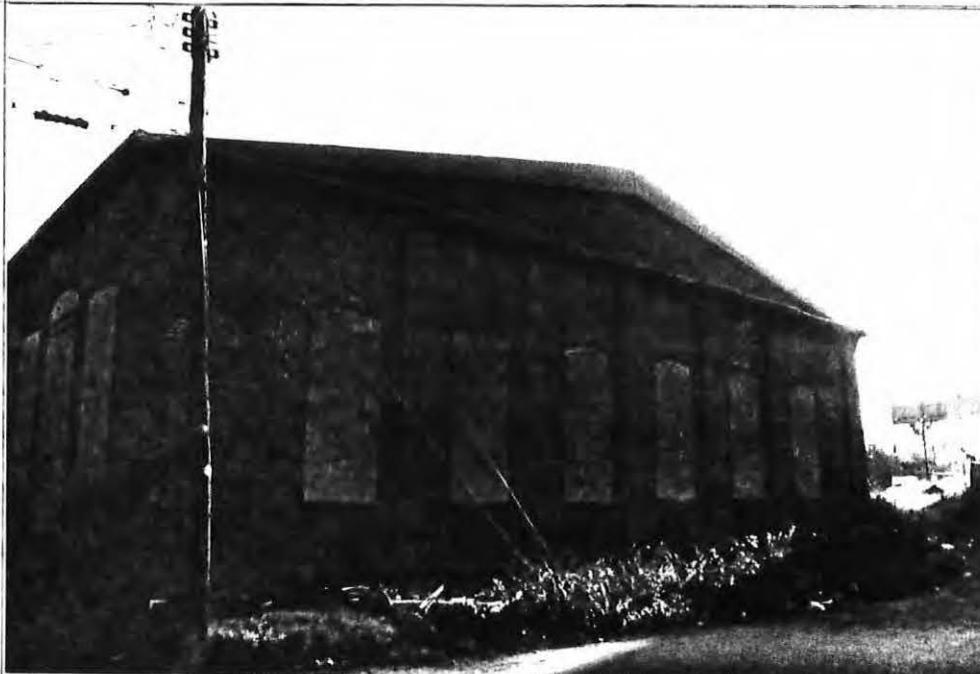
#8

North Elevation: 1-story section

Note existing truss roof form

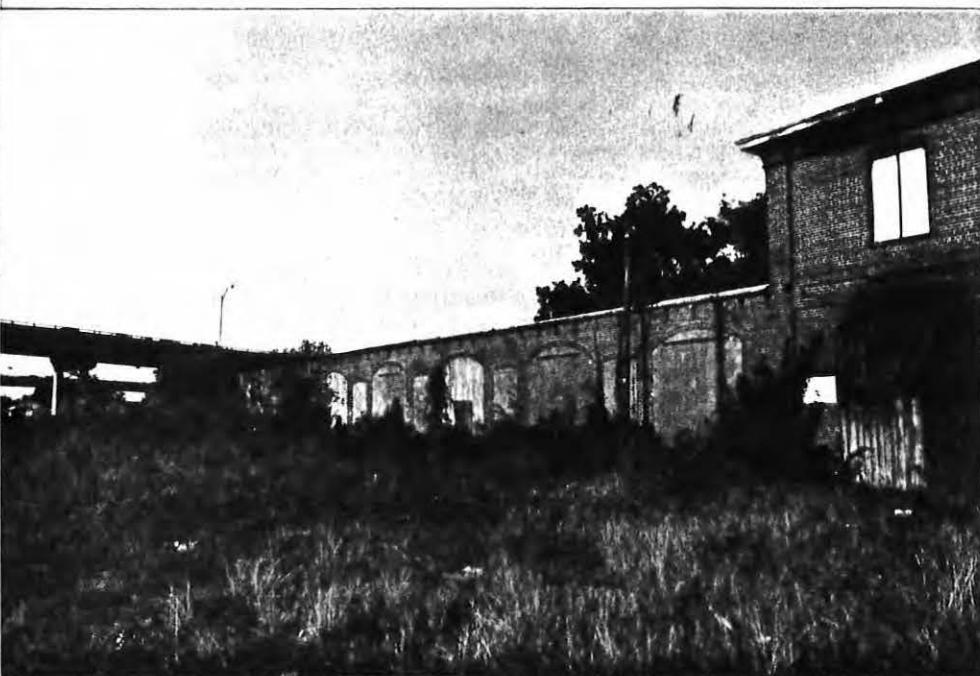
#9

West Elevation showing roofless 1-story section and 2-story section to the right of the photo

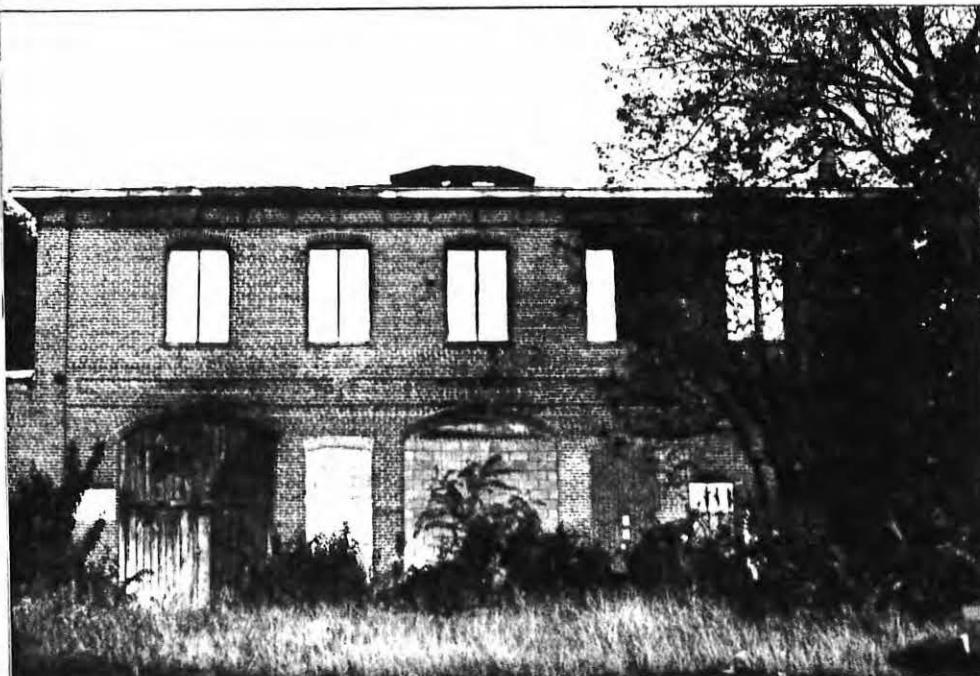
#10

West Elevation: 2-story section

Note asphalt roof and cupola base

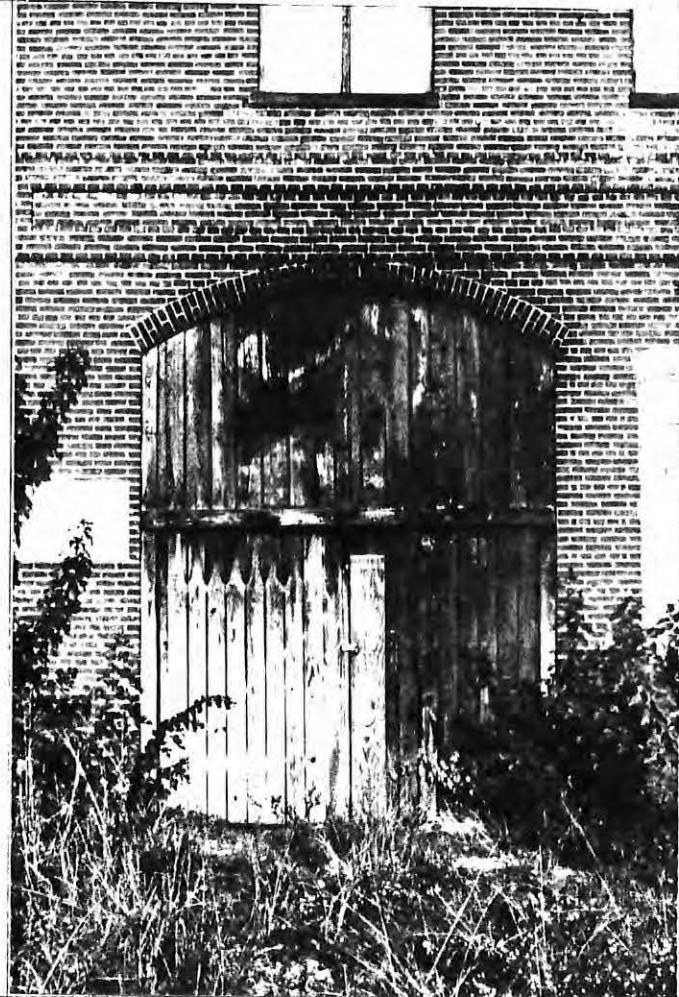
#11

Former cargo opening:
Typical segmental arched
opening with wood plank
infill

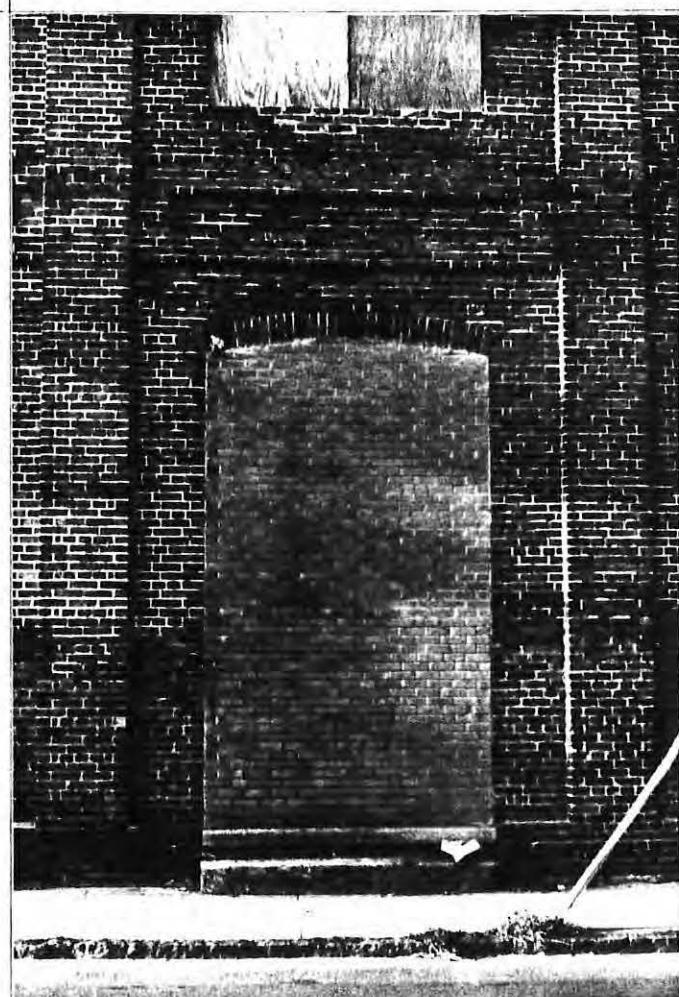
#12

Main entry arched opening
Infill is brick and will
remain

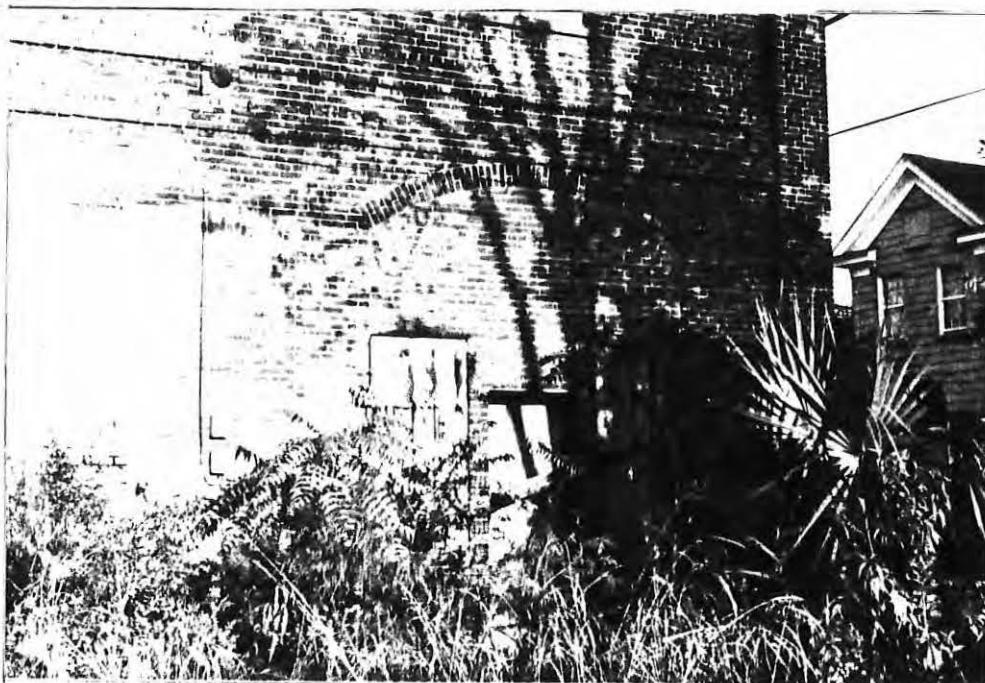
#13

Bricked arched window and cargo opening

Note segmental arches

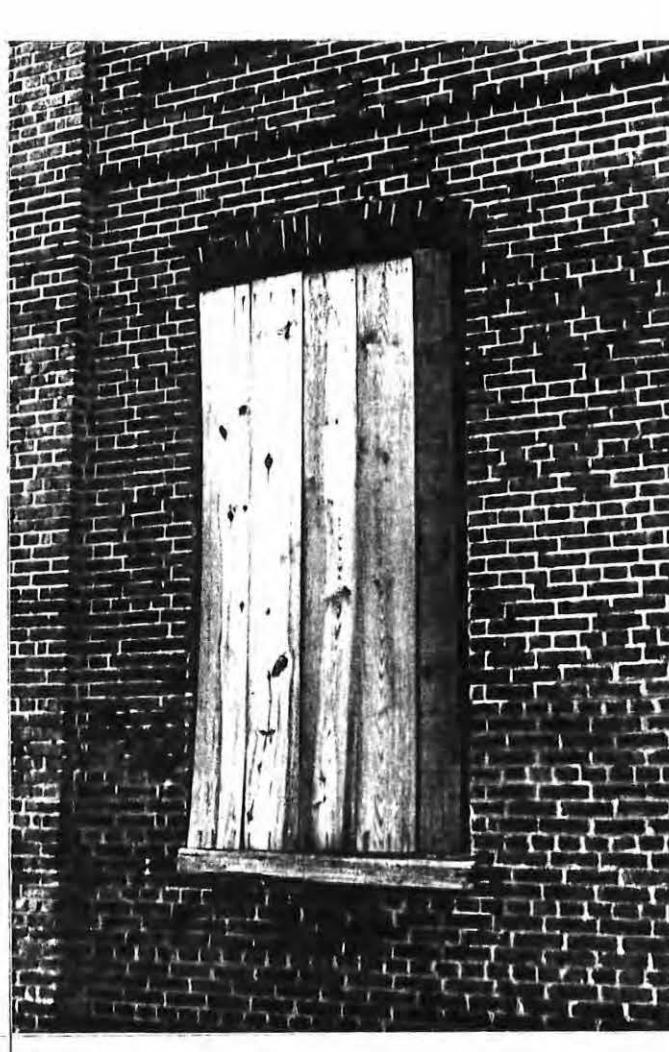
#14

Typical segmental arched opening

Note deterioration of sill

Note wood plank infill

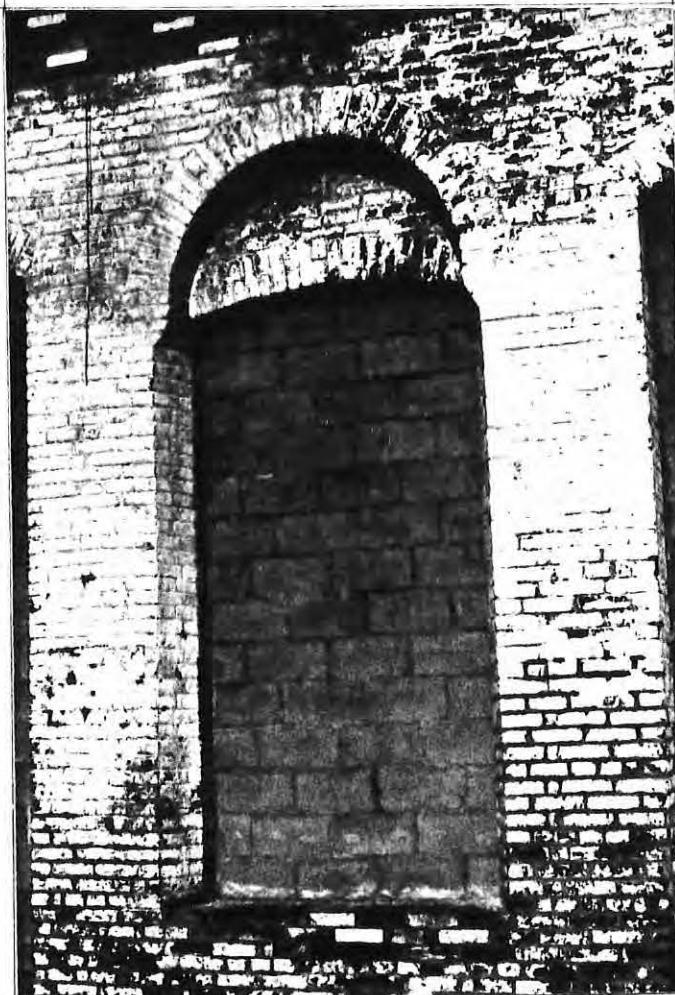
#15

Typical window opening:
1-story section viewed
from interior

Note sash and jamb
deterioration

Note plyboard infill

Wood shutters to be installed in window openings as indicated in plans. Design for shutters patterned after shutters shown in historical photographs of the building (ca. 1914) and reflect the utilitarian industrial nature of the building. Shutters to be constructed of exterior grade T&G 2X8" wood at 30° to vertical. Where possible charred wood jambs will be left within the (CONT)

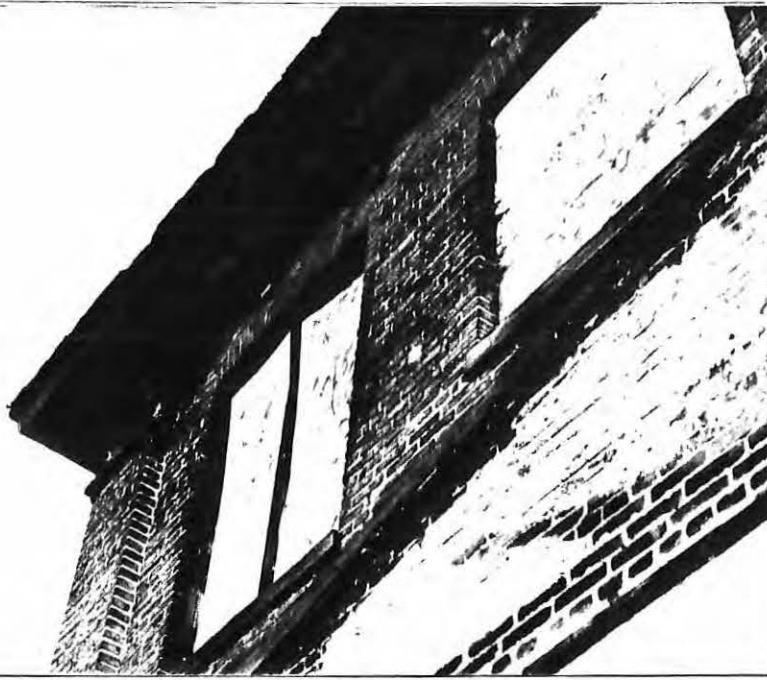
#17

Original corbelled eave with iron soffit and masonry brackets are in good repair.

2-story section:
detail of corbelled eave

Masonry will be repaired where necessary as per Preservation Brief #2. Metal soffit will be primed and painted.

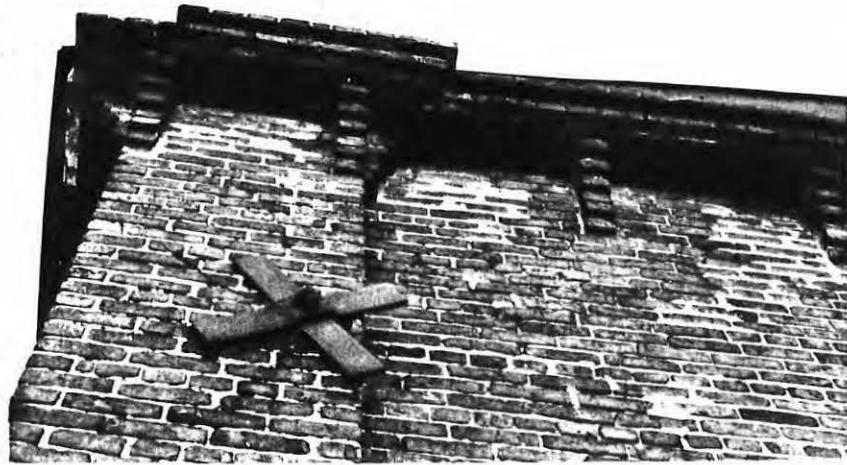
#18

1-story section:
detail of corbelled eave
Note iron soffit and
masonry bracket

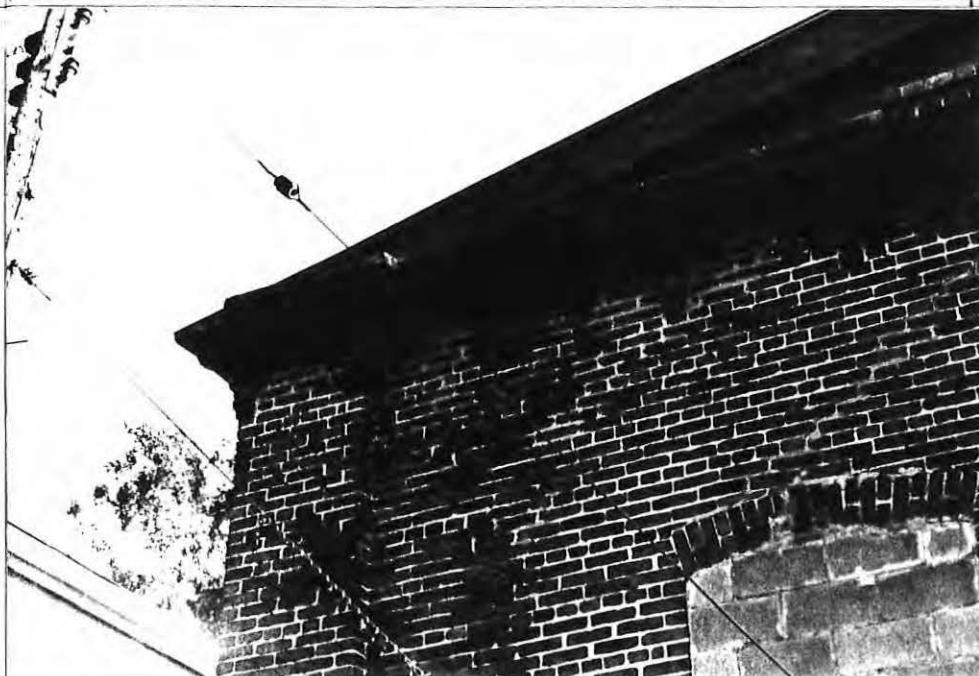
#19

Detail of corbelled eave
showing corbelled brick
cap

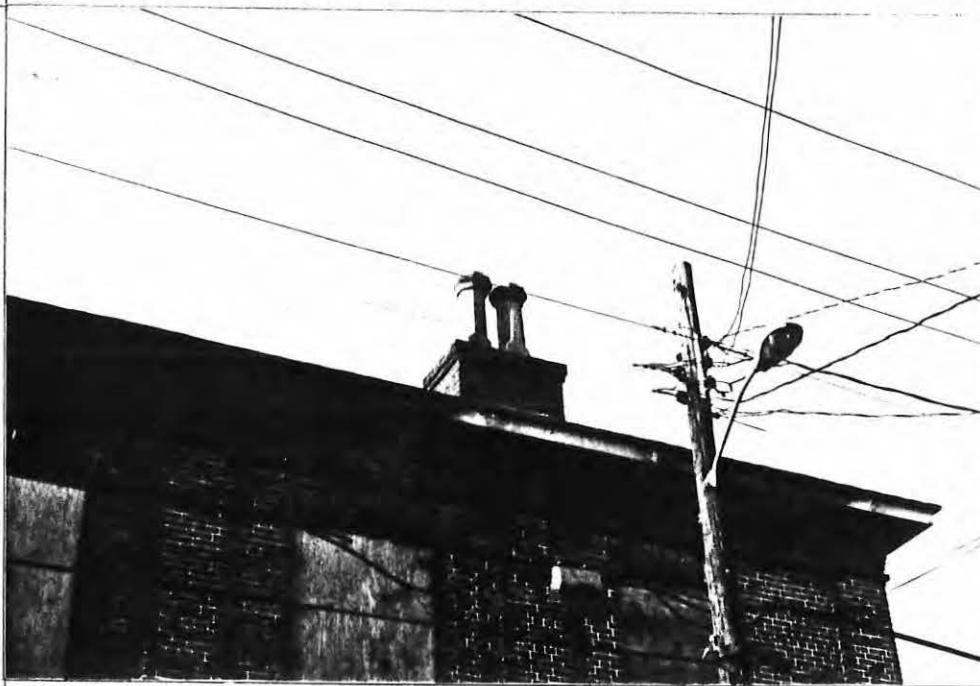
#20

Detail of chimney and
terracotta caps

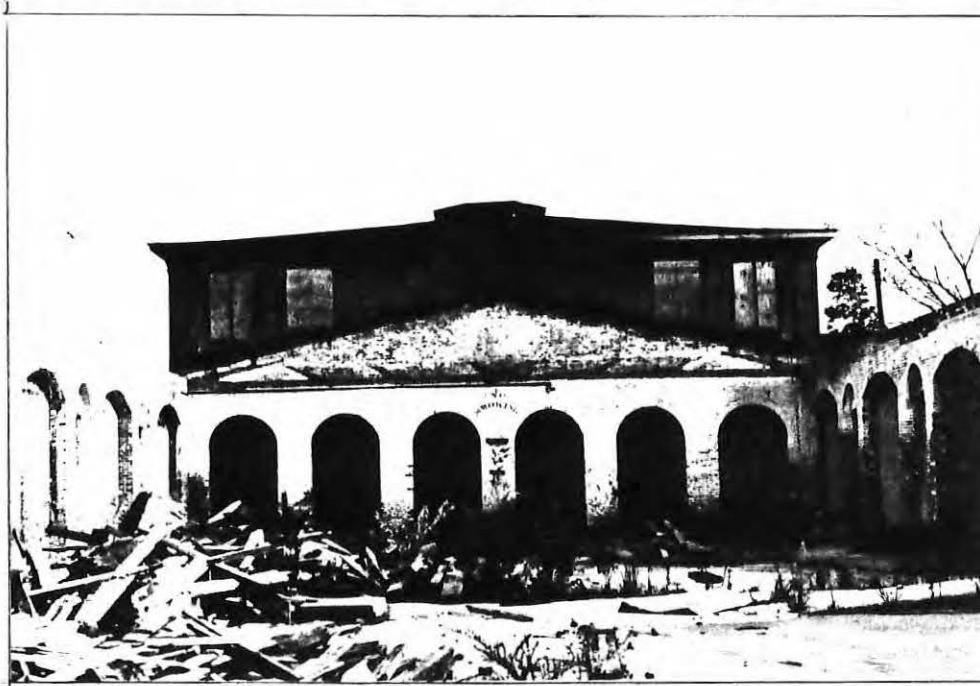
#21

1-story section: general
interior looking south

Note asphalt roof

Note cupola base

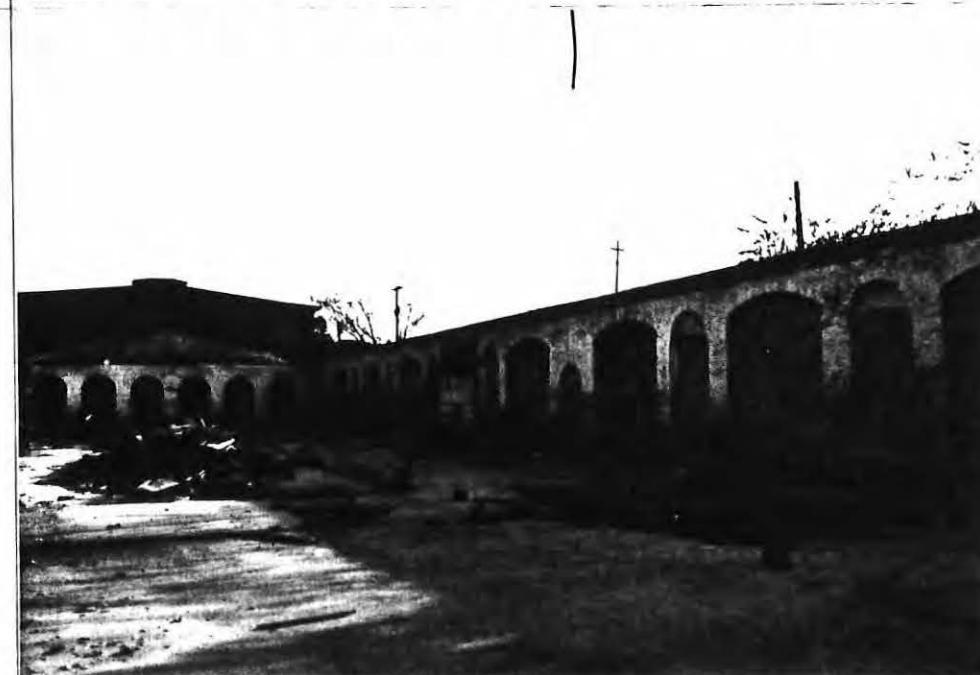
#22

1-story section: general
interior looking southwest

Note interior masonry
detail and cement slab flo

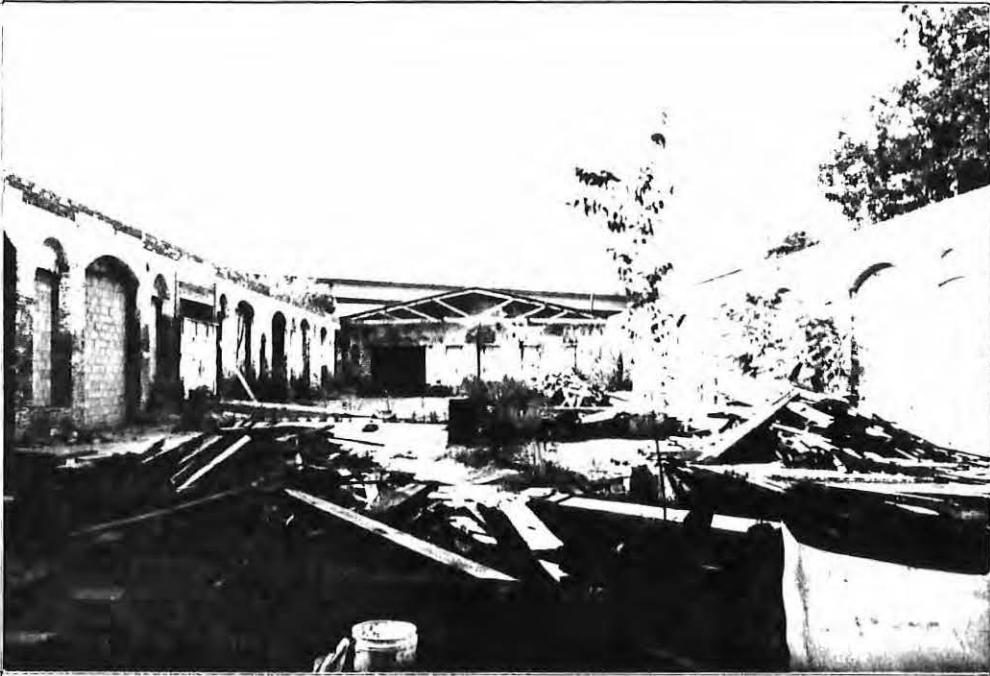
#23

1-story section: general interior looking north

Note existing truss and roof system

Note loading platform ramp

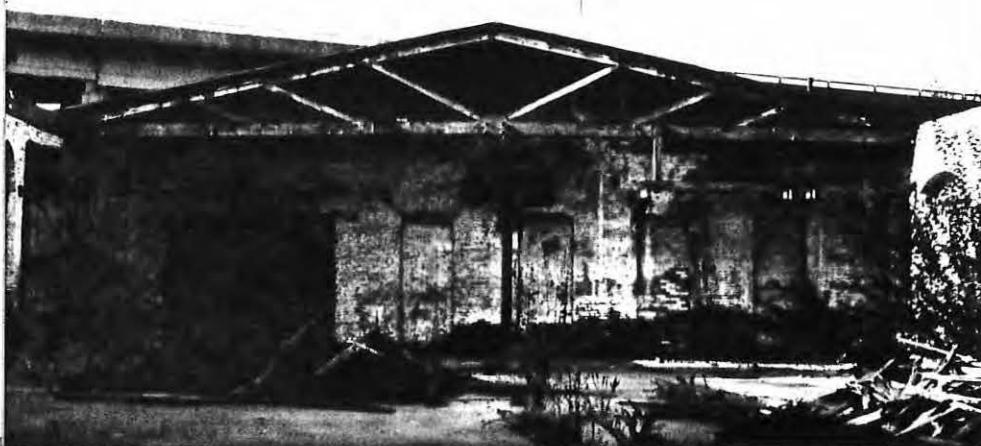
#25

Detail of original truss
and roof system:
north end of 1-story
section

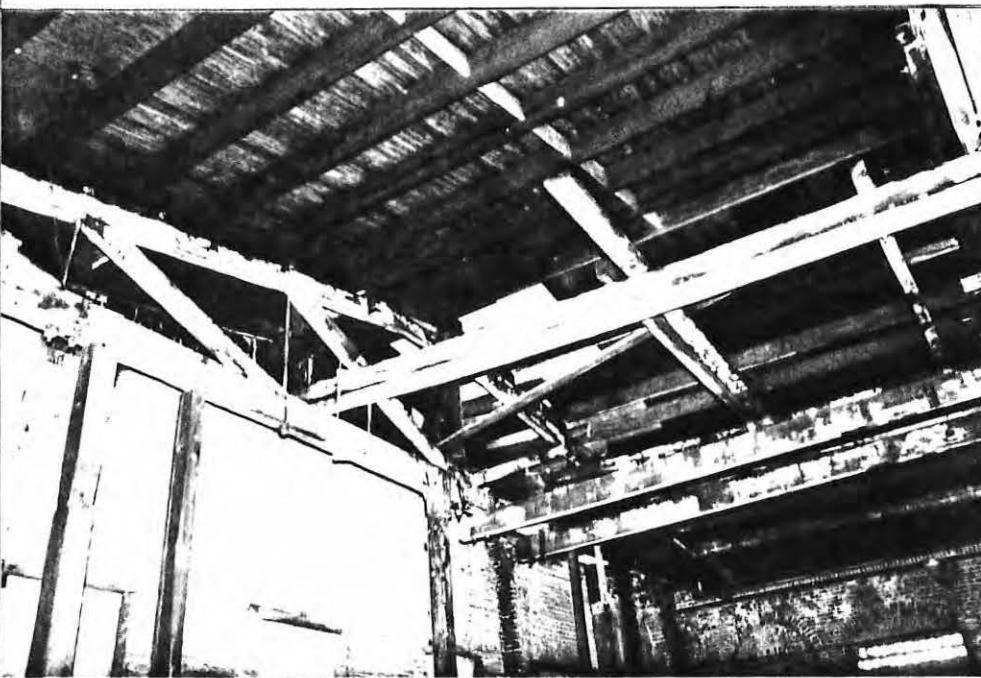
#26

Interior detail of original
truss and roof system:
1-story section

Note purlins

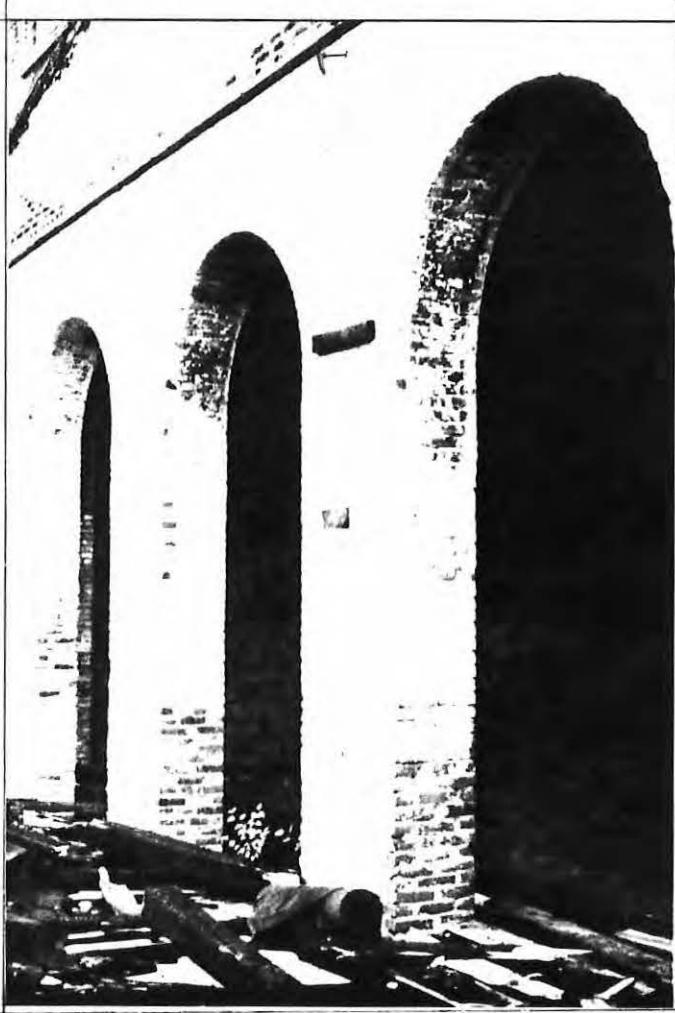
#28

Detail of arches leading into 2-story section

Arches to be infilled with 4-hour masonry wall

2" reveal will be retained to express arches

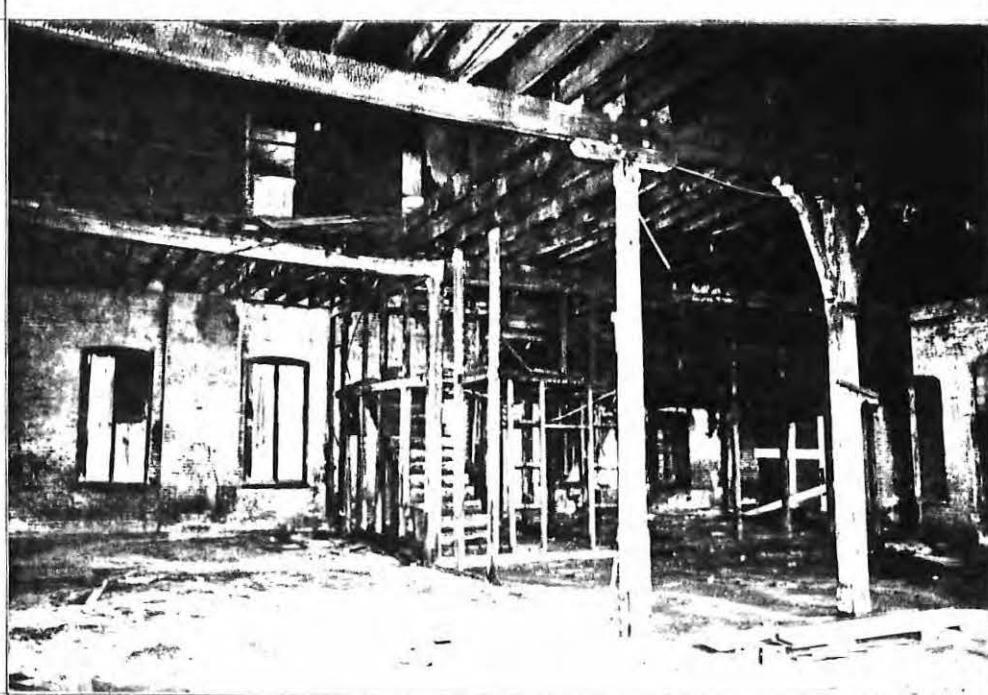
#29

General interior: 2-story section

Note charred floor system and original columns

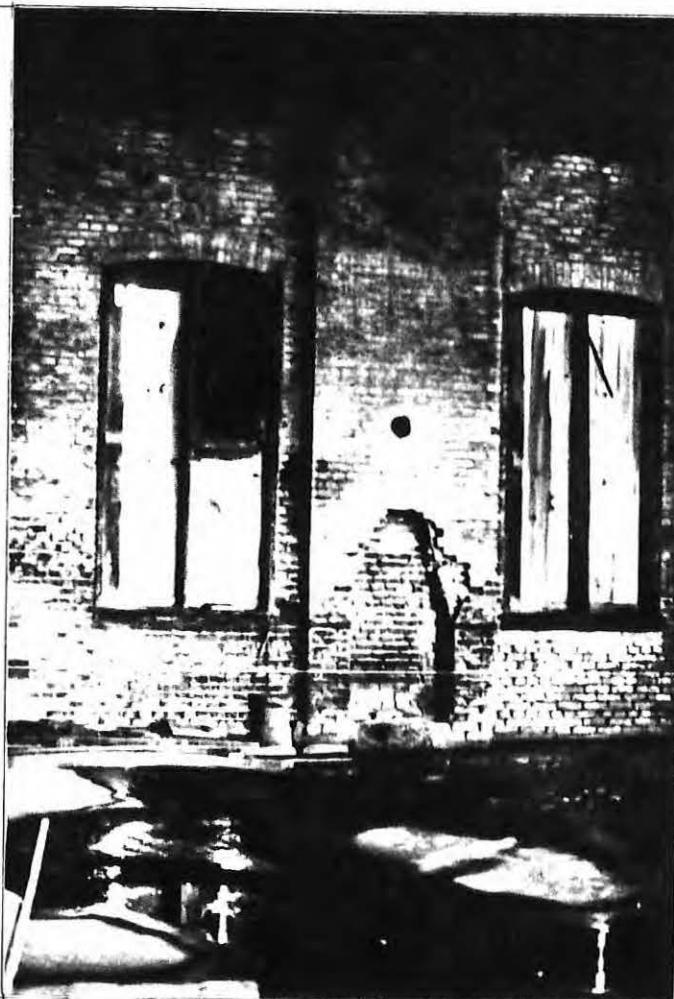
#30

Interior detail of window and chimney

Window trim and sill are charred beyond repair

Masonry at chimney will be repaired

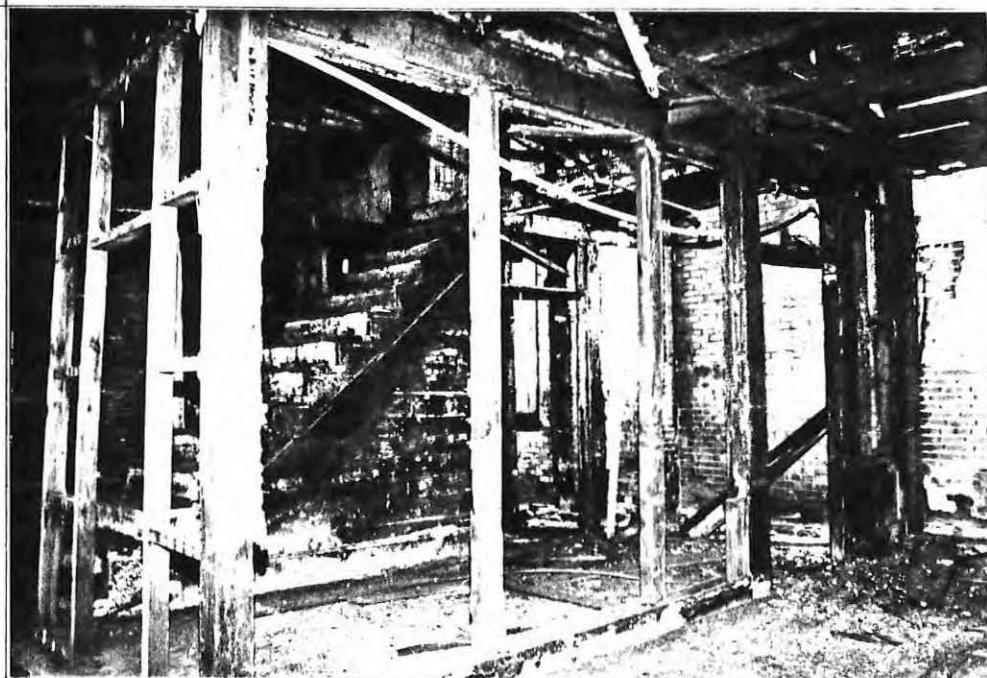
#31

Detail of original staircase

Wood partitions and stair are charred beyond repair

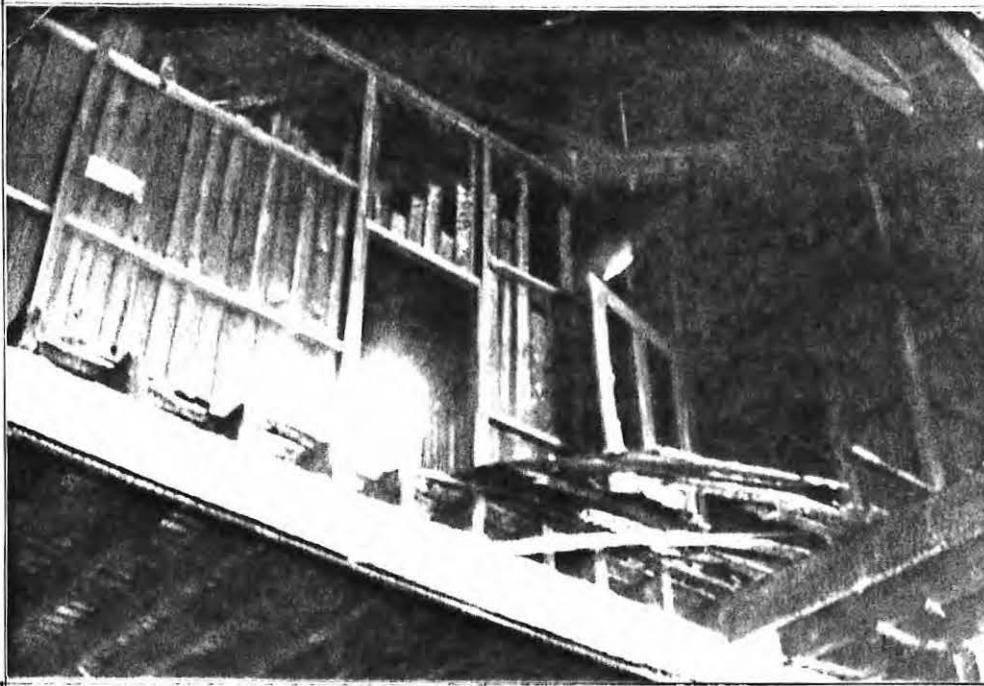
#32

View of second story
wood partitions

Second story floor system
will be removed

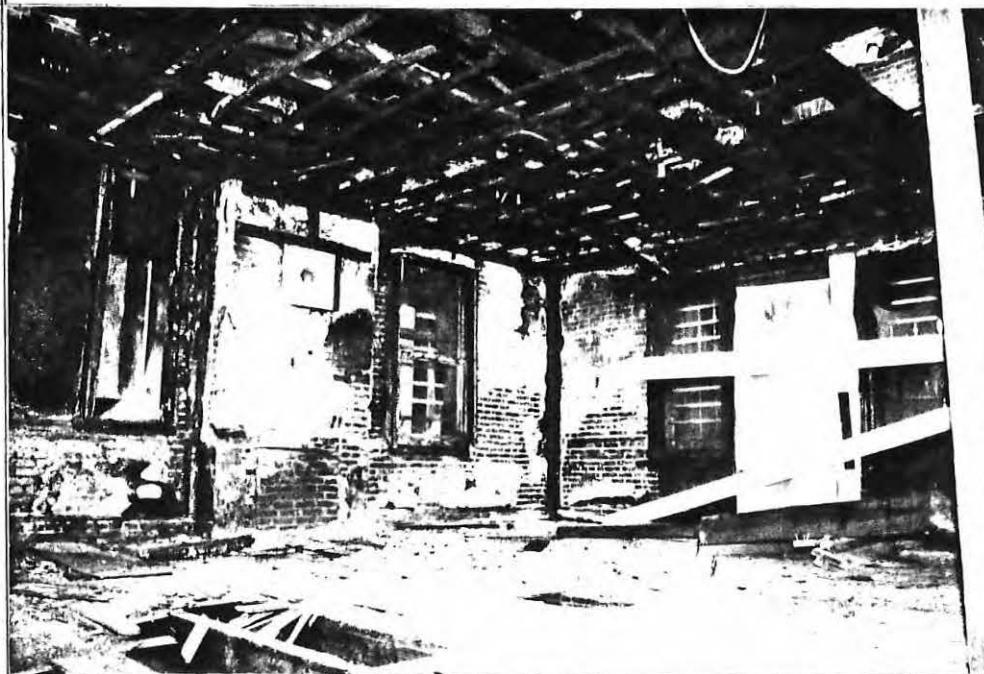
#33

General view of second
floor interior

Note exposed masonry wall:

Note infilled chimneys and
remnants of second story
woodwork

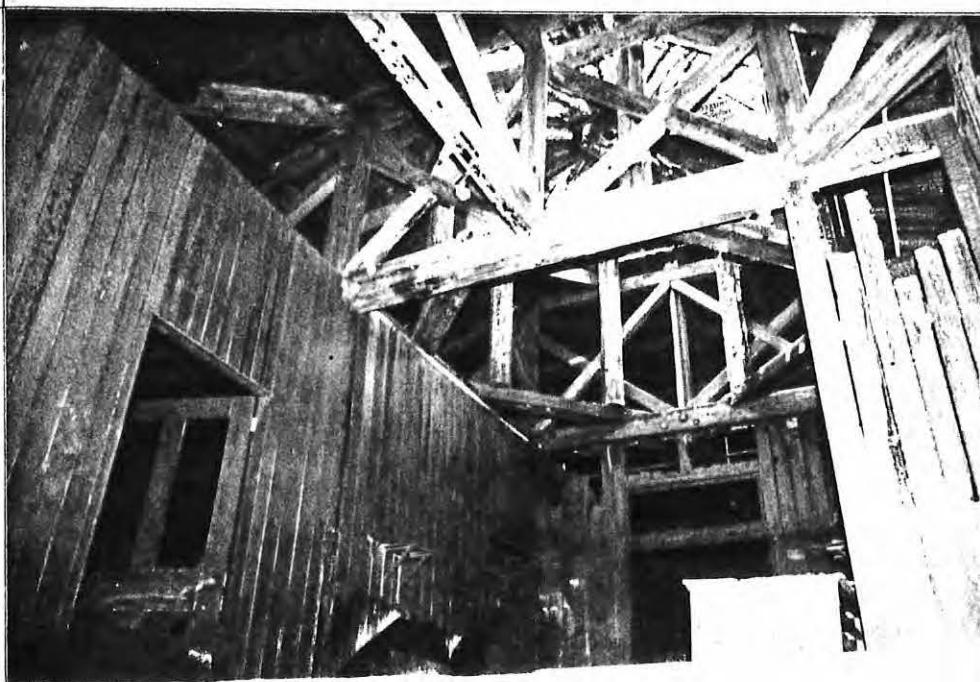
#35

General view of cupola substructure and truss system

Second floor of 2-story section

Truss system will be shored and left in place

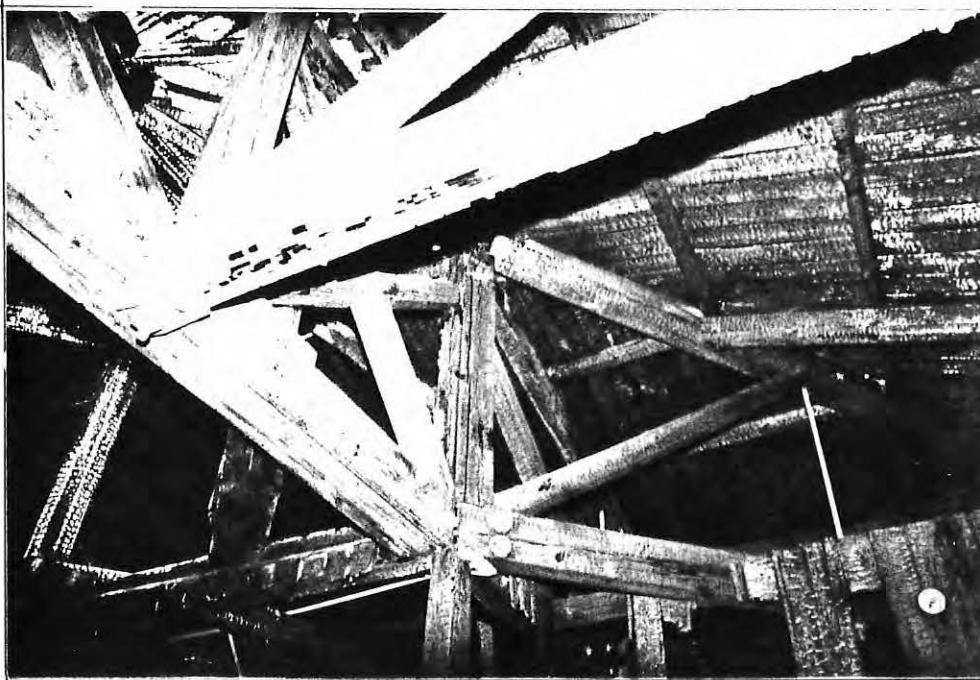
#36

Detail of cupola substructure and truss system

Trusses retain their structural integrity

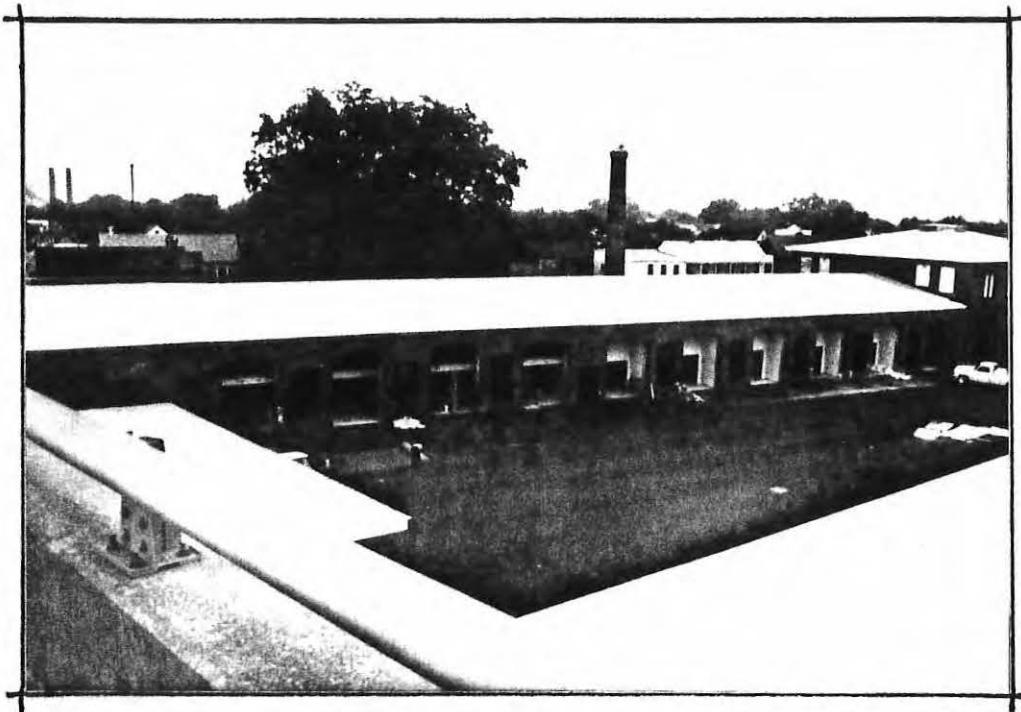
5)

Train Shed

Note New Tin Roof and
Removal of Cargo Door
Infill

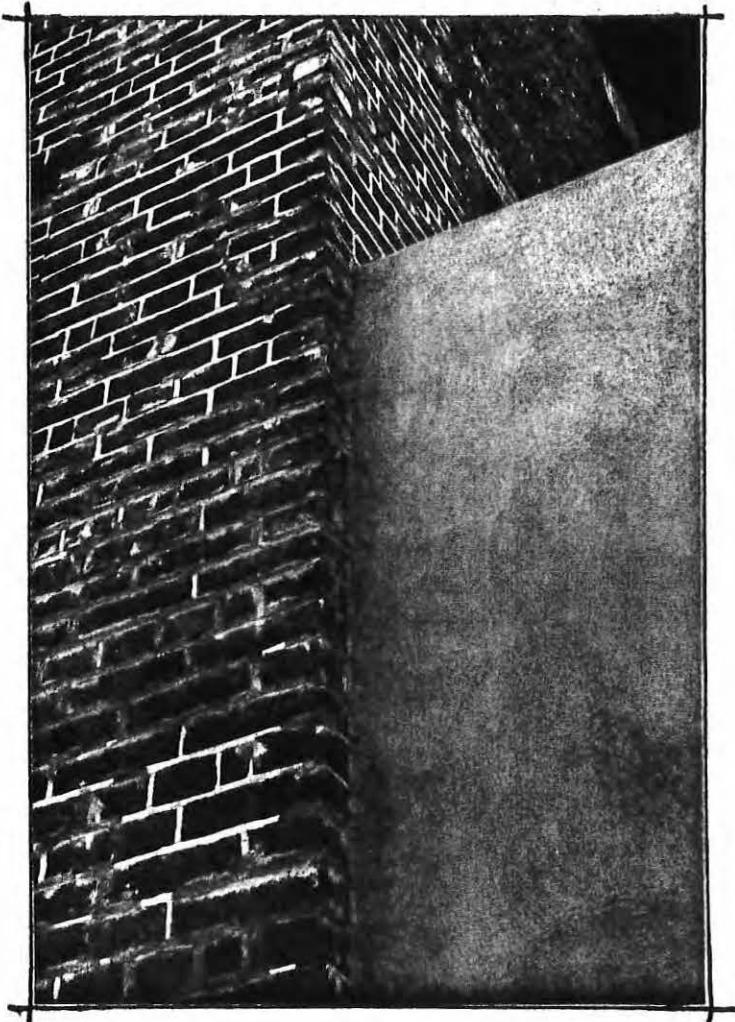
2

Detail of East Wall:
Note that Wall was set
Back from Facade

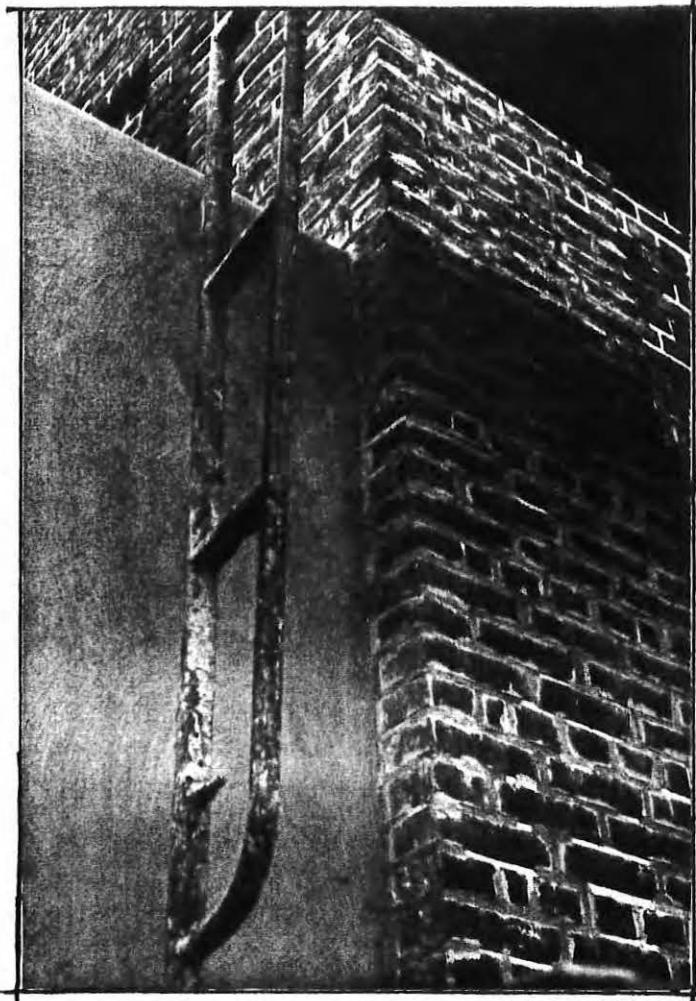
3

Detail of West Wall:
Note that Wall was set
Back from Facade

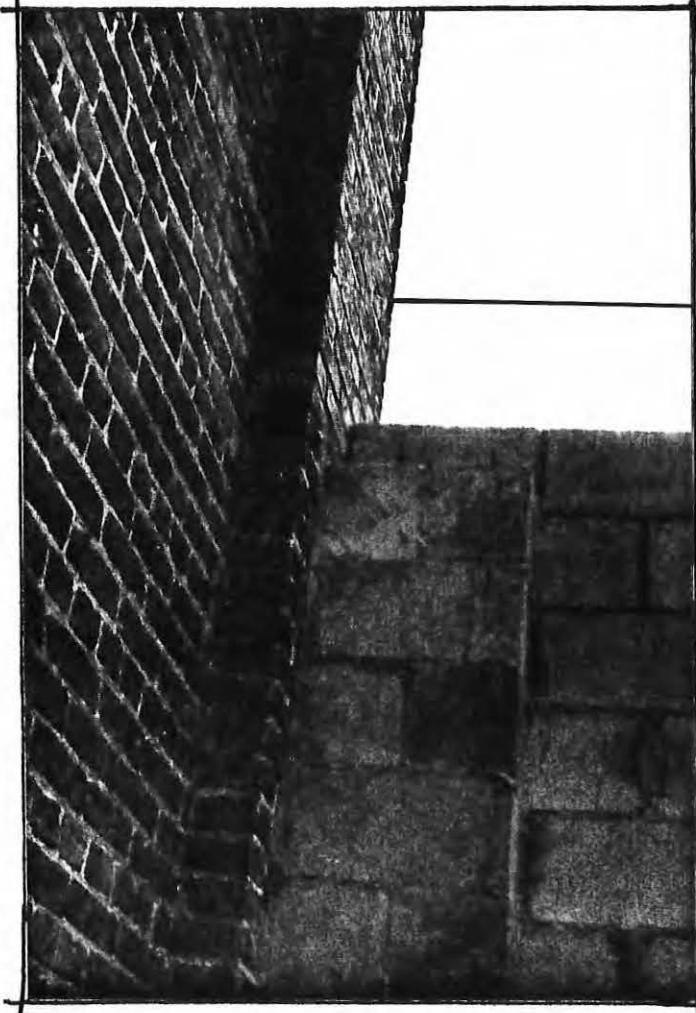
4

Detail of West Wall, Set
Back from Facade
Note that the Block has
Not been Toothinged into the
Original Brick
