NATIONAL PARK SERVICE
Washington D.C. 20240HISTORIC PRESERVATION CERTIFICATION
APPLICATION — PART 2

Part 2 DESCRIPTION OF REHABILITATION

1. NAME OF PROPERTY: Railroad Car Shop
 Address of property: Street 44 Line Street
 City Charleston County Charleston State SC Zip Code 29403

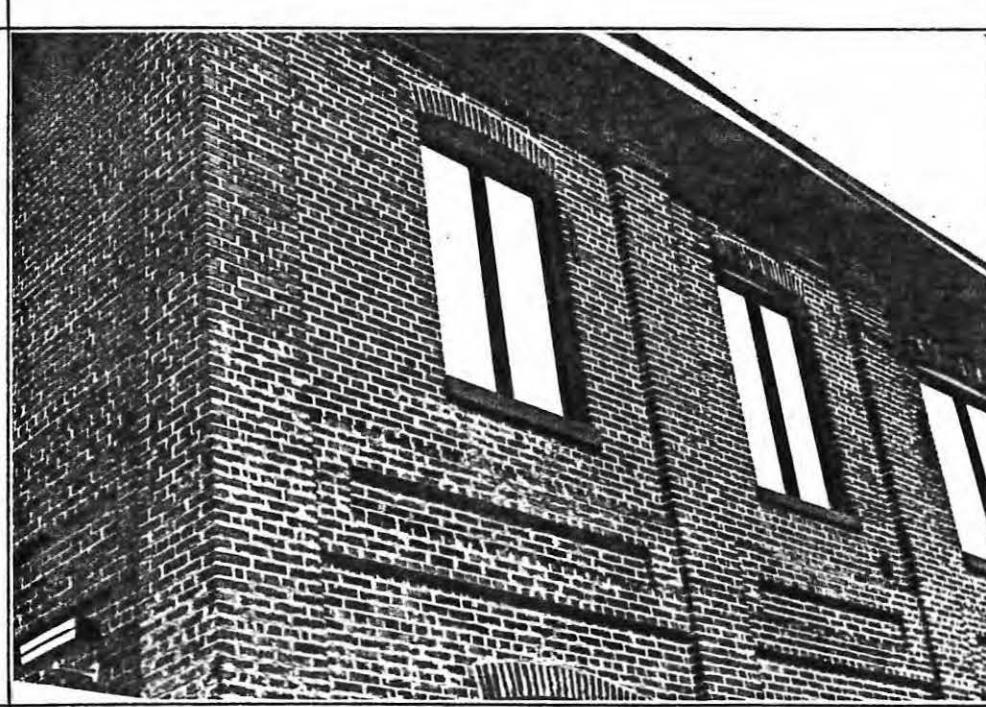
*3

DETAIL OF WINDOW IN
MAIN SOUTH FAÇADE

Note: Brick details in window arches and panels, restored and reworked window jambs, sills, and mullions

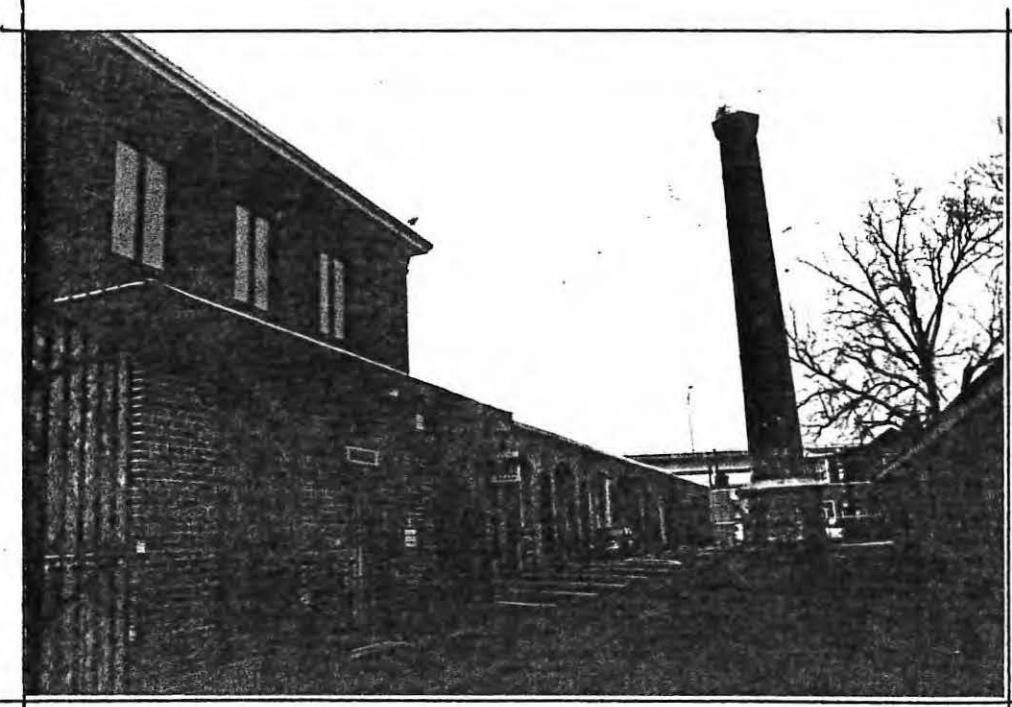
#4

EAST ELEVATION

Note: Retention of smoke stack,
reopening of original cargo
openings

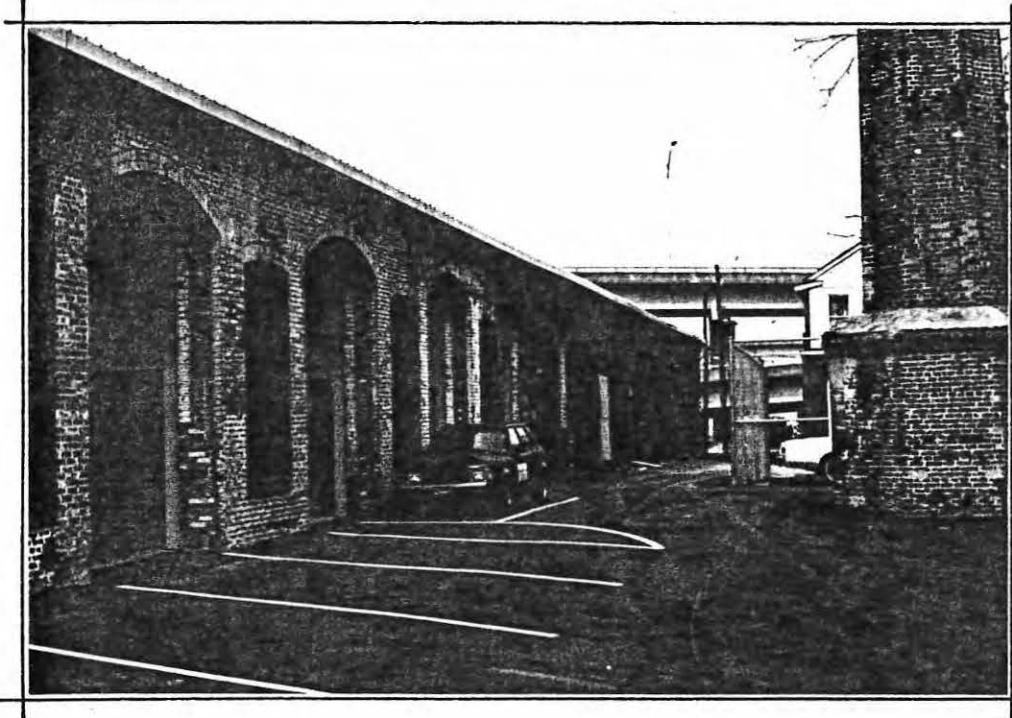
#5

EAST ELEVATION, REAR
SECTION

Detail of smoke stack and reopened
cargo doors (Doorways had been
blocked with cement block infill)

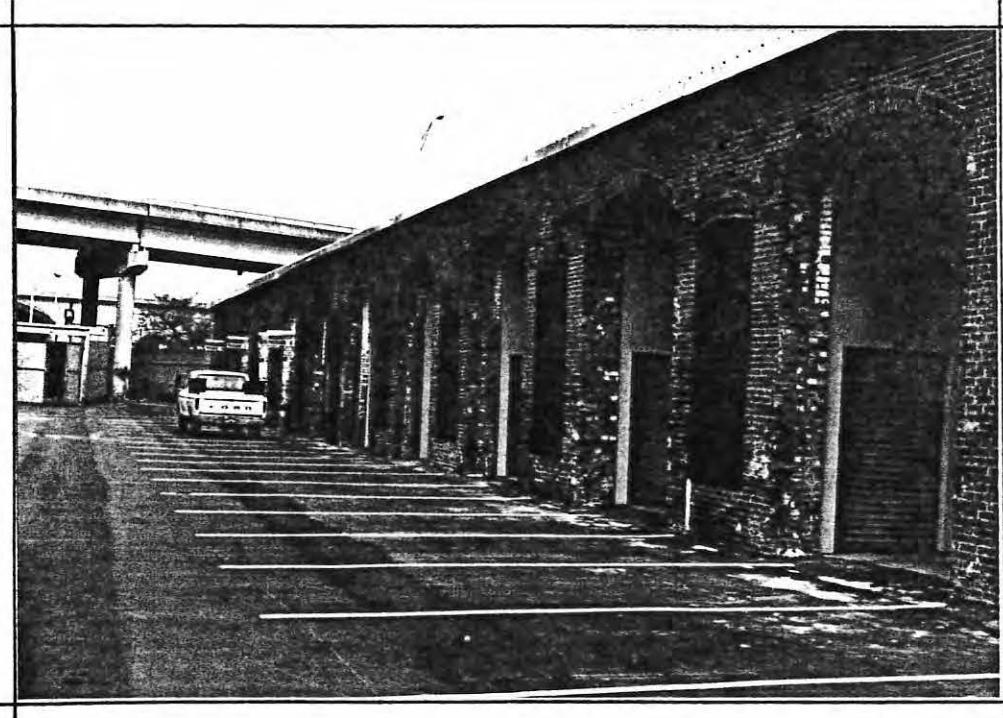
#11

WEST ELEVATION, REAR
SECTION, FACING
NORTHEAST

Note: New infill has been recessed
to read as original openings

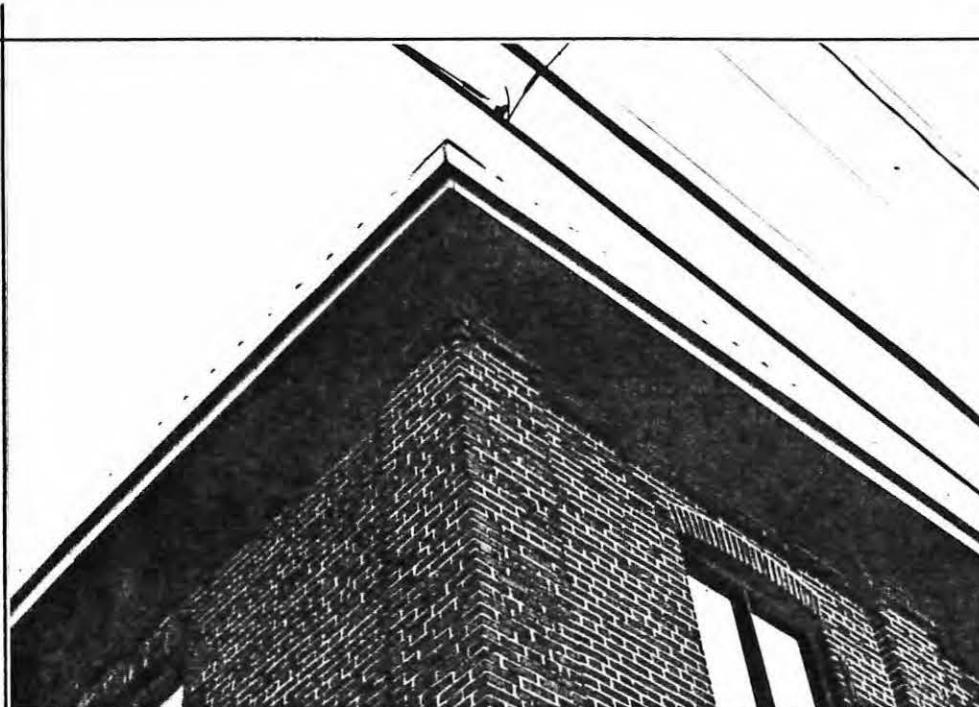
*13

CORNICE DETAIL FACING
NORTHEAST

Facia and cornice were
rehabilitated as per the 1979 HCRS
plans.

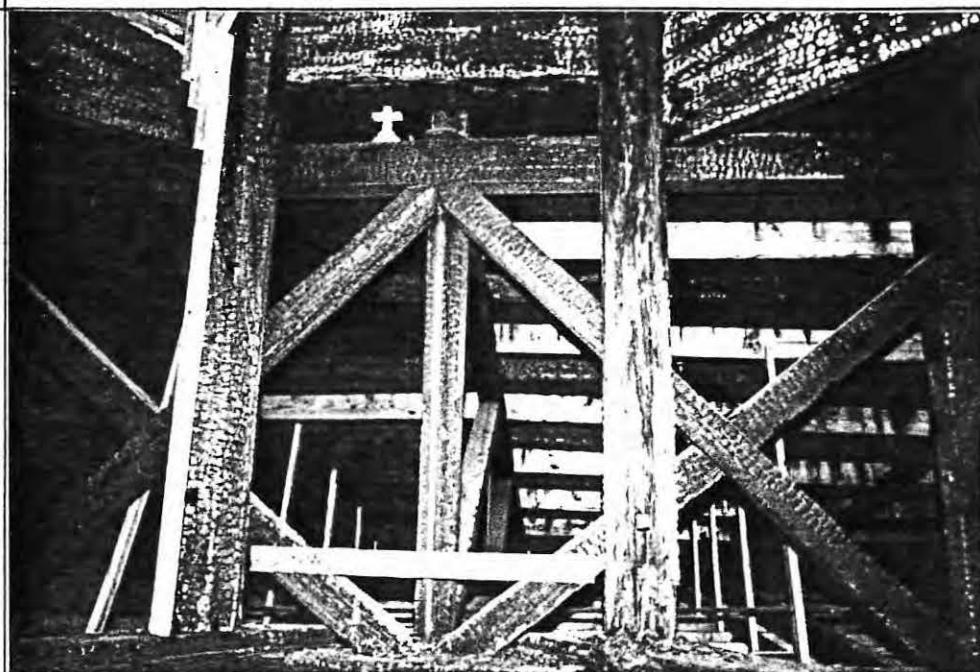
#20

DETAIL OF ORIGINAL
HEAVY TIMBER TRUSS
AND PERLINS WITHIN
ROOF

Note: Retention of original timber system of two story portion
