# 1886 Earthquake Damage Assessment

82 Church St.

HISTORIC CHARLESTON FOUNDATION  
HURRICANE HUGO DAMAGE ASSESSMENT FORM

Street Address: 82<sup>84</sup>-CHURCH ST

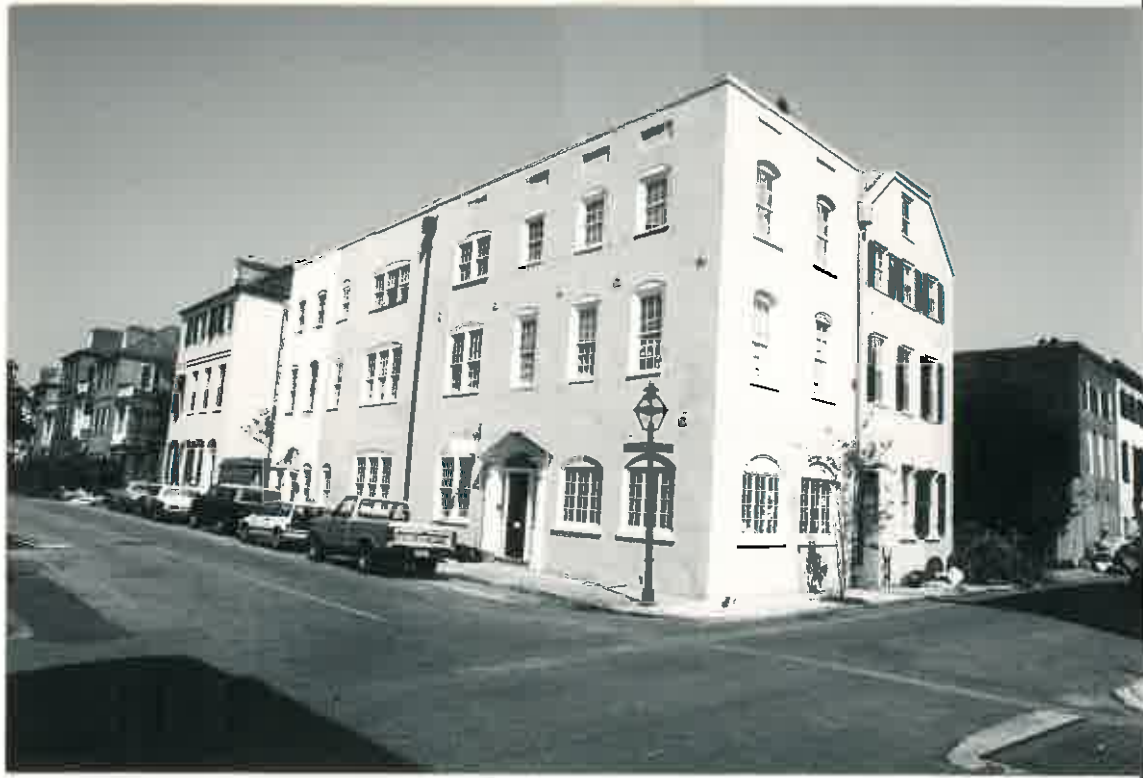
82-84 Church Street After Hurricane Hugo
