## **Part II – Stable**

### **Background:**

The paints on the interior of the stable were not studied as part of the Phase I dissertation research, so all the sample locations were selected based on discussions with Graham and Ridout, who had specific questions about how the building interior had been altered. Representative elements (woodwork, plaster, doors) in each room were sampled to document and compare their paint stratigraphies.

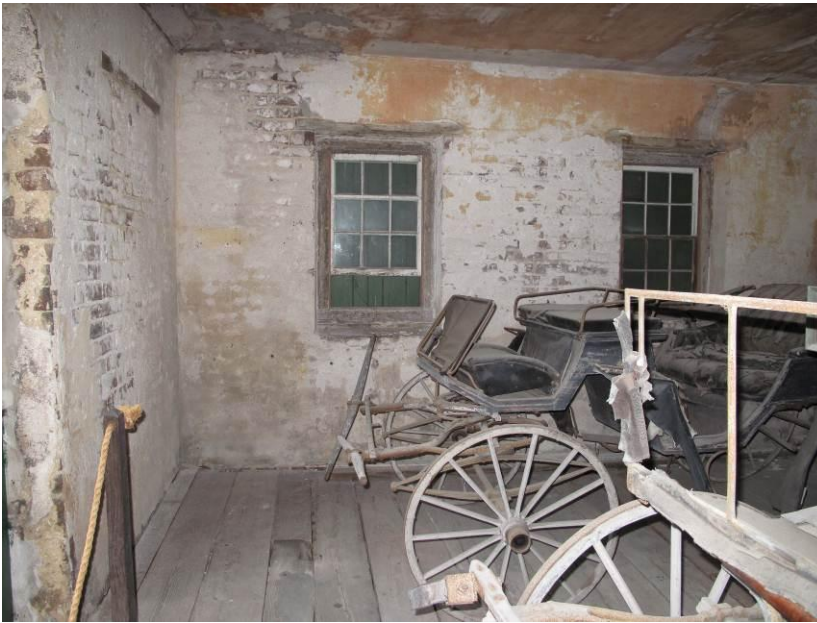
#### **S101 South Wall**

S101-1. Original window, south wall, east window W102 (Period I) left side of frame, about 4' up, to establish woodwork paint chronology for original elements.

S101-2. Original window, south wall, east window W102 (Period I) left side of frame, upper left corner of top left pane, lower sash.

S101-3. Original window, south wall, east window W102 (Period I) original exterior window frame paint, left side.

S101-4. South wall, fragment of wall plaster, just abutting left side of east window frame.

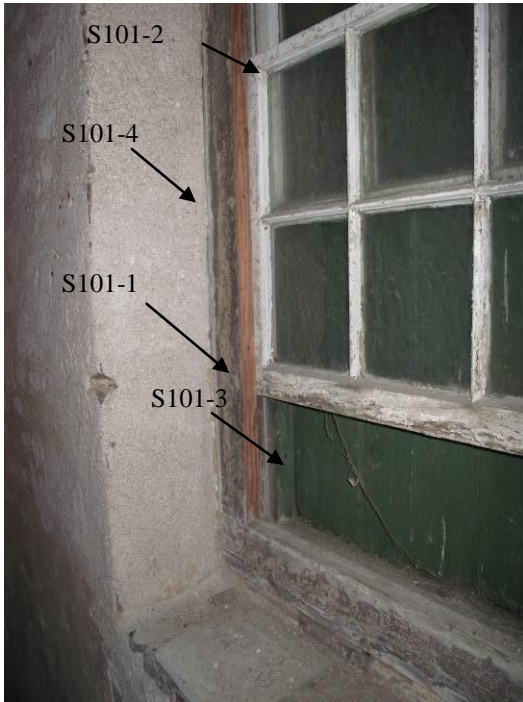
**S101 South Wall W102**

The samples taken from the interior of the original window show that (remarkably) the frame was only painted three times and the sash was only painted five times. The first generation on the frame (S101-1) is a dark cream-colored, oil-bound paint, while fragments of original paint on the sash (S101-2) suggest it was lighter cream color. There is no evidence to indicate the windows were originally left unpainted as the wood substrates are clean and unweathered. The second generation on the frame is a dark cream-colored paint with a plant resin varnish coating, while the sash was painted gray-blue. This could be the Period II palette. The third generation in both samples is a dark tan, resinous paint which is now darkened and degraded. The sash was then repainted with two generations of finely ground off-white and white paints which are likely twentieth-century coatings.

One sample was also taken from the exterior frame of the same window (S101-3) and the comparative evidence suggests that the exterior of the window was painted in the same manner as the interior window frame in generations 1 through 3. The most recent paint on the exterior window frame is a finely ground green finish coat on a gray primer which appears in the fourth generation (see the comparison of all three samples below).

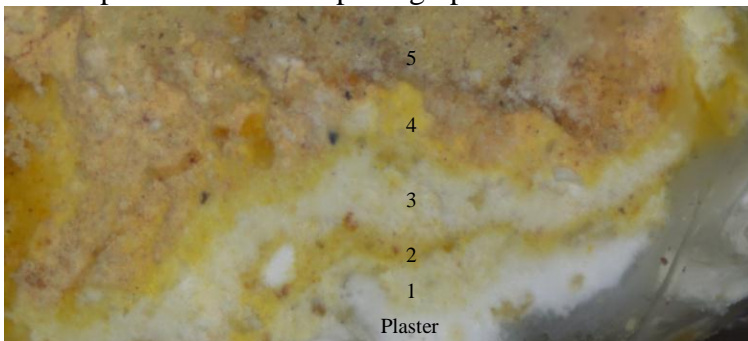
Uncast portion of S101-6 photographed at 40X to show the limewash colors

One sample from the Period II painted ceiling shows that it was initially limewashed, followed by a yellow-pigmented wash and then another unpigmented limewash. The fourth generation is also a yellow-pigmented limewash, followed by the most recent dull orange-pigmented limewash. This sequence of coatings is very similar to the accumulation of pigmented and unpigmented limewashes found on the ceiling in the stable (S104-10), suggesting these two ceilings are contemporary and date to Period II. Photomicrographs of the uncast sample and the cross-section show this accumulation of chalky coatings.

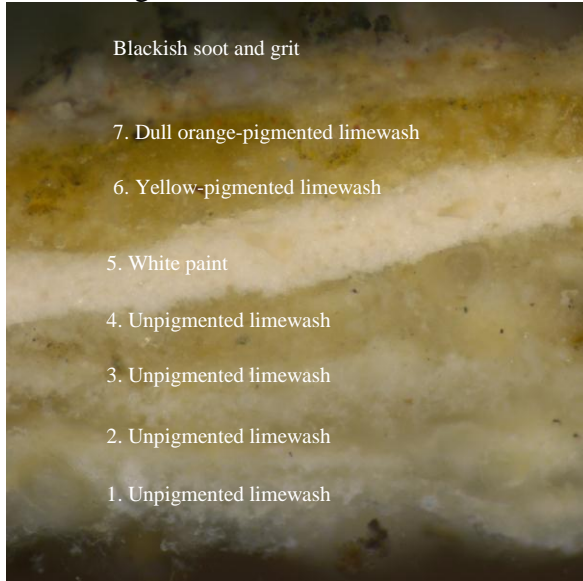
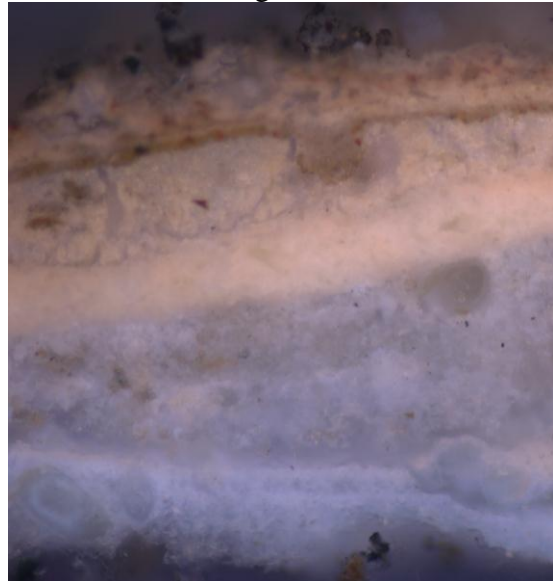
S102-1. Edge of ceiling accessible from the stair landing.

One cross-section from the ceiling (S102-1) consists of at least four generations of unpigmented limewash, followed by an opaque white paint, and then the two most recent pigmented limewashes yellow and dull orange limewashes.

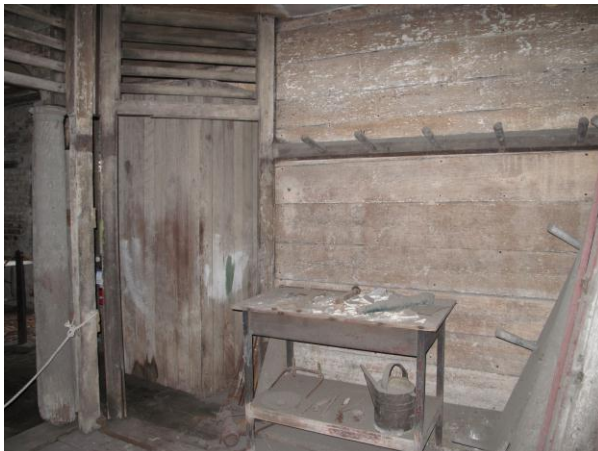
**Northeast Corner of Tack Room**

The board wall surrounding the Period II staircase in S103 appeared by eye to retain a variety of degraded unpigmented and pigmented limewashes, while elements such as the harness rack appeared never to have been painted. On the east side of the room there is a narrower, finer, beaded board wall that Graham felt might be later than Period II. Five samples were taken from different wooden elements in this space, and four of those samples were analyzed in cross-section.

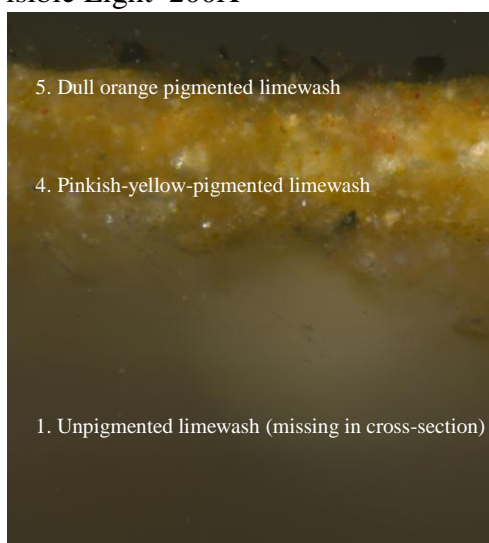
S103-5. Framing for board wall in NW corner

The framing element for the narrow board wall (S103-5) in the northwest corner was first limewashed white, followed by two pigmented limewashes that can be aligned with the pinkish-yellow limewash and the dull orange-pigmented limewash coating found as generations 4 and 5, respectively, on the wide board wall at the east side of the room. These elements seem to have both been installed in Period II. A comparison of the pigmented limewashes is shown below.

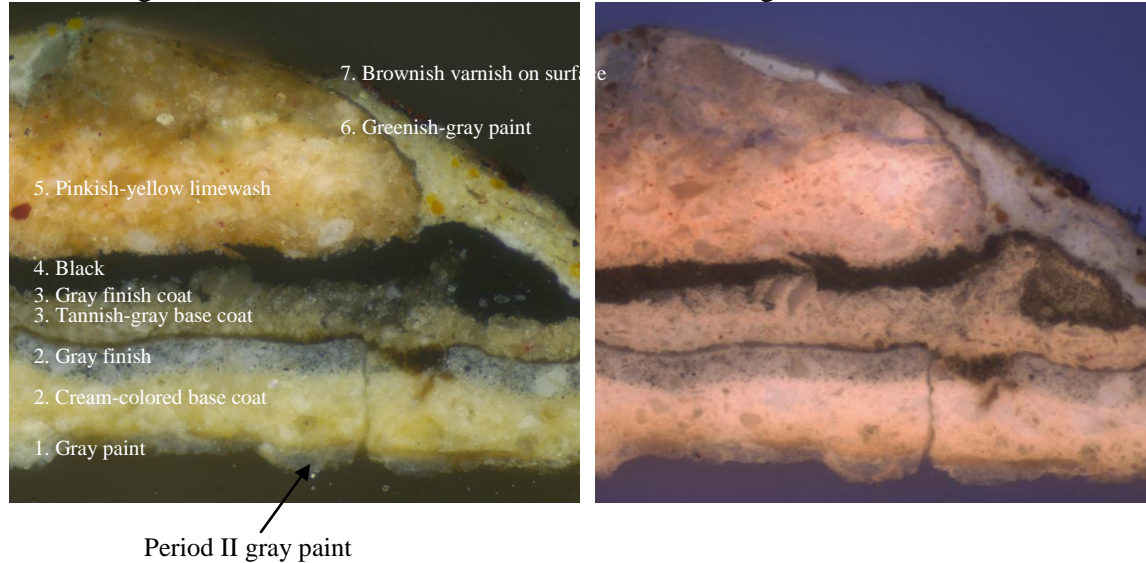
Sample S104-3. Original column, first column from the south end, west face, about 4' up.  
Visible Light 200X Ultraviolet Light 200X

The most complex paint stratigraphy on the woodwork was found in sample S104-3 from an original column. Graham hoped that the paints on this Period II column could be used as a reference sample for the paints on the other areas of woodwork. There are seven generations of paint on the column, beginning with a medium gray paint directly on top of the wood. The coating stratigraphy is shown in the chart below. The sample from the column is the only one in which a gray paint also appears in generation 2 and a black paint appears in generation 4, so perhaps this column was painted with gray and black up to about the top of wainscot level during these times, possibly to match the painted plaster. Comparison of the woodwork paints suggests that with the exception of the long stall divider board and the original Period column, all the other elements sampled date to after Period II.

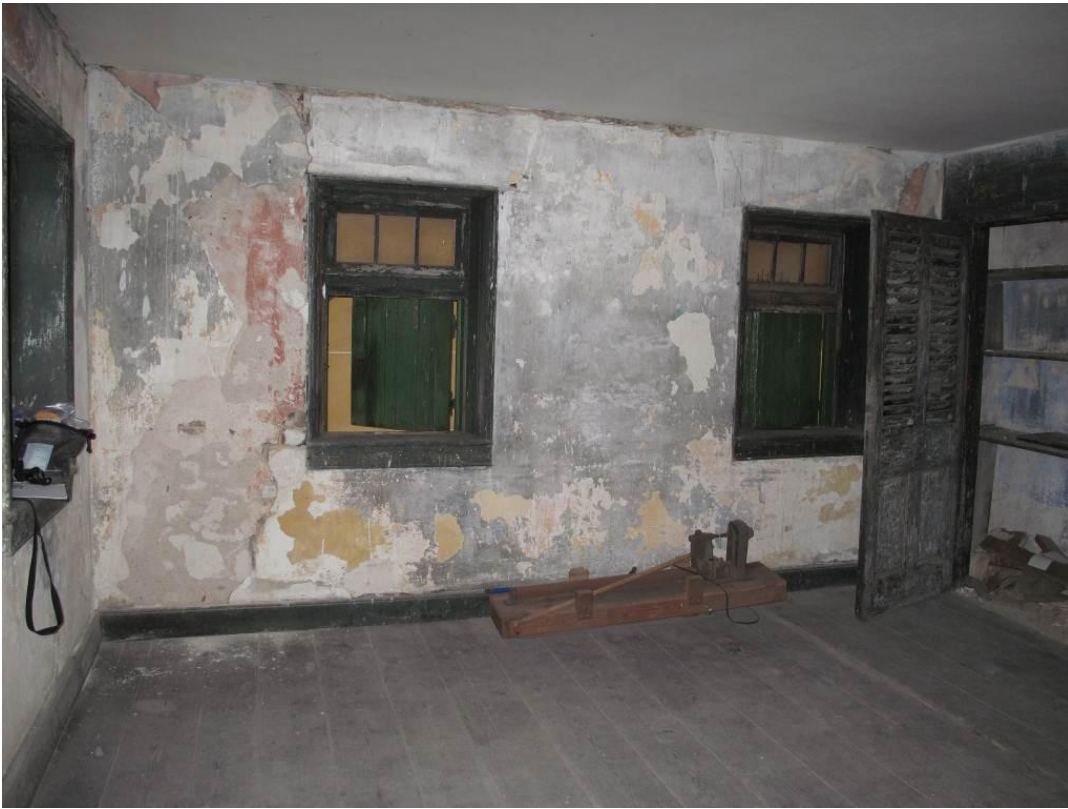
### **S201 South Wall**

- S201-1. South wall, east of east window, Period I deep red wash on coarse plaster.
- S201-2. South wall, east of east window, sequence of later washes on top of smoother plaster (used super glue to keep layers together), about 5' up.
- S201-3. West wall, Period I louvered door moved from house, half-round molding, right side of louvers (early bright green paint present).
- S201-4. West wall, closet surround, right side, below ghost for mantel shelf.
- S201-5. West wall, closet surround, right side, on ghost for mantel shelf (is there paint on this area of the shelf?).
- S201-6. Back plaster wall of closet, Period II finer plaster (deep red on coarse Period I is exposed at loss above top shelf), above middle shelf.

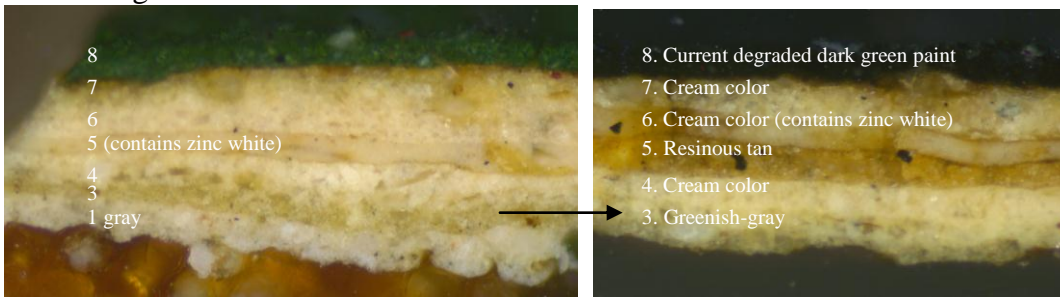
Sample S201-9. South wall, east window, architrave left side above bead molding.      S201-12. North wall door frame, above angled join.  
Visible Light 200X

S201 North Wall Door Frame and Door. The paint histories on two areas of the door frame were compared to see if there are differences between the area above the angled join on the door frame, which Graham thought may have been made to accommodate a transom, and the area just below the angled join. The two samples have quite different paint histories. Sample S201-12 from above the join contains seven generations of paint, with the first layer being the greenish-gray paint found as the third generation on the Period I window (samples S201-9 and S201-10). In sample S201-12 from above the join, the cream-colored paint with zinc white appears one generation later than on the Period I window, suggesting that the windows were not repainted with the resinous tan paint observed as generation 5 in sample S201-12 (see below).

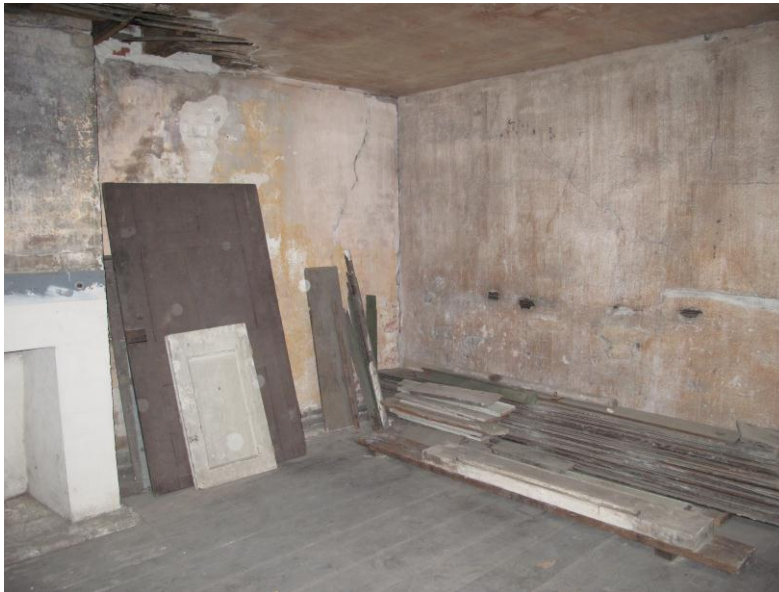
#### **S203 Northwest Corner**

S203-1. West wall, northwest corner, early deep red at large plaster loss, about 3' up. This seems to be the same early deep red found on the south wall of room S201. No evidence of painted wainscot in this room.
