**Paint Investigation
Aiken-Rhett House
Charleston, South Carolina
REVISED DRAFT
Kitchen/Laundry and Stable
Interior Paints**

For: Winslow W. Hastie
Director of Preservation and Museums
Historic Charleston Foundation
40 East Bay Street
Charleston, South Carolina 29401

Conservator: Susan L. Buck, Ph.D.
303 Griffin Avenue
Williamsburg, VA 23185

Date: January 2, 2013

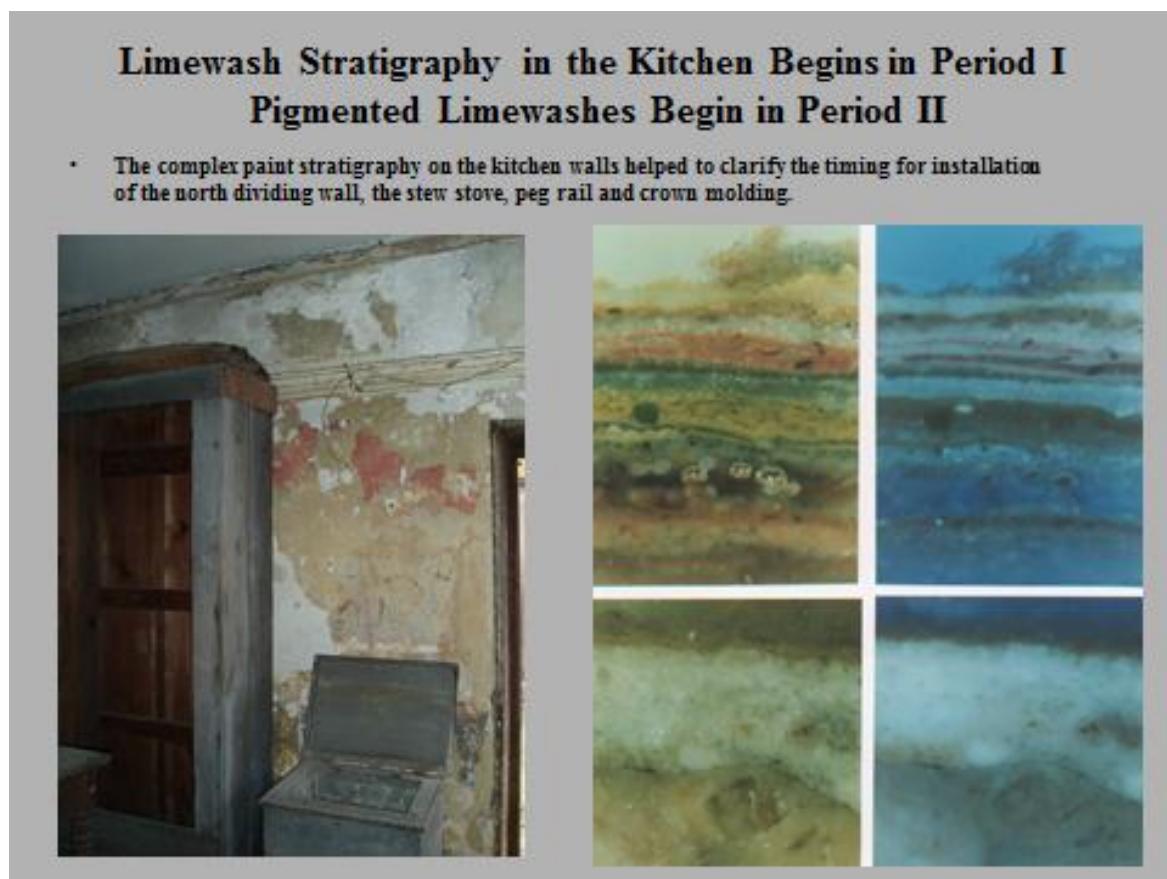
The following PowerPoint image of sample K101-15 from the south wall shows the many and varied limewashes on top of the dirty brown coat plaster substrate. In the first phase of analysis the cross-sections were all photographed with a 35mm camera and the color prints were used as references for comparing the coatings found on different areas of plaster and woodwork. In this current research all the sample images have been captured digitally with a more powerful microscope.

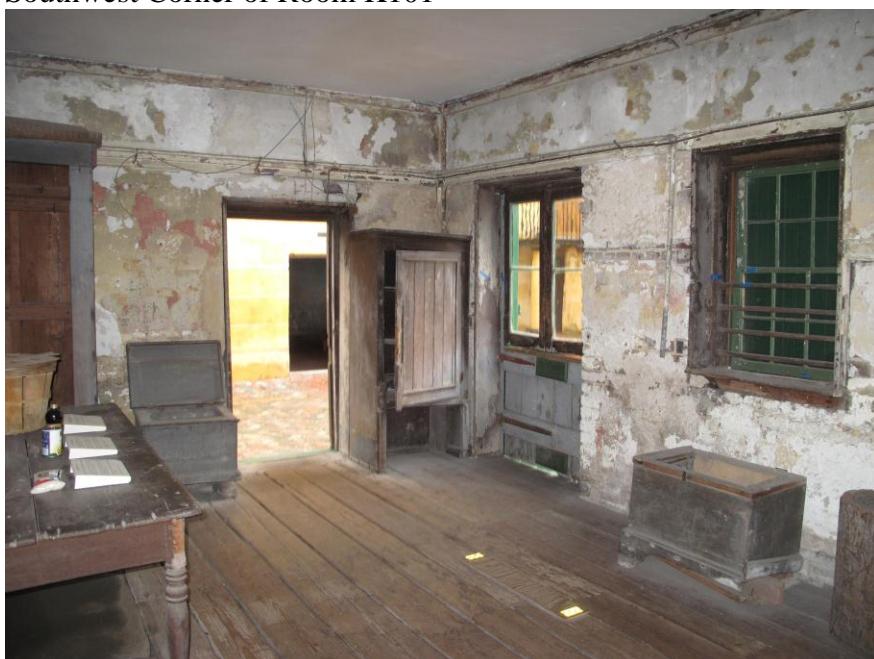
Southwest Corner of Room K101

The second phase of investigations on-site suggests there was a faux-painted dark gray or black wainscot after Period II, as remnants of the dark gray wash can be seen at wainscot level on the north wall. This was not found during the first phase of paint analysis, although there are multiple generations of black-pigmented washes used to create faux-painted black wainscoting in the second-floor passage.

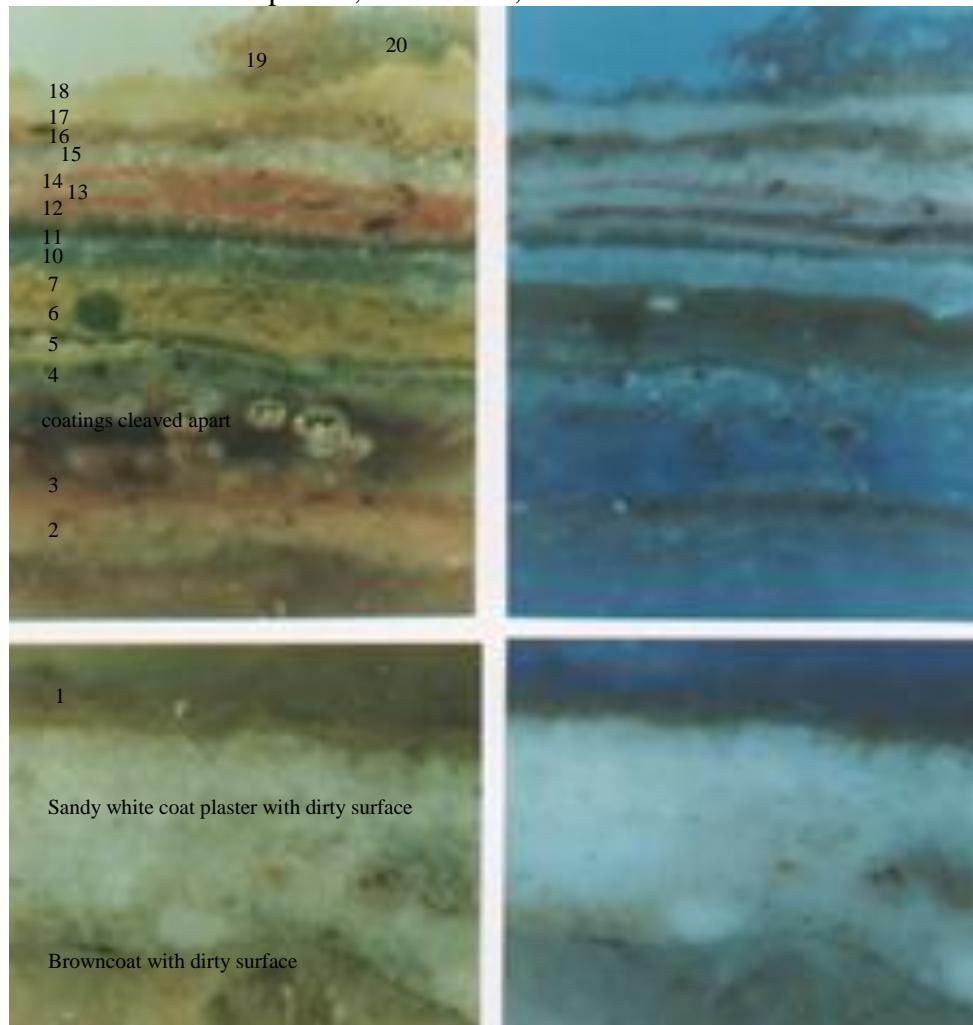
K101-1. South wall plaster, left of door, above chair board level.

In the first phase of research 19 generations of limewash were found on top of a sandy white coat plaster that seemed to have been applied during Period I, although the presence of soot on the brown coat of plaster indicated the walls had initially been left unpainted. The most complete plaster sample found in both phases of research in room K101 is still sample K101-1 with 20 coating generations (see below). A few unpigmented limewashes missing in this sample were found in other cross-sections and this evidence was used to reconstruct the full wall paint chronology to identify 23 generations of paint. A table showing the comparative stratigraphies is on page 14.

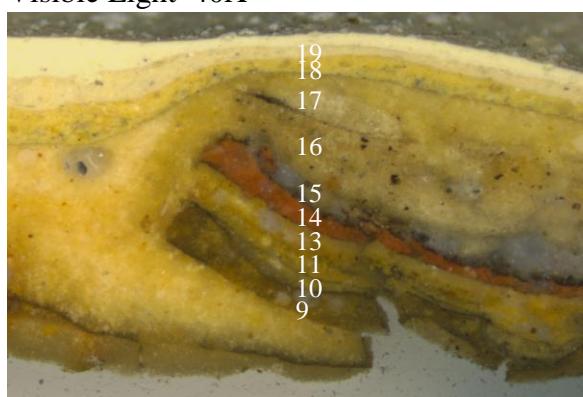
Sample K101-II-17. Paint on gas pipe, south wall, above door (surface is corroded).

The coatings on the elements associated with the gas pipe are somewhat difficult to interpret because of the corrosion on the gas pipe (K101-II-17) and the paint loss on the support board for the pipe (K101-II-16). However, the evidence does suggest that the gas pipe was installed as early as generation 9 (a degraded unpigmented limewash) as that is the first layer in the cross-section from the gas pipe. The first layer on the board supporting the gas pipe is generation 11, so it is possible that several early washes are missing on this board as most likely the board and the gas pipe were painted simultaneously.

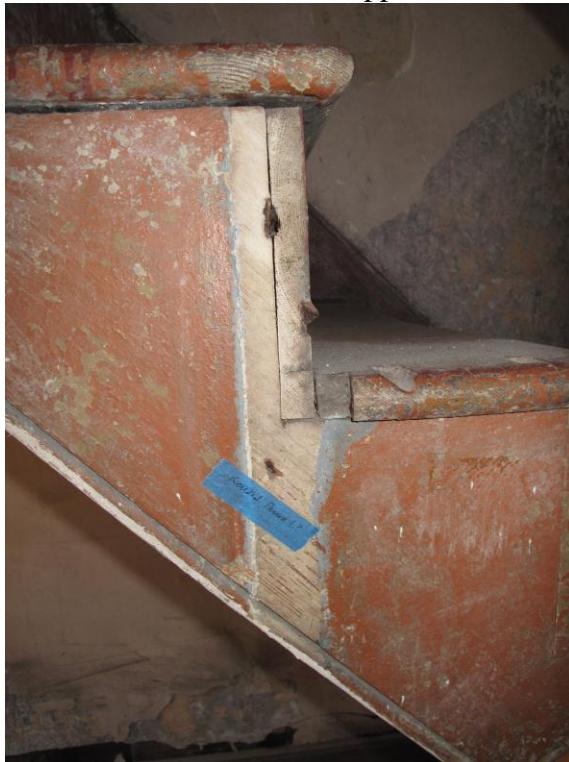
Ghost of former Vertical Support for Stair Railing

The comparative evidence shows there is only one thin layer of cream-colored paint on top of the wood in sample in K103-II-1 from the “ghost” for a former vertical support on the south side of the stair. By comparison, there are three generations of paint adjacent to the ghost, beginning with a thicker layer of coarse cream-colored paint, followed by a dull translucent gray paint, and then the current red-brown (K103-II-2). Perhaps the staircase was painted once with a primer of cream-colored paint before the now missing vertical support was installed, then after the vertical support was installed another layer of the same cream-colored paint was applied. When the staircase was moved in Period II the vertical support was removed, and the stair carriage and newel post were repainted with translucent gray paint. Considerably later, all the stair elements were coated with the current red-brown paint (which lines up with generation 19 in K101).

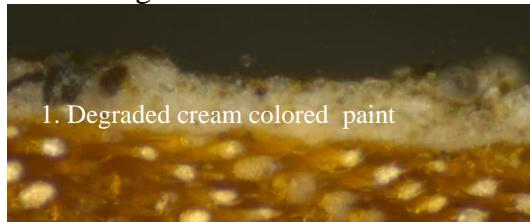
Sample K103-II-3. Staircase, newel post
Visible Light 200X

When the first coarse cream-colored paint on the stair is compared to the original, but degraded, cream-colored paint on the bar for the central window in K101 they seem to be the same. This suggests the newel post and the upper run of this staircase were part of the Period I kitchen building. A comparison of the two cross-sections follows.

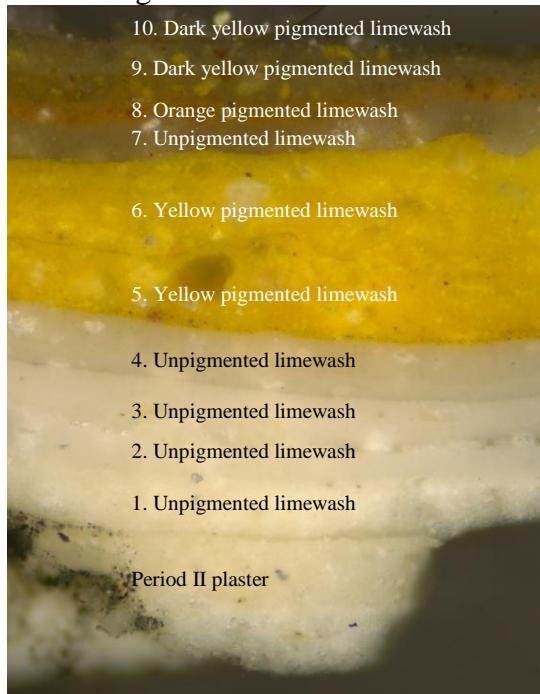
K104-II-3. South wall, southeast corner, at crack about 4' up.
Visible Light 100X

The most complete sample of washes on the Period II plaster was found in sample K104-II-3 from the south wall. There are ten generations of coatings on the plaster, beginning with four generations of unpigmented limewash. These unpigmented washes are followed by two generations of distinctive yellow-pigmented limewashes, then alternating unpigmented limewashes and pigmented orange and dark yellow-pigmented limewashes. When the sample taken from near the west wall where a yellow wash has overlapped the ghost of the former support board (K104-II-5) is compared to K104-II-3, it is apparent that the coating sequence consists of generations 1 through 4, plus generation 9. A sample taken from the narrow white band at the very top of the west wall where the water pipe support board was located consists of only generations 1 through 4. A comparison of samples K104-II-3 and K104-II-5 is shown below.

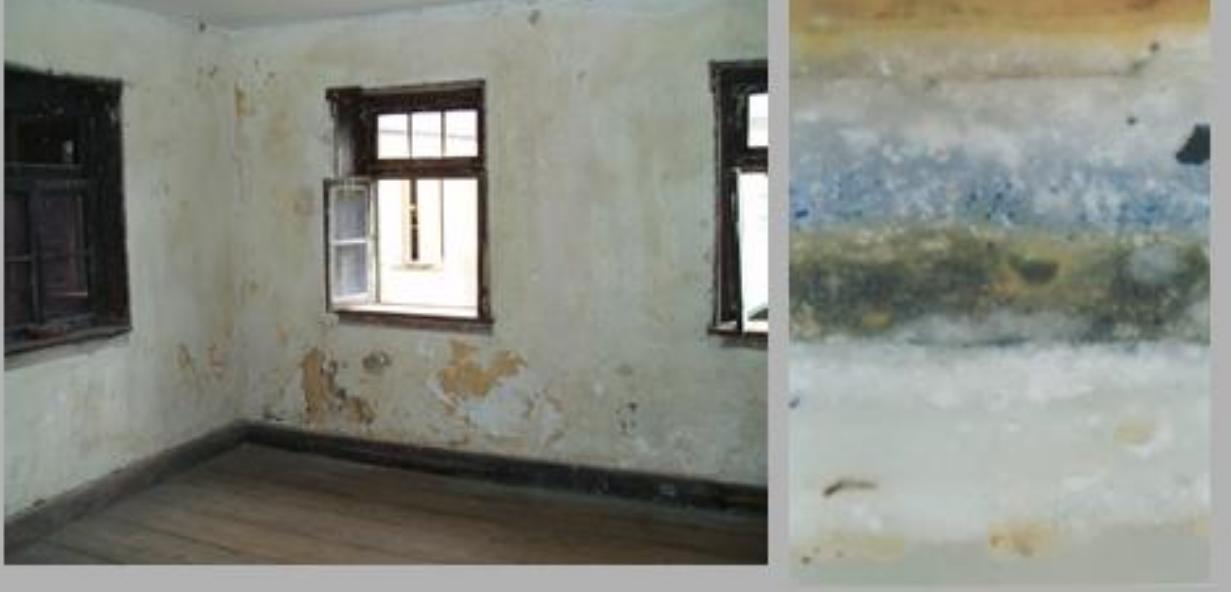
- **Polarized light microscopy helped to confirm the presence of artificial ultramarine in the ninth generation wash on the Period I plaster. This relates to the use of artificial ultramarine in decorative paints in the house in Periods II and III.**

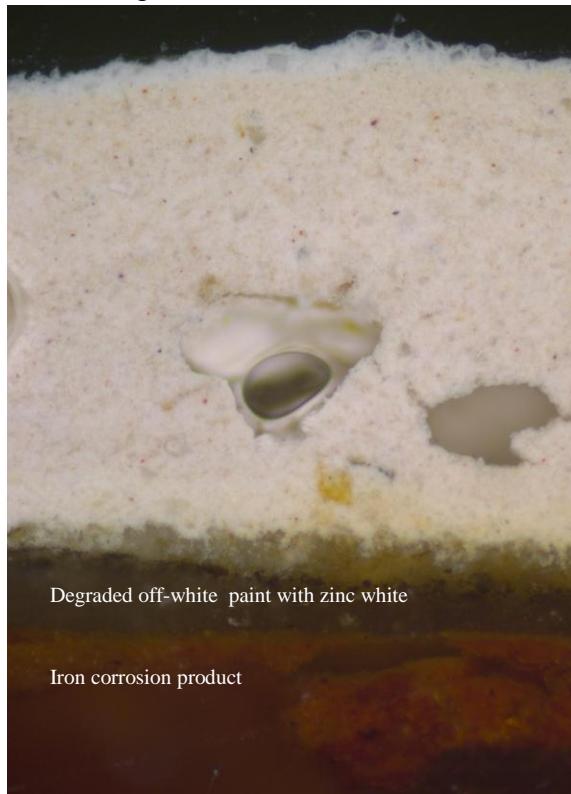
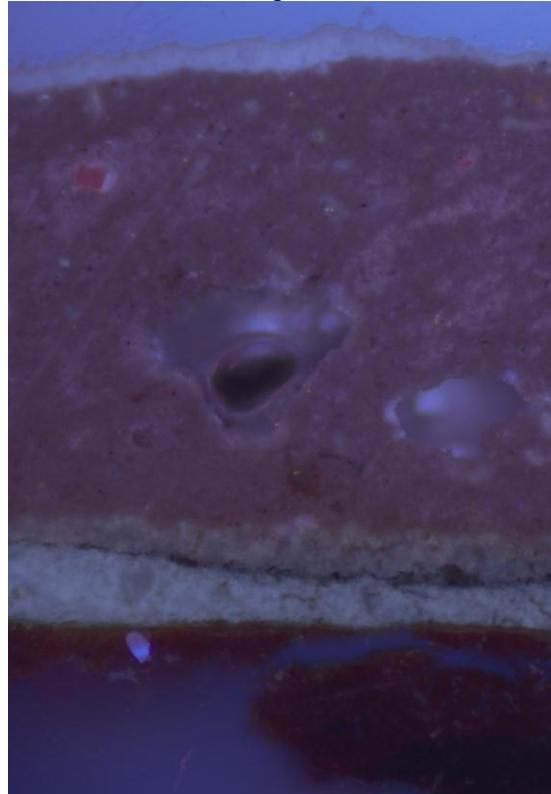
Sample K201-II-7. Picture hook on west wall (iron substrate is corroded).

The iron substrate of the picture hook is quite corroded, so the earliest coatings are likely missing. The first wall paint layer directly on top of the reddish corrosion product is a degraded off-white paint that contains zinc white. This paint layer may be generation 5 on the woodwork, but the evidence is too fragmentary to be certain about dating the installation of this picture hook. It is possible that this hook was not originally painted, which is what allowed such a thick layer of corrosion to accumulate on top of the iron substrate.

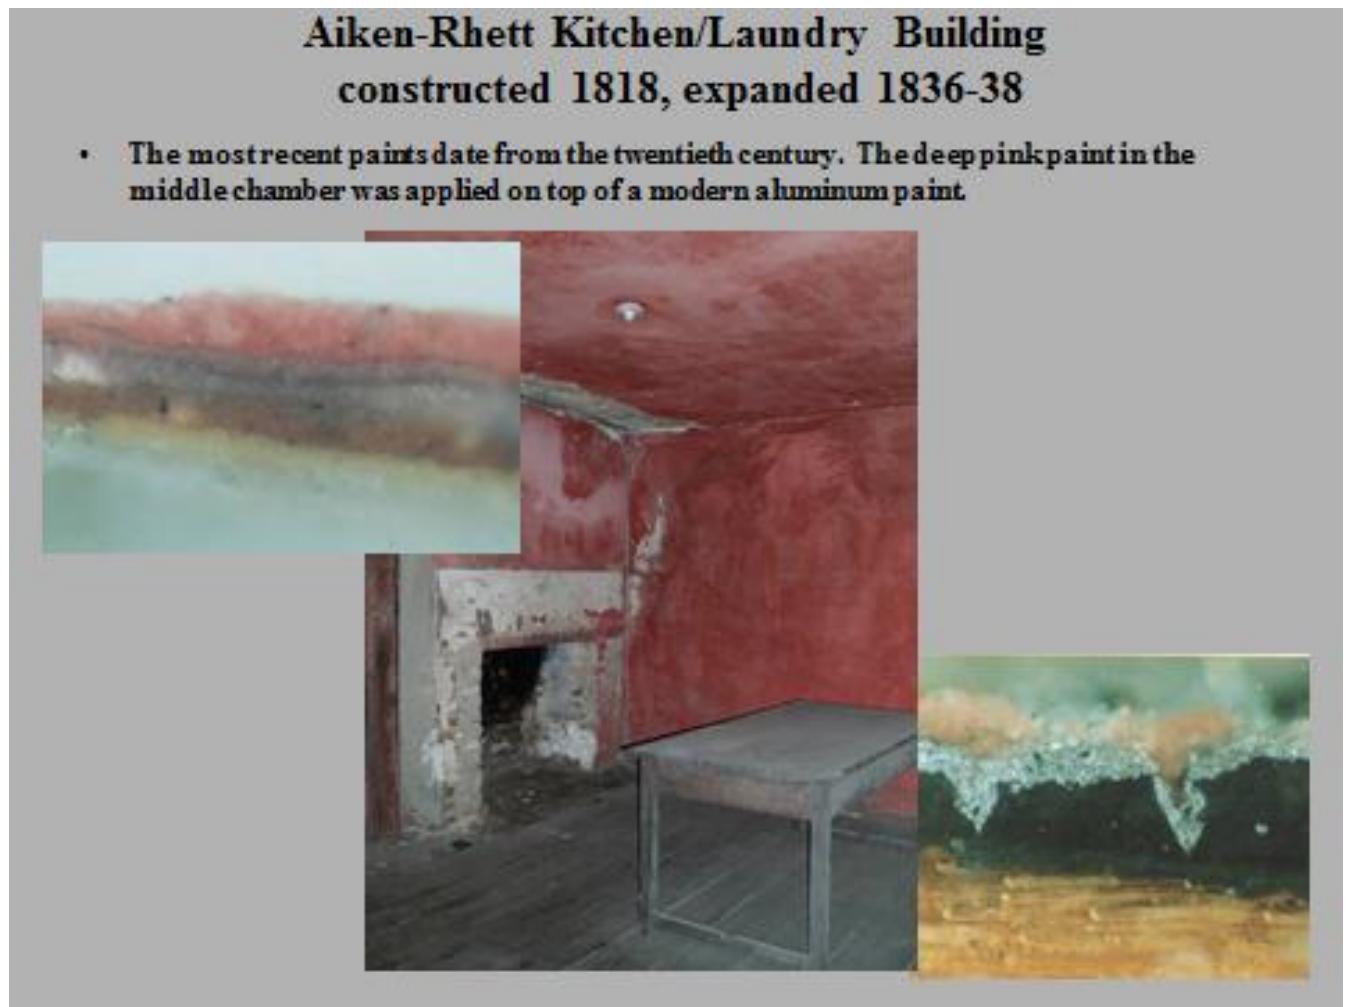
The middle room on the second floor is the darkest of all the chambers, with two small rob windows on the north and west walls, and dark pink paint on the ceilings and walls. The first phase of analysis showed that the current opaque pink paint was applied in the twentieth century as it is on top of a metallic aluminum powder paint layer on the mantel (see below). The mantel was originally painted black at least twice, and these paints became deeply fissured and damaged before the silvery aluminum paint was applied.

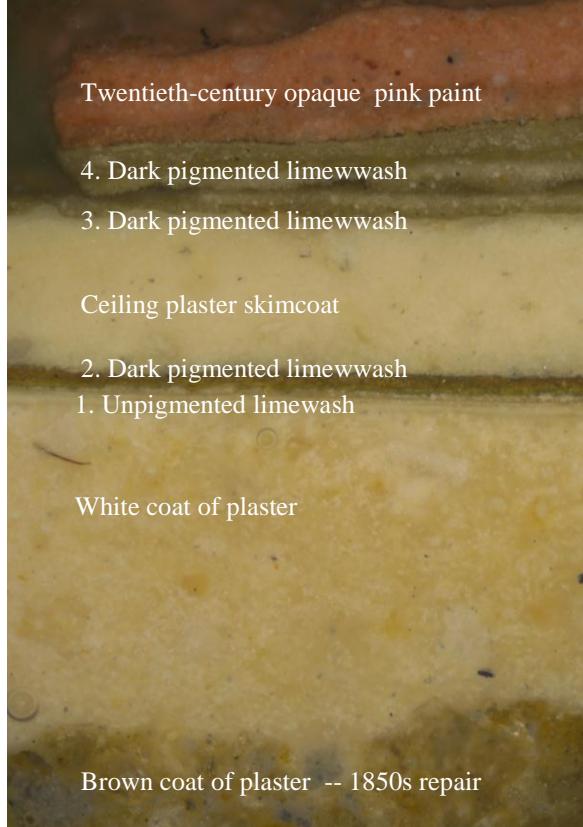
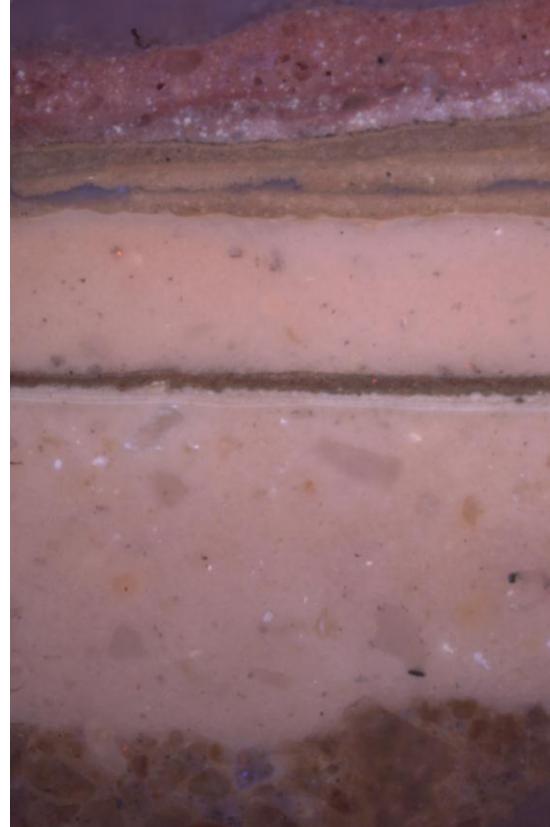
Sample K203-II-1. Ceiling in southwest corner, large fallen piece of infill in front of fireplace on top of circular sawn lath. 1850s repair.

The paint sequence found on the section of 1850s ceiling plaster shows that the brown and white plaster coats are considerably smoother, with smaller sand particles, than the Period II plaster found elsewhere. In the first phase of research two samples of ceiling plaster (K203-6 and K203-7) were analyzed and their paint histories were the same as the Period II walls, suggesting some of the ceiling plaster in this room still dates to Period II.¹⁴ The sequence from the 1850s infill is quite different, with very thinly applied limewashes sandwiched between the first and second white plaster skimcoats of fine white plaster. The most recent pink paint is thickly applied and completely opaque, unlike any of the earlier translucent limewashes.

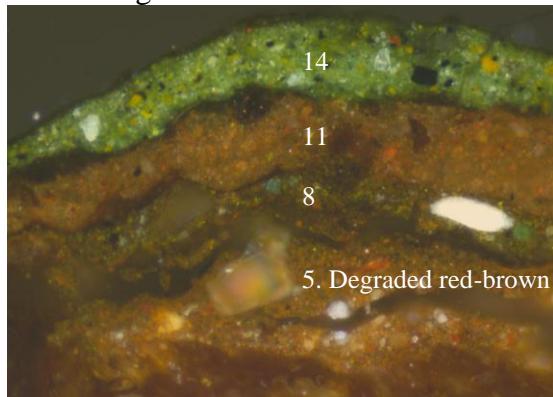
Sample K102-II-11. South wall, upper door.
Visible Light 200X

The first paint on the board door is a thick resinous red-brown coating that is now very degraded. It resembles the first (Period II) red-brown with varnish identified on the board door separating rooms K101 and K102 (see below). This door was then repainted dark green, followed by brown and then black. These two board doors seem to have been painted in the same manner until the most recent coatings, suggesting they were both installed in Period II.
