In Re: 133 Cannon Street  
Structural Inspection

I have inspected the structure at 133 Cannon Street and offer the following information.

133 Cannon Street is a two-story wood frame house that I believe to be approximately 150 years old.

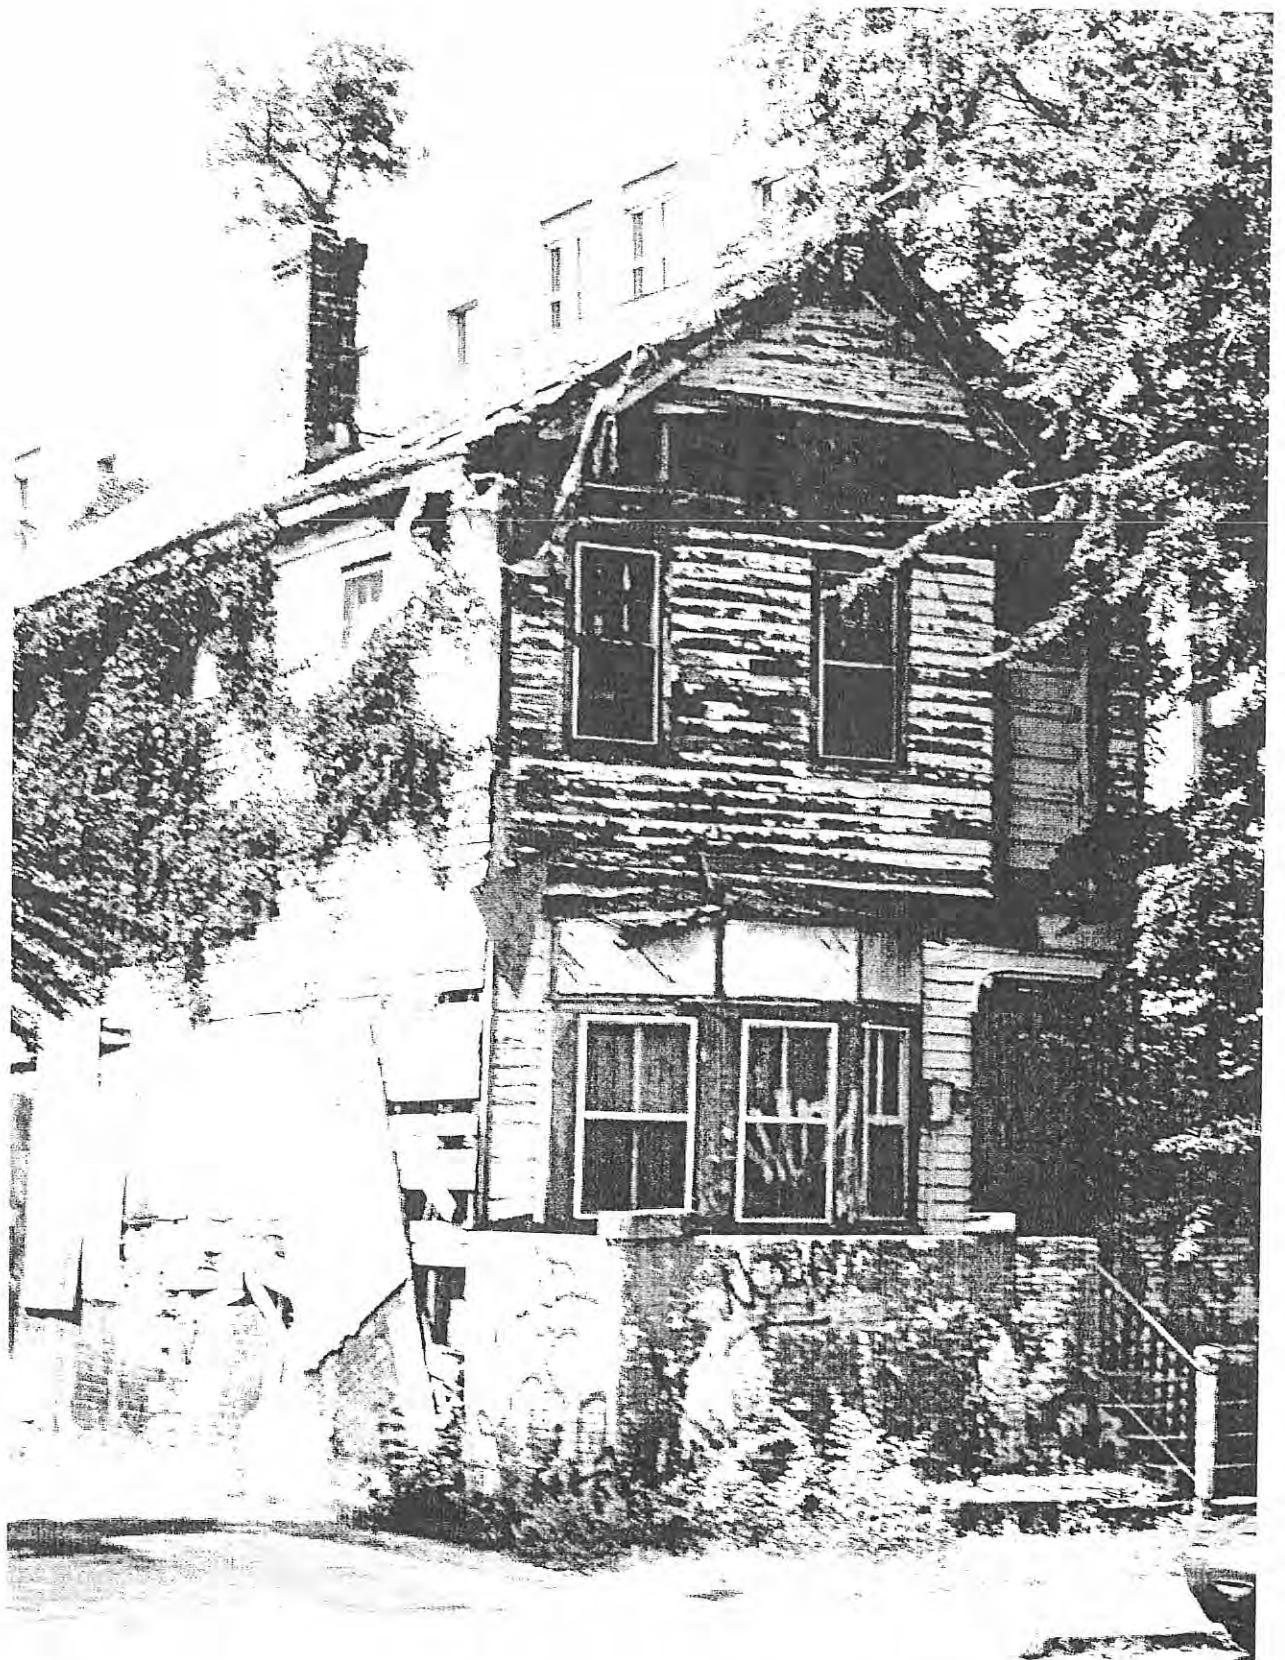
There was evidently a first and second floor front porch. The second floor porch was covered. The existing bay window at the front is not original; that is, it is built over the first floor porch (boards). These porches have been removed. A concrete first floor porch is installed.

133 Cannon Street - Left Front Corner - note that both the original first and (covered) second floor porches have been removed. There was extensive use of stucco on wire lath at the first floor on both the left and right sides.

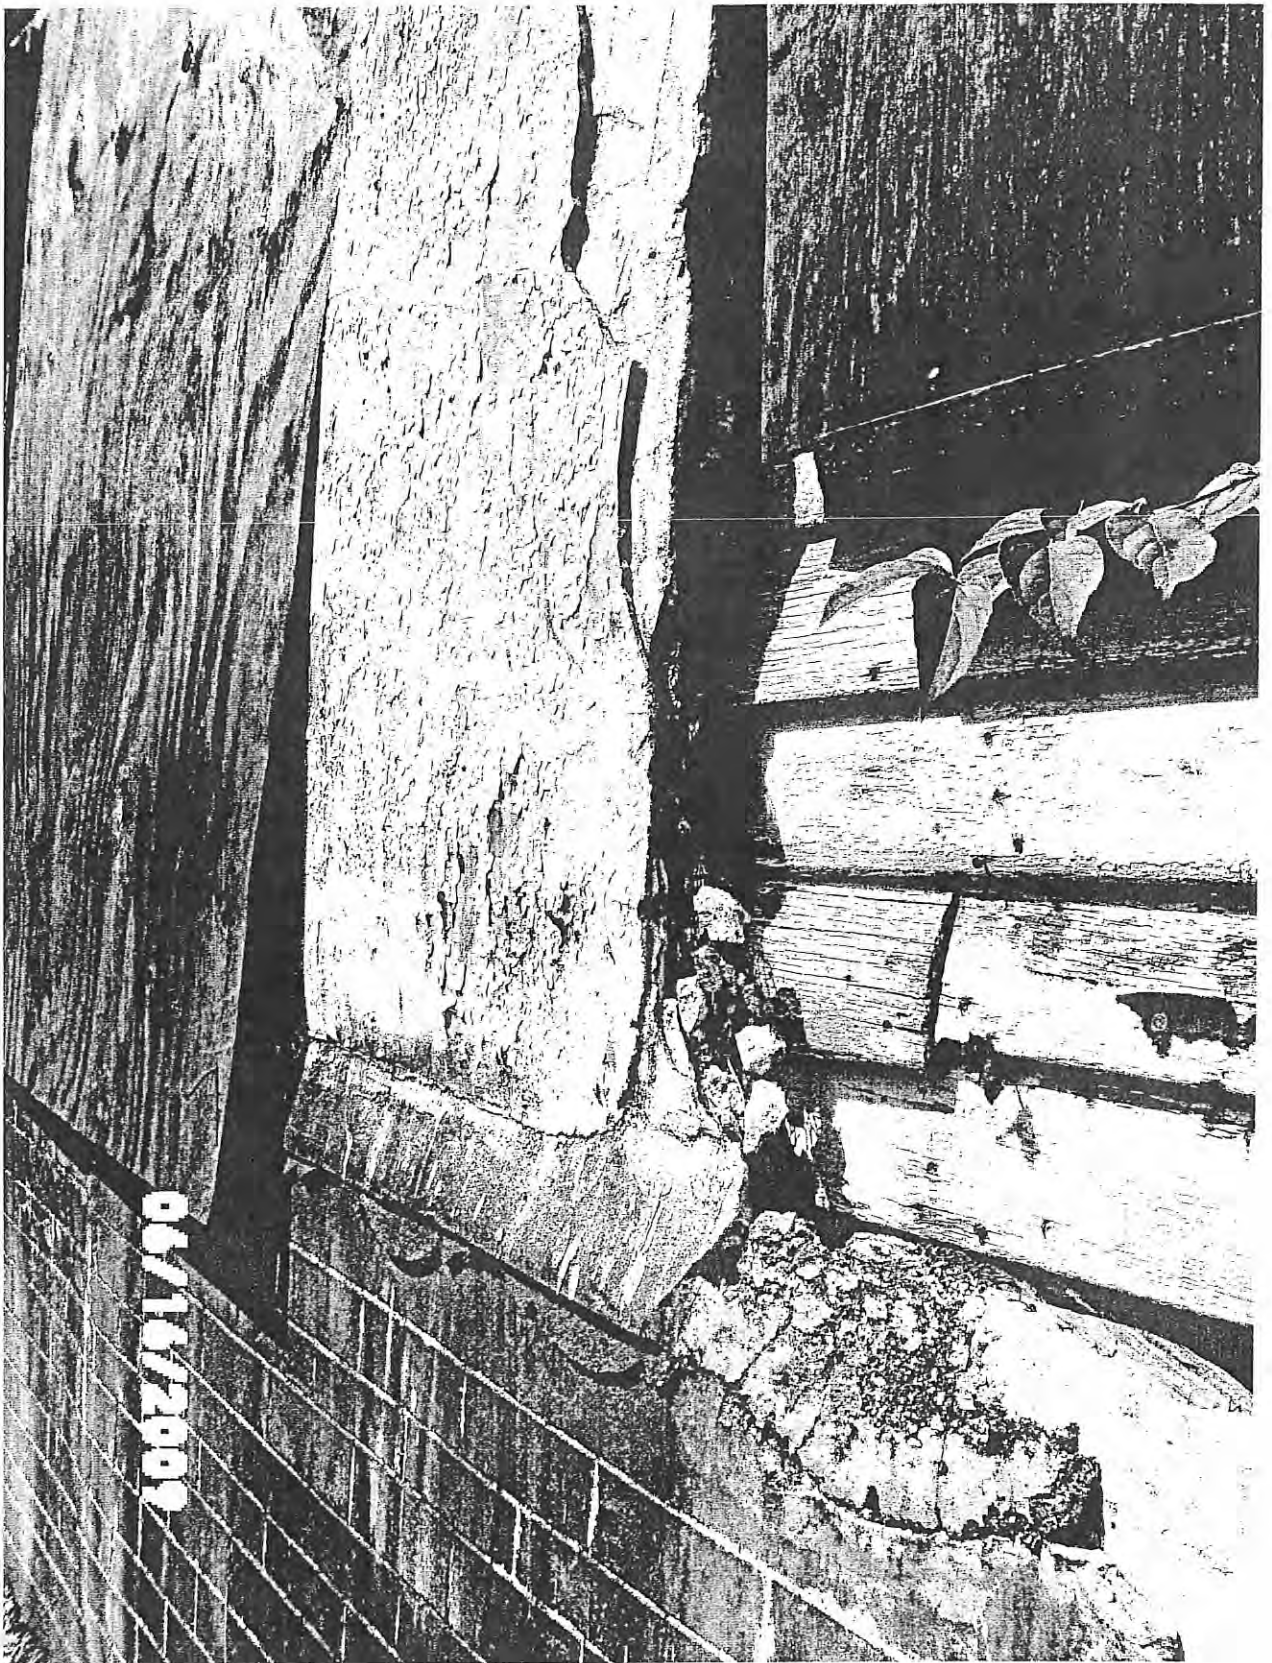
Left Side at First Floor - Lath & stucco application

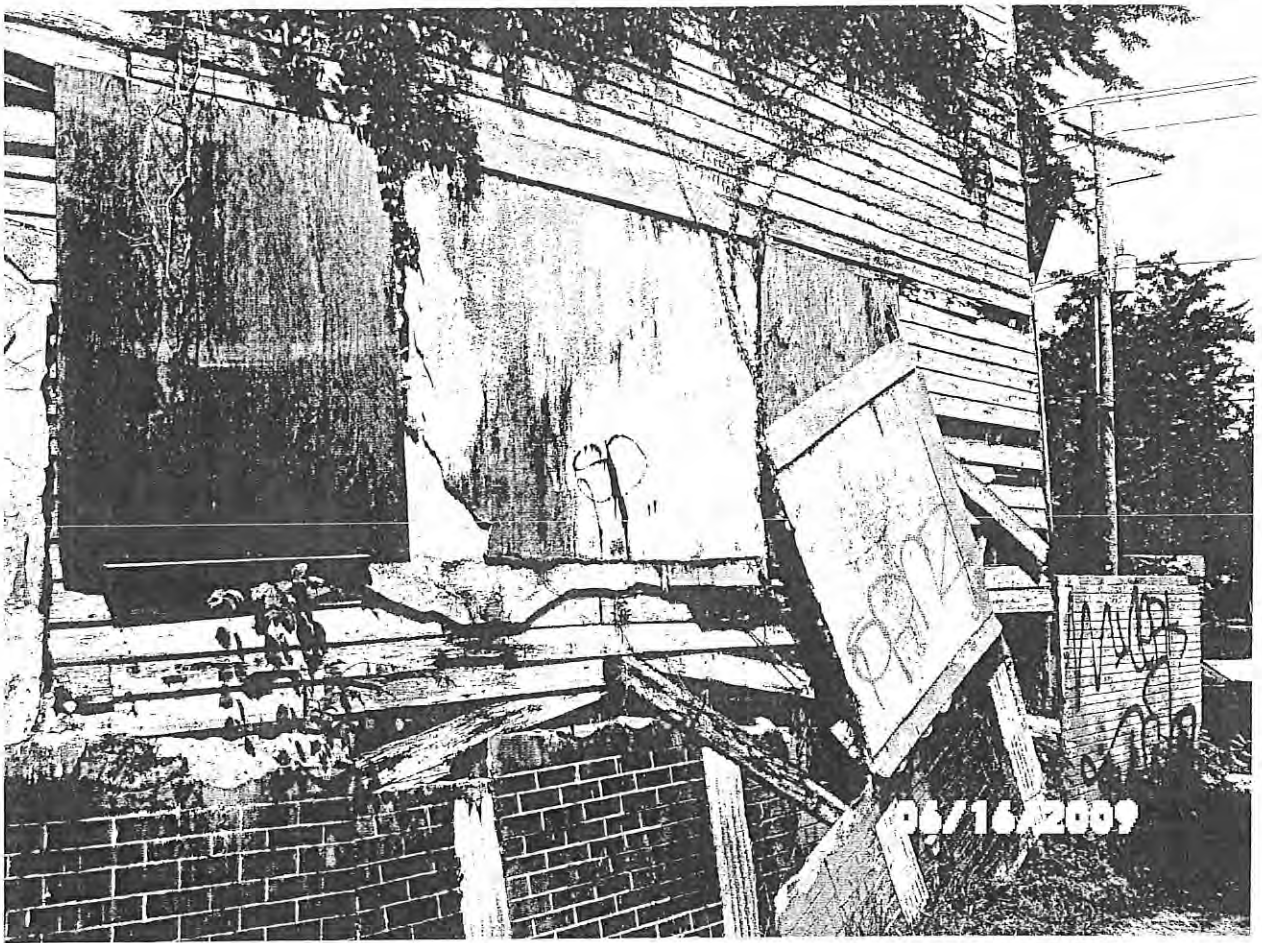
Left Side - Note that the stucco work went well up onto the first floor wall

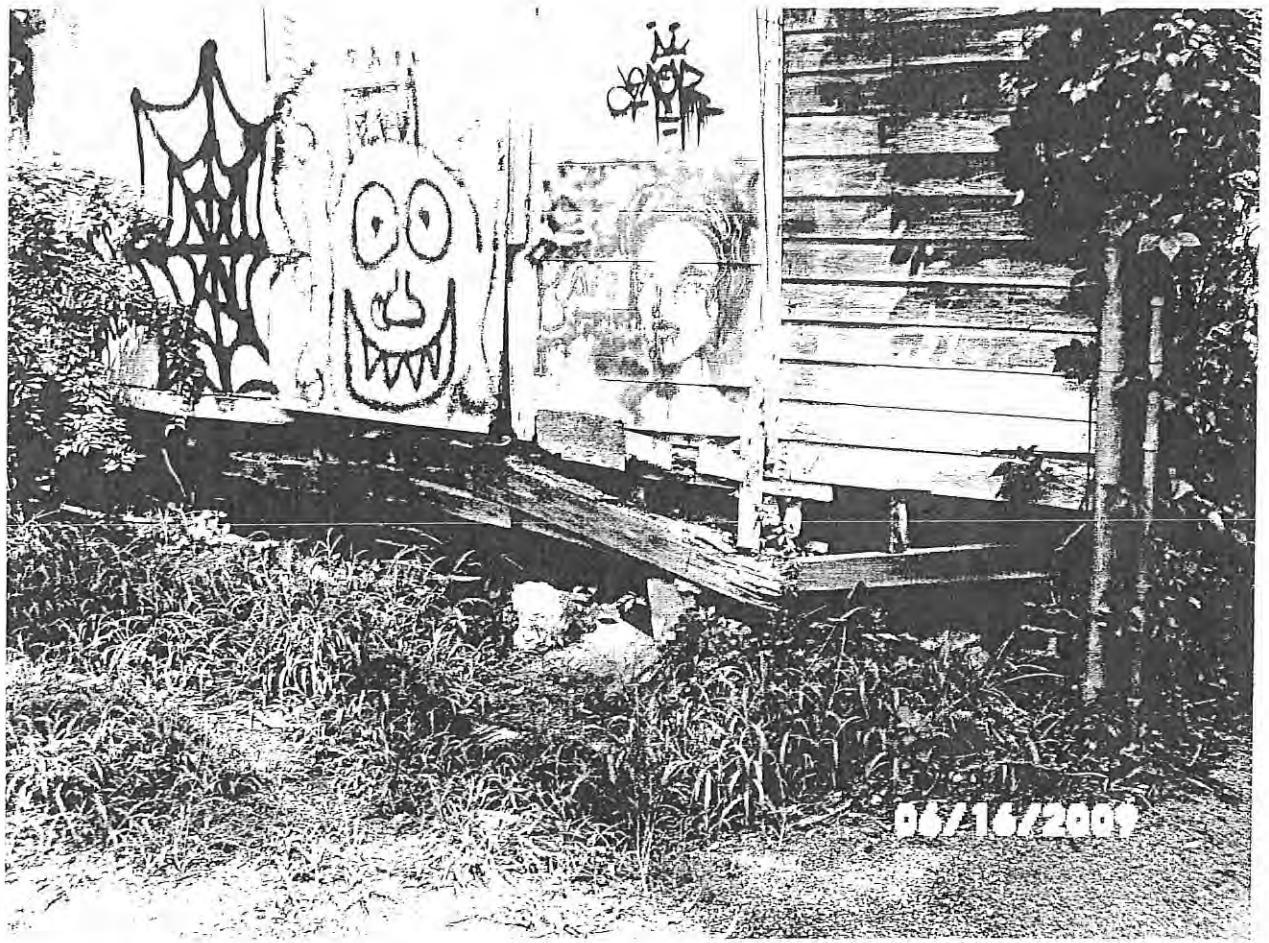
It appears that there was a 1<sup>st</sup> and 2<sup>nd</sup> floor porch on the rear which has been removed (foundations remain). There are no bathrooms in the house. It is assumed that portions of the rear porches included at least one bathroom.

Rear - Note bathroom area has been removed.

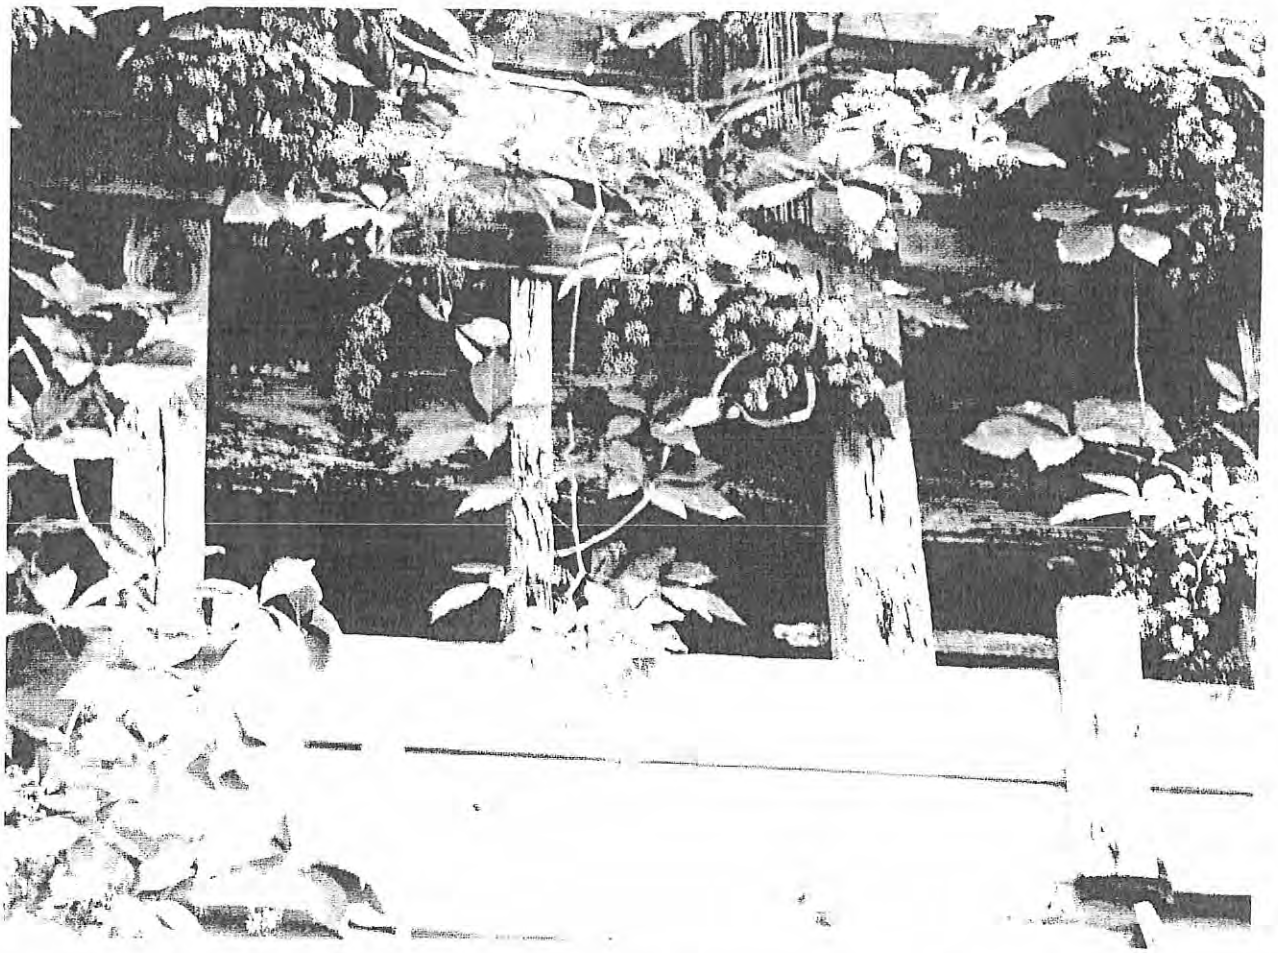
Rear - opening in exterior wall at second floor where I believe there was a porch.

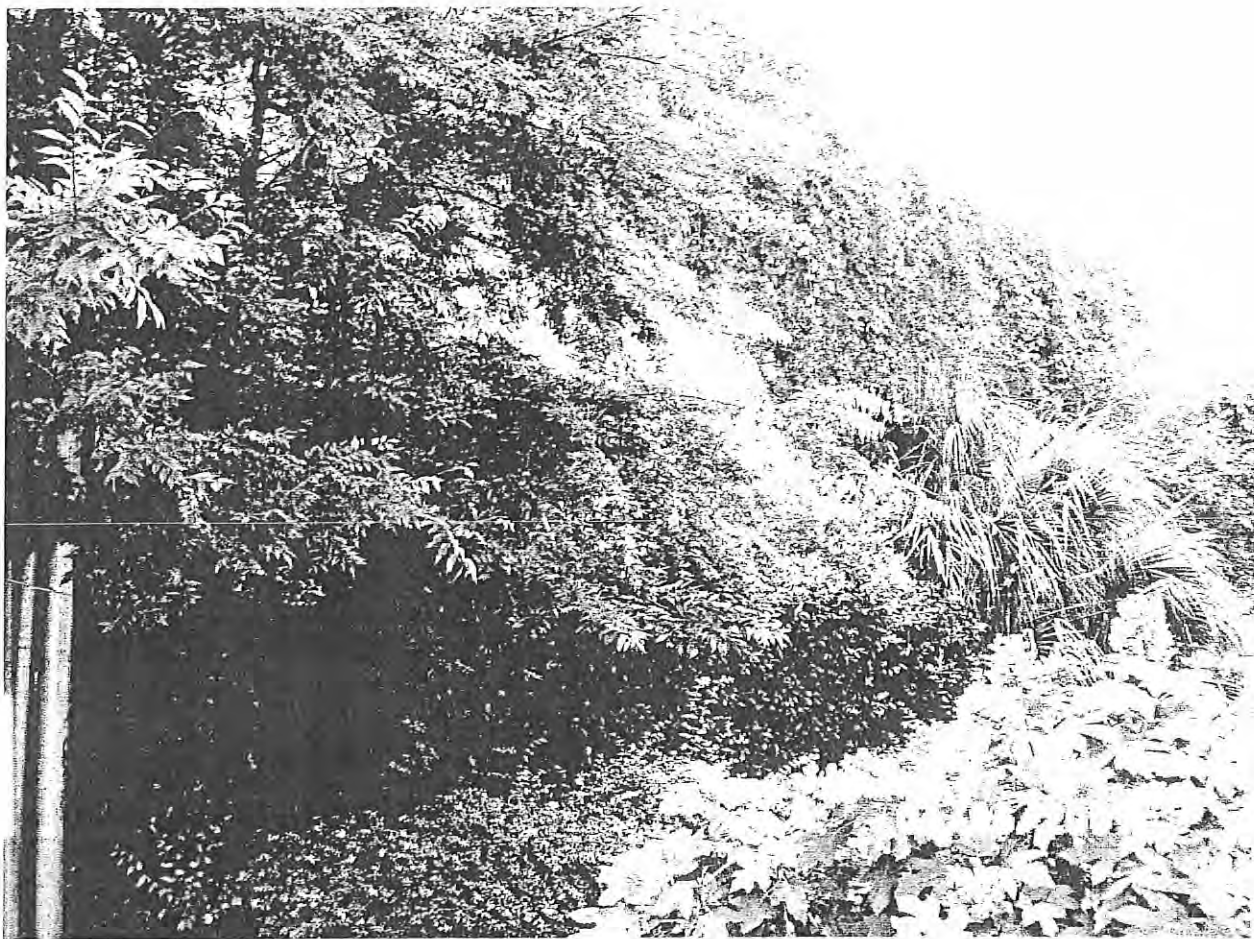
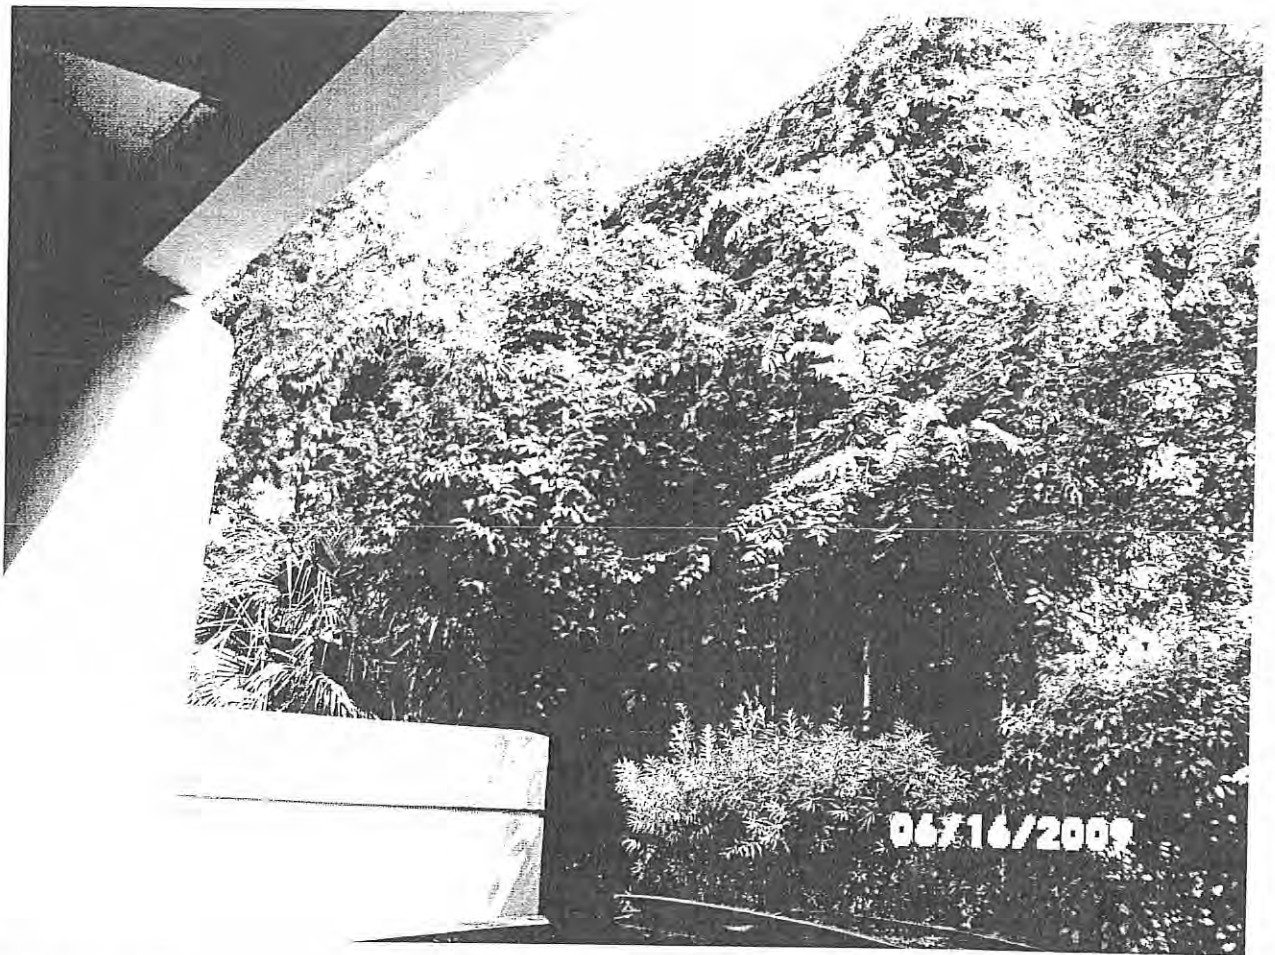
Right Side

The vine growth is so extensive that major portions of the right side and rear are not visible. It should be assumed that there is extensive decay there similar to the front and left side.

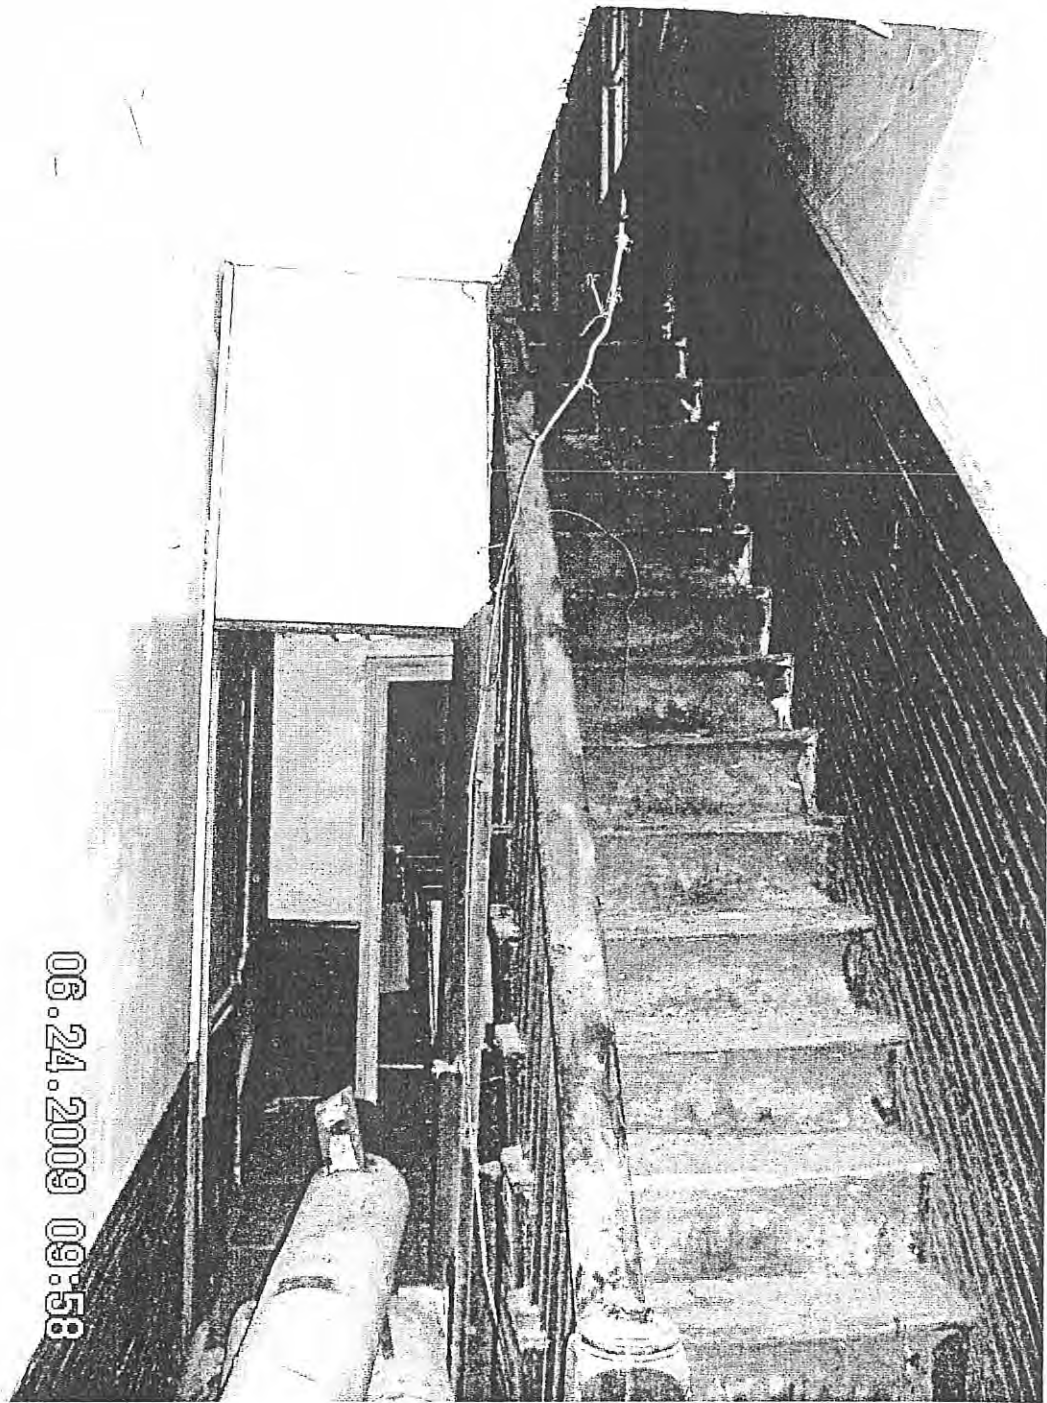
The (limited) studs, floor joists, and other structure that I was able to view contain extensive insect and water damage. My opinion is that there is further extensive damage that is concealed that will require repair. In particular, the 2<sup>nd</sup> floor system at the front will have to be replaced. The stairway is much too narrow for safe occupancy.

First Floor Hallway - note extremely narrow stair

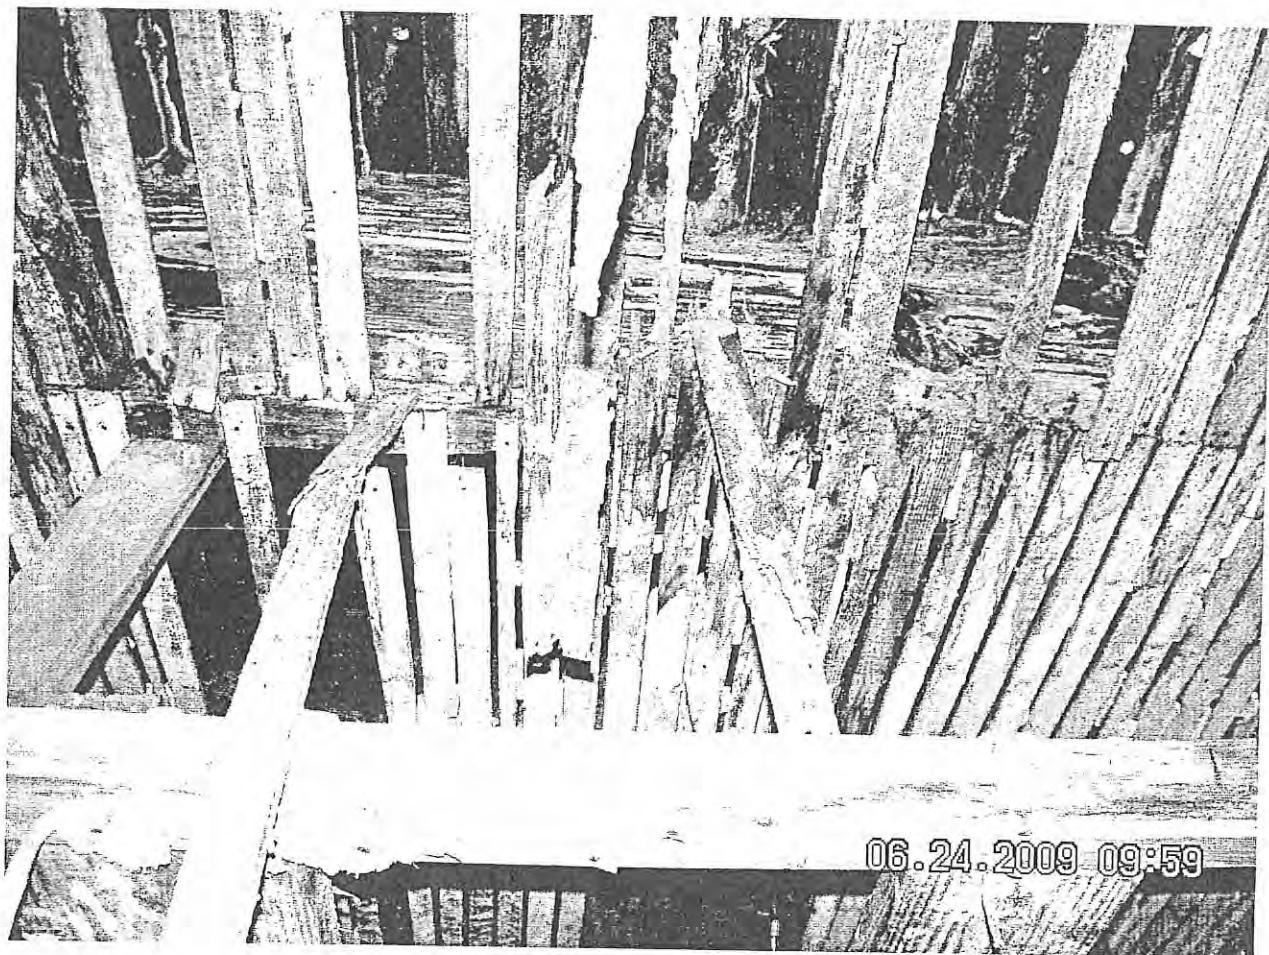
Living Room ceiling / Second floor floor - note extensive damage in floor system.

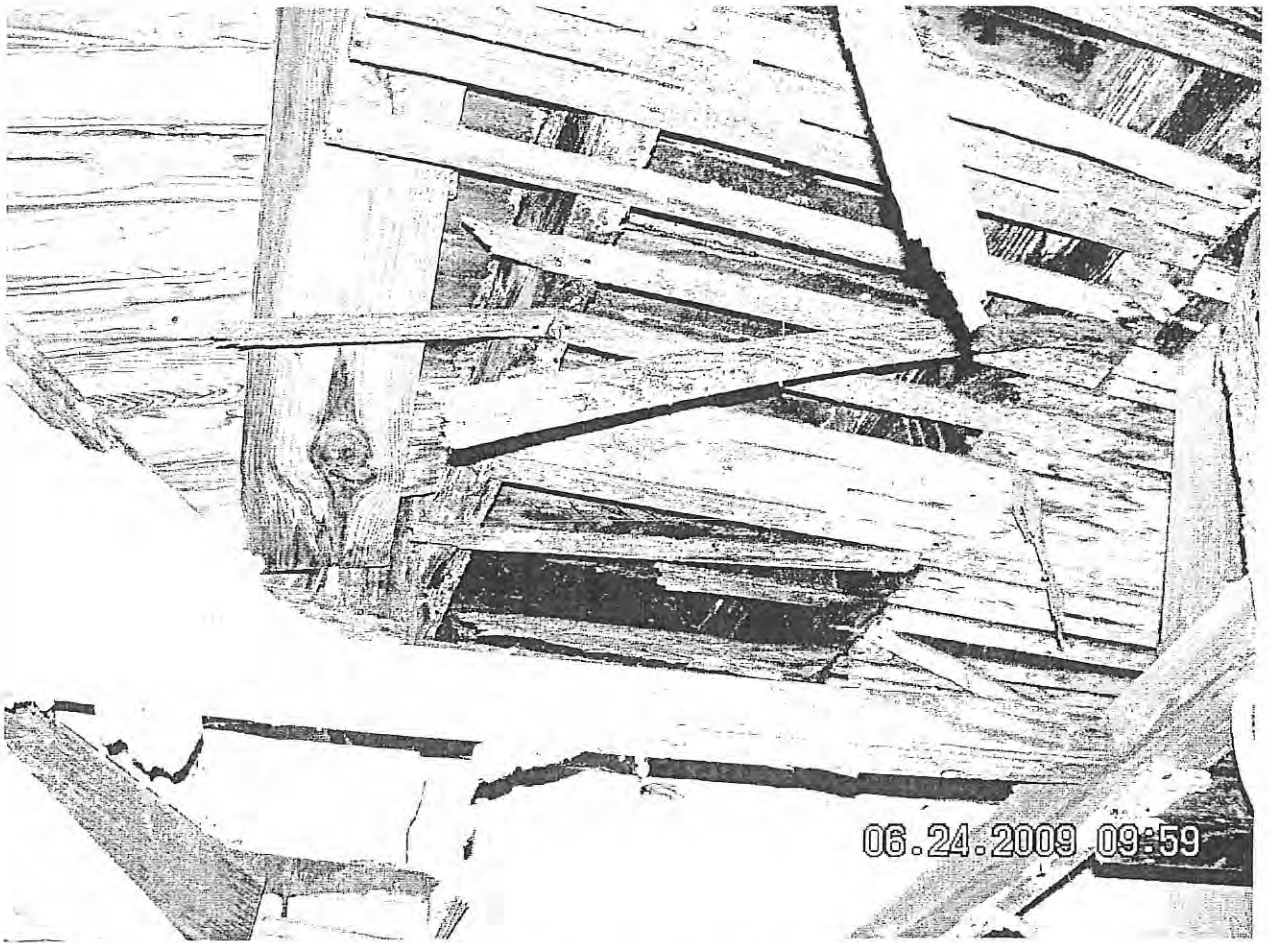
First floor ceiling - Bay window roof to left, core house to right.

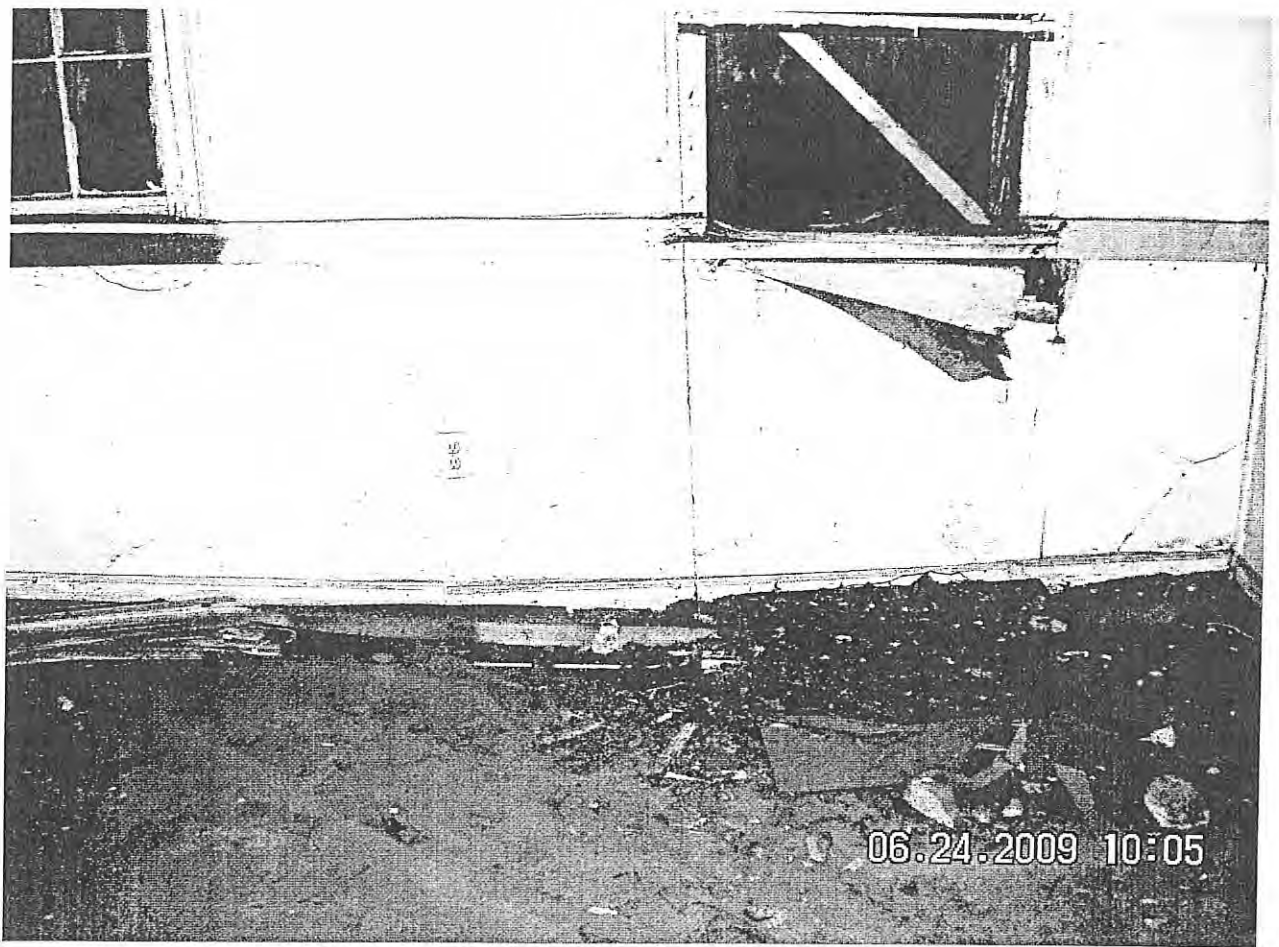
Second Floor Rear Bedroom - Note sag in floor at exterior wall.

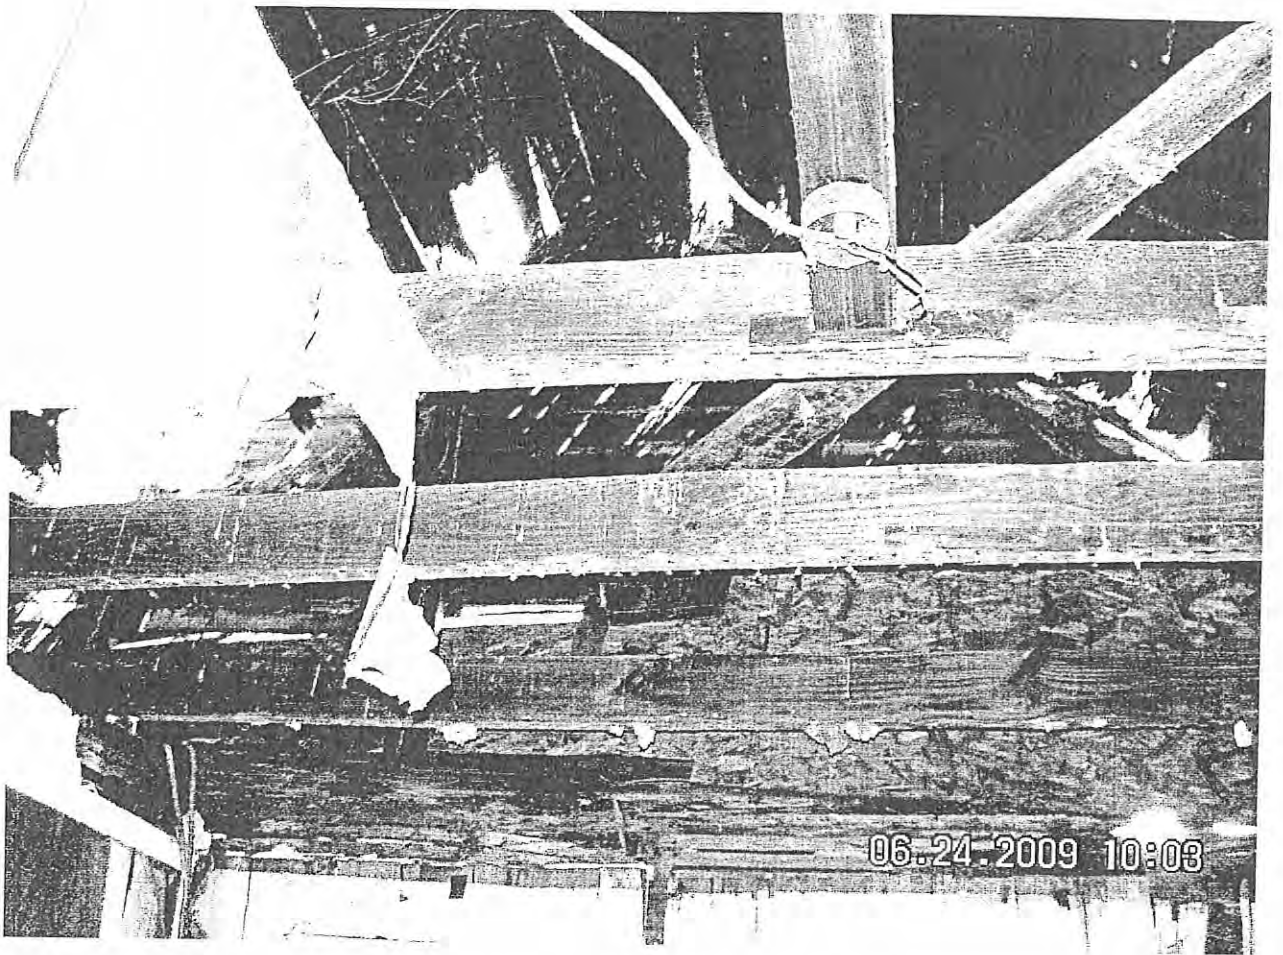
In particular, the front portion of the roof is gone and will have to be replaced.

Front roof area - white panel in upper left is ceiling.

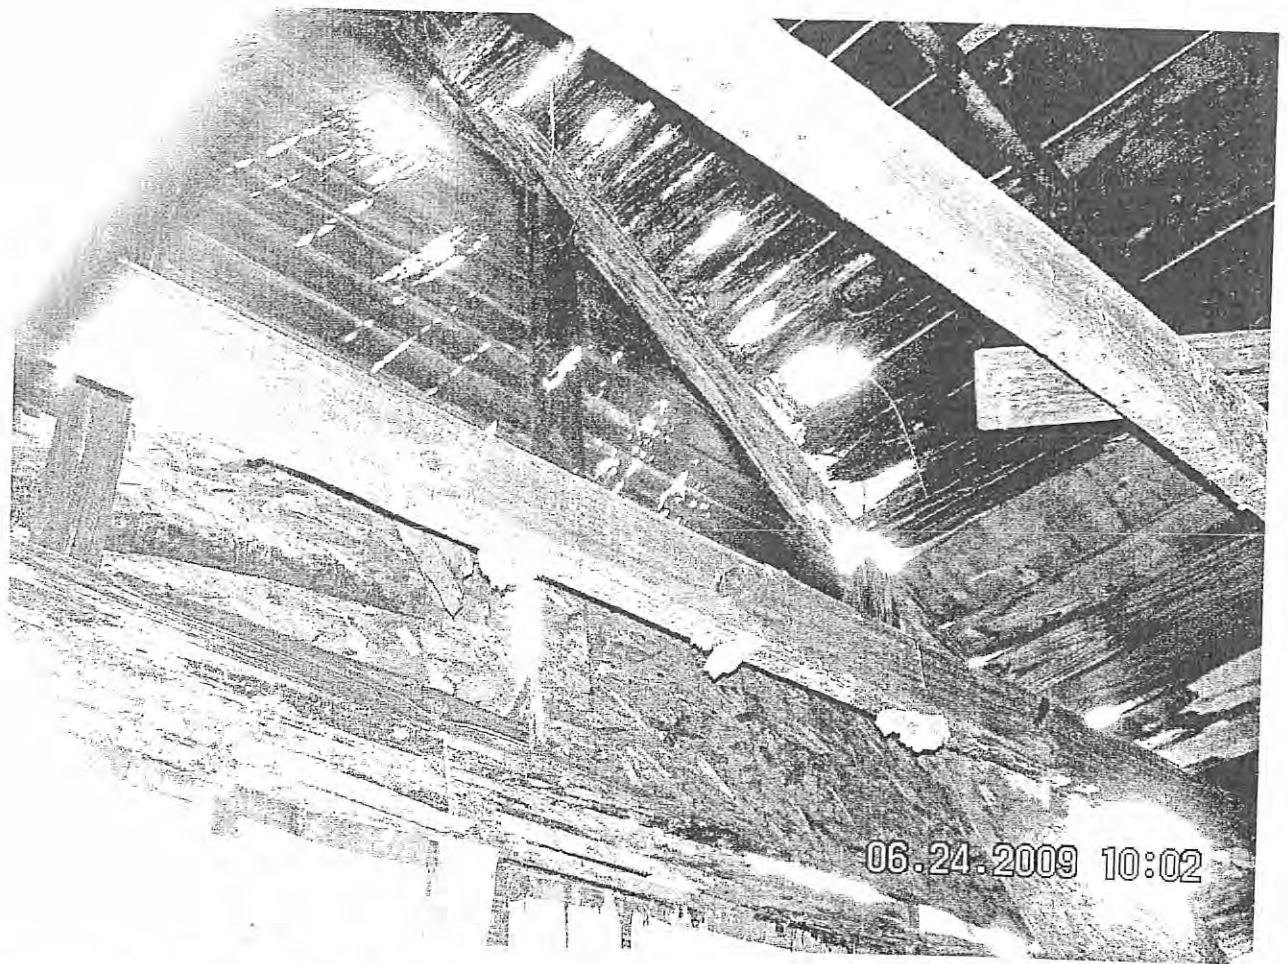
Front left corner of roof - note OSB where second floor porch roof was removed.

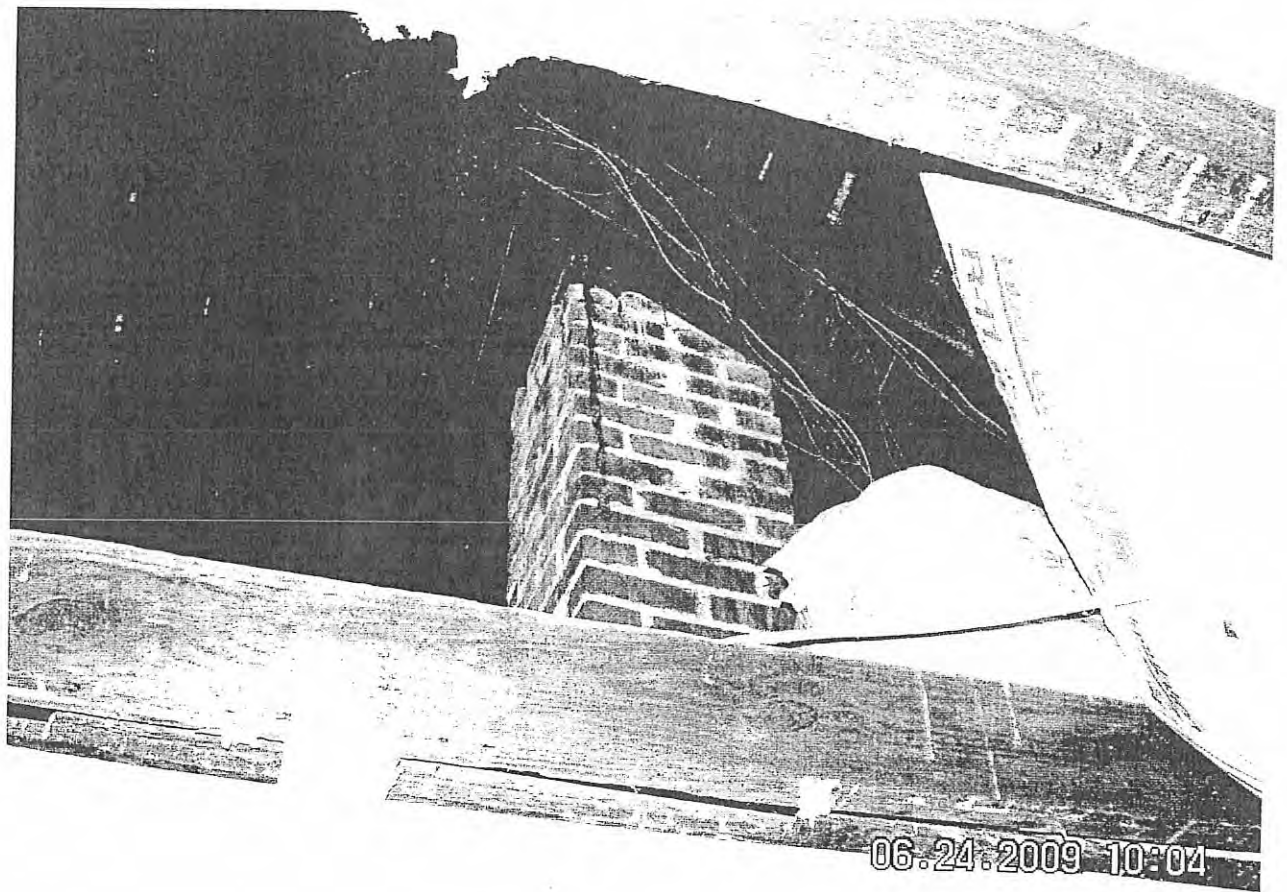
There was a flue near the center of the house. The flue was removed at the roof line and the roof covered over.

Center (Utility) flue has been removed above the roof and the roof covered over.

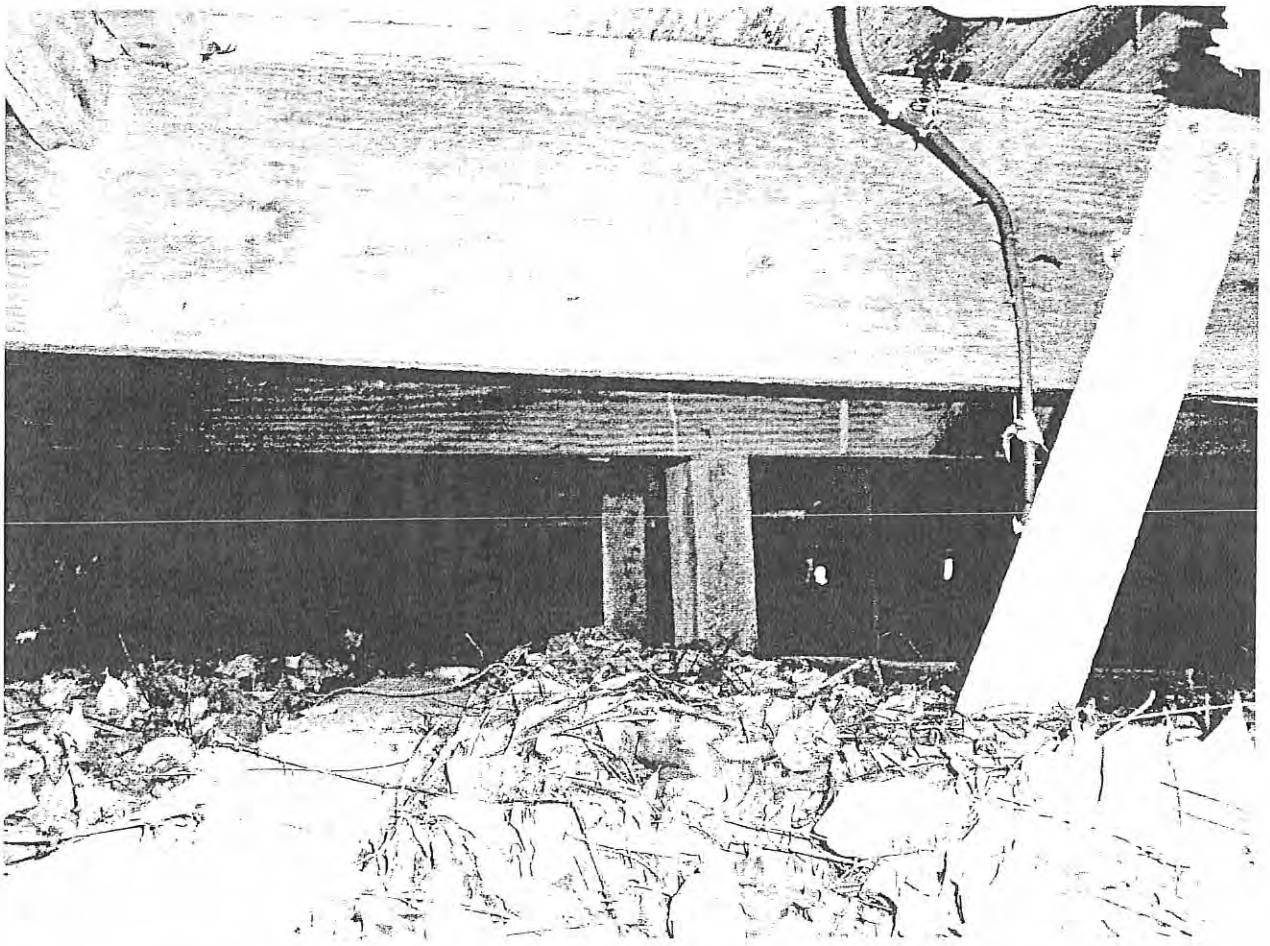
View under house from rear (under Kitchen) - note wood support posts.

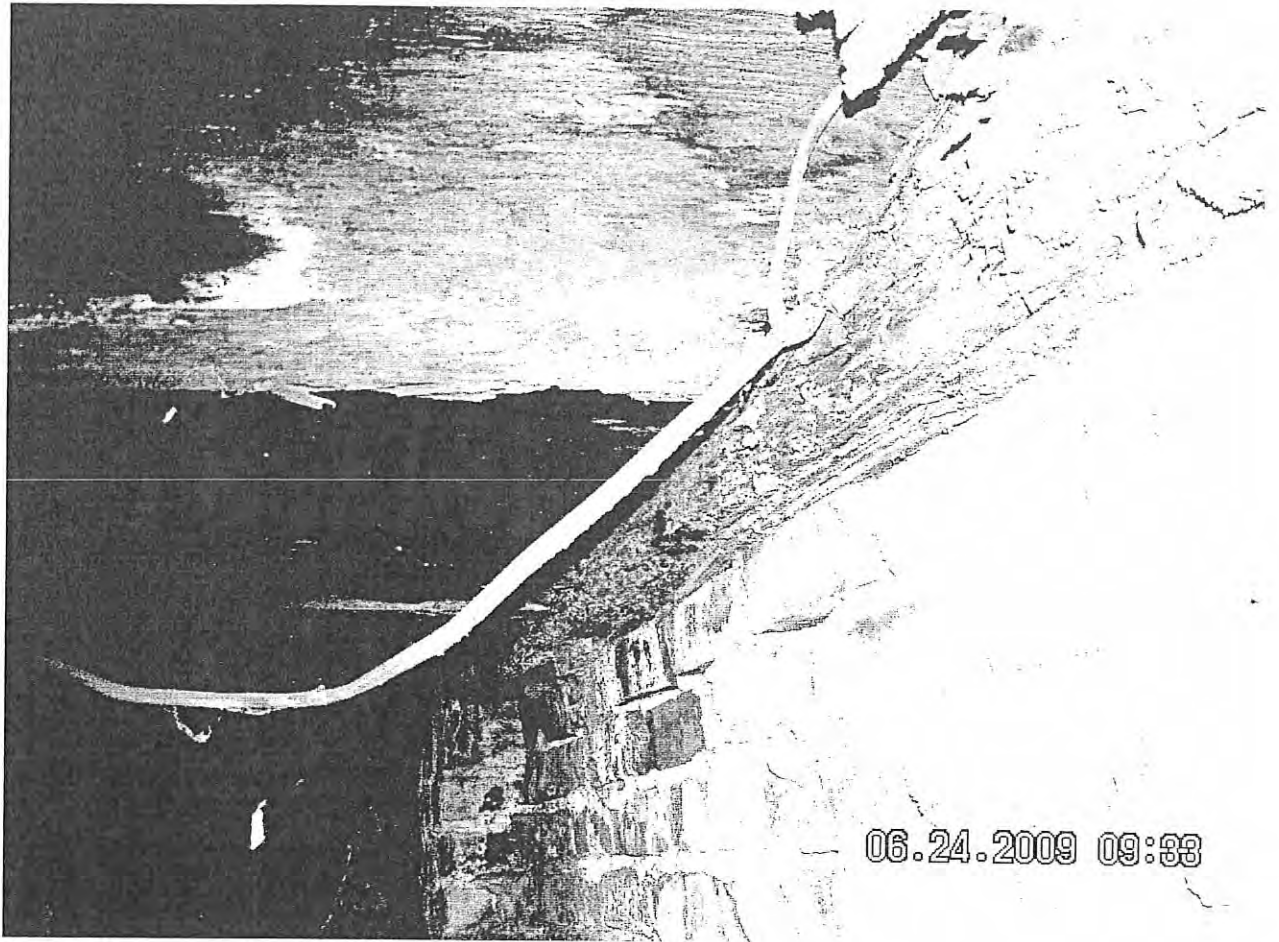
The sills at the left side and rear contain extensive decay, requiring replacement.

Decay at left side sill and first floor floor joist

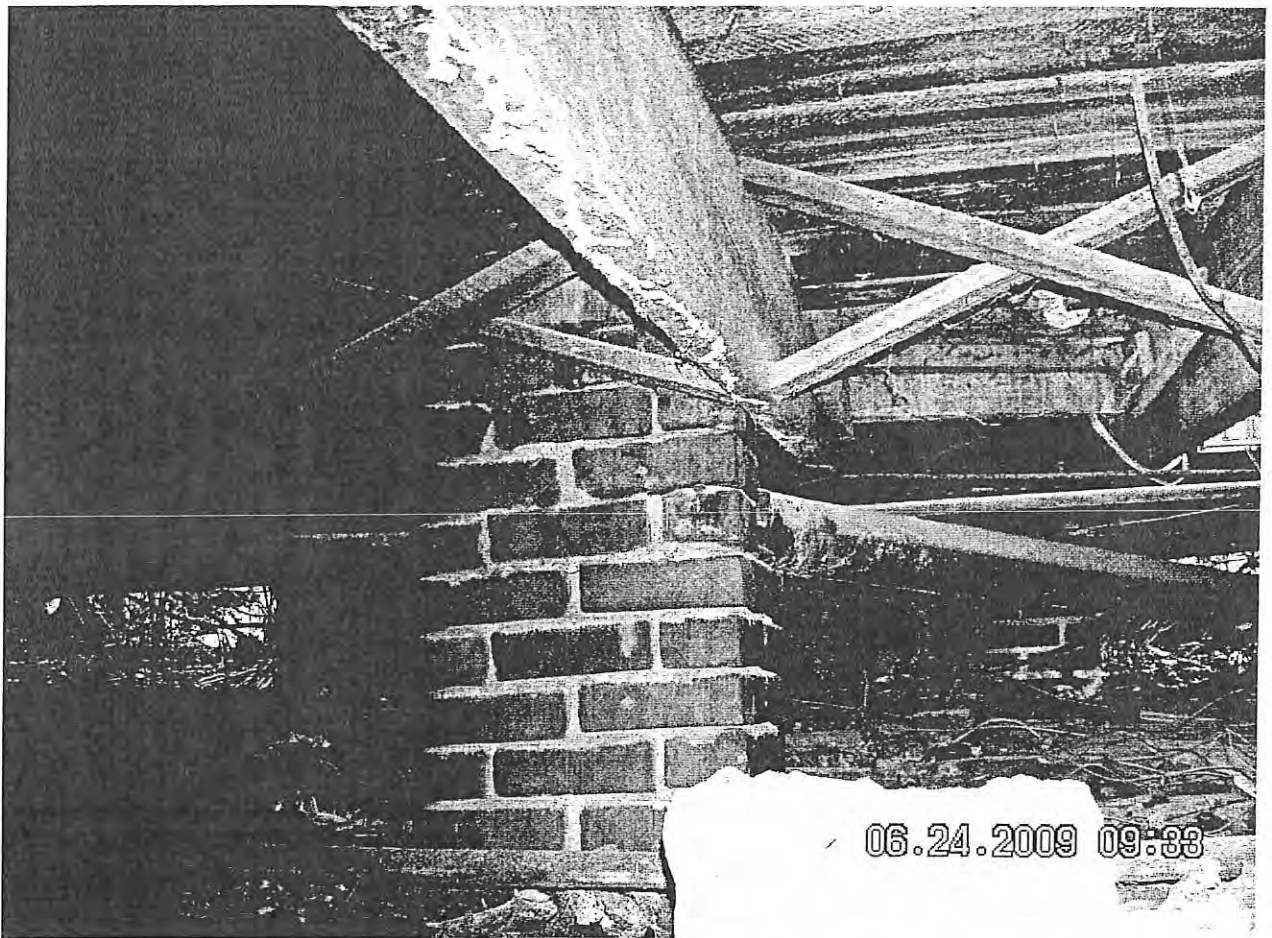
Former flue foundation - note termite shelter tube on  
joist
