In Re: 133 Cannon Street  
Structural Inspection

I have inspected the structure at 133 Cannon Street and offer the following information.

133 Cannon Street is a two-story wood frame house that I believe to be approximately 150 years old.

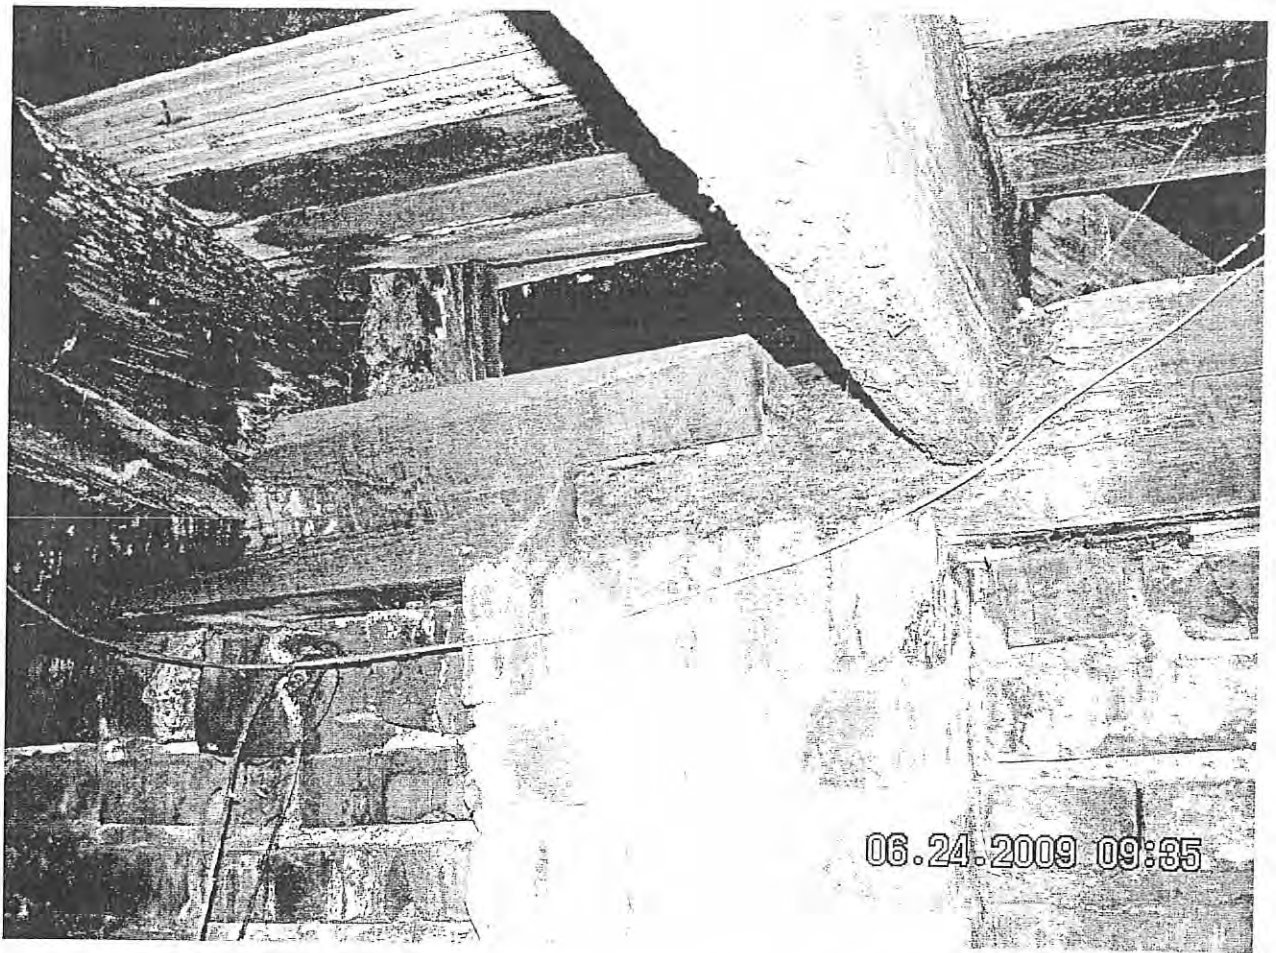
The sills at the left side and rear contain extensive decay, requiring replacement.

Left Side - note decay at sill, termites in joist, and cracked floor joist.

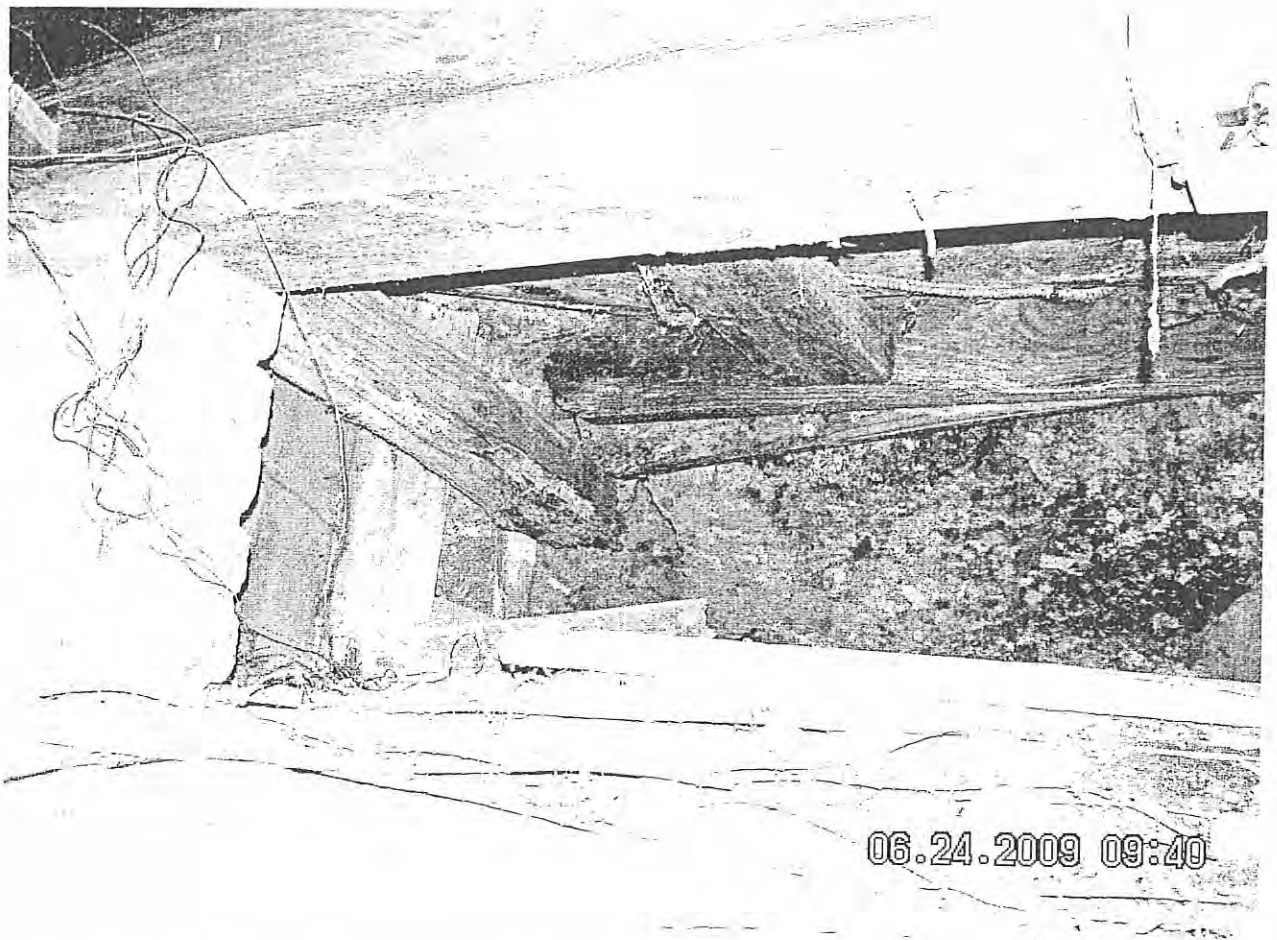
View under front porch - note there are no foundations  
under bay window area.

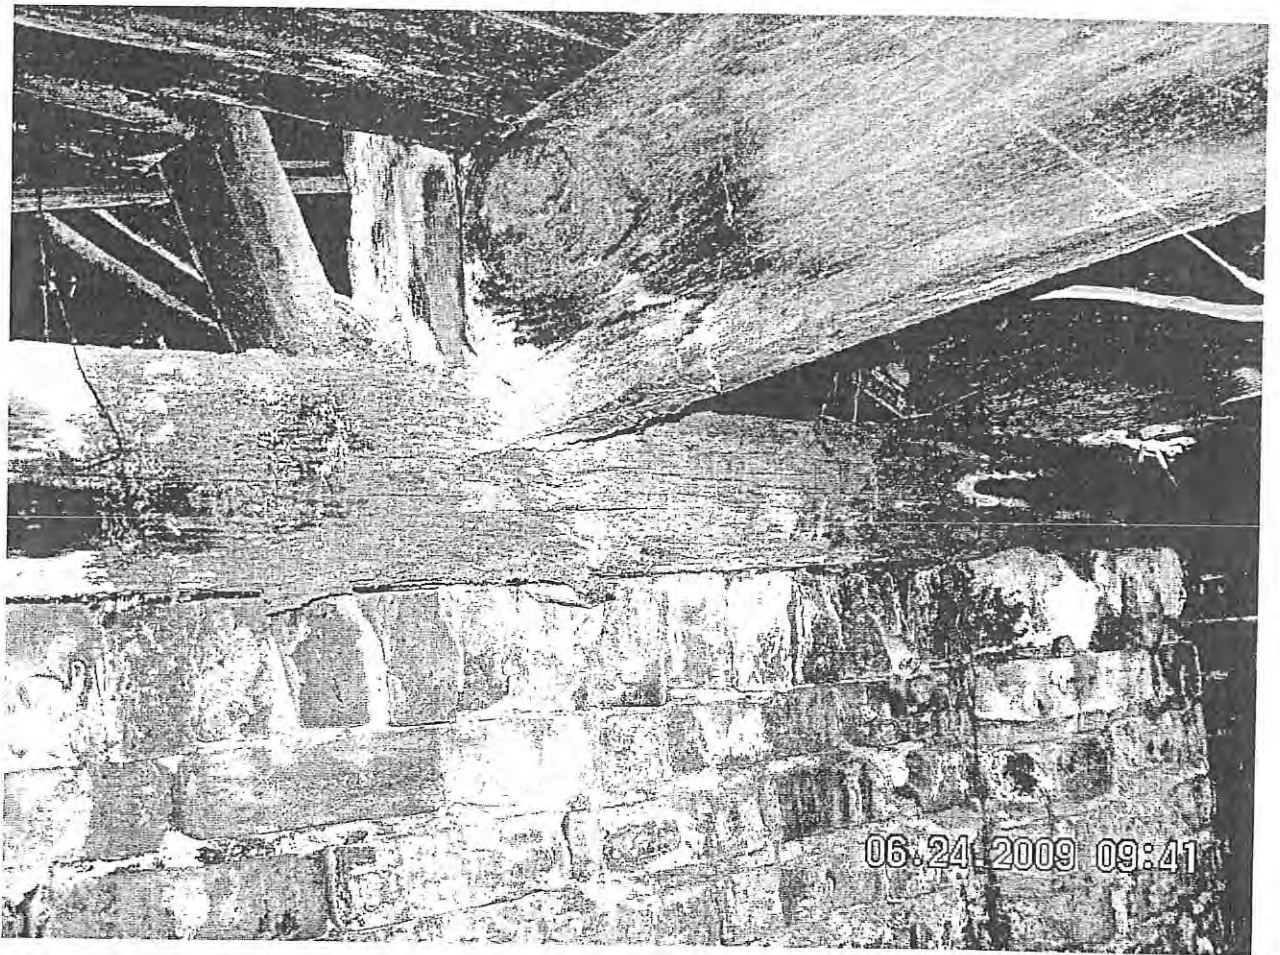
Decay in left side sill and floor joist

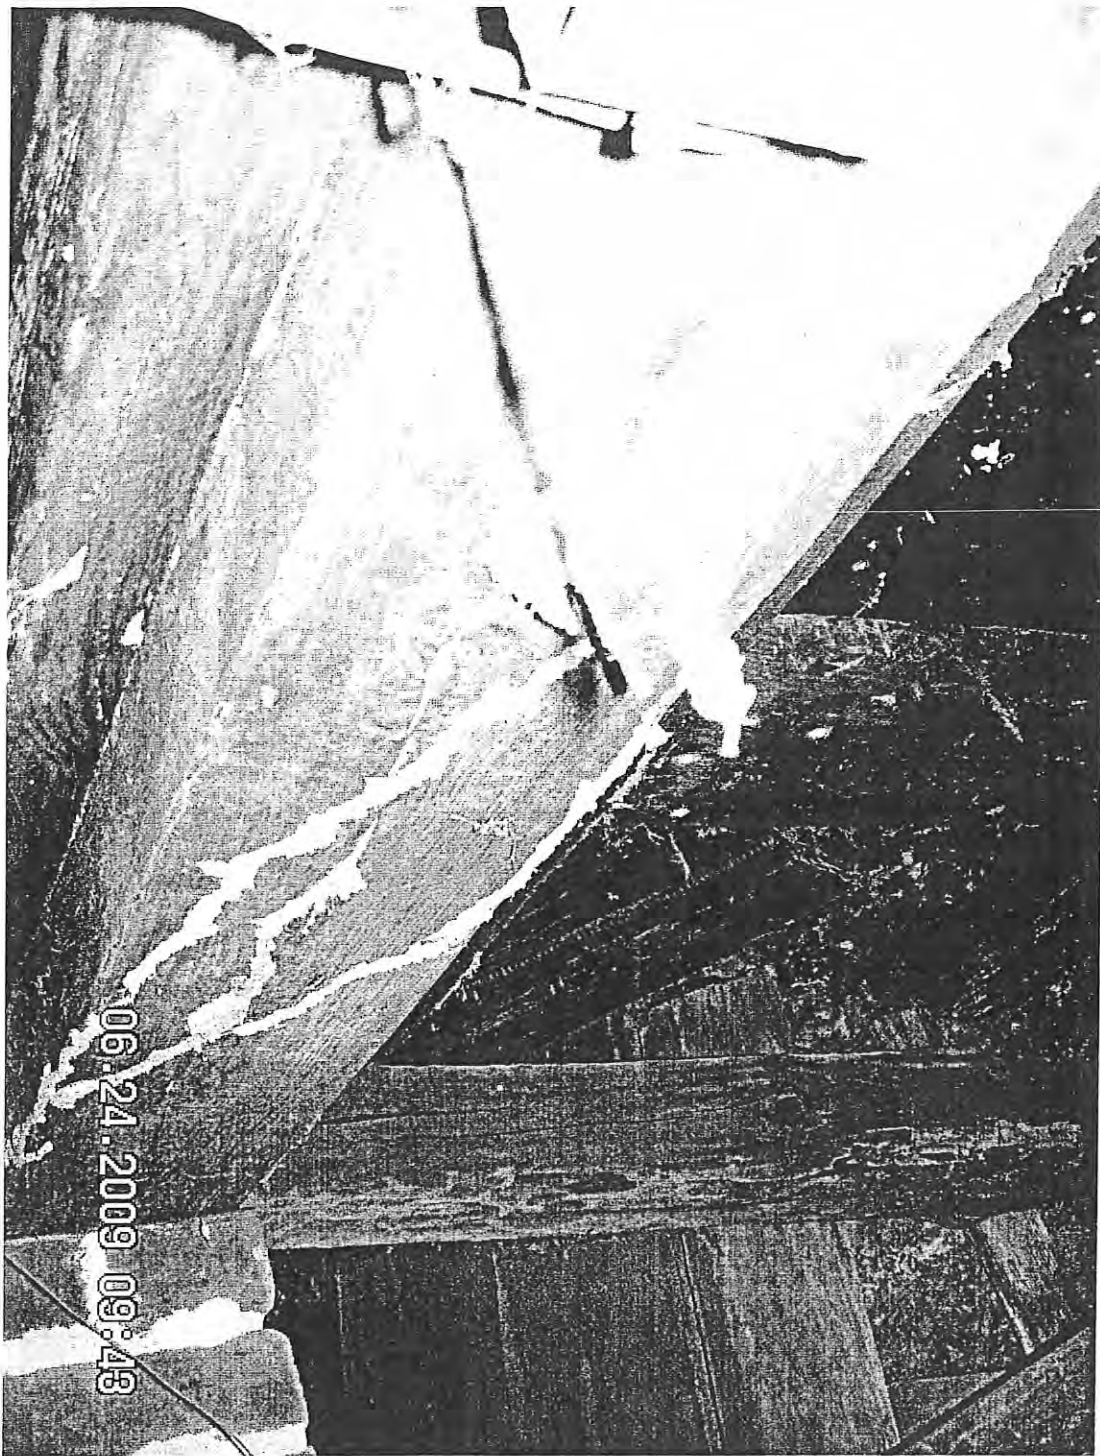
The sill under the front of the core house at the bay window contains termite damage requiring replacement.

Termite activity on girder between the bay window and house (original front sill)

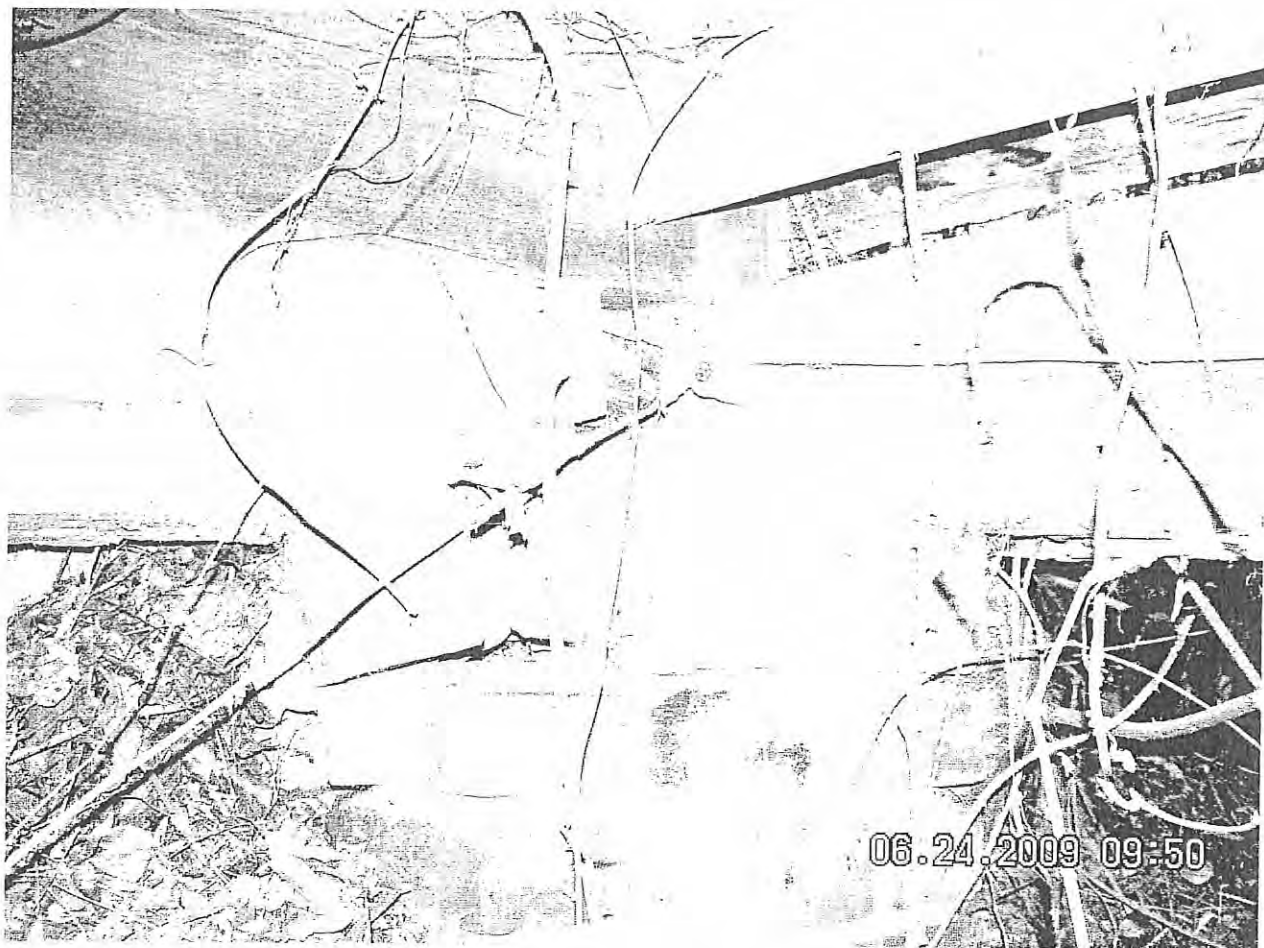
The foundations are independent brick masonry piers of marginal character.

Rear Right Corner - note pier failing.

The foundations should be replaced with contemporary type foundations, piers and tie downs in the event of any repair.
