AN ARCHITECTURAL INVESTIGATION OF  
**79 ANSON STREET**  
CHARLESTON, SOUTH CAROLINA

Willie Graham, Carl Lounsbury and Orlando Ridout V  
for the HISTORIC CHARLESTON FOUNDATION  
10 March 2005

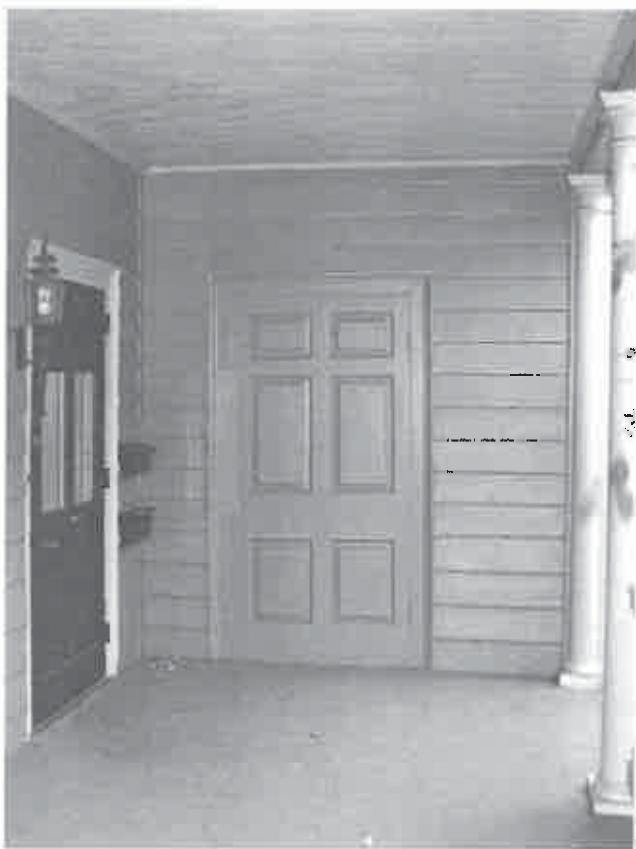
*Principal entrance doorway to left; door to southeast room (center of image) was converted to a blind door in 1956. All photographs by Carl Lounsbury, 2005.*

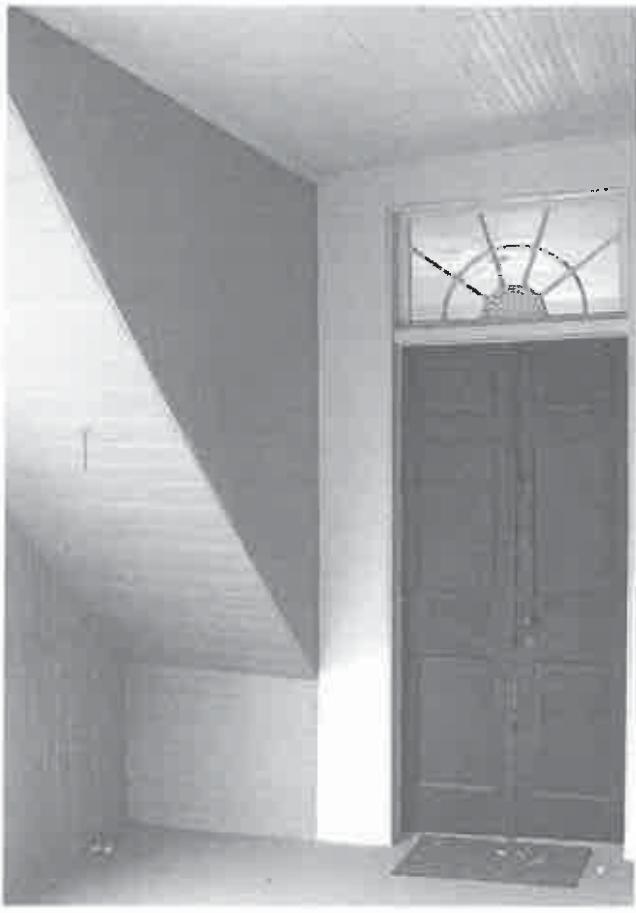
*The stair as shown here was reconfigured when the entry was enlarged and the doorway moved to its present position about 1827. The doors may have been salvaged from the period I opening, but the transom was newly created at the time of the move.*

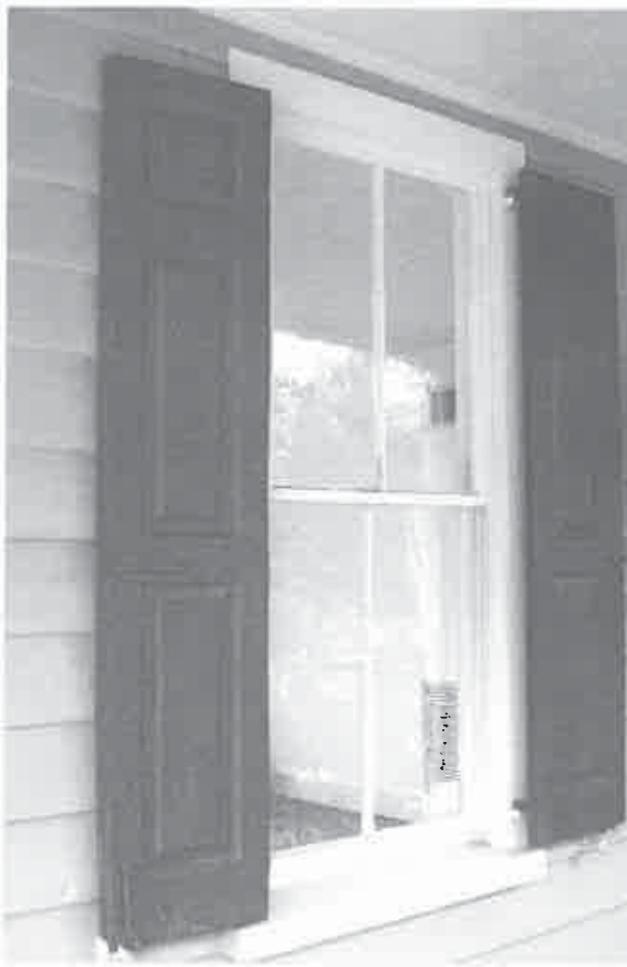
*First-floor window, south facade. The jamb, shutter and hardware are original; the sash were replaced about 1870.*

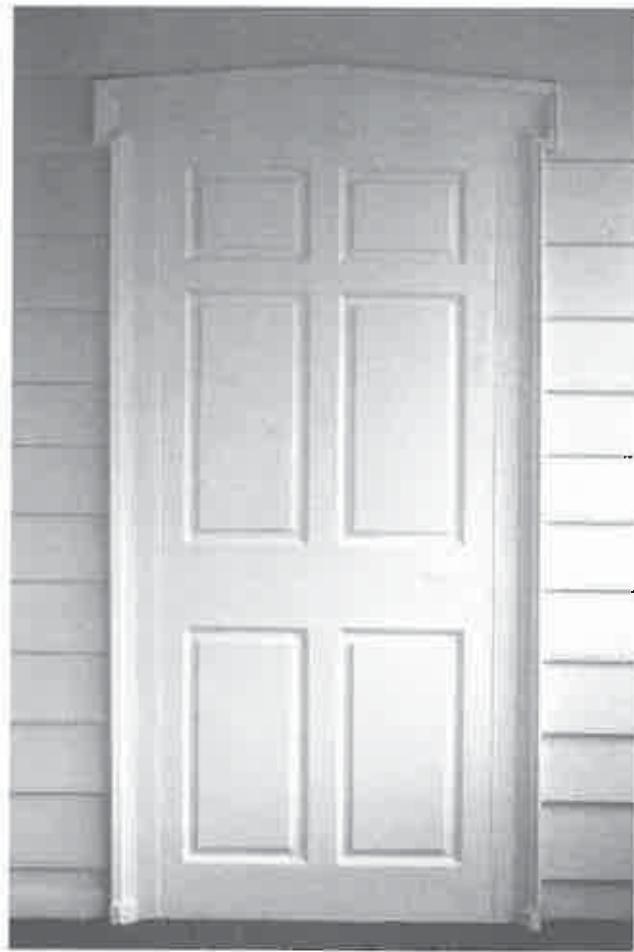
*Second-floor door to southeast room, converted to a blind opening in 1956.*

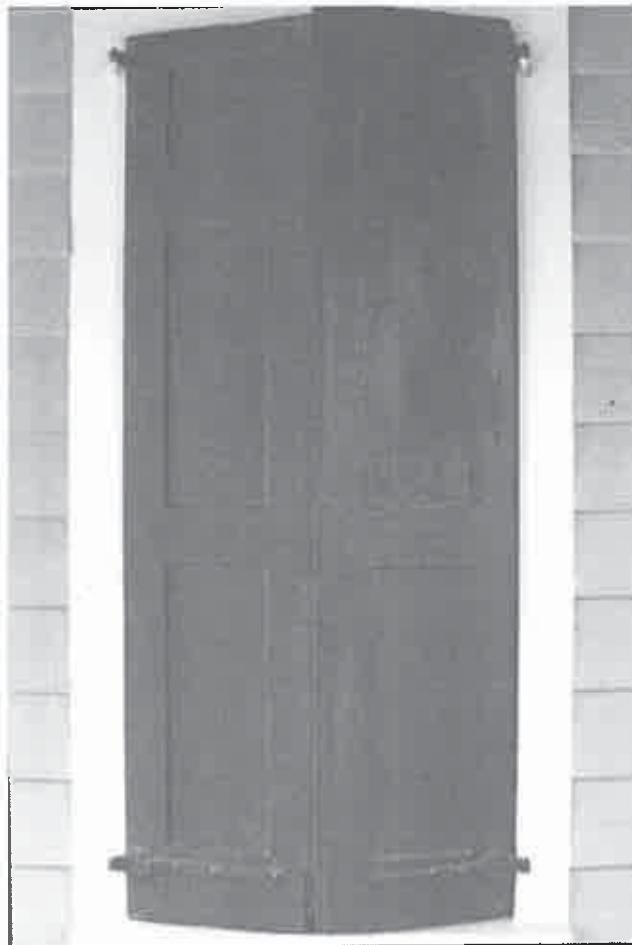
*Pair of paneled shutters with original hardware. First-floor, west elevation.*

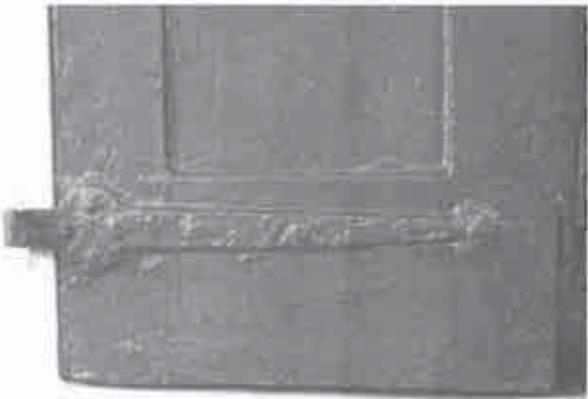
*Original strap hinge.*

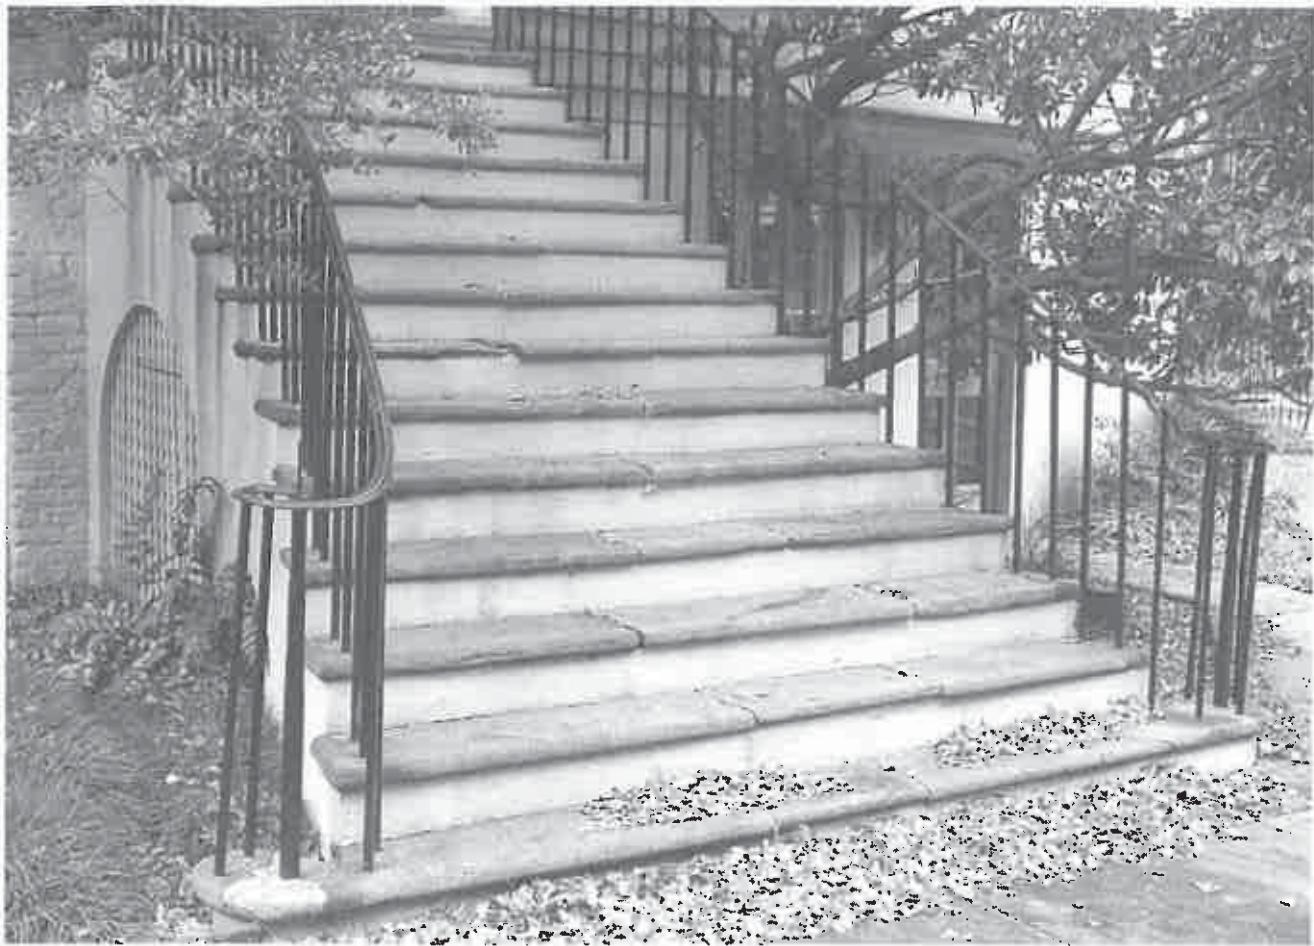
*The stone steps and associated wrought-iron railing are an early, and probably original feature.*

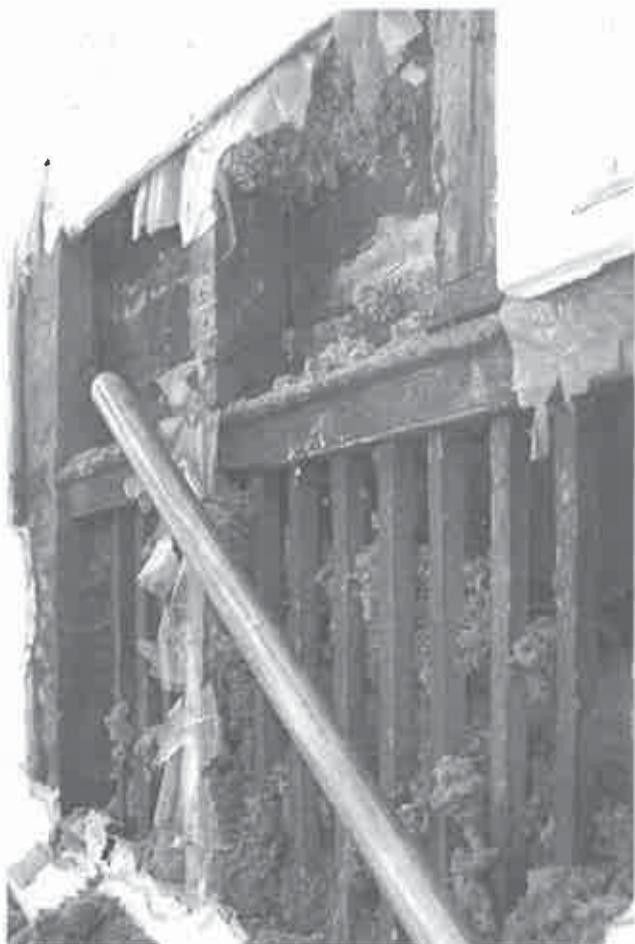
*Buried within the exterior wall of the upper floor are the remains of the original porch posts and balustrade.*

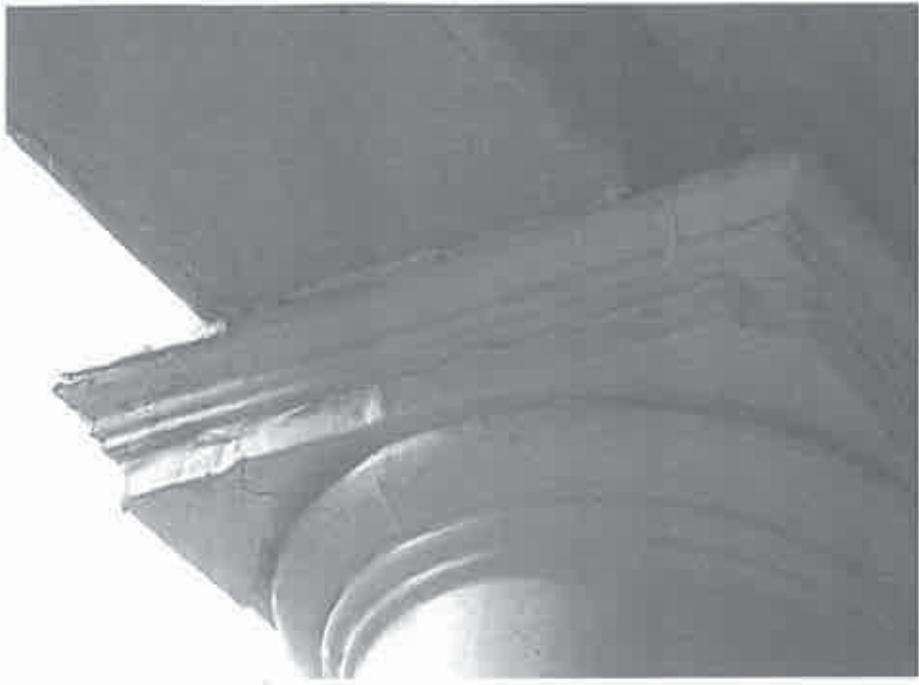
*The original chamfered columns were replaced as part of the ca. 1827 work. The new turned columns were done in the Greek revival style, as can be seen here in the moldings of the capital.*

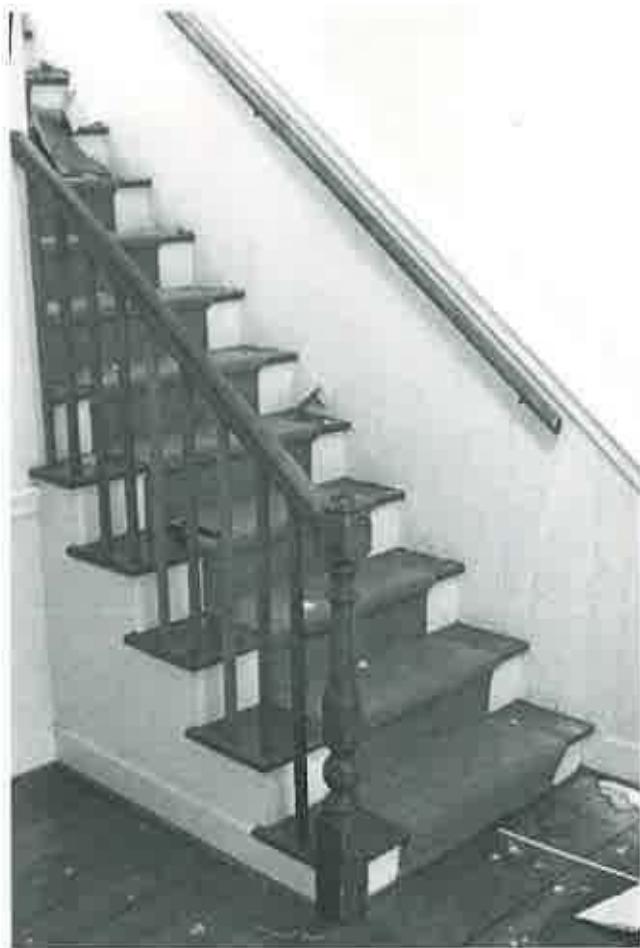
*Stair in its 1827 location.*

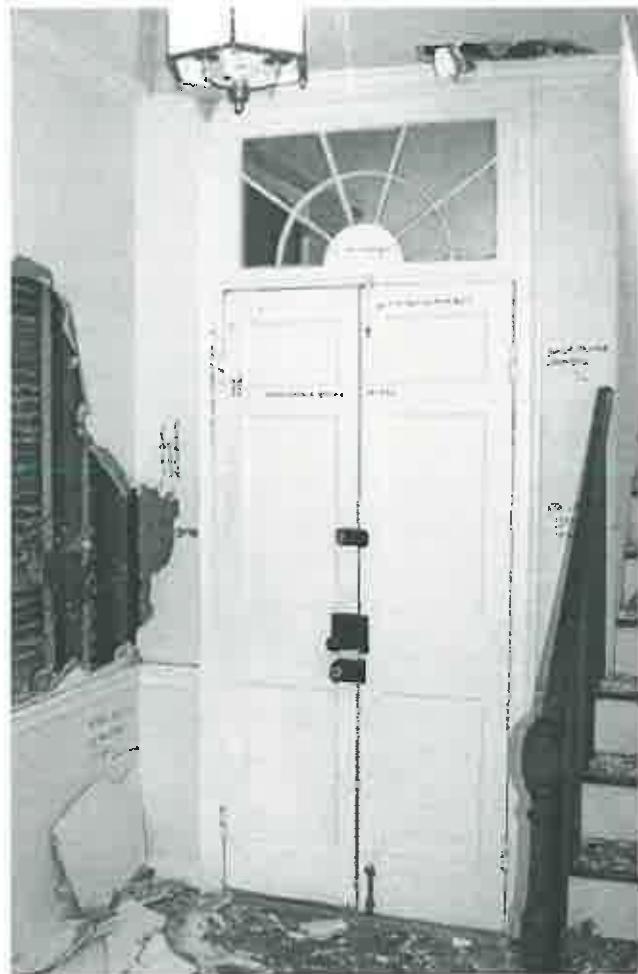
*The stair hall was expanded to the south when the stair was moved to its present location in 1827.*

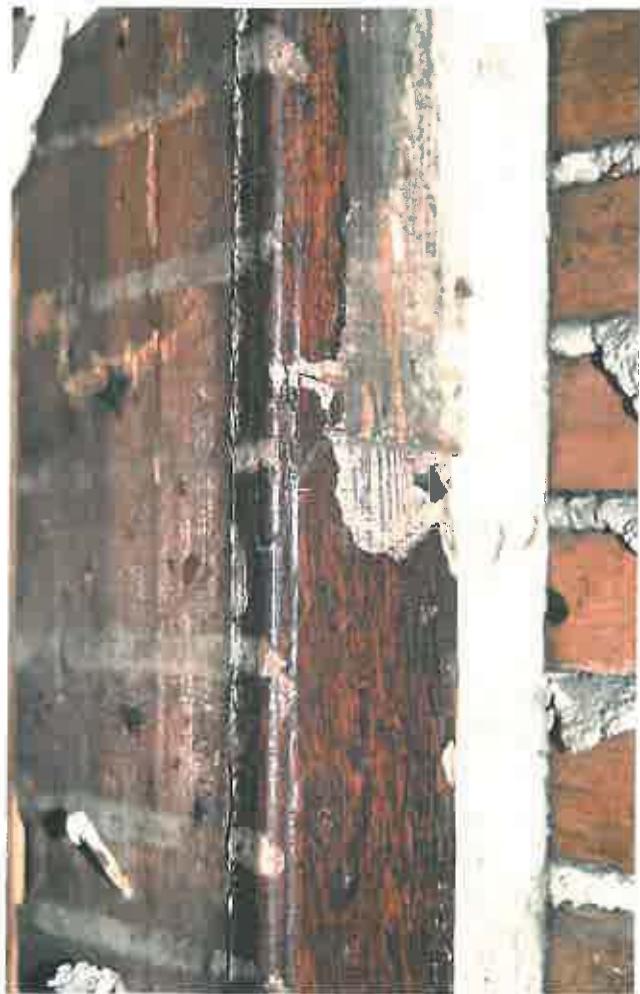
*Detail of window trim that was encapsulated in the expanded stair hall, but was not blocked until changes in the 1870s. Circular-sawn lath seen to the right is evidence of the abandonment of this opening. Note the oak graining on the bead that represents a finish predating the 1870s alterations.*

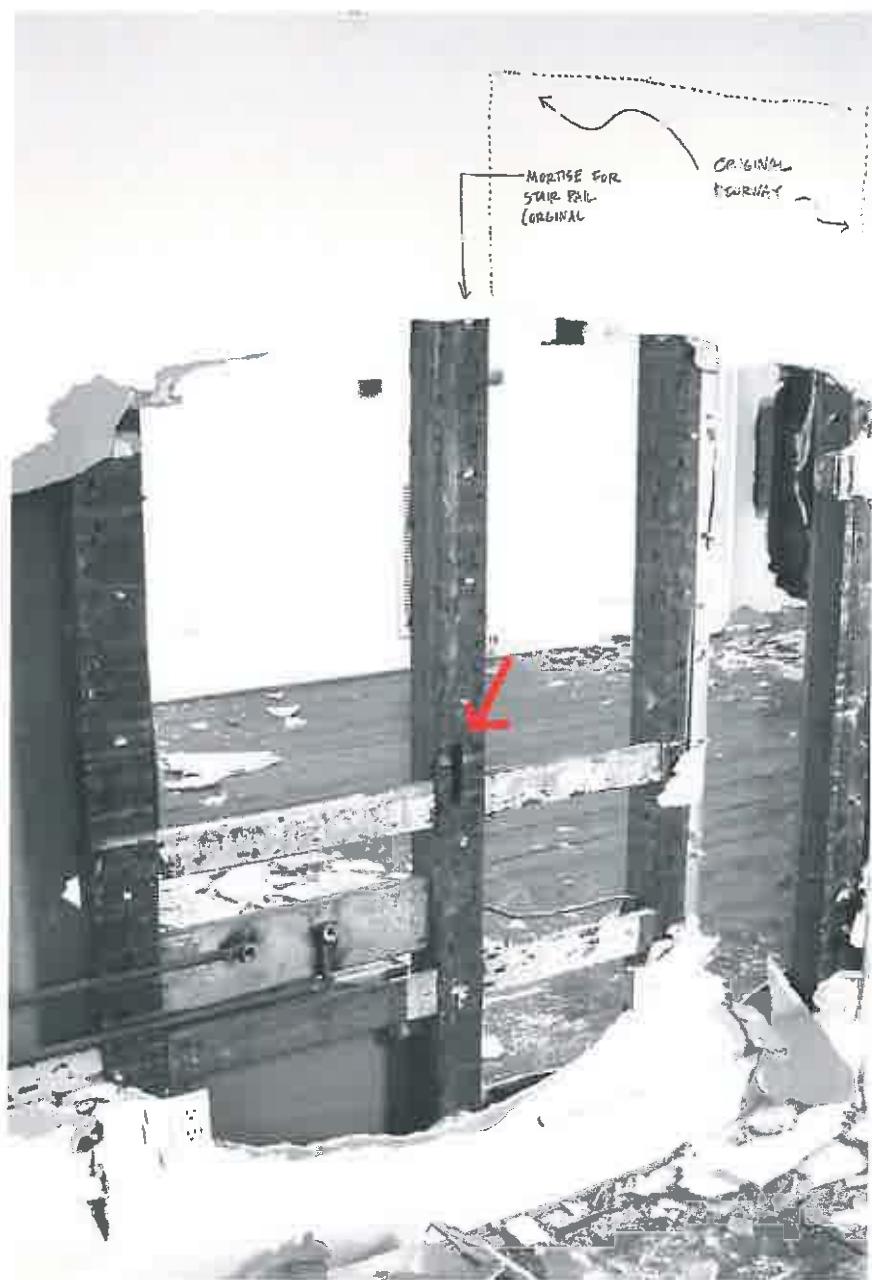
*The red arrow indicates the mortise for an original stair rail. Note the indication of the original doorway between the stair hall and the central room.*

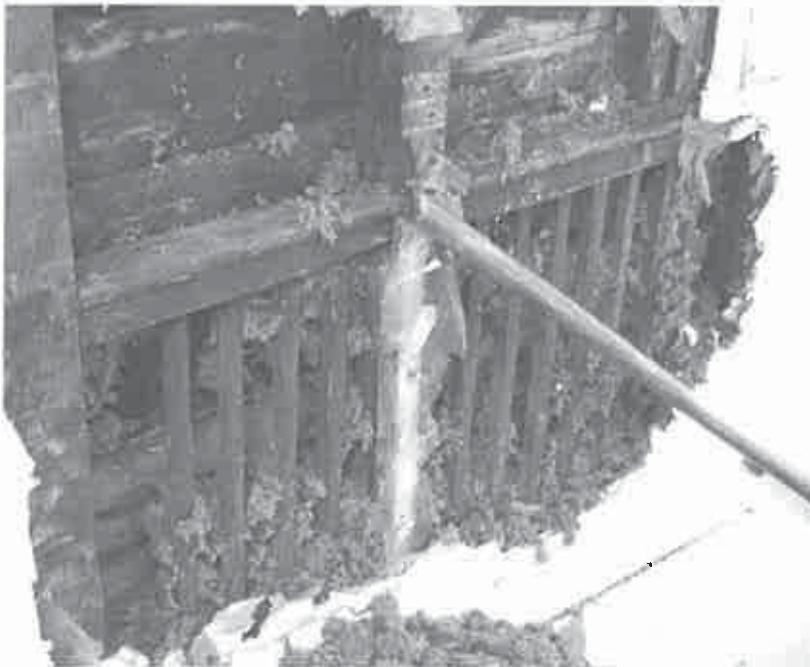
*Detail of original balustrade buried within the west wall of the southwest, second-floor room.*

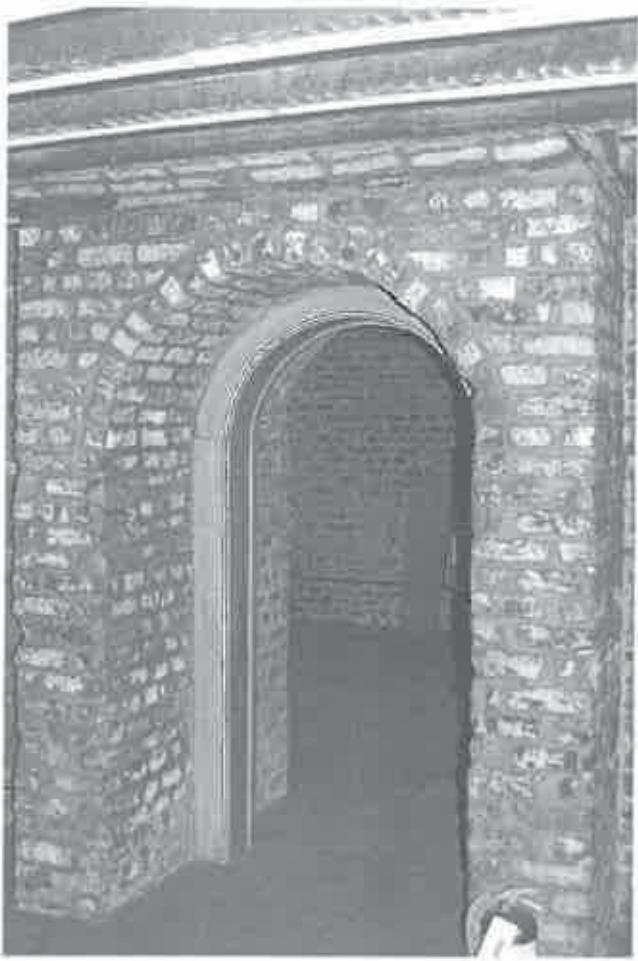
*Vaulted chimney base, east stack. A doorway was cut through the chimney base as part of twentieth-century alterations.*

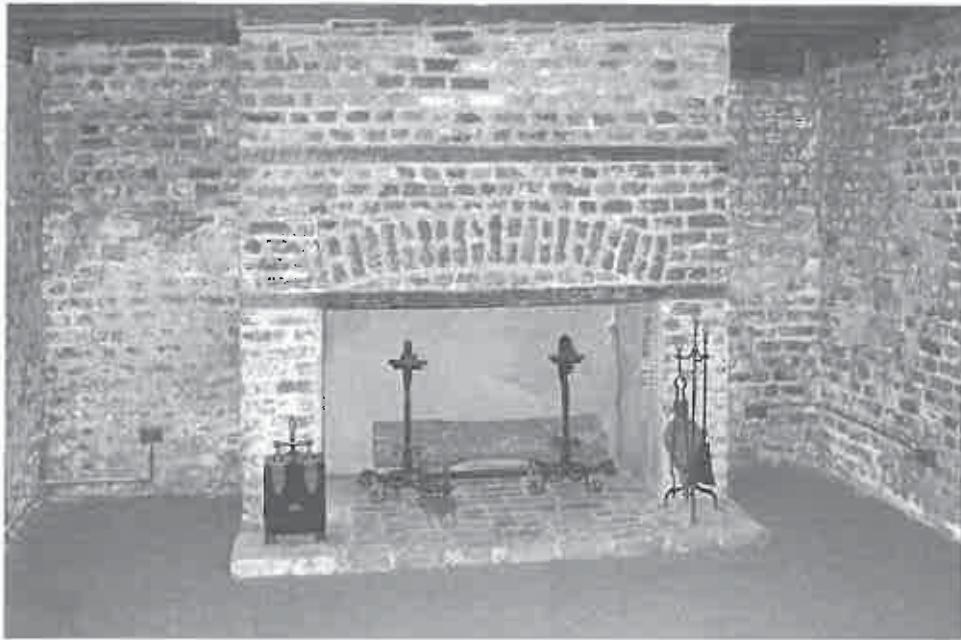
*Cooking fireplace in the central cellar room. An oven was located to the east of the fireplace and was removed in the twentieth century.*
