HISTORIC CHARLESTON FOUNDATION  
HURRICANE HUGO DAMAGE ASSESSMENT FORM

Street Address: 3 Henrietta

Tax Map Number: 459-13-3 lot 10

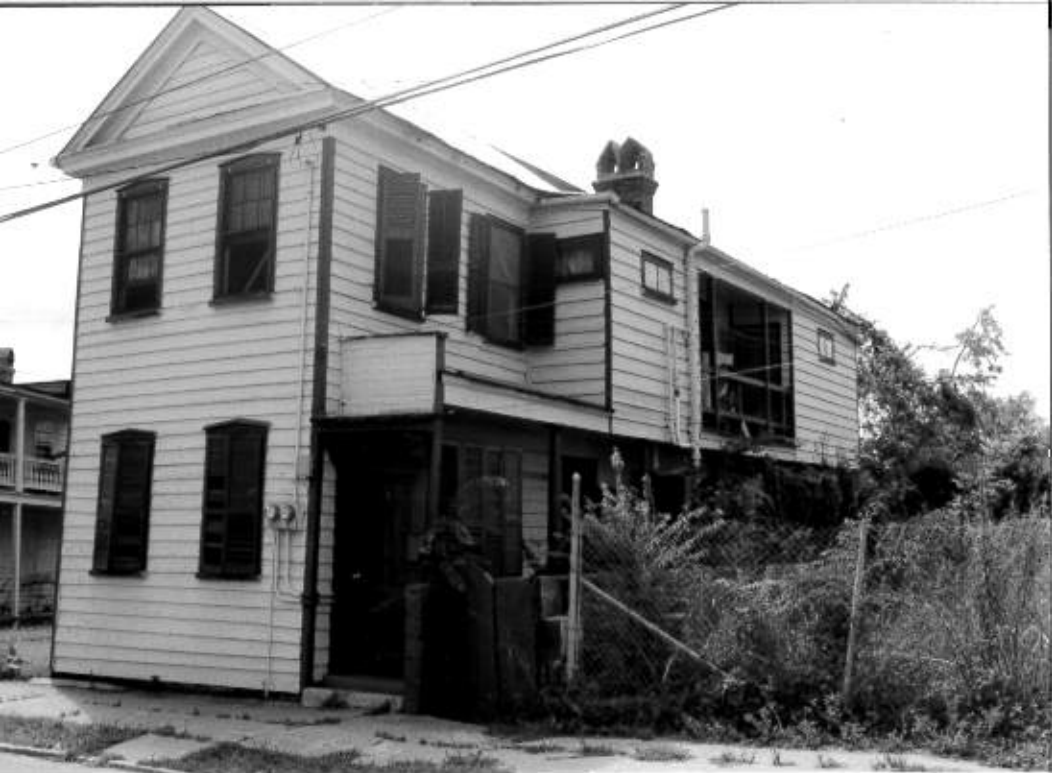
[ ]  
[ ]  
Whole house leaning toward the right

| Walls: Foundation/Basement | [ ] | [ ] | [X] <i>have coming off foundation</i> |
| Roof Covering | [ ] | [ ] | [X] <i>50% damage</i> |
| Chimneys (Number: 1) | [ ] | [X] | [ ] <i>bricks displace</i> |
