HISTORIC CHARLESTON FOUNDATION  
HURRICANE HUGO DAMAGE ASSESSMENT FORM

Name of Property: (if any) "German Friendly Society"

Street Address: 27 Archdale

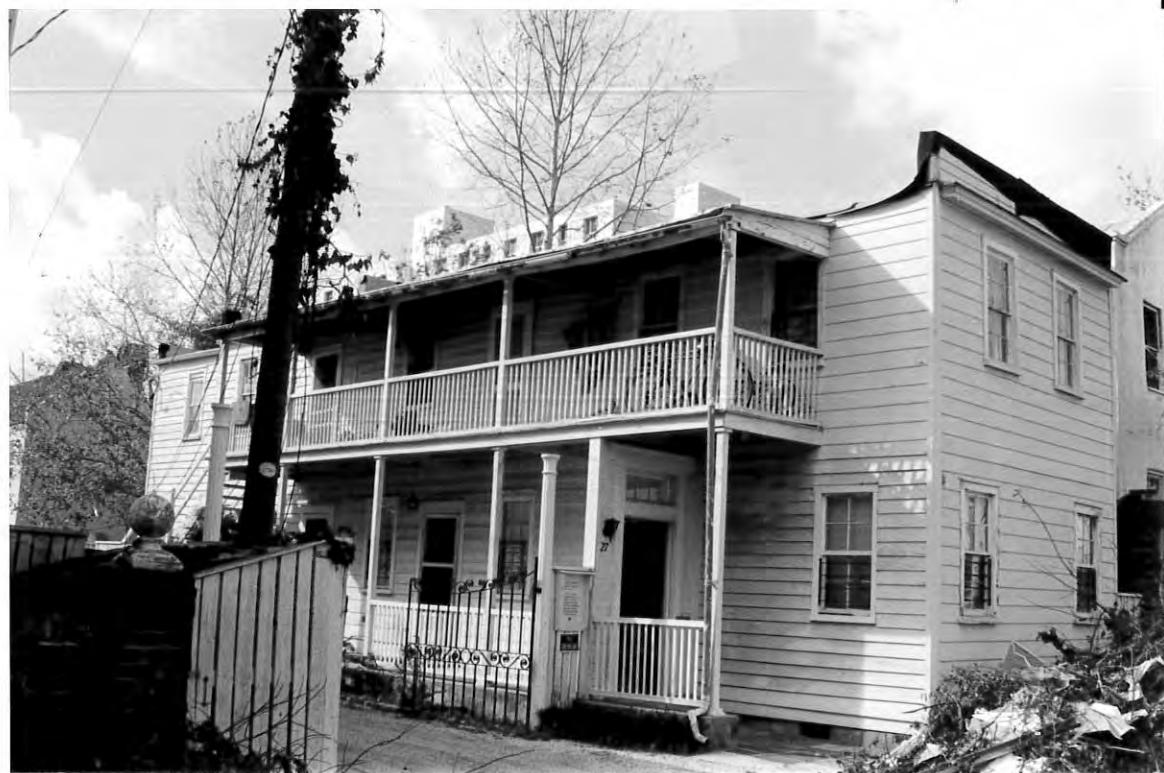
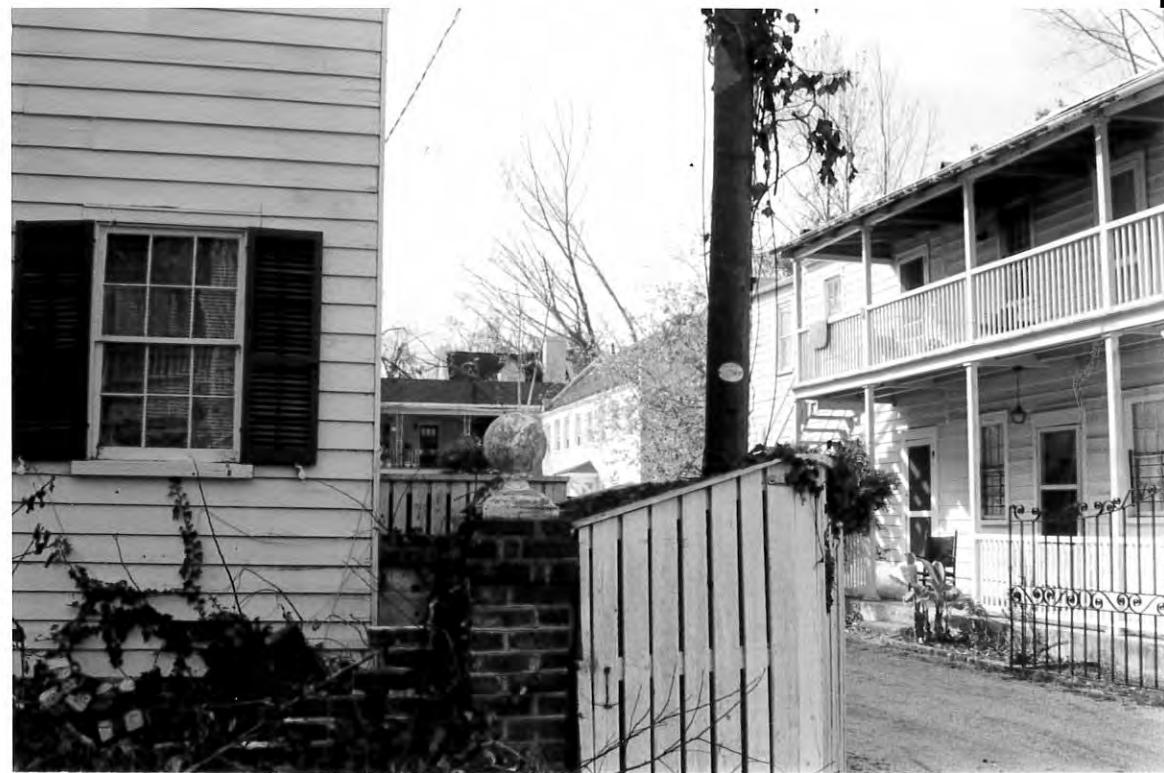
NO VISIBLE DAMAGE TO HOUSE, ROOF HAS MINOR DAMAGE,  
HOWEVER, HOUSE SEEMS TO BE IN POOR CONDITION BECAUSE  
HUGO, i.e., PAINT PEELING, RUN DOWN APPEARANCE, etc.

SOME MINOR DAMAGE
