Conservation Treatment Report

Date: 11 February 2025

Title/Description: *Attack on Fort Moultrie*

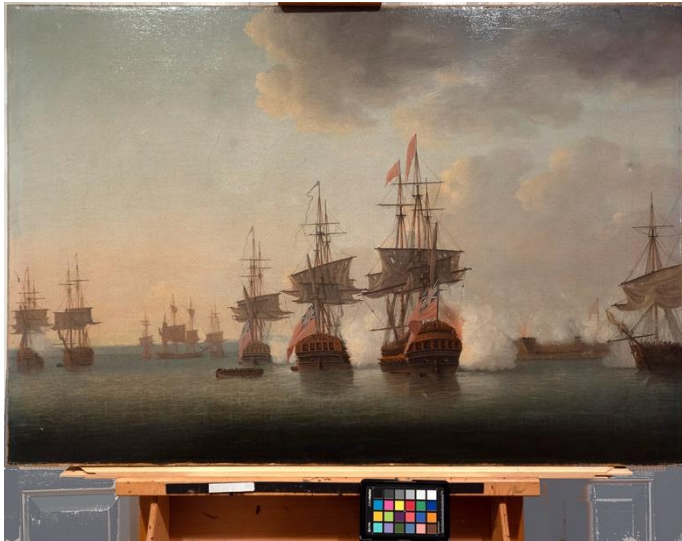
Treatment was required to repair a sharp dent in the upper right quadrant of the picture and to stabilize lifting paint along the left and right edges. A moderate layer of surface grime dulled the picture overall.

Before Treatment – Normal lighting

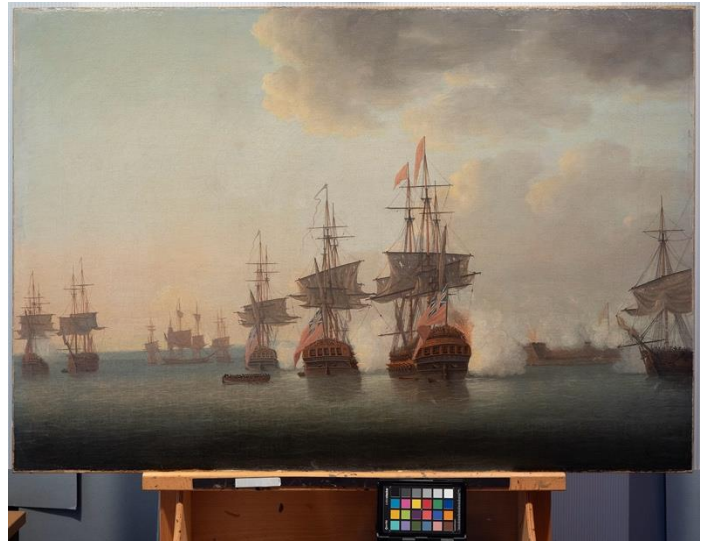
After Treatment – Normal lighting

The painting was placed face up on a flat surface and the canvas was supported from the reverse. Isinglass adhesive, 5% concentration in distilled water, was wicked into raised cracks and beneath areas of lifting paint at the left and right edges. Lifted paint was relaxed and set down through silicone-coated mylar using a heated spatula and gentle finger pressure.

The varnished paint surface was cleaned using cotton swabs and a 1% solution of sodium citrate in distilled water. The cleaning solution was cleared using swabs and distilled water. An area of loss near the lower left edge was filled using Modostuc, a fine putty of calcium carbonate in a poly(vinyl-acetate) binder. The small depression remaining in the area of the dent was filled with Cosmoloid 80H, a clear microcrystalline wax. Both areas, along with two areas of discolored retouching near the upper left corner, were inpainted with Gamblin Conservation Colors (pure pigments bound in synthetic urea-aldehyde resin). The painting was re-secured into the frame using the existing staples.

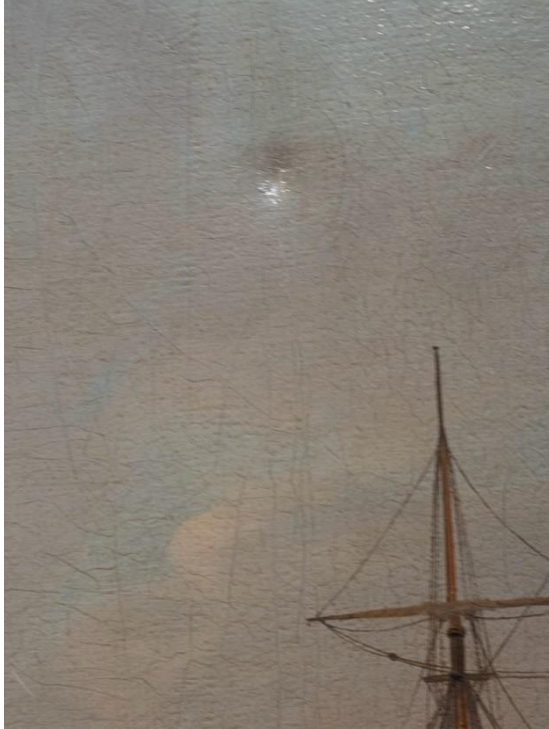
Before Treatment – Detail, Upper Right, Normal lighting

Isinglass adhesive was also wicked into cracks surrounding the dent at upper right to stabilize insecure paint in this area. The painting was placed face down on a smooth, padded surface. The reverse was cleaned of loose dust and dirt using stiff brush. In the area of the dent, the canvas was gently humidified using dampened blotter paper and slowly relaxed using a heated spatula. Heat and moisture were applied intermittently to relax the canvas and glue lining adhesive; gentle pressure was used to reduce the dent and coax the surrounding canvas into plane. The painting was then placed on the easel, and working from the front and back, lifted paint surrounding the dent was set down using a

heated spatula. Due to the particularly sharp nature of the original damage, a small depression in the paint remained in the center of the dented area.

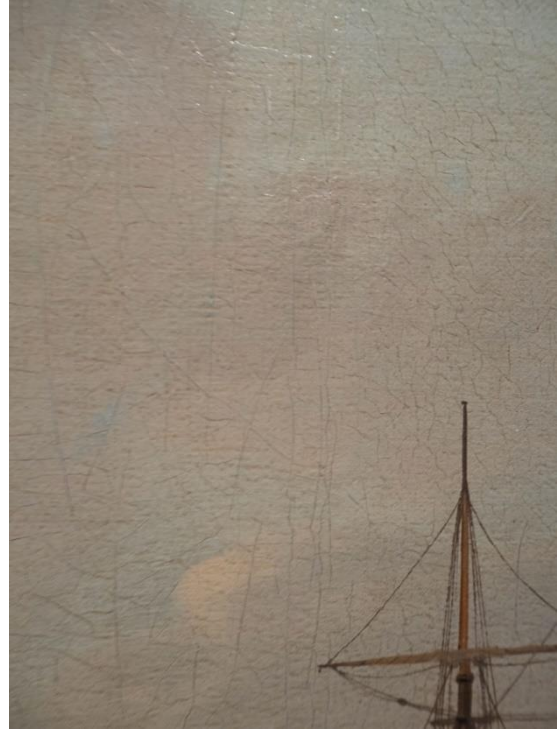
After Treatment – Detail, Upper Right, Normal lighting

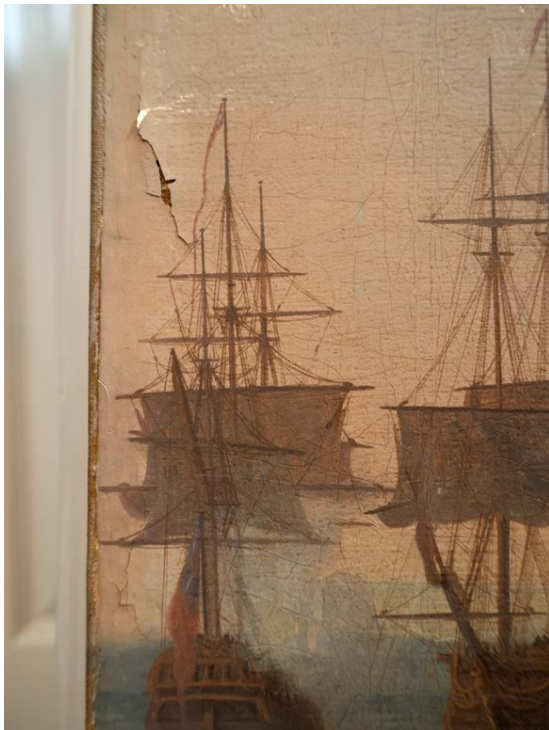
Before Treatment – Detail, Lower Left, Normal lighting

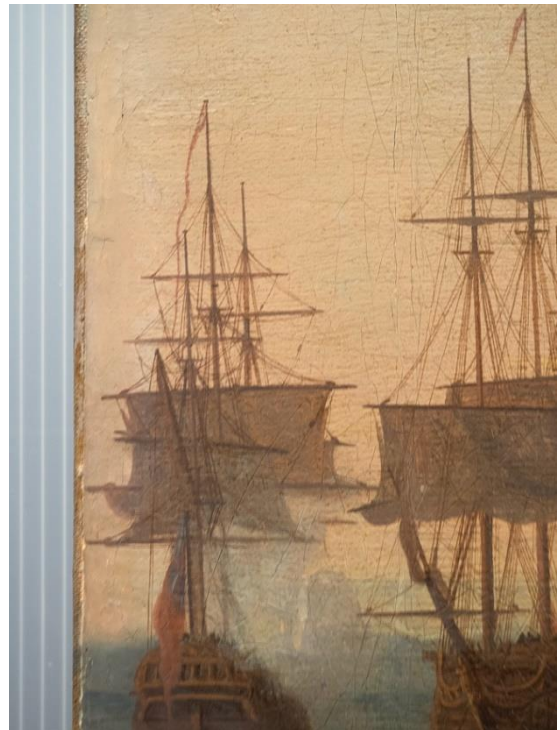
After Treatment – Detail, Lower Left, Normal lighting
