**Aiken-Rhett House
Historic Charleston Foundation
Charleston, South Carolina**

Paint Cross-Section Microscopy Report

Aiken-Rhett Art Gallery Interior Paints

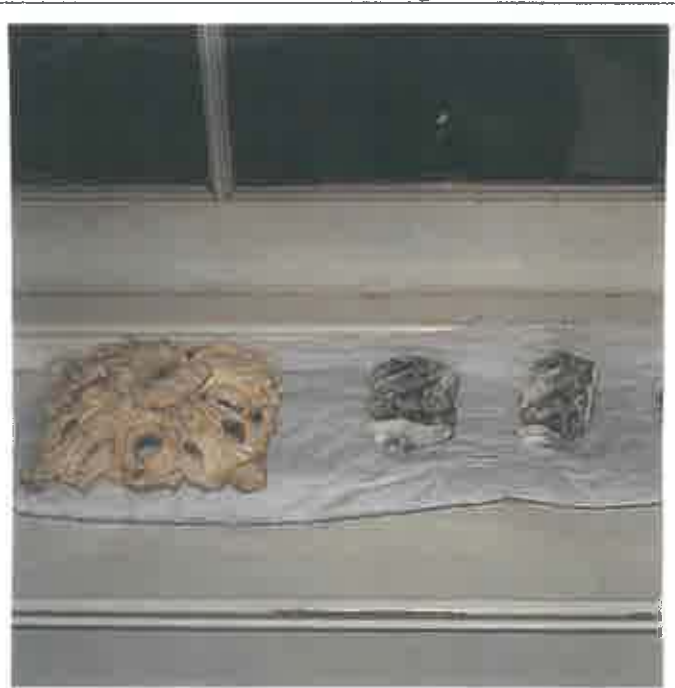
Detached Rosette and Cornice Fragments

There is only the most fragmentary evidence of the original coatings on the plaster rosette and on the cornice elements. Sample # 17 from the detached rosette contains only the plaster substrate with a film of sooty dirt on the surface. This rosette was perhaps either left unpainted, or perhaps whitewashed, but the evidence is inconclusive. Sample #18 from an original leaf form from the inner border of the cornice contains three paint layers beginning with a coarse gray-blue layer, followed by two off-white paints. It is not possible to determine whether this gray-blue layer is the original paint on the cornice, or whether the cornice was initially whitewashed (a typical treatment for ceilings and cornices) and the ephemeral whitewash simply does not survive.

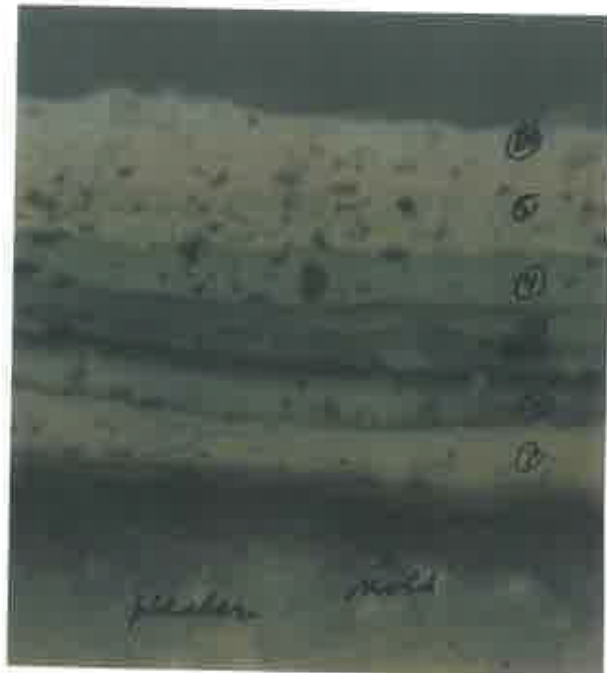
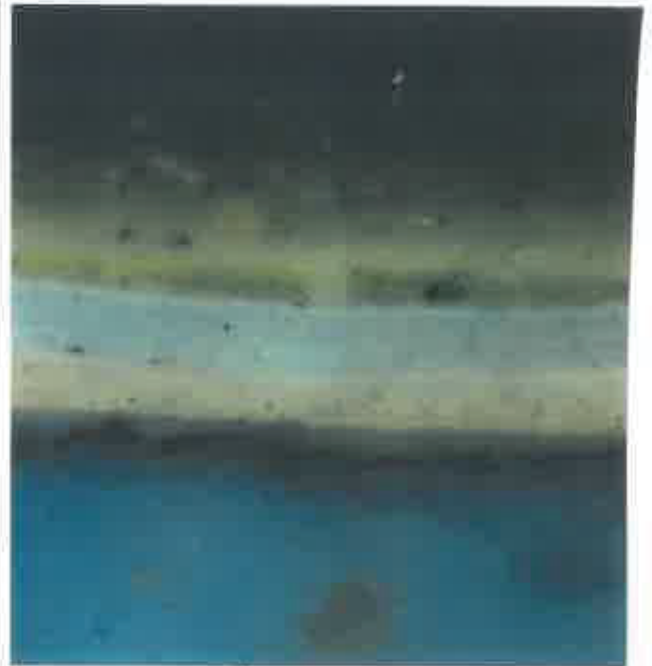
Sample #16 – Northwest corner wall plaster

The plaster walls are now painted white, while the background walls of the niches are marbled. There are two good samples that represent the paint sequence on the plaster walls. Sample # 7 is from the east wall to the right of the chimney breast. This sample contains five generations of paint beginning with a dark cream-colored oilbound paint, followed by an off-white distemper, then two generations of green paint, and then a tan paint in the fifth paint generation. The most recent matte white paint on the walls is not present in this particular sample. This paint sequence is the same in sample #16 from the west wall between the northwest niche and the window. But in this sample there is a thick black accumulation of mold spores trapped in a crack in the plaster, evidence of long periods of high relative humidity in this room, and the presence of organic additives in the paints that provide food for mold growth. Neither sample #7 nor sample #16 contains evidence of wallpaper (paper fibers, starch paste adhesive residues).

<u>Layer</u>	<u>Generation</u>
Modern white	6
Light tan	5
Blue-green	4
Deep green	3
Off-white (slightly translucent)	2
Dark cream color	1
Black mold growth in plaster	
Plaster

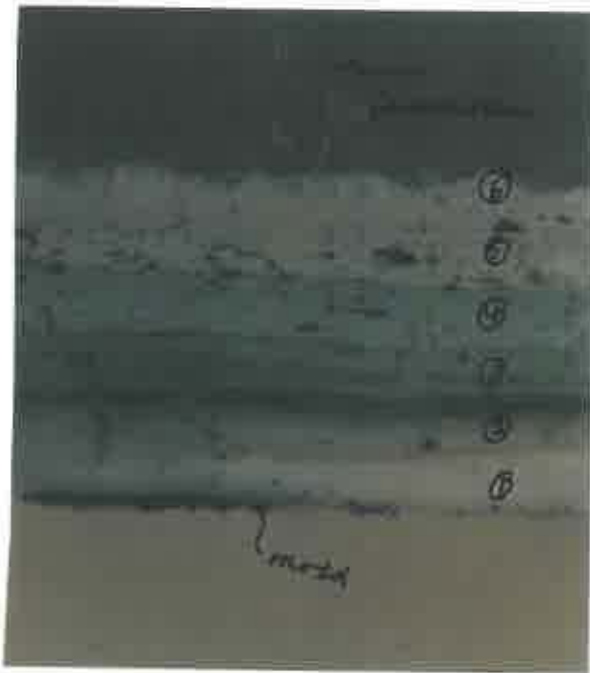
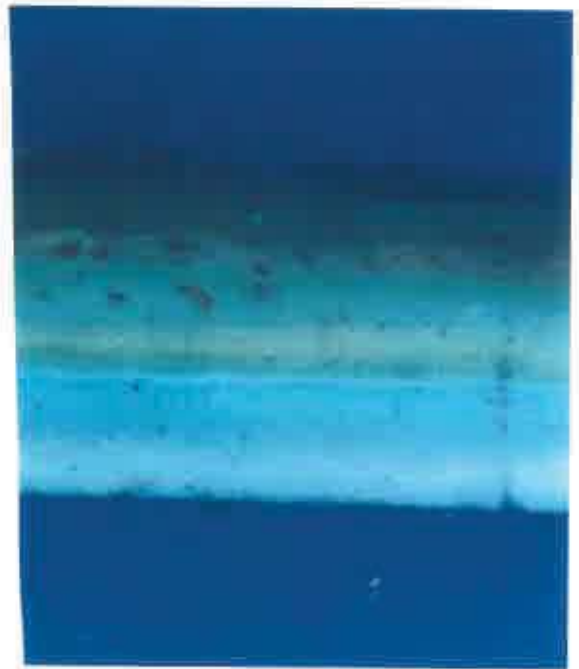
Sample 14 – Rear surface of niche in northwest corner

Sample 14 was taken from the rear wall surface of the niche in the northwest corner. Investigations on-site suggested this niche was skimcoated with a modern plaster, perhaps to cover cracks, and then repainted. However, the earlier paint evidence does still survive below the modern skimcoat, and the paint sequence is identical to that found on the plaster walls. This suggests the niches were not painted in a manner to make them visually recede or to set them off from the walls, but rather were the same as the walls.

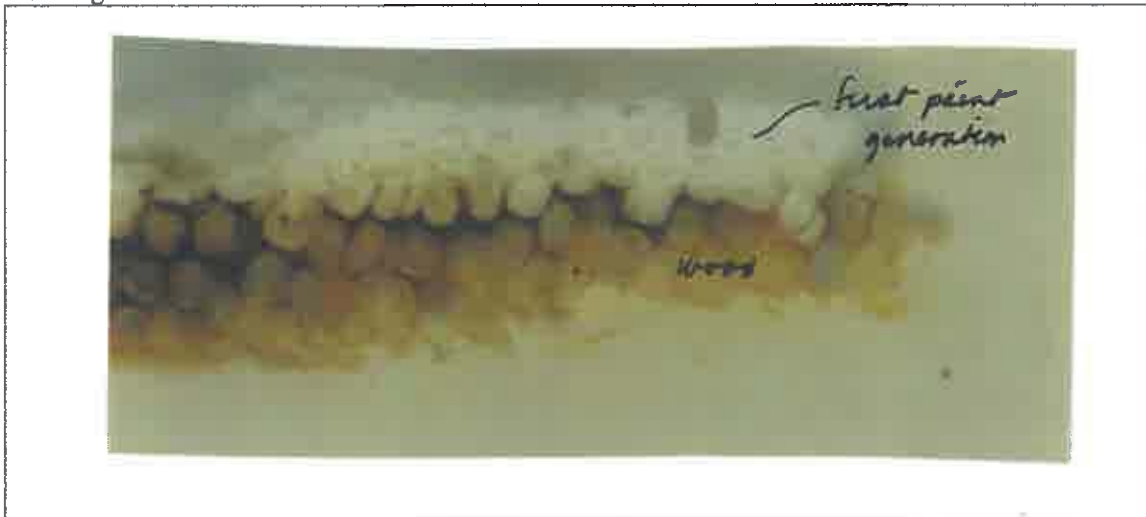
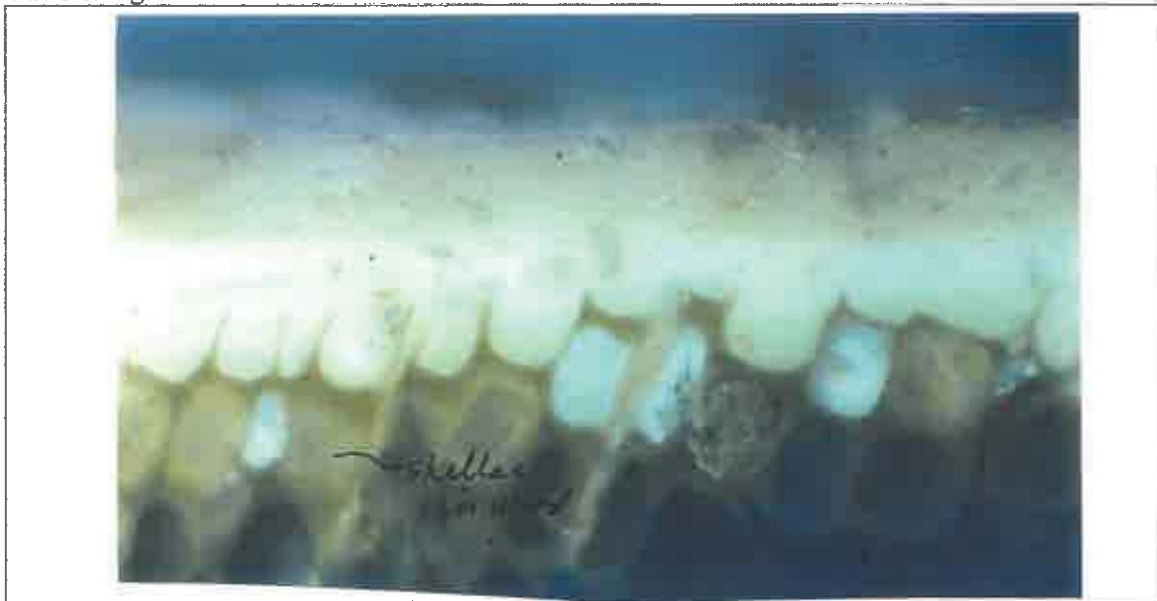
Sample 2 – Plinth block, east wall, left side of south window

The baseboards and the plinths for the pilasters in this room are currently marbled with a very dark gray base coat. Two samples (#8 and #11) were taken from baseboards, and two from plinth blocks (#2 and #12). The combined evidence in these four samples indicates there is no history of marbleizing on the plinths and the baseboards, and that in fact these elements appear to have originally been painted with an oilbound cream-colored paint on top of a shellac sealant (that survives trapped in the wood fibers). The first cream-colored paint layer discovered in sample #2 from a plinth block for an east wall window appears identical to the original paint on the bead molding for the same window. This suggests the baseboards and plinth blocks were a continuous cream color around the room, and that the window trim was originally painted the same color as the baseboards.

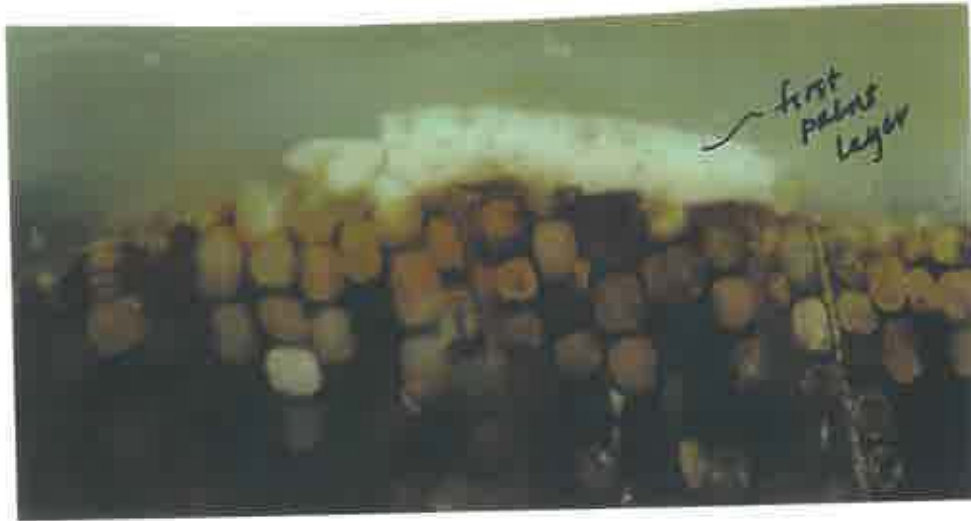
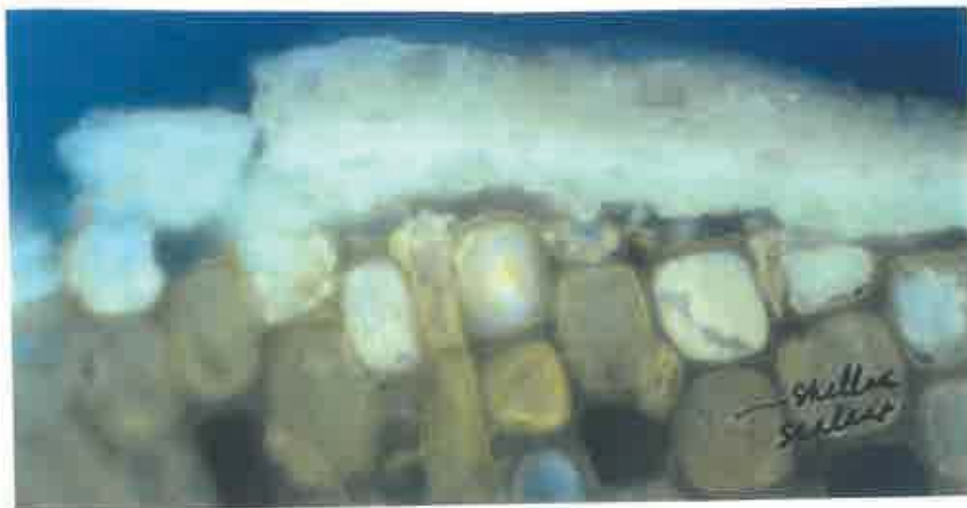
Sample 3 – East wall, bead molding, left side of south window, approximately 3-feet up
Visible Light 125X

On-site explorations with a 30X monocular microscope suggested the window architraves, the panels below the windows, and the moldings surrounding the niches were all painted in a similar manner, and were originally a monochromatic cream color. Eight samples were taken from pilaster and window trim elements to confirm all these elements were indeed all originally painted the same color. The best comparative example of the surviving first generation of paint was found in sample #3 from a bead molding on the south window on the east wall. This paint layer is identical to the original paint found in sample #2 from a plinth block, as noted in the preceding section.

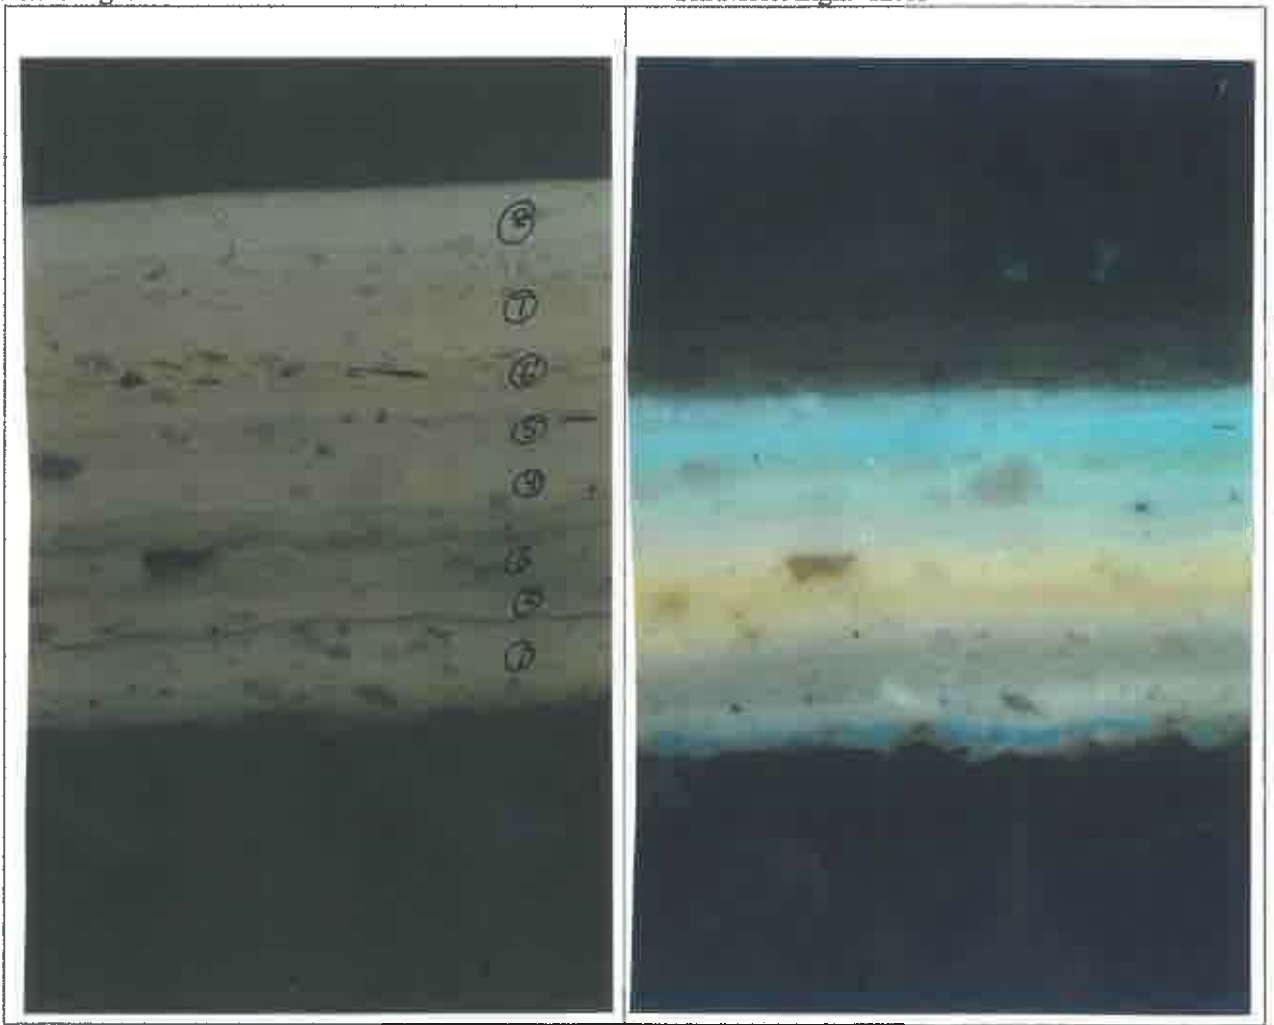
Sample #13 – North wall, central recessed element of left pilaster for northeast

Sample #13 from the central recessed portion of a pilaster appears to contain the complete paint history for the trim elements in this room. It has eight generations of paint beginning with the cream-colored paint found elsewhere in the room.

<u>Layer</u>	<u>Generation</u>
White paint	8
Light cream-colored paint	7
Light cream-color paint	6
Off-white paint	5
Off-white paint	4
Tan paint	3
Dark cream-colored paint	2
Cream-colored paint	1
Shellac sealant	1
Wood

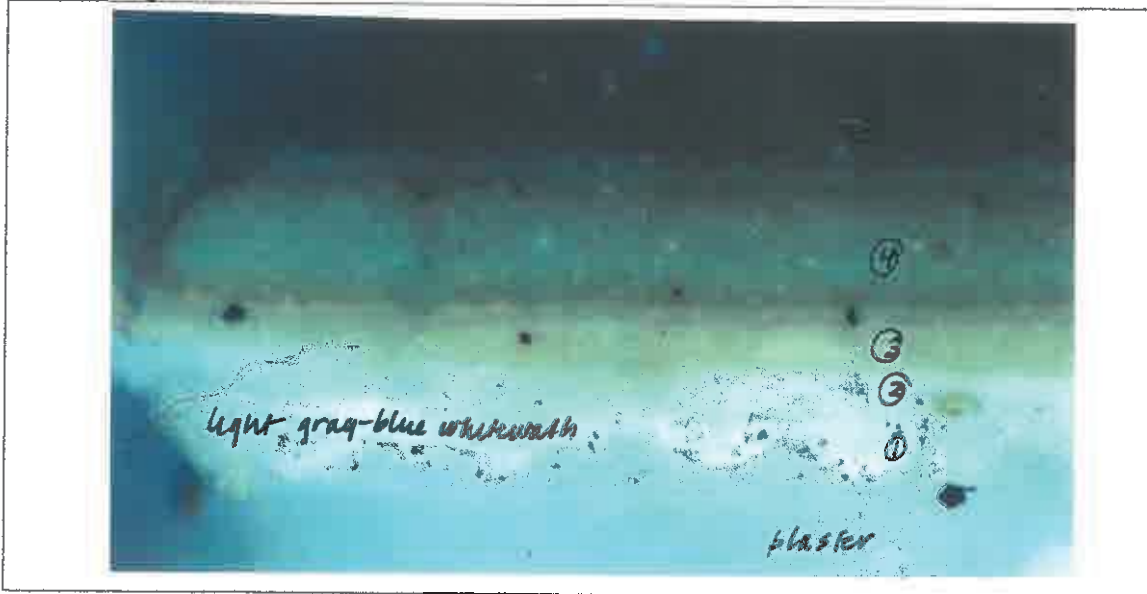
Sample 19 – Skylight, central panel of west wall of skylight

The skylight walls are now painted white with light blue bead moldings (that match the light blue on the cornice). The initial investigations on-site suggested the skylight walls could have been originally painted a different color than the walls of the room. Two samples were taken from this area to determine whether original paint evidence still survived and if so, what the original paint was. Samples #19 and #20 reveal the skylight walls and the bead moldings were painted with a light gray-blue whitewash, followed by unpigmented whitewash, and then three to four more generations of what appear to be comparatively modern paints. This whitewash (or limewash) paint on the skylight is different in composition from the oilbound paints on the walls. The skylight paint is typical of what would be found on ceilings and is considerably less durable than the wall paints. Although the ceiling in this room was not sampled because the current ceiling is a modern replacement, it is likely the ceiling paints were the same as the skylight paints.
