CROSS-SECTION MICROSCOPY ANALYSIS RESULTS

Client: Glenn Keyes Architects
12 Vanderhorst Street, Charleston, SC 29403

Date: November 29, 2006

Object: Interior Surface of Front Door
Aiken-Rhett House, Charleston, South Carolina

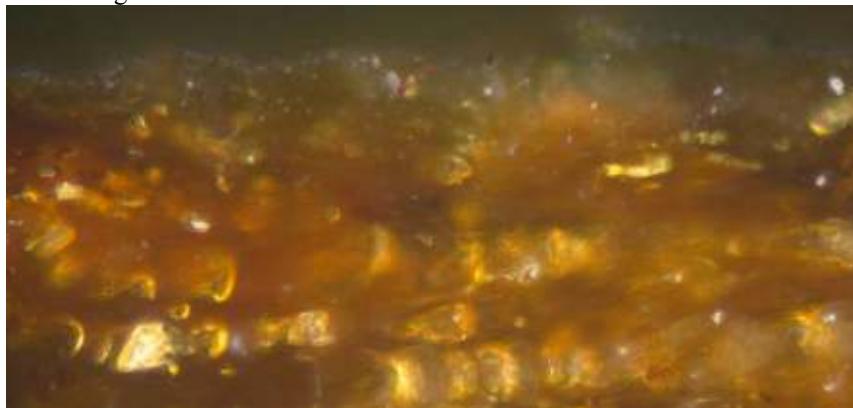
Interior Surface of Aiken-Rhett House Front Door
Visible Light 400X

Comments: The cross-section analysis results show that the finish history in this sample begins with a pigmented plant resin varnish with an oil component. There are brown and red pigments widely distributed and suspended in this layer, which confirms that the surface was not originally stained, rather the mahogany color was enhanced by using a pigmented varnish. The second generation is a clear plant resin varnish and the uppermost layer appears to be a degraded, grimy layer of pigmented plant resin varnish. The first layer has penetrated into the wood fibers and also remains as a legible layer on top of the wood. This suggests that this may be the first layer of varnish applied to the door and that the interior surfaces were not stripped. It is likely that the exterior surface of the door was originally finished in the same manner, although this type of natural resin coating would not have been a durable exterior coating. No evidence of any early coatings was found on the exterior of the door during earlier investigations.

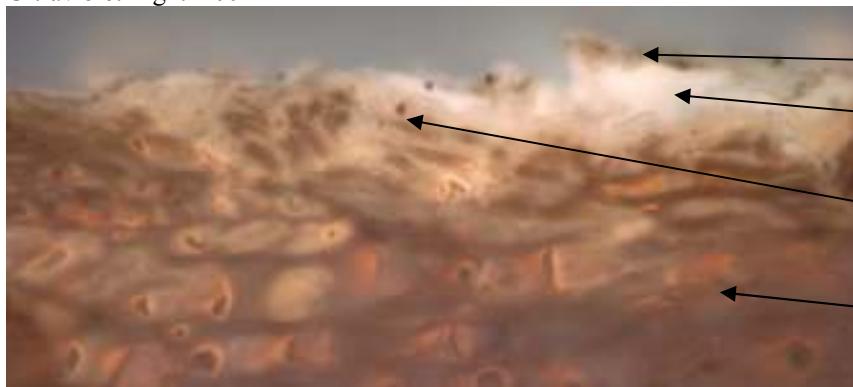
Ultraviolet Light 400X

3. Thin pigmented oil-resin varnish on surface

2. Plant resin varnish

1. Pigmented oil-resin varnish

Wood substrate

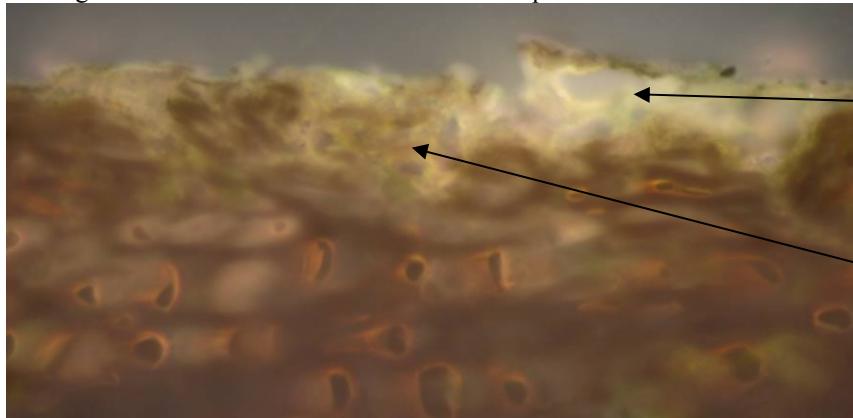
UV Light & DCF for saturated and unsaturated lipids 400X

DCF: Positive for the presence of oils in the wood and in the first and third pigmented oil-resin varnish coatings.

2. Clear plant resin varnish partially dissolved on exposure to the ethanol carrier for DCF

Positive reaction for unsaturated lipids in the first pigmented varnish
