March 10, 2017

Subject: 573 Meeting Street Structural Evaluation

Collins Engineers, Inc. (Collins) was engaged by LS3P Associates, Ltd. (LS3P) to perform a structural assessment of the existing building at the 573 Meeting Street facility in downtown Charleston, SC.

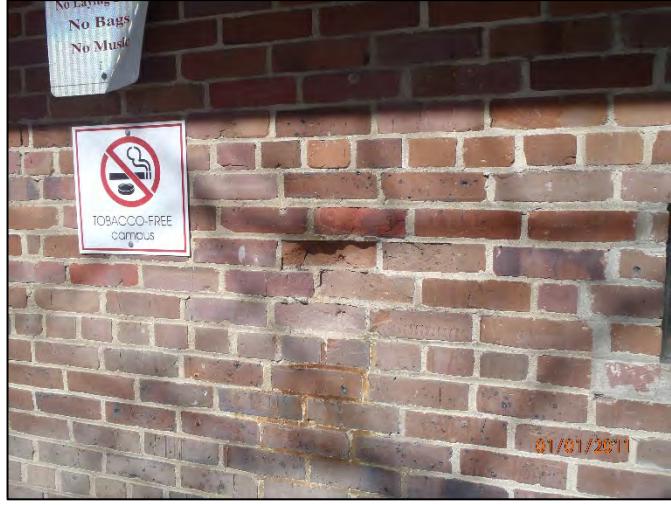
Photo 14: Broken brick in façade

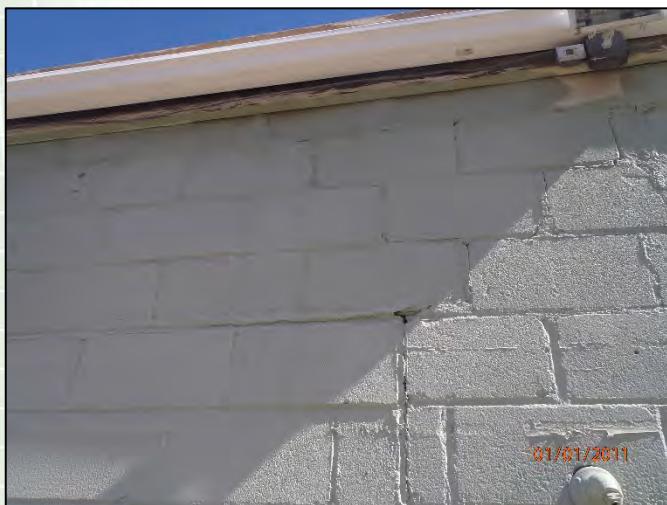
Photo 23: Cracking in CMU east all of addition

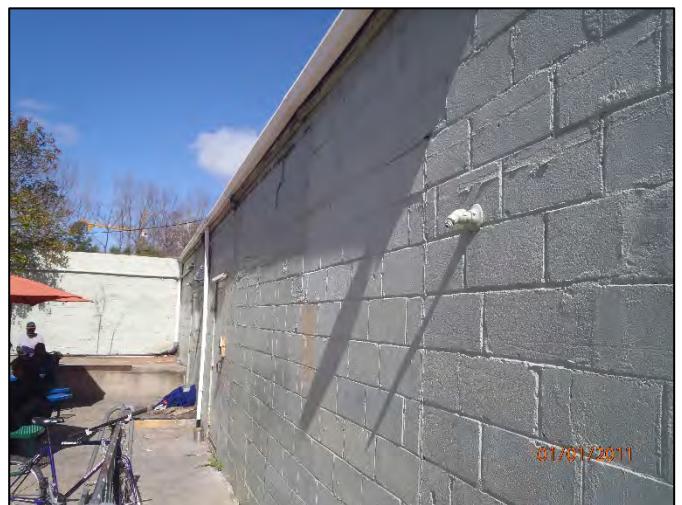
Photo 24: East wall of addition with visible cracking

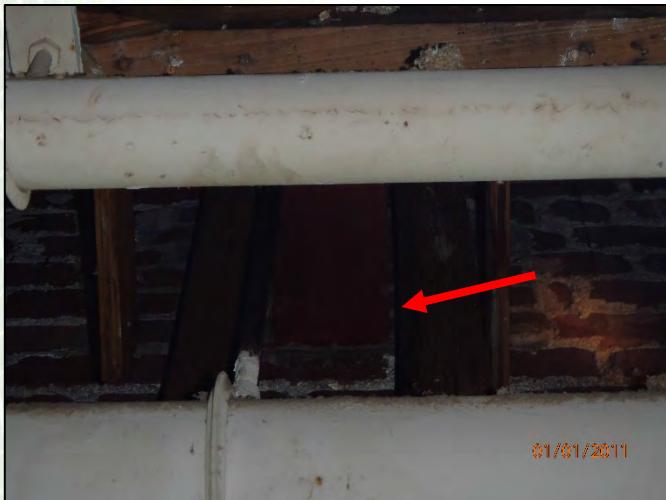
- The load bearing masonry wall at the north end facility is shared with the adjacent 575 Meeting Street. (Photo 25 and 26). The property line is at the middle of the 18 inch thick wall.

Photo 25: Steel beam bearing on shared north wall

Another concern is the sharing of the north load bearing brick masonry wall with the 575 Meeting Street building. If the structural framing of the 573 Meeting Street building is removed from the shared wall, the stress on the wall would decrease and potential fire separation issues would be remediated. The removal of the framing would require the wall to be braced for stability and the roof structure to be shored prior to removal. The roof deck and joists would then be removed. The structural steel beams would be removed and the brick beam pockets could then be filled in with the proper materials.

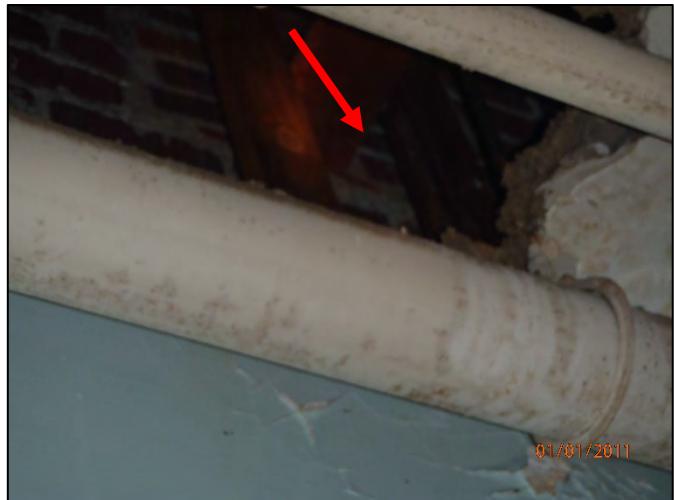
Photo 26: Steel beam bearing on shared north wall

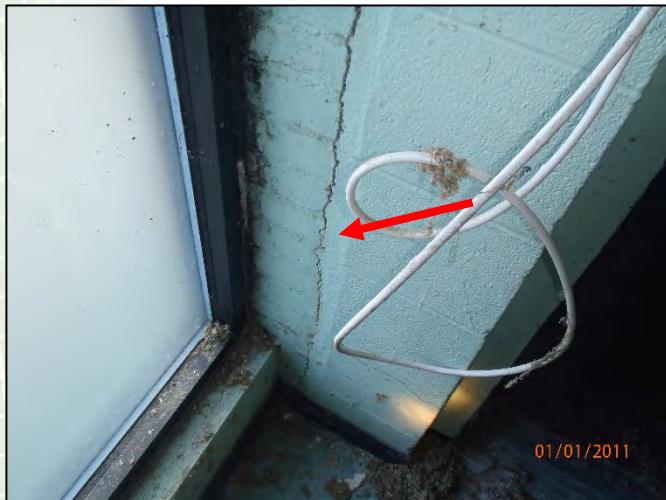
- Displaced brick was observed along the east (Meeting Street) façade. The displacement of the brick from the CMU wall increases in magnitude from the foundation to the brick shelf angle. (Photo 27 and 28)

Photo 27: Displaced brick at west façade at foundation

Significant repairs are required at the original building prior to future occupancy. Maintenance is required at the exterior front wall façade of the original building to reinstate a water-tight envelope and repair deteriorated mortar and masonry. The exterior wall at the east elevation appears to be bowed outward above the steel lintel above the openings. Collins recommends that the existing brick veneer and steel lintel impacted by the bowing should be removed and replaced with new masonry, with supplemental framing added to provide proper support. In addition the CMU load bearing wall on the east elevation that support the brick façade should be replaced due to the large pipe openings beneath the bearing point of the lintels and the bowing out of plumb alignment.

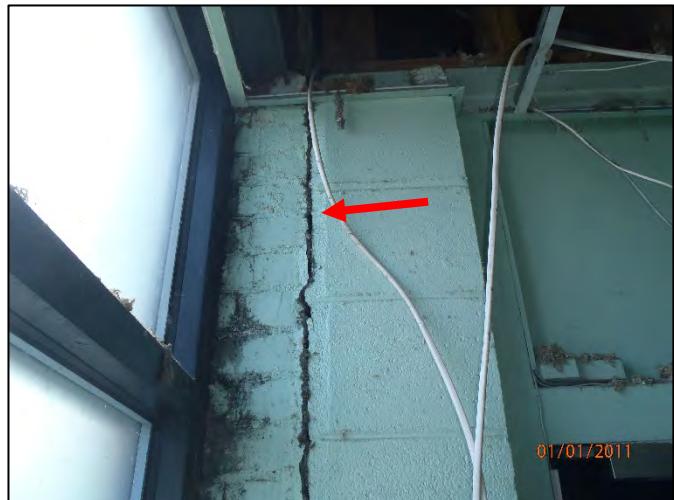
Photo 28: Displaced brick at west façade at roof

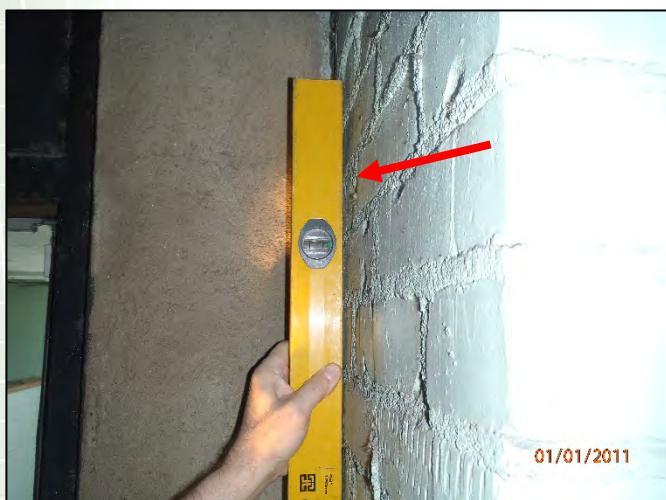
- The brick façade at the east elevation is out of plumb. (Photos 29 and 30)
- A large portion of the CMU support at the north-east corner of the building was removed for placement of gas lines and a fire department connection. (Photos 31, 32 and 33)

Photo 29: East wall out of plumb

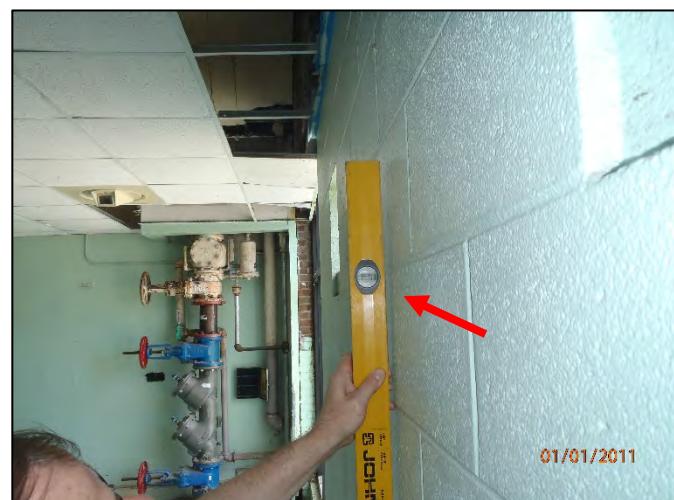
Photo 30: East wall out of plumb

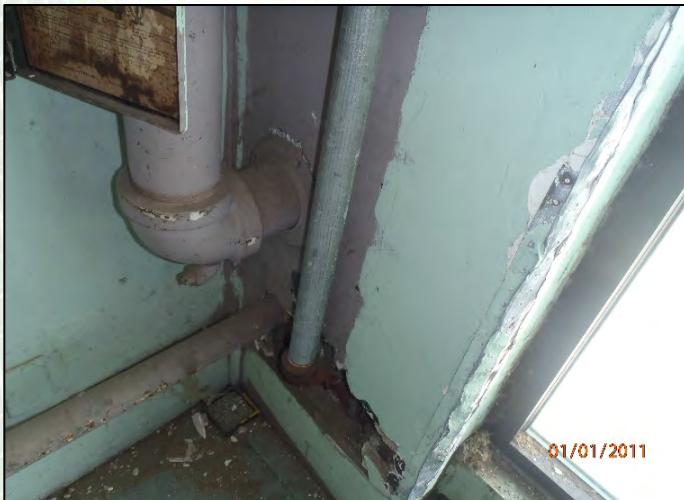
Photo 31: Penetrations at CMU bearing point in East wall

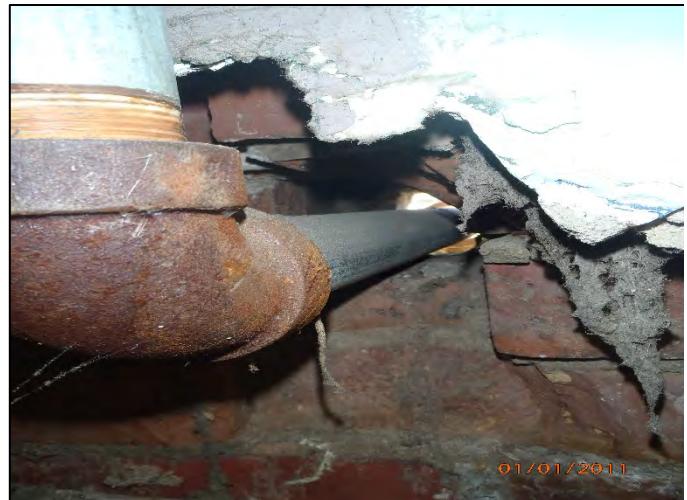
Photo 32: Close up view of penetration at east CMU wall bearing point

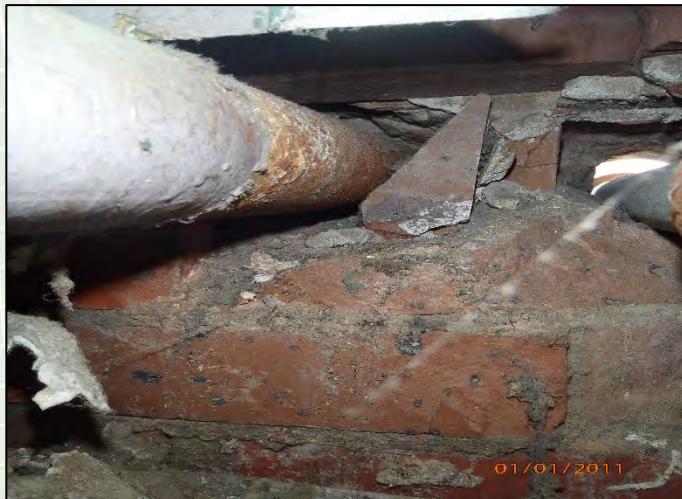
Photo 33: Pipe penetration through CMU at lintel bearing above

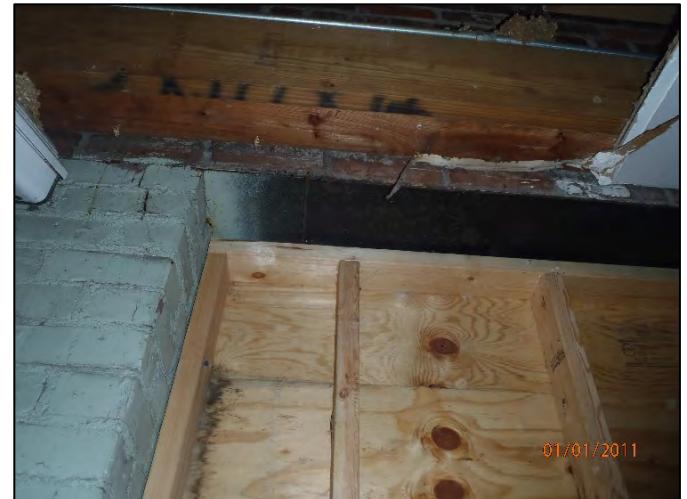
- Step cracking was observed at the steel lintel bearing point. (Photo 34)
- Cracks were observed in the brick façade above the lintel at the east elevation. (Photos 35 and 36)

Photo 34: Water intrusion damage at East face wall

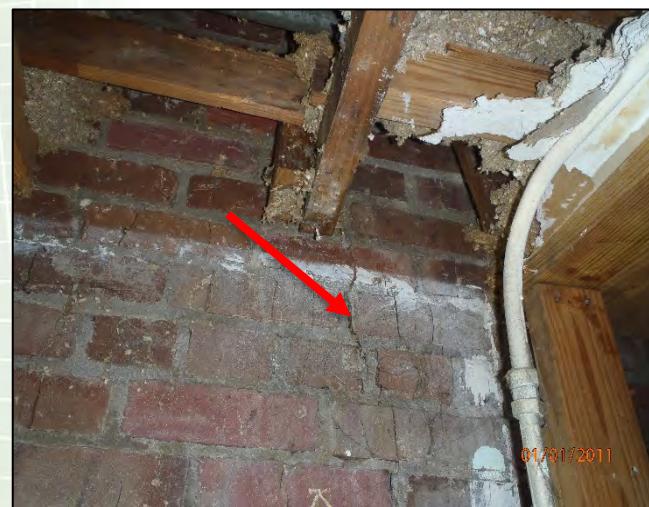
Photo 35: Crack in brick façade at east elevation

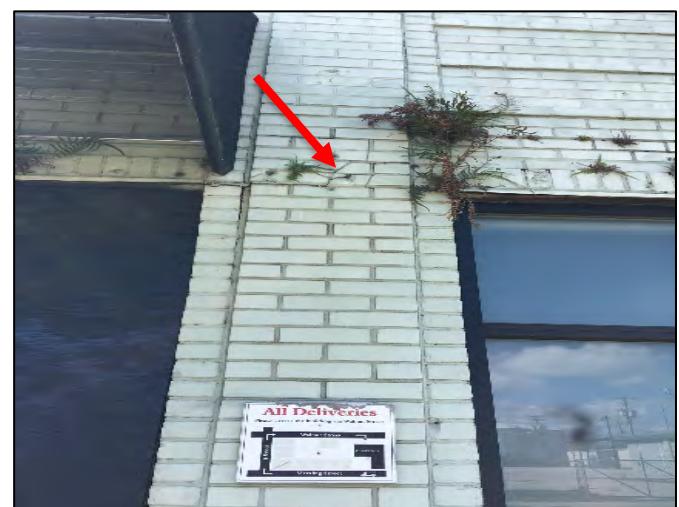
Photo 36: Cracks in brick façade at east elevation

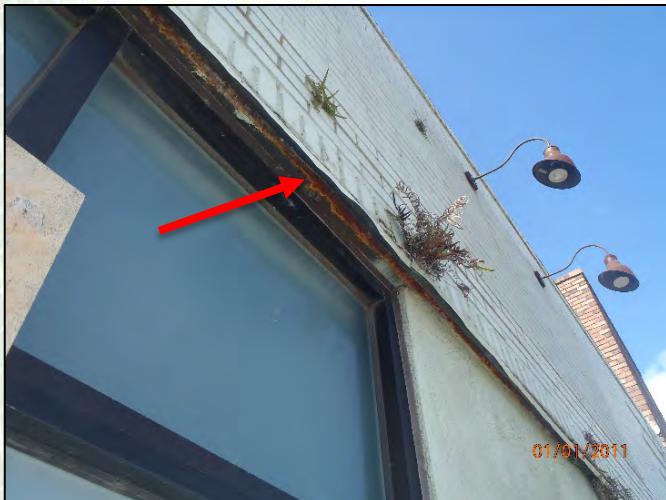
- Corrosion was observed on the steel lintel at the exterior face of the building (Photo 37 and 38)
- Cracks were observed in the stucco near the foundation along the Meeting Street façade. (Photo 39 and 40)

Photo 37: Corrosion of steel lintel at east wall

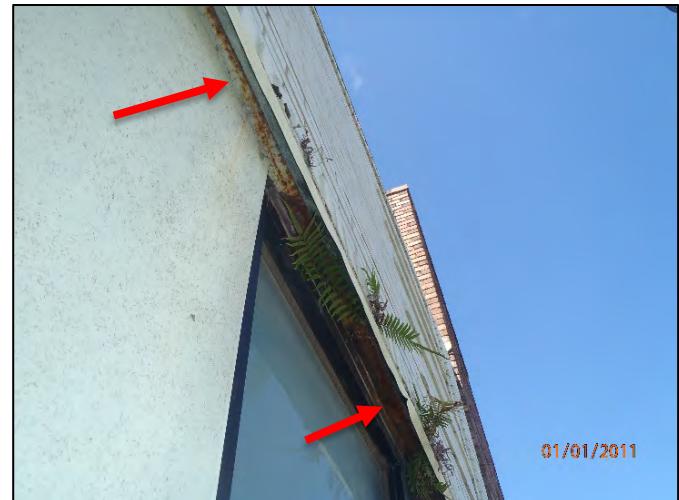
Photo 38 Corrosion of steel lintel at east wall

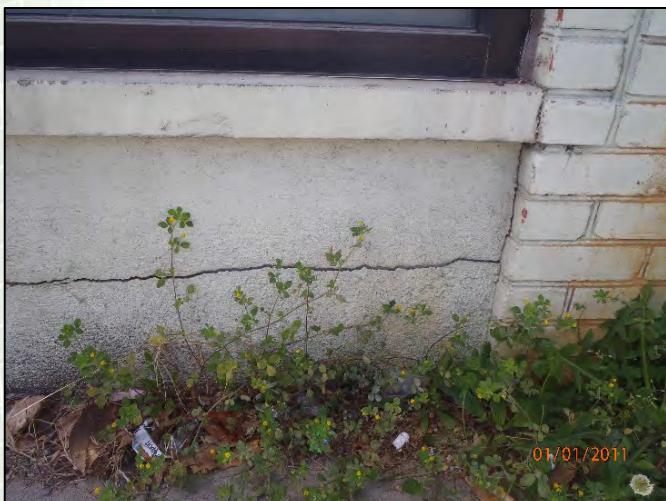
Photo 39: Cracks in stucco veneer at east wall

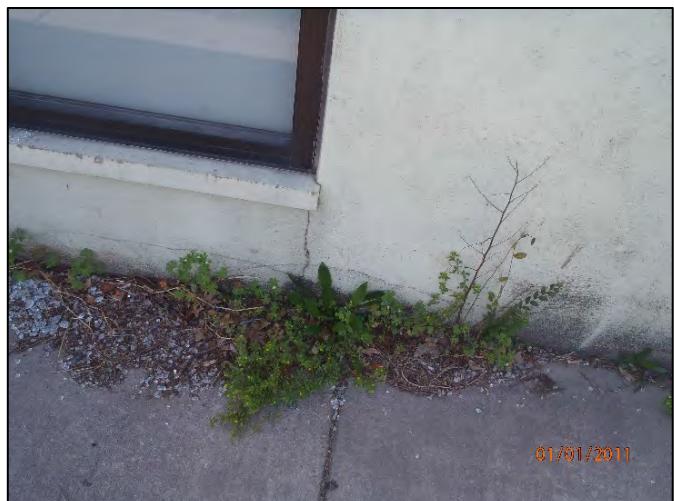
Photo 40: Cracks in stucco veneer near East wall foundation

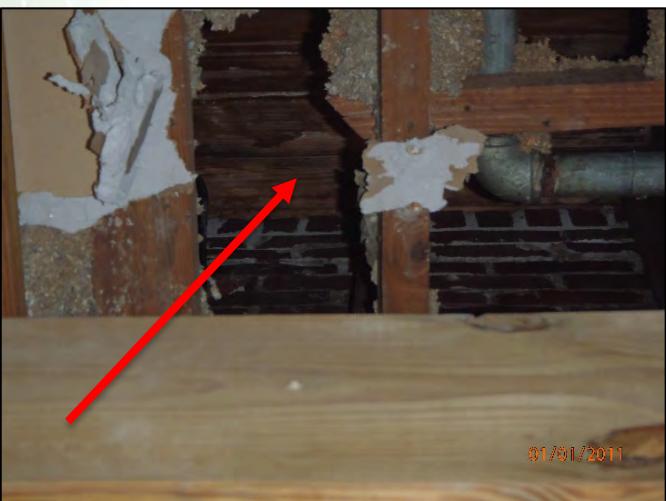
- Water intrusion was observed at the south-east end of the front façade as exhibited by damaged timber framing and roof decking. (photo 41)
- The north end of the Meeting Street façade is displaced inward with respect to the adjacent building. (photo 42)

Photo 41: Water intrusion damage near east wall

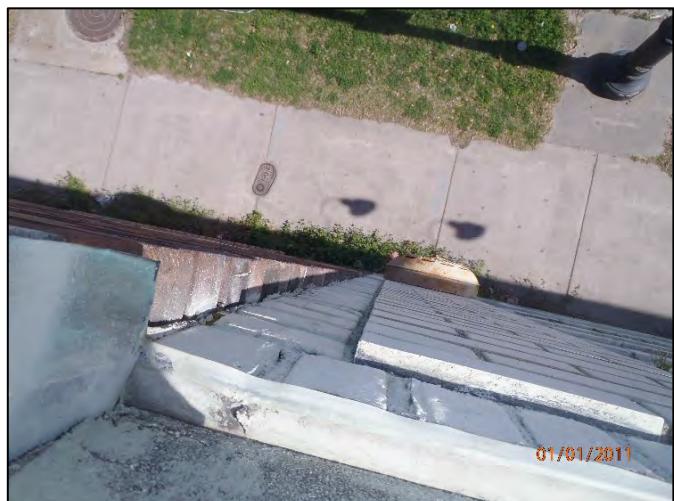
Photo 42: Brick façade bowing inward at top of parapet

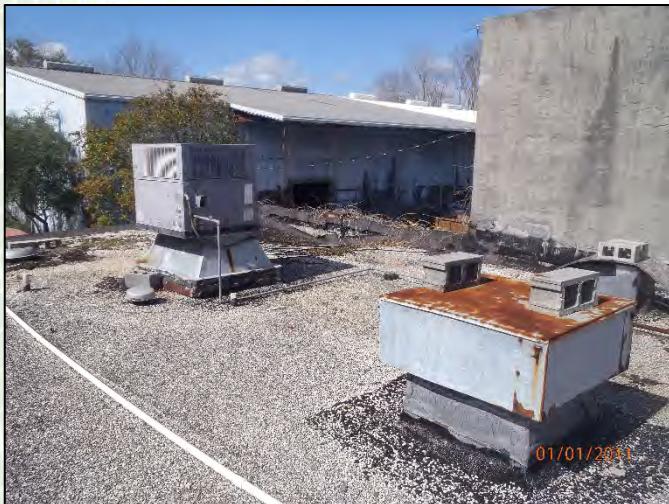
- The roof structure at the north-west corner of the building is collapsing (photo 43 and 44)

Photo 43: Collapsed north-west corner of roof

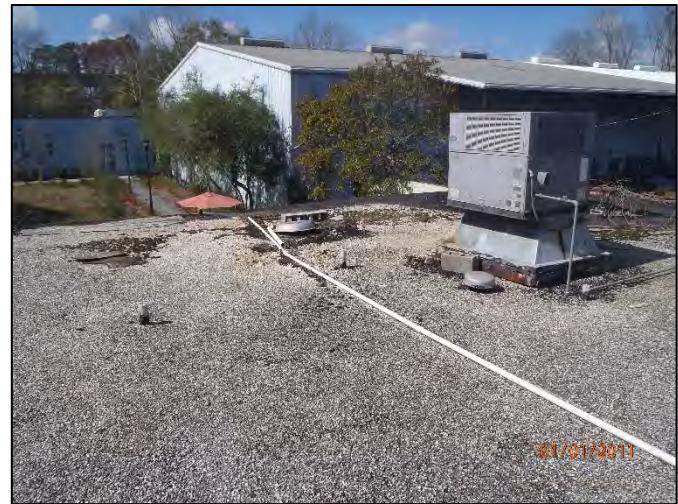
Photo 44: Collapsed north-west corner of roof

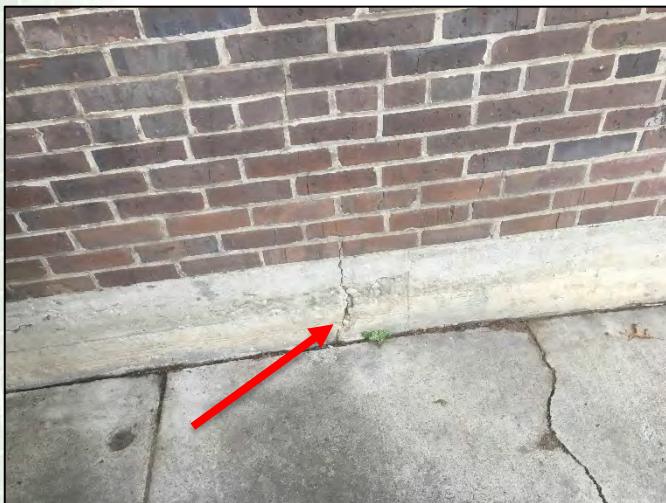
Photo 45: Visible crack in foundation wall

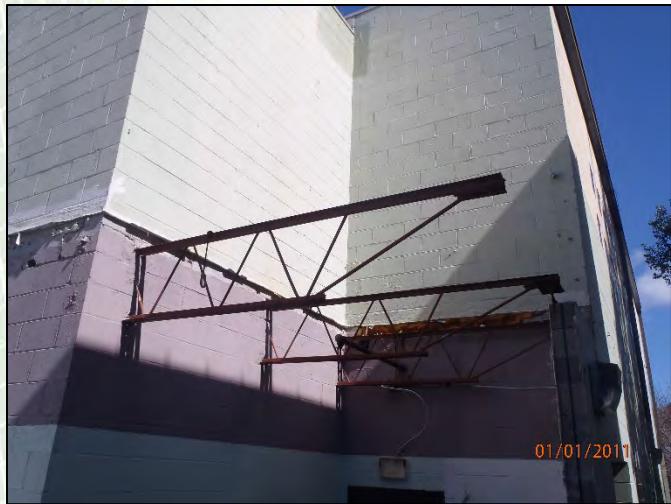
- The south-west portion of the building has been partially demolished. (Photos 47 and 48)
- Evidence of water infiltration was observed at the exterior windows. (Photo 51)

Photo 47: Partial demolition of portion of addition

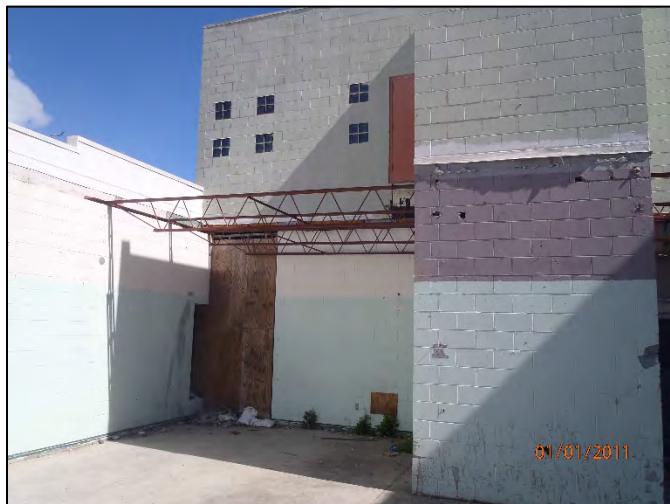
Photo 48: Partial demolition of portion of addition

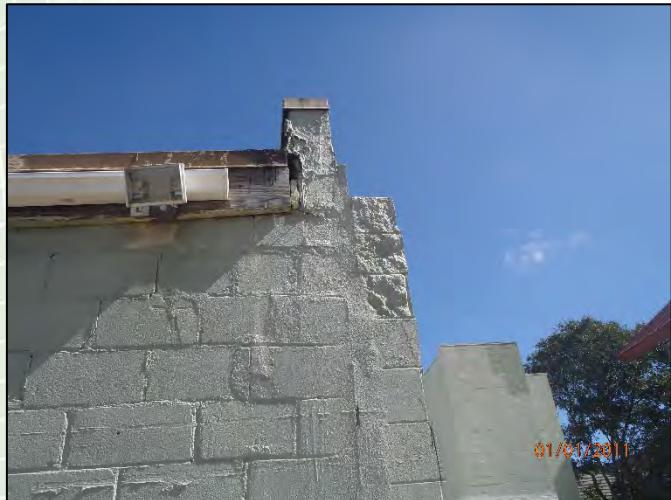
Photo 49: Visible crack in CMU west wall

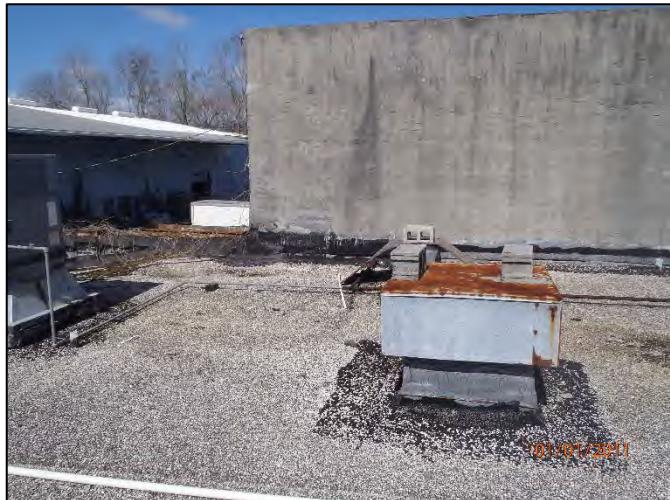
Photo 50: Roof collapsing in northeast corner

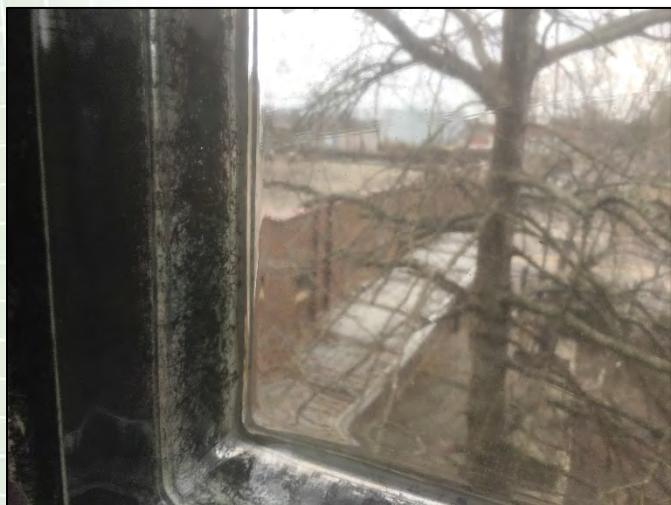
Photo 51: Water staining and corrosion at windows at west elevation of addition.
