REFLECTED CEILING PLAN

EAST ELEVATION  
BREAKFAST ROOM

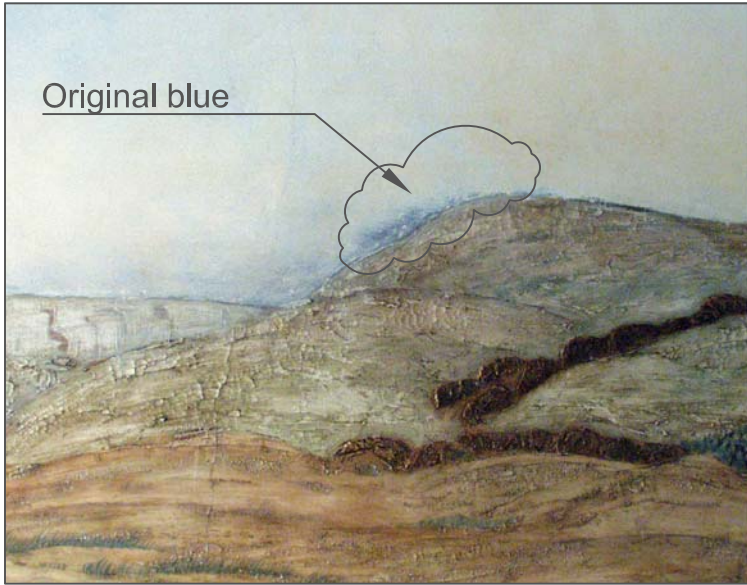
East elevation: note fragments of original blue and white-yellow over paint at horizon. Note crazing of mural paint layer.

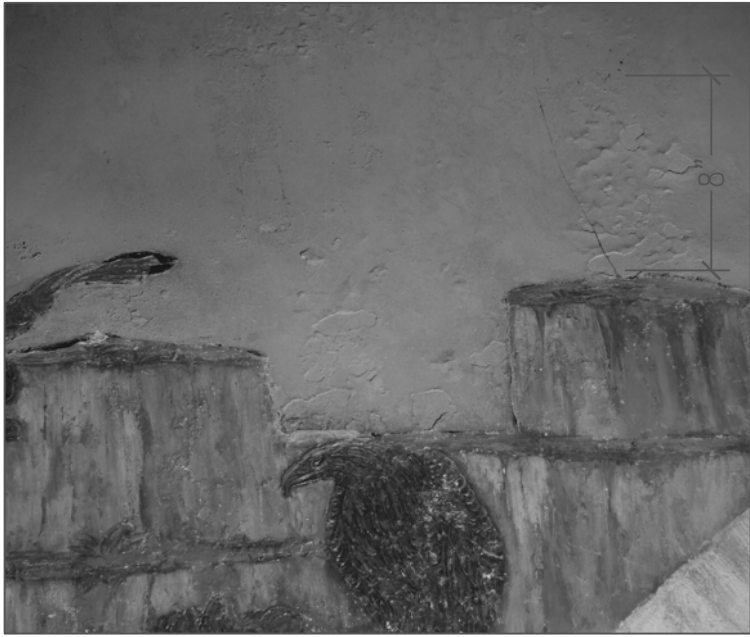
West elevation: note poor condition of mural surface at select areas of sky/ horizon. Photo digitally enhanced.

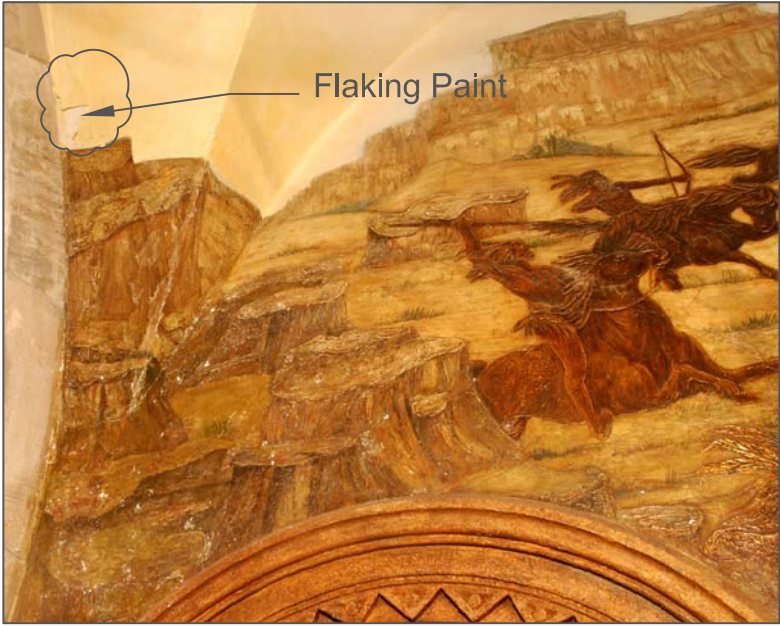
Northwest vault: note peeling/ flaking paint at sky/ horizon.

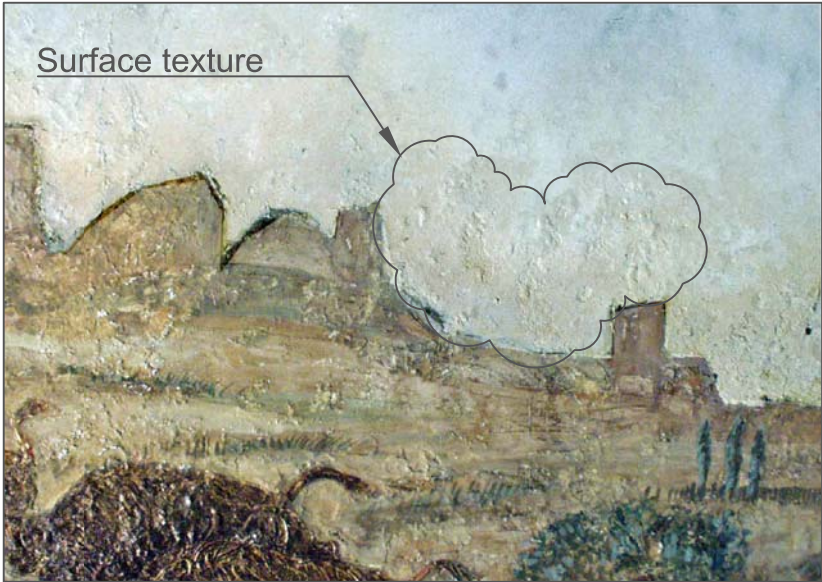
South elevation: detail of horizon. Note poor condition of mural surface at select areas of sky/ horizon. Photo digitally enhanced.

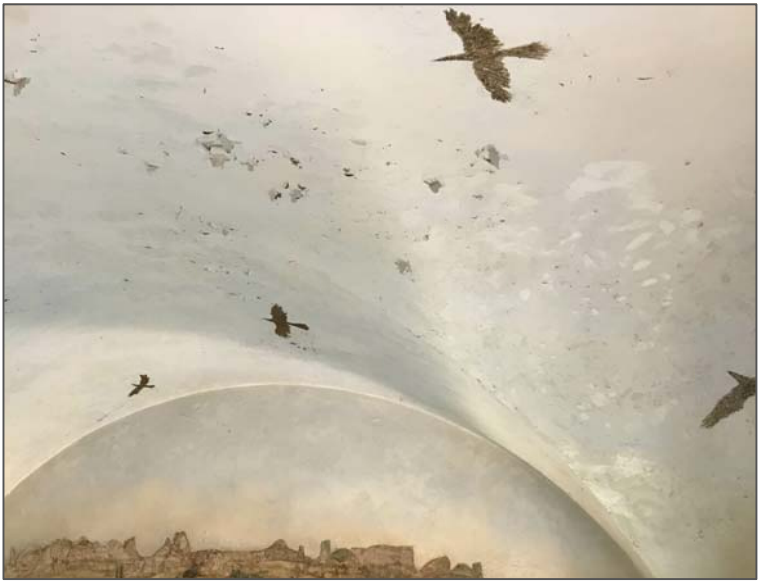
Ceiling: note large areas of peeling paint, different paint sheens and old repairs.

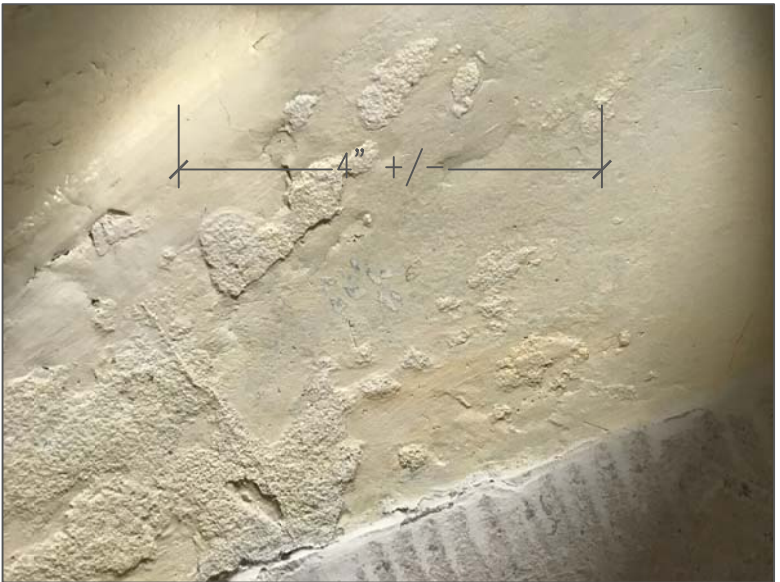
West elevation: note patches of rough surface texture including peeling paint.

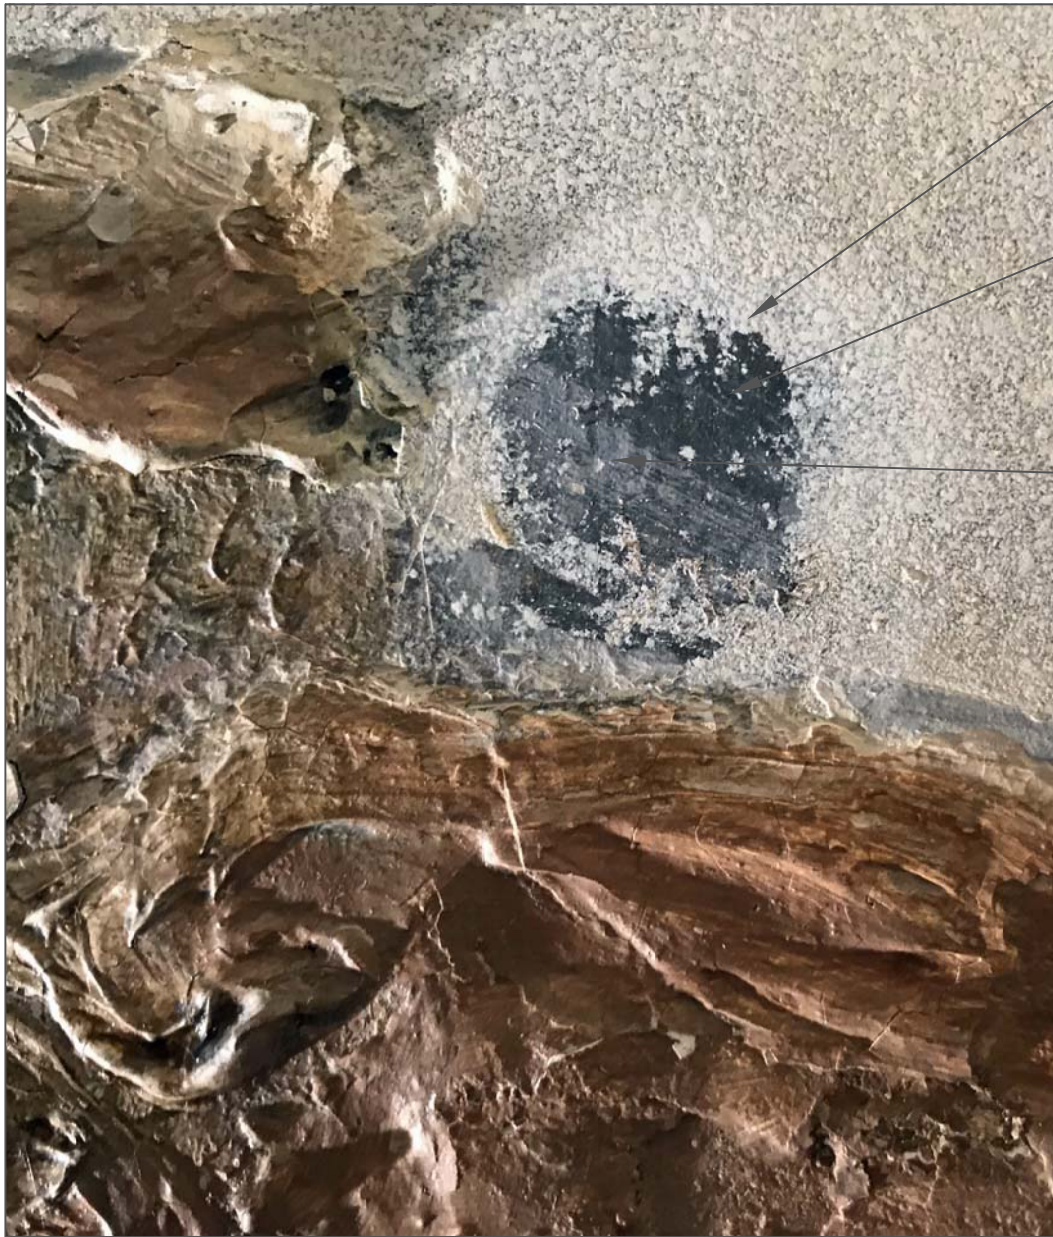
Over-paint removal test. Horizon-sky junction. Photo digitally enhanced.

Latex paint removal test. Latex is the white/yellow/beige paint layer.

Original paint under latex - base layer. Additional paint layers added over base layer to create final appearance.

Paint strokes visible under latex paint. Paint color is lighter than base color.

Note build up of paint layers. Top layer is very thin.

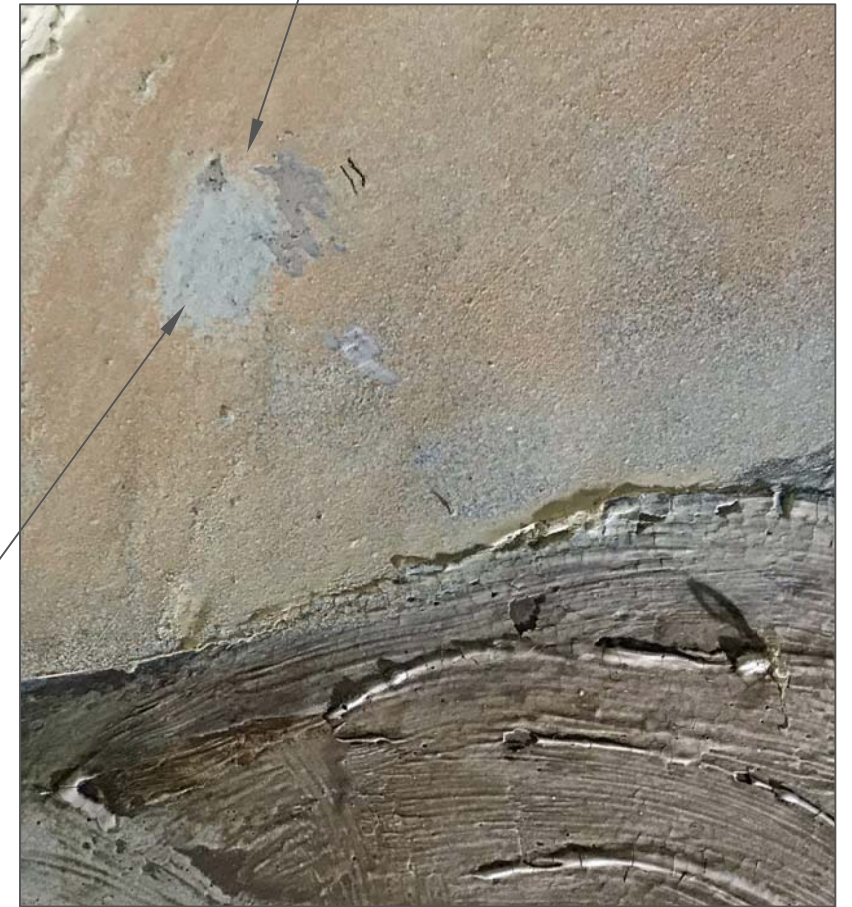
Over-paint removal test. Horizon-sky junction. Photo digitally enhanced.

Latex paint removal test. Latex is the white/yellow/beige paint layer. Thickness of latex paint varies.
