COE HALL INVENTORY WORKSHEET

PLANTING FIELDS FOUNDATION

Introduction

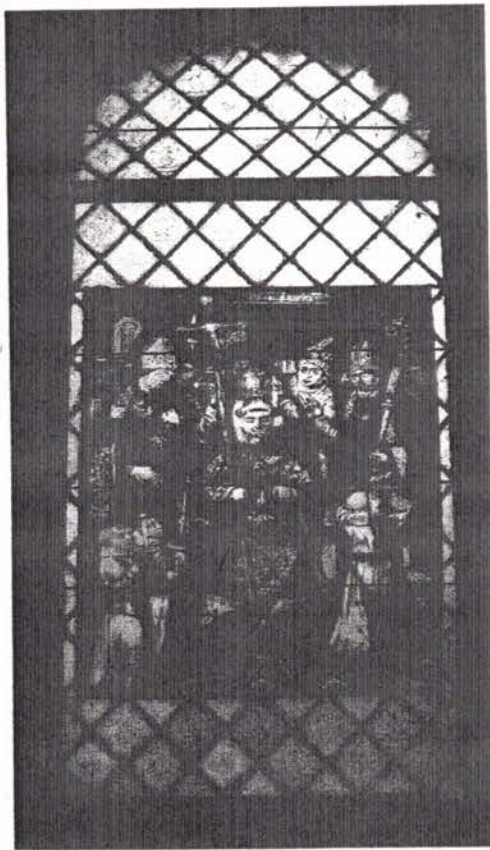
St. Nicholas before restoration

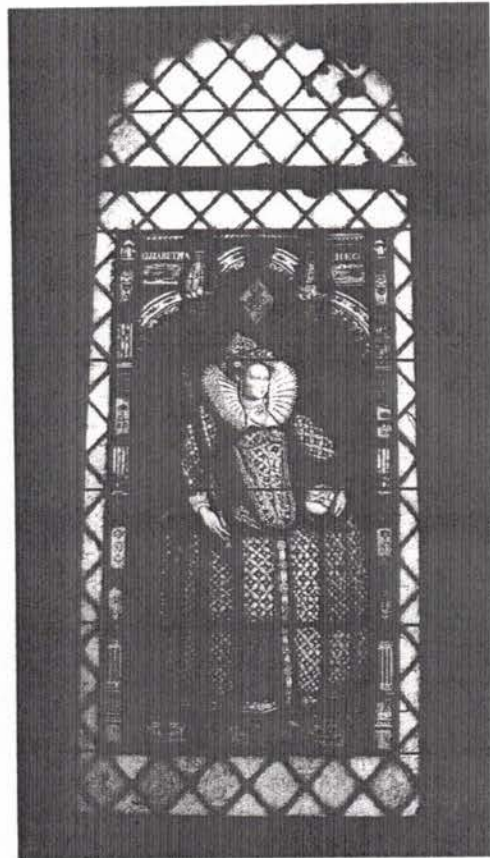
Queen Elizabeth before restoration

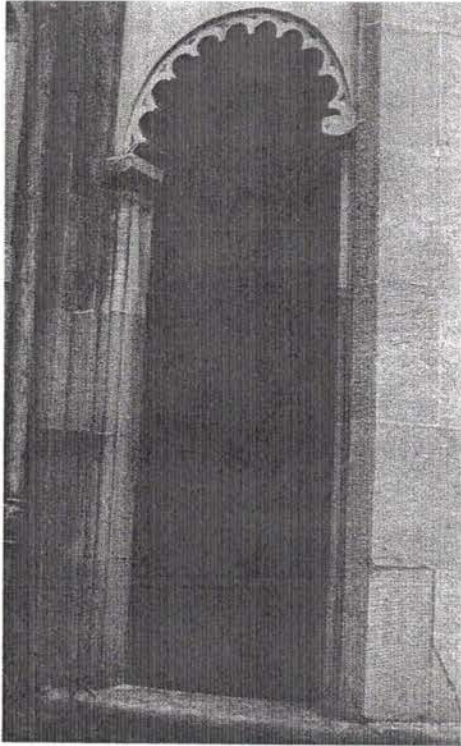
Greenland Studio installed protective glazing on the windows St. Nicholas and Queen Elizabeth in the 1970s. They attached Plexiglas into the exterior stone frame behind the stained glass window. This was done to protect the windows from exterior damage. The Plexiglas was open on all sides to allow for air circulation. A microclimate was created between the stained glass window and the Plexiglas that was open to the environment and weather conditions. We found wasp nests attached to the stained glass window behind the Plexiglas, a good environment for a wasp home but not ideal for the stained glass windows. The Plexiglas had yellowed and become opaque over time, another reason for

Plexiglas protective glazing on St. Nicholas

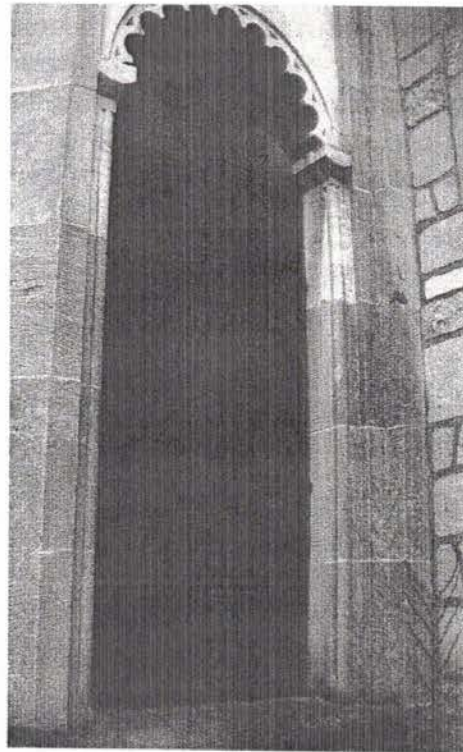
Plexiglas protective glazing on Queen Elizabeth

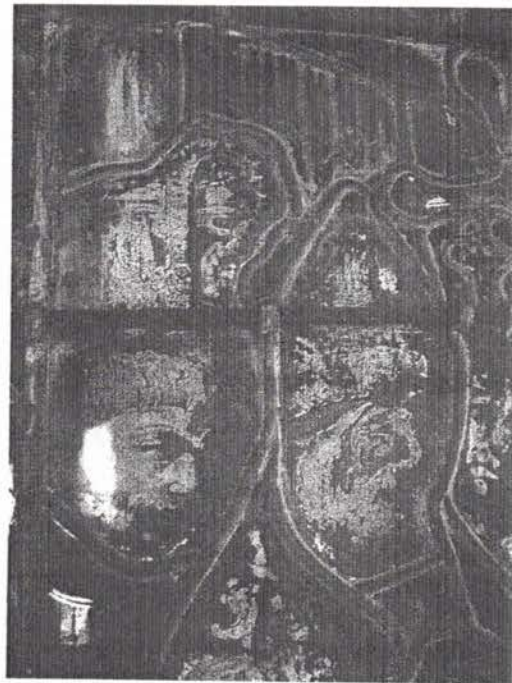
Steel rebars had kept the panels attached to their frames. The rebars were attached with wire ties to the front of the panels. The ties were neatly covered with lead to disguise them. The rebars were removed and cleaned; documentation of the wire locations was made on the rubbings (one of the rebars had run across Queen Elizabeth's face, we decided that the location of this rebar could be moved to allow for an unobstructed view of Elizabeth).

*Rebars on the
St. Nicholas
window*

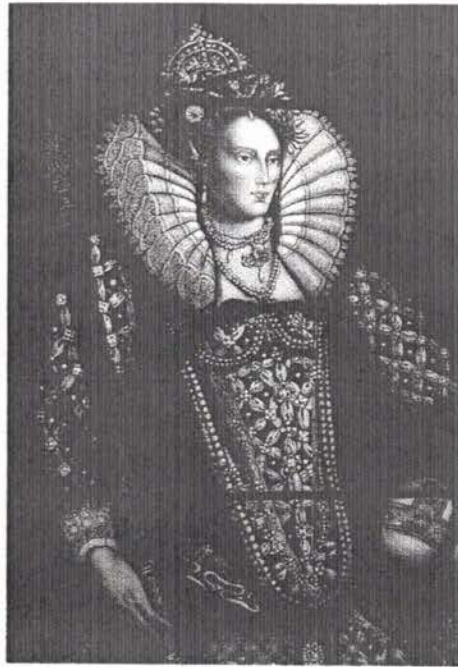
Detail showing the rebars, one crossing Queen Elizabeth's head

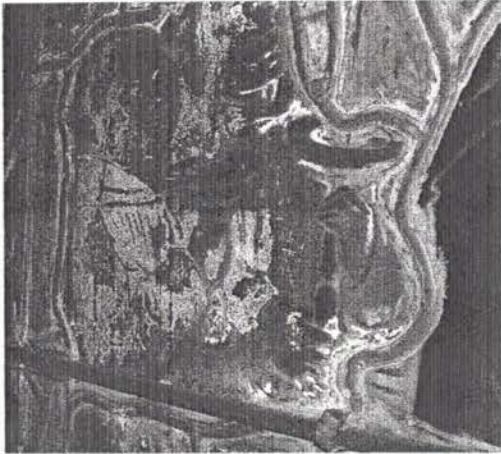
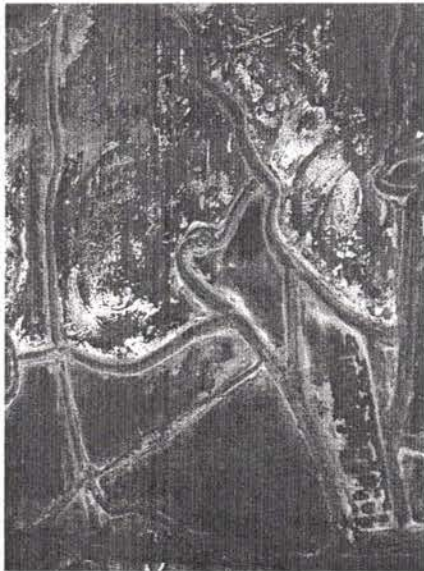
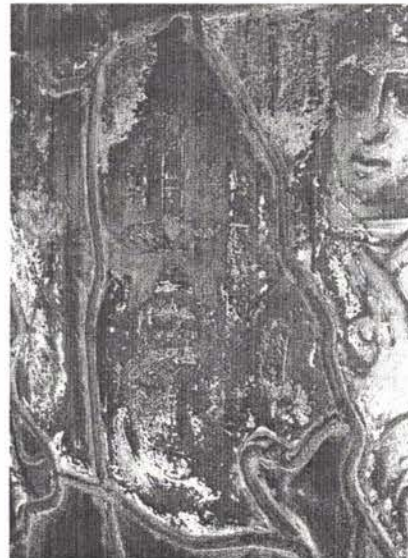
There was a white crust on the painted areas of glass in both windows. Research indicated that the white crust begins with a high level of moisture (aggravated by the condensation created by the previous unvented systems of protective glazing installed on these two windows), which leaves a deposit of sulphur on the painted areas of the window. The reaction between the sulphur and water attacks the painted areas that already contain an amount of moisture. The matte paint condition on both windows attracts and holds moisture. Each incidence of condensation reactivates the process of

deterioration and a build up of this crust then occurs each time at the same spots. Pollution can also create sulphur deposits, but it is often the final stage in a chemical process beginning with water. The process being:
Glass + water to hydroxides to carbonates to sulphates.

*Detail photos showing
the white crust and
deterioration of the
painted areas of glass.*

With closer inspection using a microscope and scalpel blades, we found that removal of this crust also removed the painted surface. We decided to do only a light cleaning on the painted side of the glass pieces.

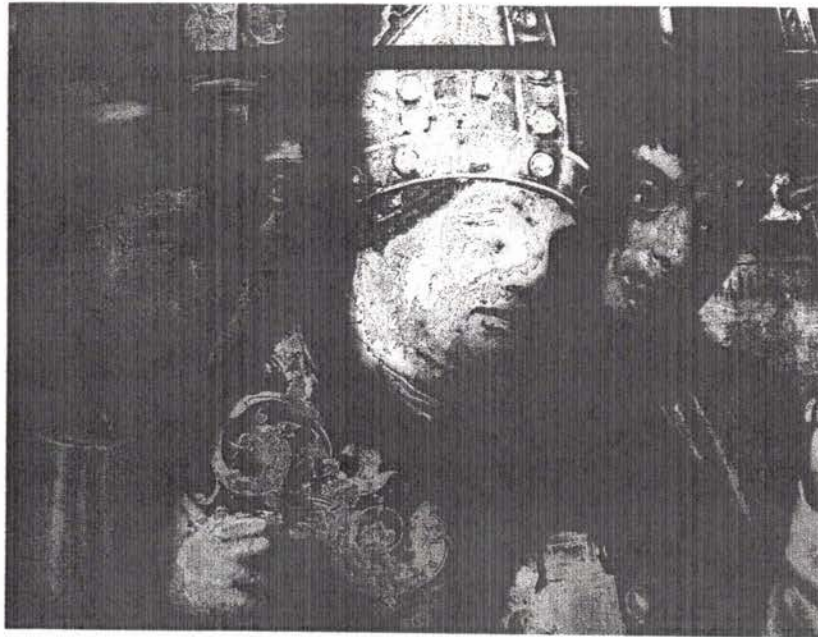
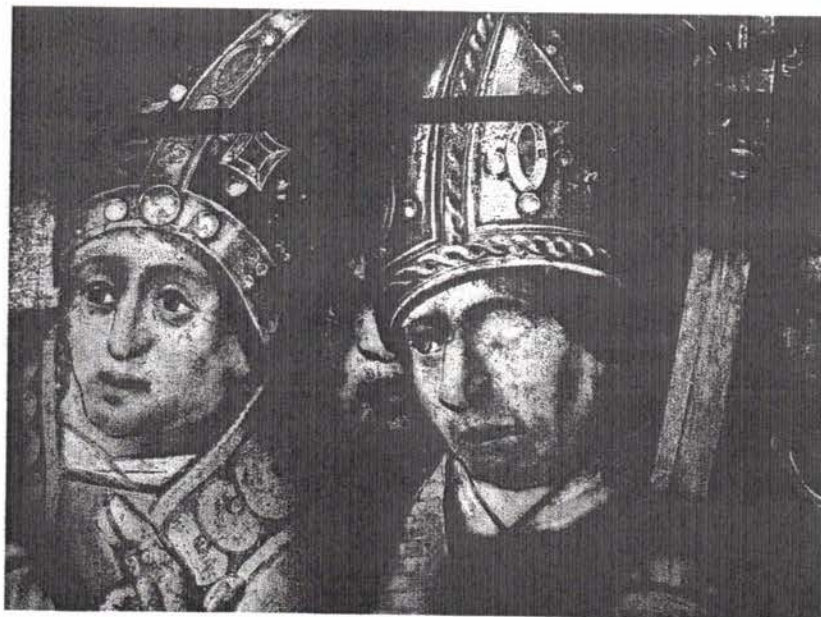
the obvious paint loss on several faces in the St. Nicholas panel. Several of the eyes were over painted at some point in time. A number were left unpainted.

Details showing paint loss on the St. Nicholas stained glass panel

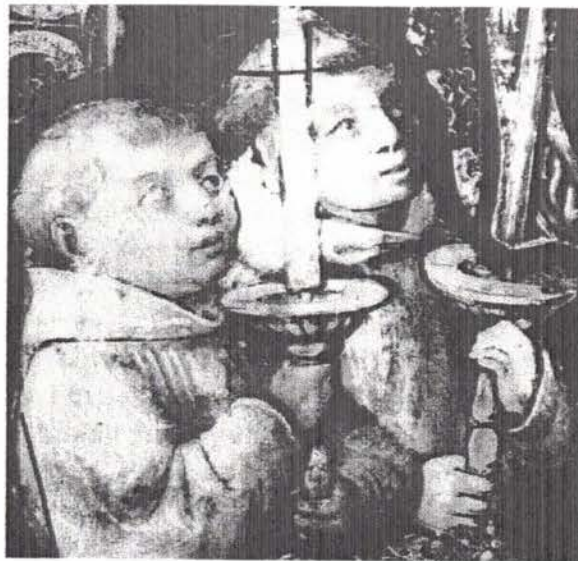
Detail showing paint loss on St. Nicholas stained glass panel

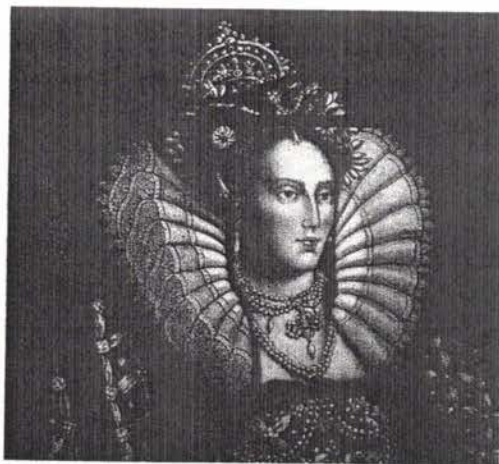
Before restoration detail showing the glass breaks in Queen Elizabeth's hair and the rebar.

The broken edges of glass were cleaned with acetone and any putty residue removed with razor blades. These pieces were then glued using Htxal epoxy. Once the cleaning and gluing were completed we were ready to re-glaze the panels.

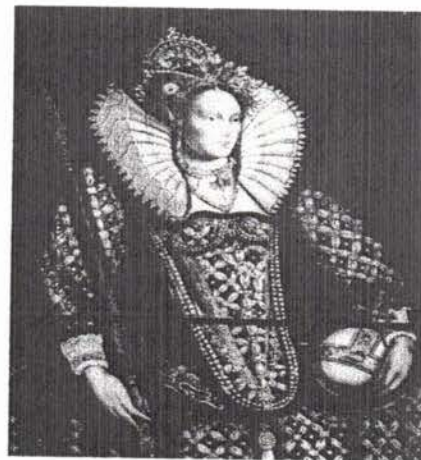
After restoration detail showing glued breaks and relocation of the rebar.

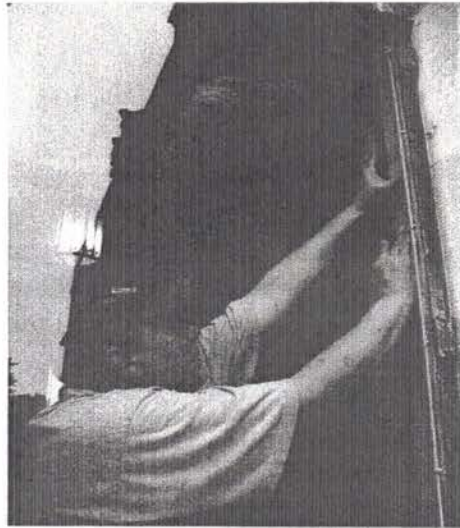
*Installation of
the steel frame*

Metalworker John McDevitt fabricated new steel frames for the (2) stained glass windows. Very precise templates of cardboard were made particularly of the top opening (housing the diamonds), which was not a regular semi-circle. From these templates the dimensions for the frame were documented and used for fabrication in the workshop.

The new steel frame sits within the stone window frame on the inside of the protective glazing. The panels sit perfectly in the frames, attached by rebars tied to the window. The stained glass panels are dry-set so that they can be easily removed from the frames. The frame is installed with a vented space between it and the protective glazing. The vent is to the interior on the bottom of the frame and has a chimney of an equal area at the top, allowing a continuous airflow. This new isothermal system reduces the chances of condensation from atmospheric changes that adversely affect the stability of the paint and glass, and gives the windows protection from any damage from the exterior.

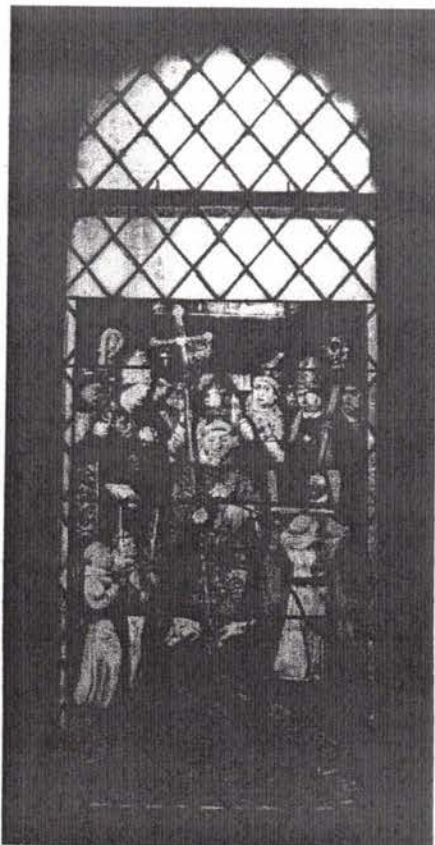
St. Nicholas after restoration

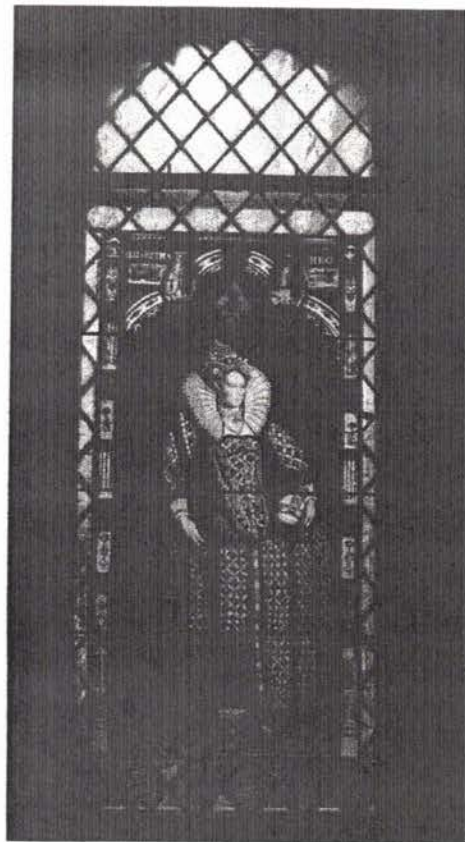
Queen Elizabeth after restoration
