**CONDITIONS REPORT FOR PLANTING FIELDS ARBORETUM:**  
**STAINED GLASS WINDOW REPAIR 2025 – 2026**

The following report will detail the conservation of one stained glass window. It will include written description of the work being done, photos of the work (including before, during, and after restoration), and recommendations for future maintenance.

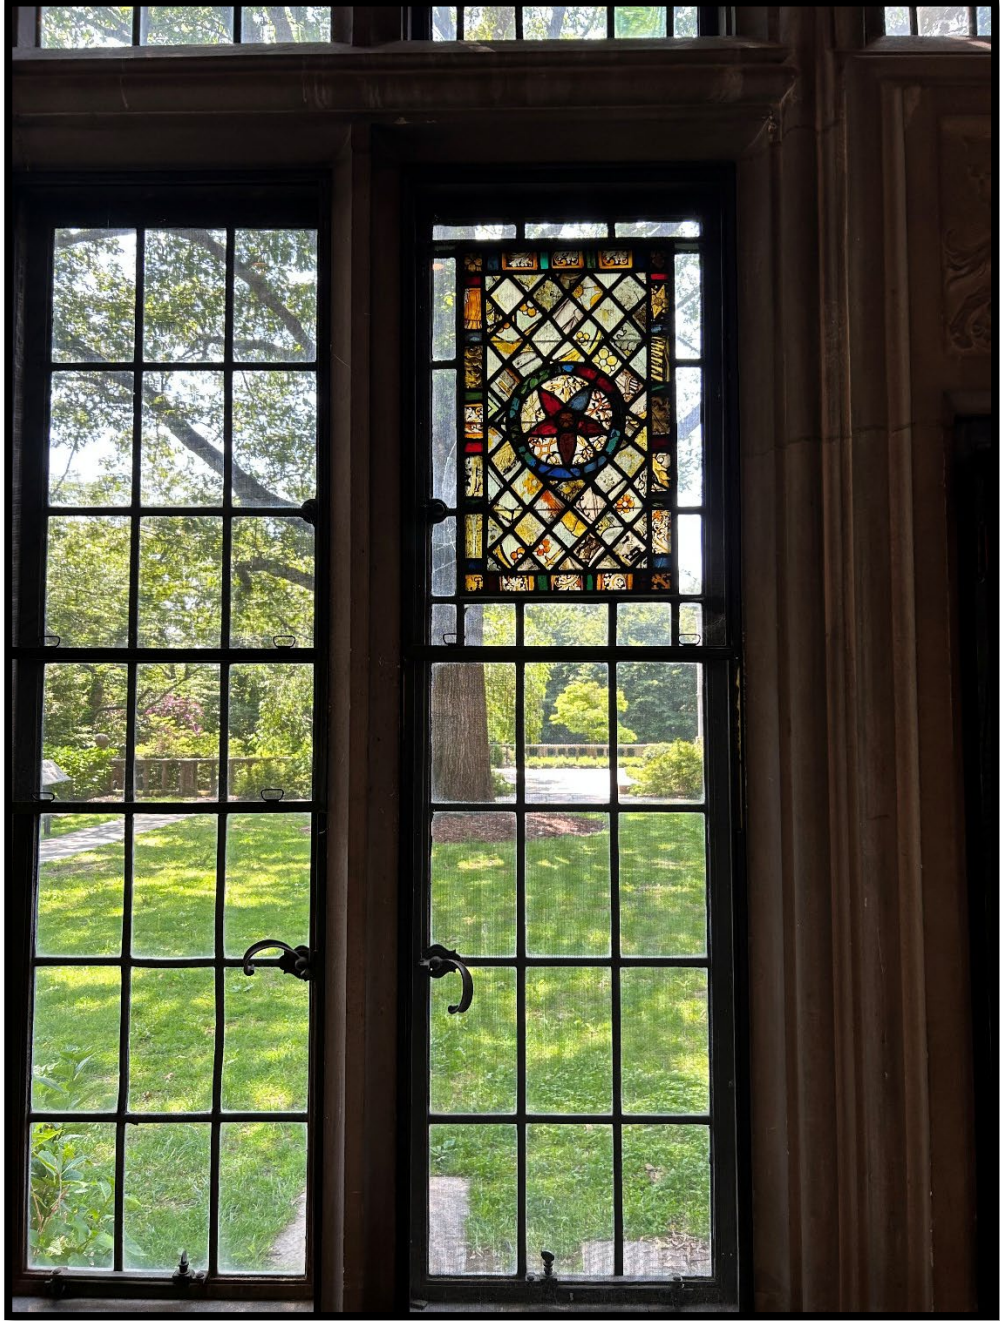
**FIGURE 1: Interior view on site, before conservation**

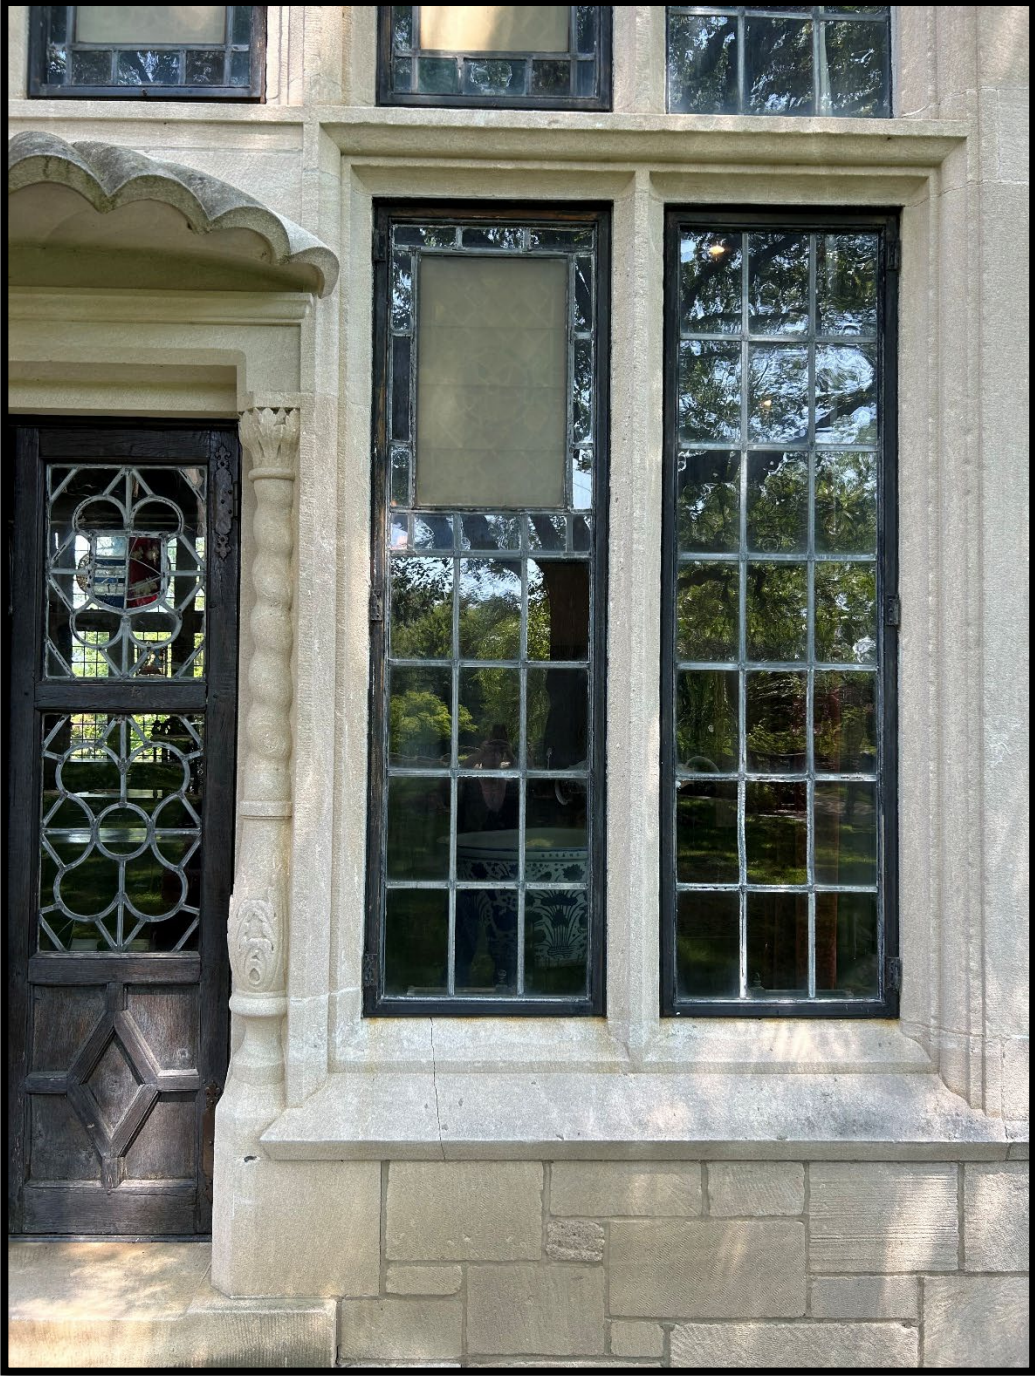
**FIGURE 2: Exterior view on site, before conservation**

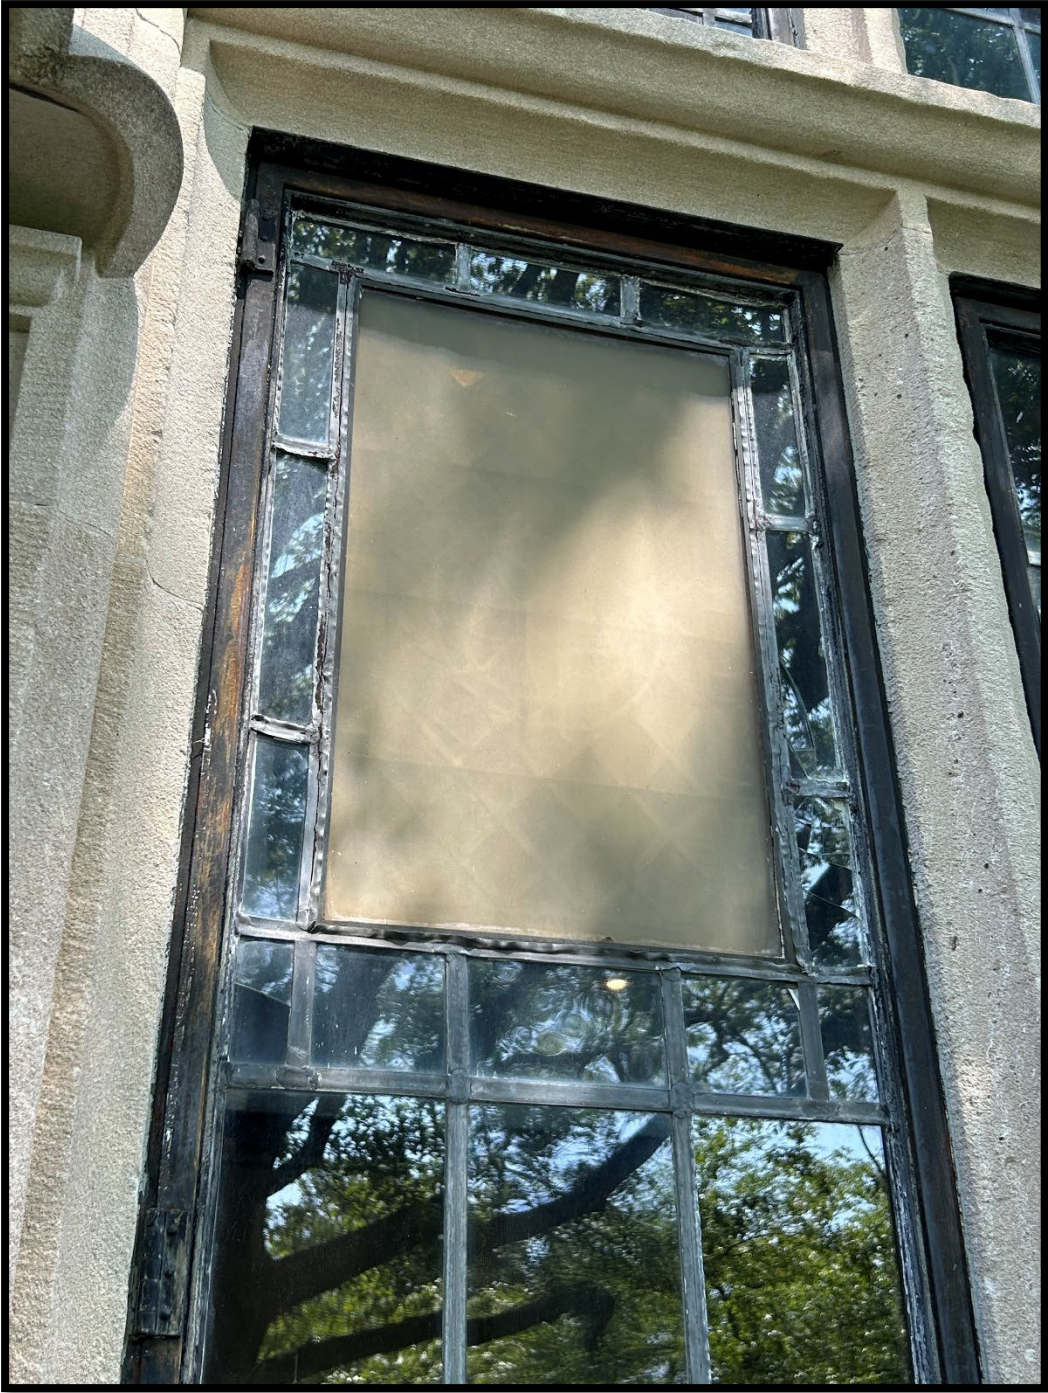
**FIGURE 3: Detail of warped/mangled lead around metal box, view from exterior**

- ❖ The decaying foam weatherstripping inside the metal frame was scraped off and replaced with new.
- ❖ To reinsert the metal box in the window, all warped/mangled lead was removed from the box, which was then gently cleaned. New lead comes were soldered neatly to the metal box, creating a smoother

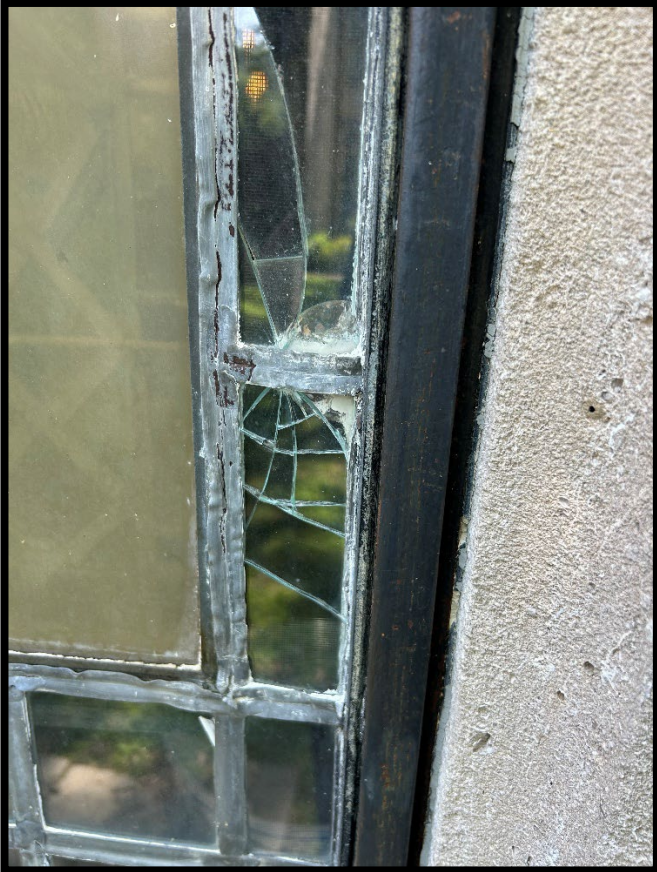
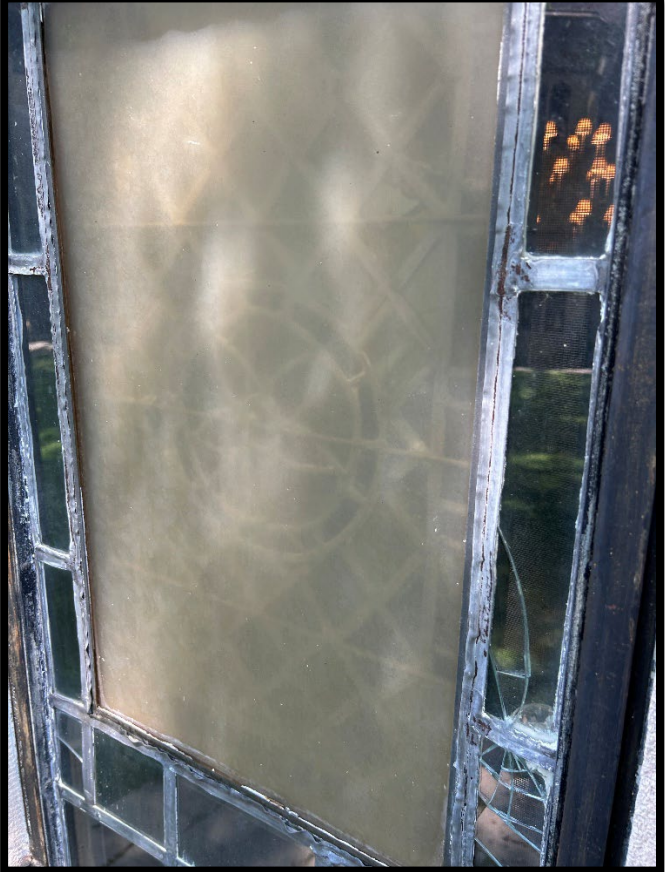
**FIGURE 4: Detailed views of broken glass and yellowed Lexan panel**

- ❖ The historic panel insert was removed from the box and the plastic sheet of Lexan was discarded. This material is known to yellow over time and exposure to the elements. A new piece of clear plate glass was purchased from a local glazier and reinstalled in the box. This greatly improved the visual of the window from the exterior of the house.

- ❖ All of the clear glass pieces were scraped of excess dirt and putty, then scrubbed with mild detergent and water for cleaning.
- ❖ There were four broken pieces in the window (Figure 11). Clear glass was chosen for replacements of these pieces. The glass was matched to the existing texture of the original glass as best as possible – slight wave texture and very clear.

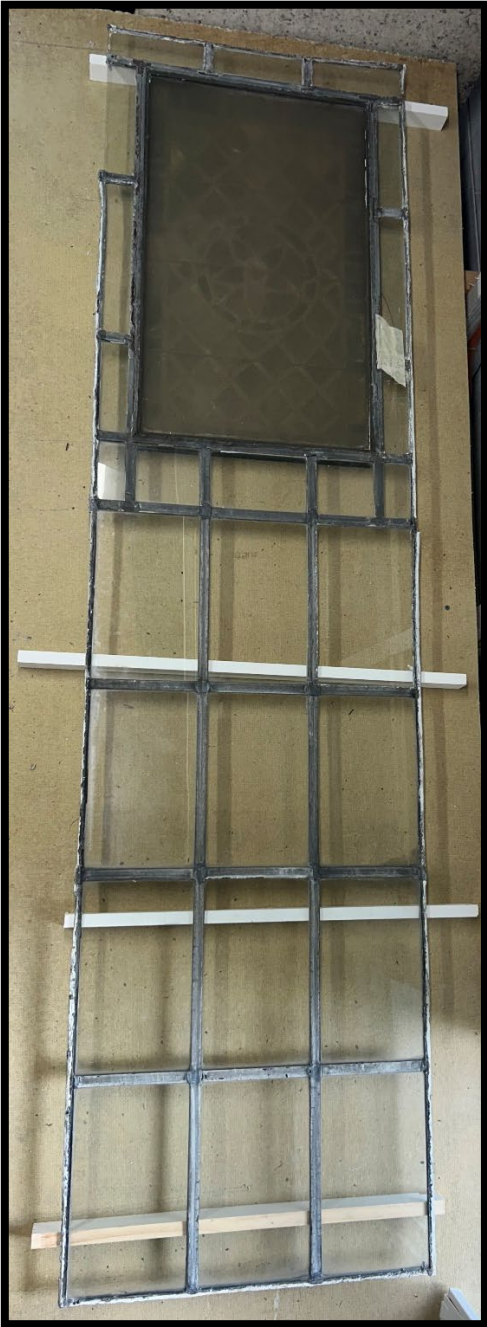
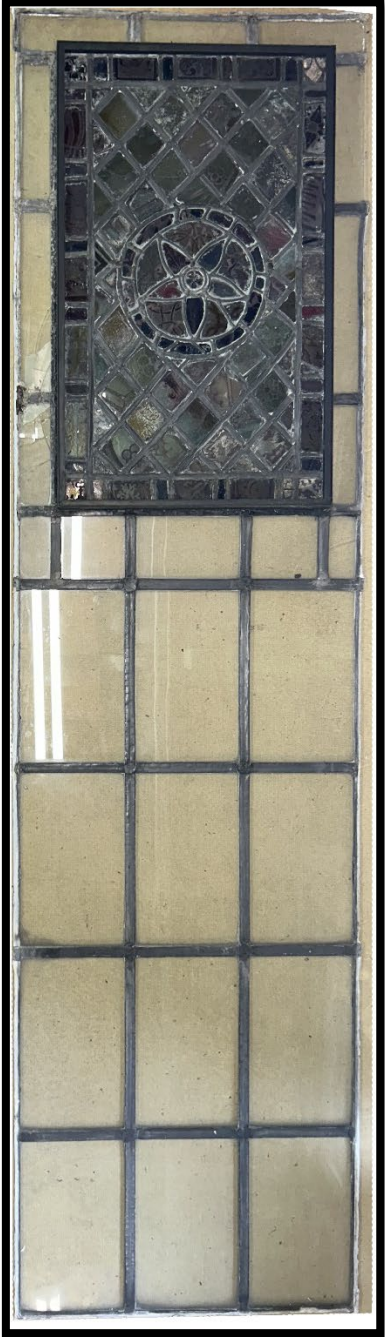
**FIGURE 5: Exterior (left) and interior (right) views, before conservation**

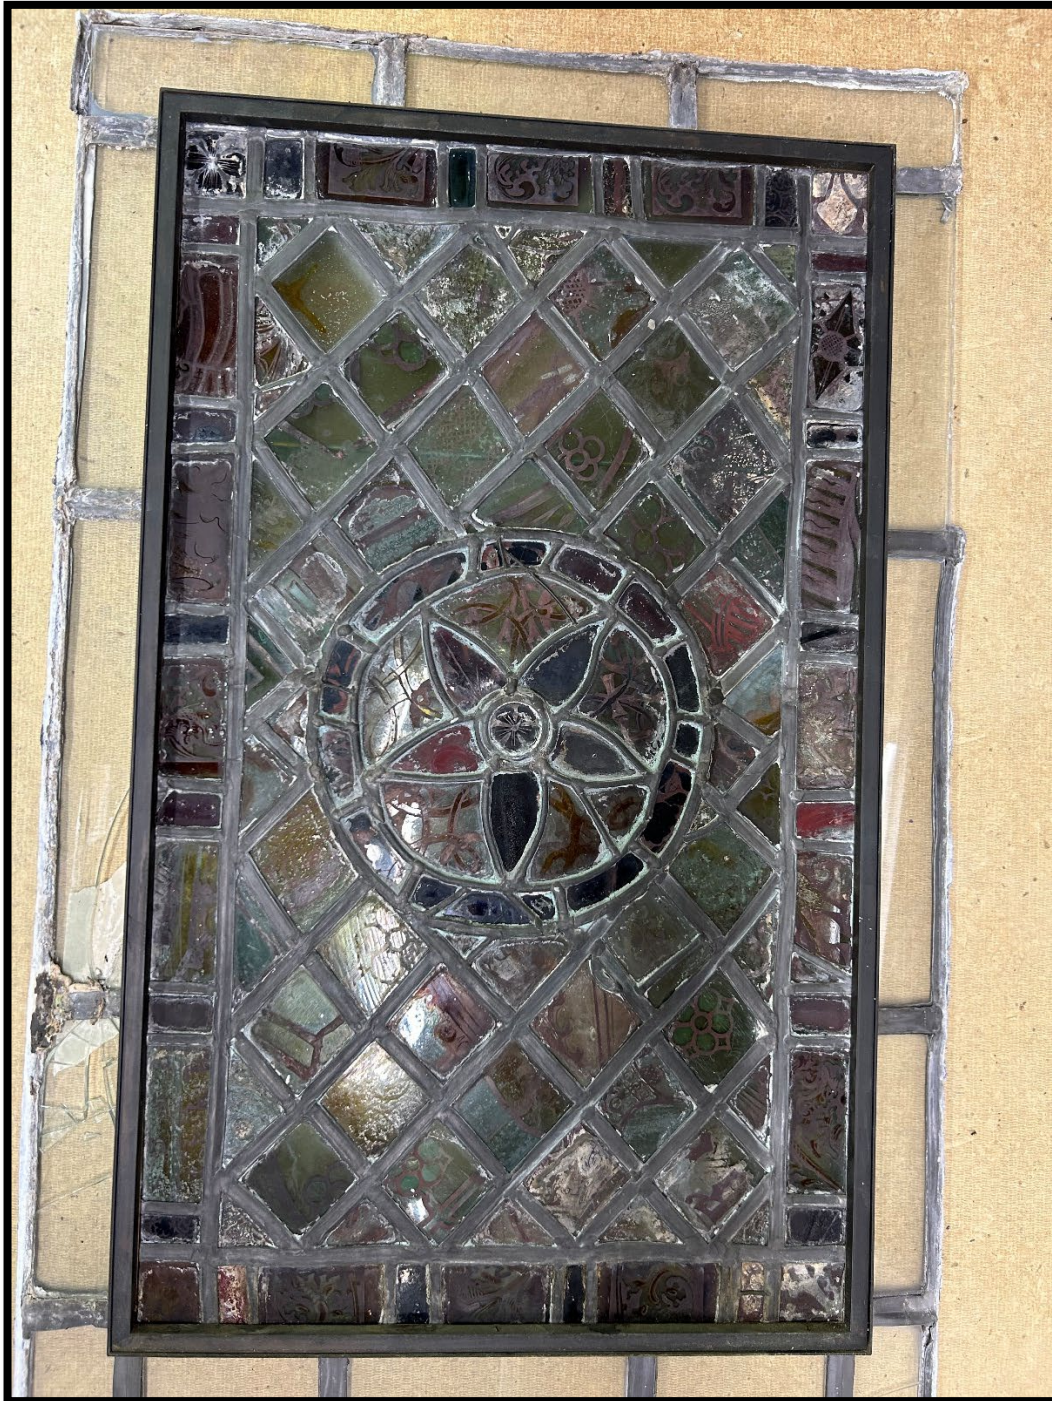
**FIGURE 6: Historic panel detail, before conservation**

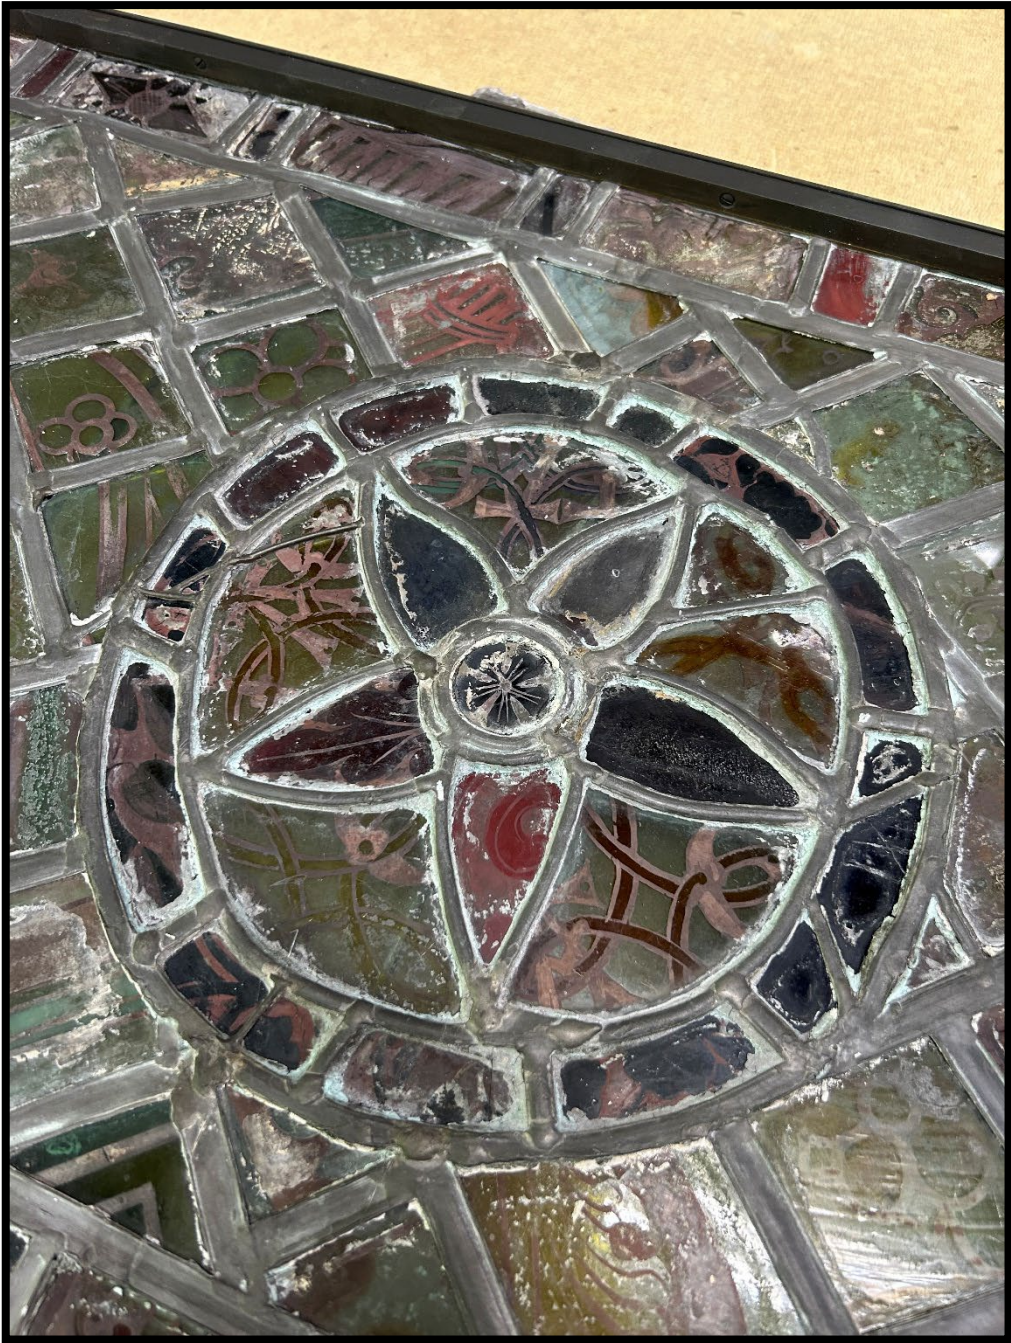
**FIGURE 7: Historic panel center medallion detail, before conservation**

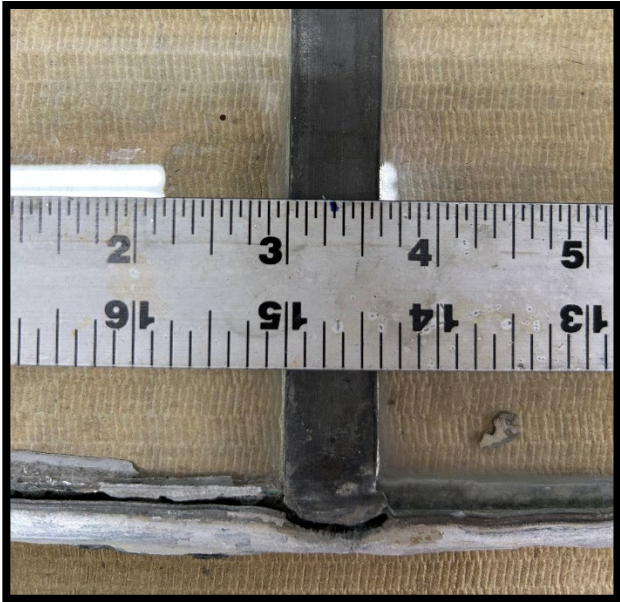
**FIGURE 8: 5/8" lead came profile**

- ❖ The grid of the window was deconstructed. Original lead was in poor condition and was discarded for recycling. New lead of the matching profile was purchased for re-leading: 5/8" flat (Figure 8).

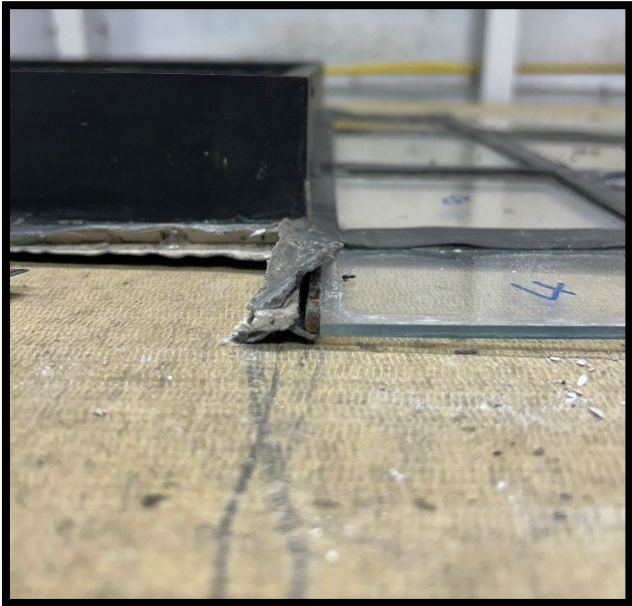
- ❖ During deconstruction, it was discovered that there were several horizontal pieces of lead that had a hollow-heart (comes that have an opening in the heart so that a flat metal bar can be inserted). The one directly under the metal box had the metal bar dangerously up against the glass with nothing in between (Figures 9-11). A diagram was created to mark those locations (Figure 12). After searching for 5/8" hollow heart lead from several suppliers, there was none available at this time. The solution was to utilize a material called Strong Line – this is an internal steel reinforcement which will provide the additional structural support the window requires. Strong Line was inserted at the same locations at the metal bars – one strip on each side of the heart of the lead.

**FIGURE 9: Metal bar directly against glass**

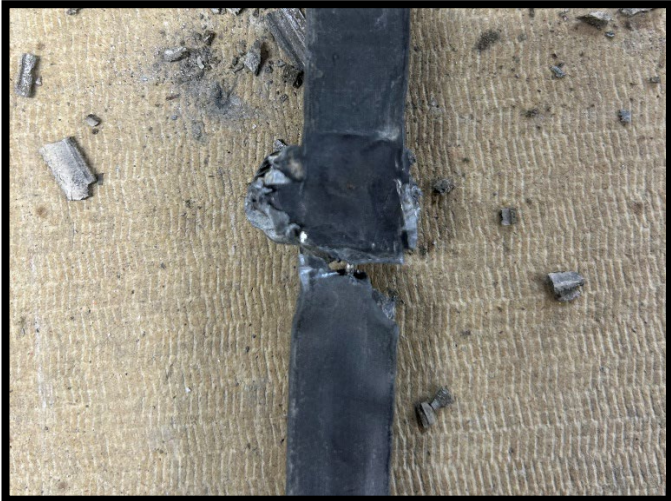
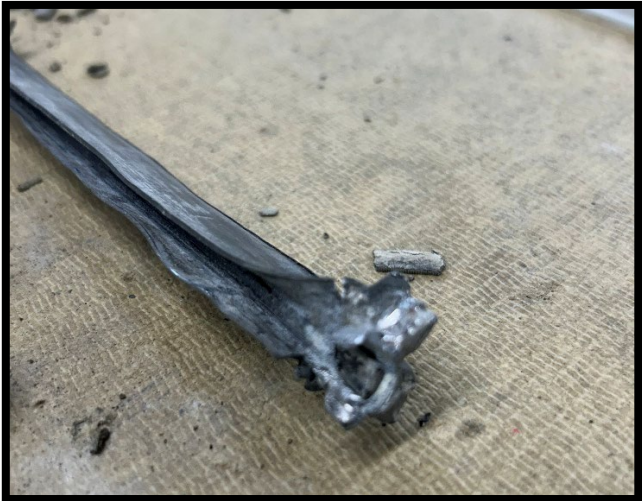
**FIGURE 10: Views of hollow heart lead came**

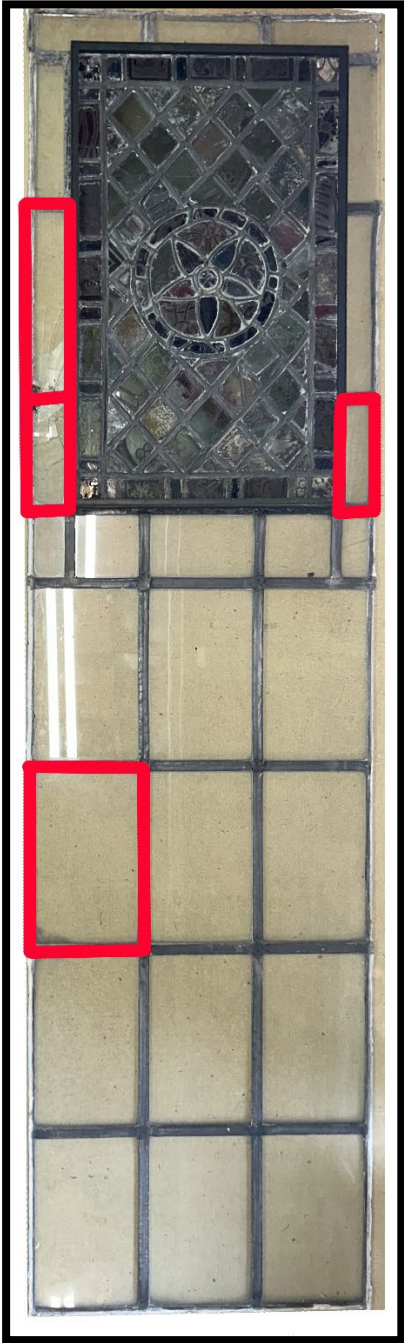
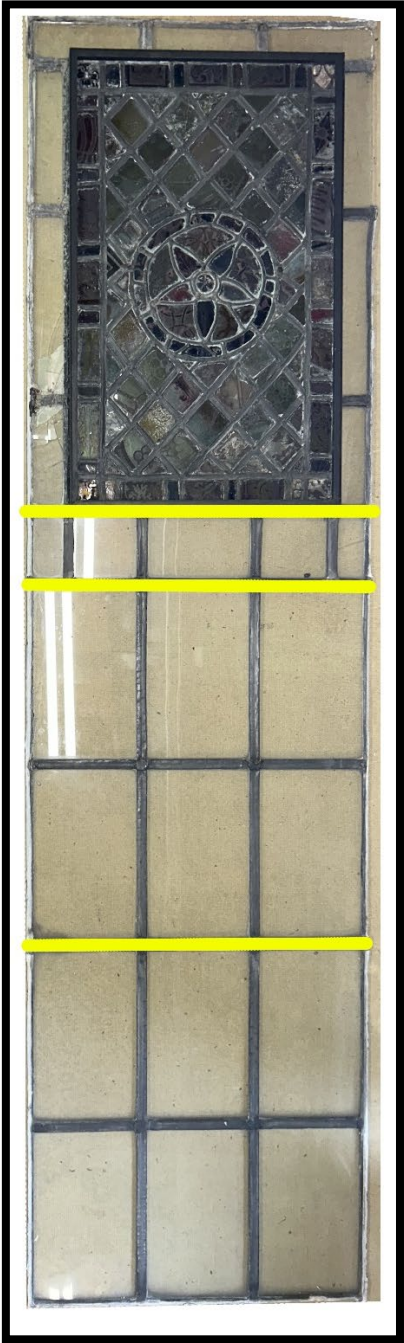
**FIGURES 11 and 12: Existing conditions diagrams, broken glass for replacement (left) and hollow heart lead came (right)**

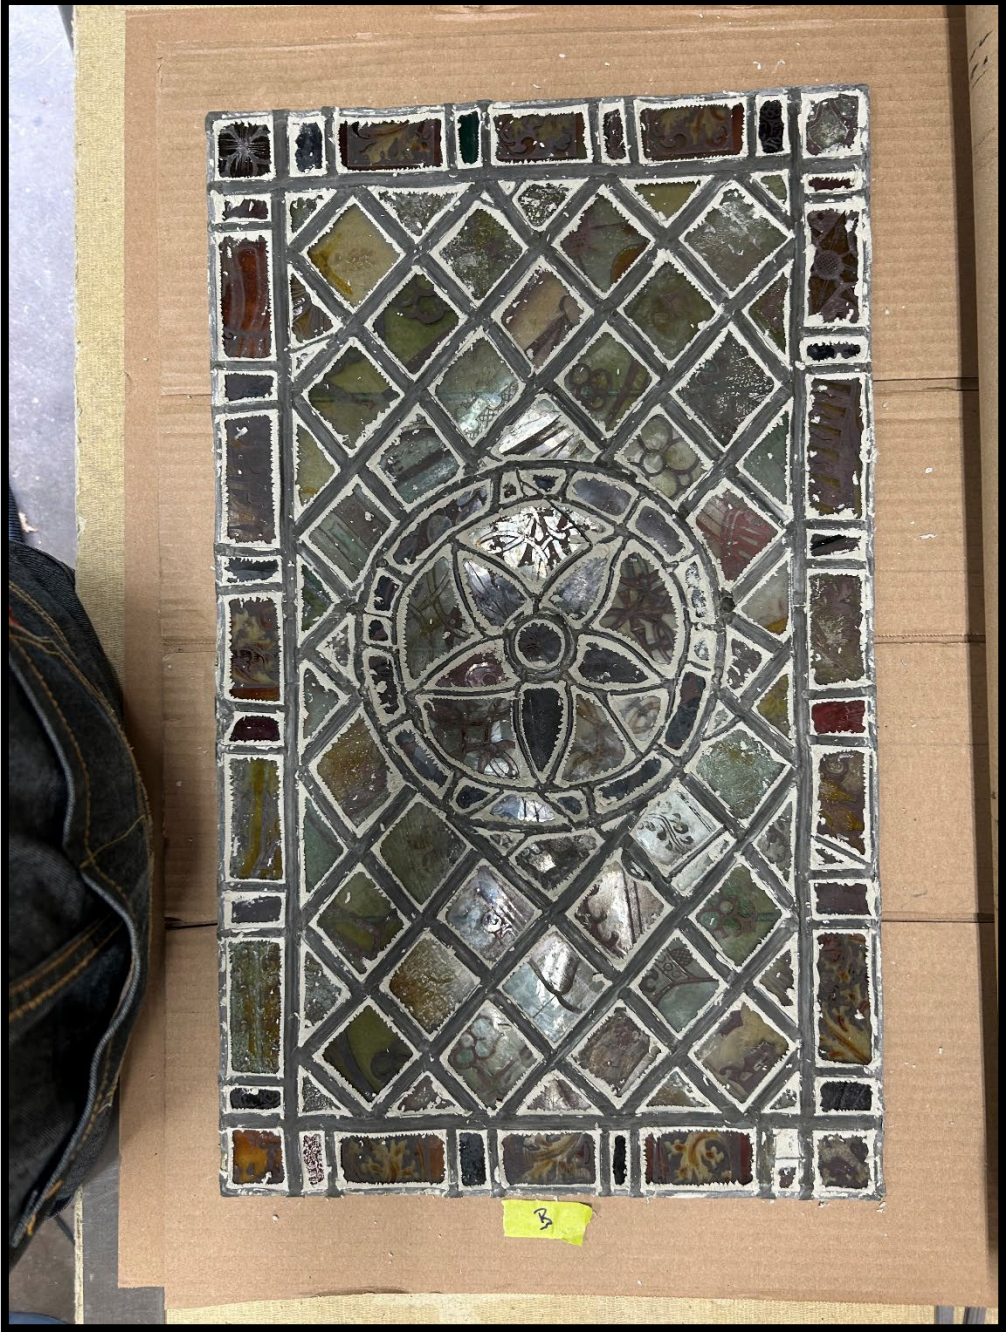
**FIGURE 13:** *New putty for the historic panel*

- ❖ The historic panel was given an extensive cleaning. This included removing as much of the old putty as possible, a detailed cleaning of the front and back of each piece of glass, and then finished with new putty for waterproofing and stability (Figures 13 and 14).

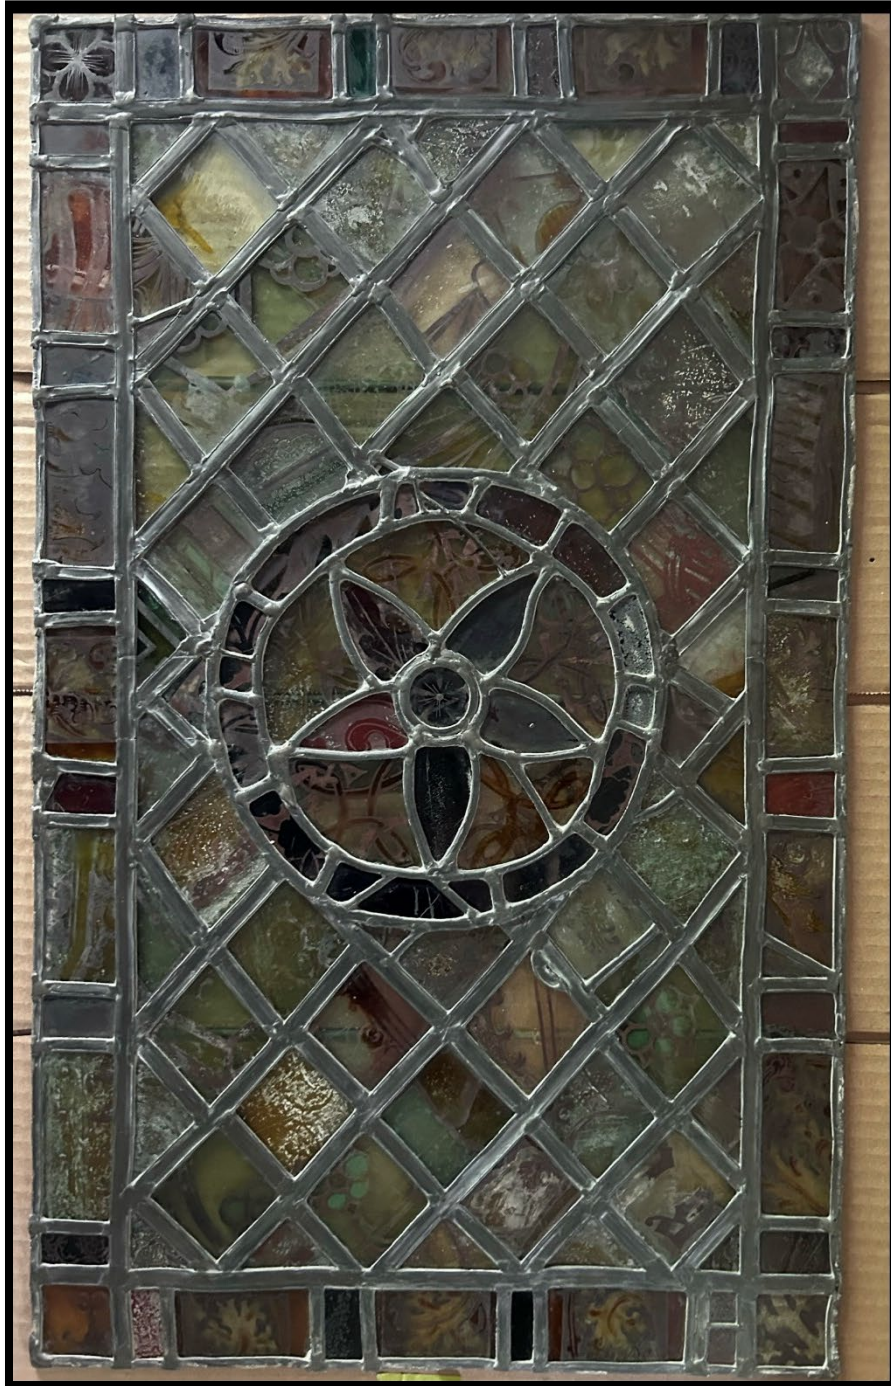
**FIGURE 14:** Historic panel, after conservation

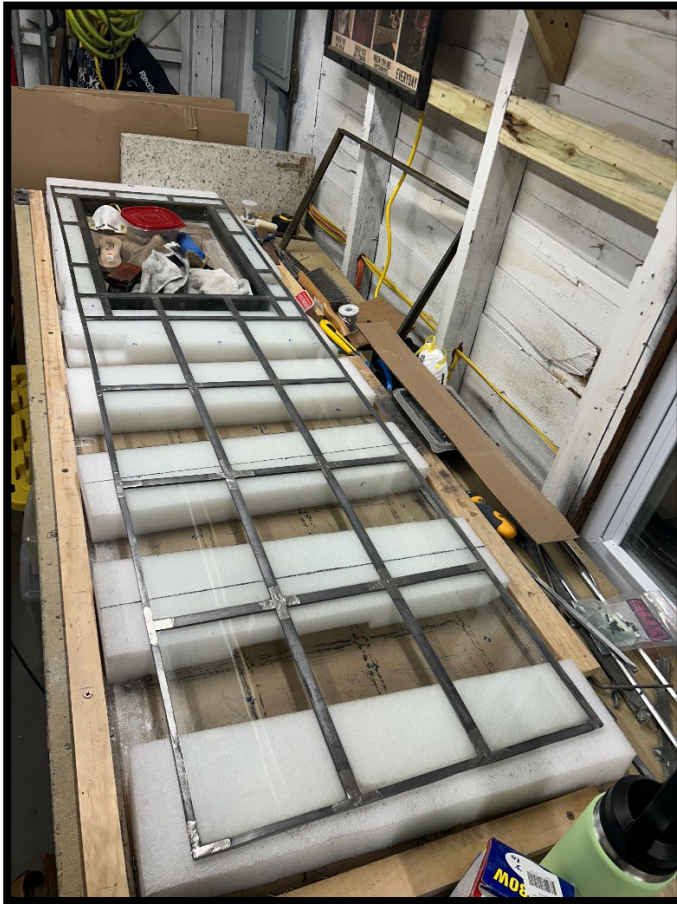
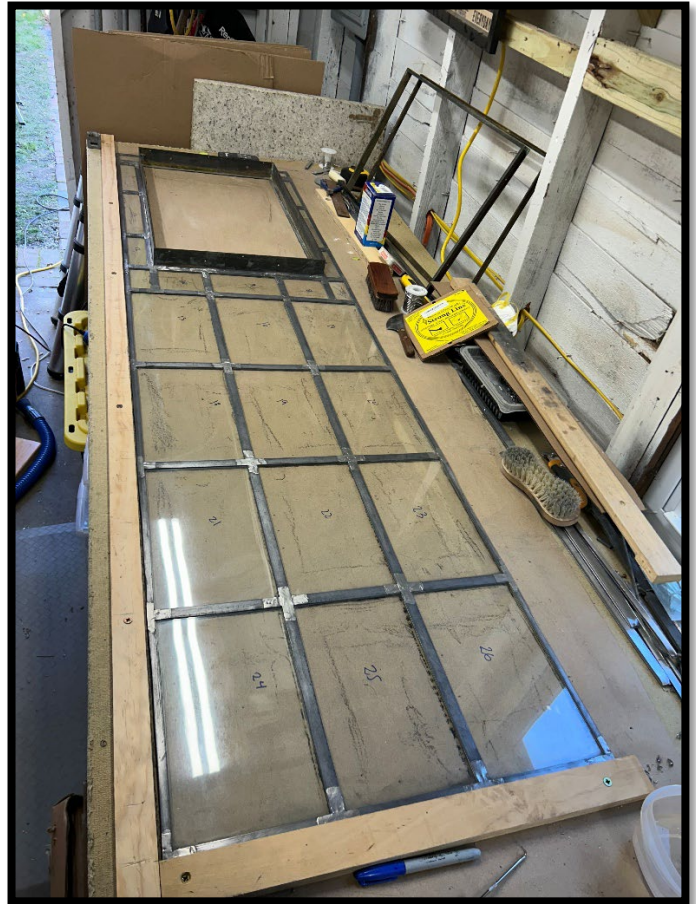
**FIGURE 15: Re-leaded panel with new comes, exterior and interior views**

- ❖ The window was then leaded with new came – the cleaned metal box was reinserted during this process. Once the window was soldered, puttied, and cleaned, the restored historic panel was reinstalled in the metal box. The entire window was then placed in a custom-built crate for transportation to the site (Figures 15 and 16).

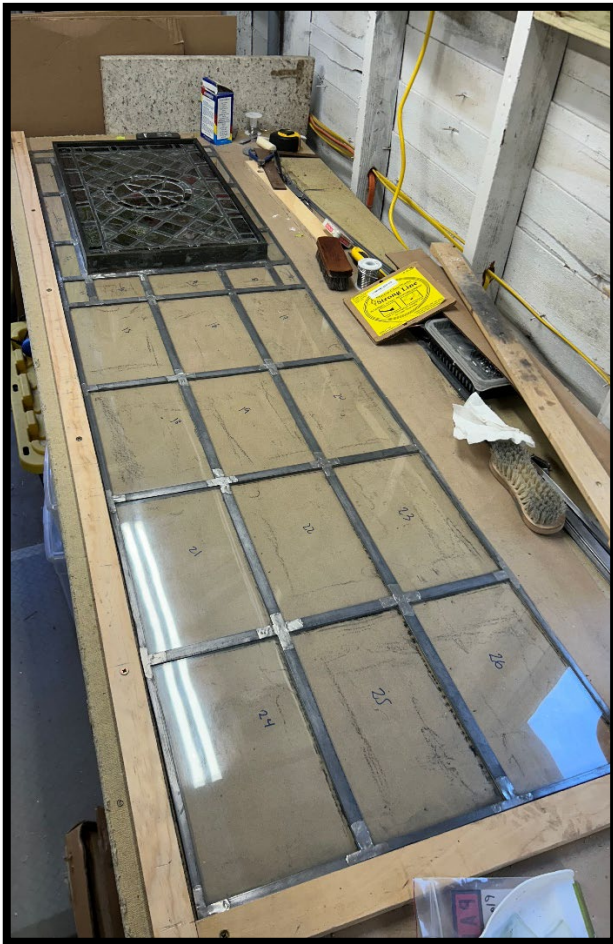
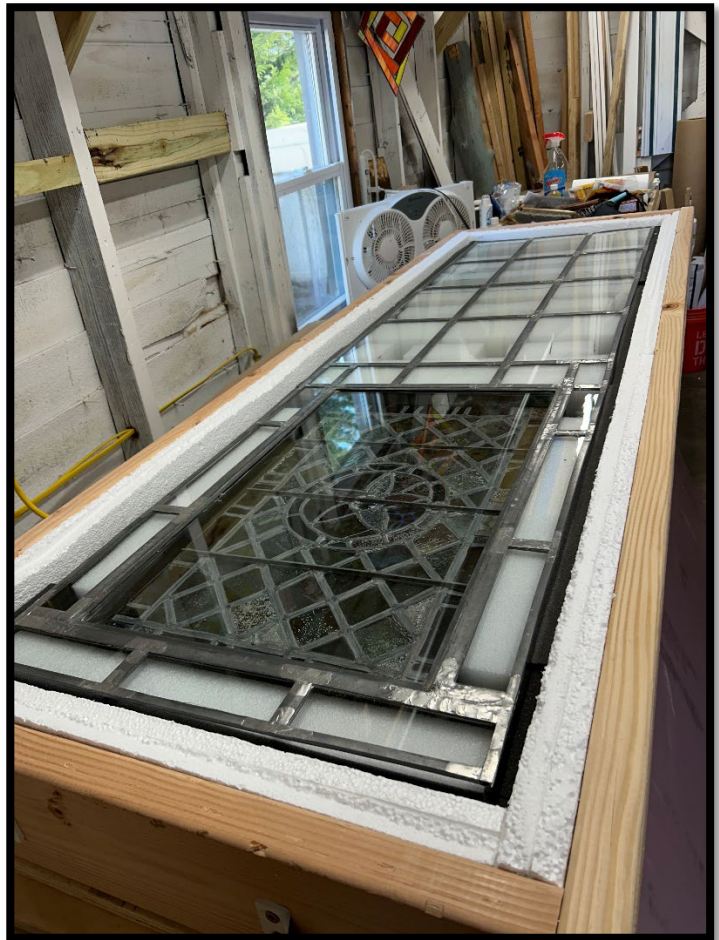
**FIGURE 16: Historic panel reinserted into window and packed in box for transport**

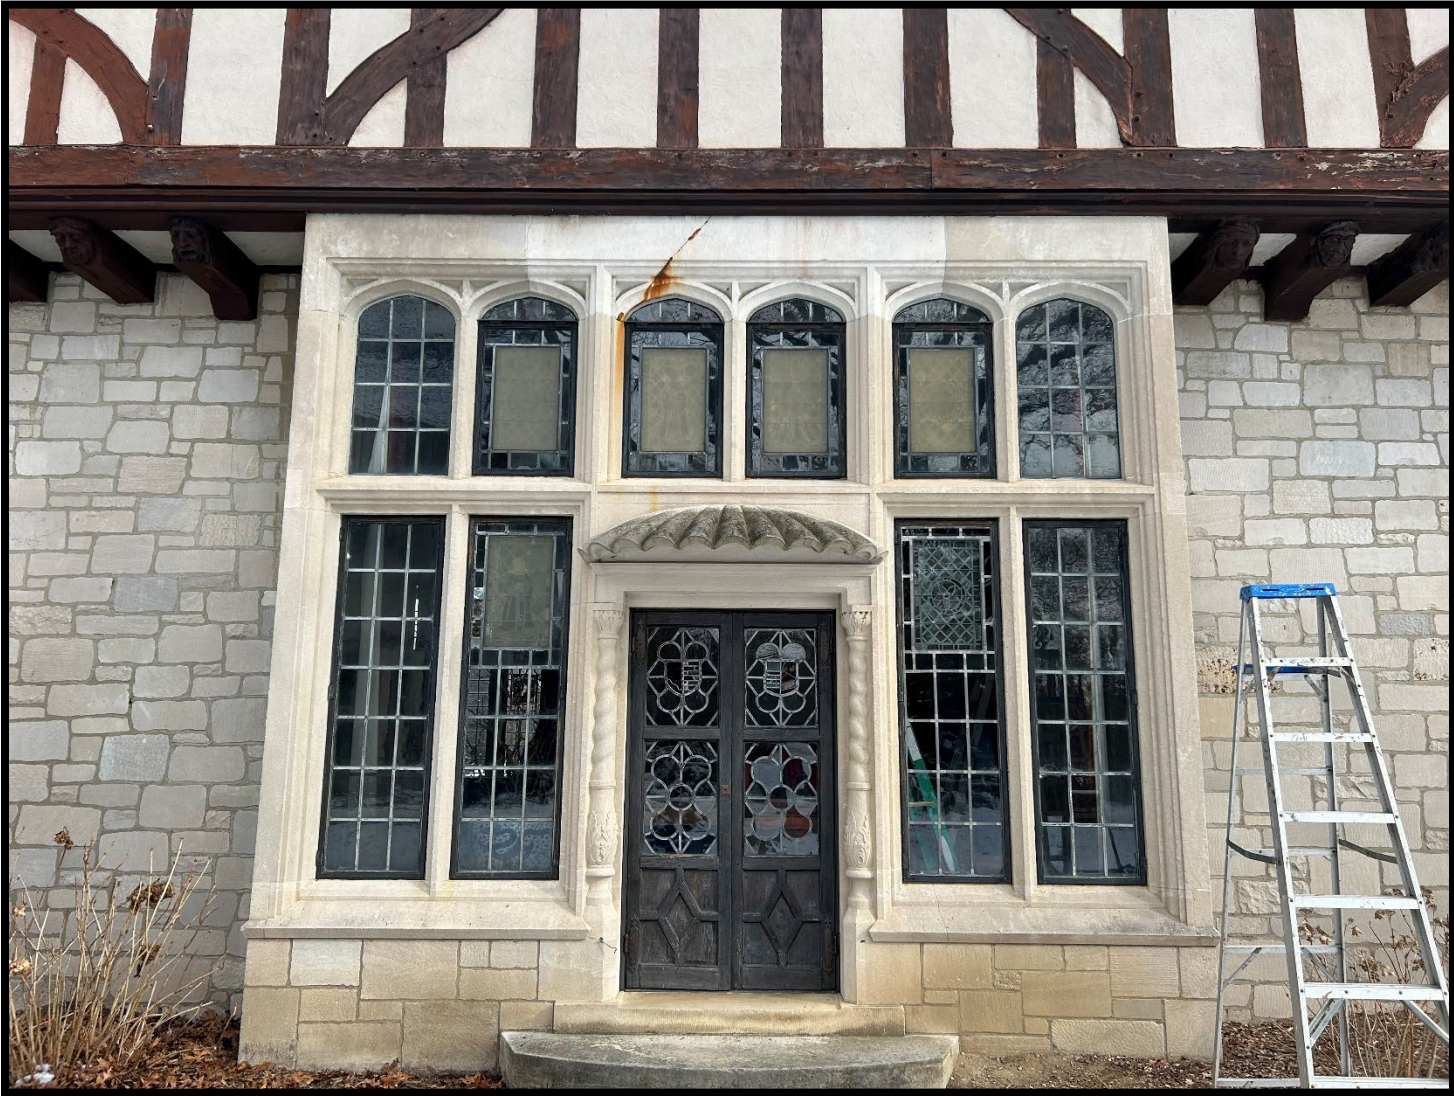
**FIGURE 17: Finished panel reinserted on site, exterior view**

- ❖ For installation, a small putty bevel was added to secure the window in place and the stops were reattached from the outside (Figures 17 and 18).
- ❖ Before and After comparisons were created for the following: cleaning test on historic panel, center medallion of historic panel, full view of historic panel, exterior view, and interior view (Figures 19 – 23).

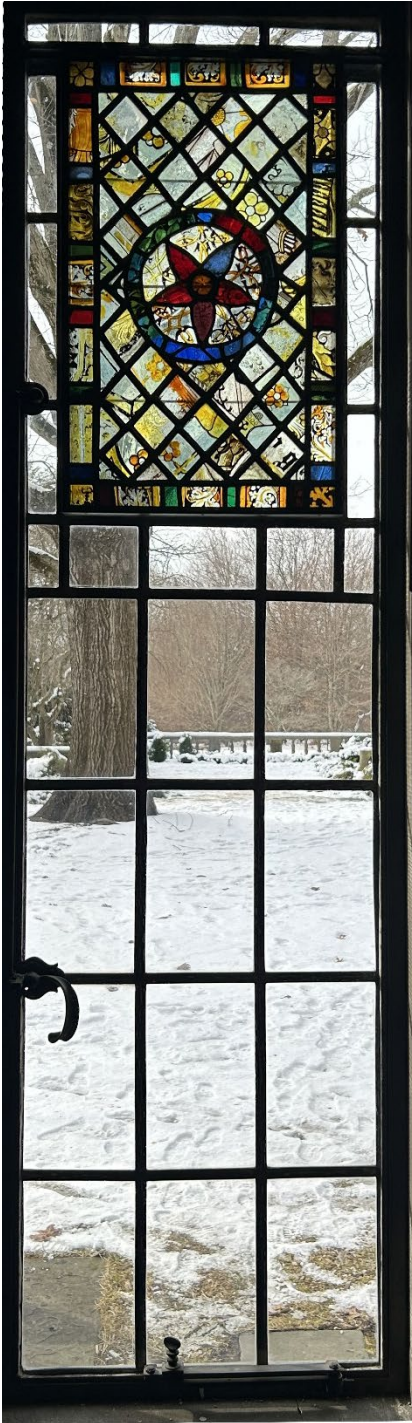
**FIGURE 18: Finished panel reinserted on site, interior view**

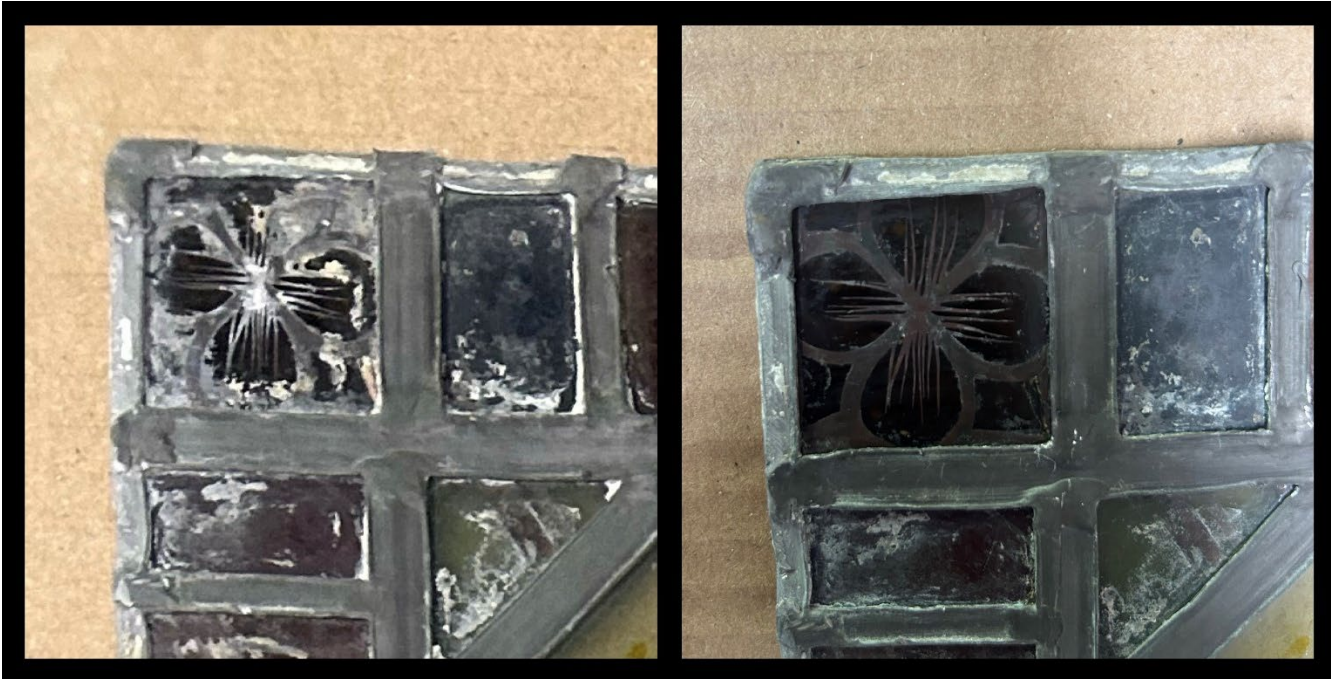
**FIGURE 19: Before and After, cleaning test of historic panel**

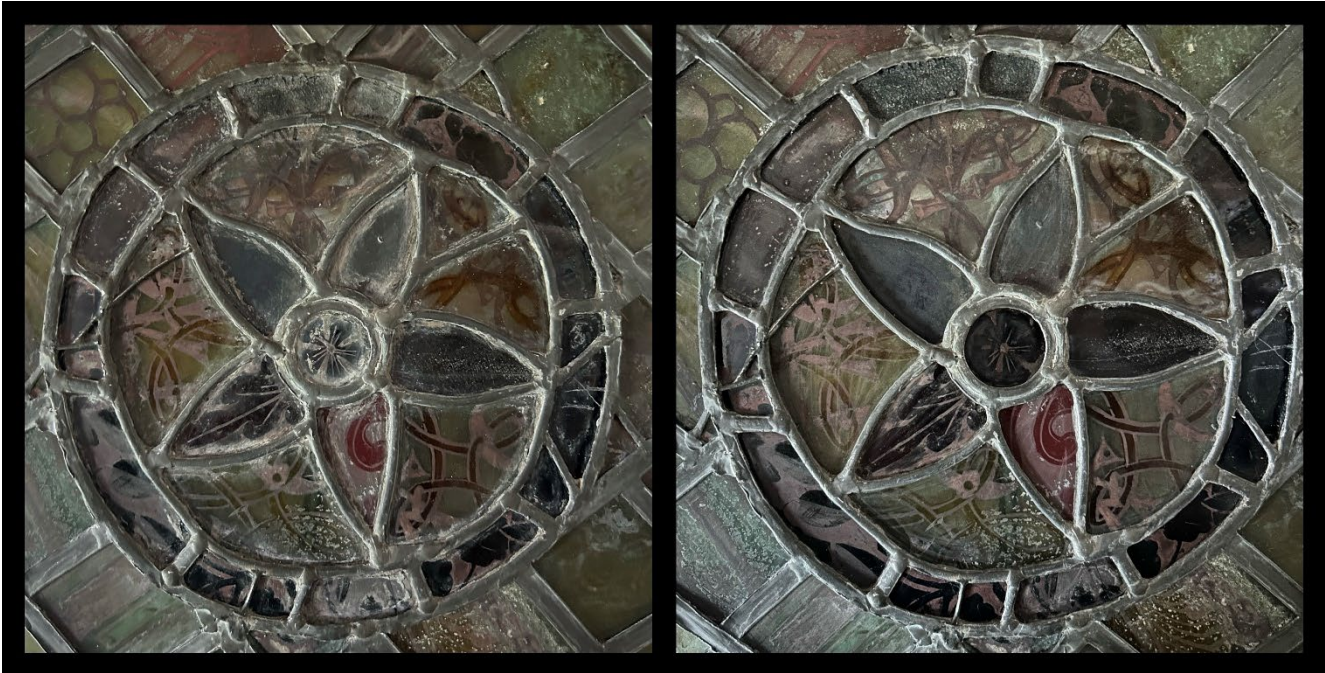
**FIGURE 20: Before and After, cleaning center medallion of historic panel**
