**CONDITIONS REPORT FOR PLANTING FIELDS ARBORETUM:**  
**STAINED GLASS WINDOW REPAIR 2025 – 2026**

The following report will detail the conservation of one stained glass window. It will include written description of the work being done, photos of the work (including before, during, and after restoration), and recommendations for future maintenance.

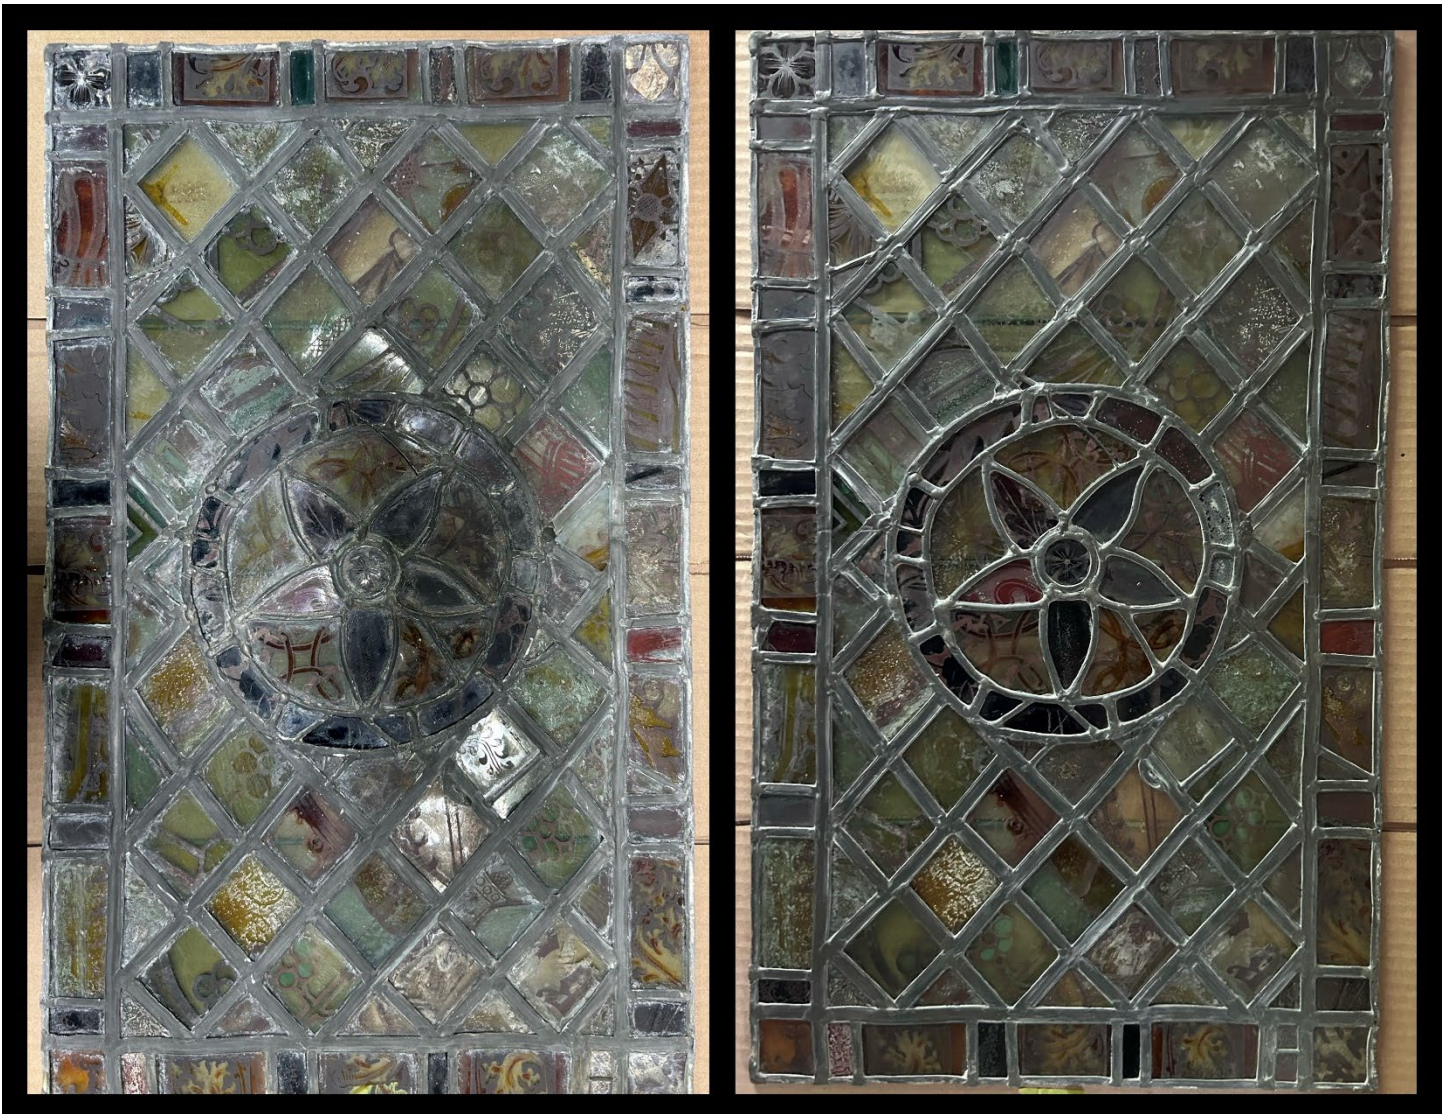
**FIGURE 21: Before and After, historic panel**

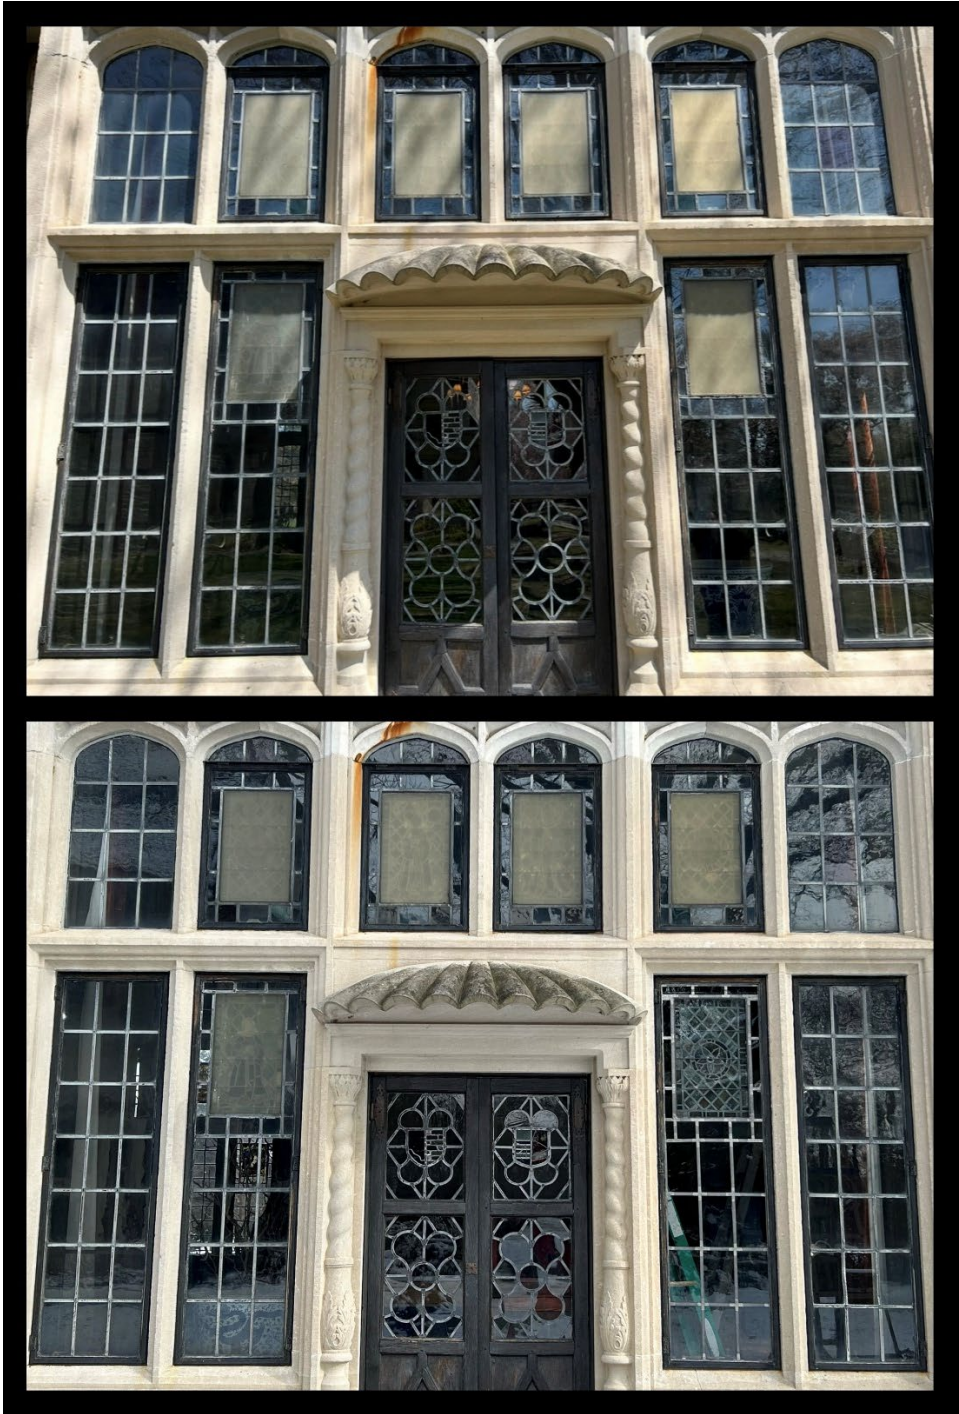
**FIGURE 22: Before and After conservation, exterior view**

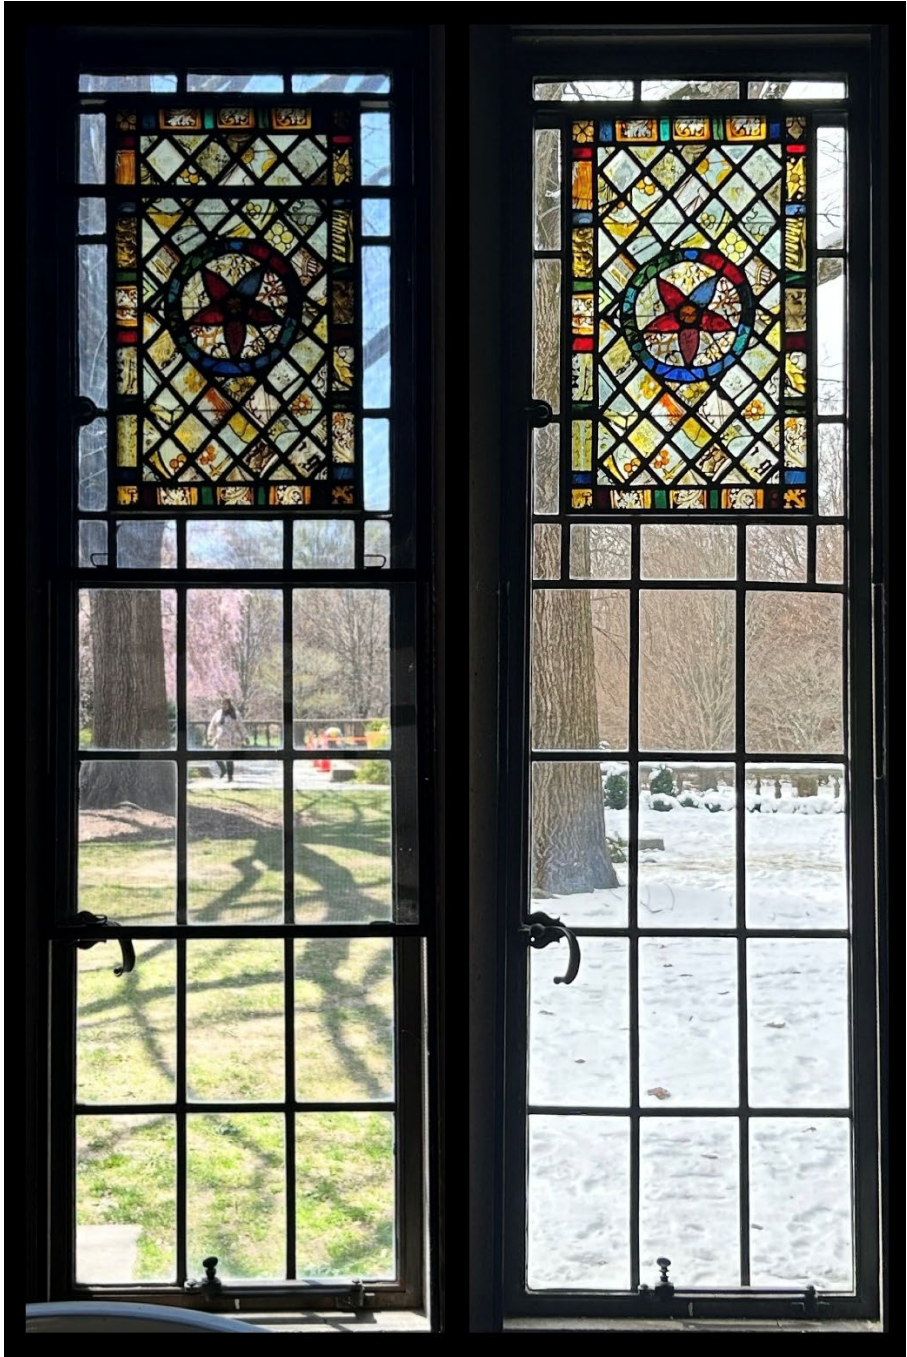
*FIGURE 23: Before and After conservation, interior view*
