## **New York State Office of Parks, Recreation and Historic Preservation**

### **Furniture Conservation Examination Report and Treatment Proposal**

*Accession Number:* COE.1955.002.131

*Furniture Type:* Sofa

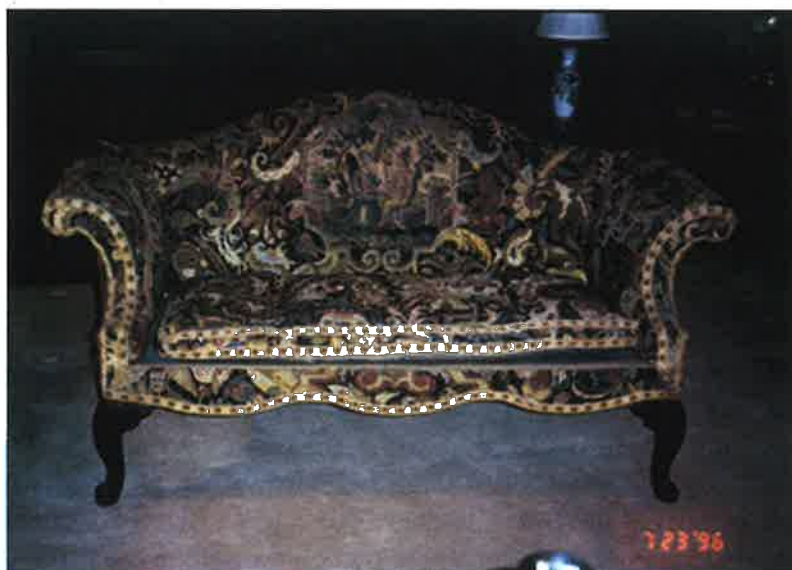
Sofa on-site, July 1996

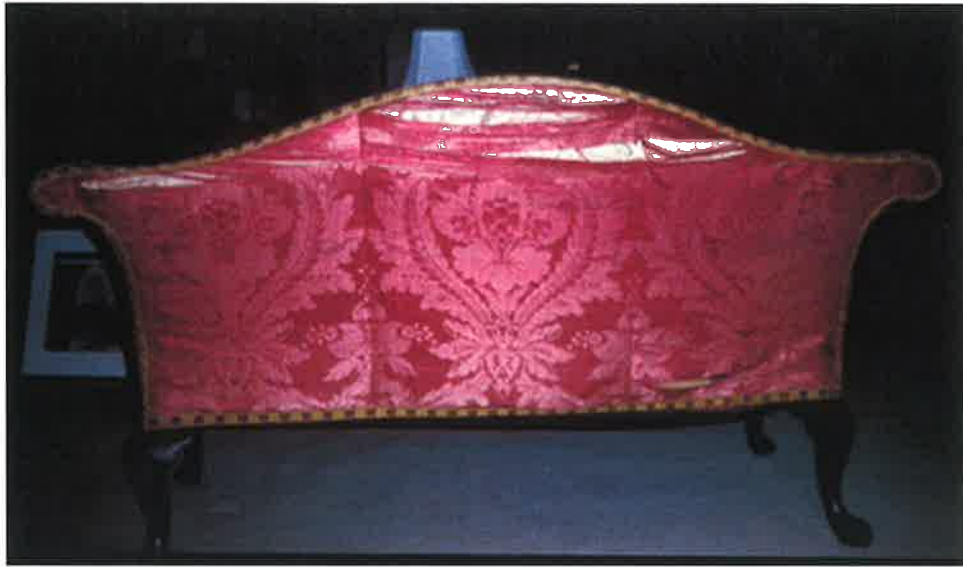
Sofa, rear view, on-site, July 1996

**Condition** Poor. The damask show cover is weak, with splitting in many areas. The worst of the splits are at the front of the proper right arm and across the top and bottom of the outside back. Some of the fabric around the splits is so weak that it is shredding. Seams in the proper right outside arm have opened. The damask pieces are sagging away from the frame. The fabric is soiled, with a grimy feel. The outside back is significantly faded.

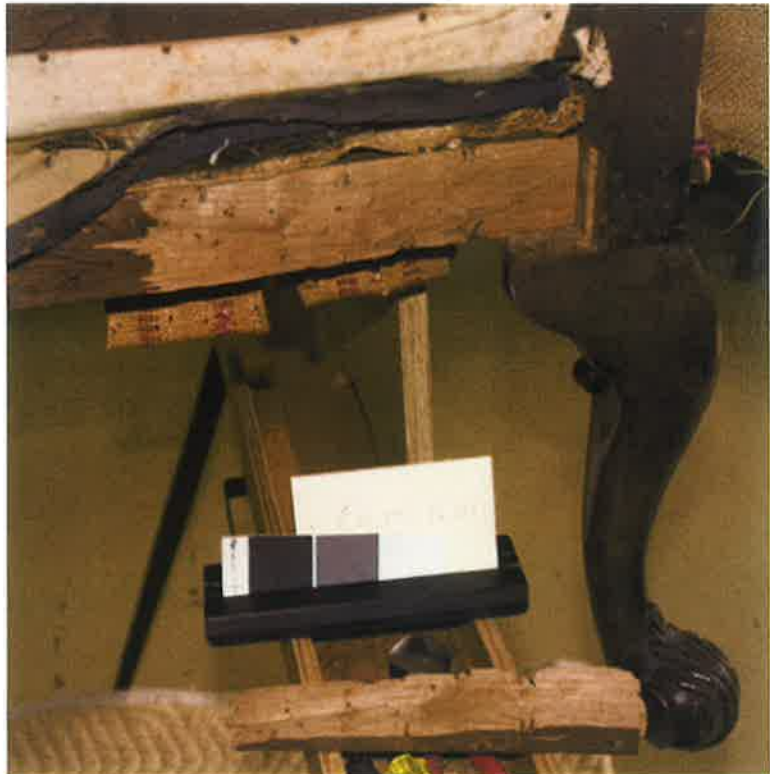
The proper right rear leg is loose because the joint with the rear rail is broken; a piece of the rail is suspended by the upholstery.

| <b>Date</b> | <b>Personnel</b> | <b>Hours</b> | <b>Techniques and Materials</b> |
|---|---|---|---|
| 10/17/<br>2012 | DB | 3.25 | The proper left rear leg was loose partly because it was not attached to the rear rail. The tenon had broken and the wood had split. The detached pieces were held with upholstery tacks. The tacks holding the smaller piece were removed. The webbing attached to the rail had retracted the rail into the interior of the sofa. Two straps of webbing were removed at the rail end. The black-white linen webbing was not disturbed. |

Note in the above picture the smaller piece in the foreground and that the rail has been partially brought back into the place and is setting on the knee block. The rail is still about 1/2" out of position. The edge of the break should line up with the inside edge of the mortise.

| 4. Repair rear rail using hot hide glue and replace missing pieces as necessary. | 15 hours |

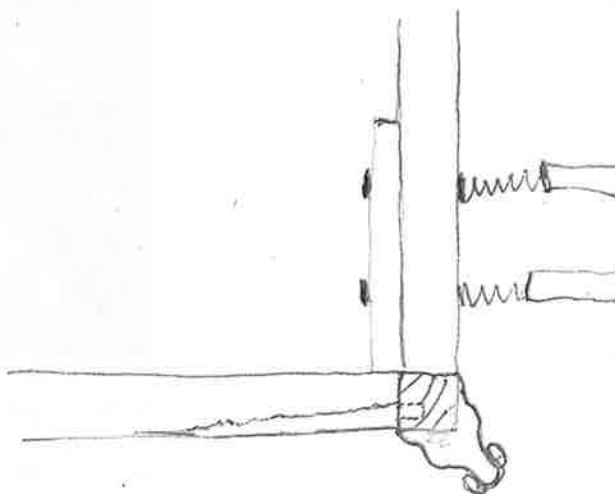
The proper right rear leg – plan view without the back. The crack and the broken rear rail are indicated. On the right, the new glue block is shown clamped in position, pushing against the front surface of the rear rail.

To hold the rail in the correct position a long block was glued to the side rail. See below.

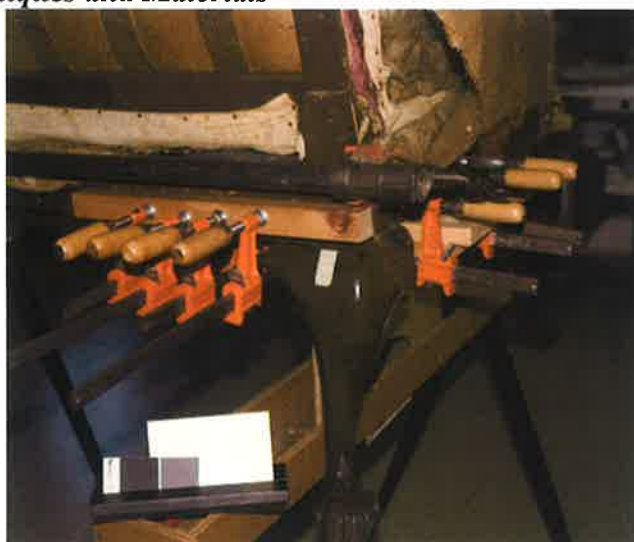
The clamps on the right are clamping the glue block to the inside surface of the right rail. The clamps on the left pull the rail into position and clamp the broken piece in rail.

A stiff caul was made that was long enough to span the break. Then by using clamps the broken rail could be pulled into position the rest of the way and clamped to the broken piece. Unfortunately it would not stay in that position because of the tension of the webbing. The broken tenon that

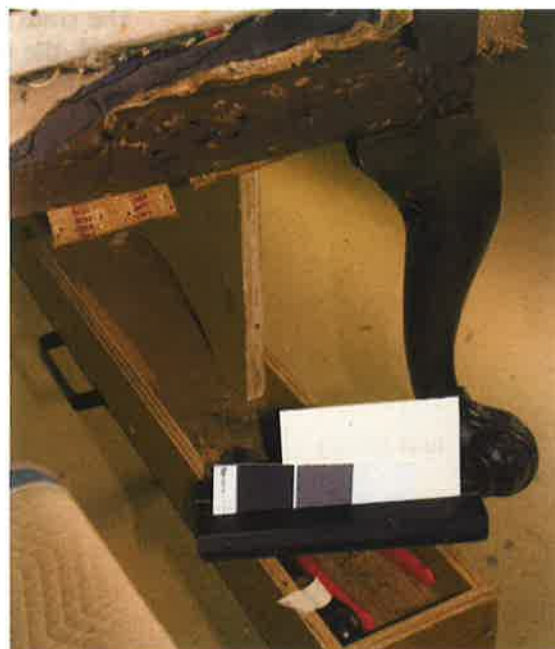
The break after the clamps were removed.

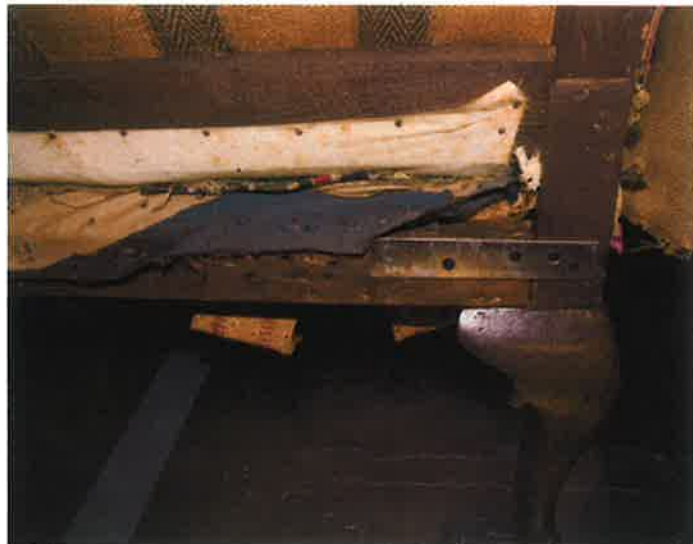
| <i>Date</i> | <i>Personnel</i> | <i>Hours</i> | <i>Techniques and Materials</i> |
|---|---|---|---|
| | | .5 | The above attempts keep the leg from going front to back but do not hold it from left to right. The only practical solution seems to be a metal plate attached to screws to the rail and the top block of the leg. The lab was searched for such a plate. |

| <i>Date</i> | <i>Personnel</i> | <i>Hours</i> | <i>Techniques and Materials</i> |
|---|---|---|---|
| 10/24 | DB | 1 | Plate was attached with five screws and engraved with "2012 PI" |
