STAIRWAY
room G

TRACERY LIGHT STAIRWAY, G1

TRACERY LIGHT (STAIRWAY, NORTH BAY, G1)

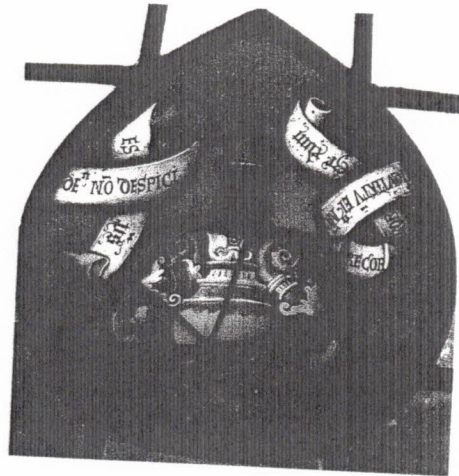
Such qualities can be perceived in this little tracery panel, with beautiful, golden silver stain applications, very fine trace with a light umber-brown grisaille and a fine matting of the same grisaille. Here the cuts are fairly simple, and the panel is dominated by one single large piece of clear painted glass, the vase itself, that was shattered in the middle.

Note the stopgap at the bottom part of the vase: a 'leftover' fragment of another panel inserted as a replacement for the missing glass. This was a process of restoration for many centuries (until recently), but in this case the search for a piece in a matching style, color and design was quite unsuccessful! The remaining pieces are original, with the exception of one or two blue background pieces.

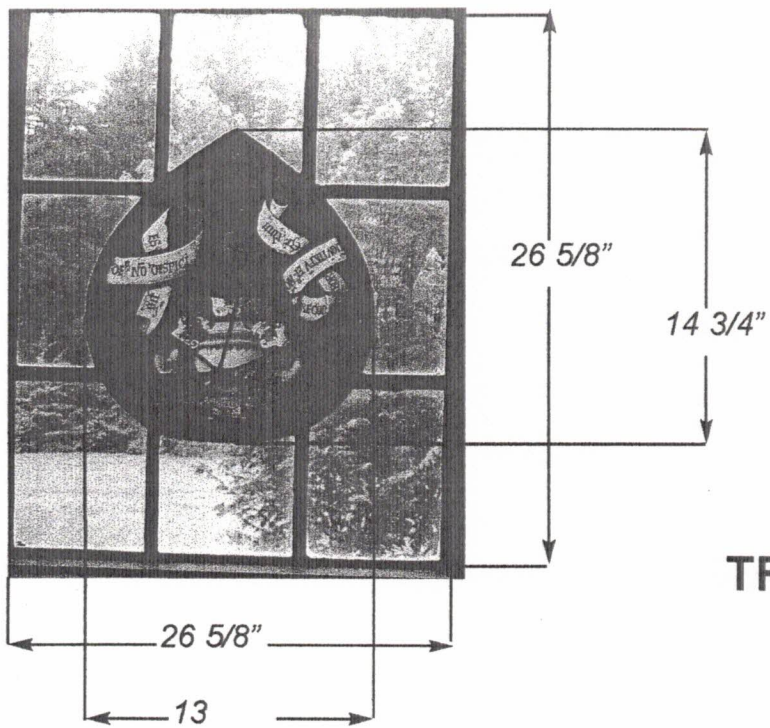
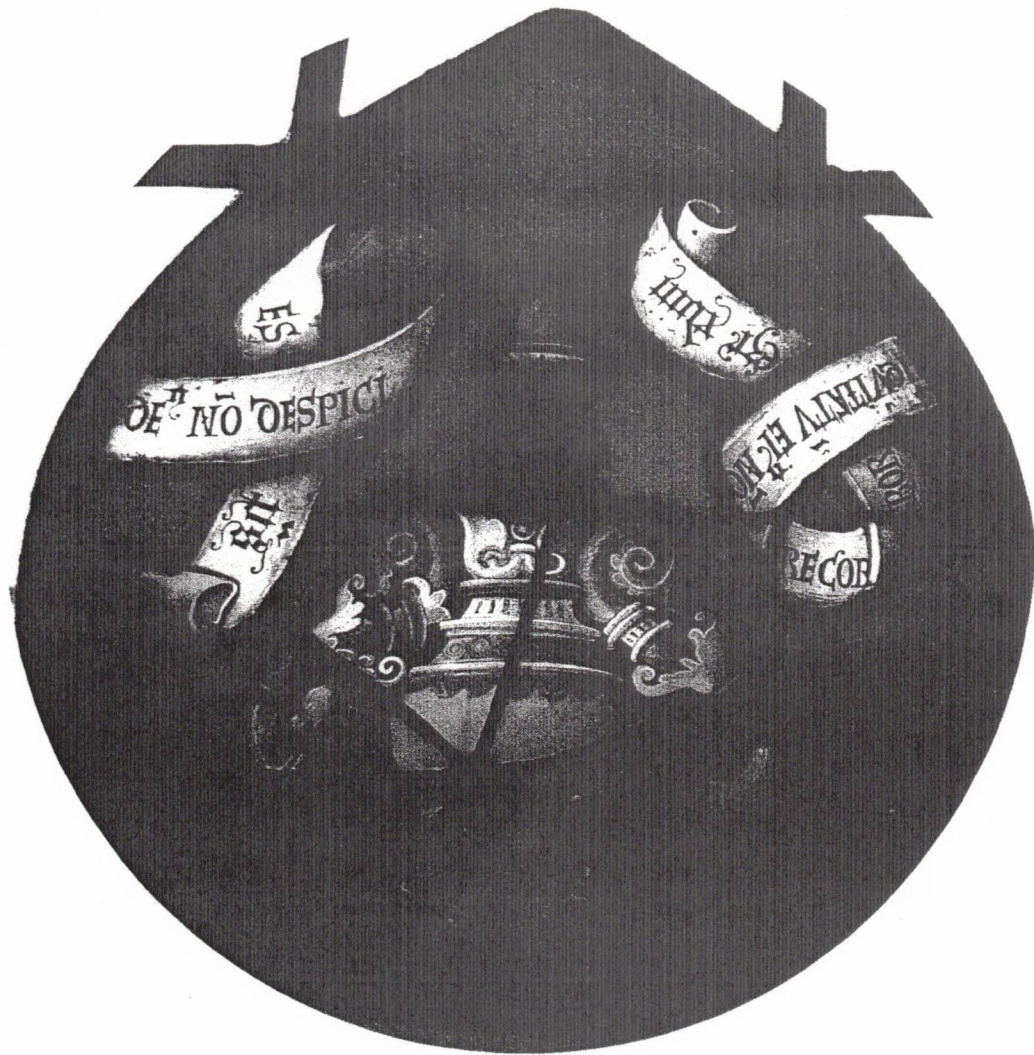
TRACERY LIGHT
STAIRWAY, G1

- Single section of a quarry window installed in stone.
- Exterior protective glazing for the figurative panel: PG#1. The lack of air allows moisture to settle and is potentially dangerous for the glass.
- Installation of the central panel: its border lead is inserted into the quarry's large lead. No joint is soldered with the rest of the window.

- *Lead:* 5/8" flat H lead came, in good condition. The putty is falling off.
- *Glass:* mostly clear blown glass, no apparent replacement. Evidence of a water-soluble deposit around the edges of the quarries on some areas. Three panes of glass are broken on other quarry panels of the bay.

- *Lead:* main leading pattern with 1/8" (3 and 4mm) flat H. Repairs done with 2 and 3 mm leads. The lead is sometimes too wide and covers some of the paint details. No flange repair. Overall good condition.
- *Glass:* (based on the interior surface) The panel is dominated by a contrast between the blue background and the yellow and clear pieces. The seedy blue glass, very thick in some areas and thin on others, a variation that creates beautiful value nuances, has a smooth and slightly corroded surface. The clear seedy glass is stained with silver stain and shows no sign of alteration. The central (clear) piece of glass was unfortunately shattered and its bottom piece replaced with a stopgap. The stopgap contains paints of different hues and the design is quite disruptive. There are one piece of red and one piece of yellow glass, both painted.

- *Paint:* Dark umber-brown grisaille for trace, a thin matting was highlighted by a fine stipple (possibly mixed with oil) with a satin brown grisaille, and a dark paint was applied as a wash to darken areas of shade. =All pieces except the stopgap have the same paints, including the scroll. A warm hue of silver stain was widely used on clear glass to create golden features on the jar and shade on the scroll. The brush applications reveal the hand of a skilled painter. The paints are in stable condition. No enamel.

- Removing the protective glazing sheet and inspecting the condition of the exterior side of the glass.

- Cleaning the glass in-situ and removing the residue.
- Replace broken glass.
- A lighter PG#3 type of protection glass might be recommended for this particular panel.

- Category B
- Removing the backplate is a priority.
- Figuring a lighter version of PG#3 for protection glass.
