## EXAMINATION REPORT

Title: Painted panel  
Artist: Robert W. Chanler  
Client: Planting Fields Foundation

ArtCare #: 4123  
Examiner: KO, ArtCare Conservation NYC

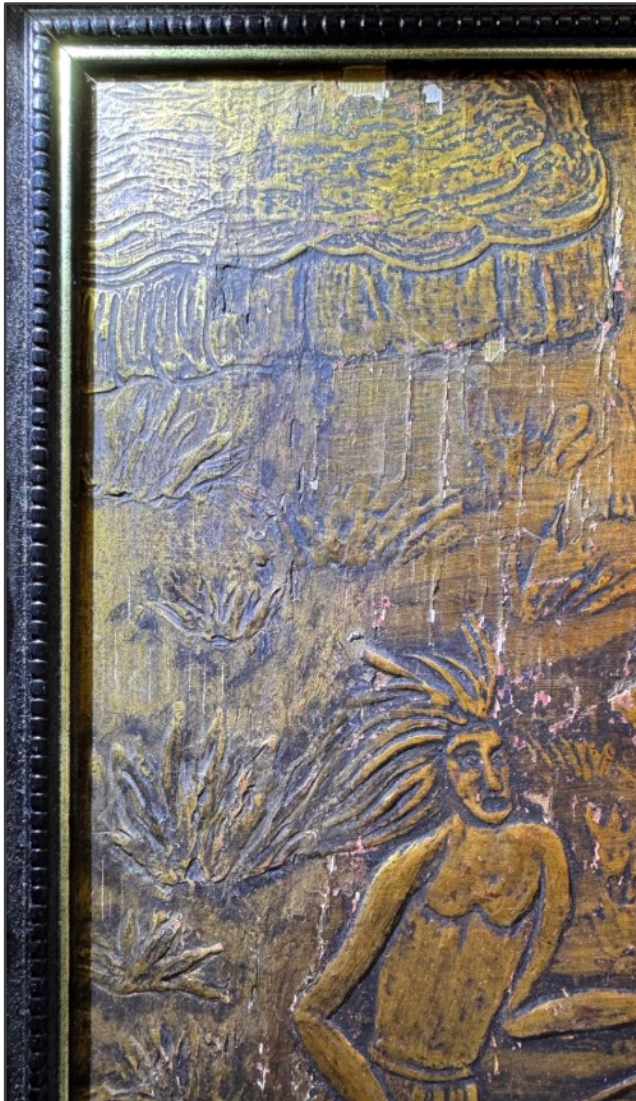
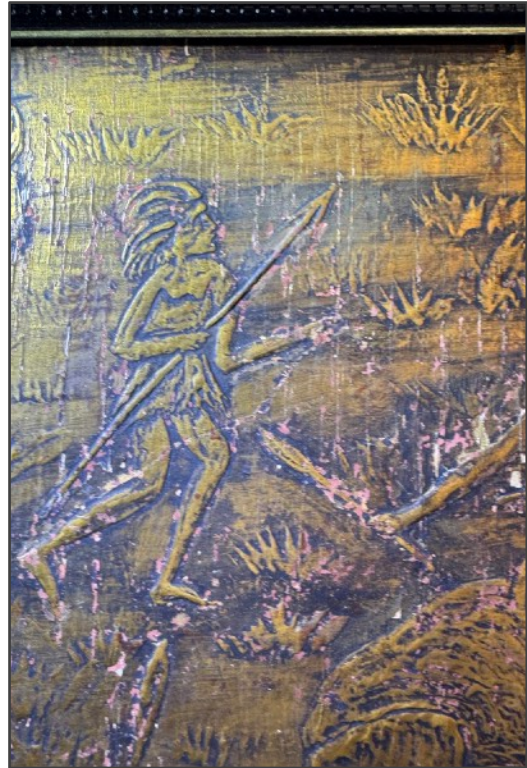
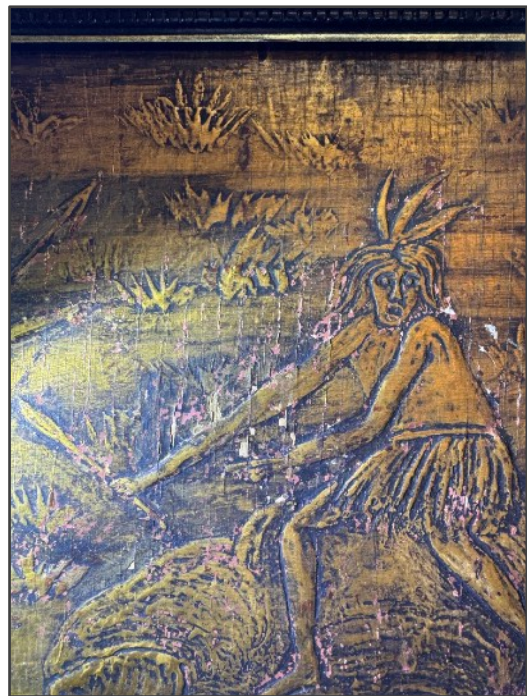
Cleavage: Intra-layer cleavage (lifting) is occurring within the design layers and interlayer cleavage is occurring between the design layers and the wood veneer. Areas along the bottom and top edge appear to be actively lifting at this time.

Craquelure: Vertical craquelure is evident throughout the surface, attributed to the grain in the wood veneer.

Overview of various surface issues (craquelure, loss, tenting and lifting) in raking light

1. Written and photographic documentation, before, during and after treatment
2. Consolidate surface insofar as possible with conservation grade adhesive
3. Surface clean to remove grime, after testing
4. Further consolidate as necessary
5. Fill and tone losses
6. Adjust discolored retouches as necessary
7. Adjust surface sheen as necessary

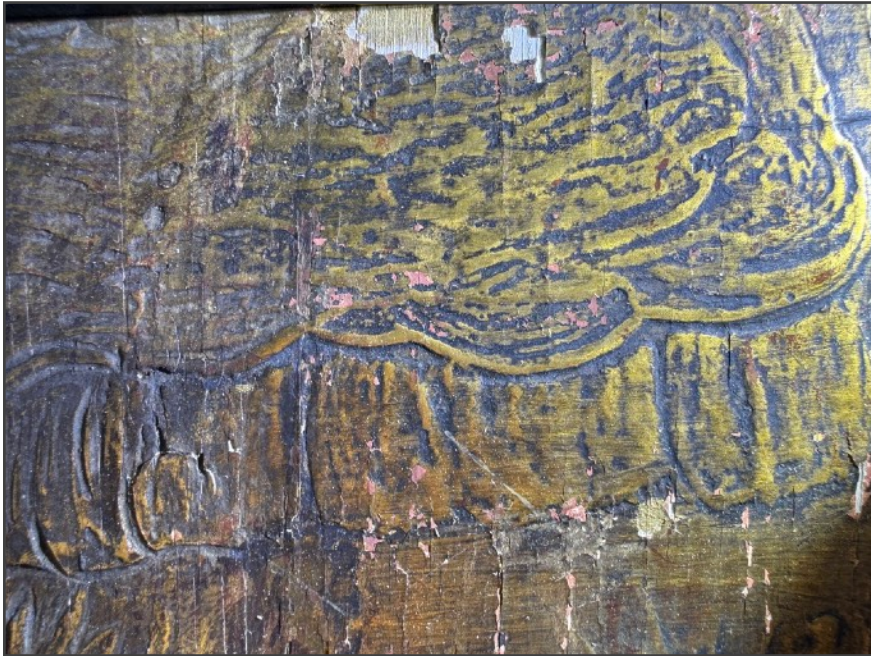
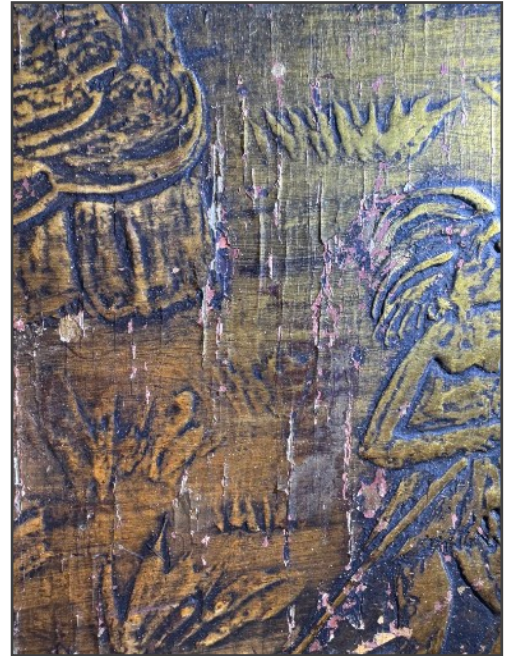
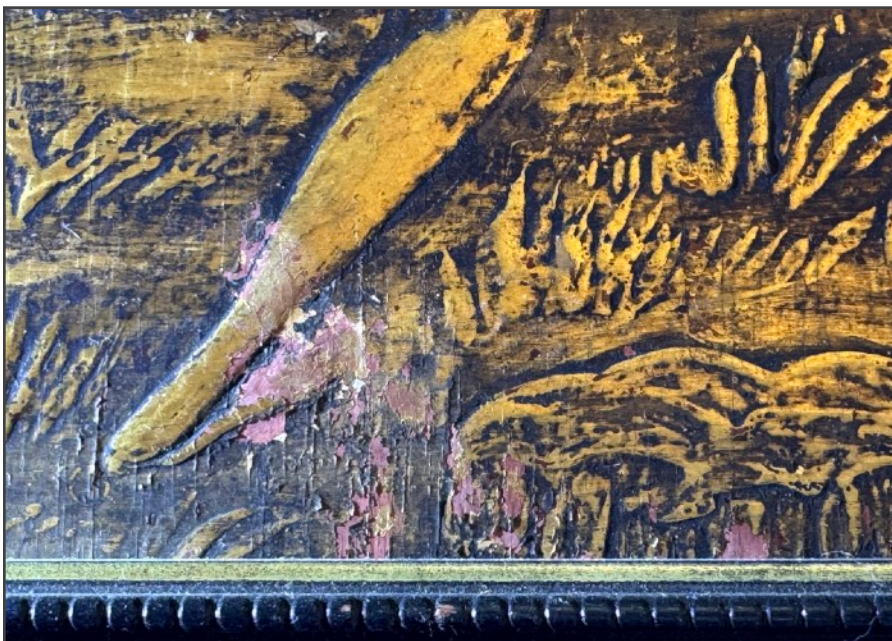
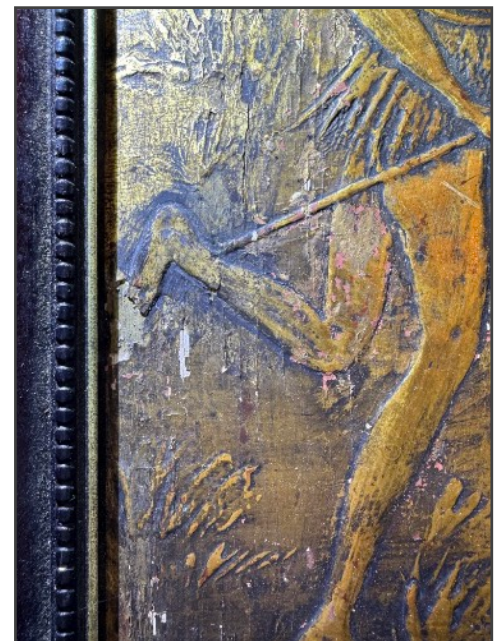
Previous Treatment: Previous retouching campaigns evident in areas of previous paint loss

More details of tenting, active lifting and retouching over old loss in raking light

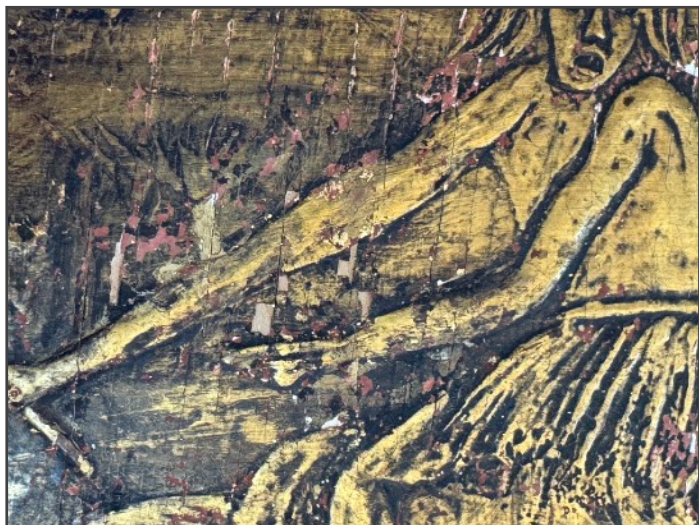
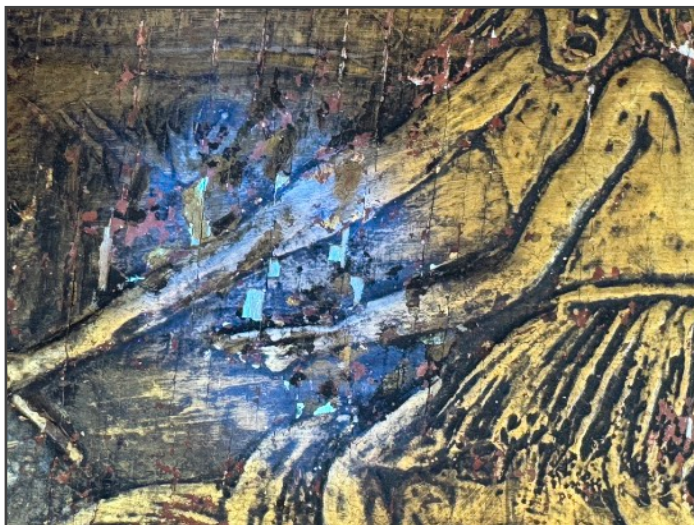
Details of previous retouching and new damage in normal light and under uv examination

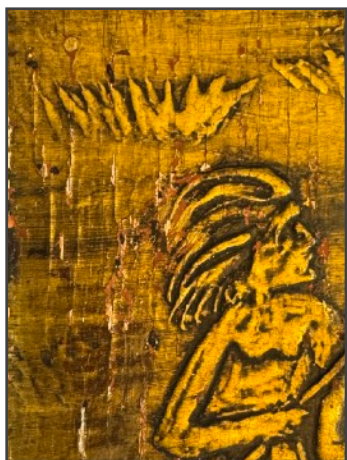
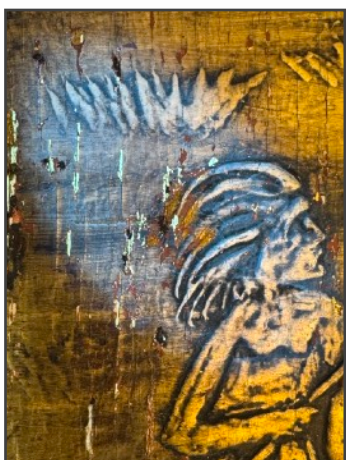
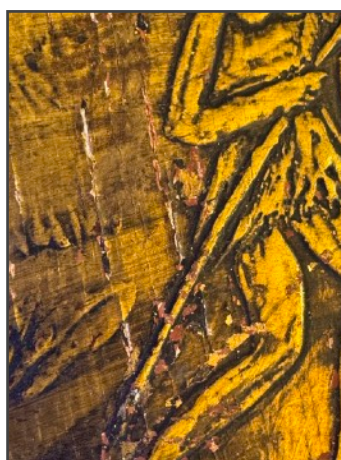
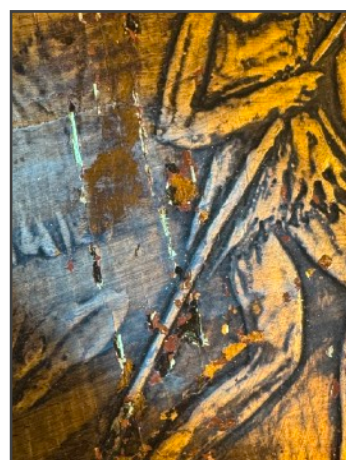
Details of previous retouching and new damage under normal light and under uv examination

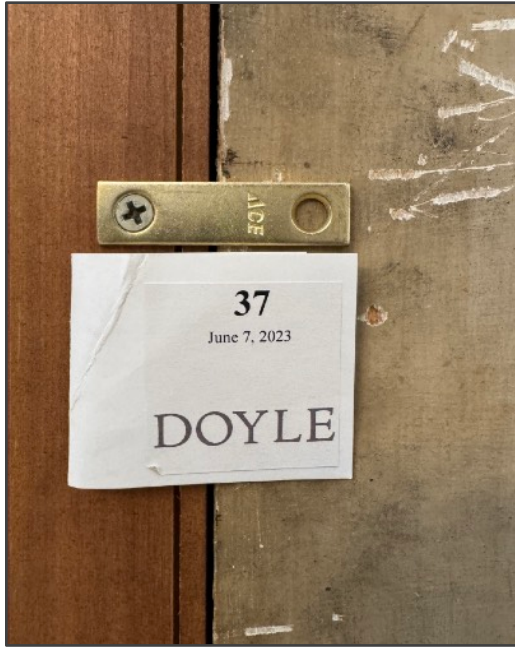
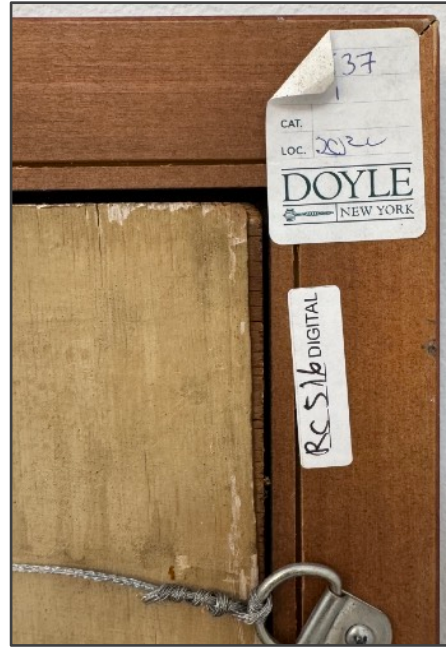
Details of auction labels, abrasion and edge of back veneer

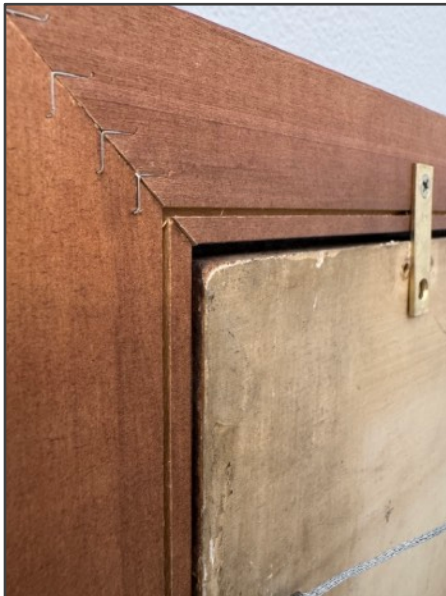
Protects Surface: Appears to protect the perimeter of the panel; however, the panel sits proud of the verso, putting the work into direct contact with wall during installation

Panel verso slightly proud of the frame

Proposed Treatment: A new frame or adapting the current one to protect the verso of the panel during display

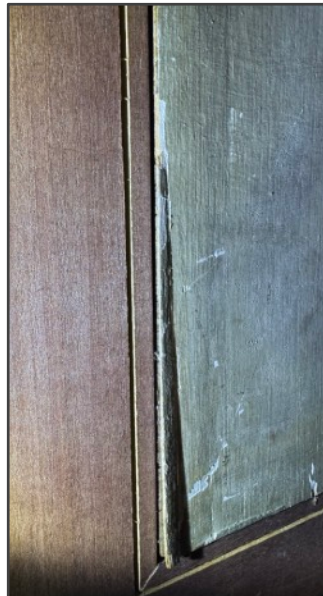
Damage, Loss, Distortion: The composite wood panel has areas of lifting veneer on the front and back side of the panel. On the back, there is split and lifting about to break off of the back proper left corner. On the front, there is vertical craquelure and scattered loss to the wood veneer.

Splitting of the wood veneer
