**Brussat Sculpture Conservation, LLC**

**Examination and Treatment Report**

May 22, 2025

Sofa

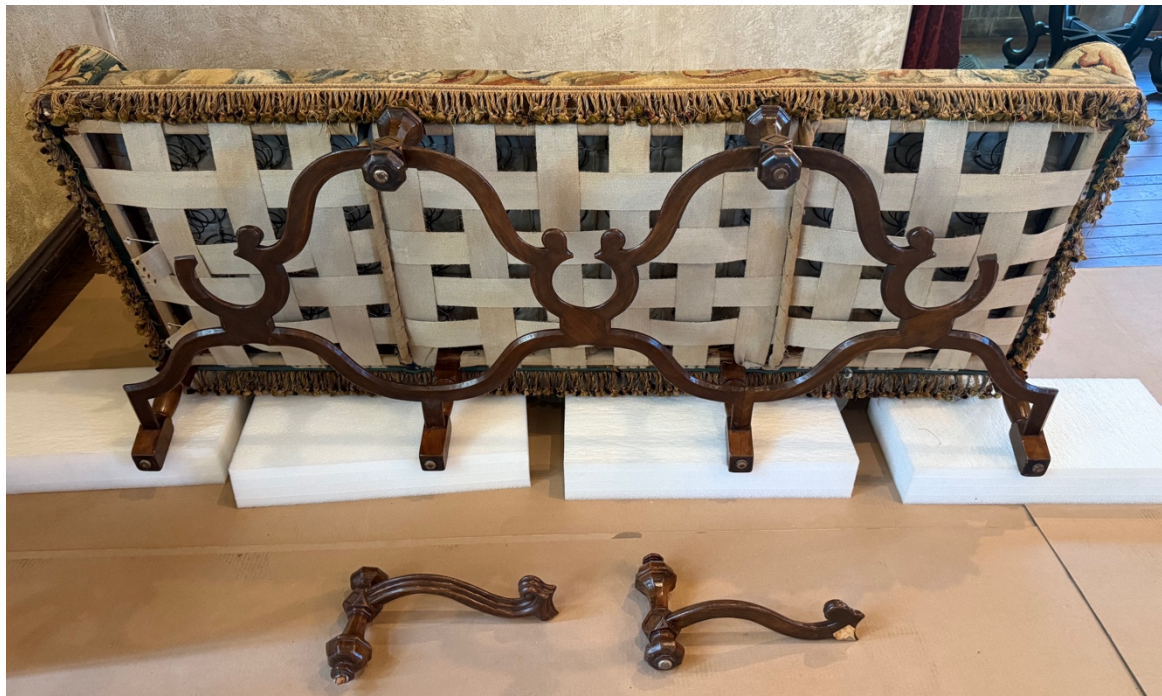
The wood base of the sofa was damaged following a film shoot. The right and left front legs have snapped off, along with two breaks in the decorative wood tracery on the base.

1. Before Treatment, overall

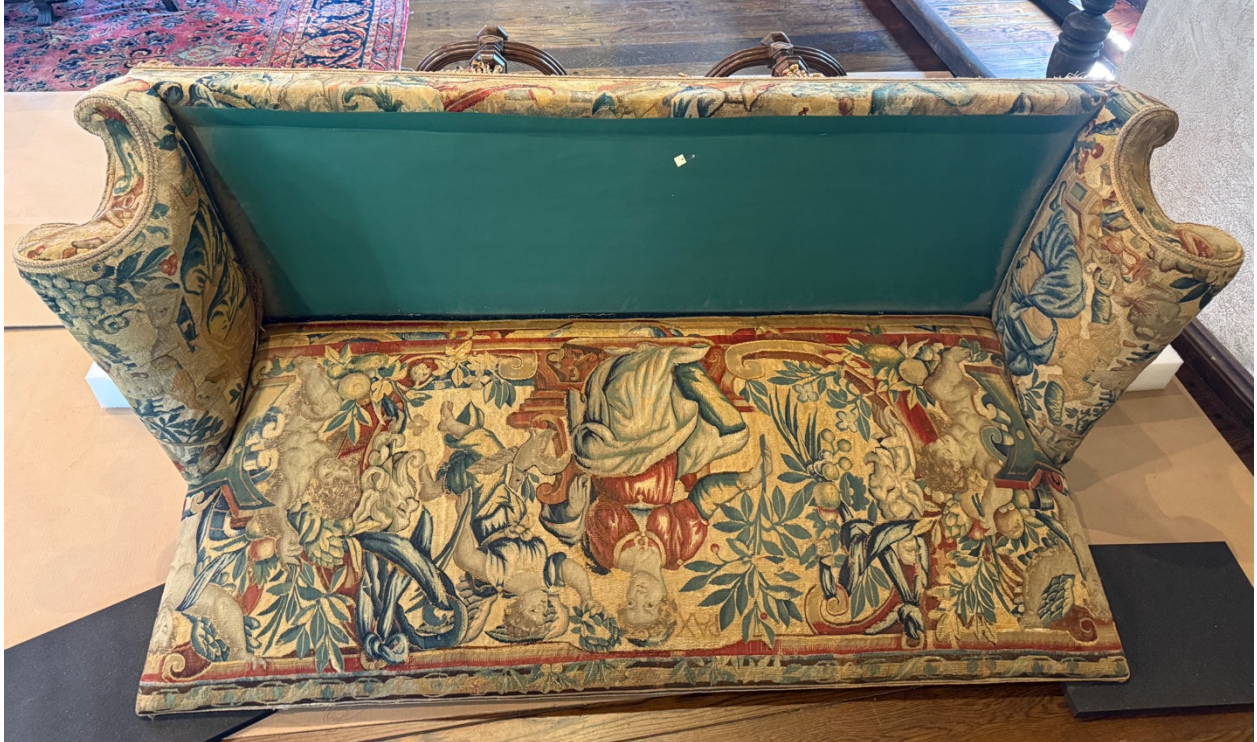
2. Before Treatment

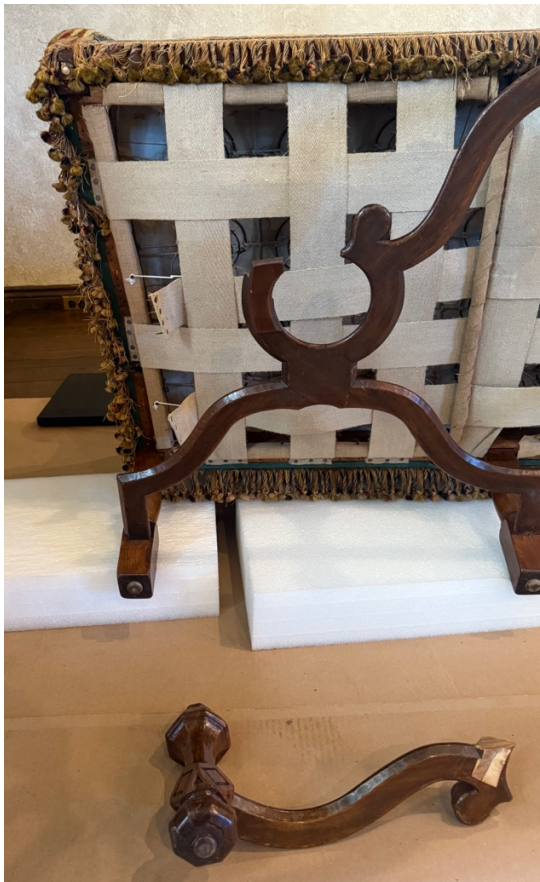
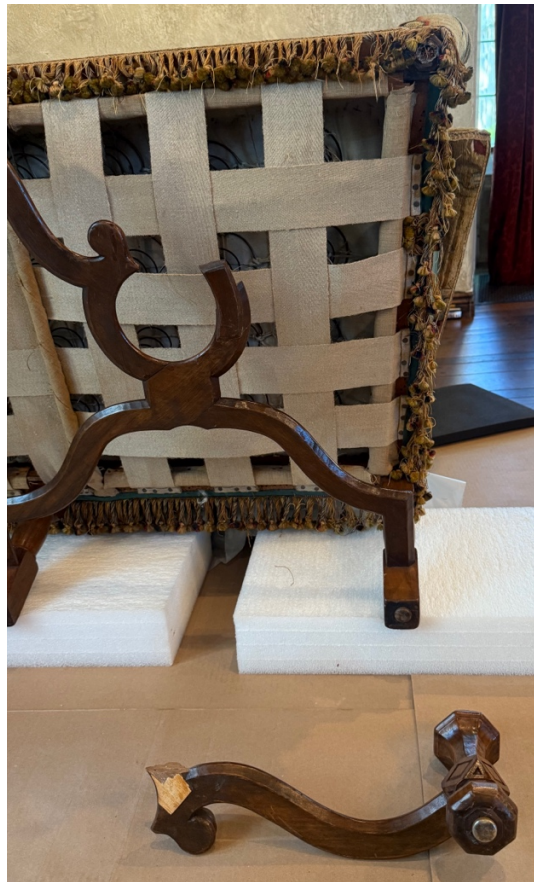
3. Before treatment, details

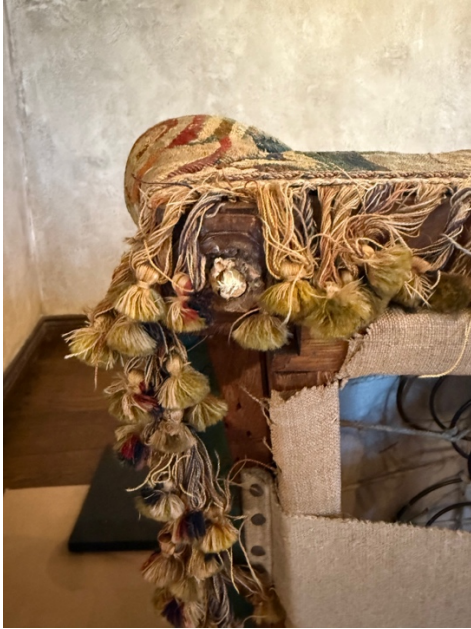
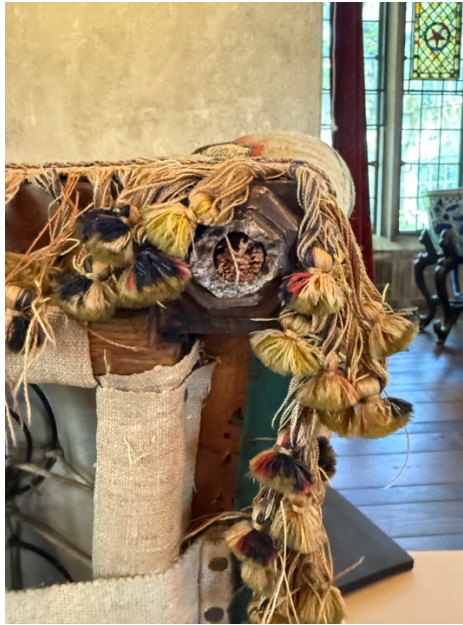
4. Before treatment, details of broken dowels and old adhesive in dowel holes

1. The broken dowels and excess adhesive were removed with a drill, acetone, water, and a scalpel, as necessary.
2. New oak dowels were cut to fit the existing holes.
3. The dowel hole on the right (when facing the sofa) was sealed with Acryloid B72, the dowel was inserted, and the gaps around the dowel were filled with WoodEpox epoxy putty. This joint was treated differently than the others, because it had been adhered with epoxy in the past, and the new adhesive needed to be compatible.
4. The remaining joints (the left dowel hole and the two joins on the wood tracery) were sealed with dilute Kremer high tack fish glue, and joined with full strength high tack fish glue after inserting the new dowel. All joints were clamped at least overnight.
5. A small area of WoodEpox that was visible around the right dowel was inpainted with Gamblin Conservation Colors.

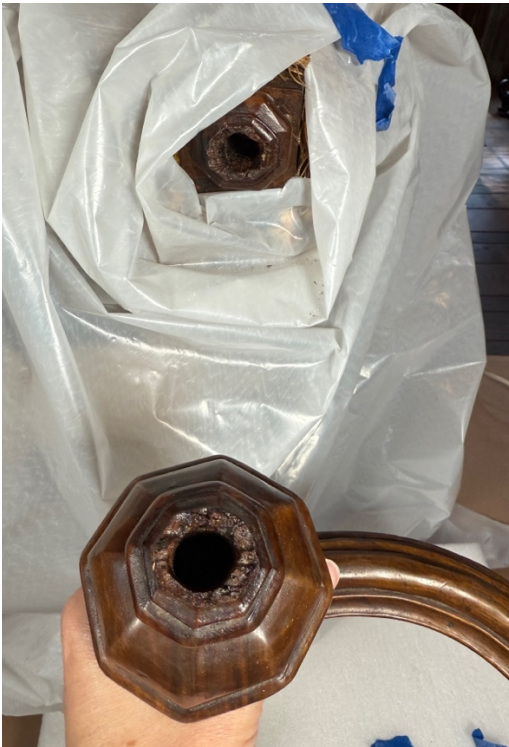
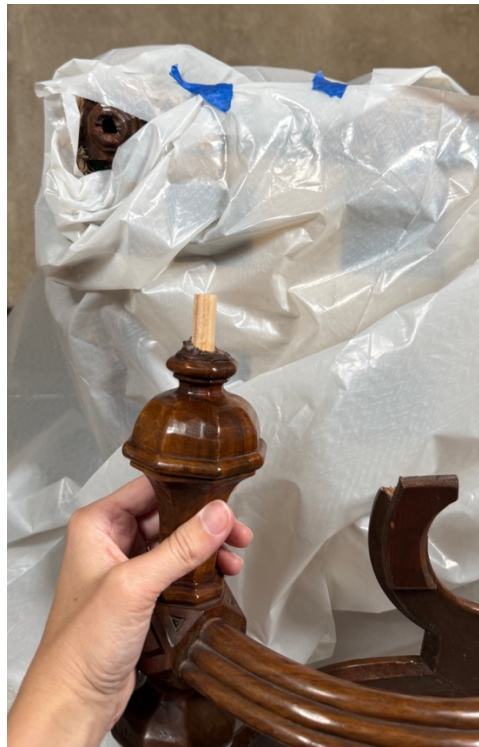
5. During Treatment, detail of dowel holes cleared of old dowels and adhesive, with new dowel in place

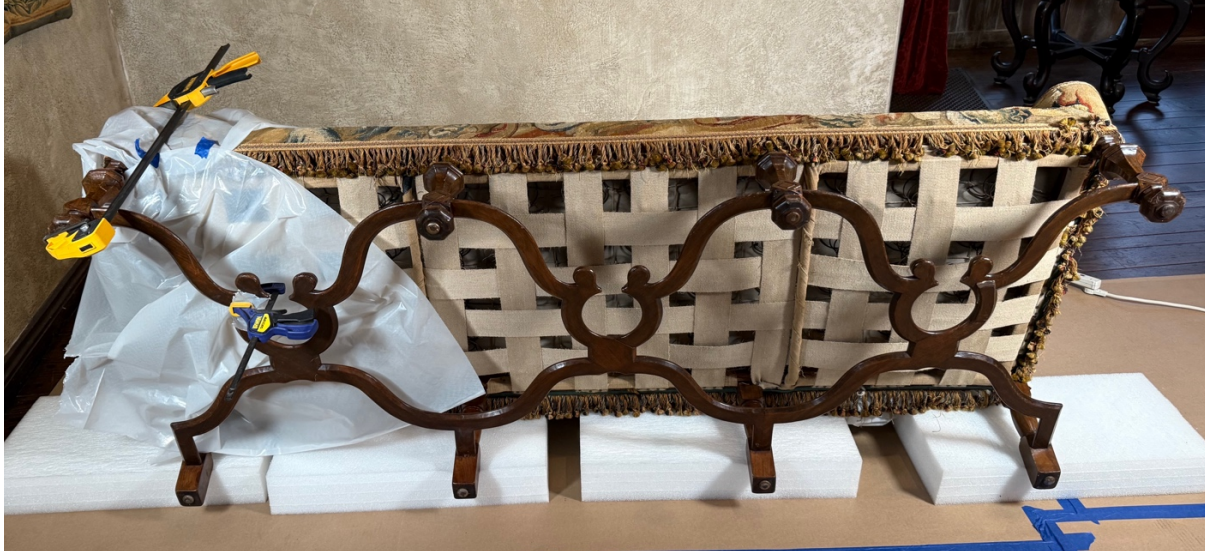
6. After Treatment (with clamps and protection still in place on left side)

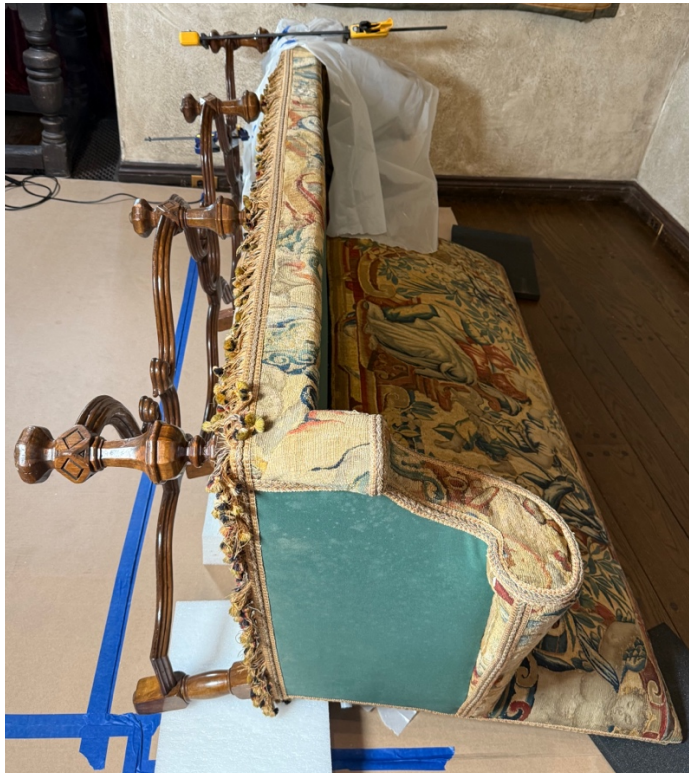
7. After Treatment
