Coe Hall Frame Survey

Title: Adriane Van Ostade
Location: Sitting Room
Frame Type: Carved wood; Gesso; Gold leaf
Maker/Date: Unknown Maker/
Examiner: Eric Price

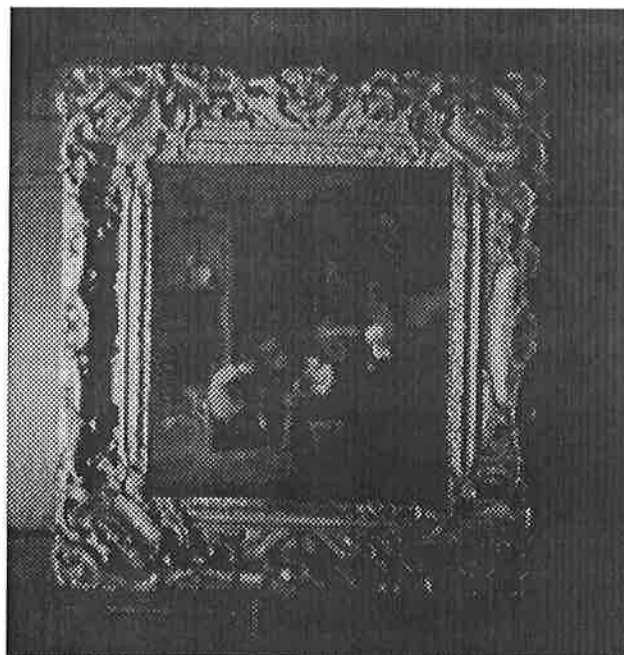
The frame has been completely overpainted with a heavy layer of discolored bronze powder paint. The inside of all corners have been crudely repaired. There is a general loss of detail due to heavy paint layer. The gesso is flaking in scattered areas. The corners are cracked but appear stable.

The face of the painting contacts the bare wood rabbet.

PRIORITY: HIGH

Option One: Remove overpaint and improper repairs. Repair ornament losses as needed. Consolidate gesso layer. Gild as required and tone. Install the painting properly.

Option Two: Remove surface grime. Consolidate flaking gesso. Install the painting properly.
